# **Maryland Department of Environment**

Site Name: Patapsco WWTP

# **NPDES Municipal Major Surface Water**

Inspection Reason: Follow-up (Non-Compliance)

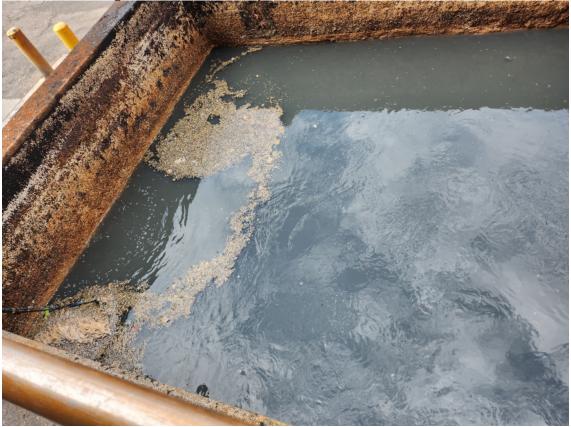
Concerns: During the unannounced inspection, I find that this area is not maintained properly.

8/24/22 Influent tank.

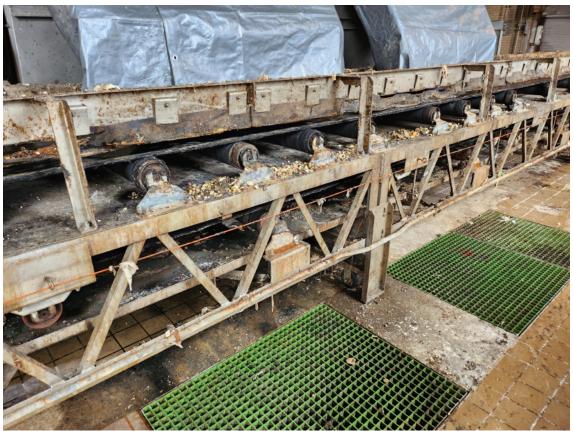
8/24/22 Trash conveyor belt.

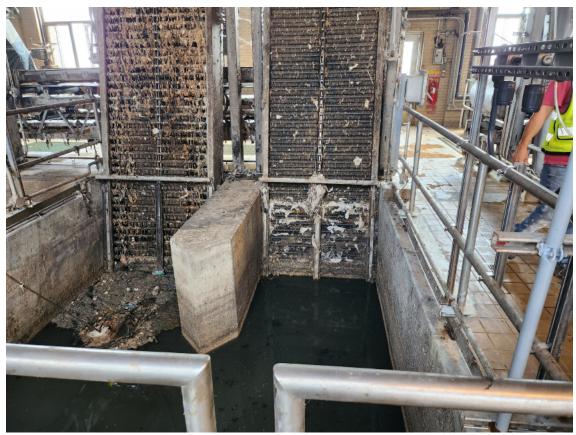
8/24/22 Fine screen units out of service.

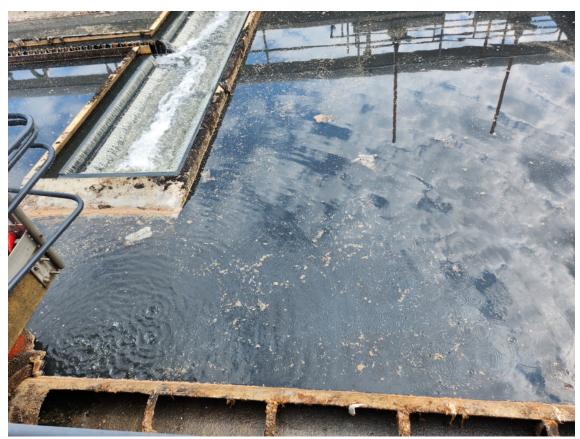
8/24/22 PST.

**Concerns:** Extensive Repairs are needed to get the PSTs functioning. According to the plant manager, the major repairs are either approved or scheduled. Trash and scum are making it through the system into the PST effluent. Skimming is being conducted at the level required.

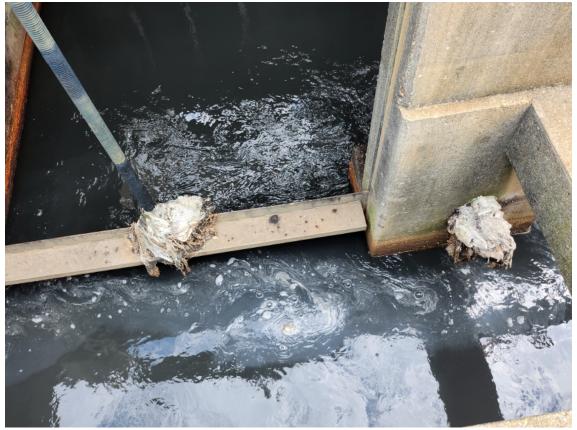
8/24/22 Trash and scum in effluent from PSTs.

I observed a layer of scum and FOG in PST #2 and a fine layer in the remaining in PST #3.

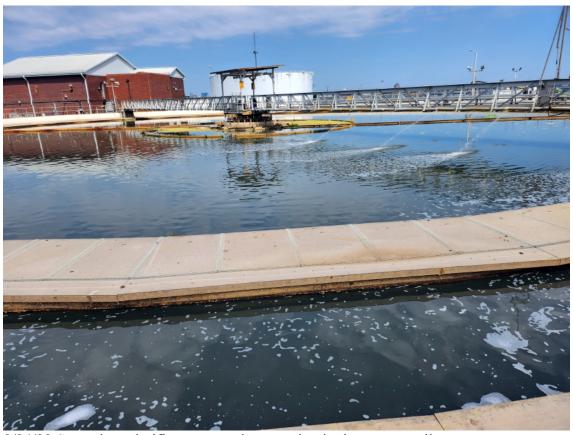
**Concerns:** Routine maintenance required and vegetation growing in the clarifiers.

8/24/22 Secondary clarifier – vegetation growing in the center well.

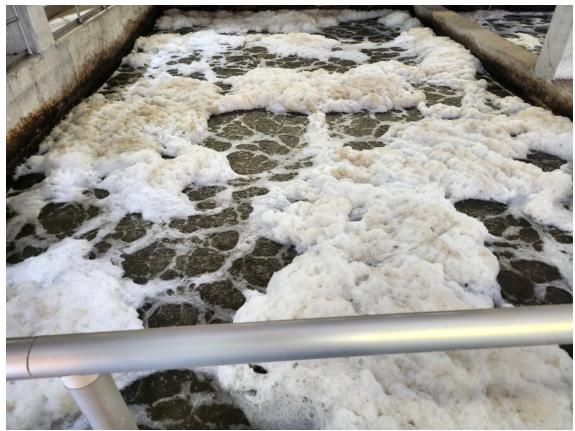
**Concerns:** Poor nitrification and the media in the BAF backwash mud wells. This media is not confined.

8/24/22 BAF cell. Note, excessive foaming.

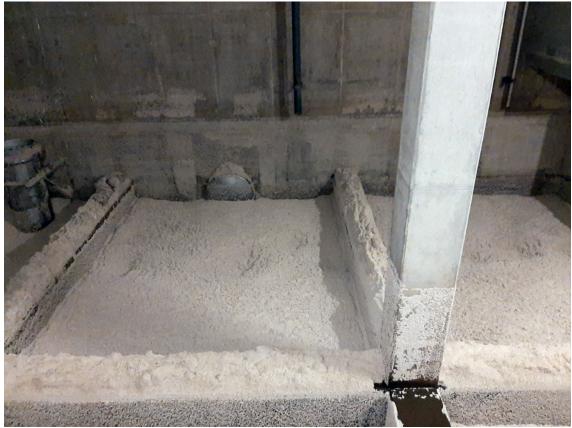
7/7/22 BAF mud well containing a heavy layer of media.

The media shall not discharge to the surface waters of the state and final effluent containing media is not acceptable. **This issue must be addressed and permanently resolved.** This accumulated media must be removed from the backwash well and disposed of appropriately. Patapsco WWTP shall submit a plan of action on how it proposes to remove the media from the mud wells and provide updates to the Department every 30 days as specified in the 6/29/22 and 7/7/22 report.

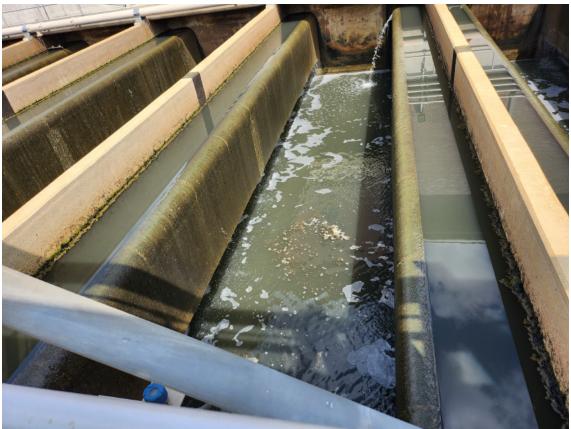
8/24/22 DNF: A small amount of floating solids was observed.

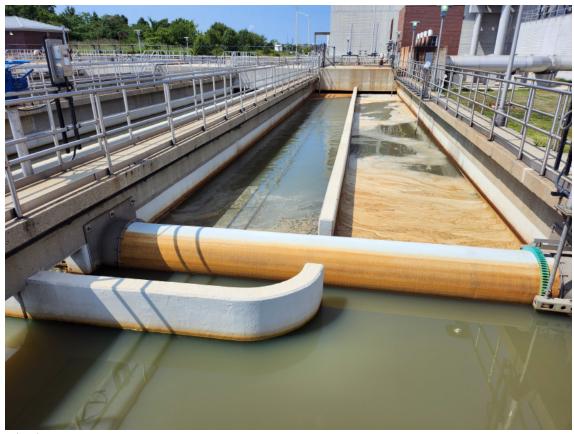
8/24/22 CCC.

Next, I inspected the chlorine contact basins prior to the final discharge. There are four contact chambers and three are currently online. Each contact chamber has three scum logs or troughs to remove floating scum. Contact chamber #3 is offline and the #2 scum trough is not functional and needs repairs. I observed floating scum and FOG at the chlorine contact chambers. **However, there was no staff skimming at the chlorine contact basins.** I questioned Jackson and Johnson regarding my observations. I was told that everyone was at lunch. The lunch breaks should be staggered so that there is adequate staff to perform the FOG skimming as required.

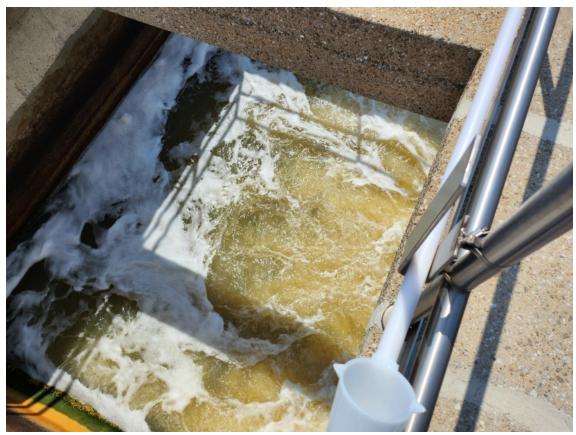
Next, I inspected the final effluent. The facility is collecting 24-hour, flow-proportional composite samples at Outfall 001 in accordance with the requirements of the permit. The primary refrigerated, automatic composite sampler was inspected, and I found that the temperature of the compartment was satisfactory, and the sampling container was also clean. The temperature of the refrigerated compartment was 4.5° C, which meets 40 CFR Part 136 requirements. I inspected the final effluent in the sampling container and observed that the composite sample was a medium amber color with visible suspended particulates (see picture).

8/24/22 Final effluent.

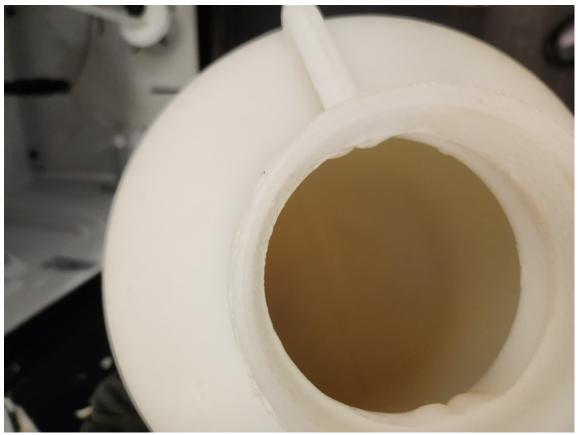
8/24/22 Effluent from composite sample container.

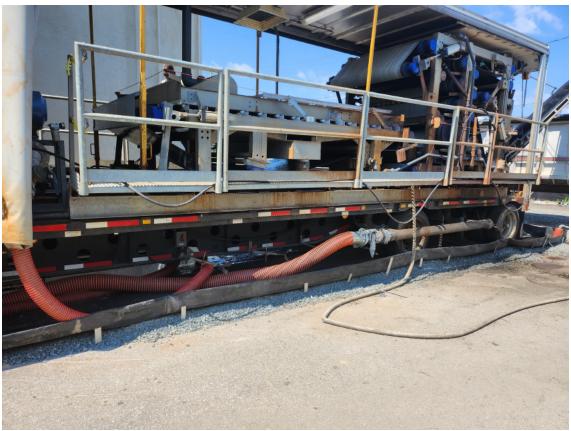
During the next phase of the evaluation, I inspected the GSTs and the solids processing at the SBTs. A portable belt press has been set up at the SBTs and Synagro is currently processing the sludge. The dewatered sludge is being trucked off-site and the water is being sent to the head of the plant.

8/24/22 Portable belt press at the SBTs.

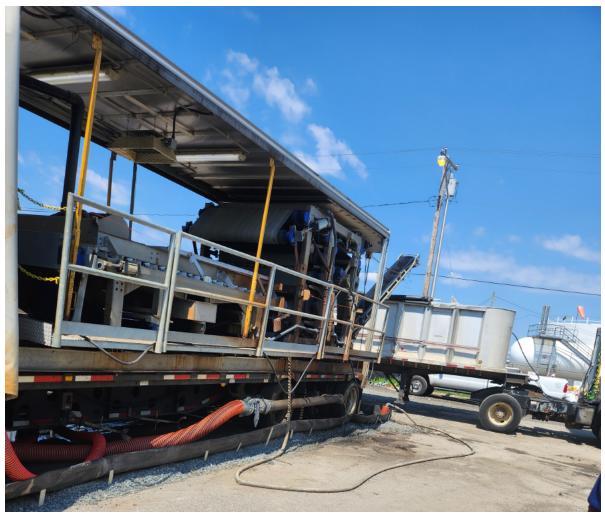
8/24/22 De-watered solids from the SBTs are being trucked off-site.

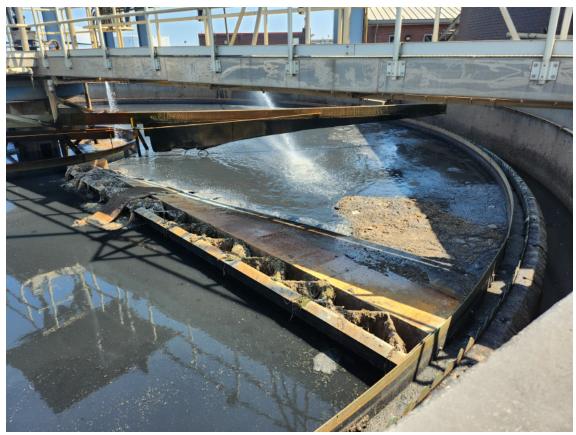
8/24/22 GST #1.

After inspecting the belt press operation, we traveled to the GSTs. The facility has three GSTs (#1, #2, and #4) and only 2 are functional. GST #4 is not functional and requires a series of repairs to get it back online. The scrapers, drive, and pumps require replacement. According to Jackson, the funding to repair the scrapper arm that was causing a shaft drive problem was approved and the repairs are expected to be completed by next year. The water level was down, and the GST #1 was not discharging at this time so I could not evaluate the supernatant. The surface water in both GST tanks contained floating solids and there was an accumulation of scum and solids in both tanks, but not an excessive amount. A water spray was being used to break up the solids. GST #2 had fewer floating solids than observed during the July inspection and the sludge blanket was down. I could not get to the weirs due to heavy water spraying being used to break up the solid masses in the GST.
