Lessons Learned from Spillway Failures

Causes of Dam Incidents

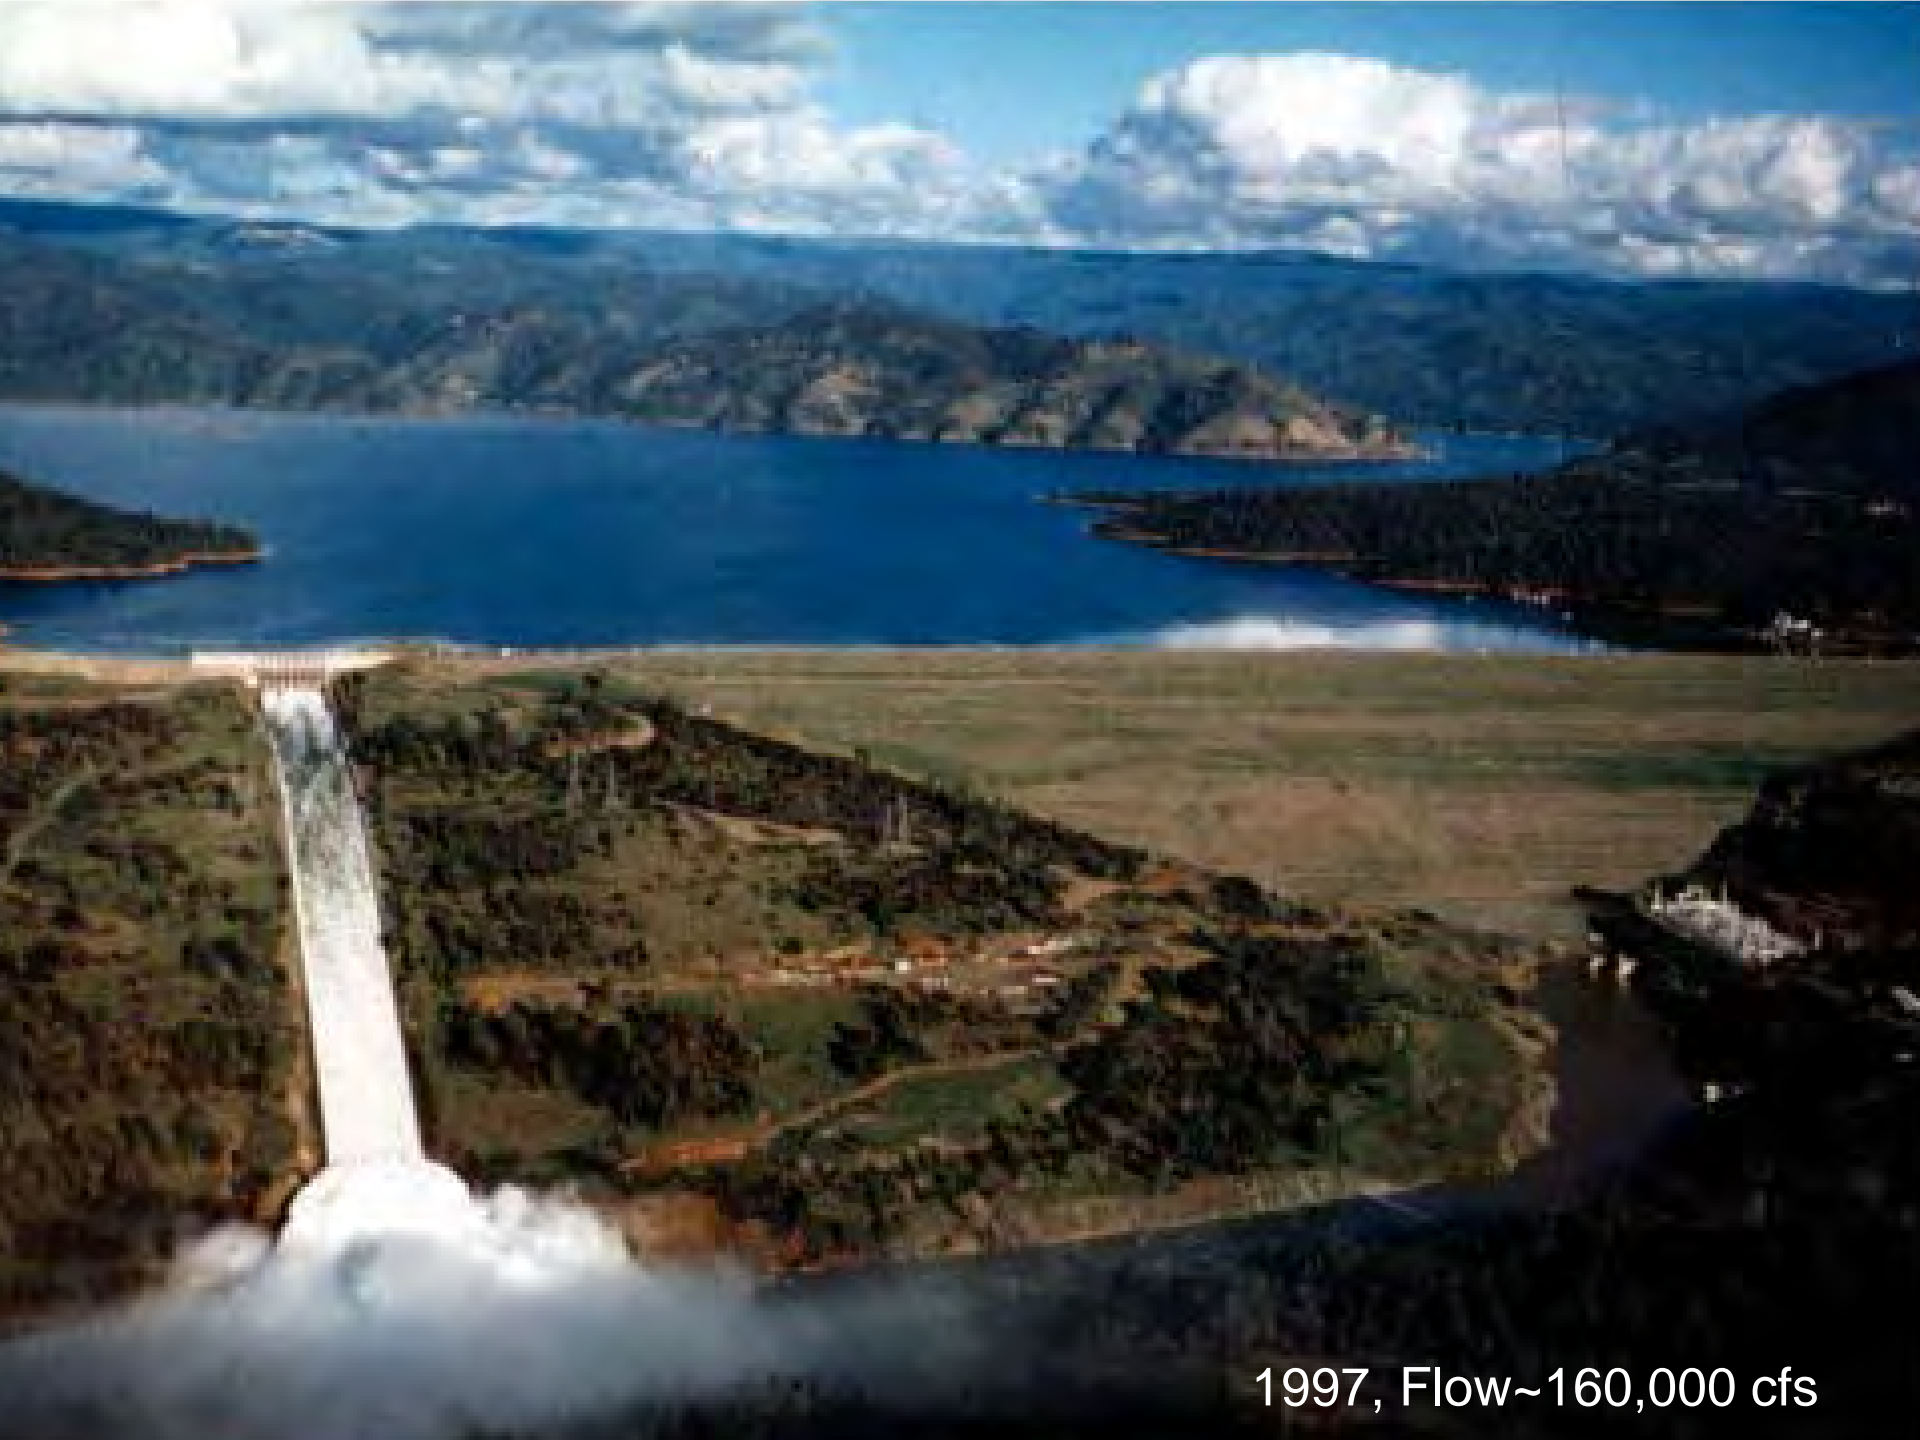
1997, Flow~160,000 cfs

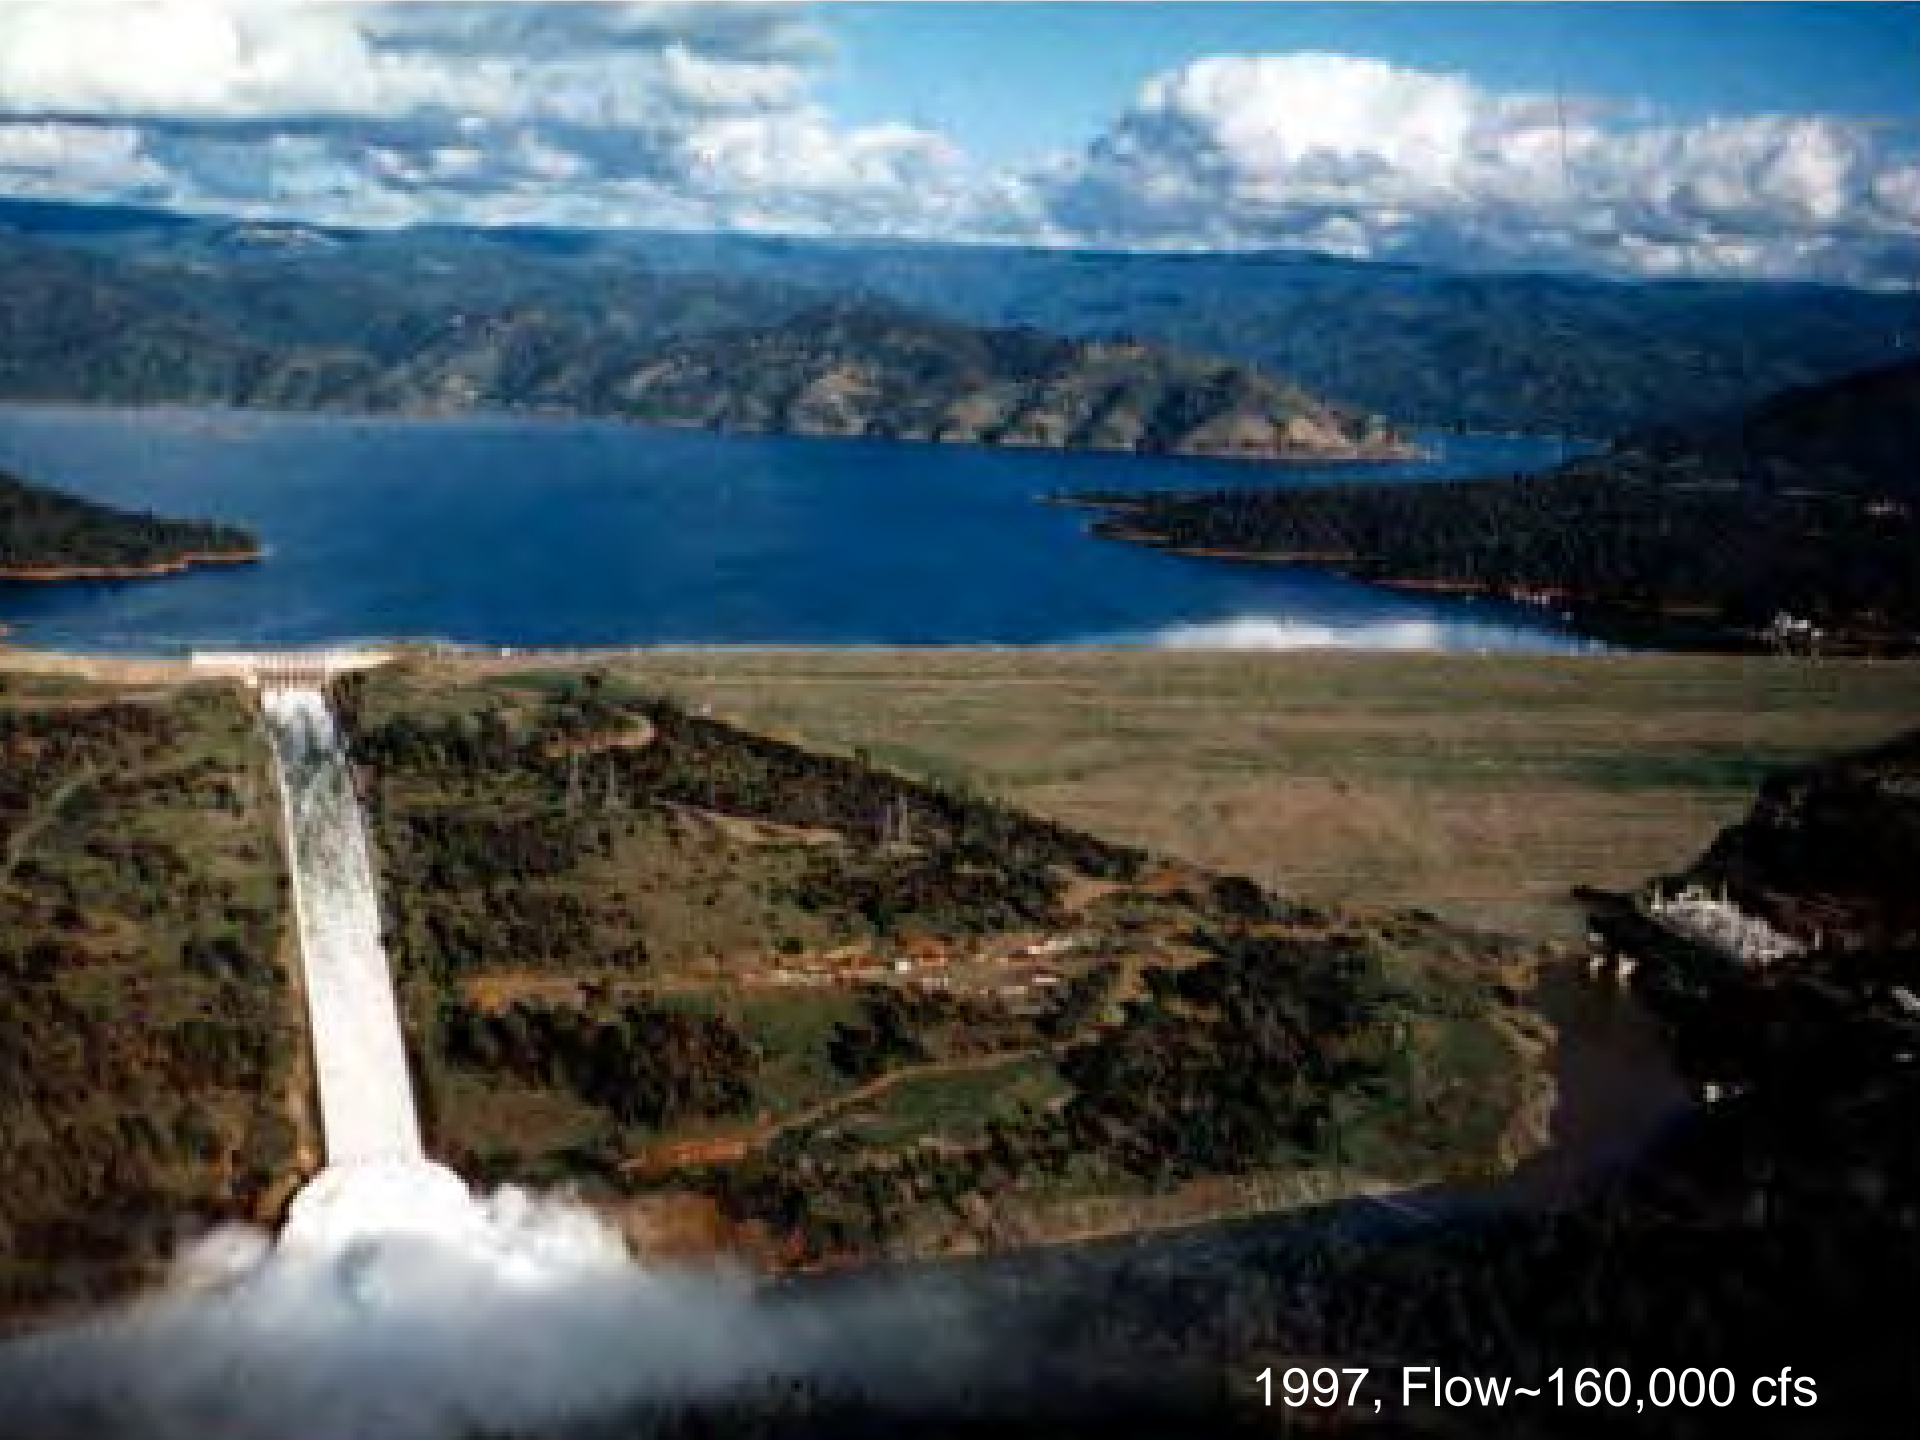
1997, Flow~160,000 cfs

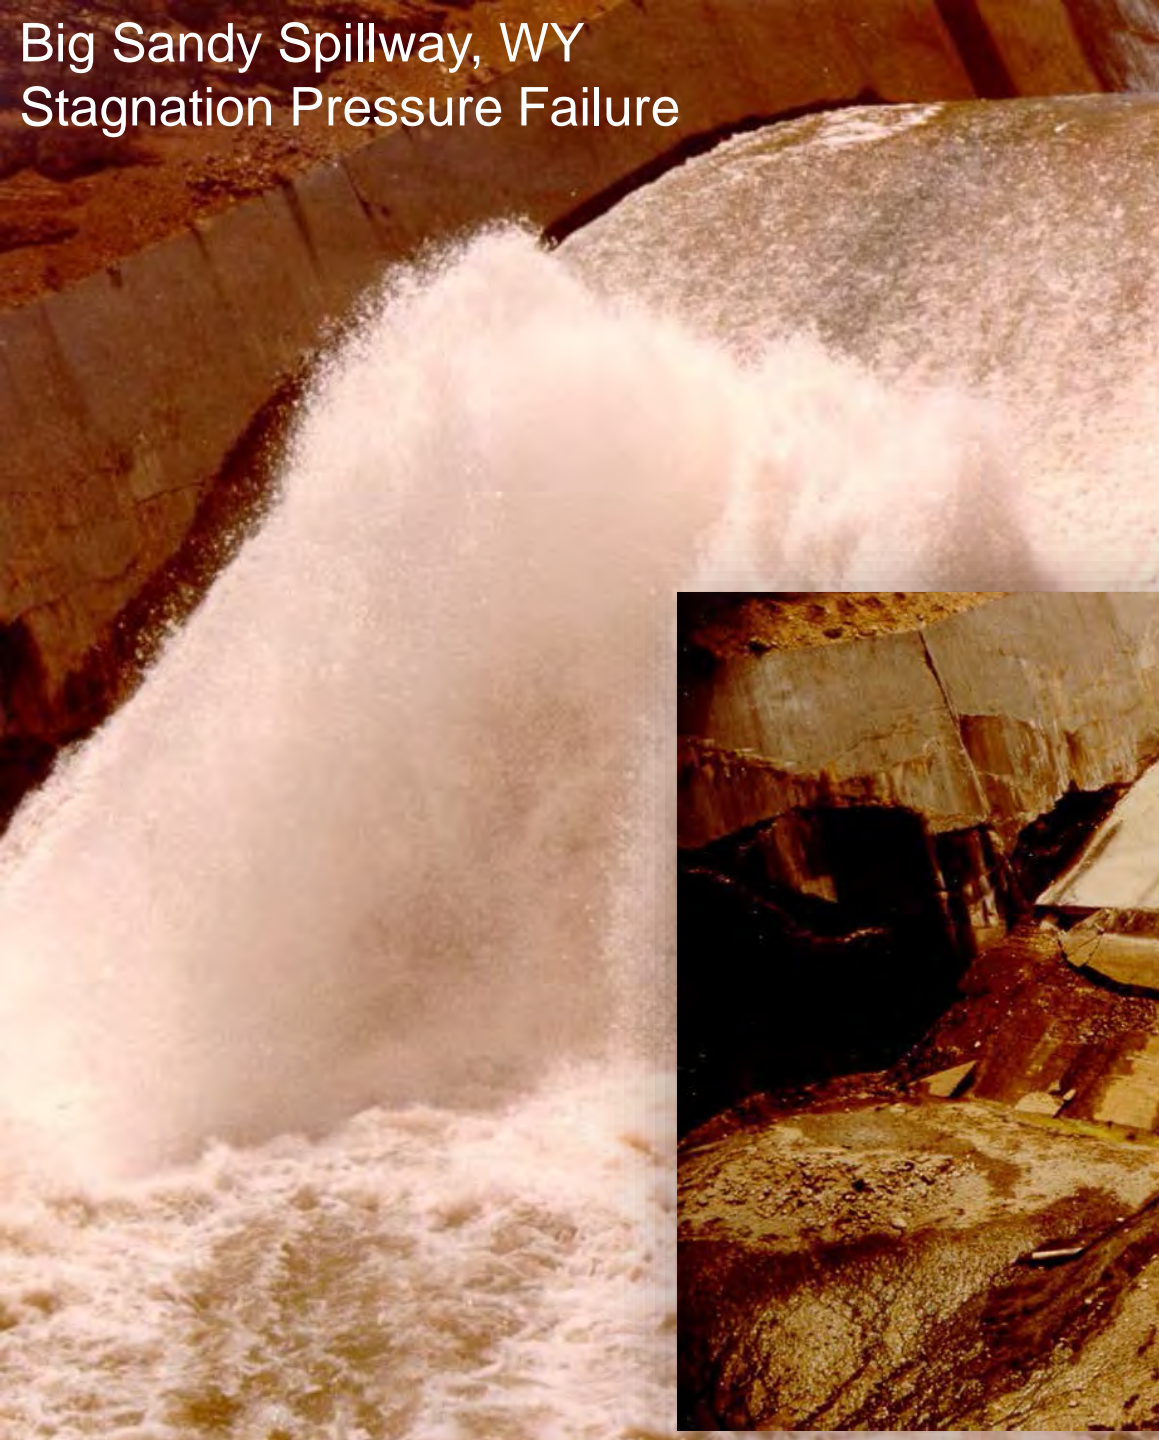
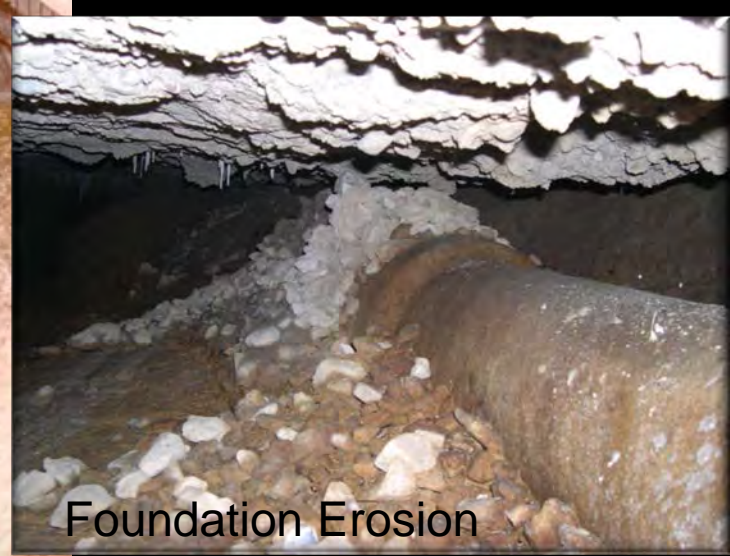
Big Sandy Spillway, WY Stagnation Pressure Failure

Slab Failed in 1983
After 30 years of Operation

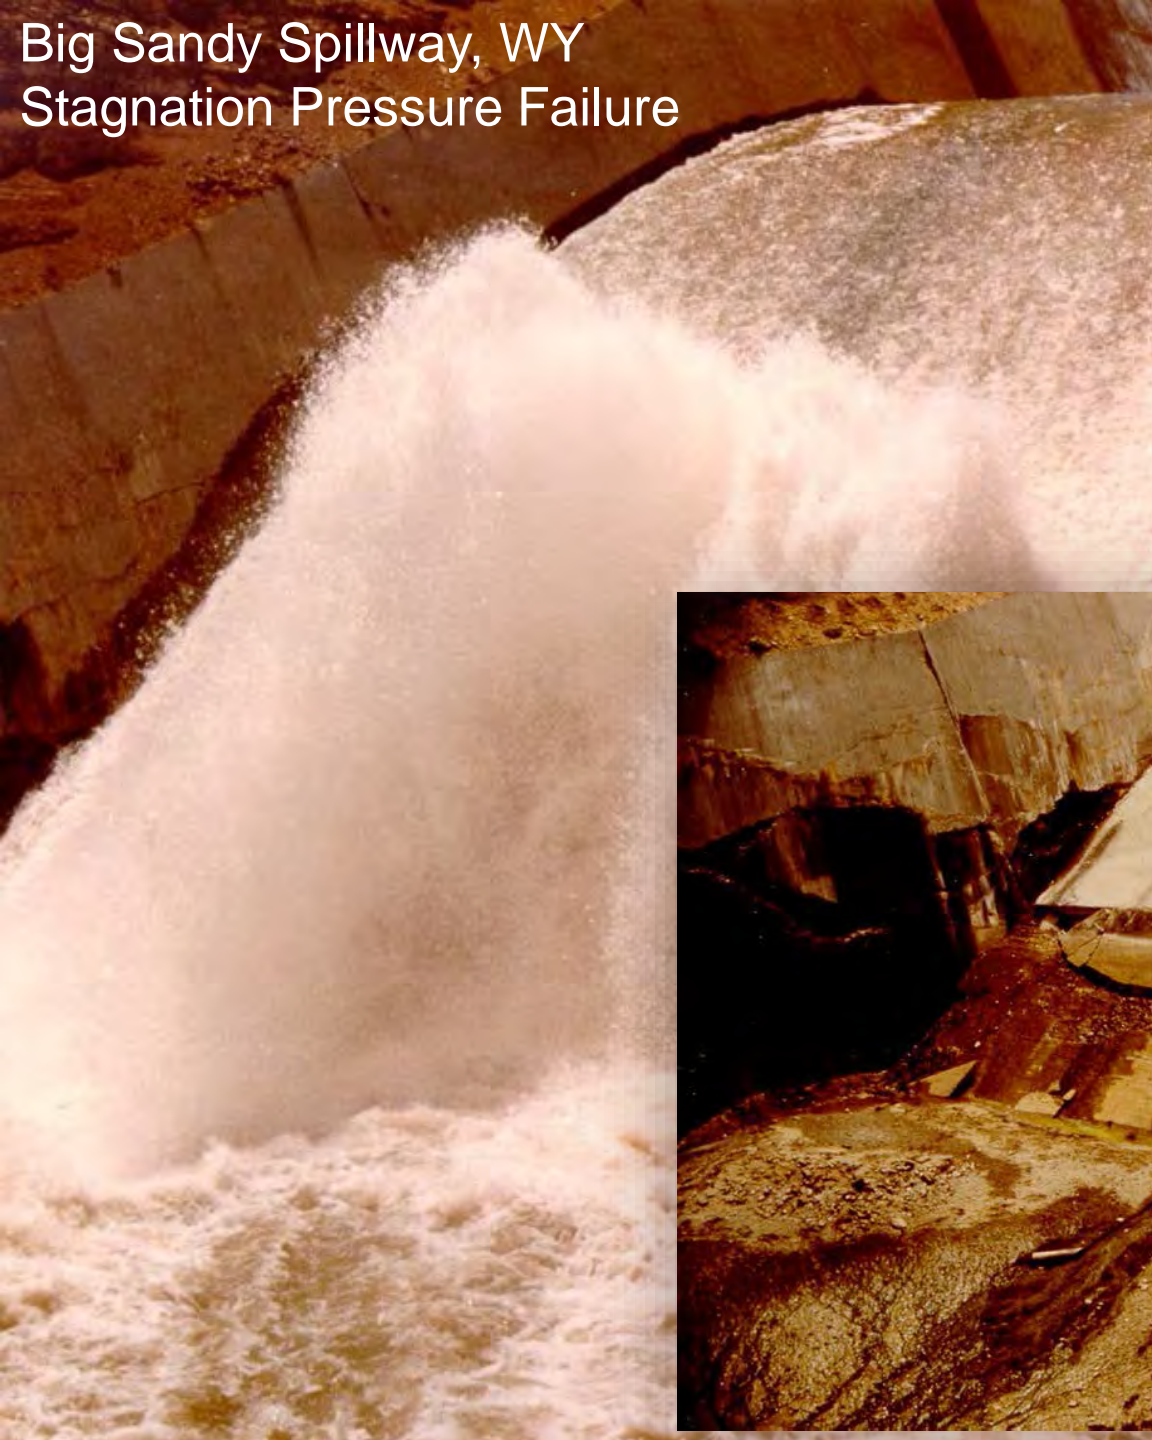
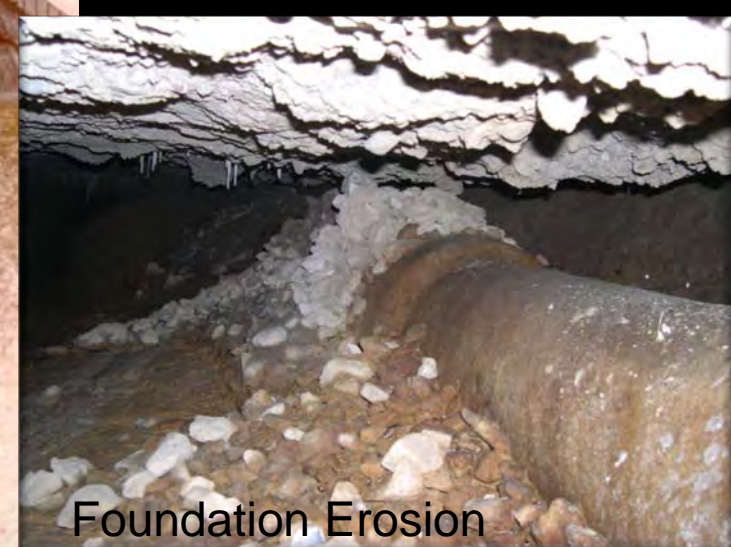
Big Sandy Spillway, WY Stagnation Pressure Failure

Foundation Erosion

Slab Failed in 1983
After 30 years of Operation

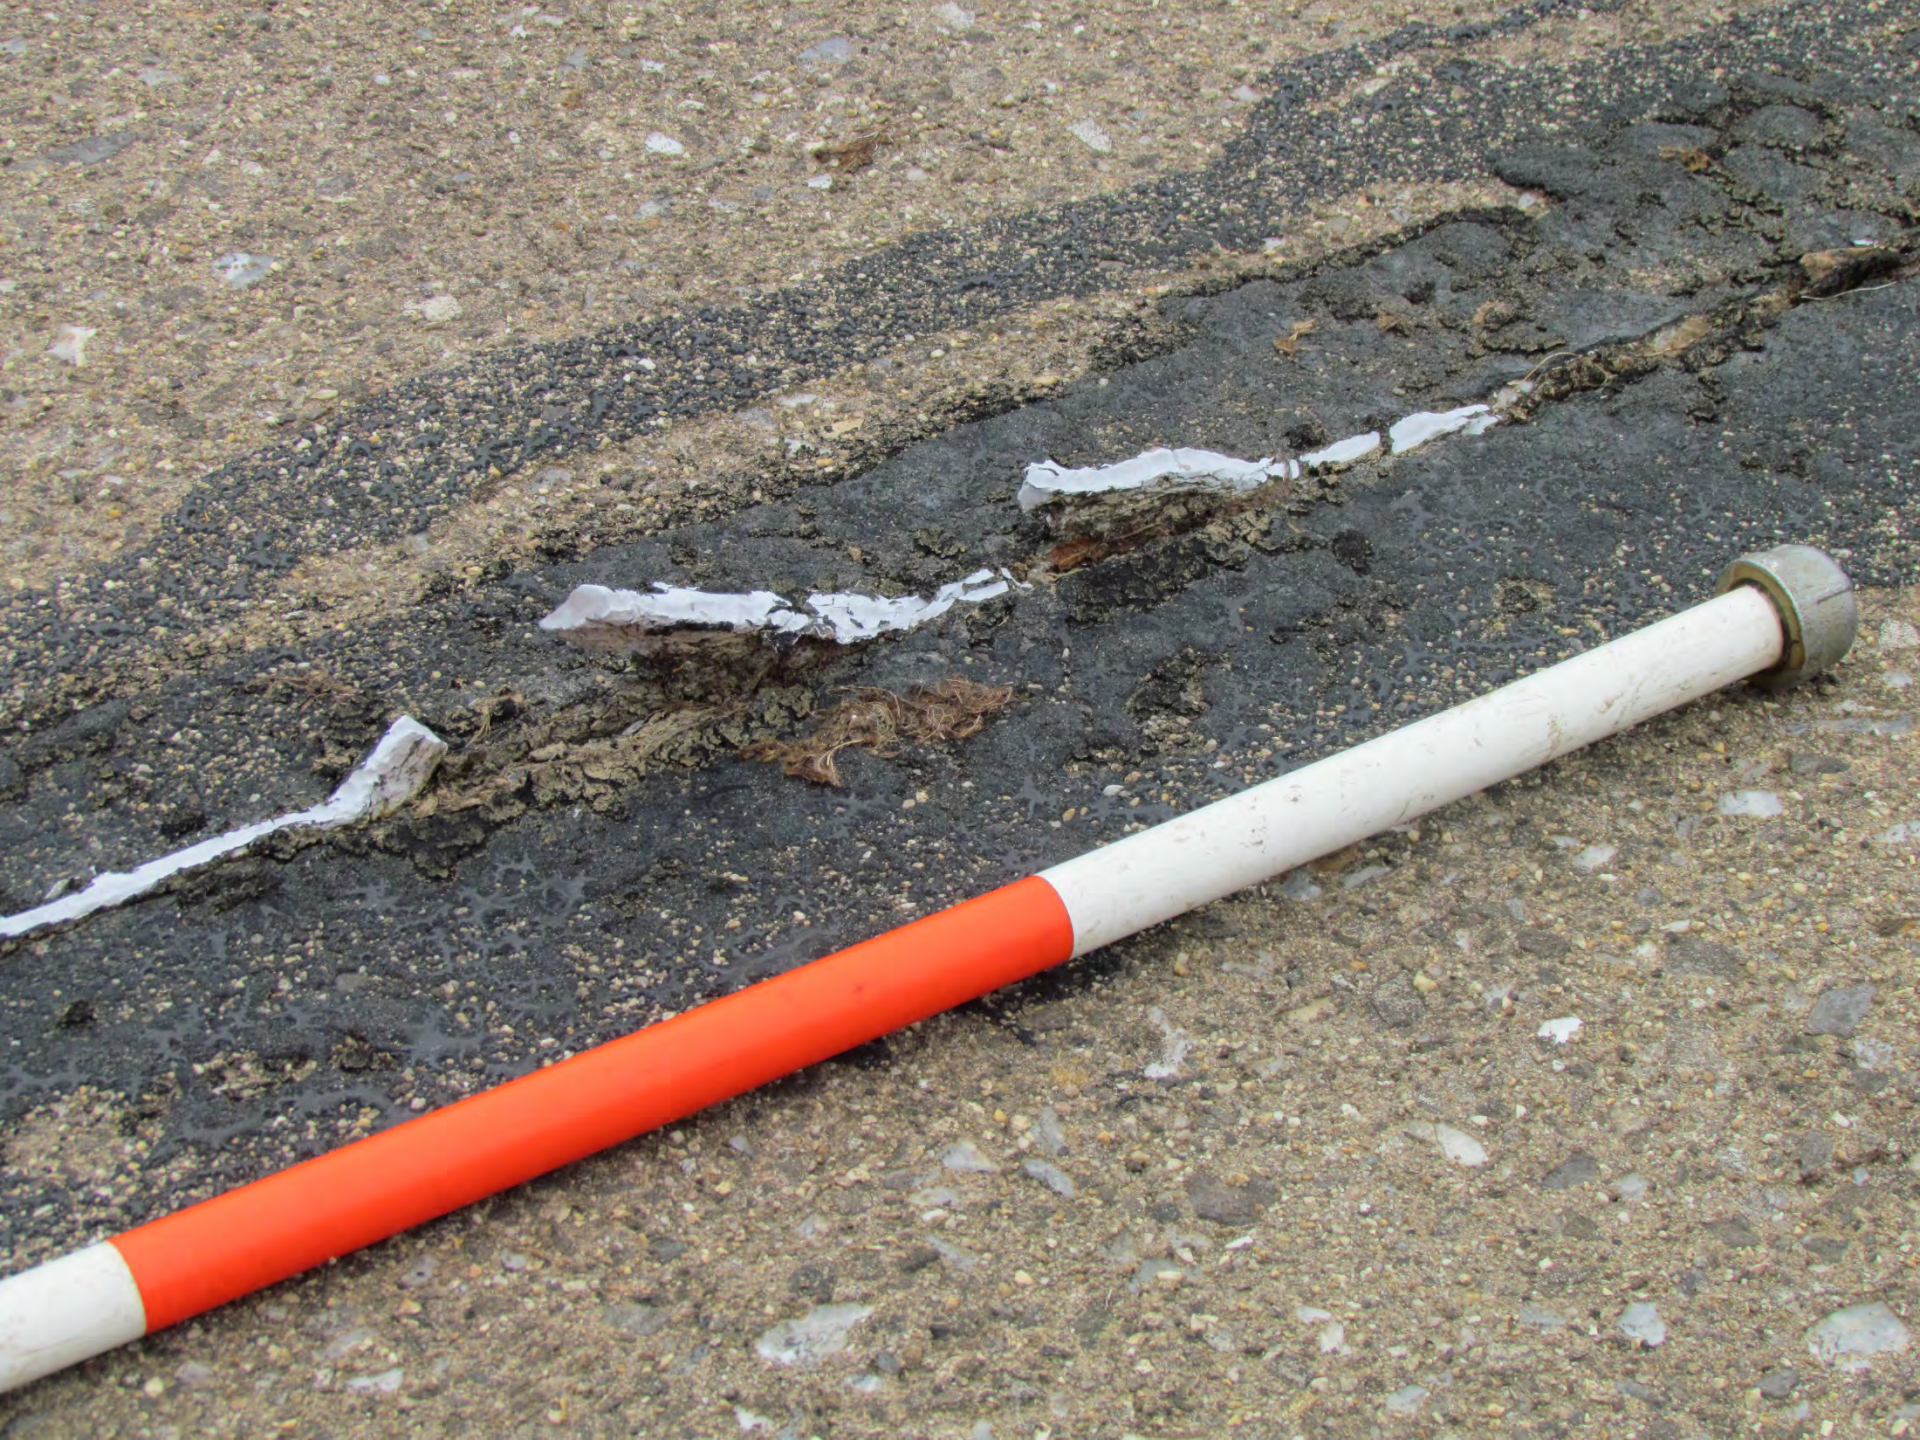
Old sealant between
concrete expansion joints
needs to be removed and
replaced.

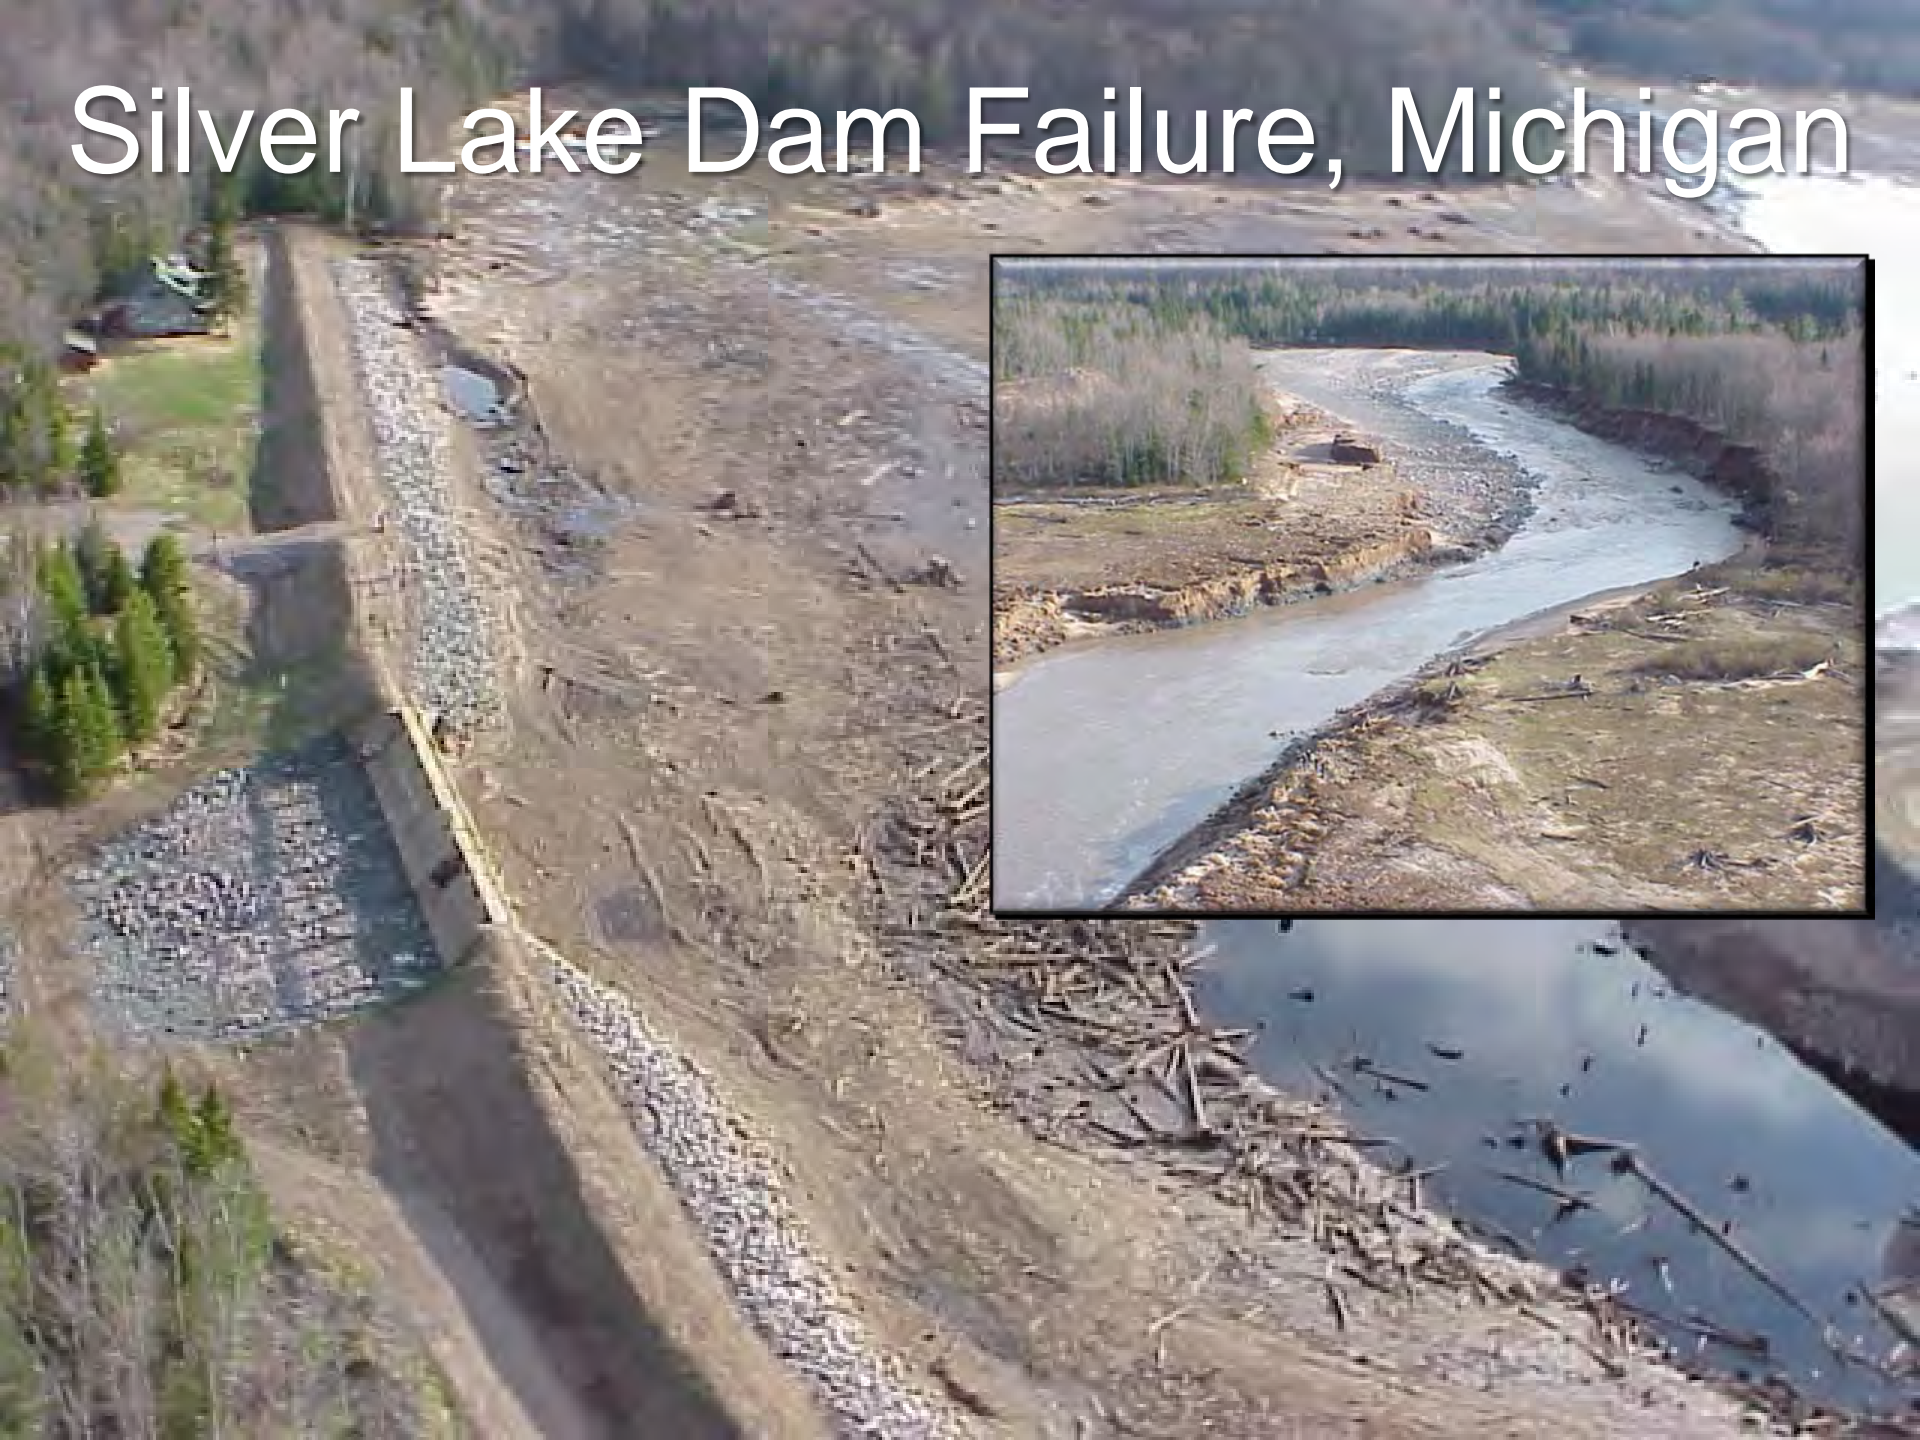
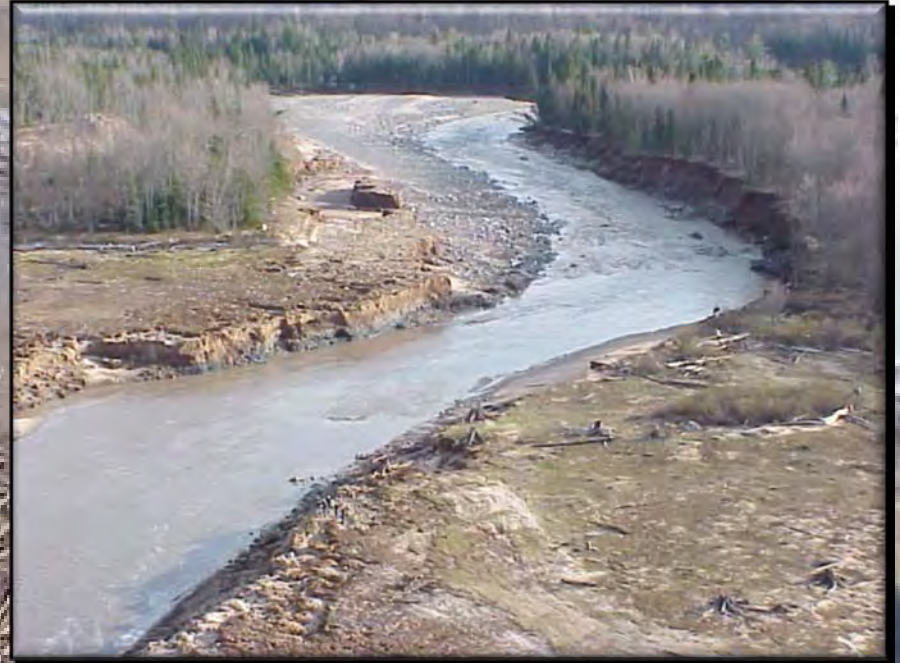
Silver Lake Dam Failure, Michigan

- 5-10 year flood event on May 14, 2003
- Fuse plug activated
- Spillway channel eroded well below fuse plug foundation
- Fuse plug 9" below service spillway crest
- Fuse plug foundation and channel susceptible to erosion
- Fuse plug flows 5,000 → 30,000 cfs ~PMF

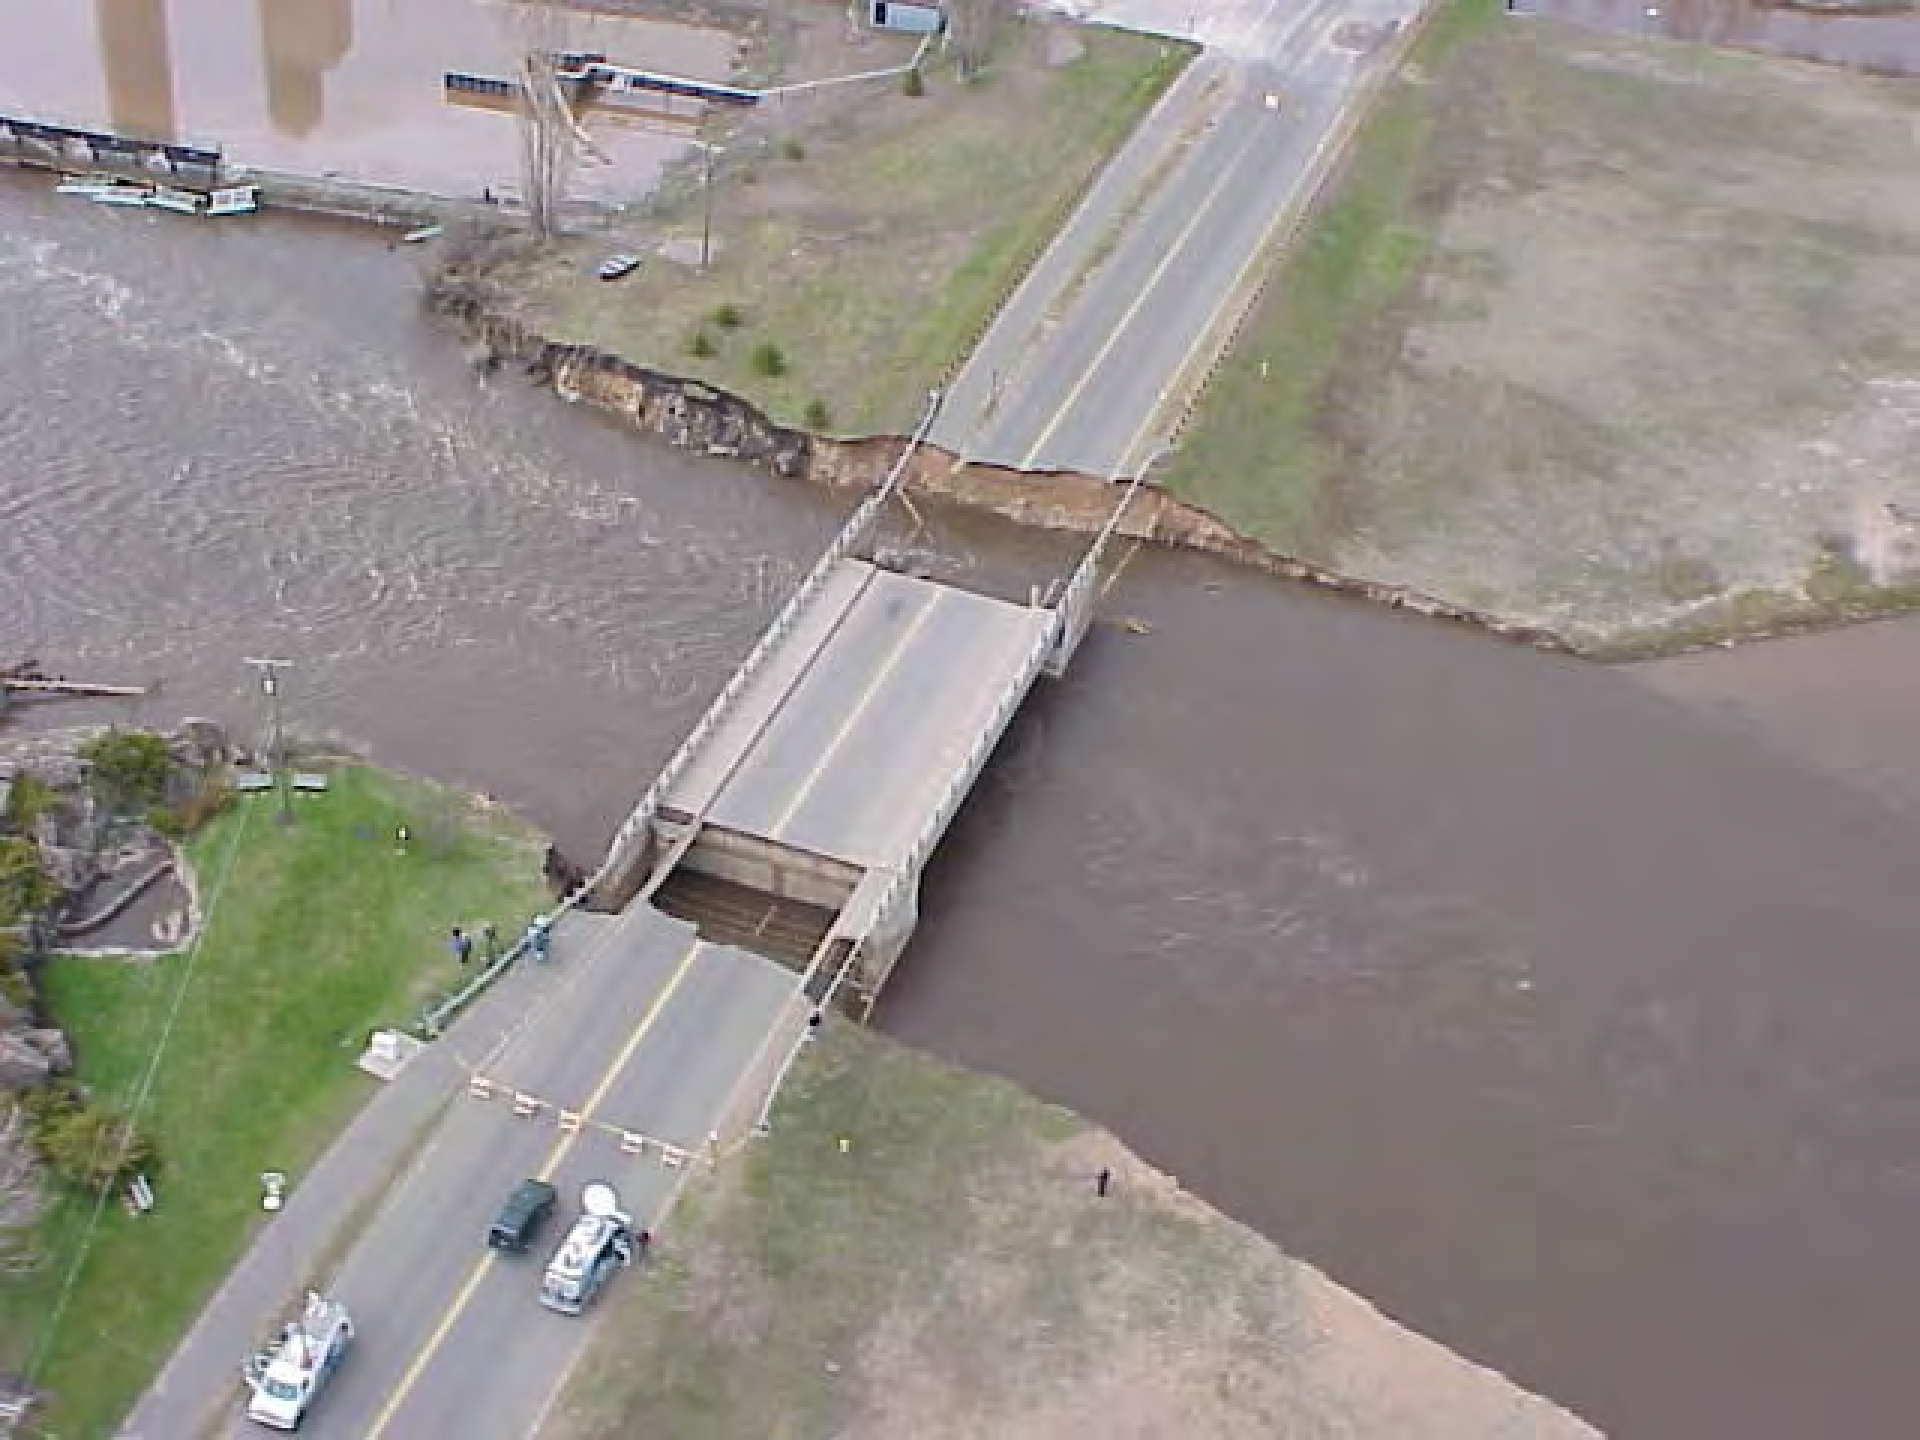
Final Eroded Fuse Plug Breach

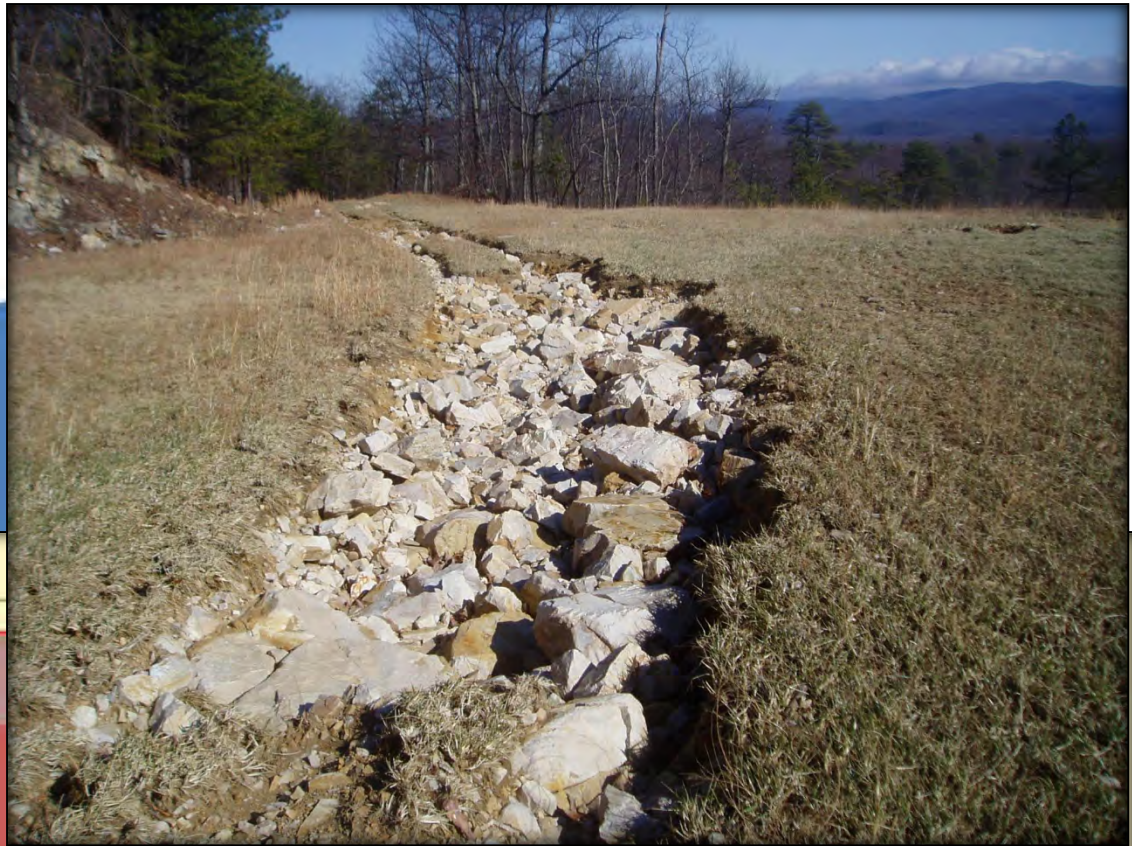
**Spillway
Breached (27%)**

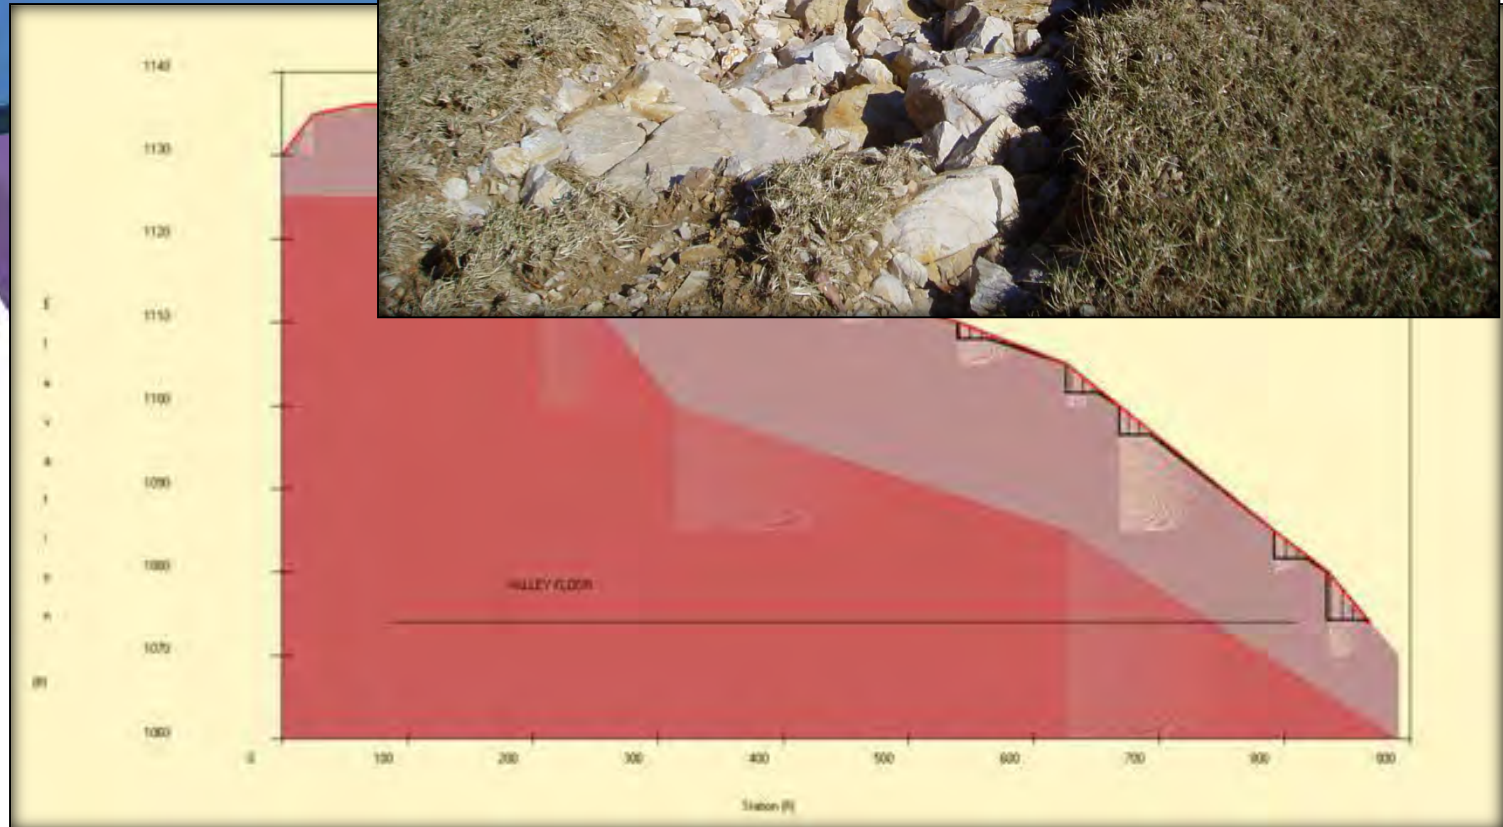
**Minor
Damage
5%**

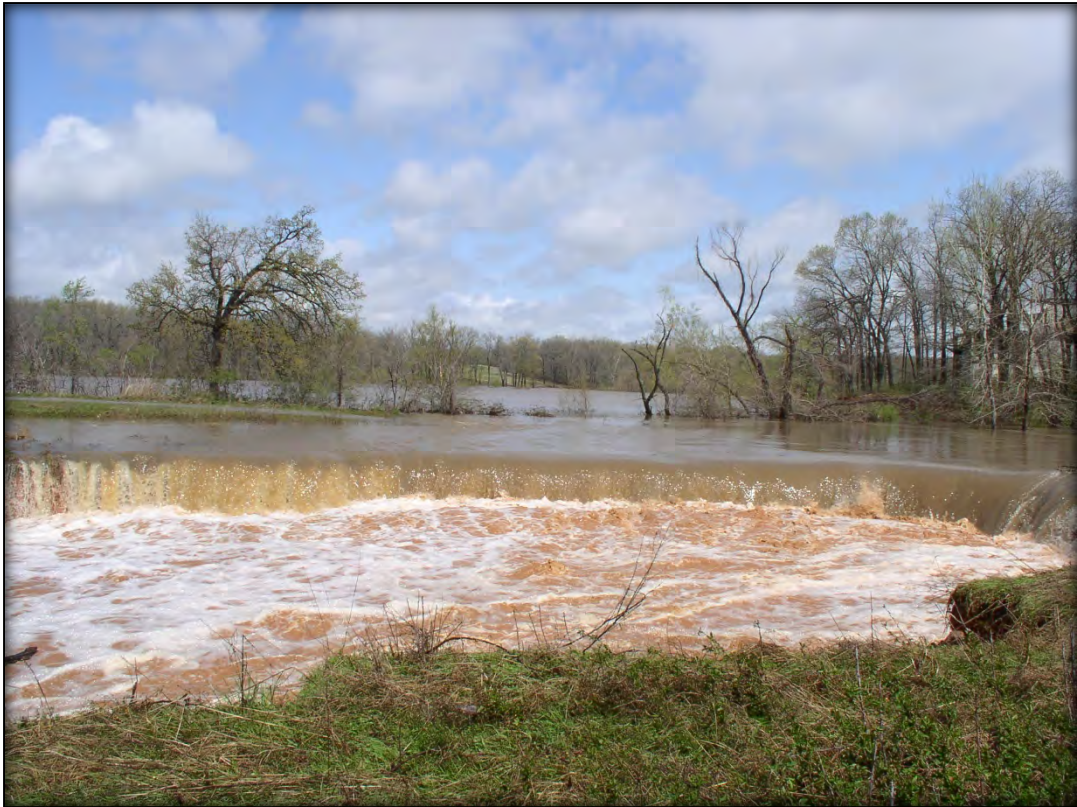
Significant Damage (39%)
