Lessons Learned from Concrete Dam Failures

Gannett Fleming

Maryland
Department of
the Environment

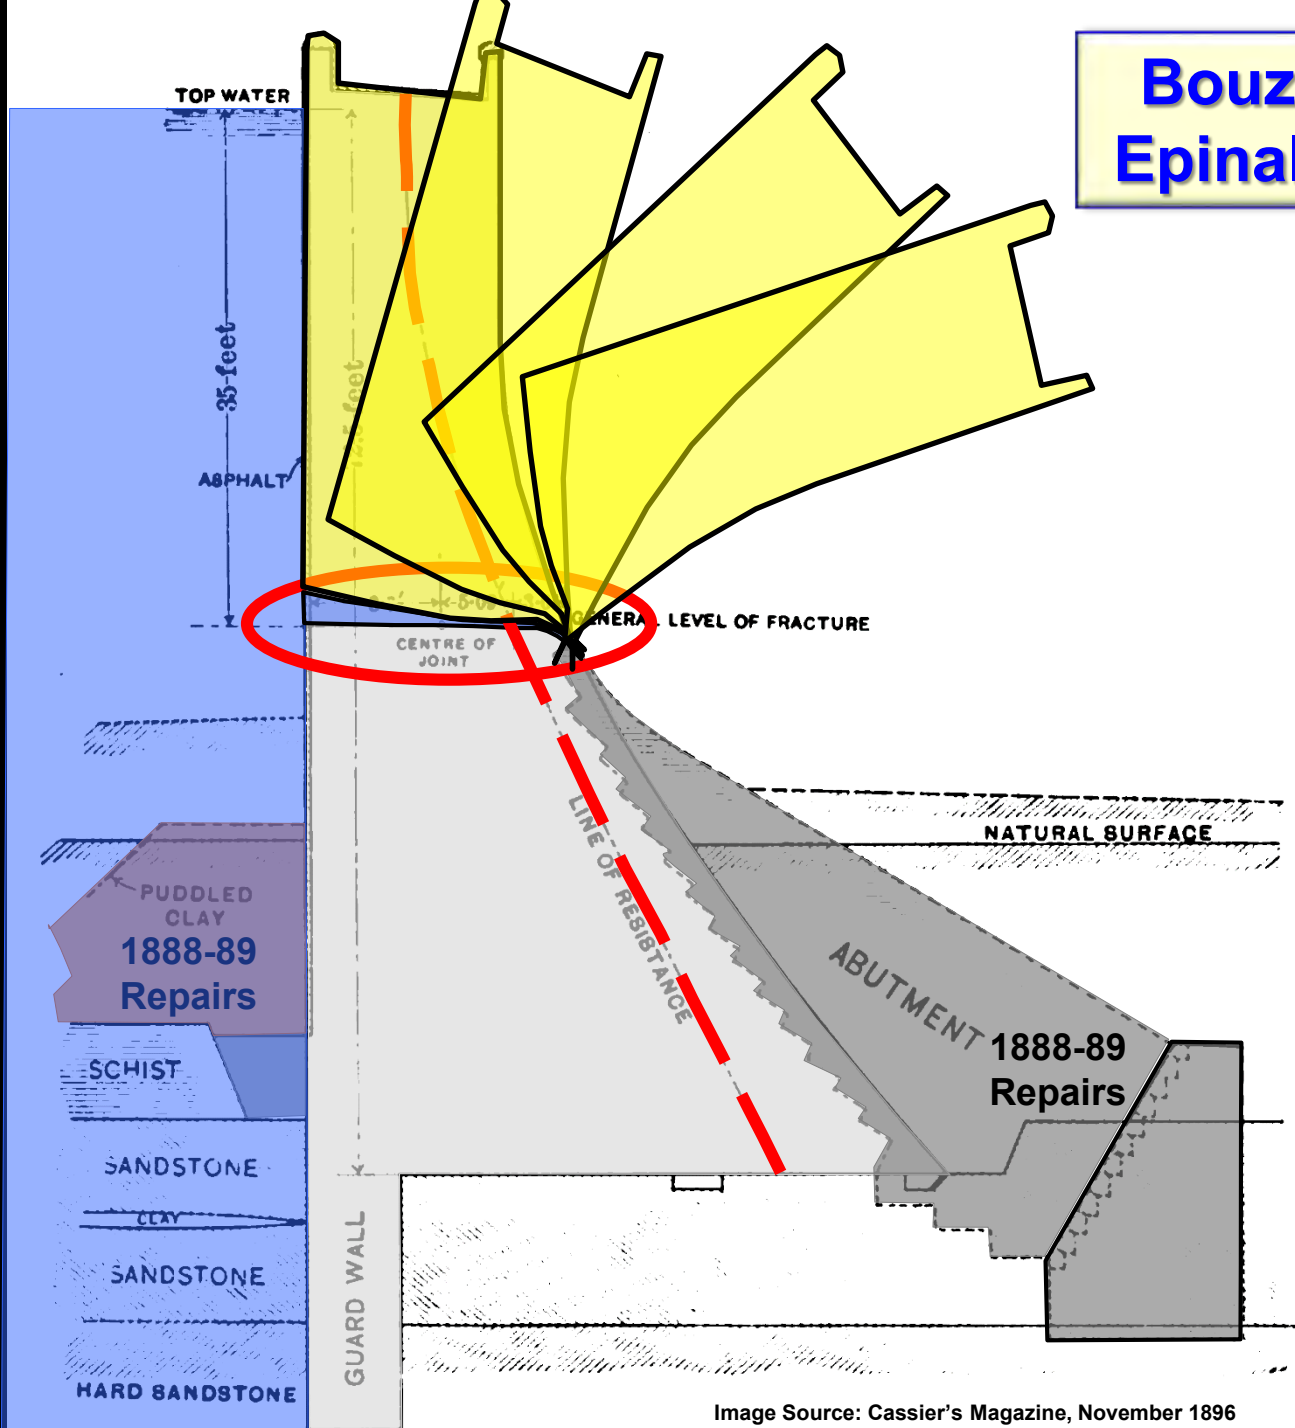
Bouzey Dam Epinal, France

Overturning Failure 1895, Loss of Life = 85 people

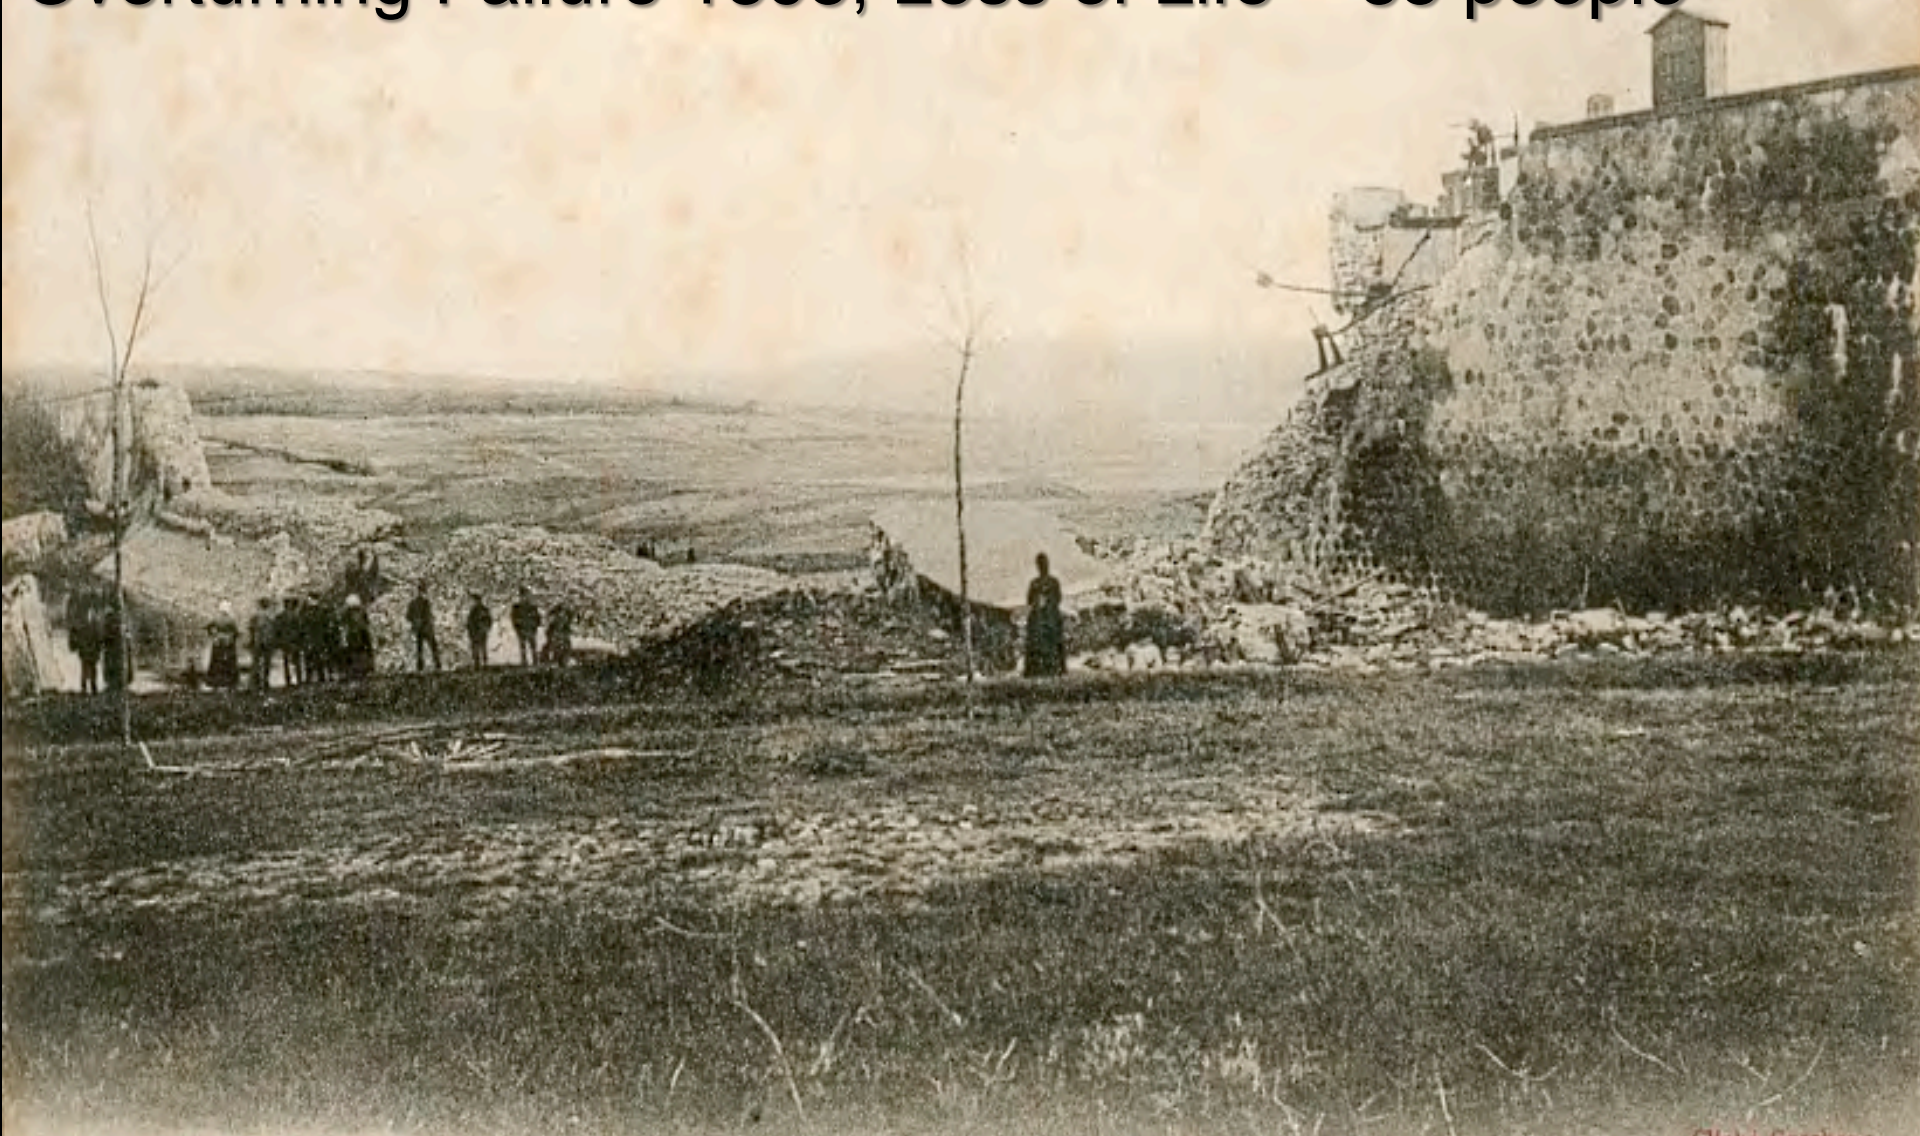
BOUZEY. - La Digue après la rupture (27 avril 1895)

Looking Toward Left Abutment

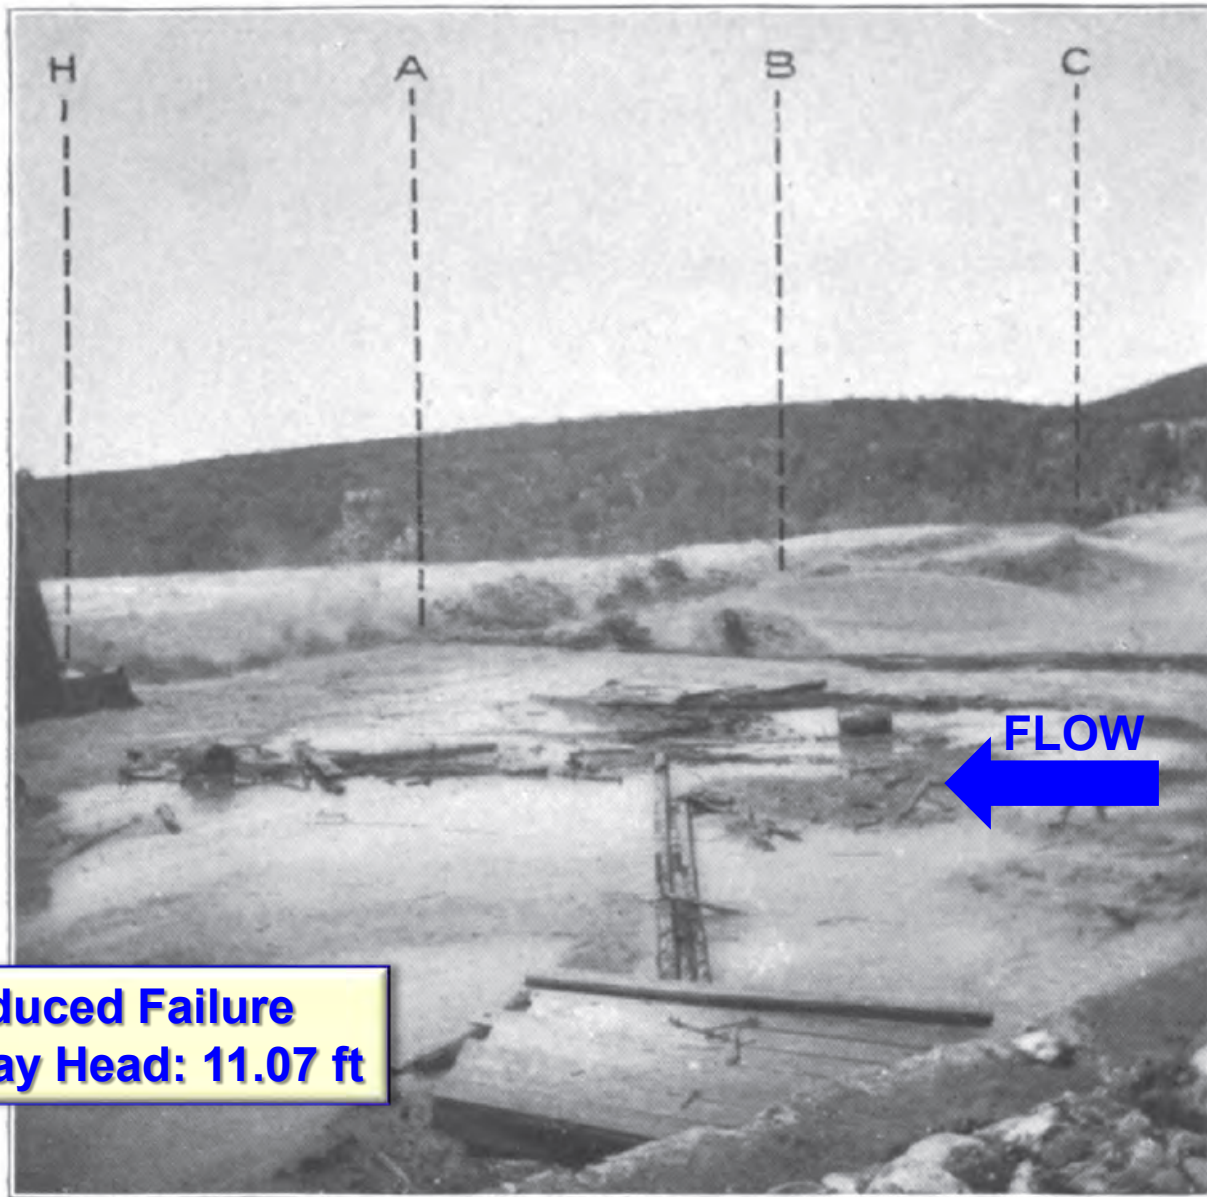
Flood-Induced Failure
Peak Spillway Head: 11.07 ft

A. VIEW THREE MINUTES AFTER FAILURE OF DAM.

A—B and B—C are portions of dam first broken; H—A is eastern part of dam (83 feet long on crest) left standing.

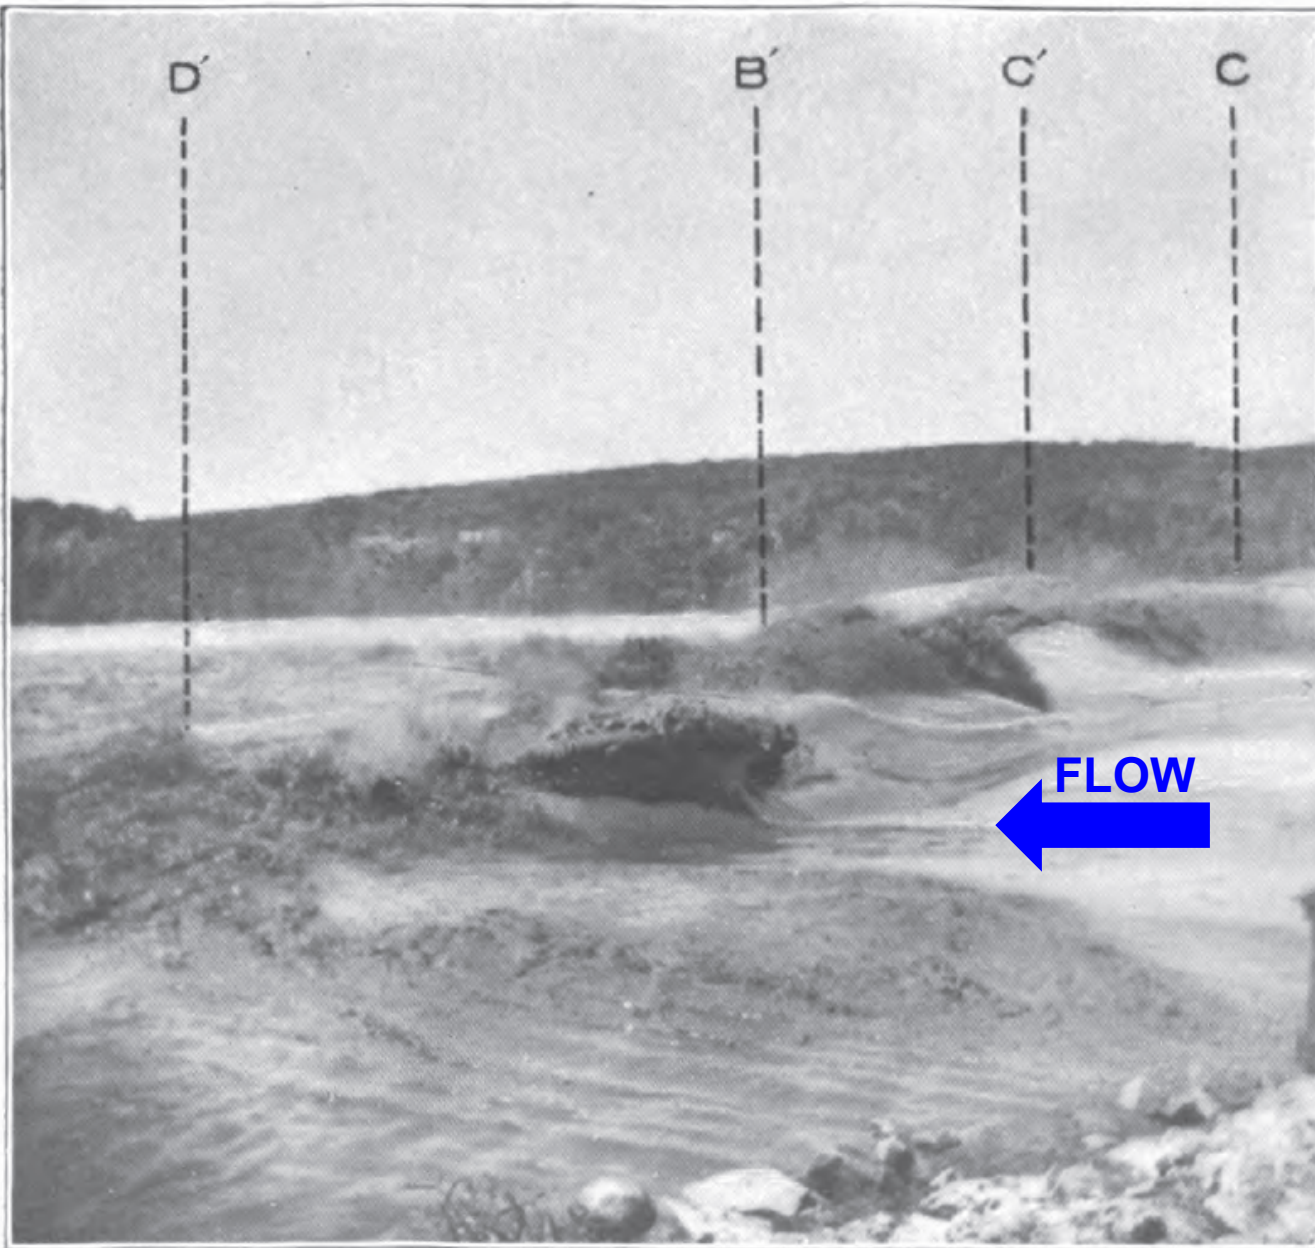
B. VIEW TEN MINUTES AFTER FAILURE OF DAM.

D'—B' is broken portion of dam still standing; B'—C' is western portion of break; C is end of western part of dam (456 feet long on crest) left standing.

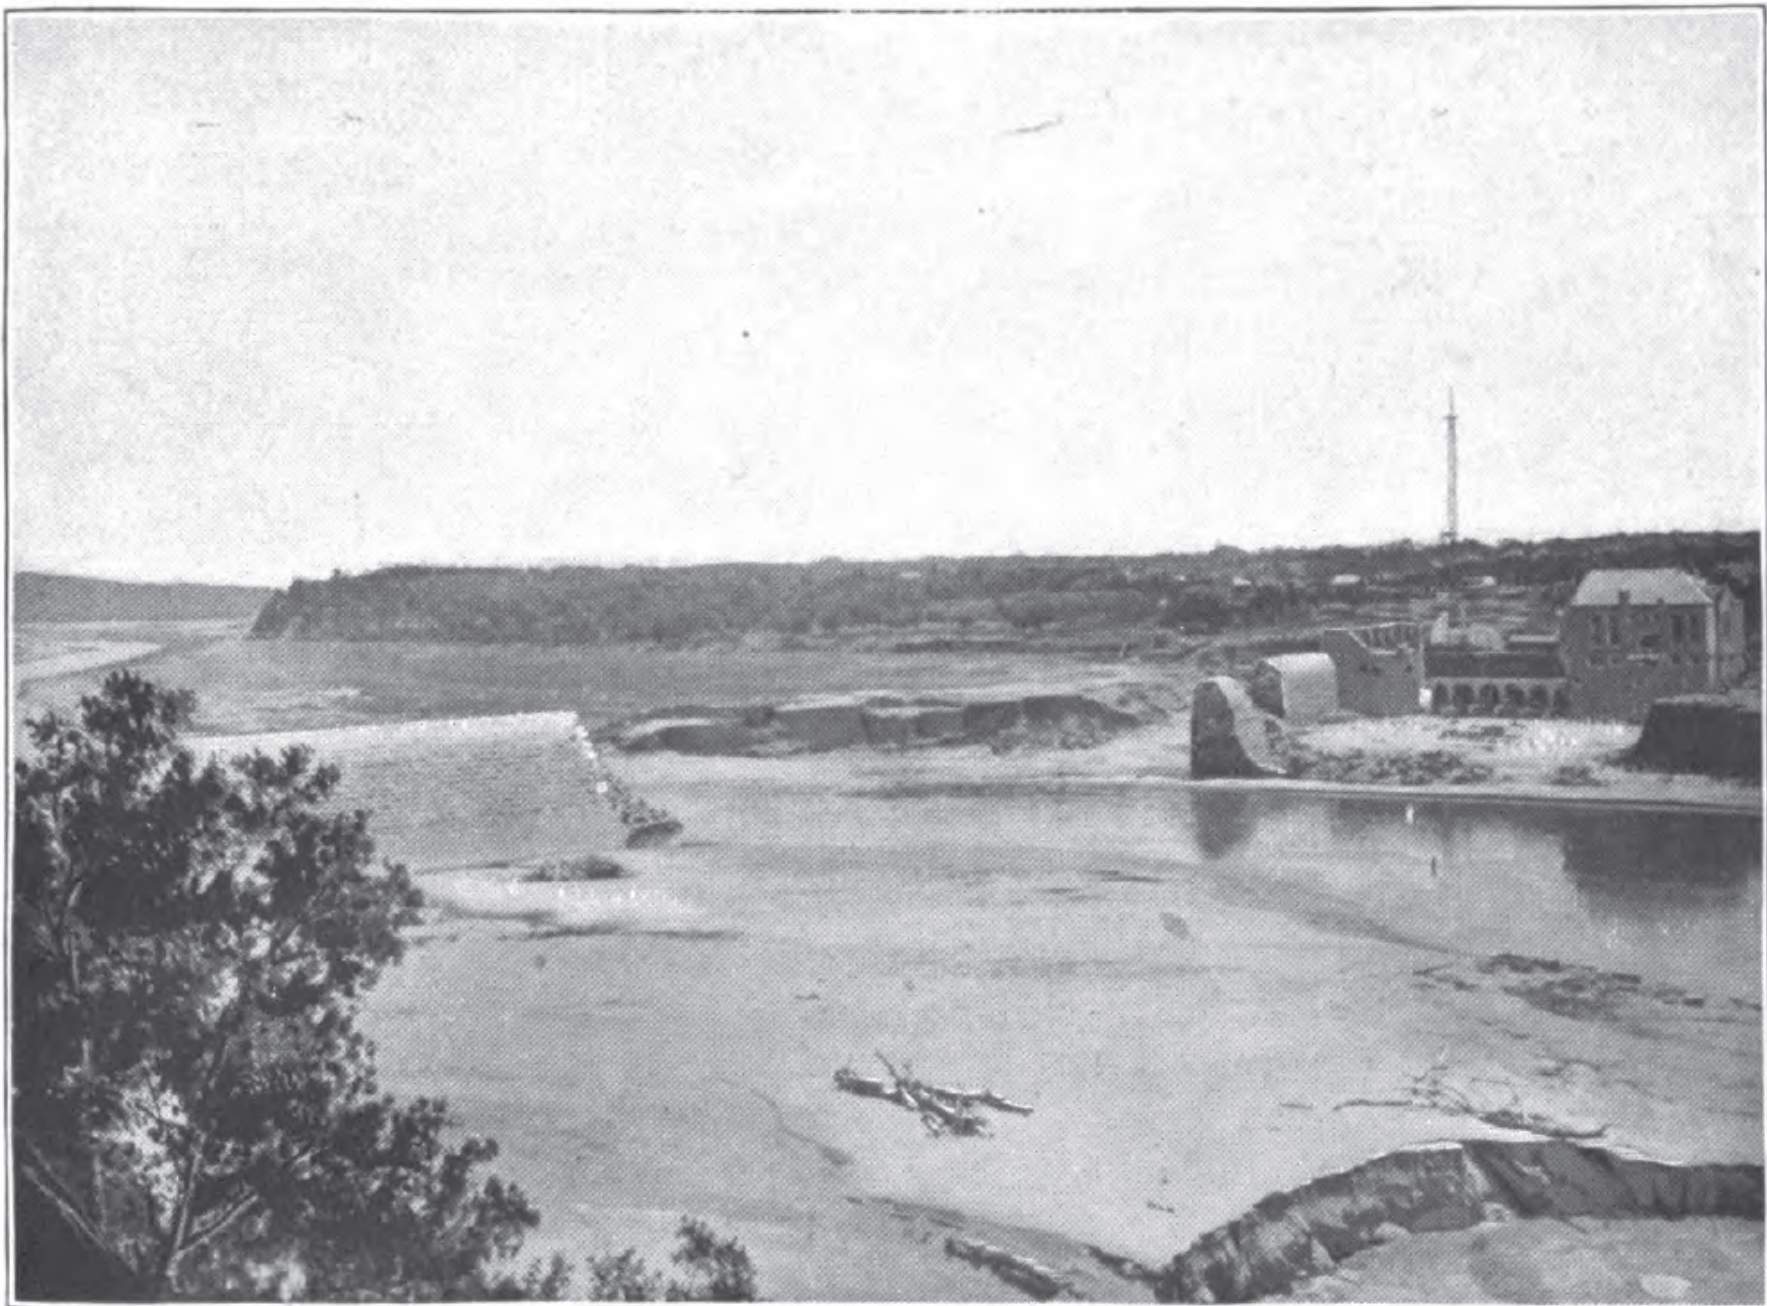
1. BROKEN DAM, SHOWING IN FOREGROUND SAND BAR LEFT IN MAIN CHANNEL.

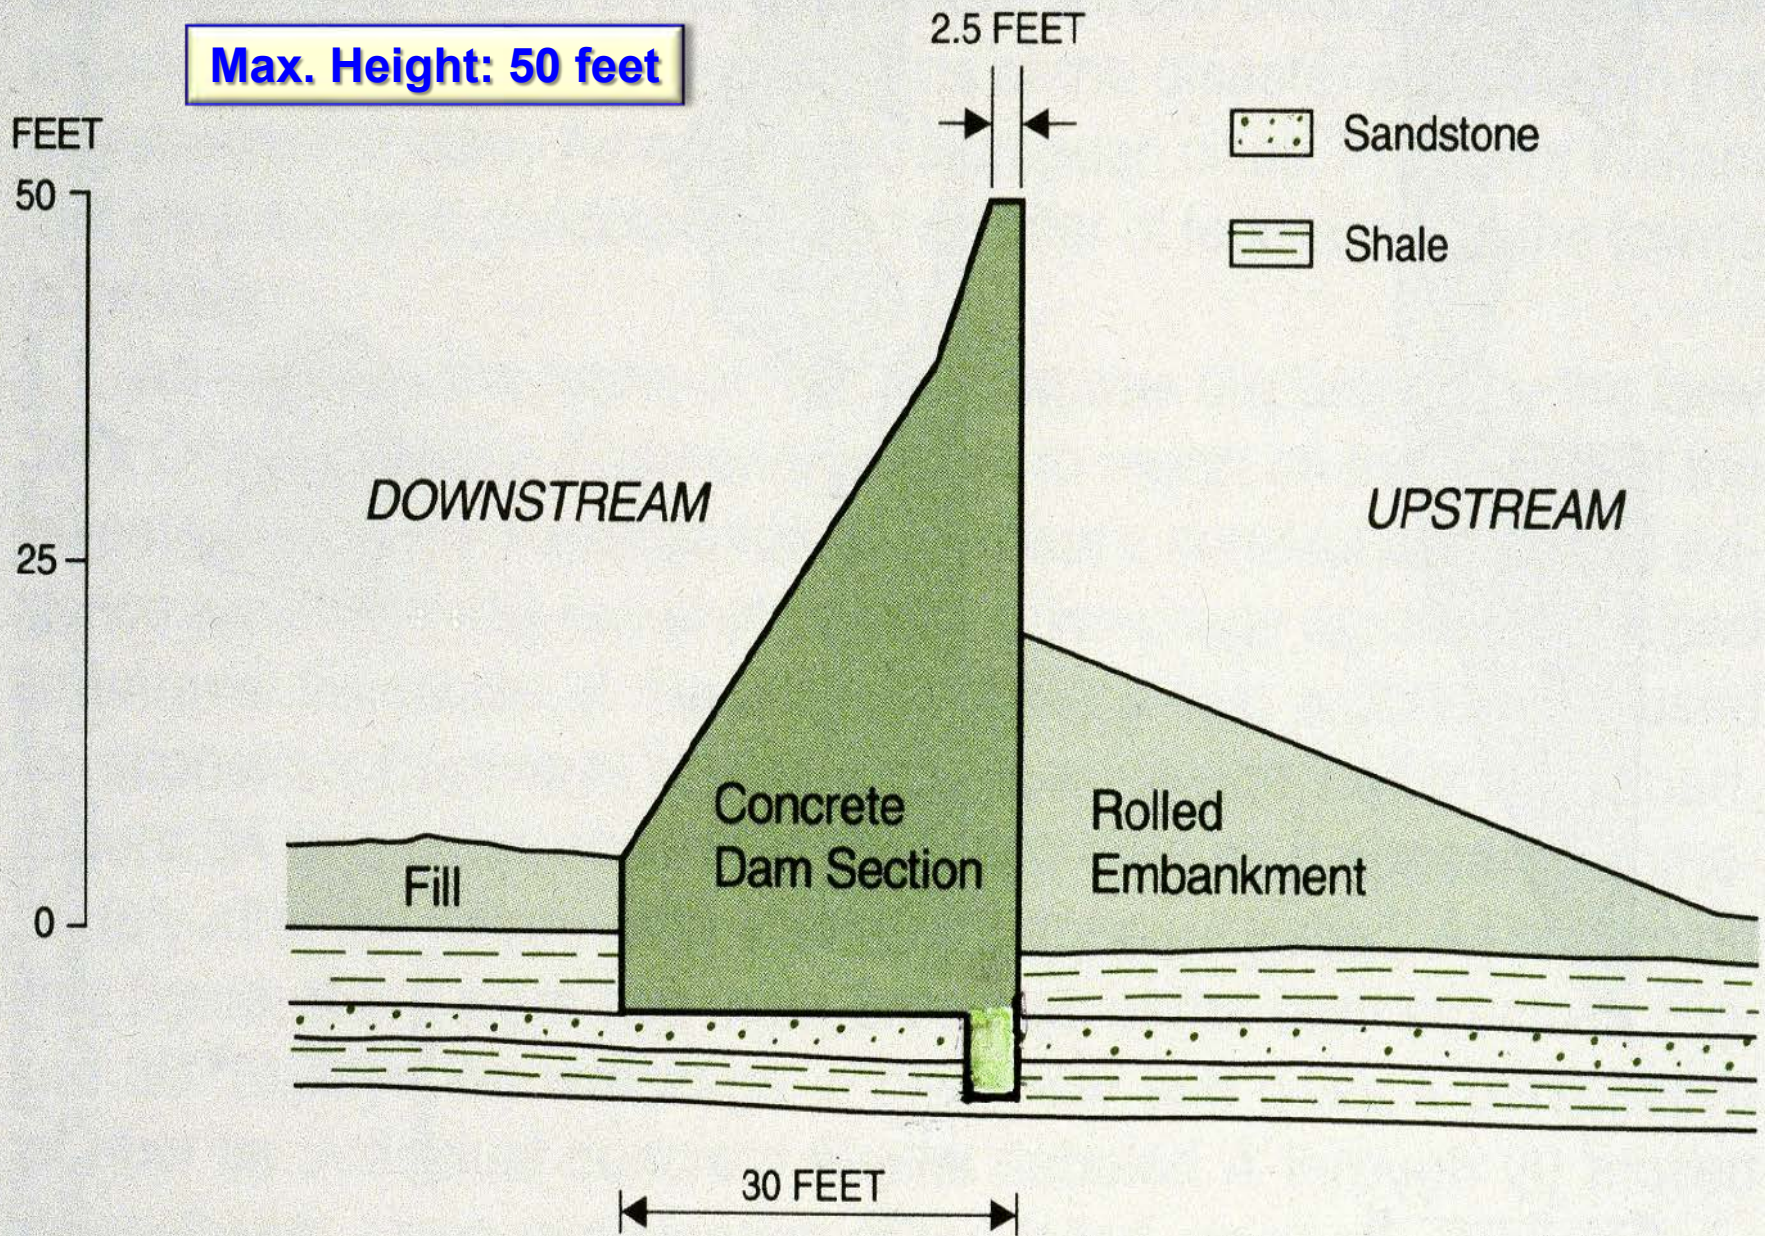
Figure 4. Prefailure cross section of Austin Dam at Block "D."

1. Neglected Uplift Pressure
2. Embankment to Reduce Hydrostatic Load
3. Vertical Rods for Overturning Stability
4. Key Wall for Sliding Stability
5. 2-in. Dia. Boreholes on 15-20-foot Centers
6. 25-45-foot Monoliths with Keyways
7. Concrete Mix – 1.25 Barrels Cement per CY
8. Each Cement Delivery Tested
9. Outlet Works – 36-inch dia. Pipe
10. Spillway Crest Raised 2 feet

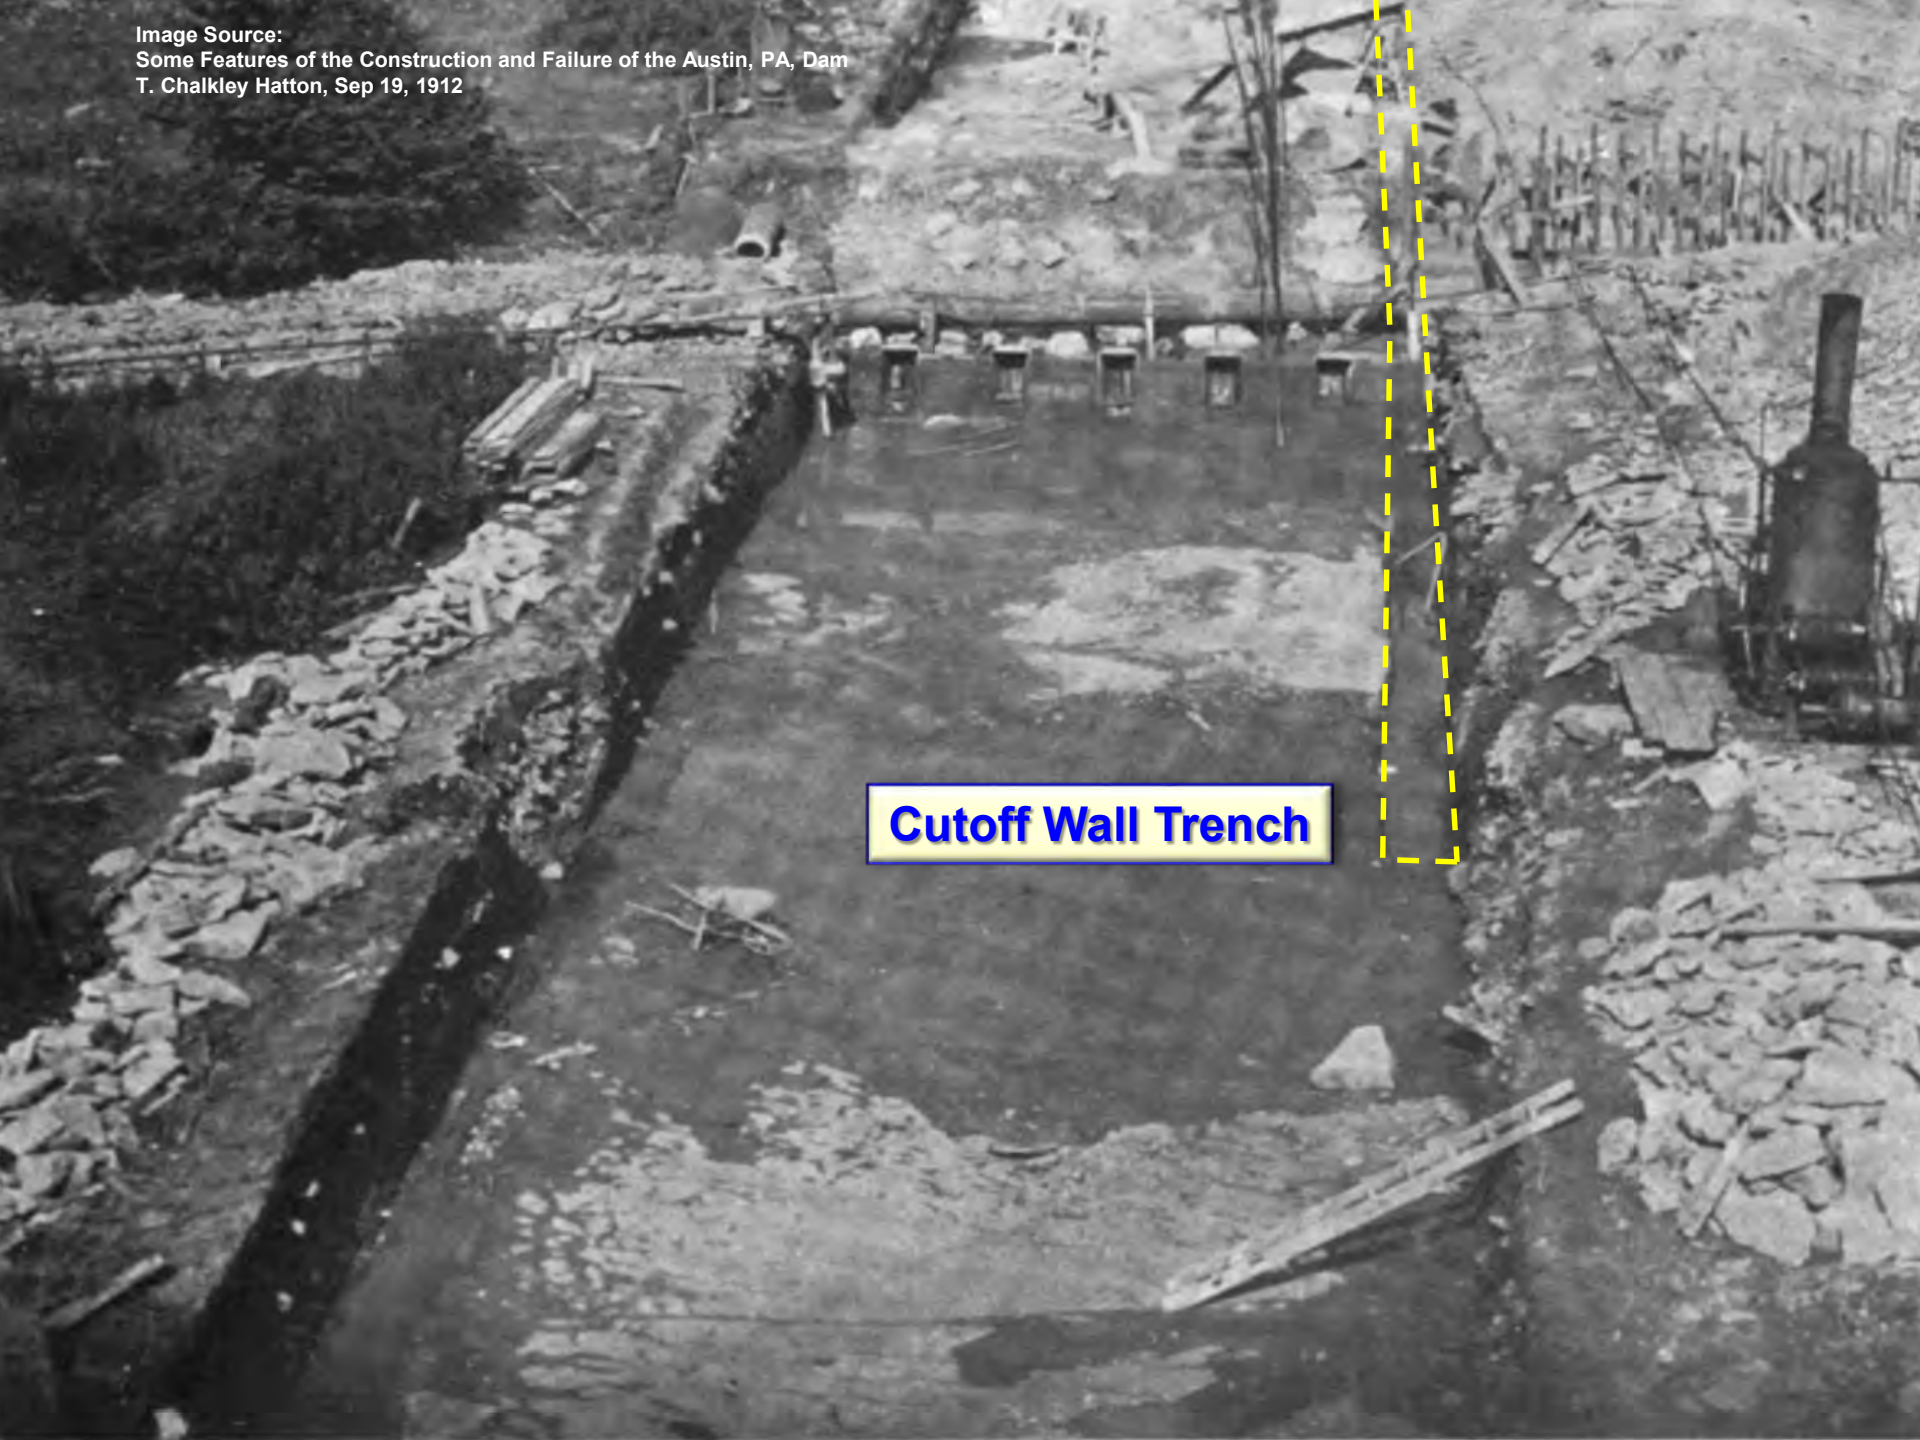
Cutoff Wall Trench

January 21, 1910

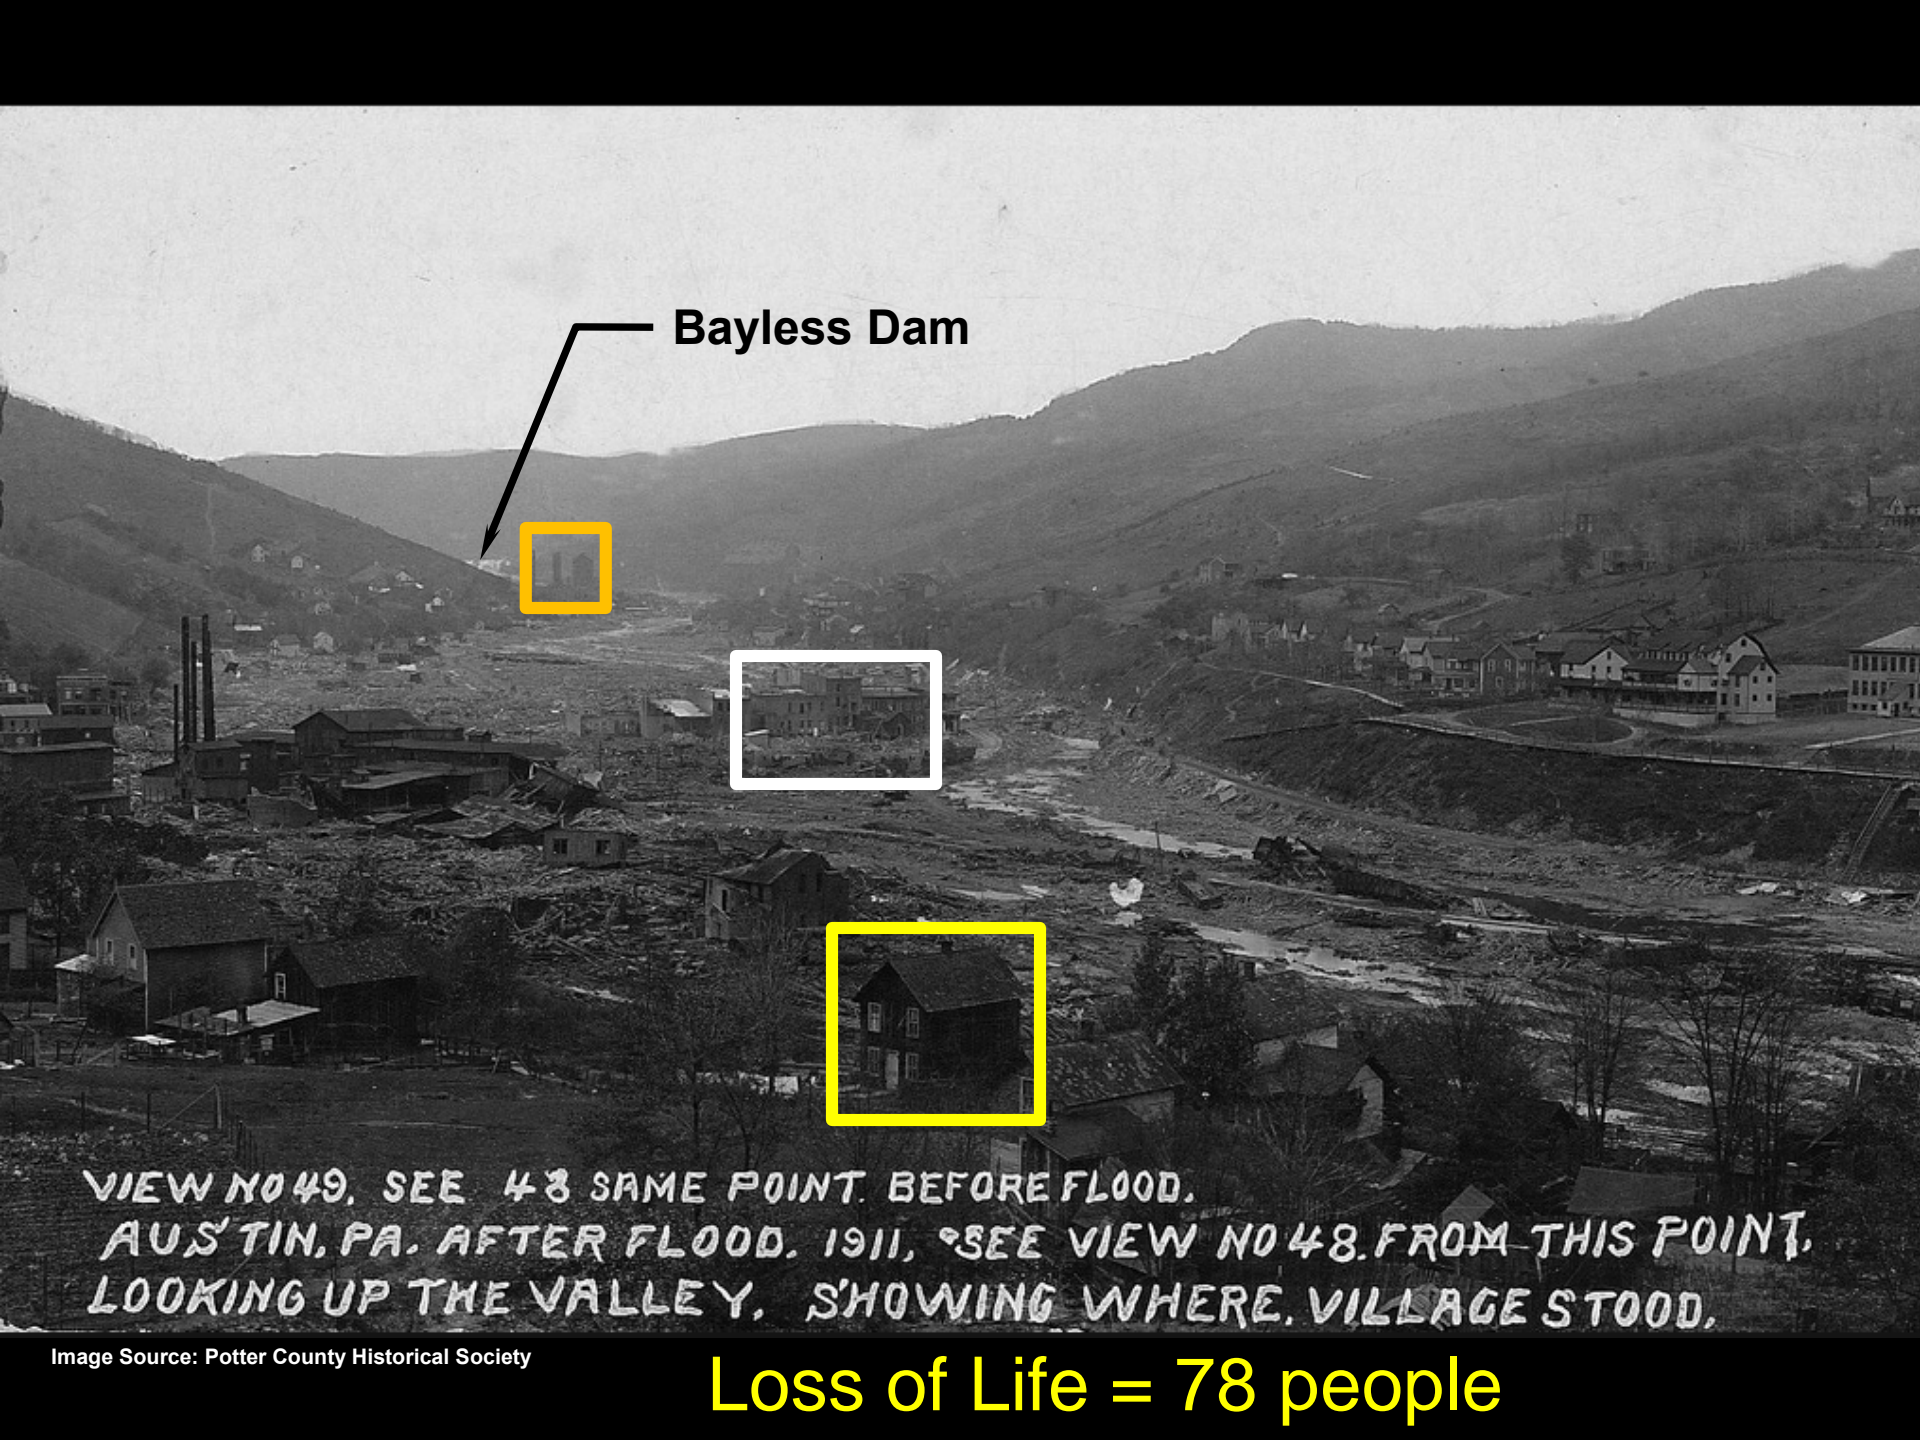
Bayless Dam

VIEW NO 49, SEE 48 SAME POINT. BEFORE FLOOD.
AUSTIN, PA. AFTER FLOOD. 1911, SEE VIEW NO 48. FROM THIS POINT,
LOOKING UP THE VALLEY, SHOWING WHERE VILLAGE STOOD.

Loss of Life = 78 people

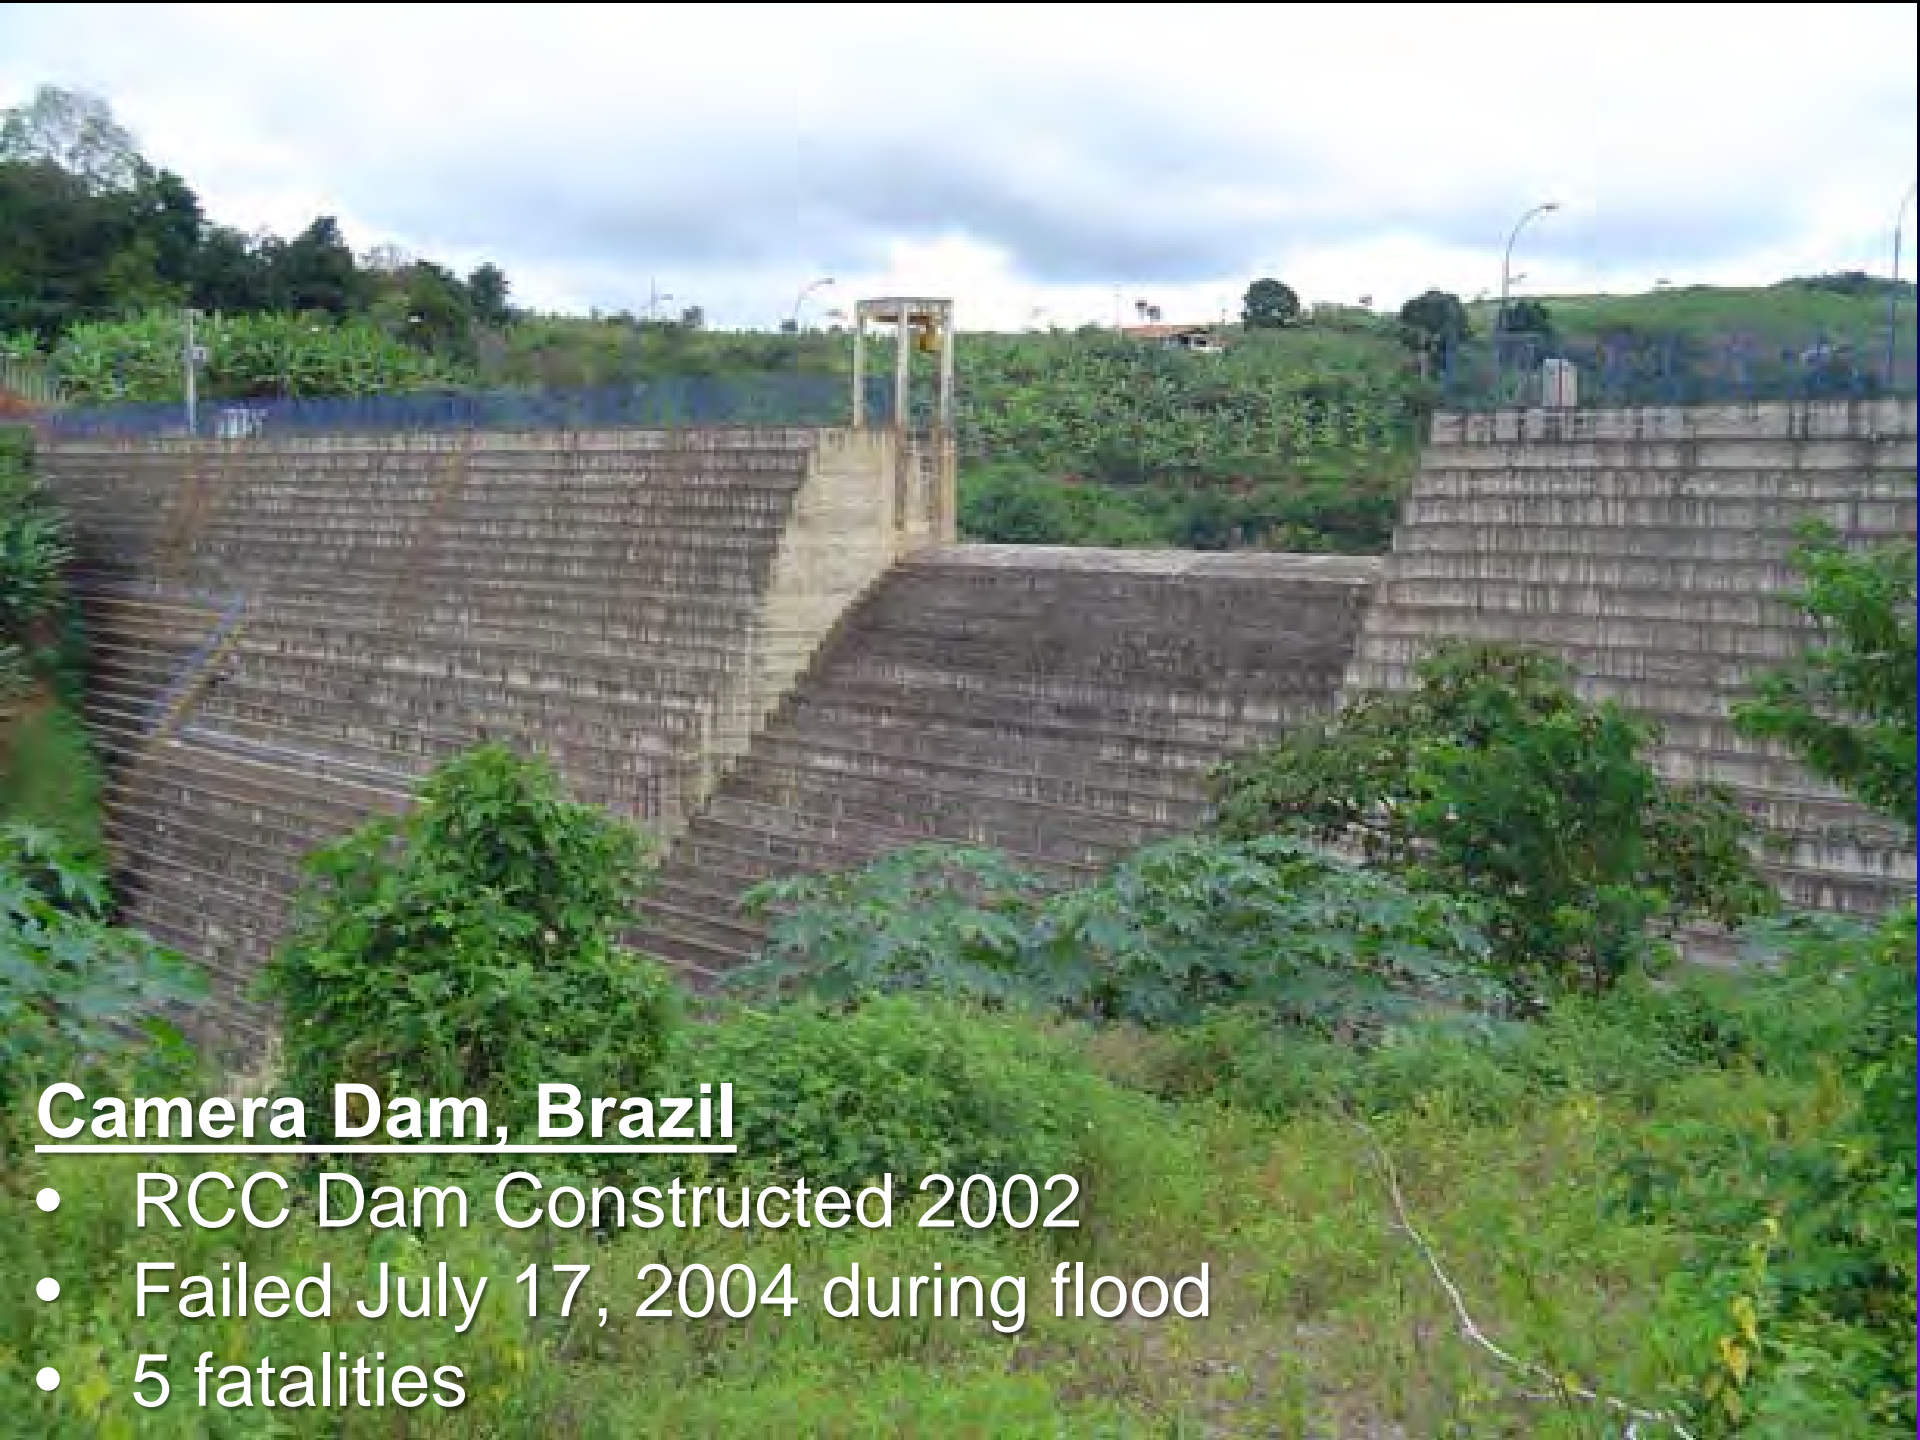
Camera Dam, Brazil

- RCC Dam Constructed 2002
- Failed July 17, 2004 during flood
- 5 fatalities

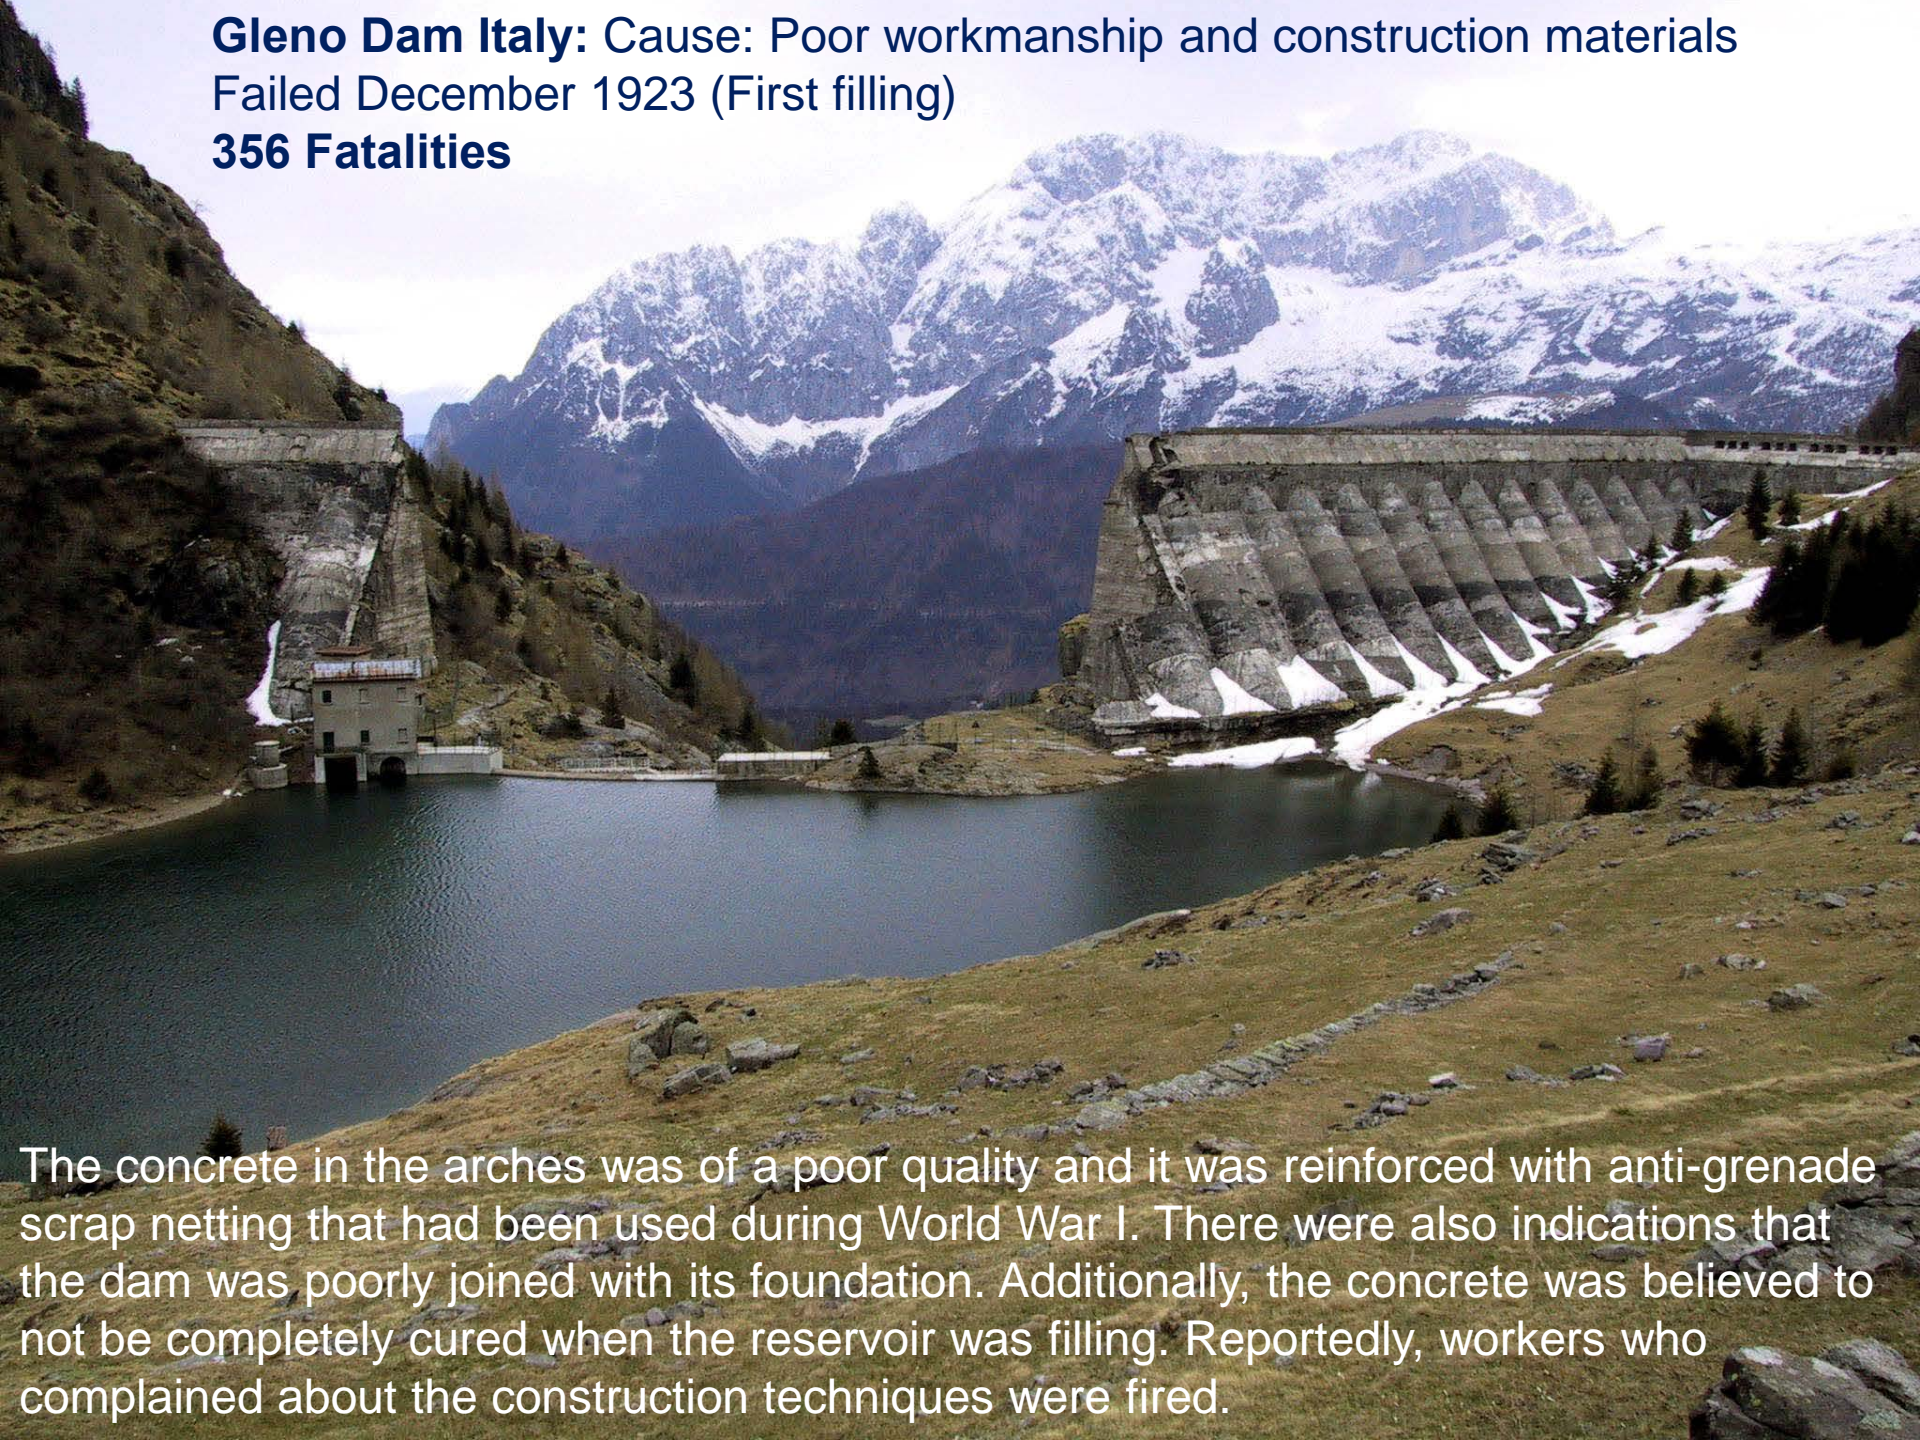
The concrete in the arches was of a poor quality and it was reinforced with anti-grenade scrap netting that had been used during World War I. There were also indications that the dam was poorly joined with its foundation. Additionally, the concrete was believed to not be completely cured when the reservoir was filling. Reportedly, workers who complained about the construction techniques were fired.
