# Phase II Investigation Work Plan

## Area A: Parcel A8 Sparrows Point Terminal, LLC Sparrows Point, Maryland

October 23, 2015

ARM Project 150298M

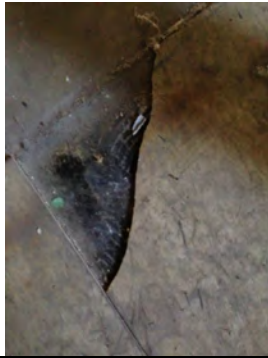
Photo 6: 12x12 Off White Floor Tile w/Black Mastic

The identified asbestos-containing materials should be removed prior to disturbance if they are to be impacted by any demolition activities. It is recommended that personnel trained in accordance with EPA, OSHA, and Maryland regulations for asbestos-related activities conduct abatement of these materials. ACMs should be removed prior to disturbance and/or alteration.

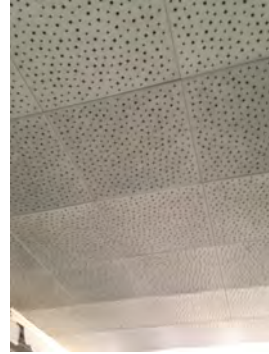
Photo 7: 12x12 White Dotted Ceiling Tile

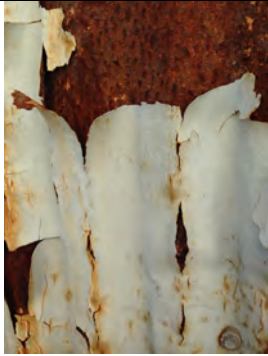
Photo 8: Sheet Metal Siding Paint Exterior Walls/Roof

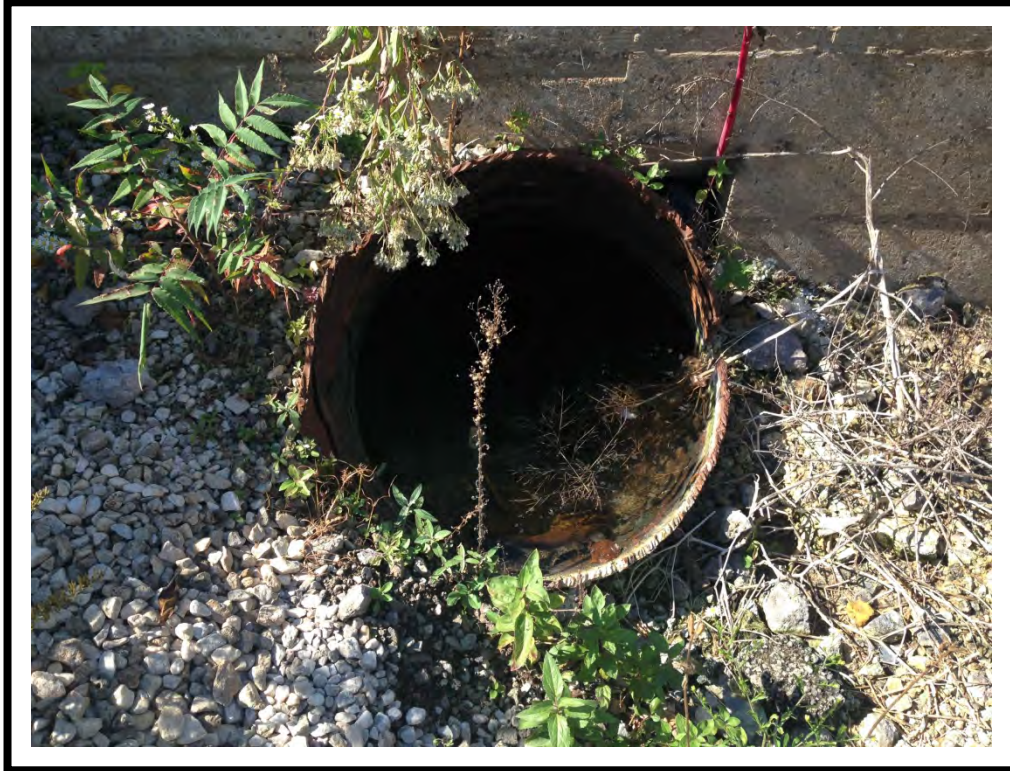
walk at the supposed location of REC 11B. ARM located a discharge pipe in the area, but observed no evidence of staining on the ground or oily sheen on the surface water. A baffle was observed in the reservoir at this location, but not a sorbent boom. Several photographs were taken during the site walk, which are included as **Appendix B**. The REC 11B area is still targeted for sampling as part of this work plan.

**Photo 1:** Outfall/drain pipe in REC 11B area.

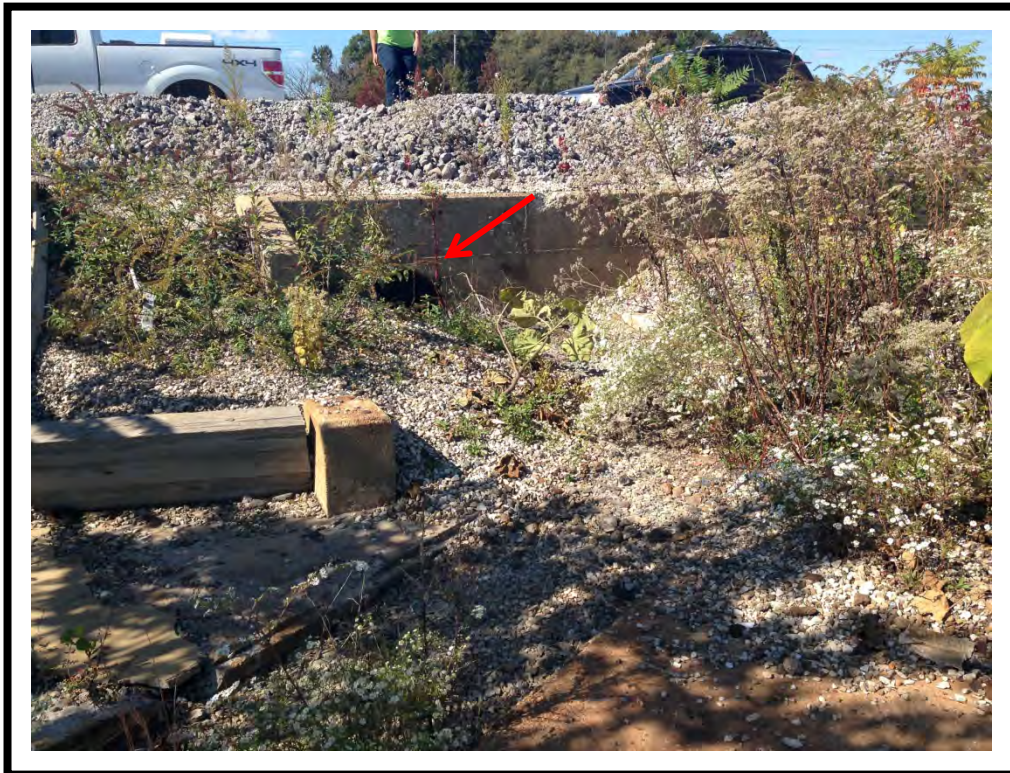
**Photo 2:** Looking west at headwall with outfall/drain pipe and shallow culvert filled with gravel.

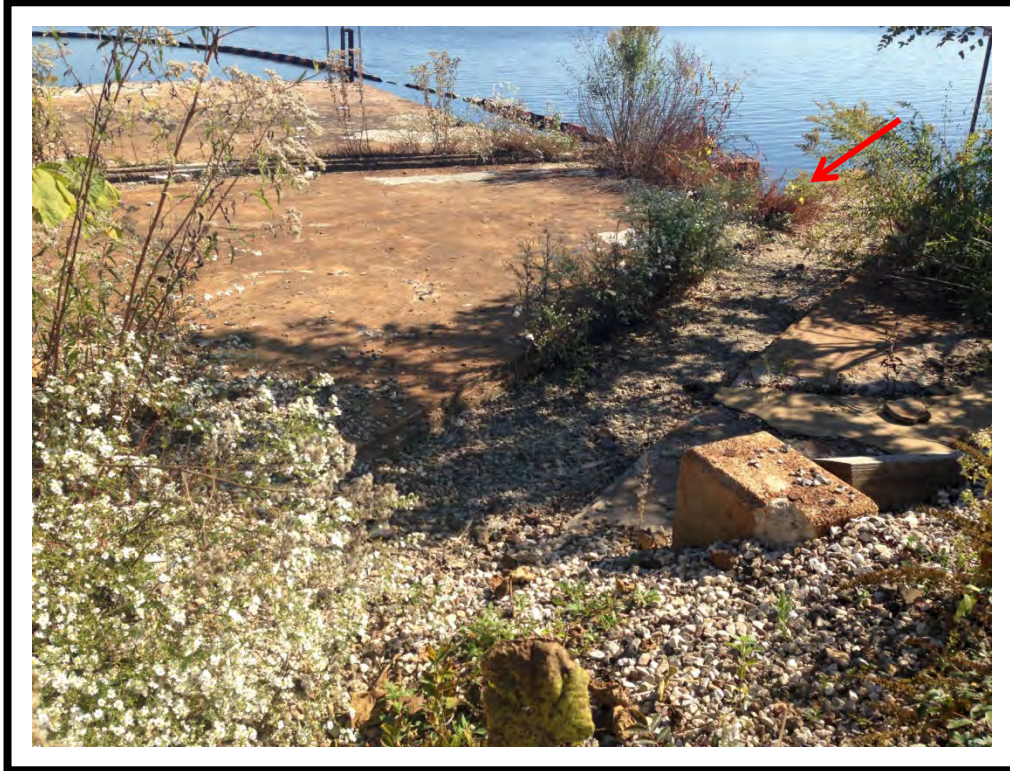
**Photo 3:** Looking southeast. Pipe discharges into shallow culvert filled with gravel prior to discharging to High Head Reservoir.

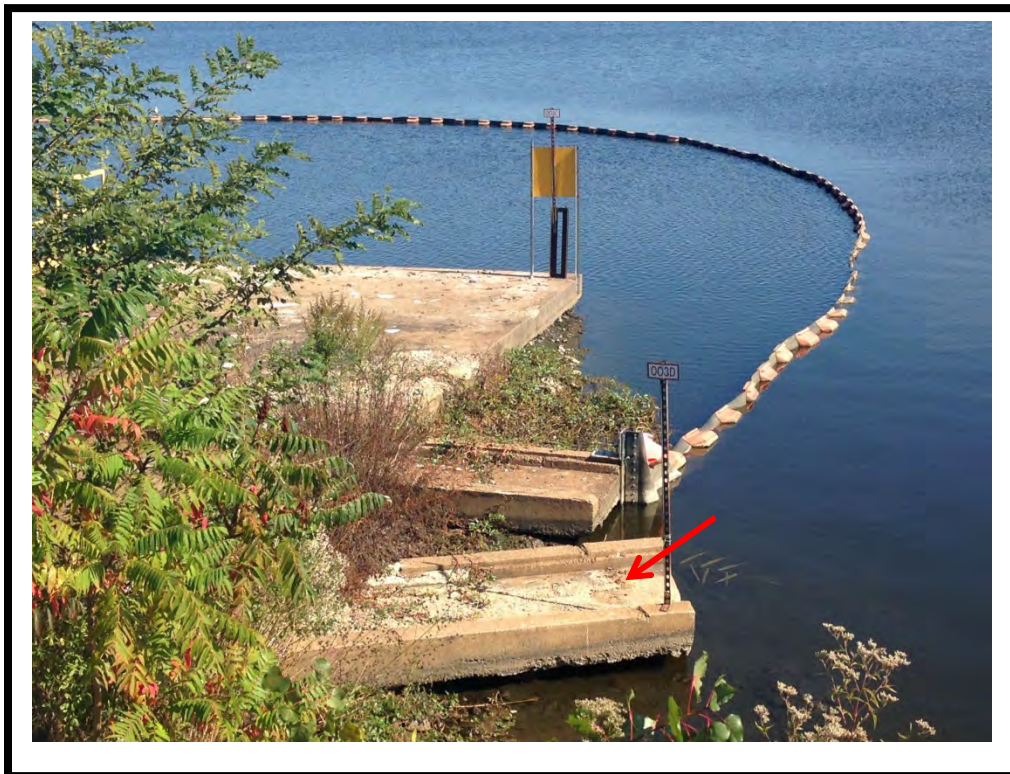
**Photo 4:** Looking northeast from shore towards end of culvert (the discharge point), baffle (boom), and concrete platform.

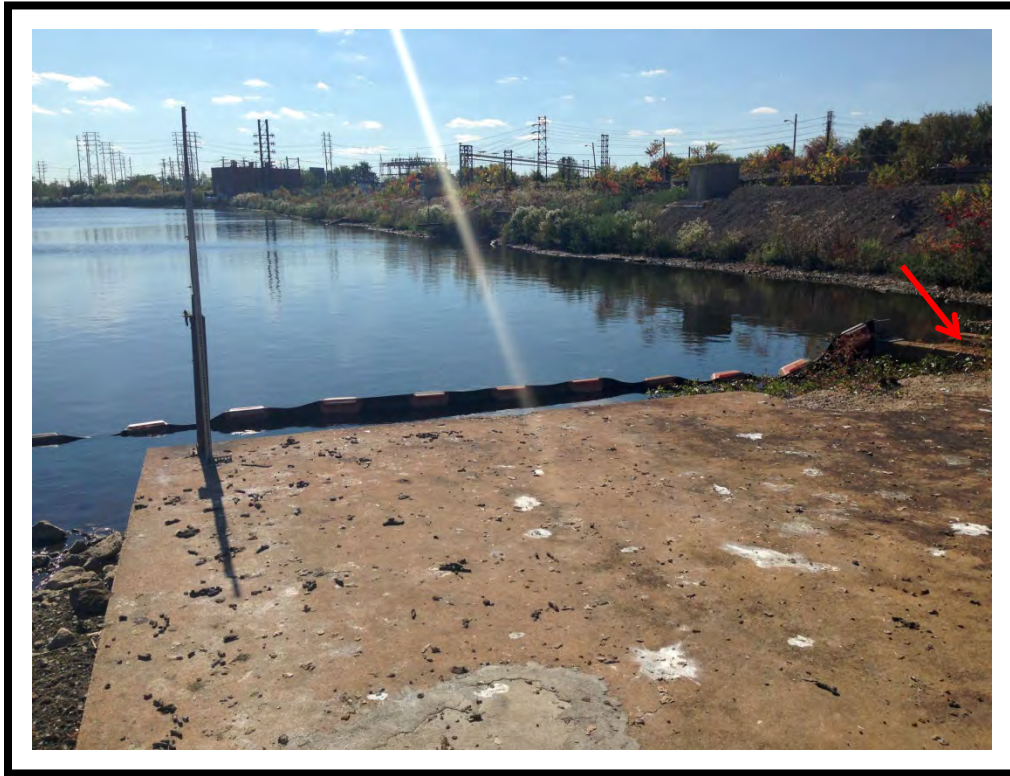
**Photo 5:** Looking south from concrete platform. Discharge pipe and culvert are to the west.

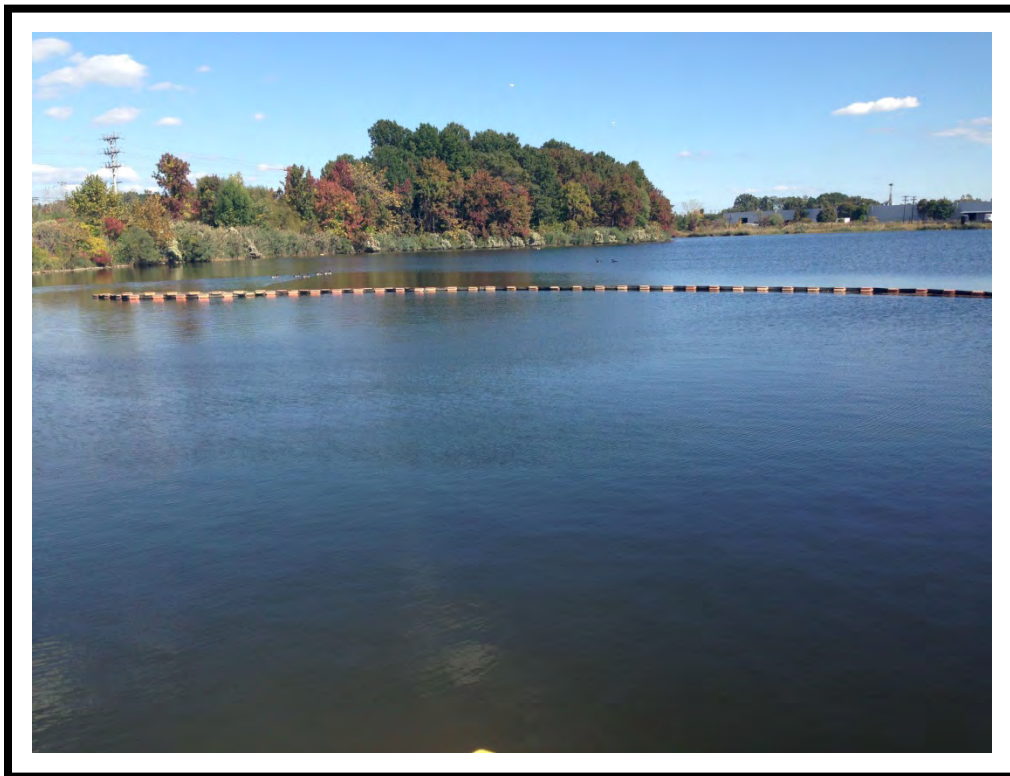
**Photo 6:** Looking northeast from concrete platform at baffle (boom) on High Head Reservoir.
