Re: Generals Highway Sanitary Landfill, Site Inspection Report
SEMS I.D. No. MDN000306755
State I.D. No. MD-599; SSID: A3SR

SITE INSPECTION
of the
Generals Highway Sanitary Landfill (MD-599)
Crownsville, Anne Arundel County, Maryland

January 2015

Prepared by: Maryland Department of the Environment
Land Management Administration
1800 Washington Boulevard
Baltimore, MD 21230

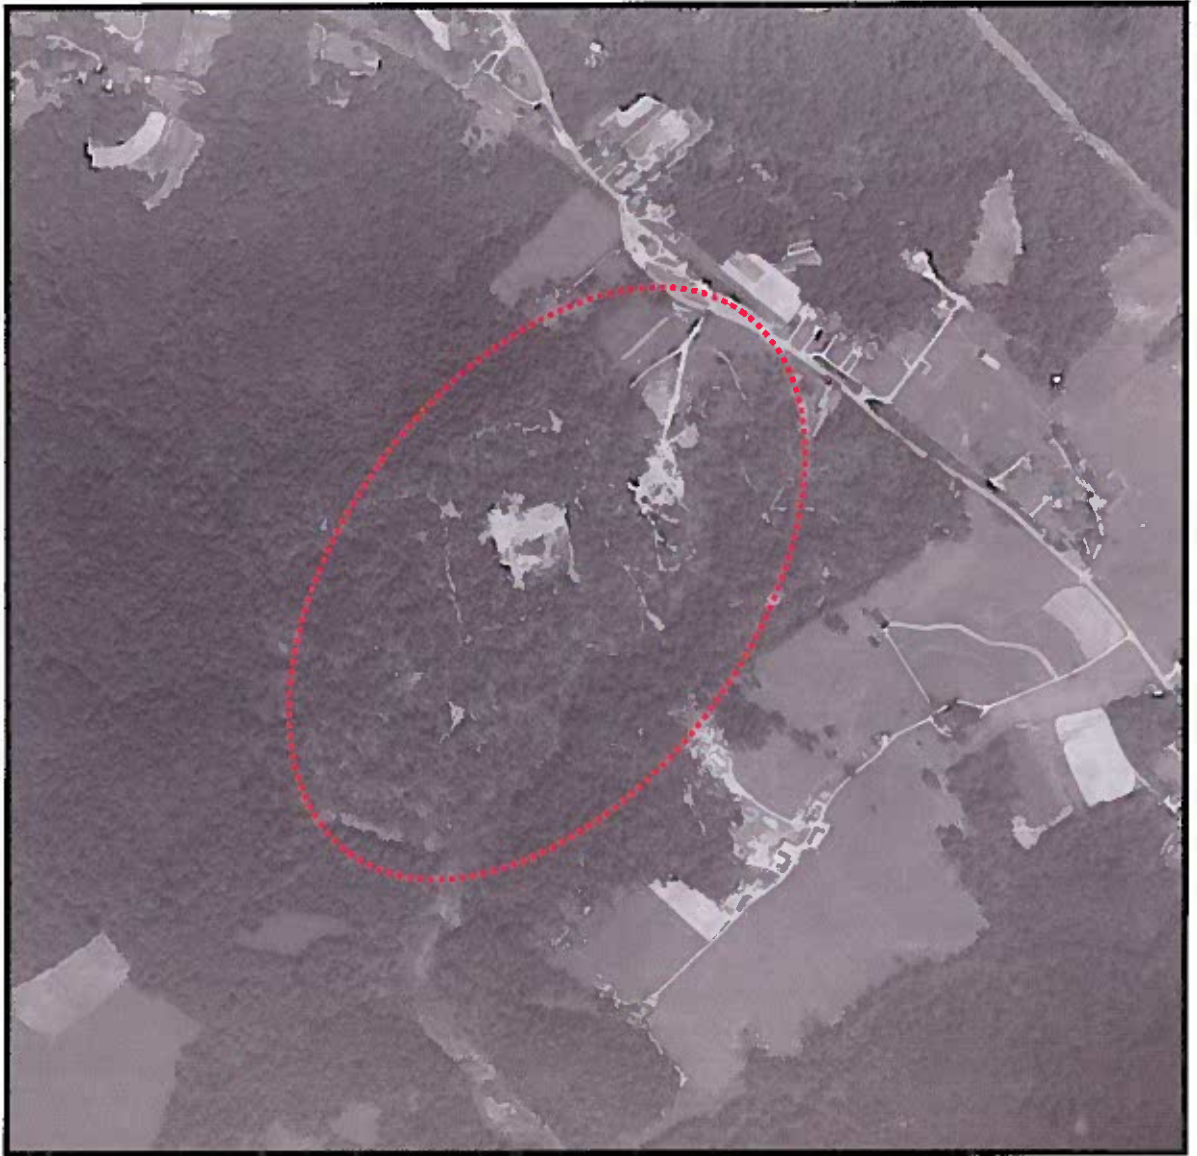
Figure 2: 1959 Aerial Photograph

Photographic analysis of the areal photograph indicated that there are vehicles lined up around the central cleared area and some dumping has occurred along the entrance road.

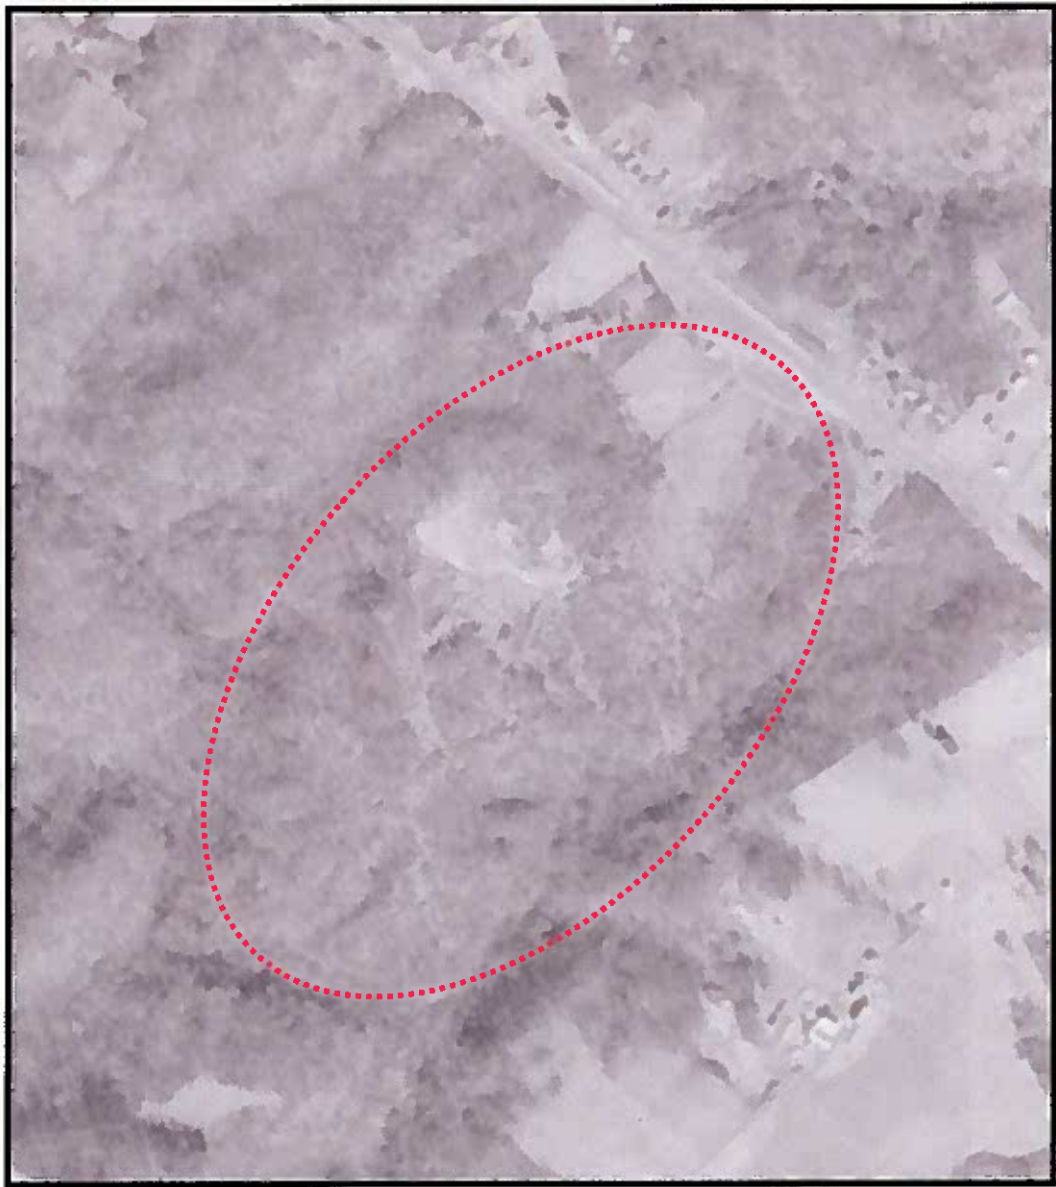
Figure 3: 1970 Aerial Photograph

No more vehicles observed on the site. There are trails in the southern portion of the site.

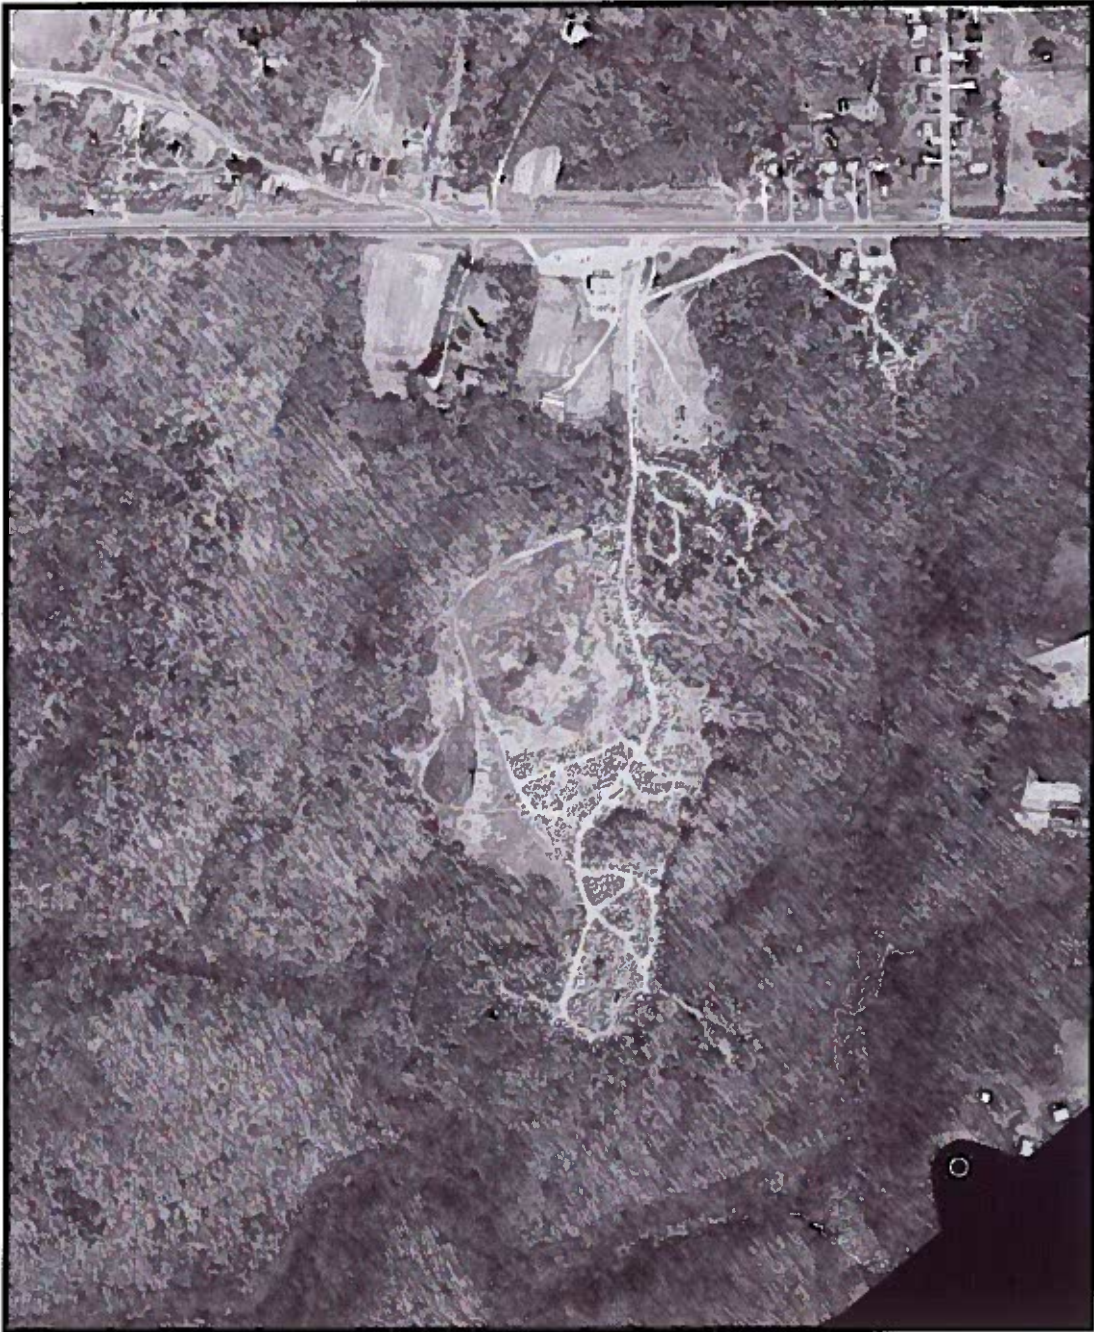
Figure 5: 1984 Aerial Photograph

Vehicles stored along entrance road and southern section of site

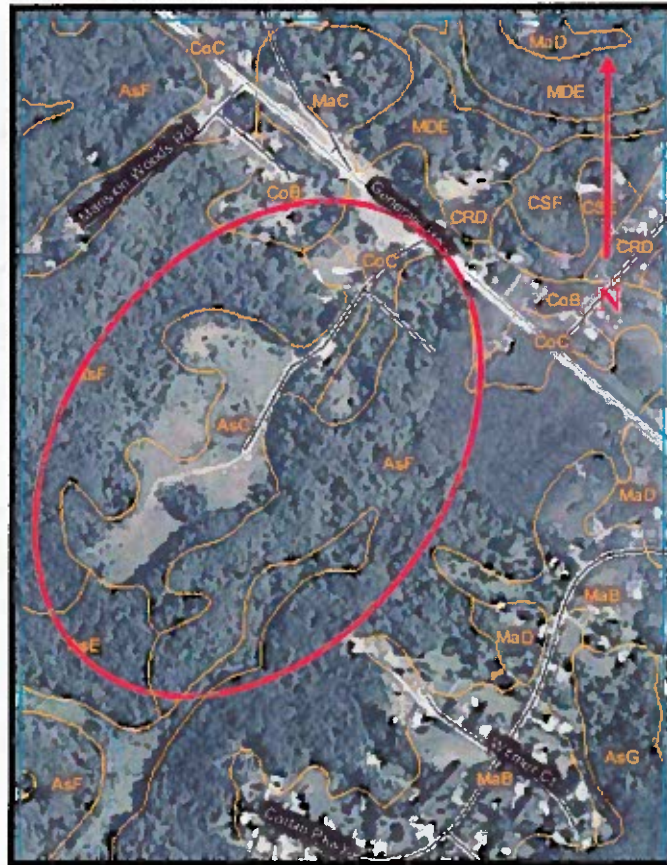
Figure 10: Soils

Soils on the site are primarily the Annapolis fine sandy loam (As) which is described as a well drained soil with moderate water holding capacity (Figure 10). These soils cover approximately 80% of the site. The other soil group found on the site is the Collington-Wist complex (Co) which is described as a well drained soil with a high available water capacity. These soils cover approximately the other 20% of the site.

Map Unit Symbol	Map Unit Name	Acres in AOI	Percent of AOI
AsC	Annapolis fine sandy loam, 5 to 10 percent slopes	23.7	12.2%
AsE	Annapolis fine sandy loam, 15 to 25 percent slopes	7.7	4.0%
AsF	Annapolis fine sandy loam, 25 to 40 percent slopes	103.1	53.1%

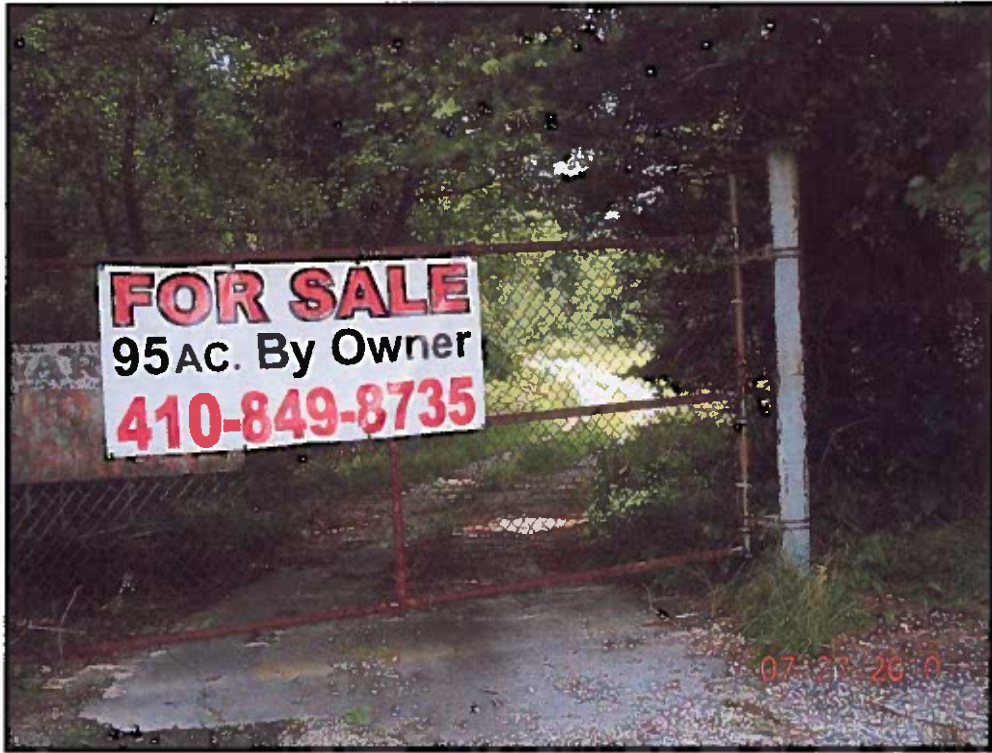
The site consists of approximately 95-acres of undeveloped property located south of and adjacent to Generals Highway in Crownsville, Anne Arundel County, MD. The site is listed on the Anne Arundel County tax map 44 parcel 48 and is situated at 39.007456 degrees north latitude and -76.569105 degrees west longitude (center of site). The site sits on a topographic high that slopes down to the west, south and east to streams that are tributaries of the North Basin, a reservoir formerly used by the City of Annapolis as a public water supply and from there to Broad Creek, a tributary of South River (Figure 1). The topographical elevation difference between the top of the hill to the stream valleys is approximately 100 feet. The property is wooded except for the central portion which is vegetated in grasses and shrubs (Photos 2, 5, 6, and 7). This grassy area is on the topographic high of the site and contains some random piles of rubbish along with some abandoned vehicles and motor homes (Photos 12 and 14). It is also the area where trash was buried. There is a gate at the entrance of the site which limits vehicle access but does not prevent someone from walking onto the site (Photo 1).

Photo 1 - Entrance Gate

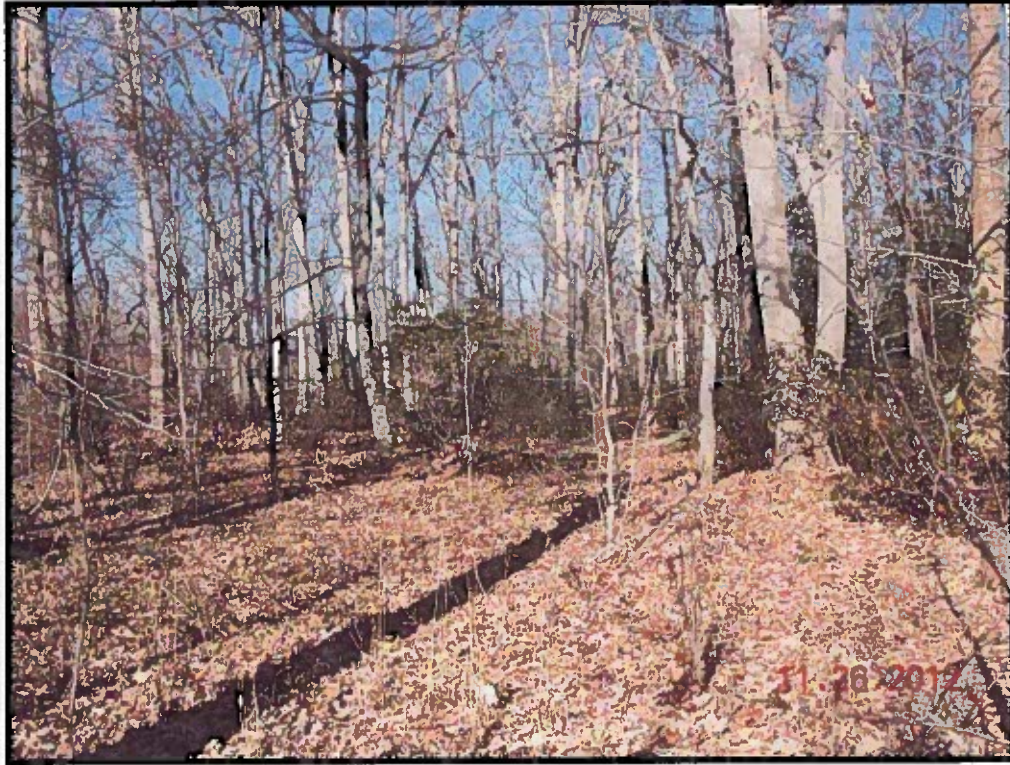
Photos 5 & 6- Wooded areas where vehicles were stored

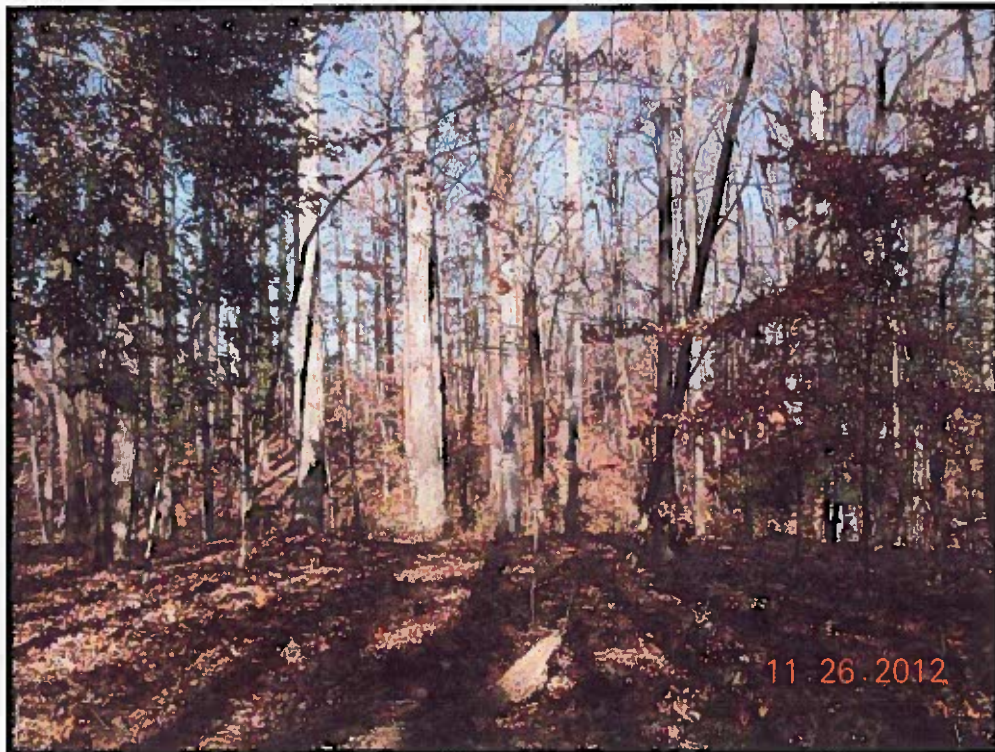
Photo 7 - Abandoned camper

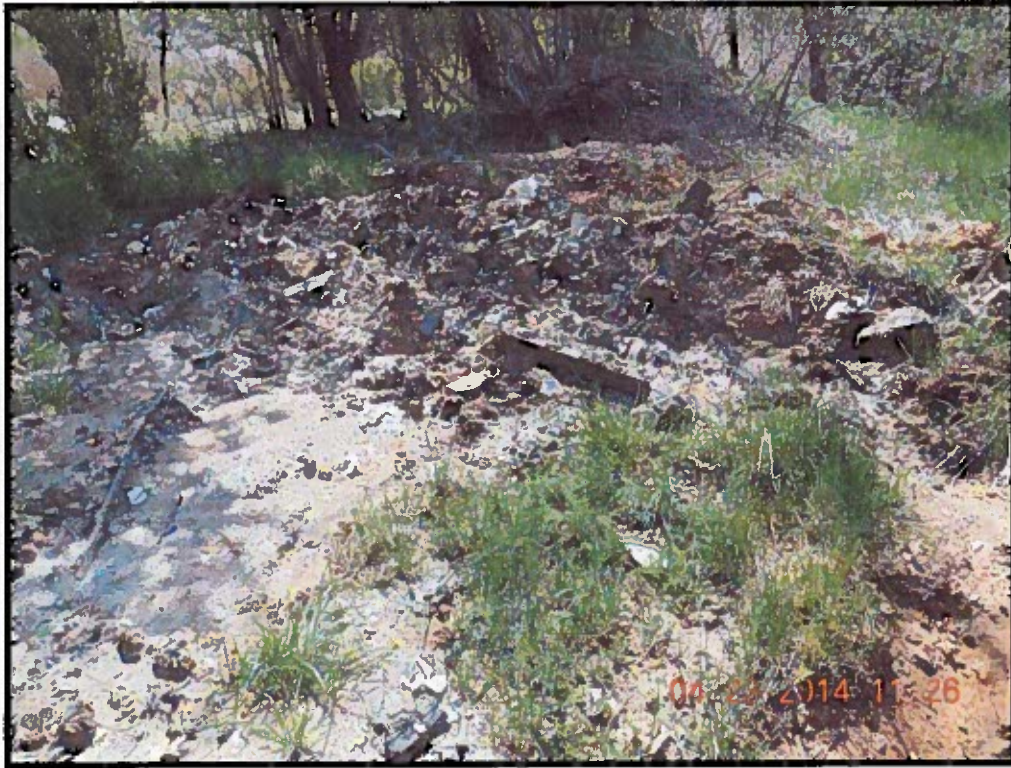
The site was the location of an unpermitted landfill which accepted unregulated waste. Test pits have revealed general household and commercial waste products (Photos 9, 10 and 11). The site was also used as a storage area for hundreds of junked vehicles with the potential to have leaked oils, fuels and other liquid wastes associated with motor vehicles. There were also complaints from local citizens that drums of potentially hazardous wastes were dumped and buried on the site.

Photo 9 - Former Test Pit Location

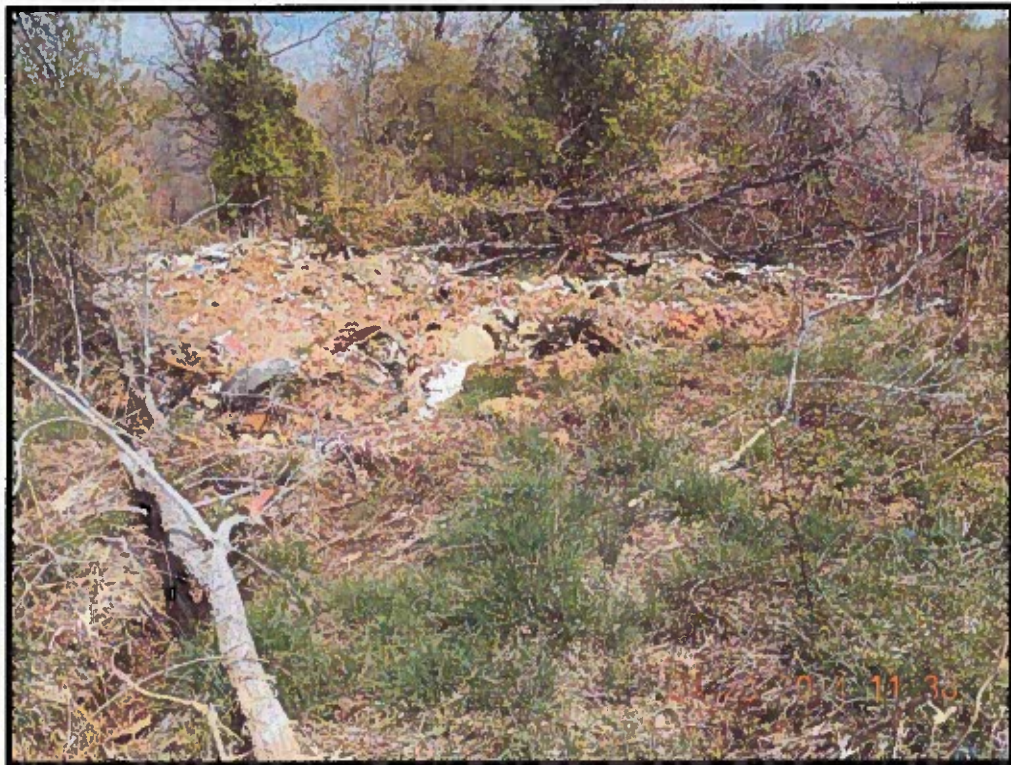
Photo 10 - Former Test Pit Location

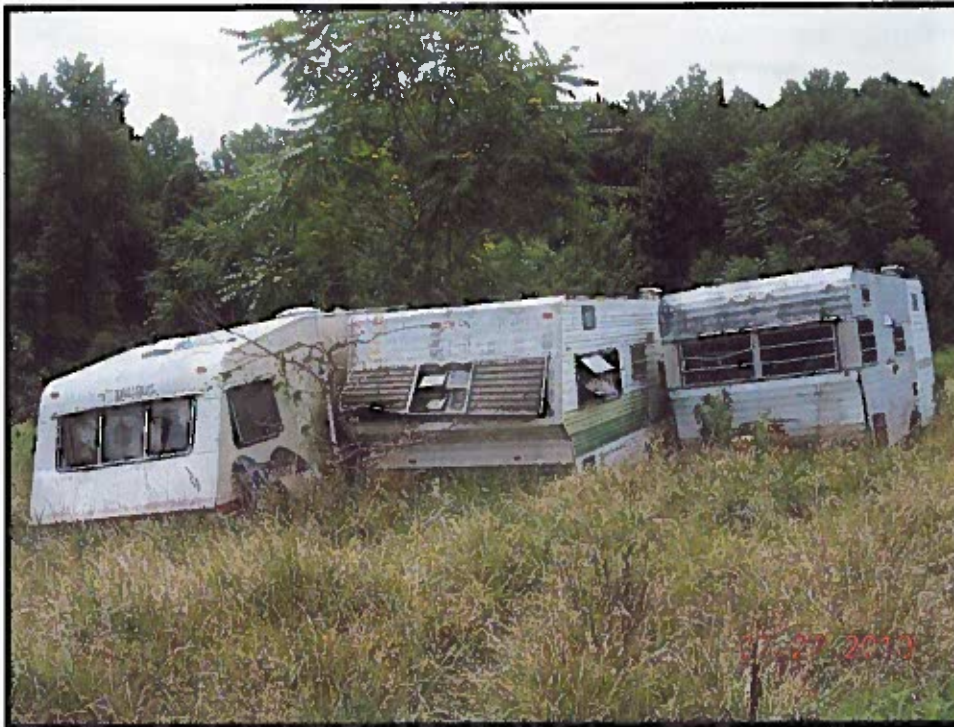
Photo 12 – Abandoned campers

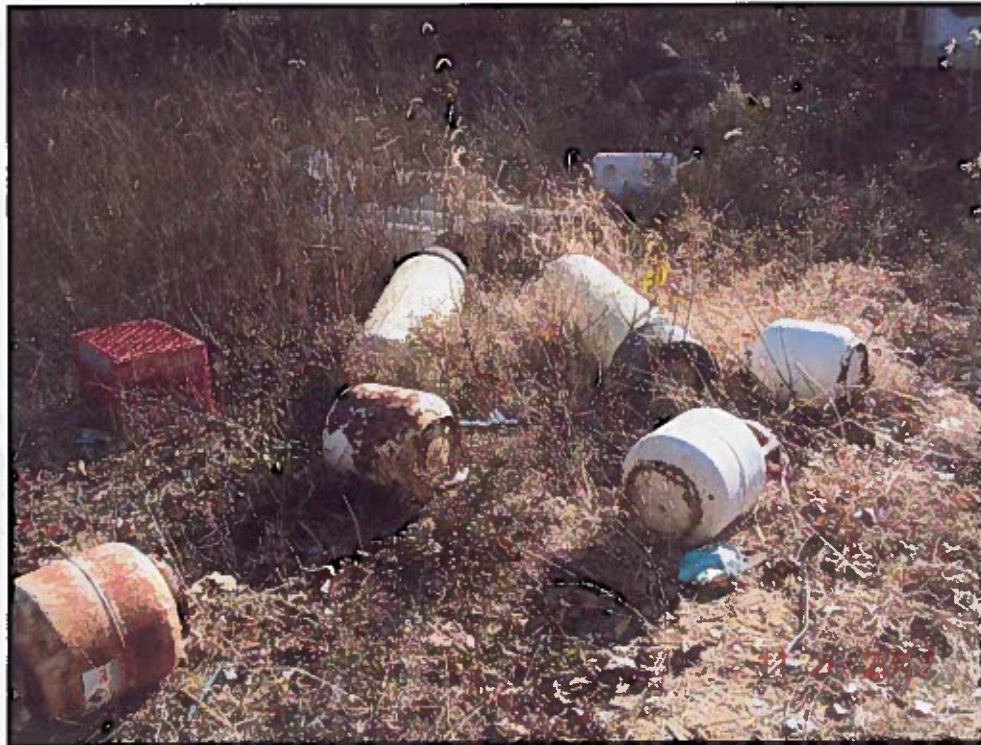
Photo 13 – Discarded propane tanks

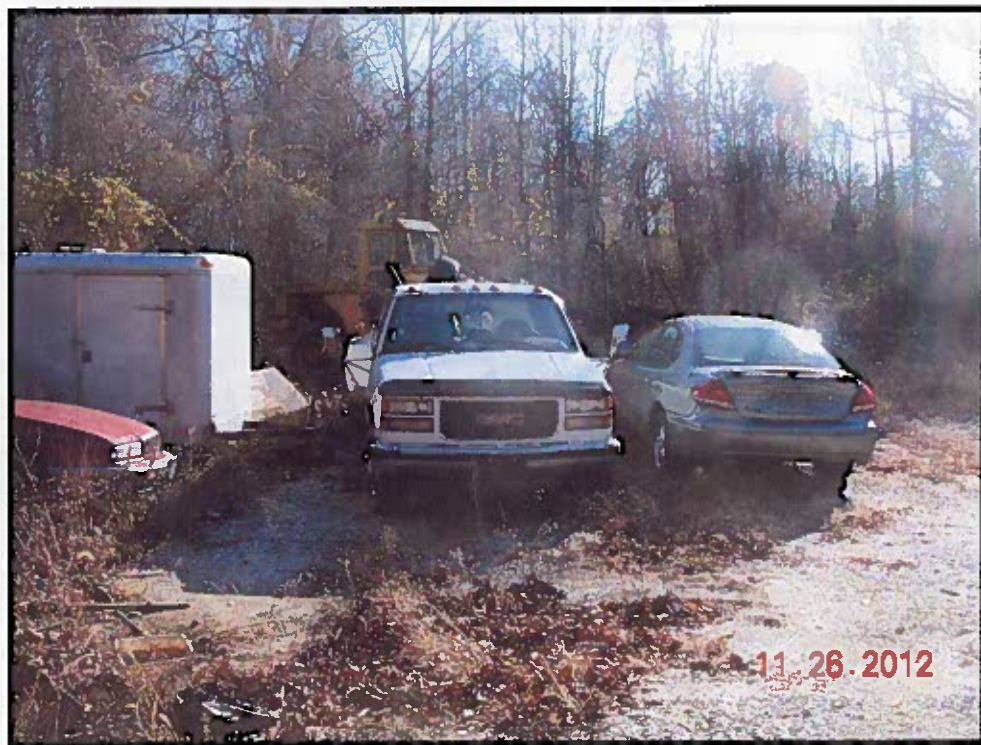
Photo 14 – Abandoned vehicles

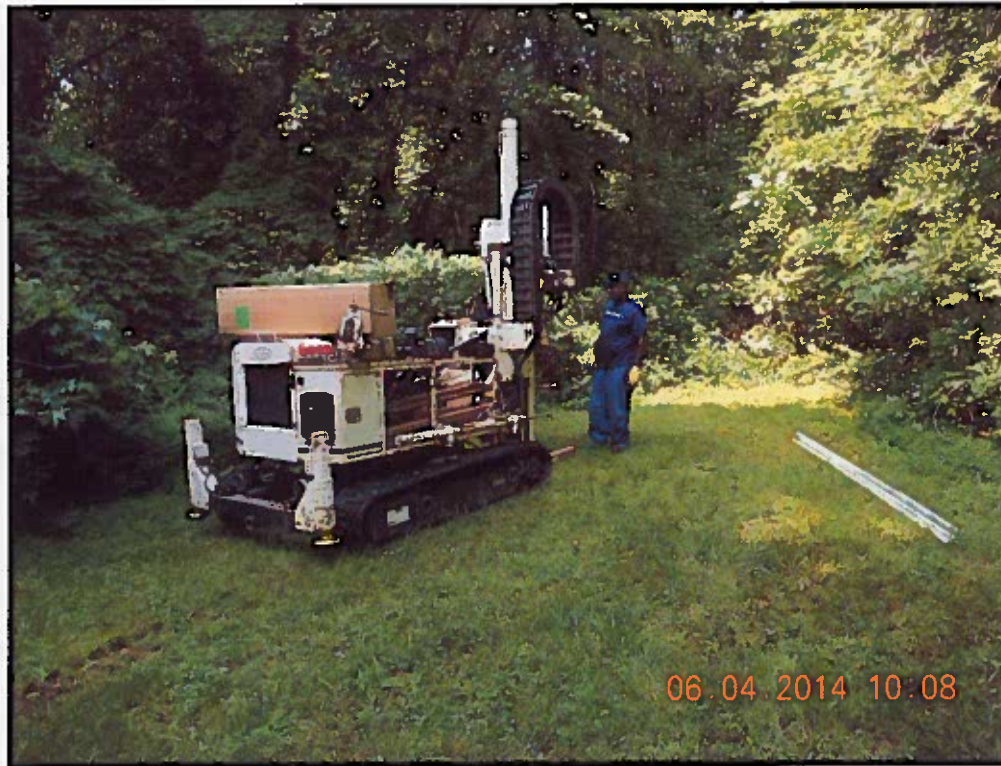
Photo 19 - S-1/SS-1 Behind 1789 Generals Hwy

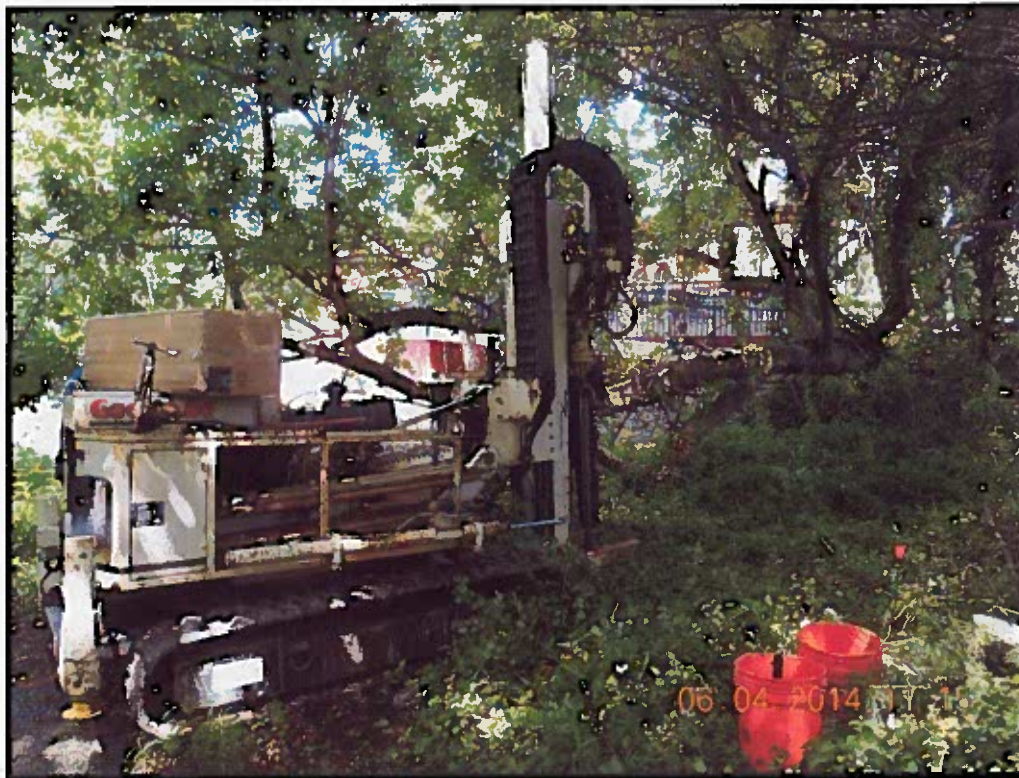
Photo 20 - S-13/SS-13 Near Site Entrance

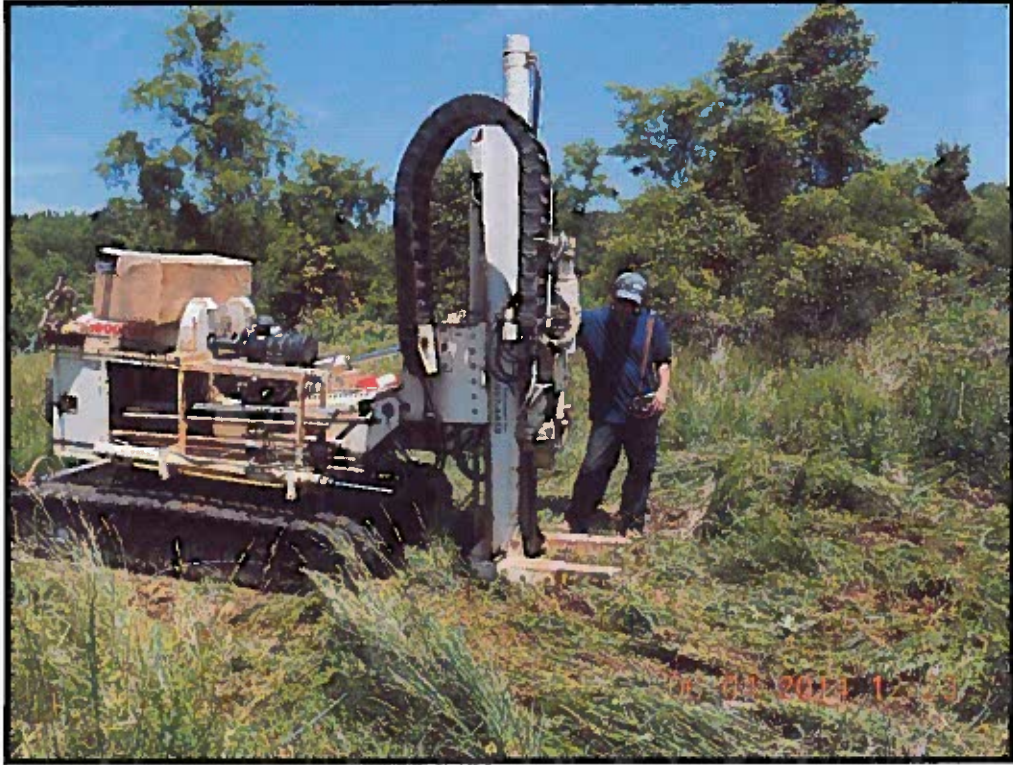
Photo 21 - S-6/SS-6

SVOCs ug/kg	MDE Residential Cleanup Std.	EPA RESIDENTIAL SOIL RBC	S-1	S-2	S-3	S-4	S-5	S-6
Chrysene	22,000	15,000	ND	ND	ND	160J	ND	ND
Bis(2-ethylhexyl)phthalate	46,000	---	ND	ND	ND	ND	ND	ND
Pyrene	230	1,700,000	ND	ND	ND	230	ND	ND
Benzo(a)anthracene	220	150	ND	ND	ND	110J	ND	ND
Benzo(b)fluoranthene	220	150	ND	ND	ND	130J	ND	ND
Benzo(a)pyrene	22	15	ND	ND	ND	130J	ND	ND
Benzo(g,h,i)perylene	230,000	---	ND	ND	ND	140J	ND	ND

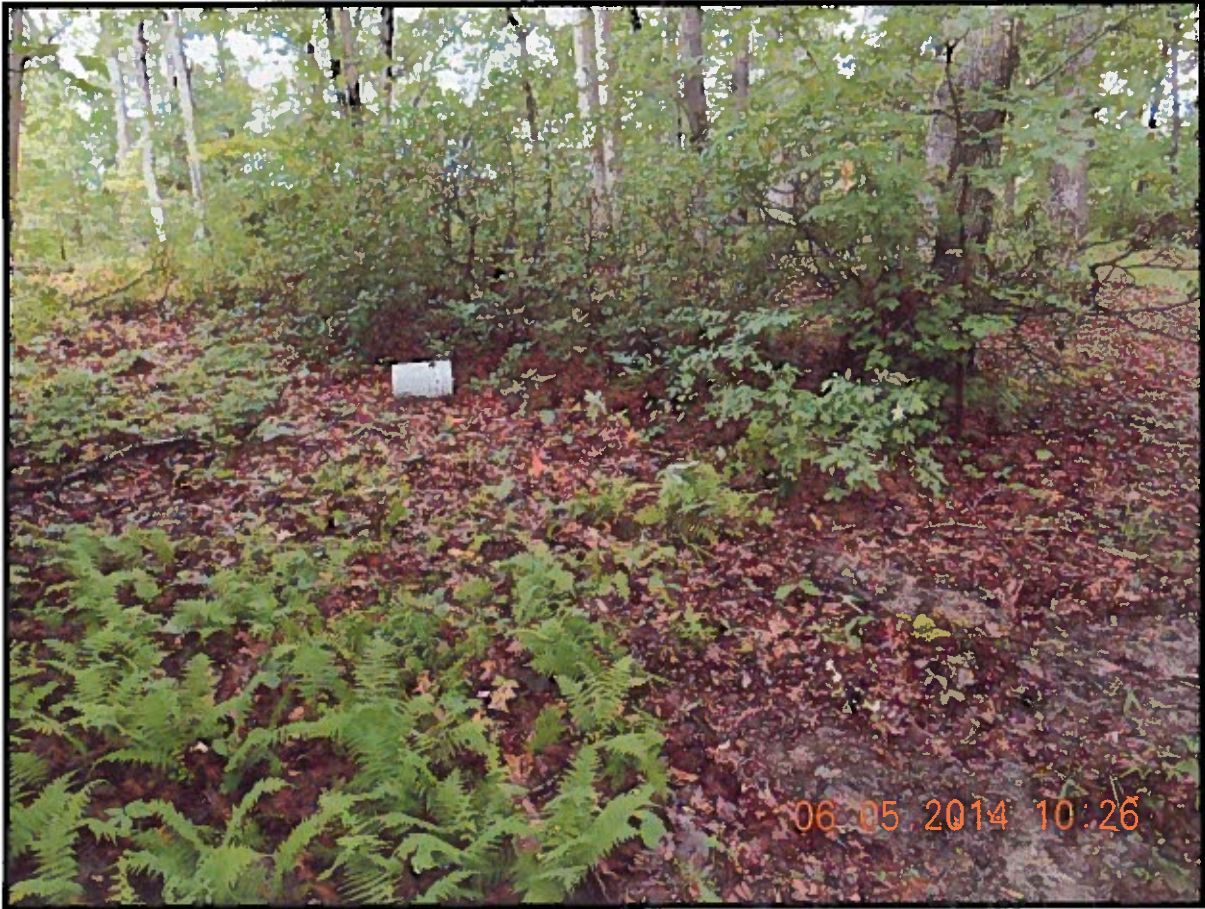
Photo 23 - S-11/SS-11 Area where vehicles were stored

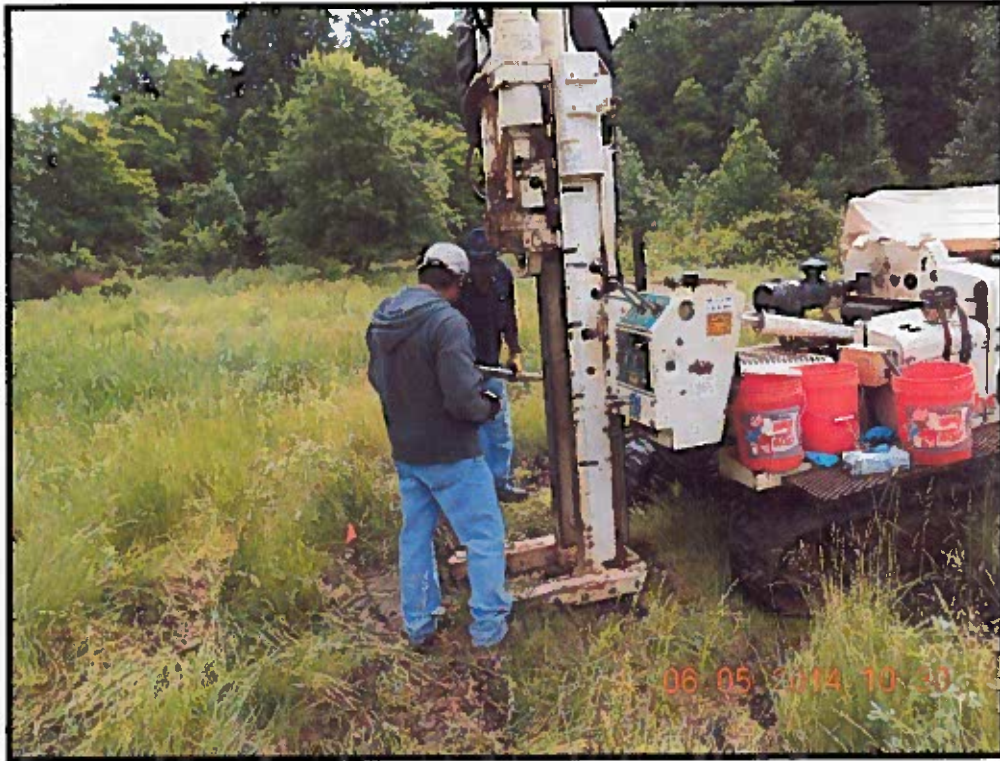
Photo 27 - S-10/SS-10

SVOCs ug/kg	MDE Residential Cleanup Std.	EPA RESIDENTIAL SOIL RBC	S-7	S-8	S-9	S-10	S-11	S-12
Chrysene	22,000	15,000	ND	ND	ND	160J	ND	ND
Bis(2-ethylhexyl)phthalate	46,000	---	ND	ND	ND	100J	ND	ND
Benzo(a)anthracene	220	150	ND	ND	ND	ND	ND	ND
Benzo(b)fluoranthene	220	150	ND	ND	ND	ND	ND	ND
Benzo(a)pyrene	22	15	ND	ND	ND	220	ND	ND
Benzo(g,h,i)perylene	230,000	---	ND	ND	ND	350	ND	ND

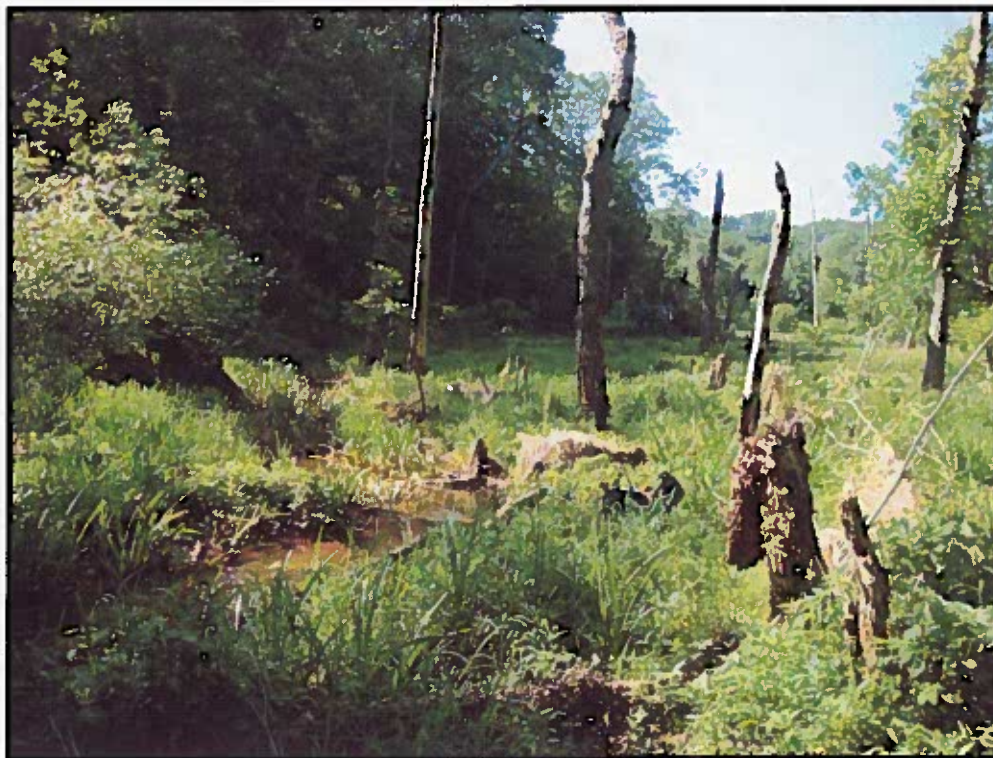
Photo 32 - SW-1/Sed-1

There are wetlands and floodplains located in the northwestern/western edge of the site in the valley that carries the stream that feeds the North Basin reservoir (Photos 32, 33 and 34). Wetlands in the stream valley are classified as "Freshwater Emergent Wetlands" and extend down to the basin (Figure 8). The 100-year floodplain is located within the same stream valley and extends beyond the wetland boundaries but not beyond the bottom of the stream valley (Figure 7). The stream valley runs along just south of the property line and then south/southeastward toward the basin with a tributary that is located southeast of the property. There is an approximate 100 foot elevation differential between the top of the hill and the stream valleys.
