LOWER ZONE CORRECTIVE ACTION PLAN

ExxonMobil Baltimore Terminal

SEPTEMBER 10, 2009

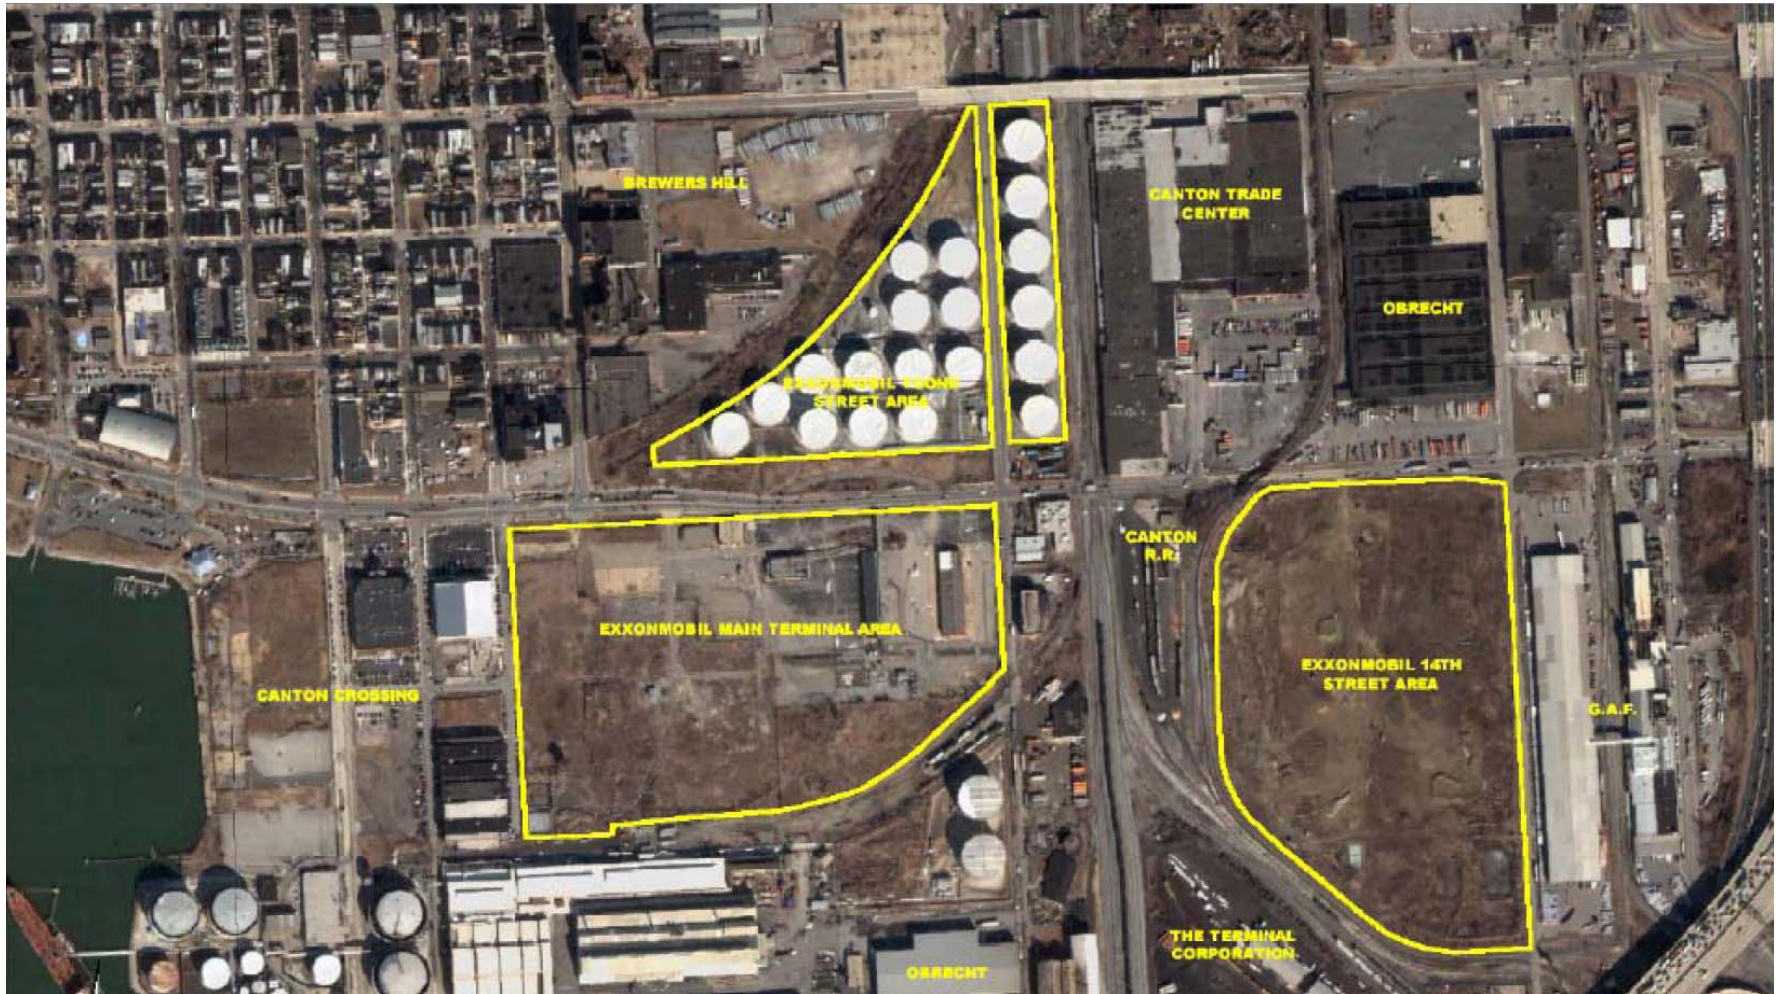
TITLE:		Aerial Map with Project Areas	
LOCATION:		ExxonMobil Baltimore Terminal Baltimore, Maryland	
CHECKED		FIGURE:	1
DRAFTED			
FILE			
DATE	2/17/09

The former ExxonMobil Baltimore Terminal project area has historically included three main parcels which are presented in **Figure 1**. These include the “Main Terminal”, the “Toone Street Tank Field” and the “14th Street Parcel”. From the late 1800s through 1957, these parcels were used for refining, storing, and distributing petroleum products. The refinery was a key fuels production and distribution facility during World Wars I and II. From 1957 through 1998 the Main Terminal and Toone Street Tank Field parcels were used for the storage and distribution of petroleum products. Adjacent off-site properties include Baltimore City, Canton Railroad, Canton Trade Center, Obrecht, Terminal Corporation, Tulkoff, and Warner Graham.

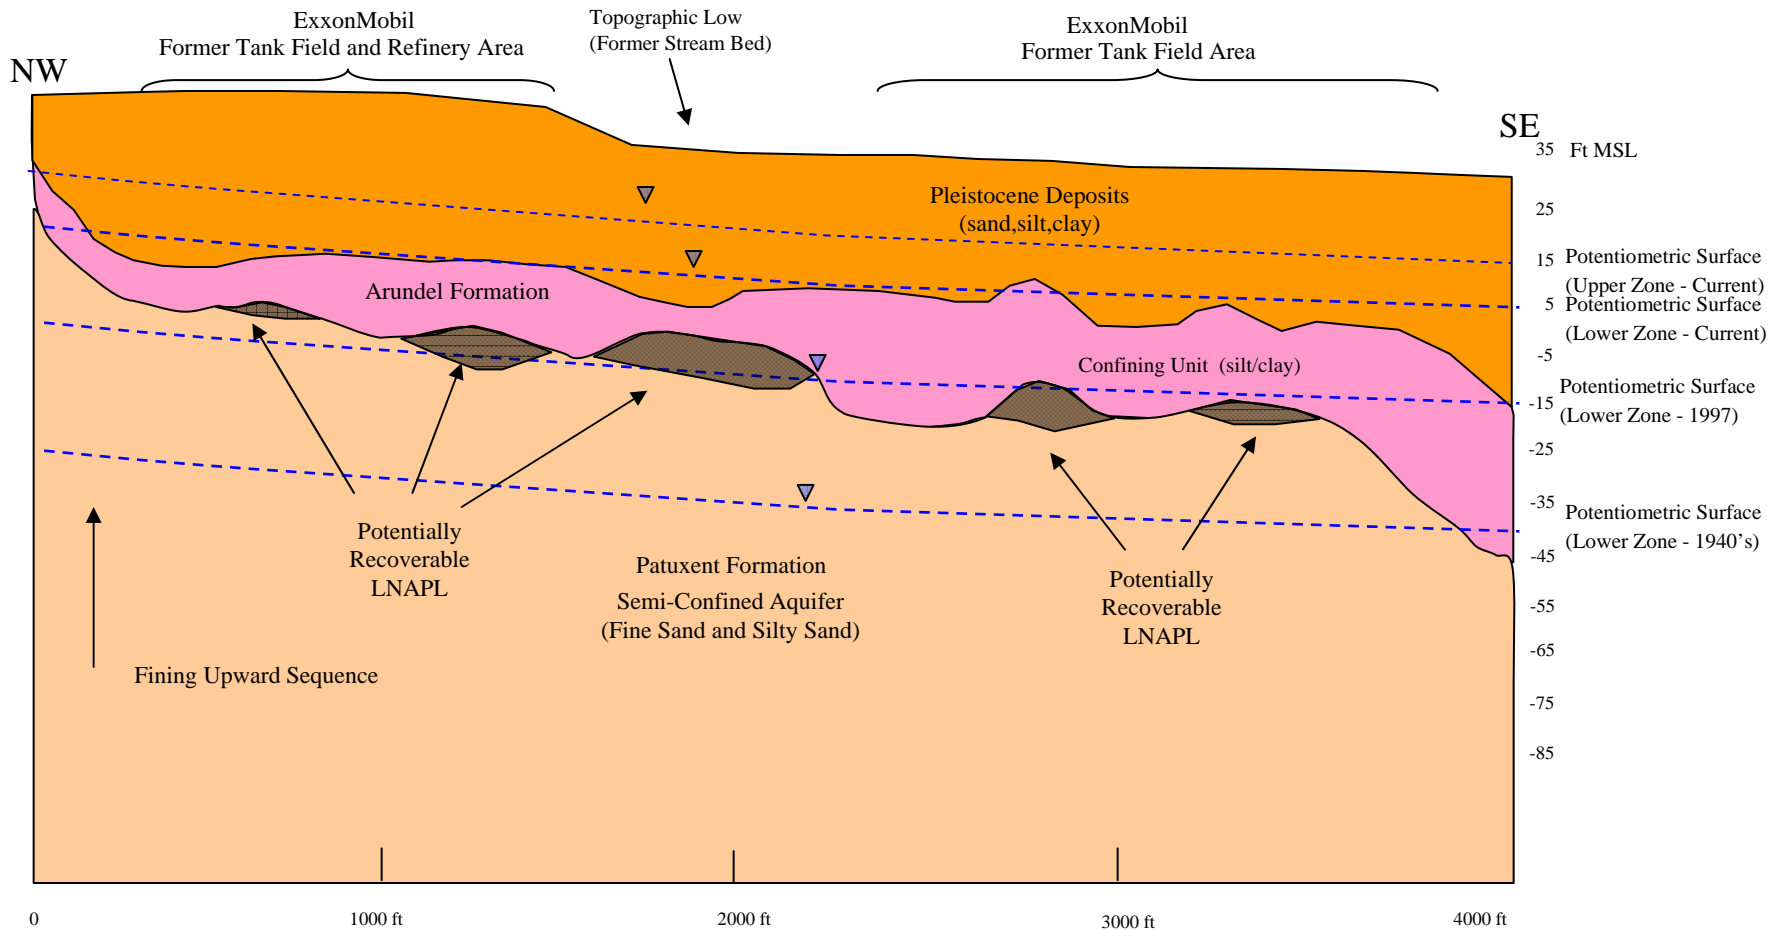
CHECKED		FIGURE: 2
	DRAFTED		
	FILE		
	DATE	2/17/09

TITLE: Site Conceptual Model Diagram			
LOCATION: ExxonMobil Baltimore Terminal Baltimore, Maryland

The potentiometric surface of the groundwater in the Patuxent Formation has changed significantly over the past 60 years. Prior to industrialization of the project area, the potentiometric surface in the vicinity of the site ranged from +5 to -5 feet MSL. The potentiometric surface in the 1940s is estimated to have reached a depth of approximately 70 feet BGS (-40 feet MSL) as a result of heavy industrial pumping in the vicinity of the project area. In 1997, the potentiometric surface was measured at approximately 45 feet BGS (-15 feet MSL), with one down-gradient industrial well (Red Star Yeast) still in operation. As a result of the shutdown of this industrial well in the late 1990s, and additional wells over the past several years, water levels in the Patuxent Formation currently range from 20 to 25 feet BGS (+5 to +10 ft MSL)(**Figure 2**).

Since initial operations began in 1996, recovery rate and gauging data (LNAPL thickness) have been collected and utilized to optimize LNAPL recovery over time. **Attachment I** presents examples of graphs that are currently used to track individual well recovery rates, cumulative LNAPL recovered, and the presence and thickness of the recovery zone. Review of the graphs indicates the connection between the recovery zone thickness in an individual well and pumping rates. Specifically, for those wells with deeper Arundel/Patuxent contacts, LNAPL recovery rates and the thickness of its recovery zone are generally less than those wells with shallower Arundel/Patuxent contacts. This is due to the long-term collection and entrapment of the LNAPL at the Arundel/Patuxent contact (**Figure 2**).

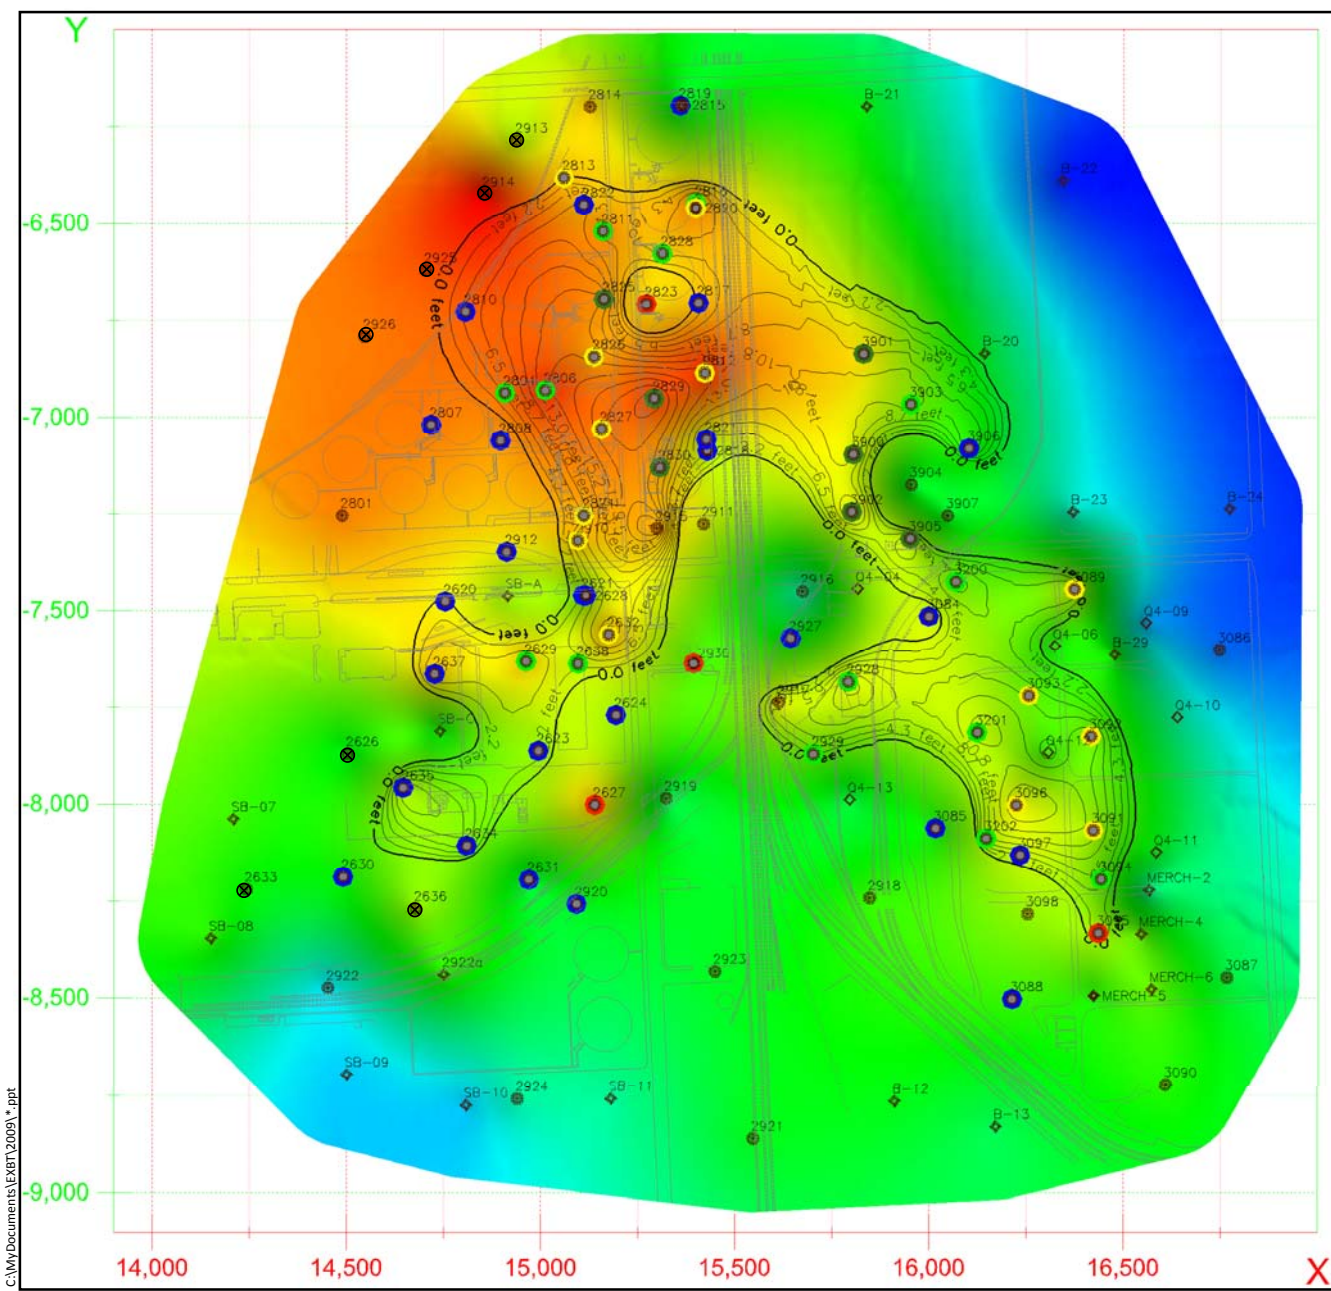
11490 WESTHEIMER ROAD	
		SUITE 150	
		HOUSTON, TX 77077	
EXXONMOBIL BALTIMORE TERMINAL BALTIMORE, MARYLAND			
LOWER ZONE LNAPL RECOVERY ZONE MAP (SCR Addendum 6/09)			
PROJECT NO:	GTH3109	DRAWN BY:	EBD
REVISION NO:	00	CHECKED BY:	
DATE:	01 JUNE 2009	APPROVED BY:	
			FIGURE 7

Based on the Site Conceptual Model and the remedial activities completed to date, LNAPL recovery is directly related to the presence/absence of a definable “recovery zone” for the project area. The term “recovery zone” (**Figure 6**) is defined as the vertical and horizontal extent of recoverable LNAPL below the Arundel/Patuxent contact. The recovery zone is measured as the difference between the oil/water interface elevation and the elevation of the stratigraphic boundary of the Arundel/Patuxent. Specifically, it is that LNAPL interval which is in direct communication with LNAPL-yielding sediments which results in higher LNAPL recovery rates which are able to be sustained during recovery efforts. In comparison, for those wells without a recovery zone, LNAPL typically “weeps” in from submerged zones which results in very low and inconsistent/unsustainable LNAPL recovery. **Figure 7** presents a contour map of the recovery zone area as documented in the Lower Zone Site Characterization Addendum Report (6/09).

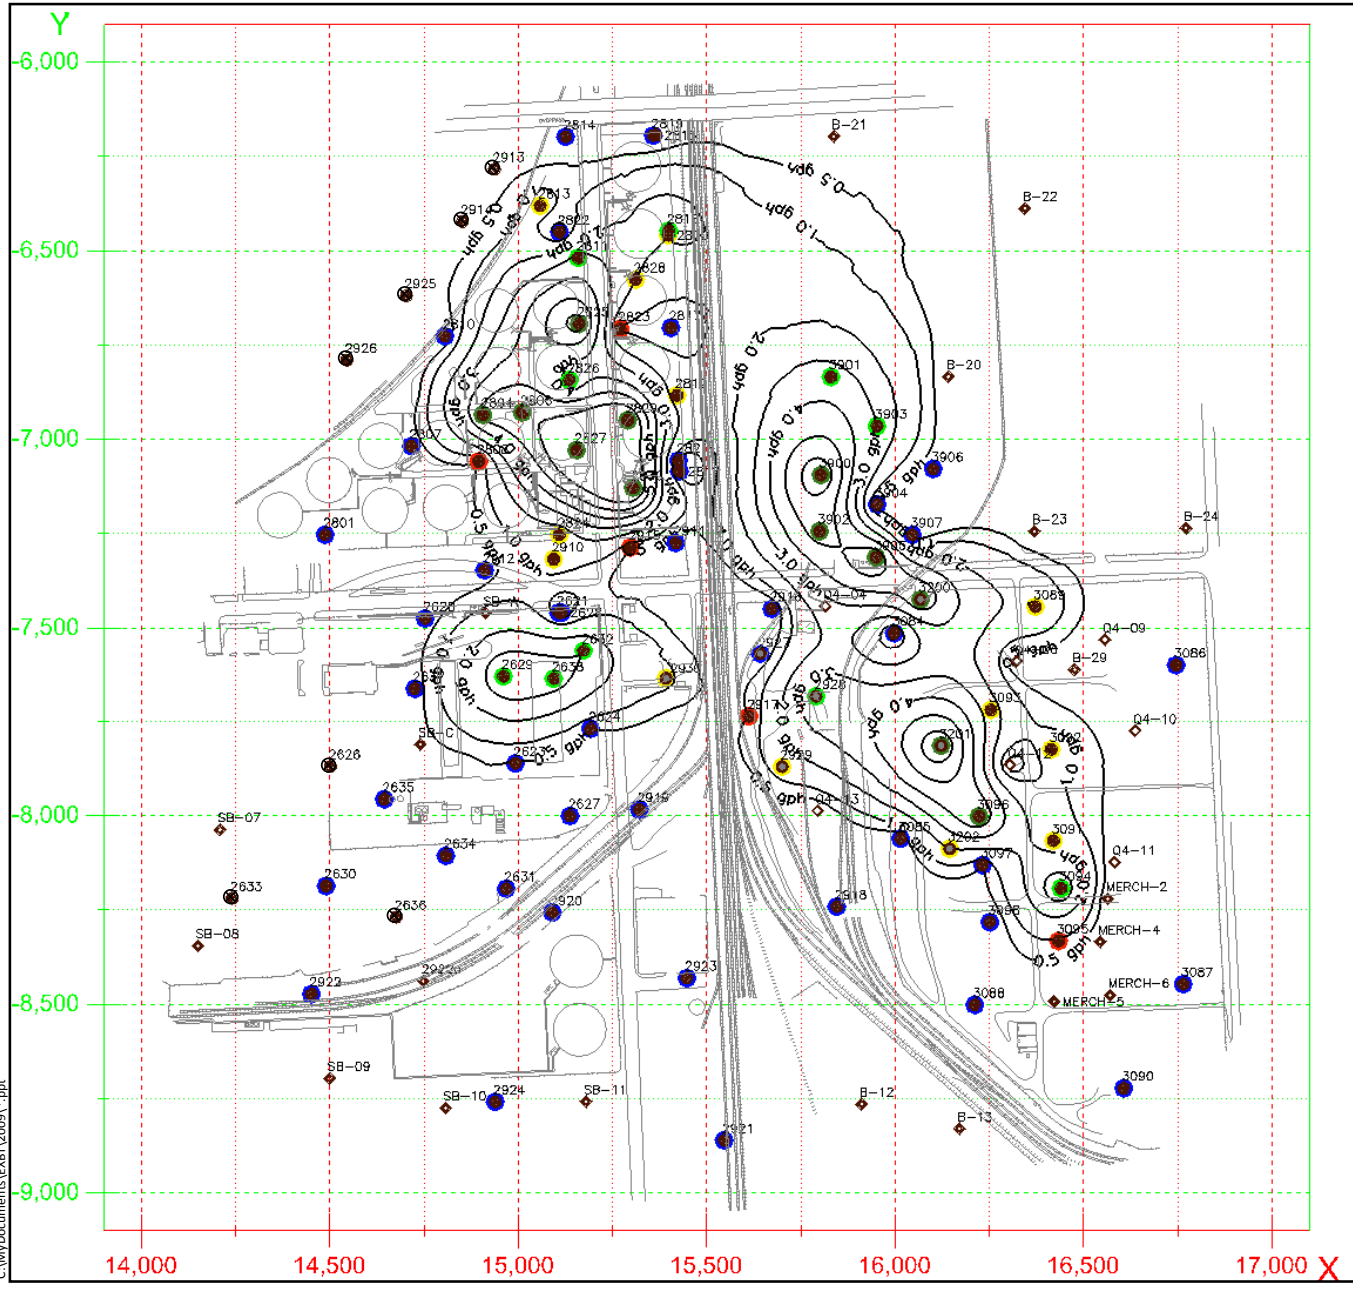
Geosyntec consultants		11490 WESTHEIMER ROAD SUITE 150 HOUSTON, TX 77077
EXXONMOBIL BALTIMORE TERMINAL BALTIMORE, MARYLAND		
UPDATED LOWER ZONE LNAPL RECOVERY RATE MAP		
PROJECT NO:	GTH3109	DRAWN BY: EBD
REVISION NO:	00	CHECKED BY:
DATE:	18 AUG 2009	APPROVED BY:
		FIGURE 8

An updated summary of bail-down testing results, historic short and long-term recovery testing, and recovery rates is presented in **Table 1**. Historical recovery rates vary significantly across the site and have been categorized as < 1 gallon per hour (GPH), 1 to 3 GPH, 3 to 5 GPH, and greater than 5 GPH. **Figure 8** presents an updated recovery rate contour map.

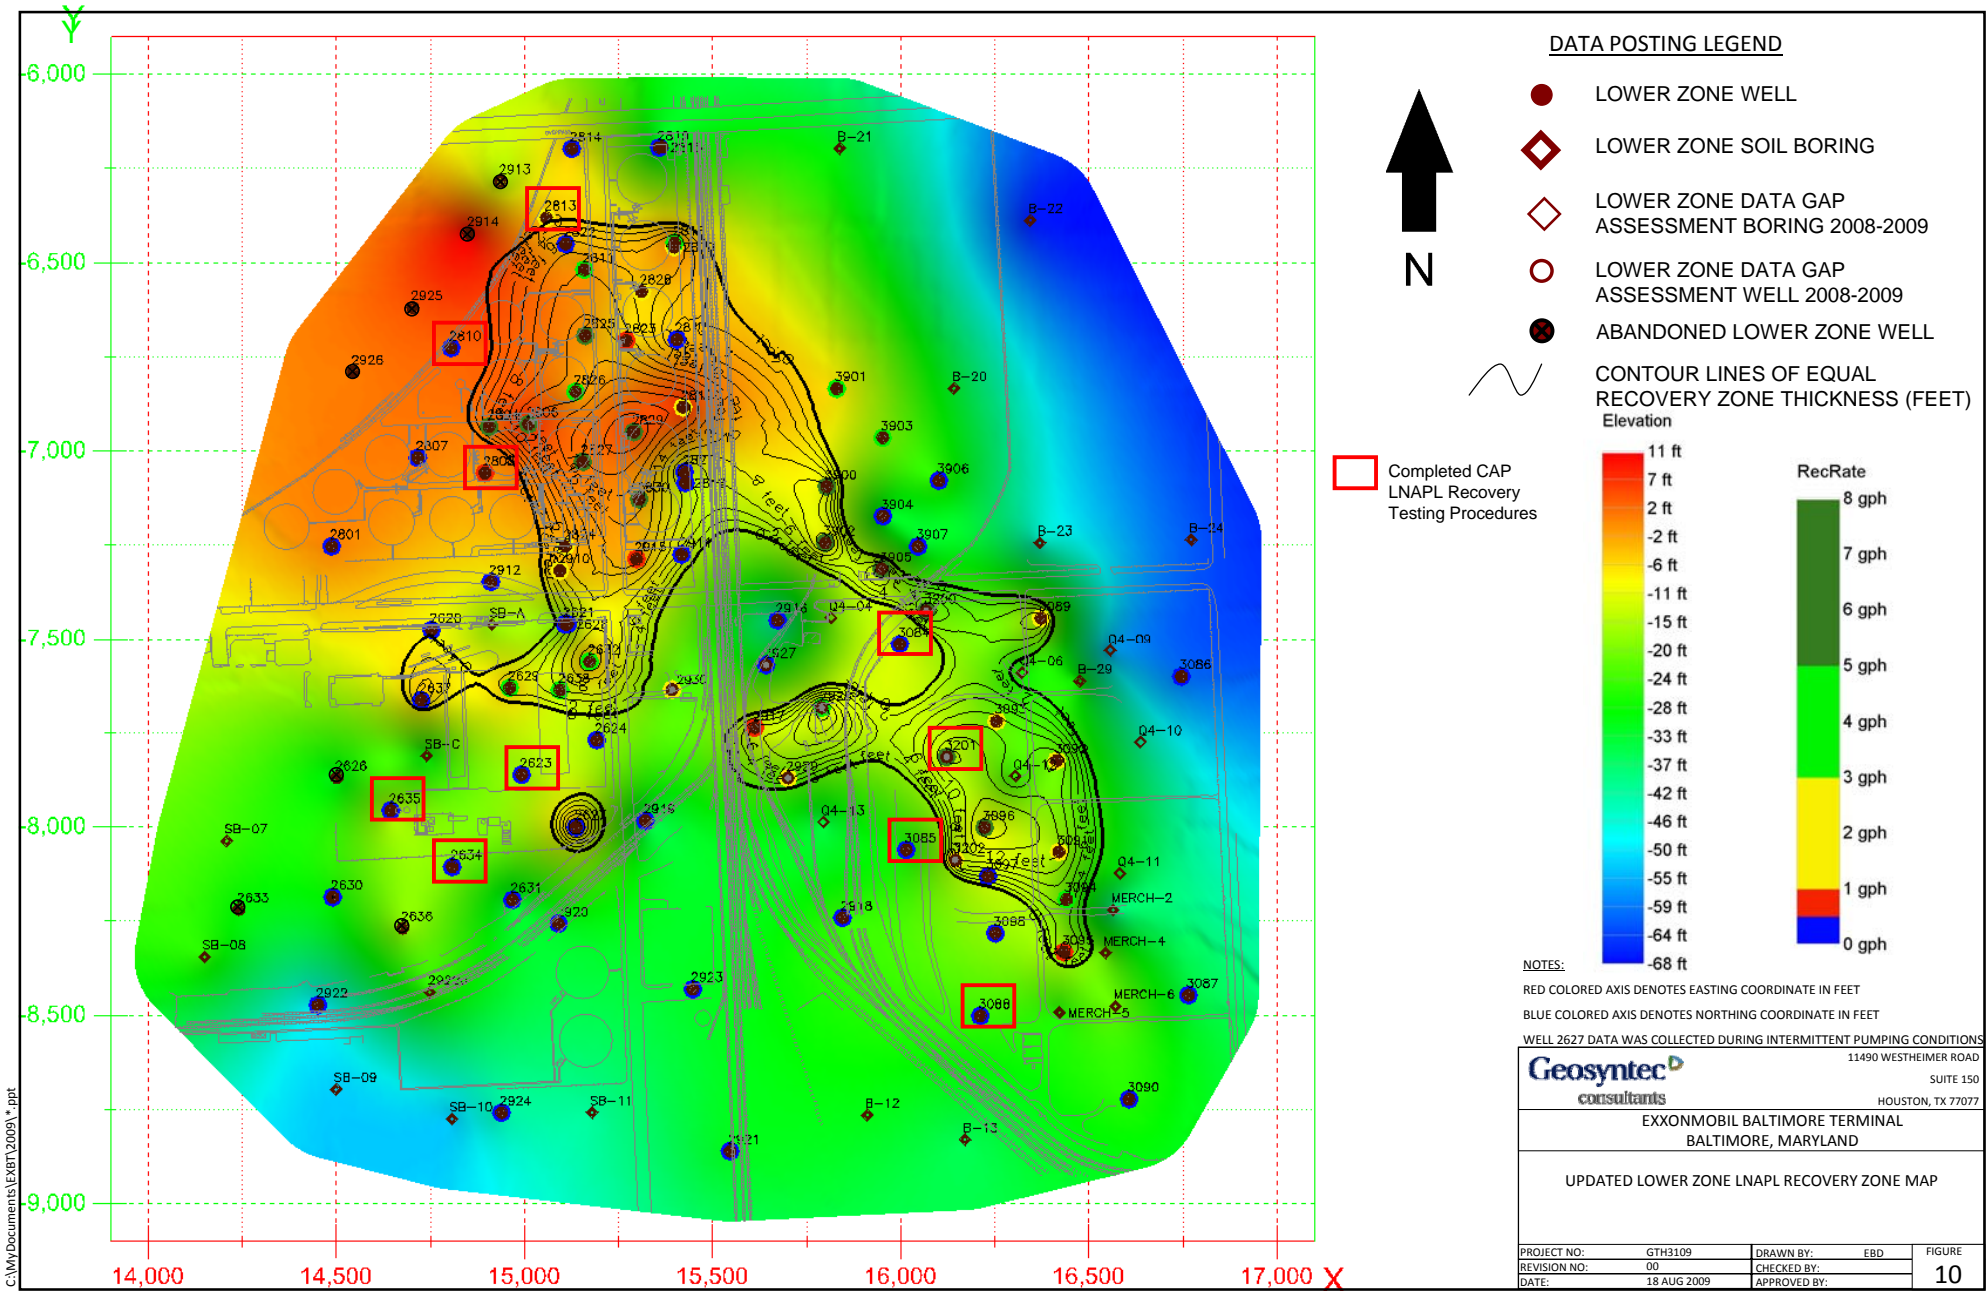
CONTOUR LINES OF EQUAL RECOVERY ZONE THICKNESS (FEET)
Elevation

UPDATED LOWER ZONE LNAPL RECOVERY ZONE MAP

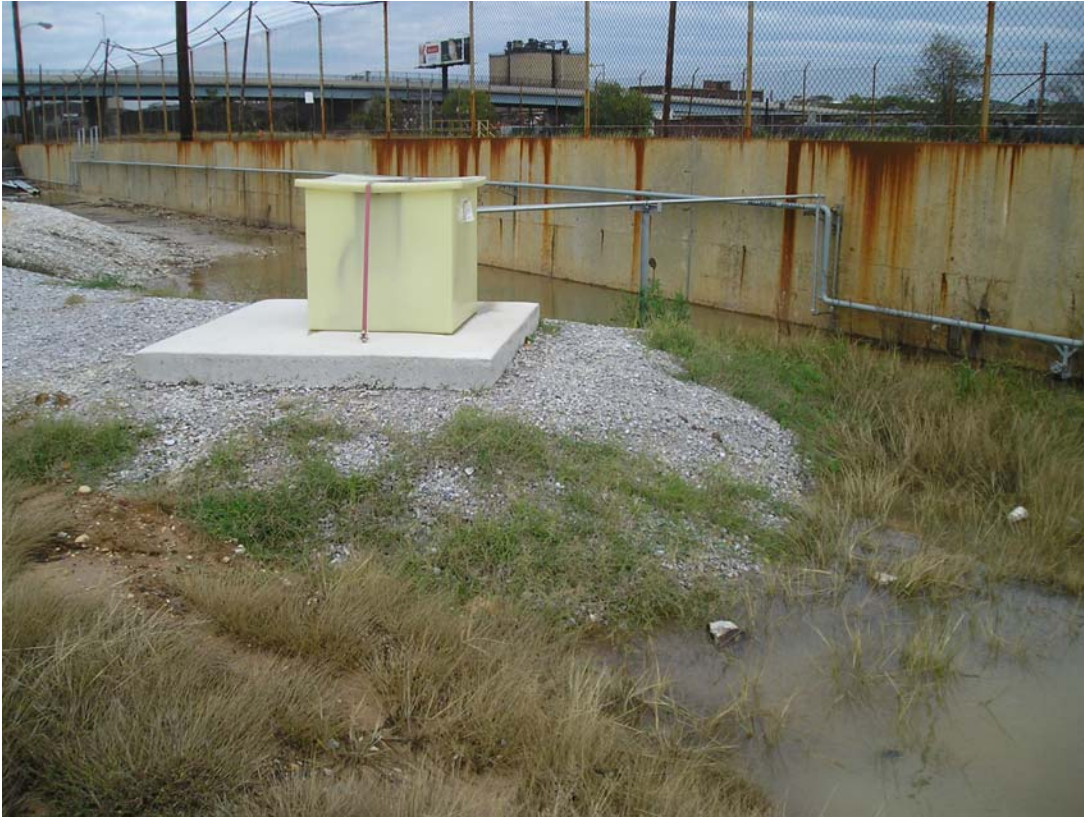
View of above grade sump in Toone Street Tankfield.

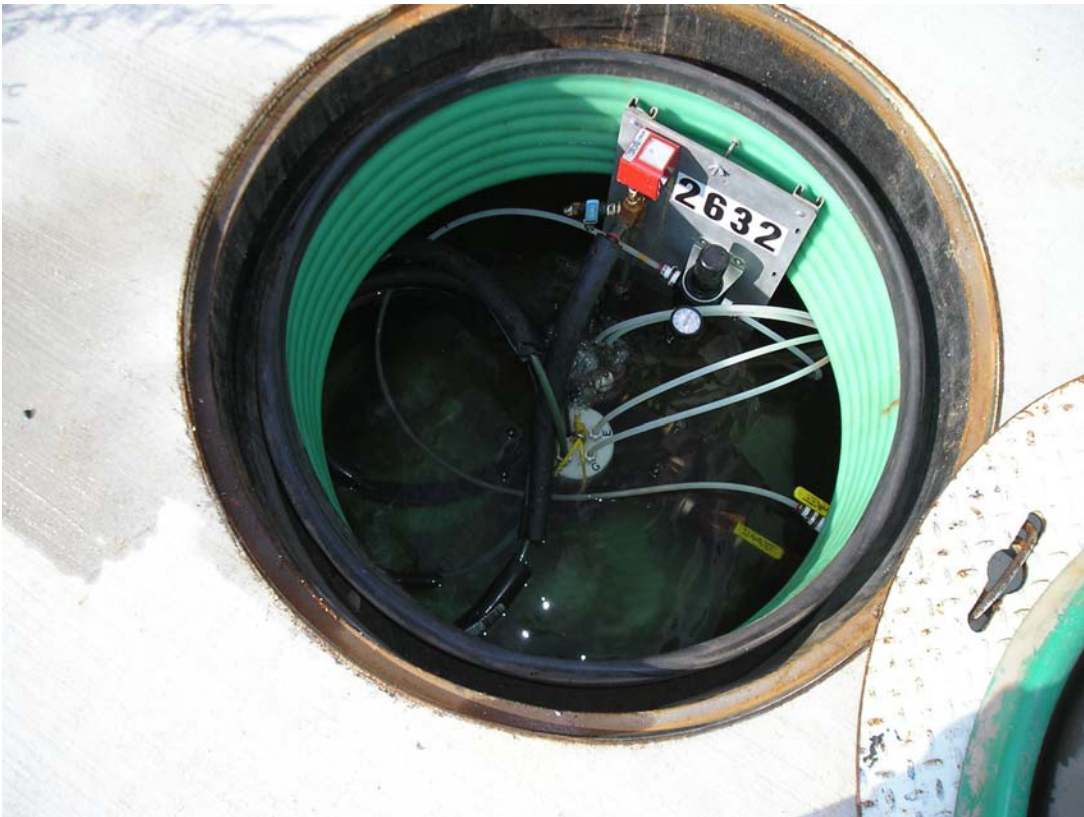
View of below grade sump in Main Terminal Area.

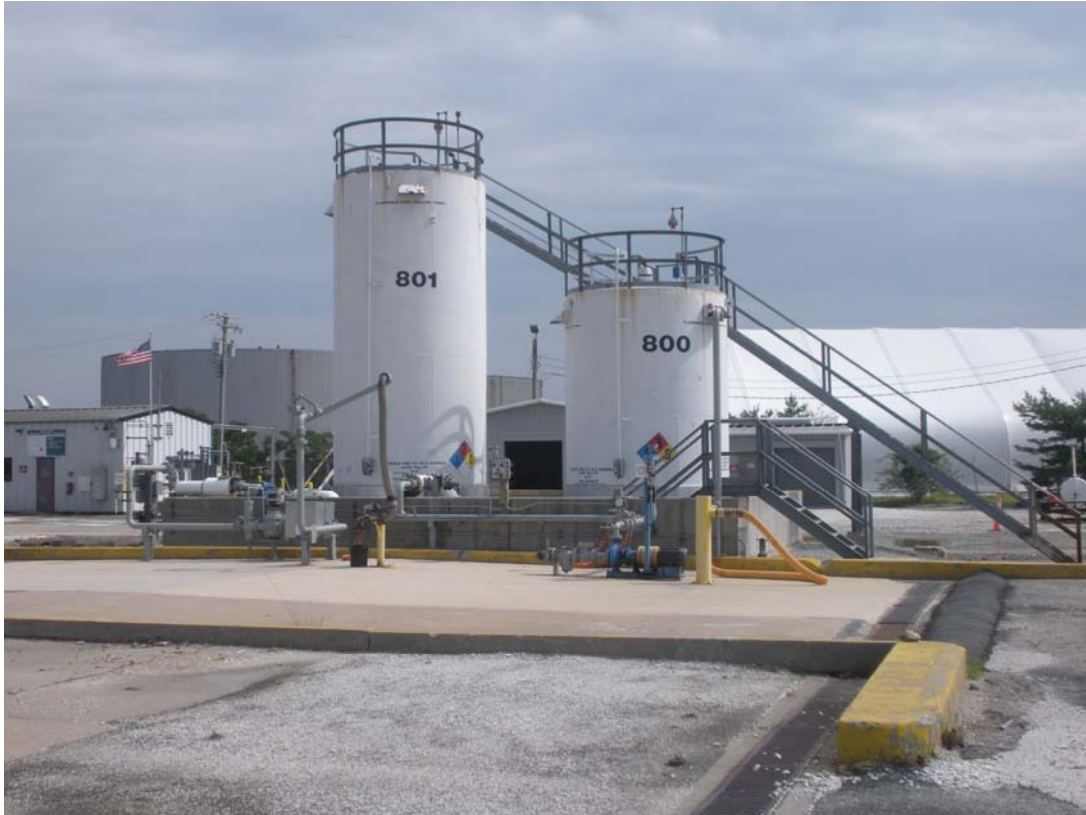
Main Terminal Area recovery tanks 800 and 801

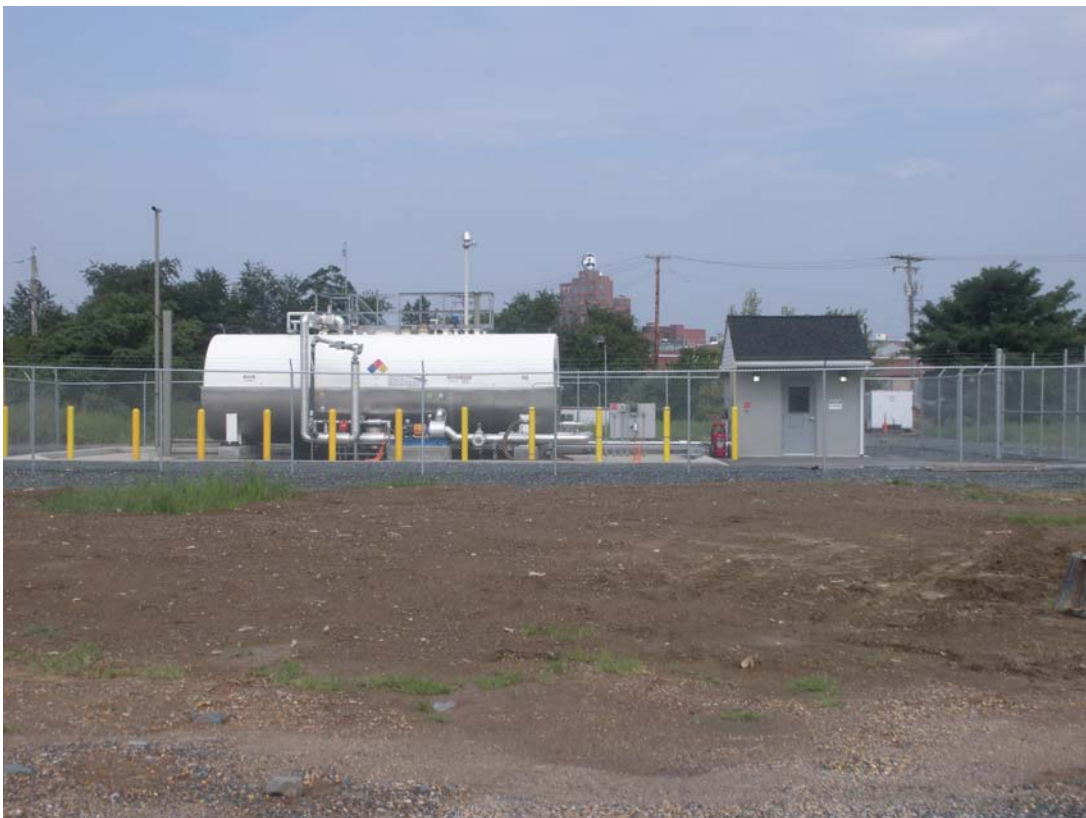
14th Street Area recovery tank 802
