Re: NAPL Delineation Completion Report
Area A: Parcel A10 (A10-006-PZ)
Tradepoint Atlantic
Sparrows Point, MD 21219

Parcel A10 (A10-006-PZ)
NAPL Delineation Area

Figure
1

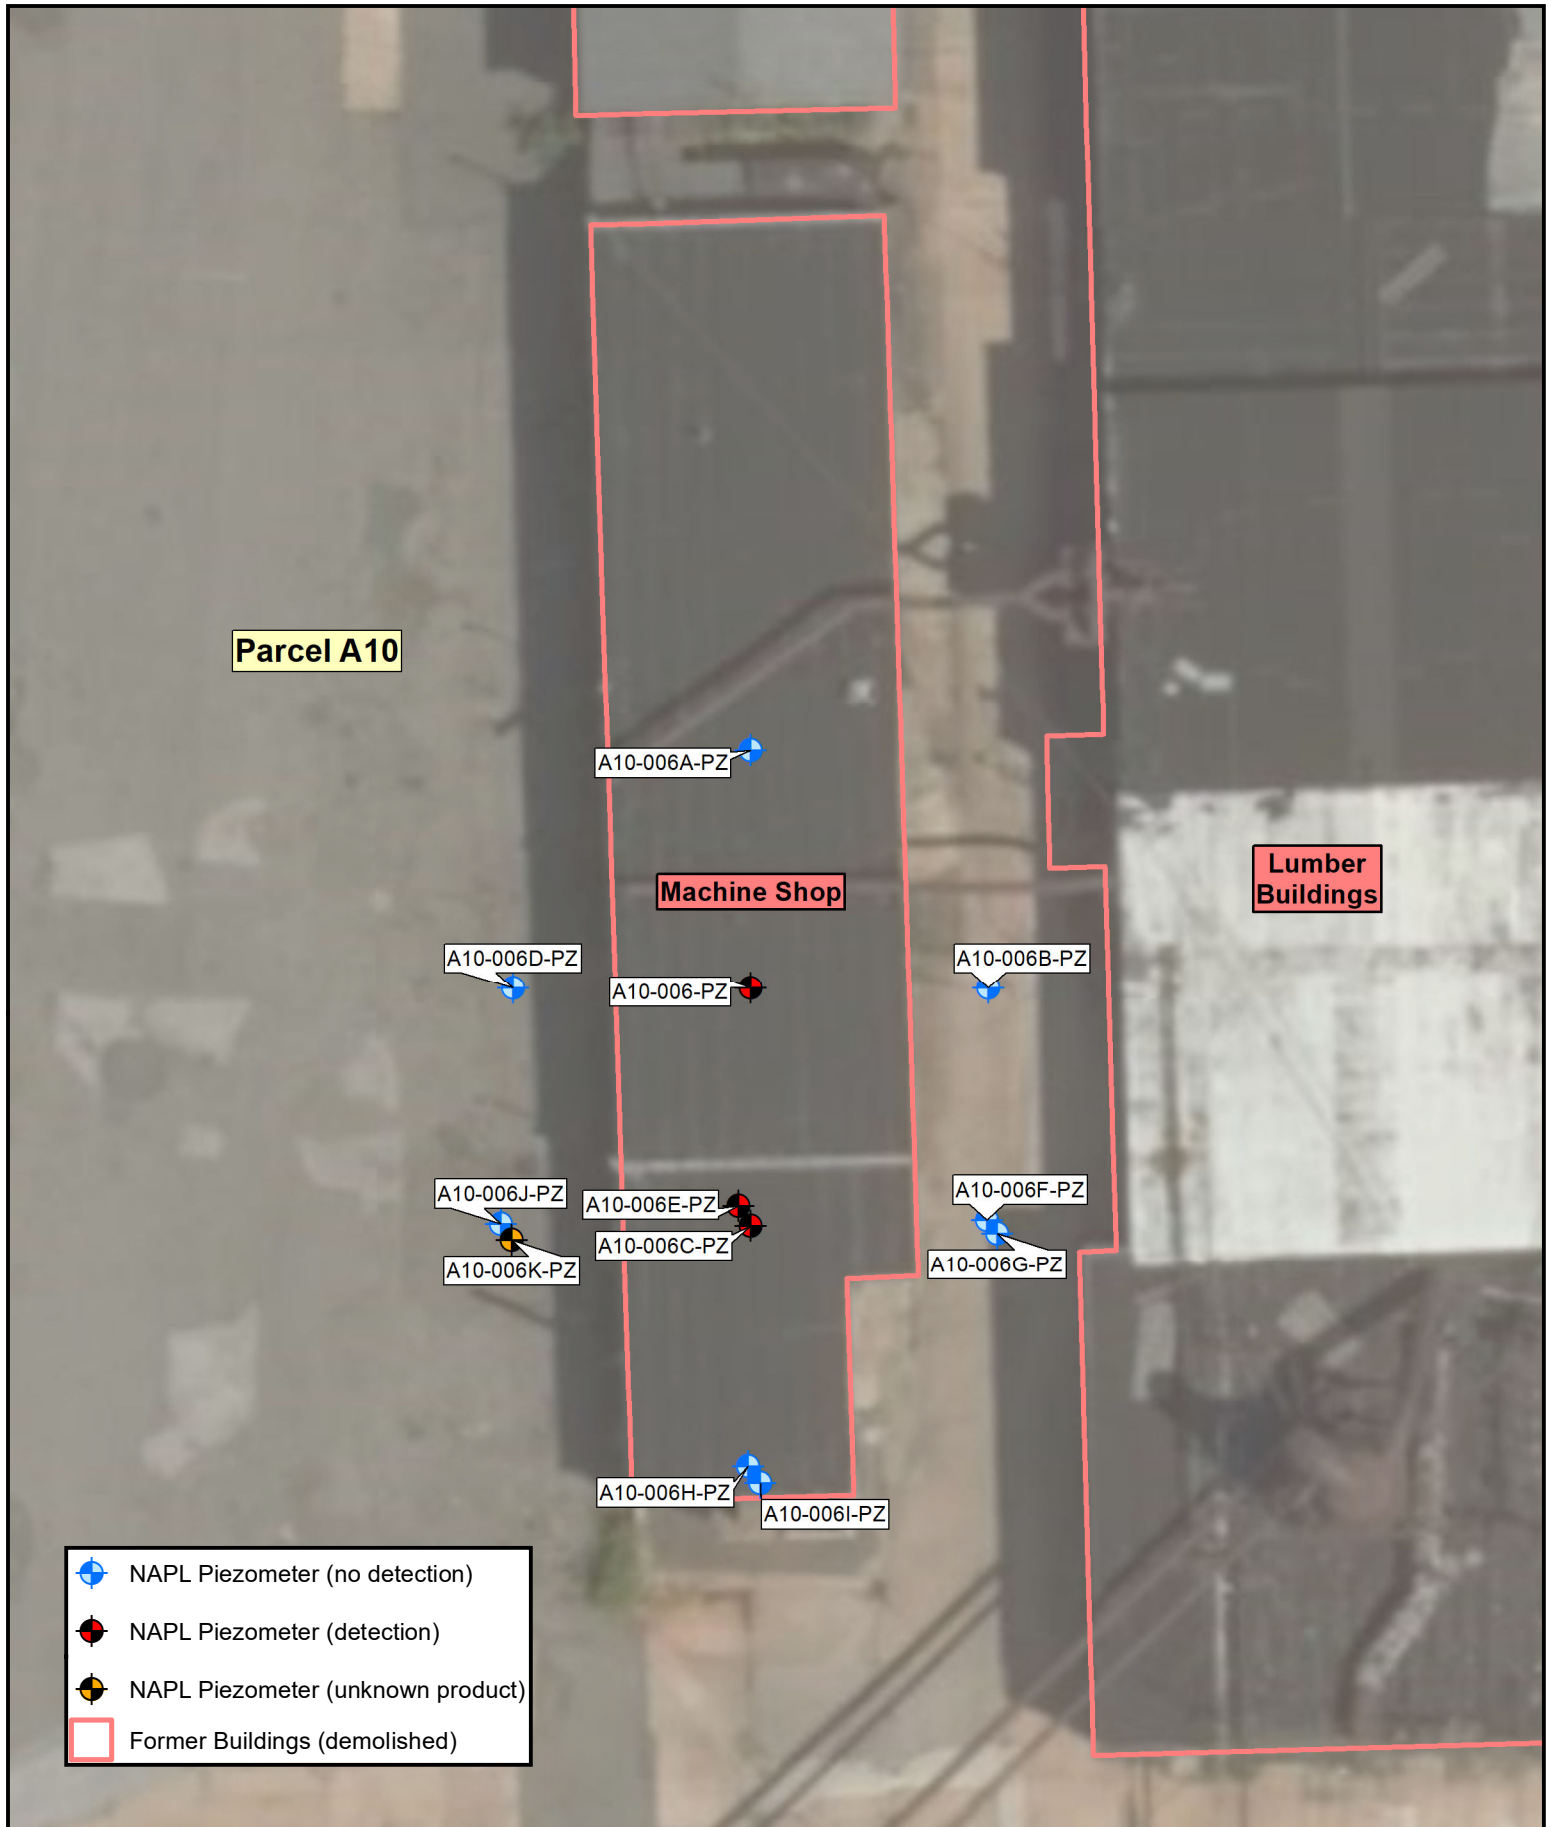
As indicated on **Figure 1** and in **Table 1**, NAPL has been detected at three piezometer locations: A10-006-PZ, A10-006C-PZ, and A10-006E-PZ. A thin layer of light NAPL (LNAPL) was identified in piezometer A10-006C-PZ during the 0-hour gauging event, and a significant amount of dense NAPL (DNAPL) was identified during the 48-hour gauging event and subsequent gauging events. The observed thickness of the DNAPL is likely due to the product settling within the screen interval from an overlying NAPL-impacted layer (NAPL was observed in the soil core from roughly 9.5 to 13 feet bgs). While no NAPL was identified in A10-006E-PZ during the 0-hour gauging event, a significant layer of LNAPL was present during the 48-hour gauging event and subsequent gauging events. Only trace amounts of NAPL have been detected in A10-006-PZ since the initial discovery on January 4, 2019, and NAPL was not detected during the most recent event on December 17, 2019.

The NAPL impacts in the vicinity of A10-006-PZ have been adequately defined. Therefore, approval is requested to abandon the piezometers within the delineation area. The NAPL delineation piezometers will be gauged a final time on the abandonment date as recommended by the MDE, and subsequently abandoned in accordance with COMAR 26.04.04.34 through 36. The MDE will be notified if NAPL is detected in any piezometers which were not previously determined to be impacted.

Following the abandonment of the piezometers, test pitting using an excavator is proposed to further investigate the extent of NAPL impacts in the vicinity of A10-006-PZ. It is anticipated that the test pits will extend to a depth of approximately 13 feet bgs (top of clay). The MDE will be notified of any observations of NAPL identified during the test pitting, and a brief letter report will be prepared to summarize these field activities. Any additional response activities or future monitoring will be coordinated with the MDE pending the results of the test pitting investigation.

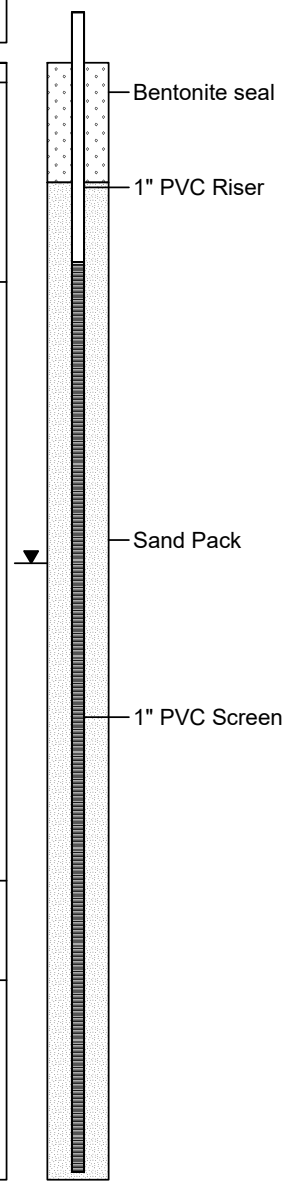
Boring ID: A10-006B-SB/PZ

Depth (ft.)	% Recovery	PID Reading (PPM)	Sample ID/Interval	DESCRIPTION	USCS	REMARKS
0	-	-		(0-0.5') CONCRETE	NA	
0	0	-		(0.5-5.5') SANDY CLAY, soft, gray and yellowish red, very moist, low plasticity, cohesive	CL	
5	-	-		(5.5-20.5') CLAY, very firm, reddish yellow with some gray mottling grading to pale brown with reddish yellow, dry to moist, low plasticity, cohesive	CL	
60	3.5	0.0		None Collected	CL	Wet at 21' bgs
10	0.0	0.0				
74	0.1	0.1				
15	0.1	0.1				
80	0.0	0.0		(20.5-23') CLAYEY SAND, medium dense, light brownish gray, wet, non-plastic, non-cohesive	SC	
25	0.0	0.0		(23-28') SAND, fine to coarse, medium dense, reddish yellow and yellowish red, wet, non-plastic, non-cohesive	SW	
30	-	-		End of Boring

Boring terminated at 28' bgs due to water and piezometer installation.
 TOC: Top of PVC casing
 DTW: Depth to water
 bgs: Below ground surface
 AMSL: Above mean sea level

Riser Stickup: 2.37'
 Riser: 0 - 5' bgs
 Screen: 5 - 28' bgs [Slot Size: 0.010"]
 Sand Pack: 3 - 28' bgs [Grain Size: WG #2]
 Bentonite Seal: 0 - 3' bgs [Grain Size: 3/8" chips]

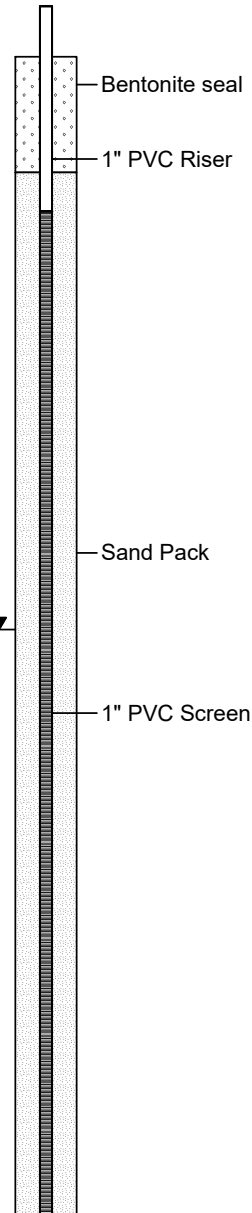
Boring ID: A10-006C-SB/PZ

Depth (ft.)	% Recovery	PID Reading (PPM)	Sample ID/Interval	DESCRIPTION	USCS	REMARKS
0	-	-		(0-0.2') CONCRETE, SAND and GRAVEL-sized, loose, pale yellow, dry, non-plastic, non-cohesive	SP	Light sheen with light odor 3.2-3.5' bgs
40	-	-		(0.2-1') SLAG GRAVEL, fine, loose, very dark brown, wet, non-plastic, non-cohesive		
5	1.2	9.9		(1-11.5') SANDY CLAY, soft, light grayish brown, very moist, low plasticity, cohesive	CL	
50	-	-				Very light product at 9.5' bgs Trace NAPL 11-13' bgs
10	8.1	3.5		(11.5-13') CLAYEY SAND, dense, very light brown and light brownish gray, moist, non-plastic, non-cohesive	SC	
80	-	-				Wet at 24' bgs
15	4.1	7.4	None Collected	(13-21.5') CLAY with trace SAND, very firm, light grayish brown and reddish yellow, moist, low plasticity, cohesive	CL	
20	1.6	3.3		(21-24') SILT, very firm, gray, moist, low plasticity, cohesive	ML	
25	3.4	4.2		(24-30') SAND, fine to coarse, dense, reddish yellow and yellowish red then very pale brown at 28' bgs, wet, non-plastic, non-cohesive	SW

Boring terminated at 30' bgs due to water and piezometer installation.
 TOC: Top of PVC casing
 DTW: Depth to water
 bgs: Below ground surface
 AMSL: Above mean sea level

Riser Stickup: 2.92'
 Riser: 0 - 4' bgs
 Screen: 4 - 30' bgs [Slot Size: 0.010"]
 Sand Pack: 3 - 30' bgs [Grain Size: WG #2]
 Bentonite Seal: 0 - 3' bgs [Grain Size: 3/8" chips]

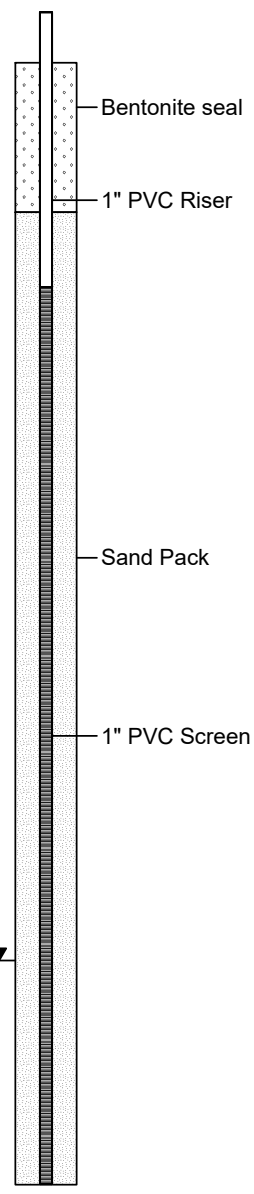
Boring ID: A10-006D-SB/PZ

Depth (ft.)	% Recovery	PID Reading (PPM)	Sample ID/Interval	DESCRIPTION	USCS	REMARKS
0	-	-		(0-7') SLAG, SAND and GRAVEL-sized, medium dense to loose, very dark brown, dry to moist, non-plastic, non-cohesive		
8	-	-			SW/GP	
5	-	0.0				
70	-	4.3	None Collected	(7-15') CLAY with SAND grading to CLAY, very firm, light brown to light brownish gray with reddish yellow, dry to moist, low plasticity, cohesive		
10	-	0.0			CL	
100	-	0.0				
15	-	0.0		End of Boring

No water encountered

Boring terminated at 15' bgs due to water and piezometer installation.
 TOC: Top of PVC casing
 DTW: Depth to water
 bgs: Below ground surface
 AMSL: Above mean sea level

Riser Stickup: 2.45'
 Riser: 0 - 3' bgs
 Screen: 3 - 15' bgs [Slot Size: 0.010"]
 Sand Pack: 2 - 15' bgs [Grain Size: WG #2]
 Bentonite Seal: 0 - 2' bgs [Grain Size: 3/8" chips]

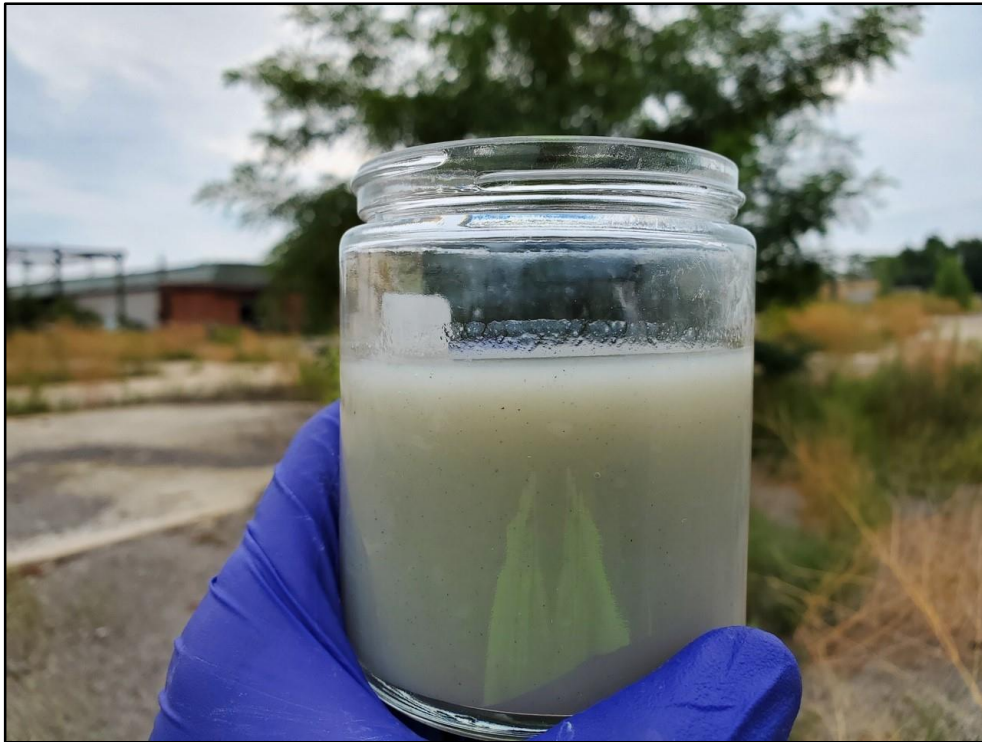
On August 13, 2019, a pale gray, moderately thick product was observed on the oil-water interface probe upon withdraw from A10-006K-PZ. There was no odor and the oil-water interface probe did not react to the product. A sample of product was removed from A10-006K-PZ using a bailer on August 13, 2019 and placed in a clear unpreserved laboratory sample jar for observation. On October 28, 2019, ARM personnel re-examined the jar of product and observed that there was a separation of water and the unknown product. The unknown product had settled to the bottom of the sample jar; indicating a DNAPL. Photographs of the observations on August 13, 2019 and October 28, 2019 have been included as **Attachment 2**.

Photograph 1: Unknown product extracted from temporary piezometer A10-006K-PZ. Product is pale gray and moderately thick. Photograph was taken in the field immediately after removal using a bailer.

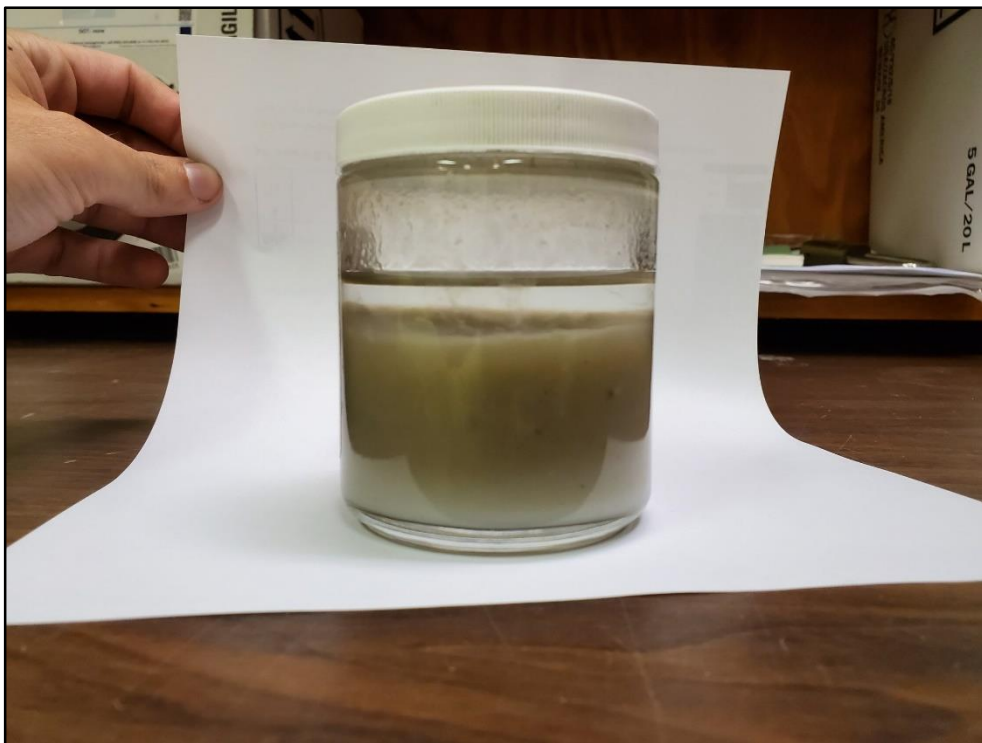
Photograph 2: Unknown product extracted from temporary piezometer A10-006K-PZ. Product has settled to bottom of sample jar (appears to be a DNAPL). Photograph was taken several weeks after removal via bailer.
