Phase II Investigation Work Plan

Area A: Parcel A4 Sparrows Point Terminal, LLC Sparrows Point, Maryland

Revision 2
October 29, 2015

ARM Project 150298M

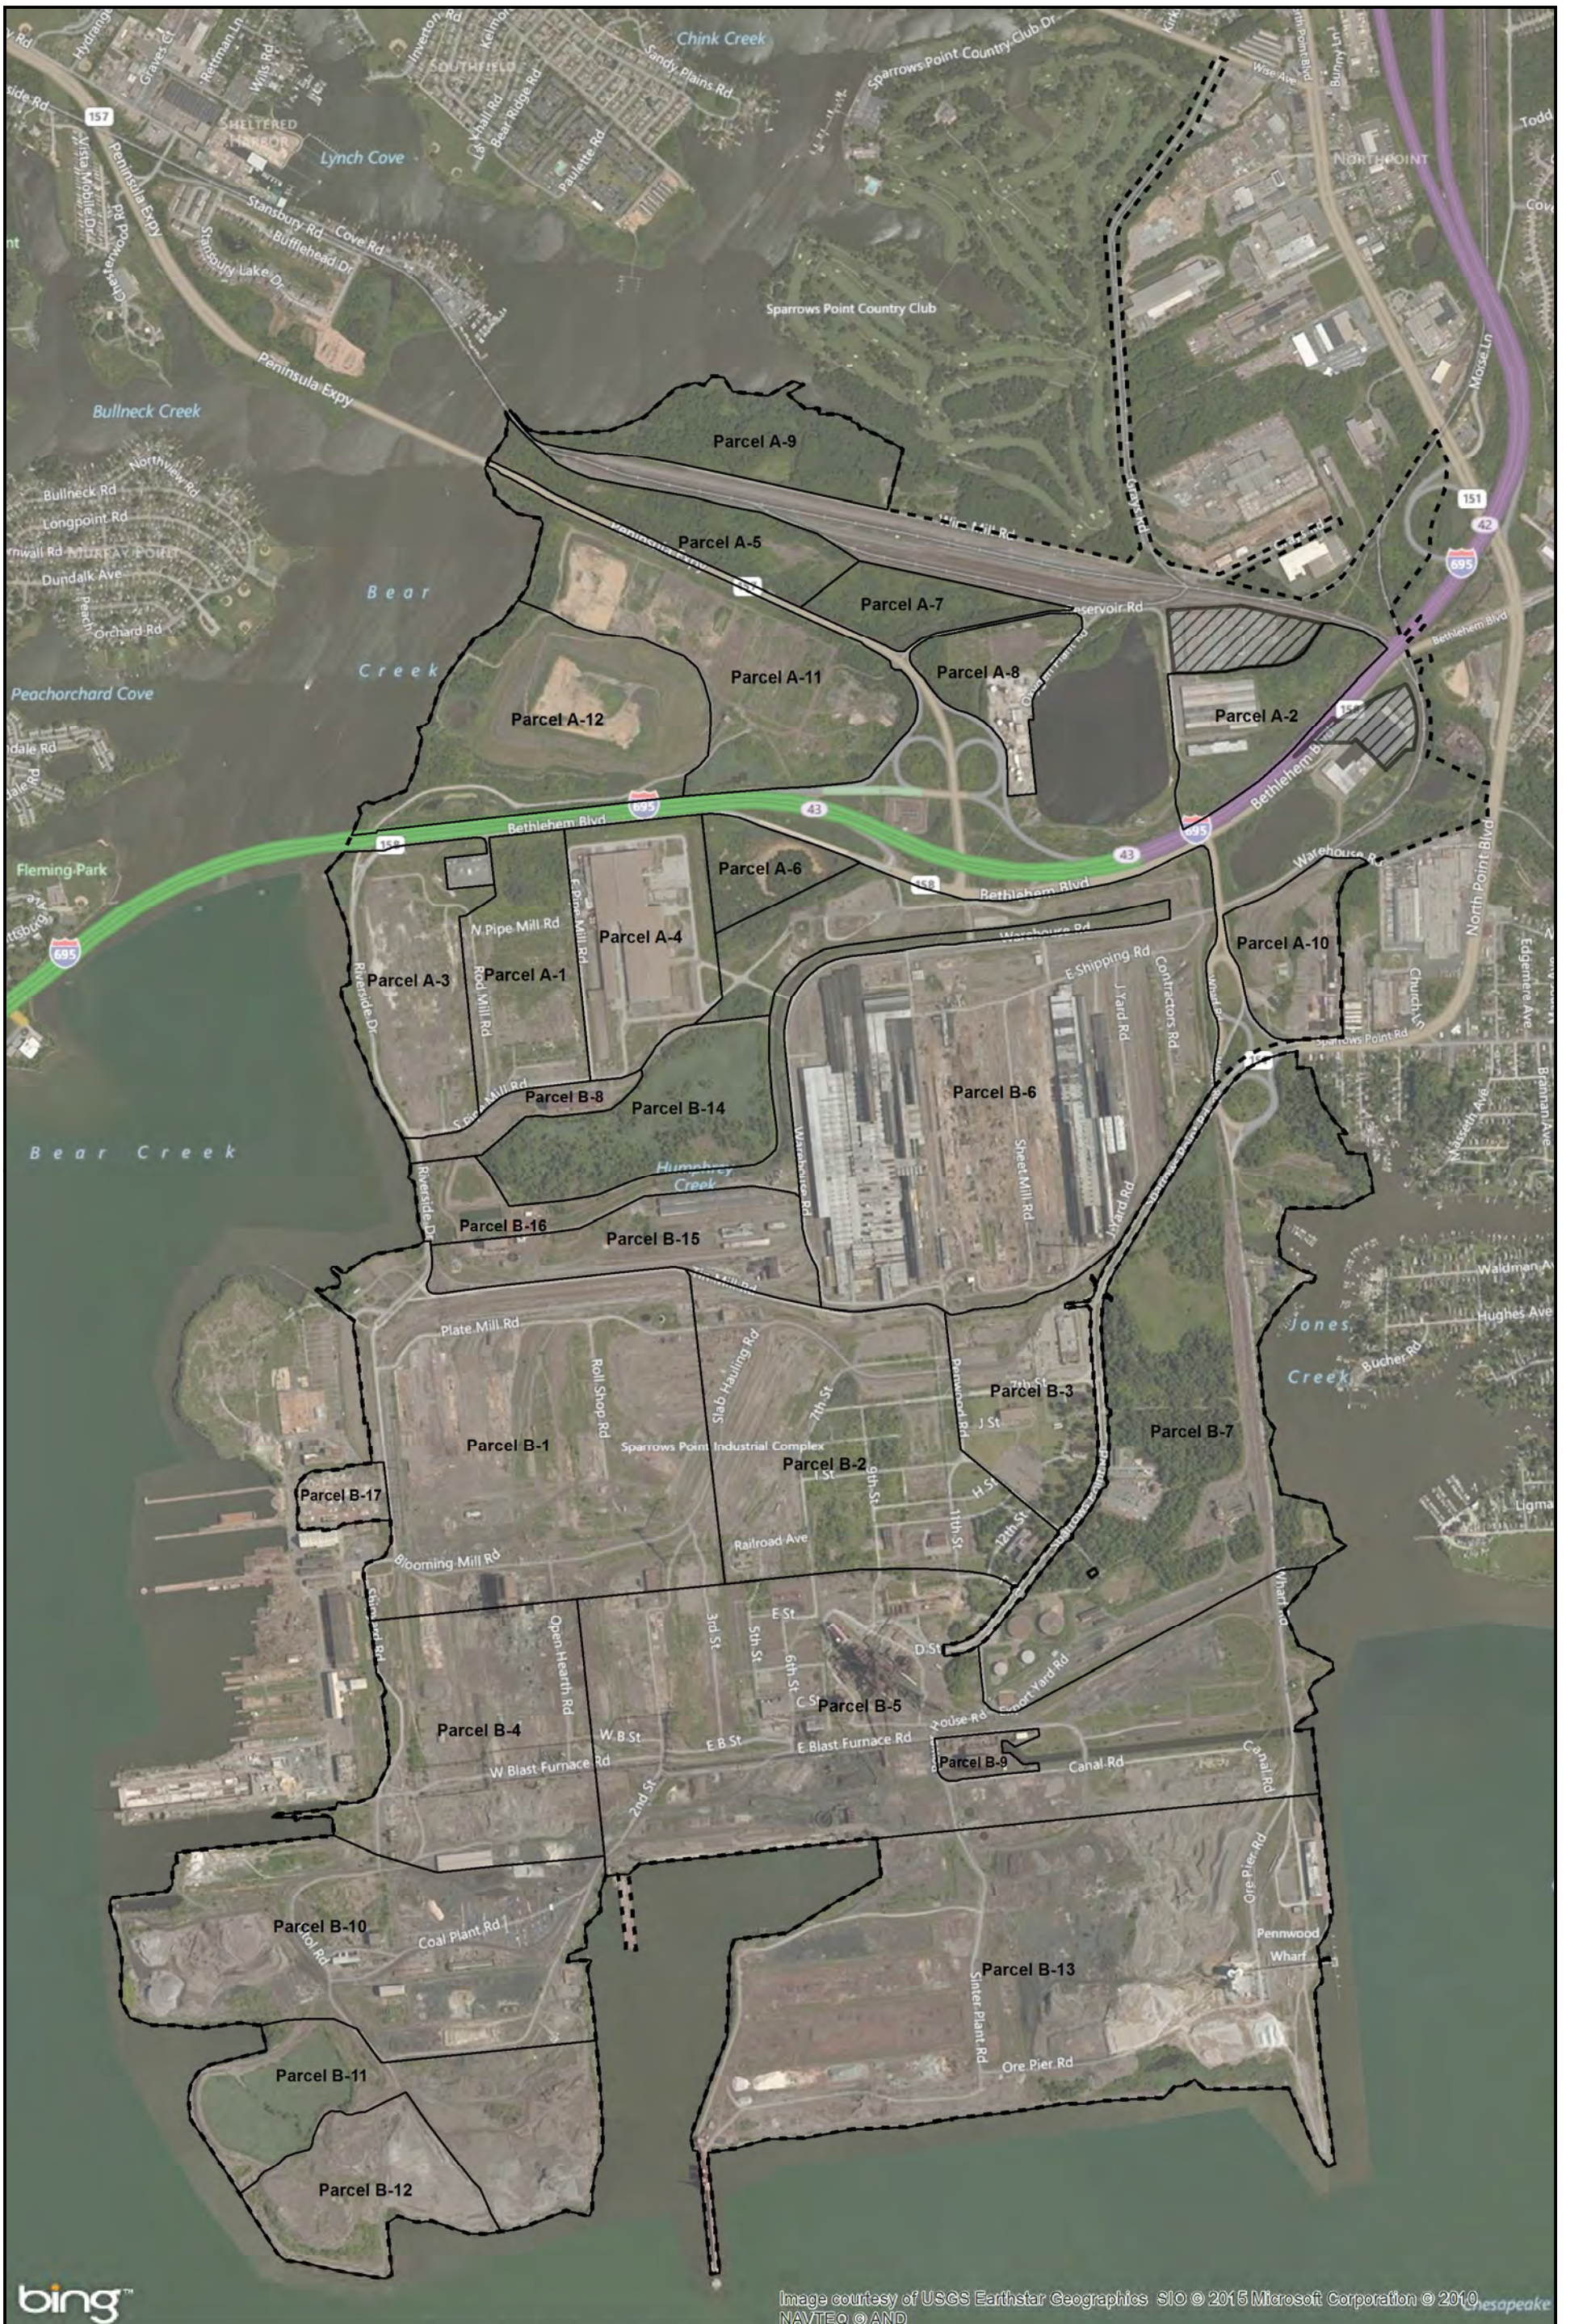
Figure
1

ARM Group Inc. (ARM), on behalf of EnviroAnalytics Group (EAG), has prepared the following Work Plan to complete a Phase II site investigation on a portion of the Sparrows Point Terminal, LLC property that has been designated as Area A, Parcel A4 (the Site). Parcel A4 is comprised of 61.4 acres of the approximately 3,100-acre former plant property located as shown on **Figure 1**.

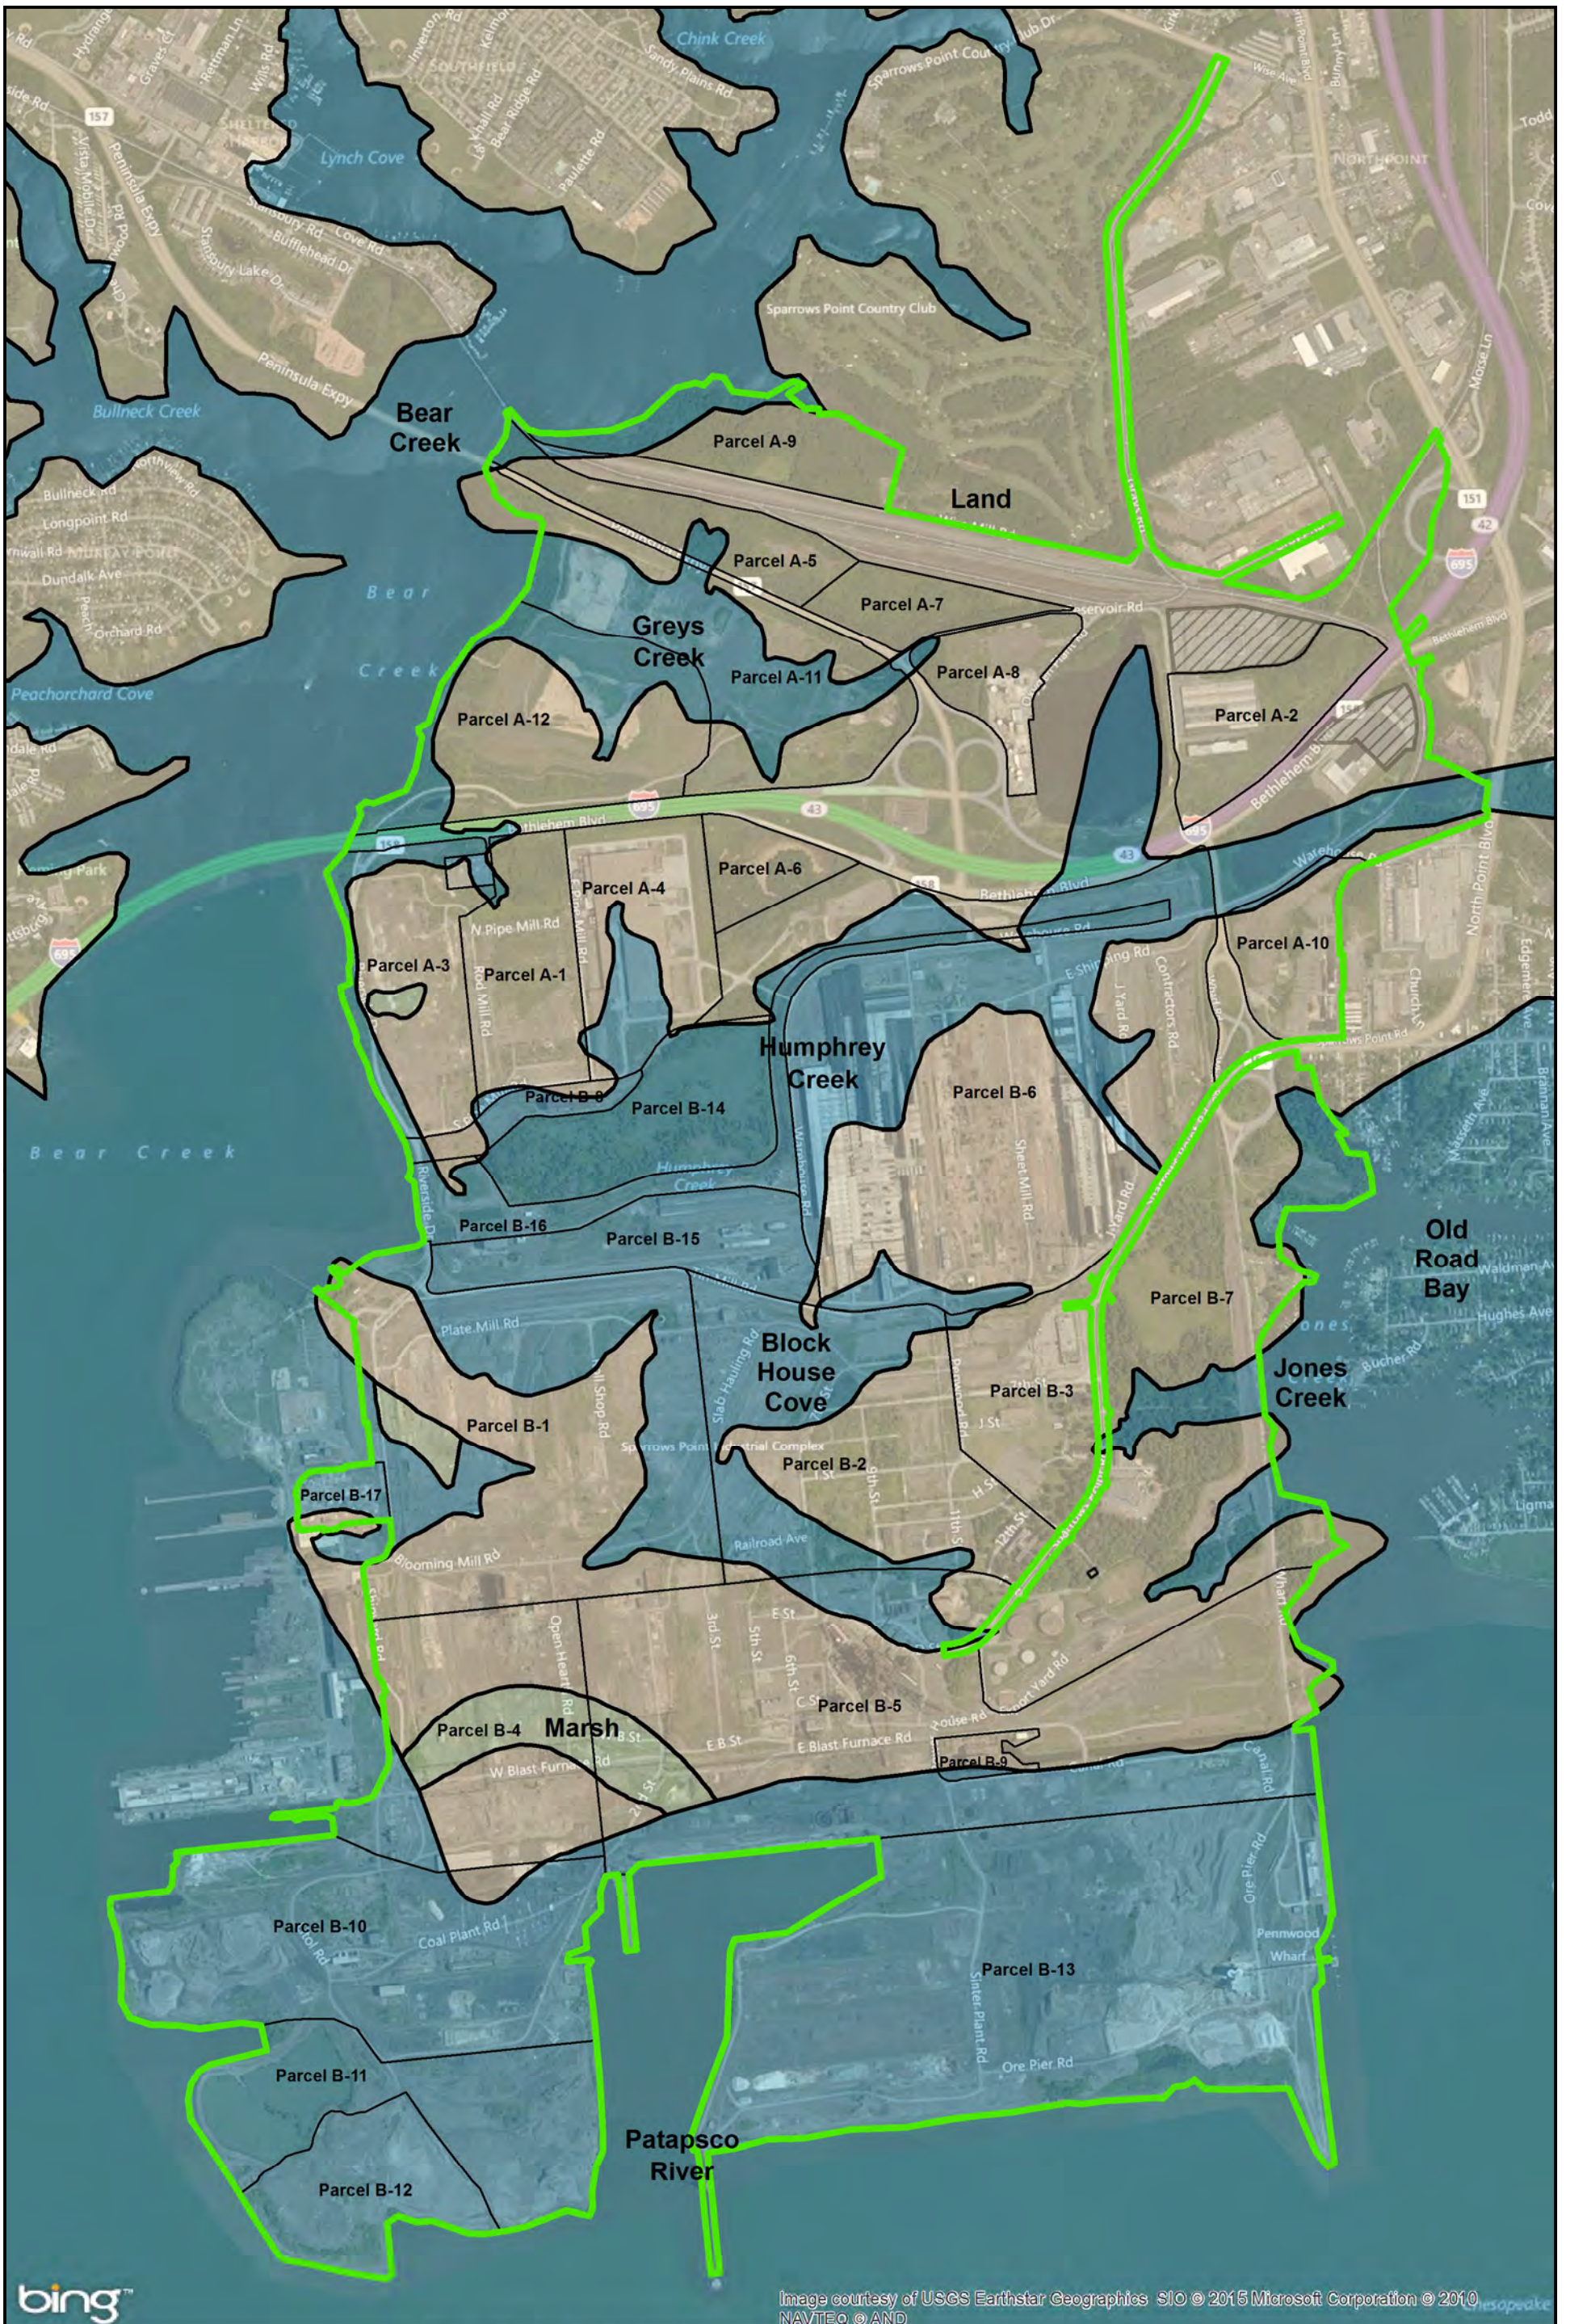
Groundcover at the Site is comprised of 74% natural soils and 26% slag fill based on the approximate shoreline of the Sparrows Point Peninsula in 1916, as shown on **Figure 2** (Adapted from Figure 2-20 on the Description of Current Conditions Report (DCC) report prepared by Rust Environmental and Infrastructure, dated January 1998). The Site is partially occupied by the New Cold Mill Complex (NCMC) building.

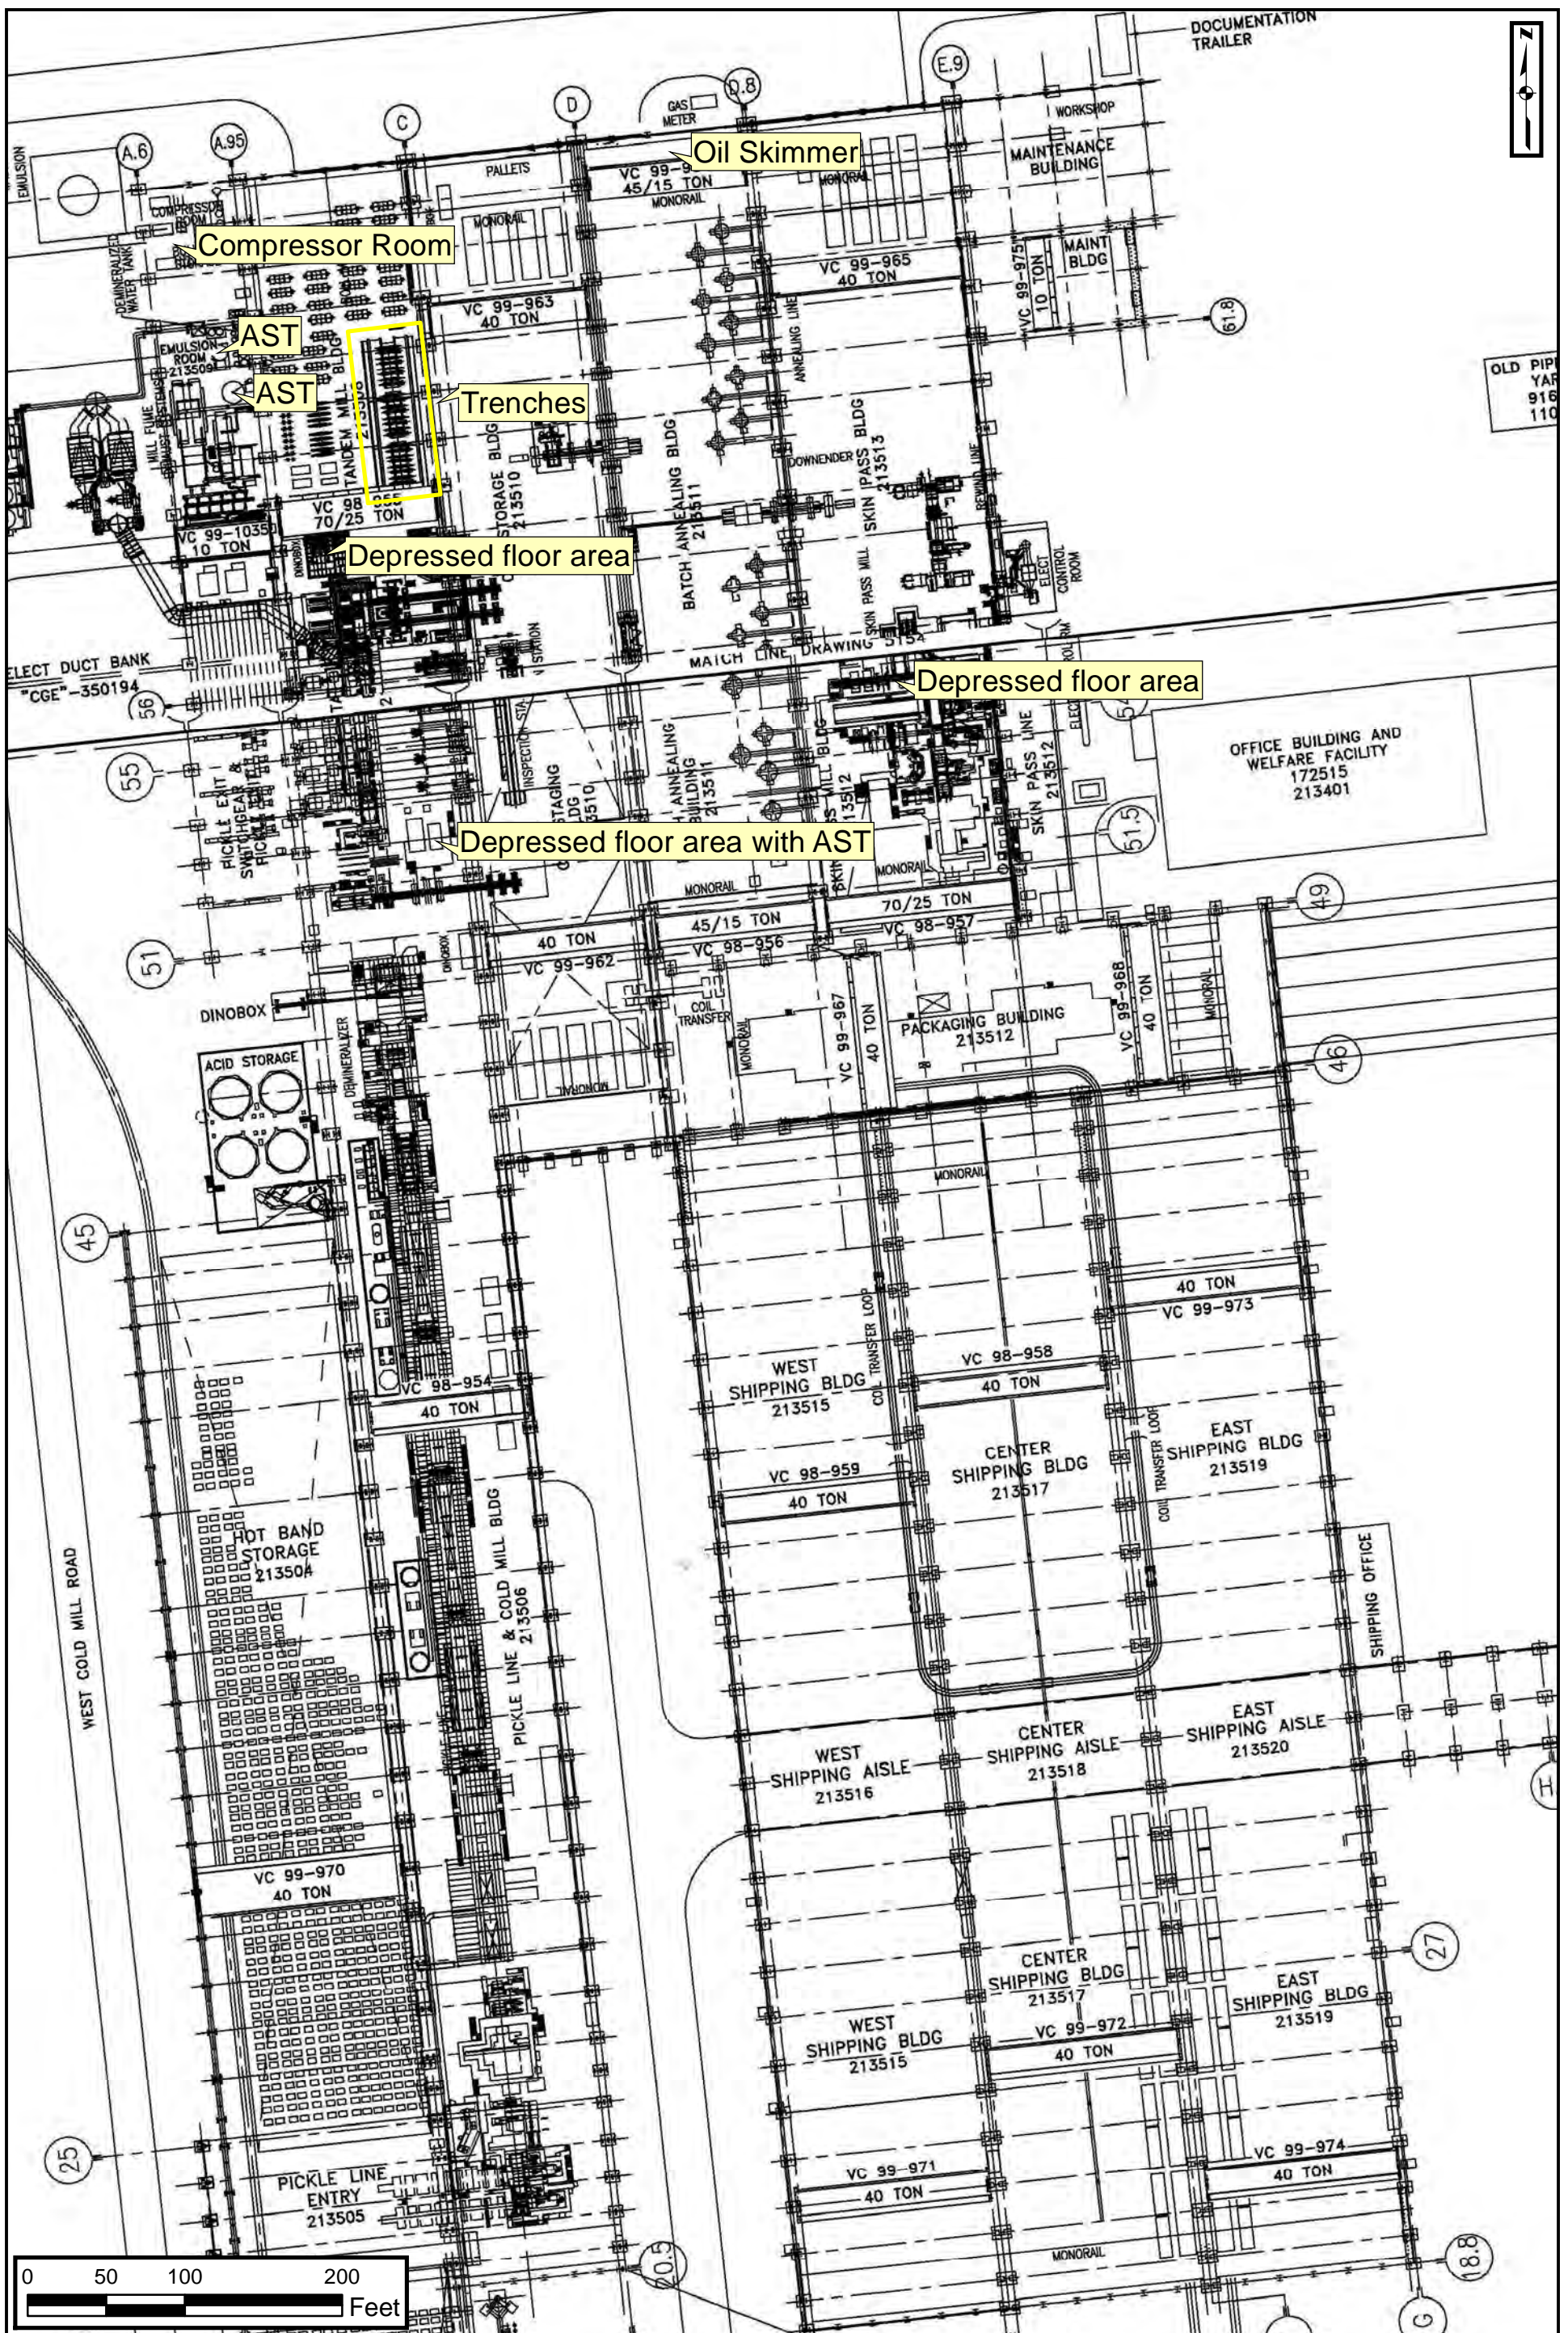
Figure 1
 New Cold Mill Complex
 Site Drawings
 March 30, 2015

- An oil skimmer associated with the cooling water sumps was present along the northern wall of the complex;
- an air compressor room was present in the northwest corner of the building with oil stained floors and floor drains;
- a bulk oil storage room, located south of the compressor room, contained two large tanks surrounded by concrete containment; and
- multiple collection trenches and depressed floor areas throughout the NCMC were noted to contain what appeared to be oil or hydraulic fluid.

Areas of interest observed during the walkthrough and subsequently targeted by the sub-slab soil gas sampling, are provided on **Figure 1** (attached), and the sub-slab soil gas sample locations are provided on **Figure 2** (attached).
