PHASE II INVESTIGATION REPORT

AREA A: PARCEL A7
TRADEPOINT ATLANTIC
SPARROWS POINT, MARYLAND

ARM Project No. 150298M-15

Revision 1 – July 8, 2019

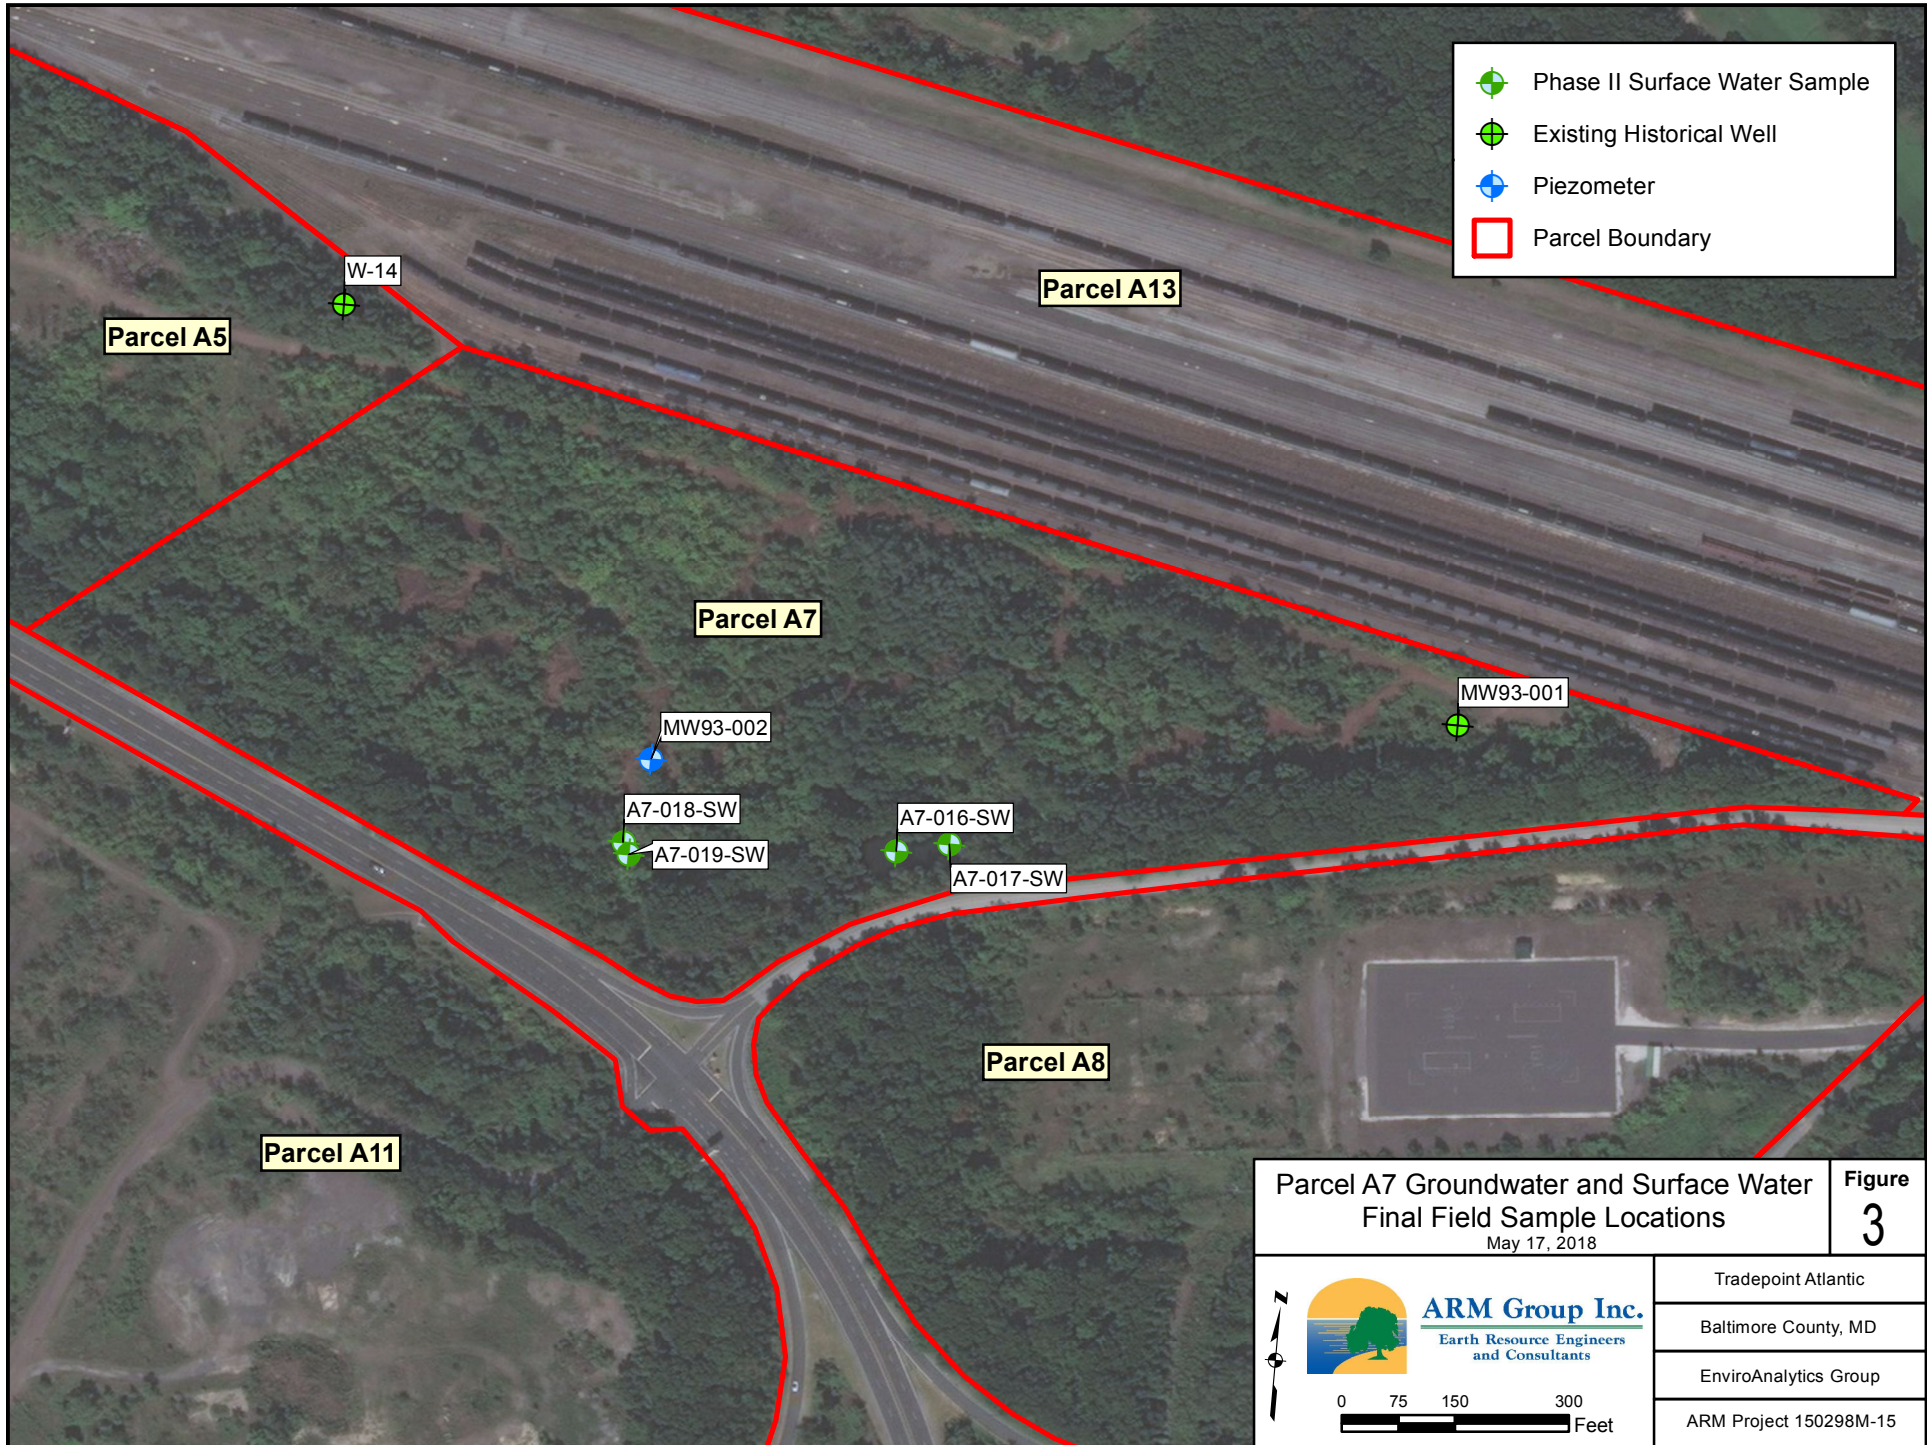
Figure
3

Parcel A7 Groundwater and Surface Water
 Final Field Sample Locations
 May 17, 2018

Three existing groundwater wells in the shallow hydrogeologic zone (MW93-001, MW93-002, and W-14) were selected to investigate shallow groundwater conditions at the Site. During vegetation clearing activities, permanent groundwater well MW93-002 was damaged by heavy equipment and was unable to be sampled. A temporary groundwater sample collection point was installed as a replacement sample point at this location (using the same ID). The locations of the groundwater sampling points are indicated on **Figure 3**. Four surface water samples were also collected from the two stormwater ponds in the southeast portion of the parcel (two from each pond). The locations of the surface water samples are also provided on **Figure 3**.

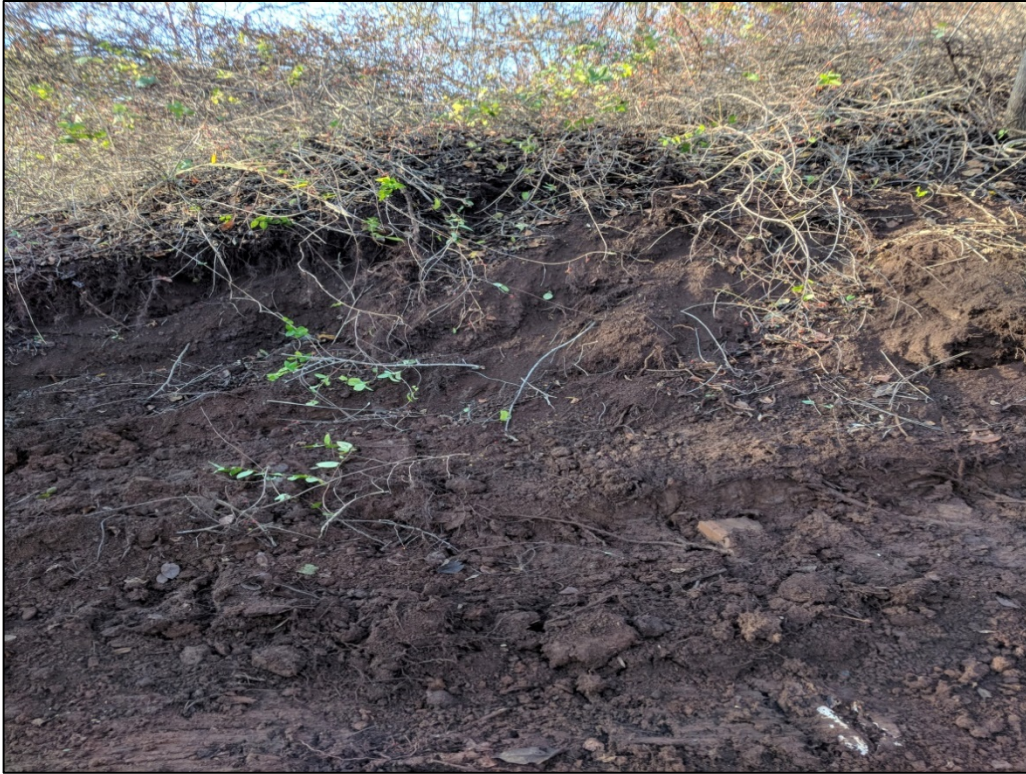
Photo 1: View of test pit at A7-001-TP before excavation.
No visible contamination is evident.

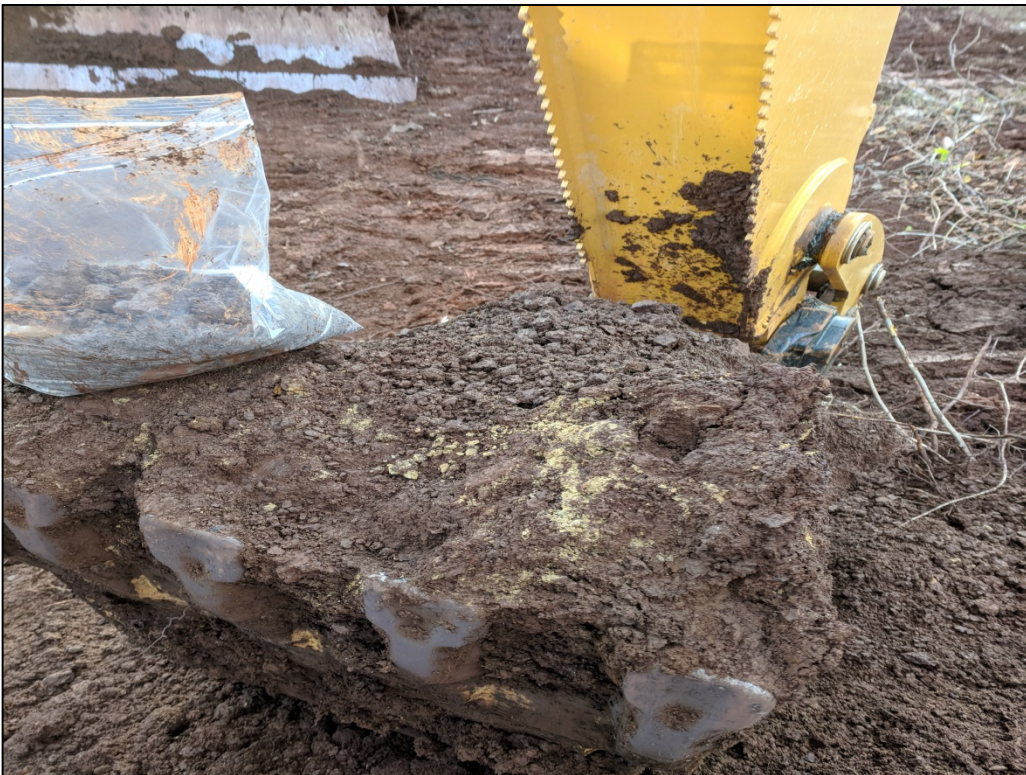
Photo 2: View of the soil observed during test pit activities at A7-001-TP.
Soils appear to consist of silty clay. No visible contamination is evident.

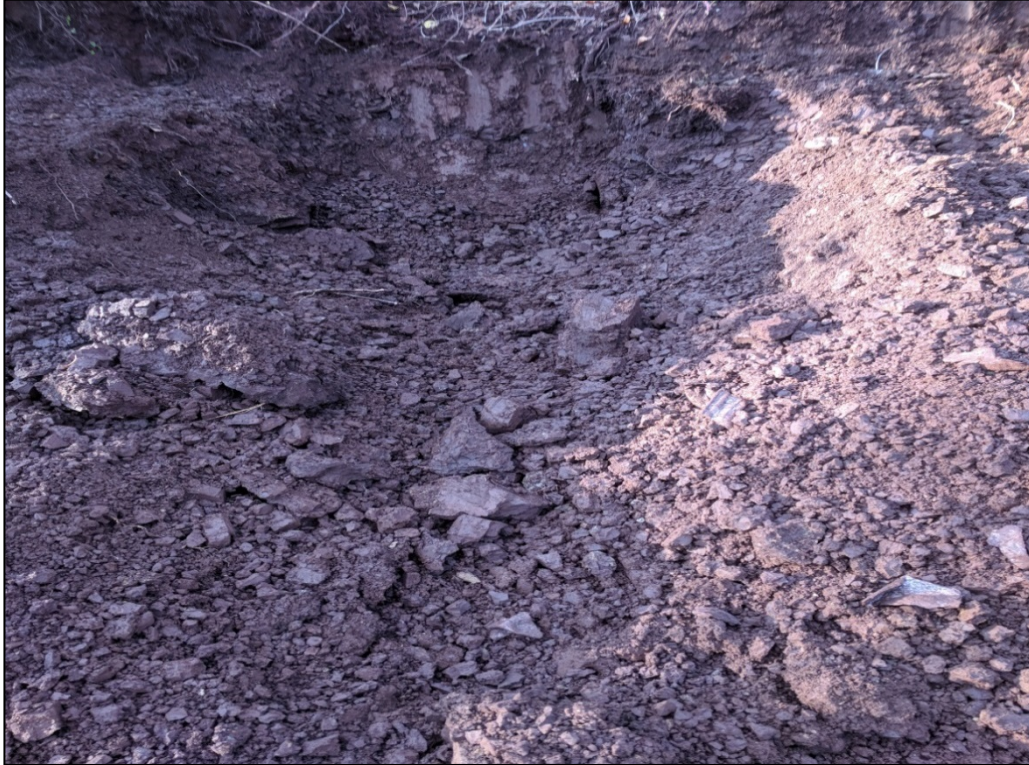
Photo 3: View of test pit at A7-001-TP after excavation.
No visible contamination is evident and PID reading equals 3.9.

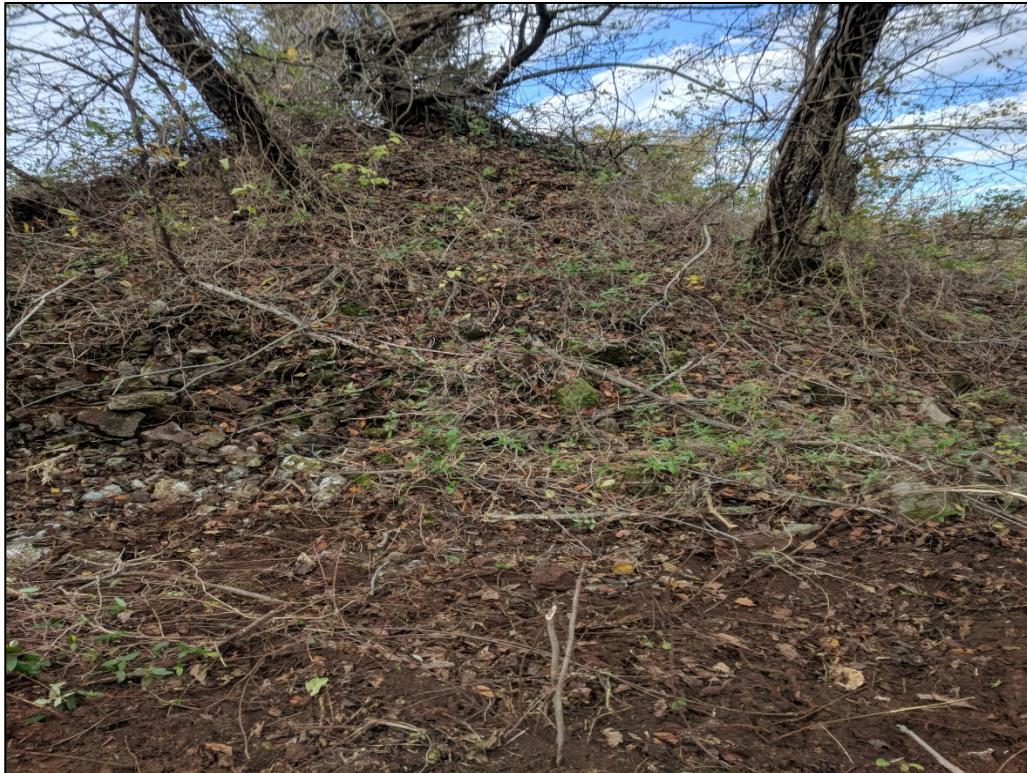
Photo 4: View of test pit at A7-002-TP before excavation.
No visible contamination is evident.

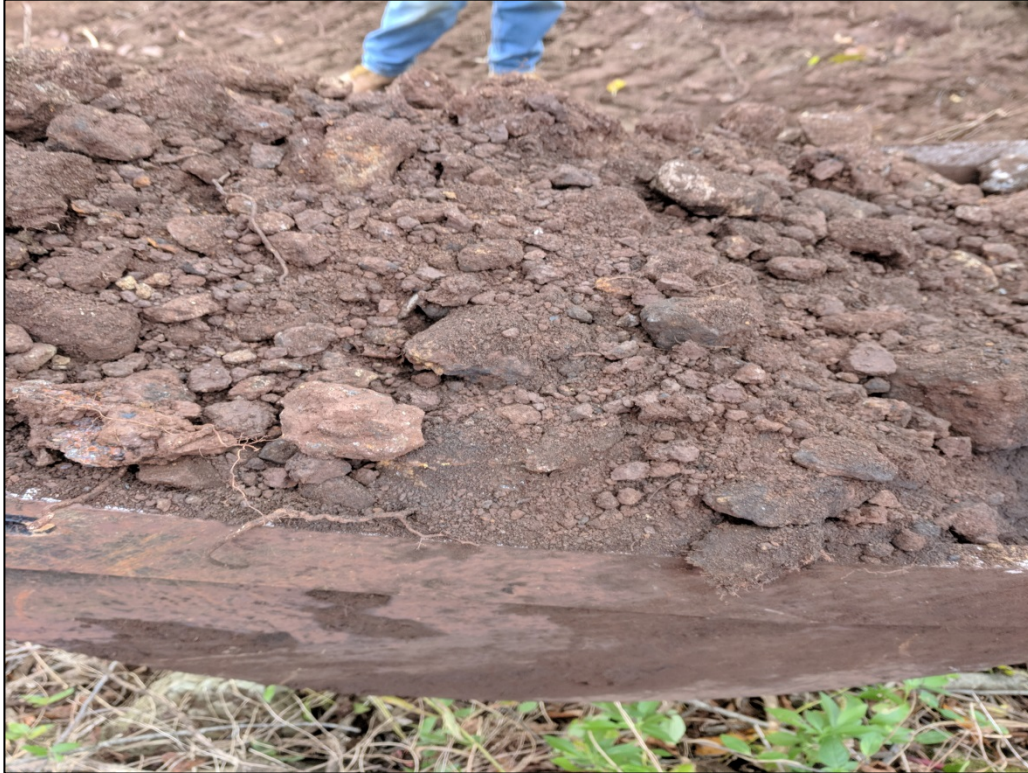
Photo 5: View of the soil observed during test pit activities at A7-002-TP.
Soils appear to consist of silty clay with gravel. No visible contamination is evident.

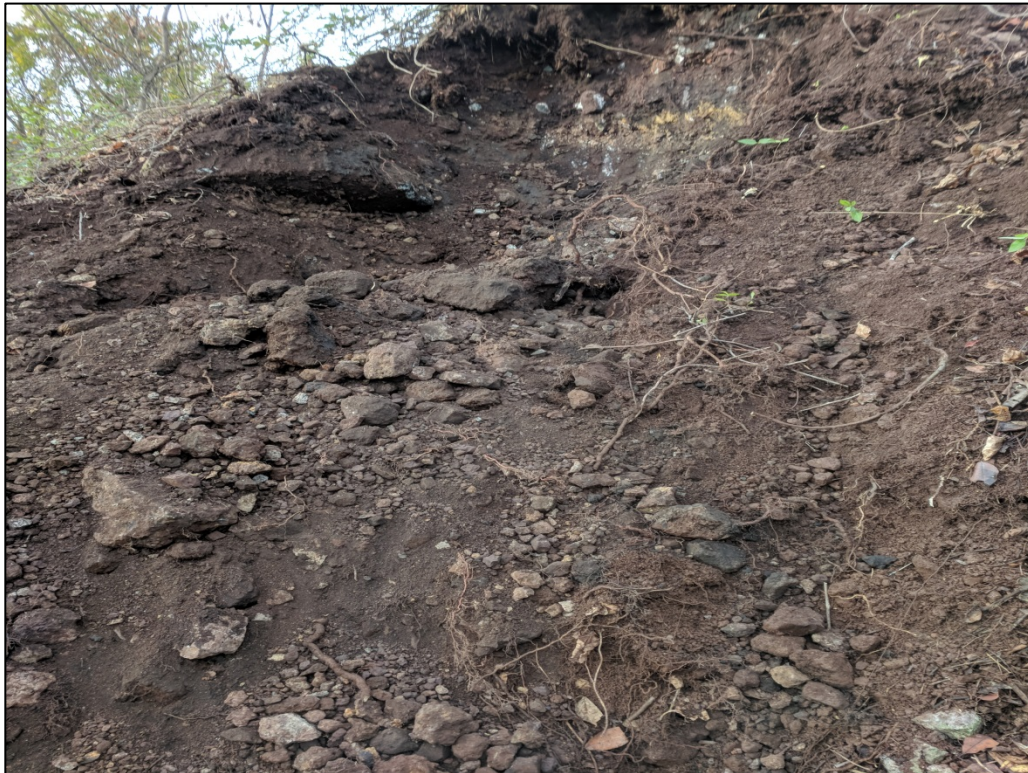
Photo 6: View of test pit at A7-002-TP after excavation.
No visible contamination is evident and PID reading equals 4.1.

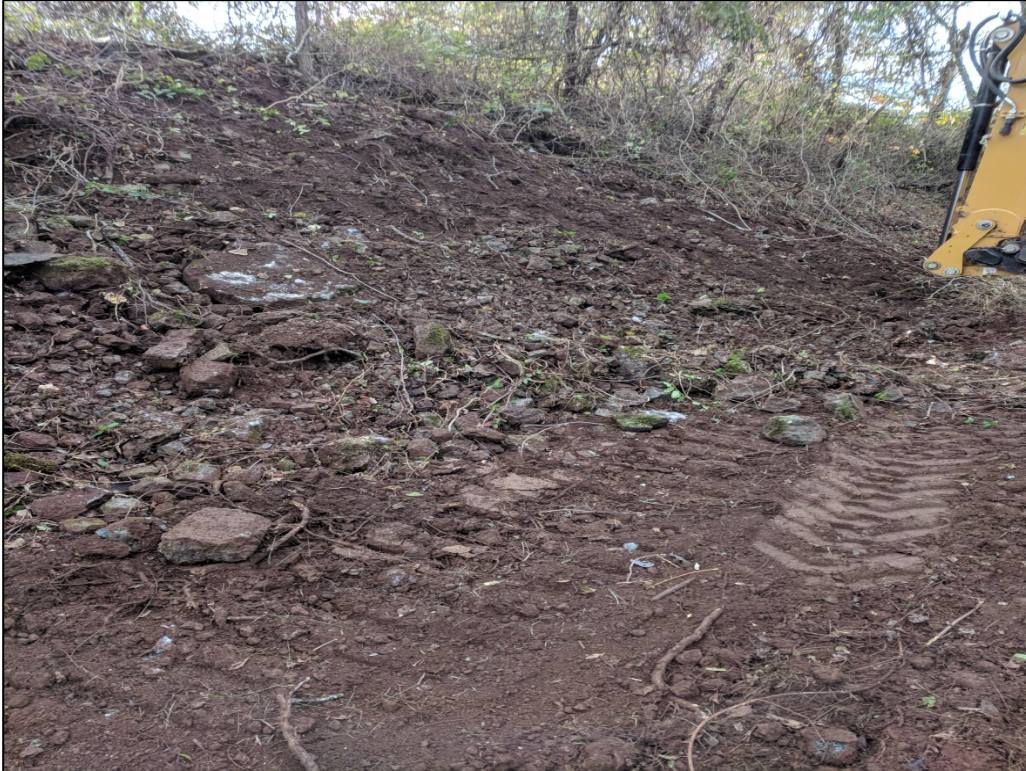
Photo 7: View of test pit at A7-003-TP before excavation.
No visible contamination is evident.

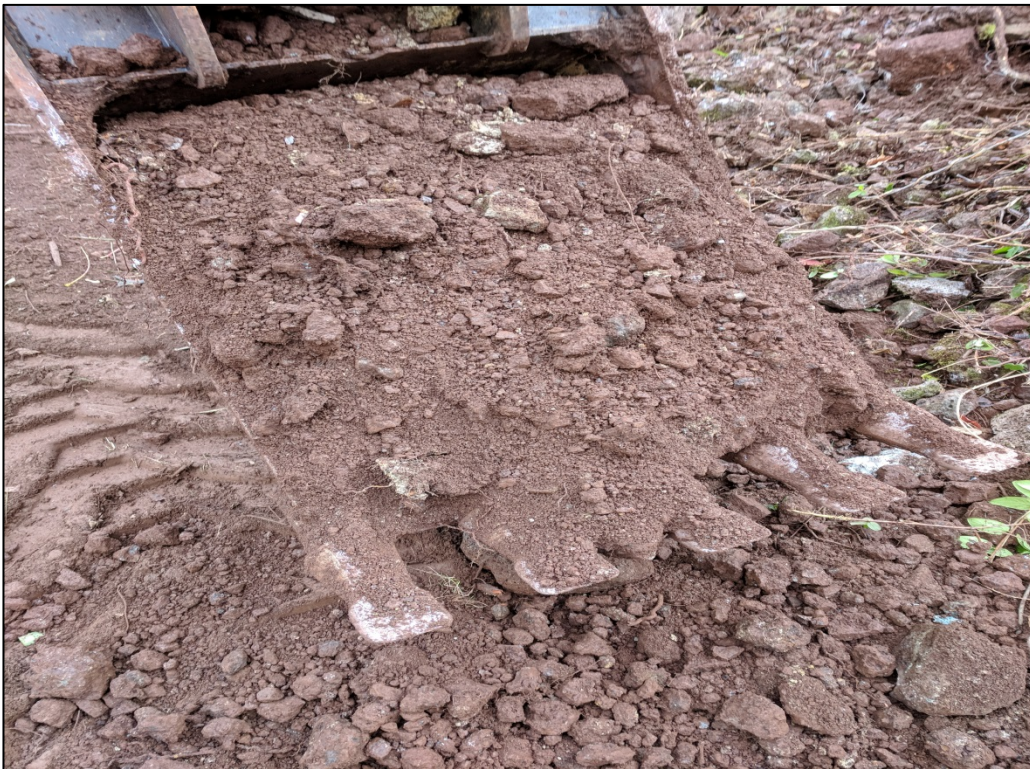
Photo 8: View of the soil observed during test pit activities at A7-003-TP.
Soils appear to consist of silty clay with gravel. No visible contamination is evident.

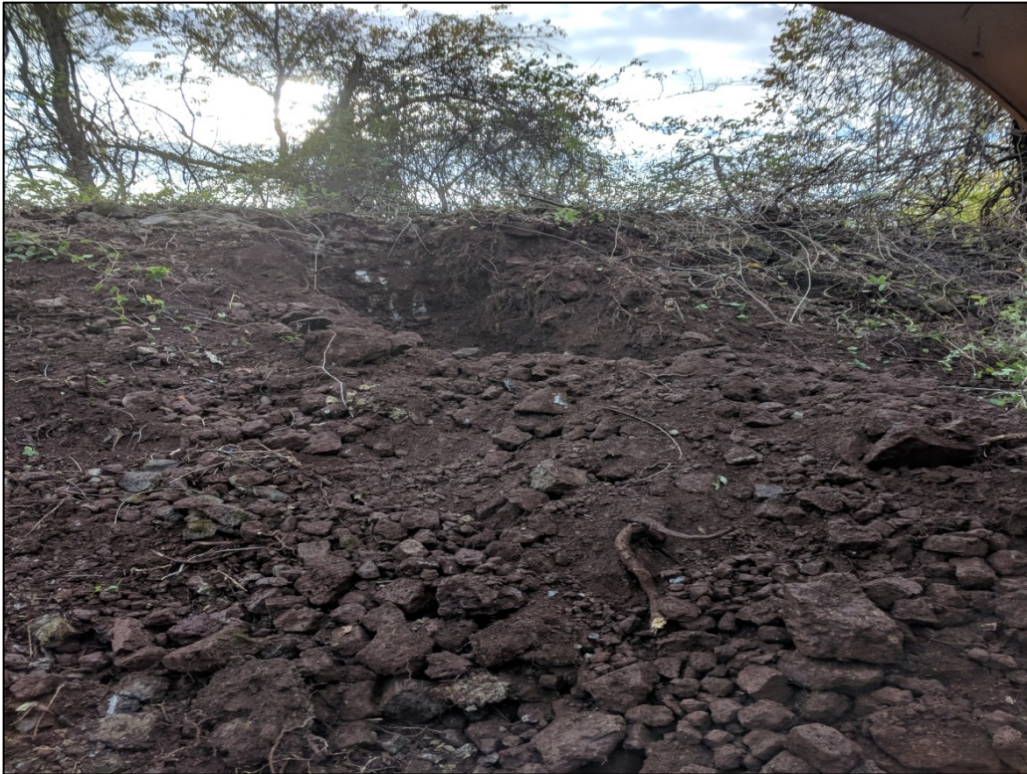
Photo 9: View of test pit at A7-003-TP after excavation.
No visible contamination is evident and PID reading equals 2.8.

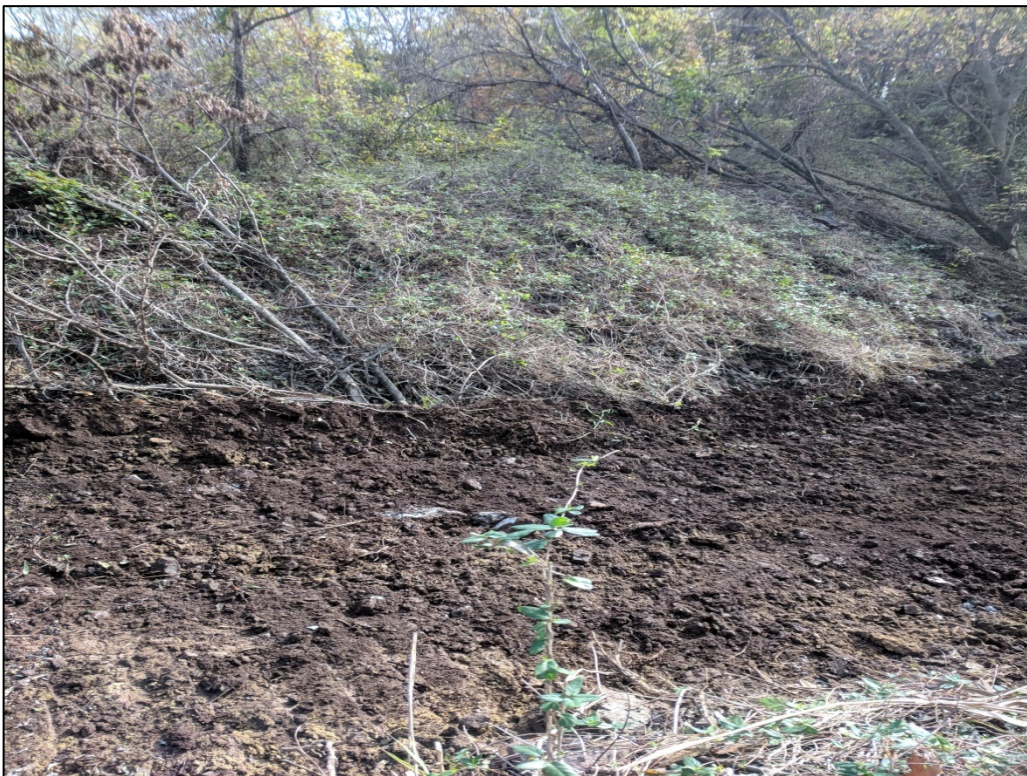
Photo 10: View of test pit at A7-004-TP before excavation.
No visible contamination is evident.

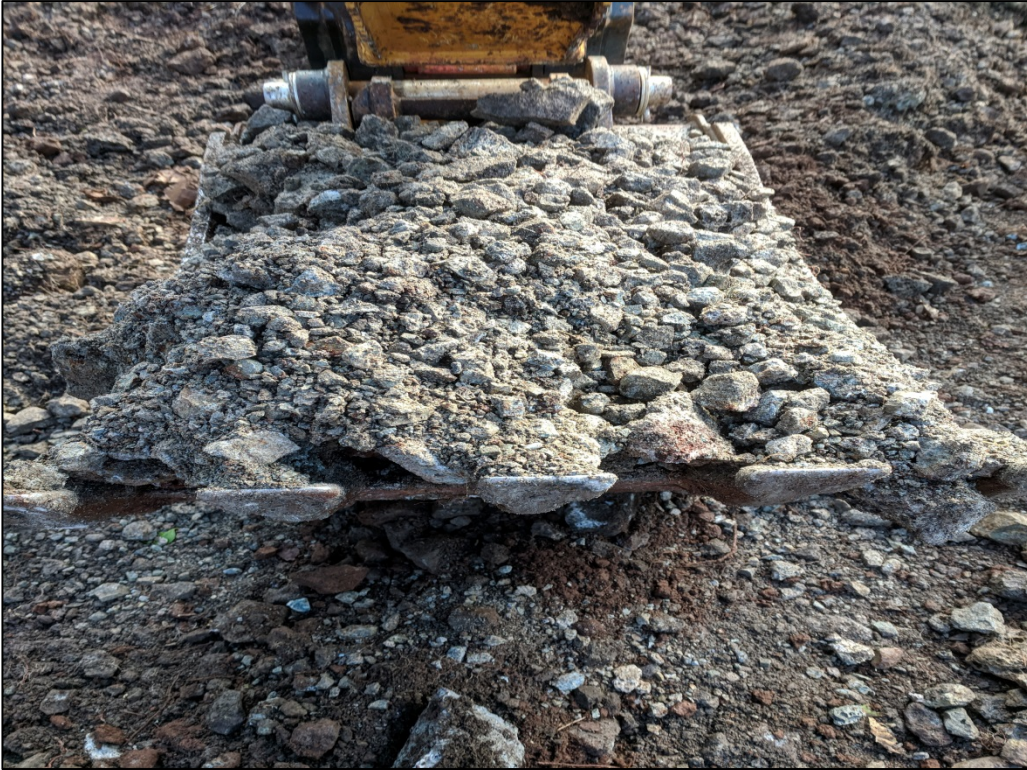
Photo 11: View of the soil observed during test pit activities at A7-004-TP. Soils appear to consist of gravel. No visible contamination is evident.

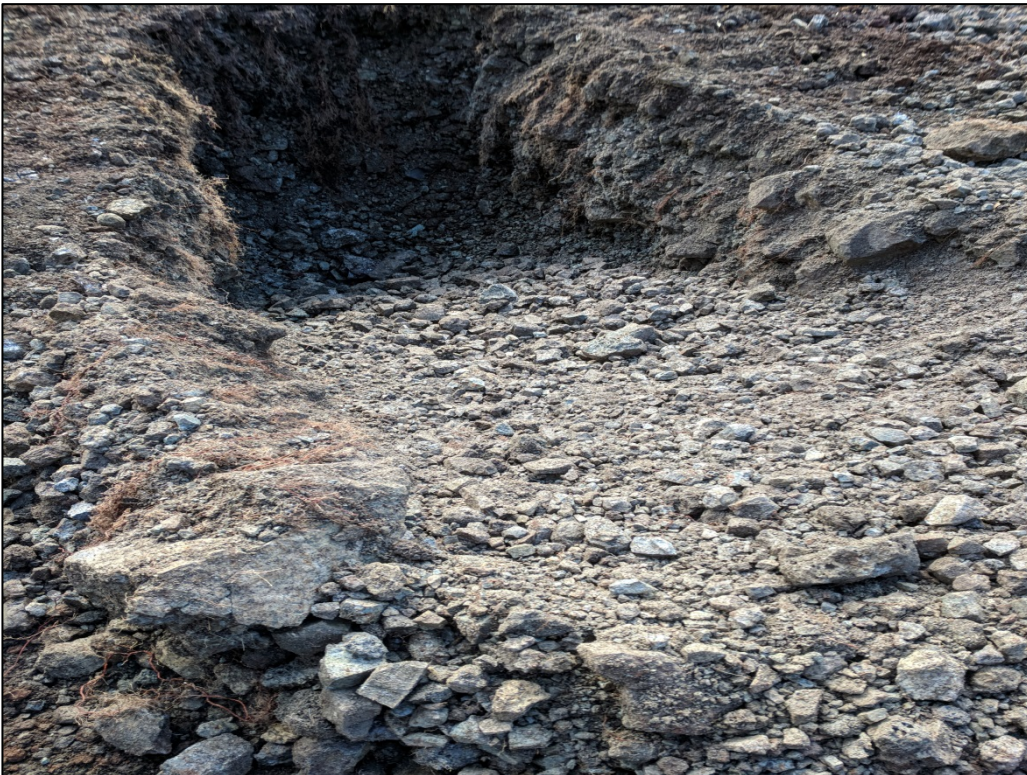
Photo 12: View of test pit at A7-004-TP after excavation. No visible contamination is evident and PID reading equals 2.3.

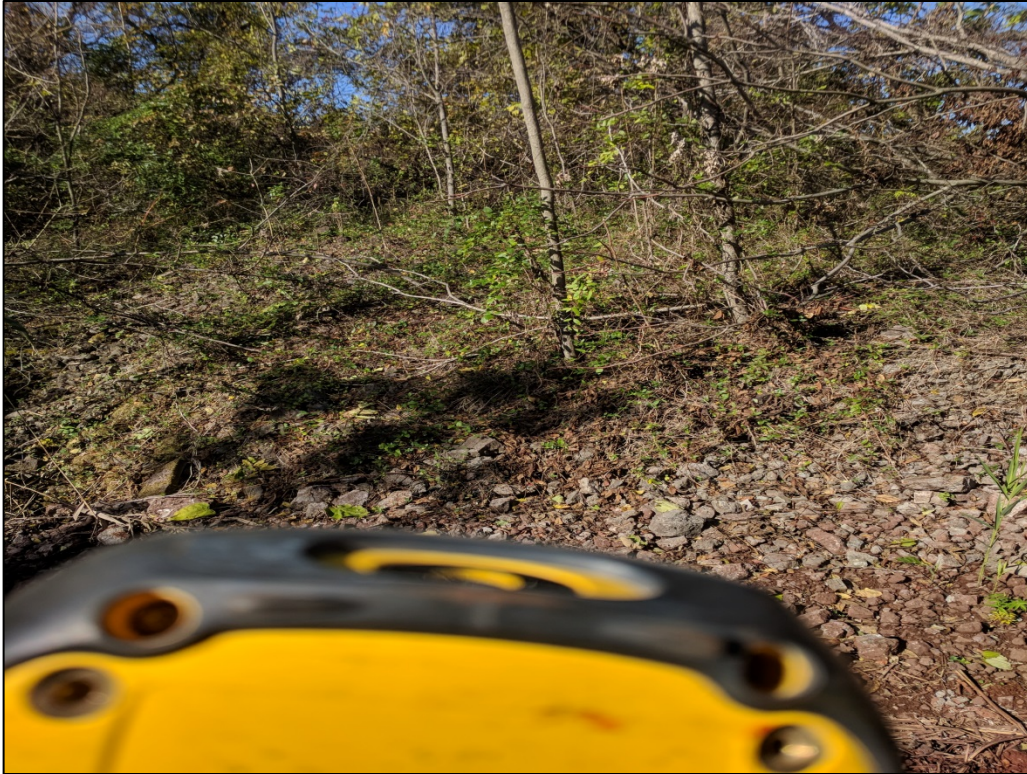
Photo 13: View of test pit at A7-005-TP before excavation.
No visible contamination is evident.

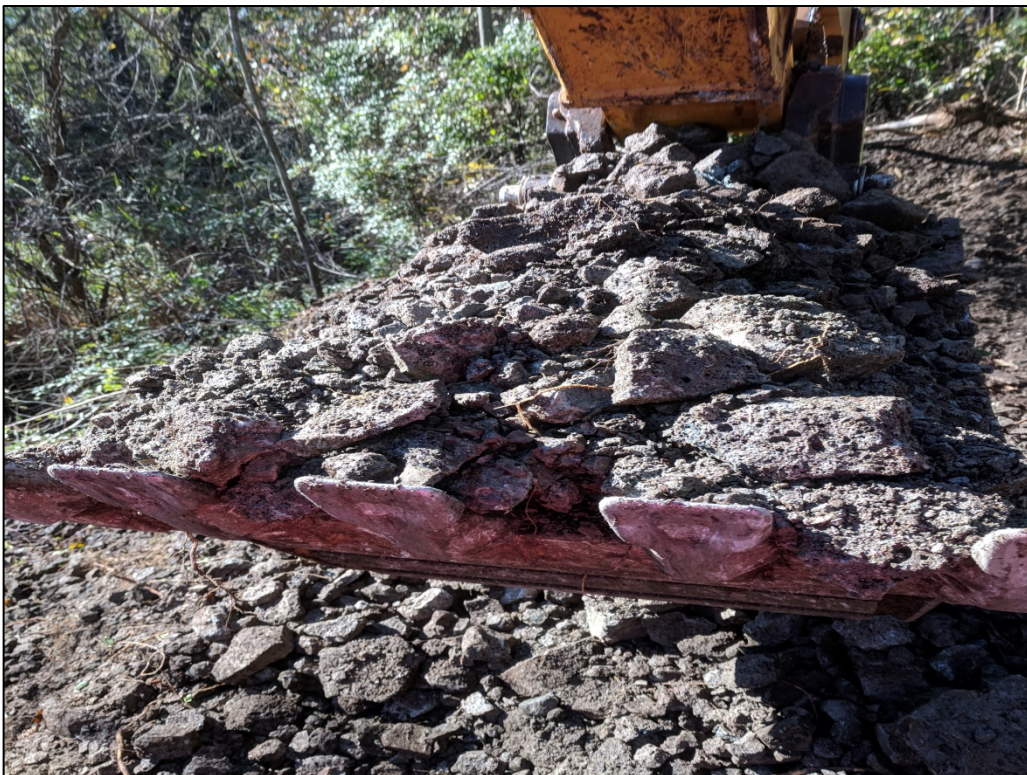
Photo 14: View of test pit at A7-005-TP after excavation. Soils appear to consist of gravel.
No visible contamination is evident and PID reading equals 4.6.

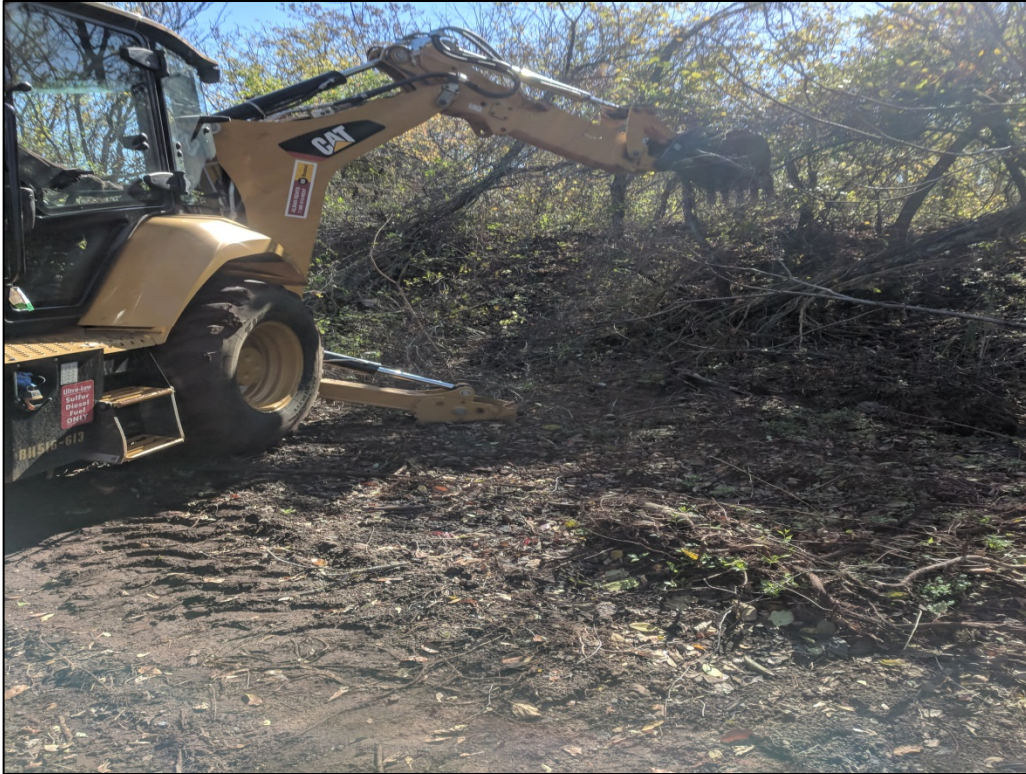
Photo 15: View of test pit at A7-006-TP before excavation.
No visible contamination is evident.

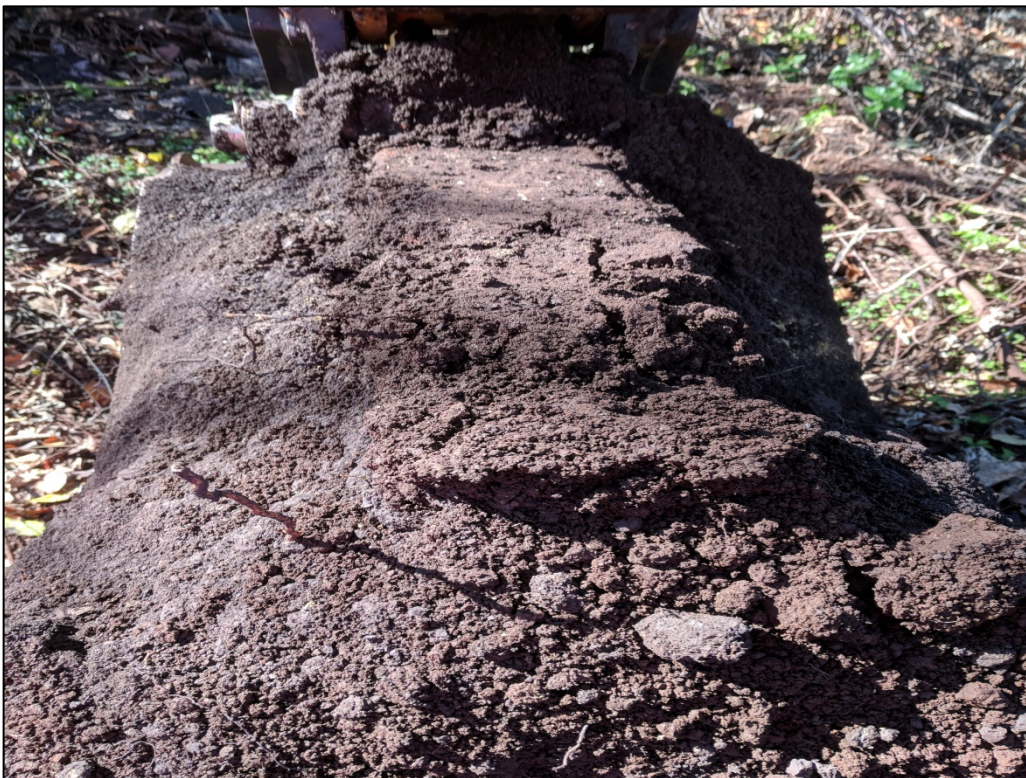
Photo 16: View of the soil observed during test pit activities at A7-006-TP.
Soils appear to consist of sandy silt. No visible contamination is evident.

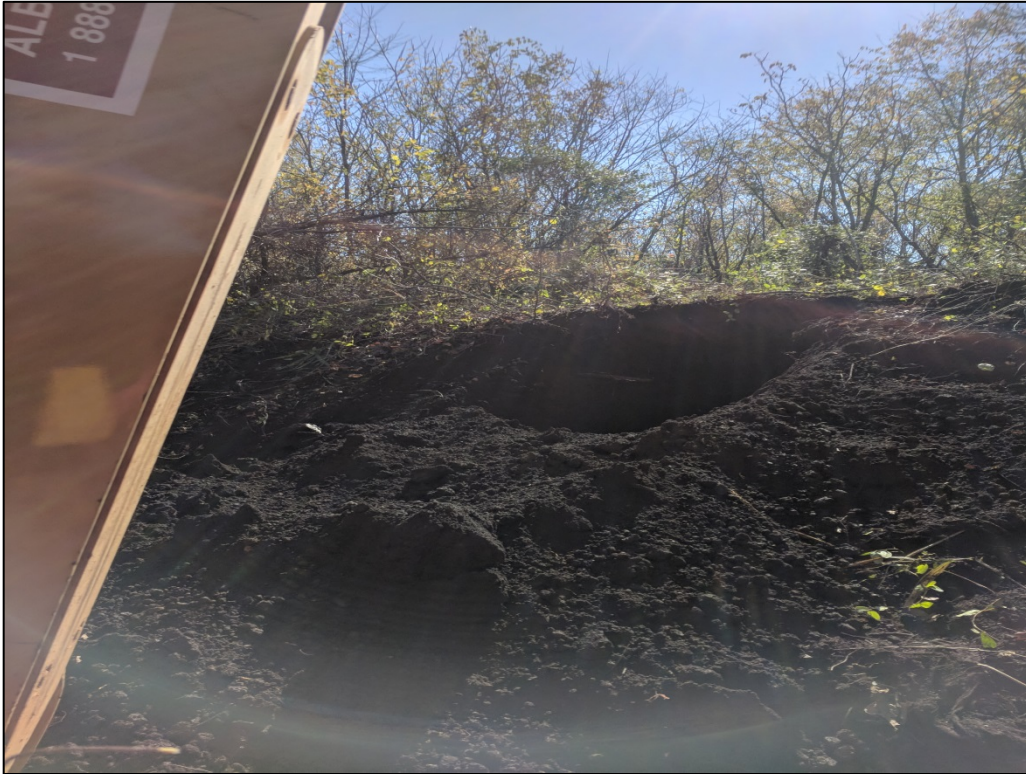
Photo 17: View of test pit at A7-006-TP after excavation.
No visible contamination is evident and PID reading equals 7.0.

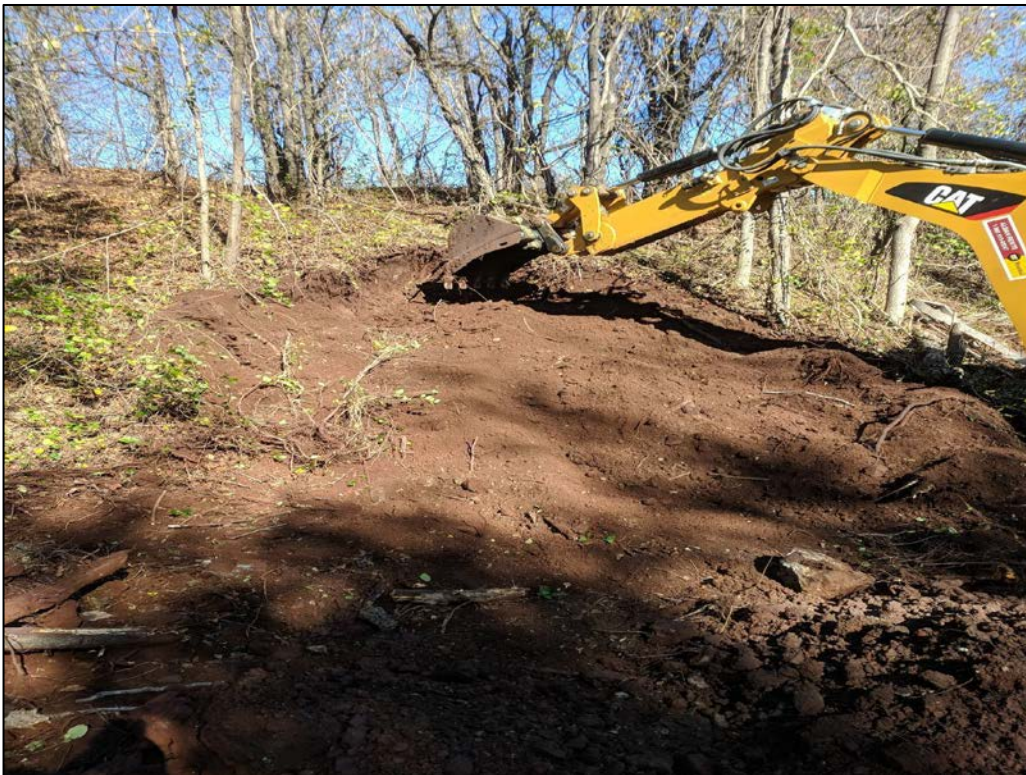
Photo 18: View of test pit at A7-007-TP before excavation.
No visible contamination is evident.

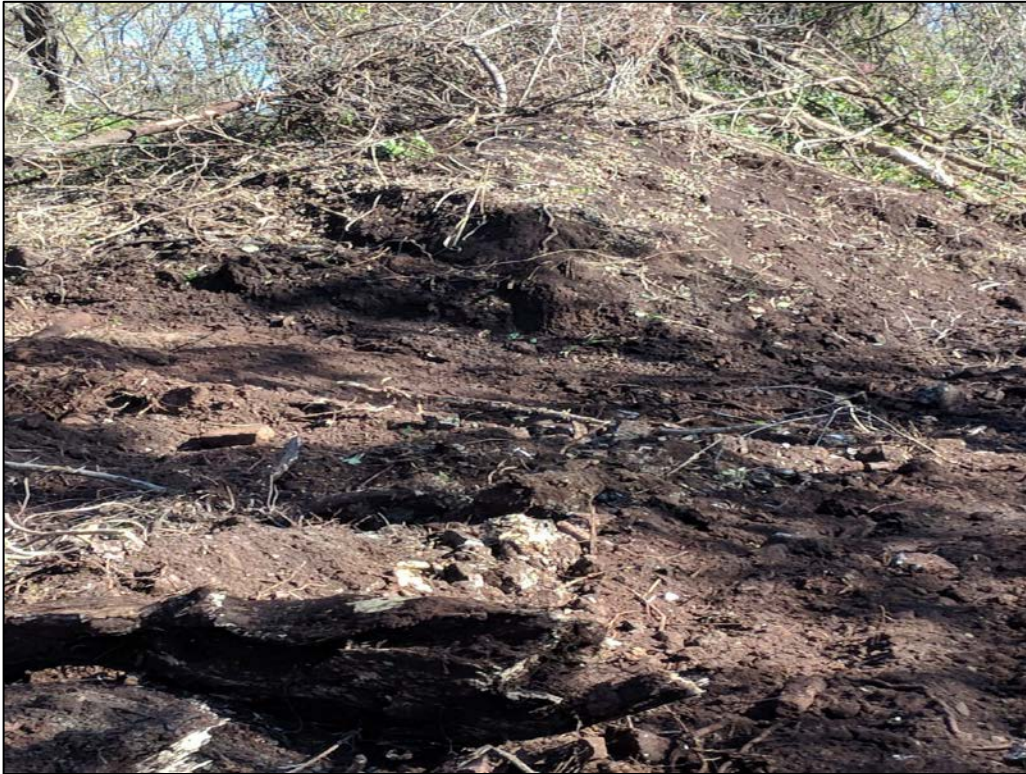
Photo 19: View of test pit at A7-007-TP after excavation.
No visible contamination is evident and PID reading equals 7.1.

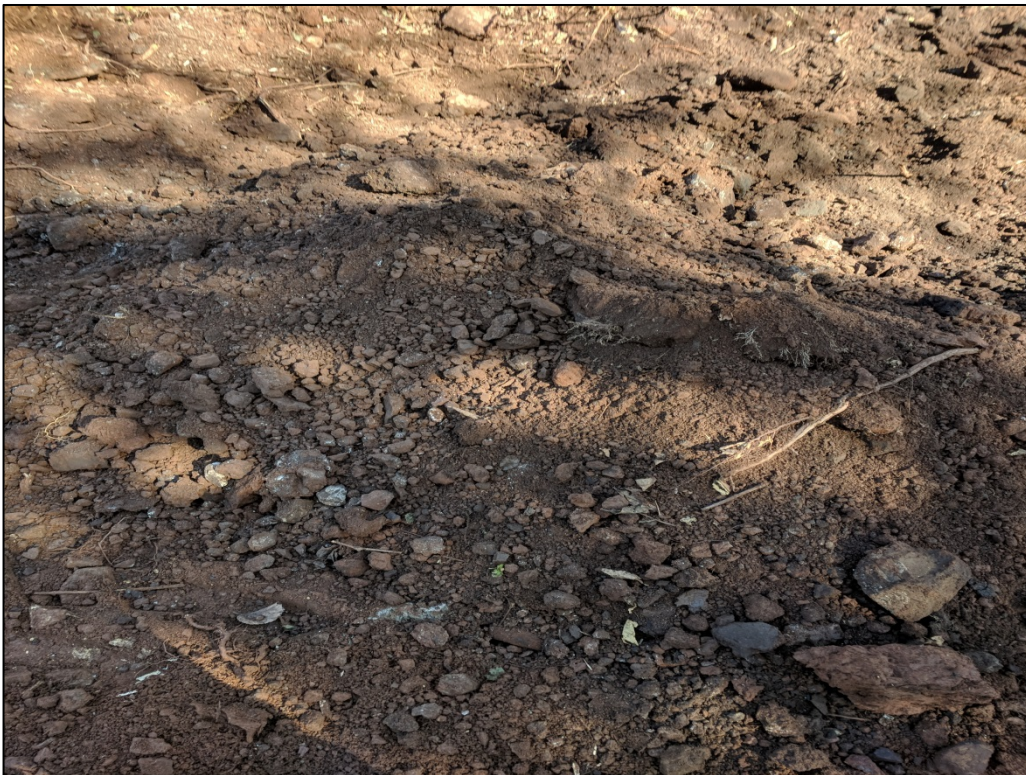
Photo 20: View of test pit at A7-008-TP before excavation.
No visible contamination is evident.

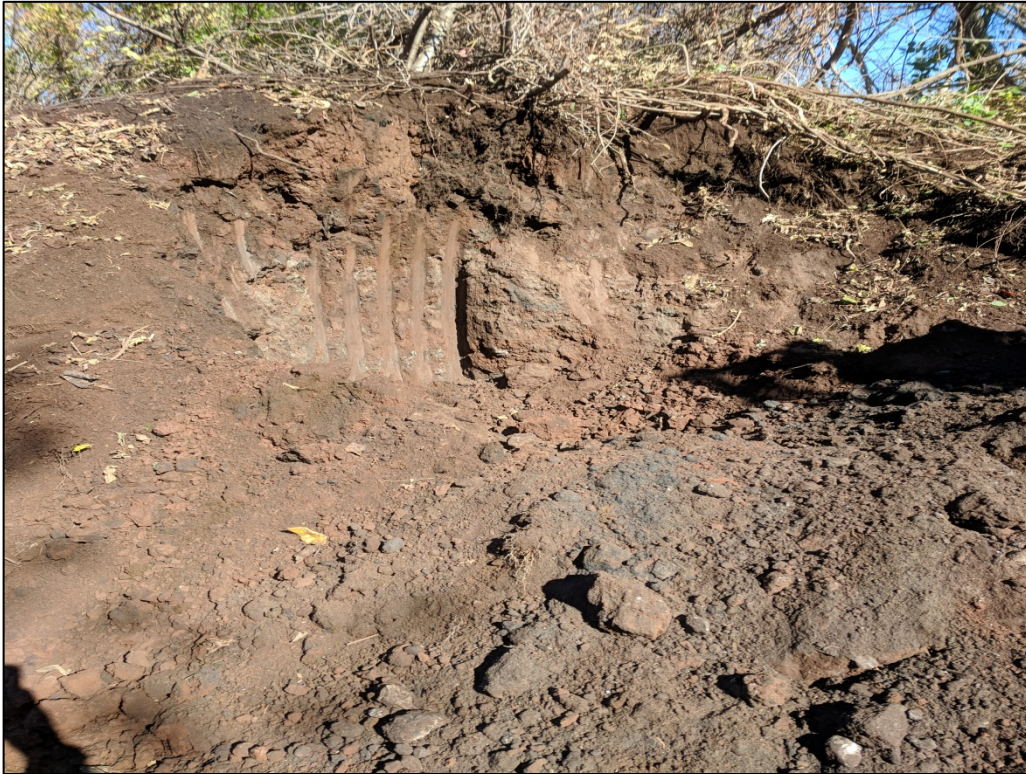
Photo 21: View of test pit at A7-008-TP after excavation. Soils appear to consist of silty clay. No visible contamination is evident and PID reading equals 6.7.

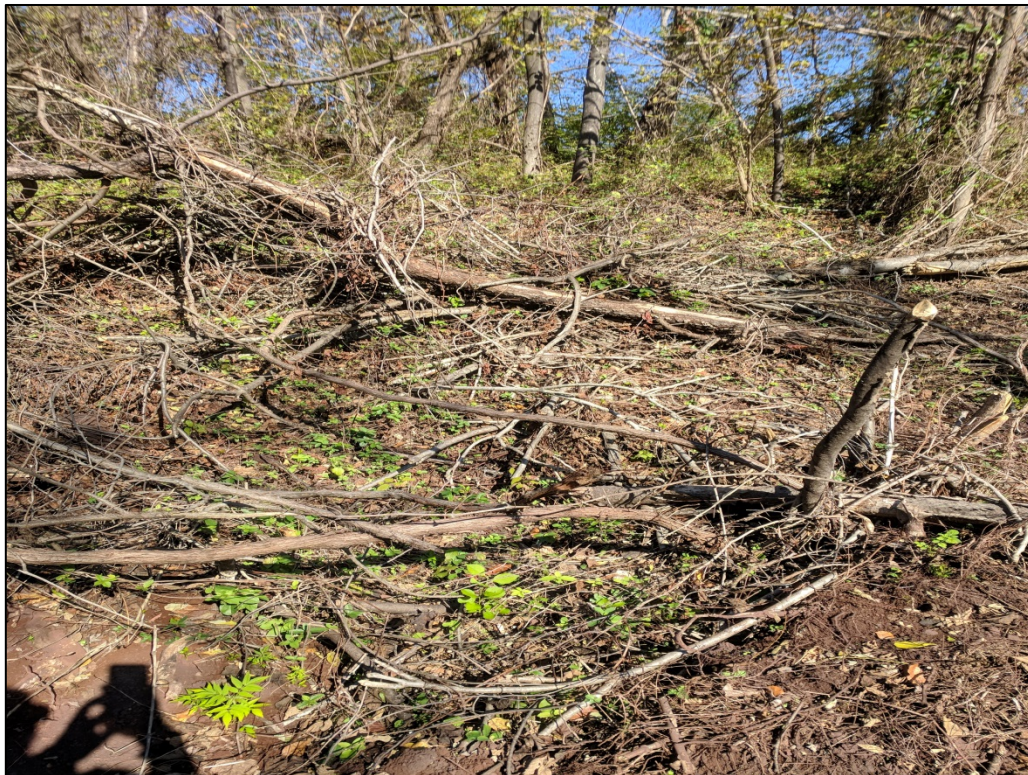
Photo 22: View of test pit at A7-009-TP before excavation. No visible contamination is evident.

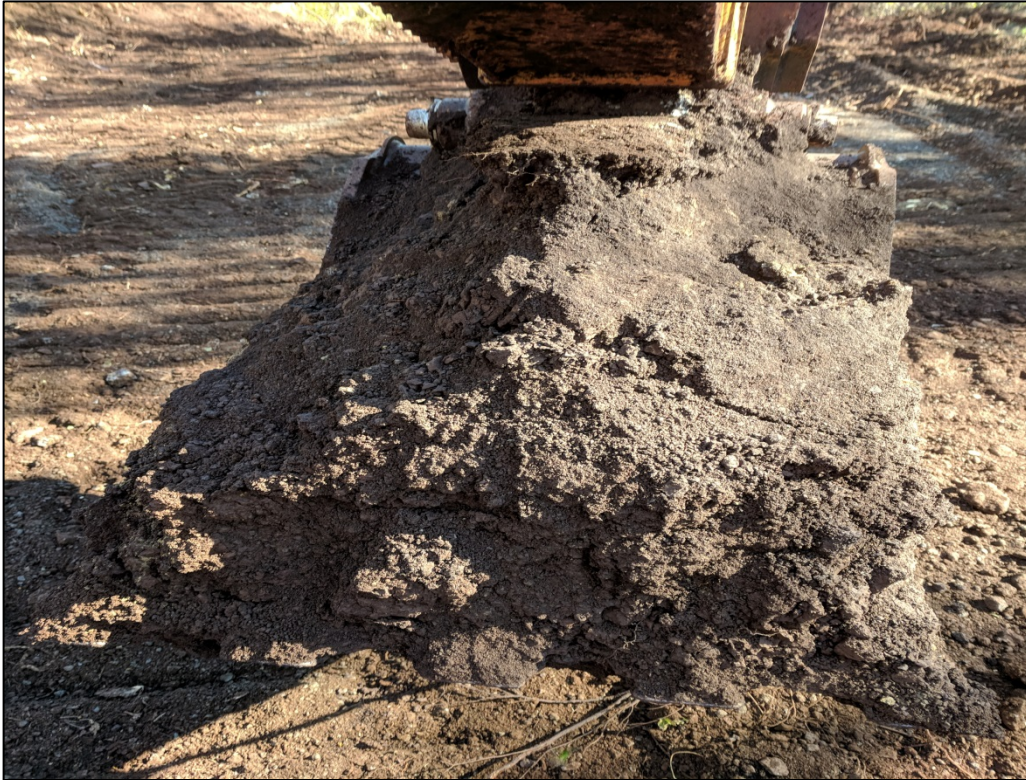
Photo 23: View of the soil observed during test pit activities at A7-009-TP. Soils appear to consist of sandy silty. No visible contamination is evident.

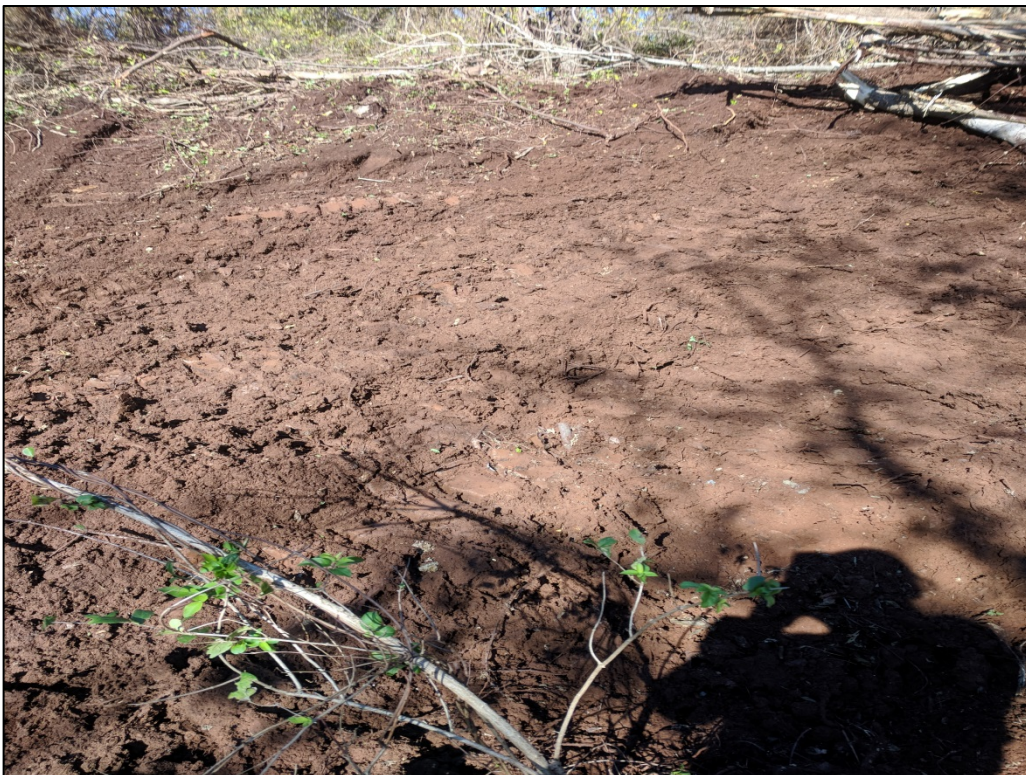
Photo 24: View of test pit at A7-009-TP after excavation. No visible contamination is evident and PID reading equals 3.6.
