PHASE II INVESTIGATION REPORT

AREA A: PARCEL A7
TRADEPOINT ATLANTIC
SPARROWS POINT, MARYLAND

ARM Project No. 150298M-15

Revision 1 – July 8, 2019

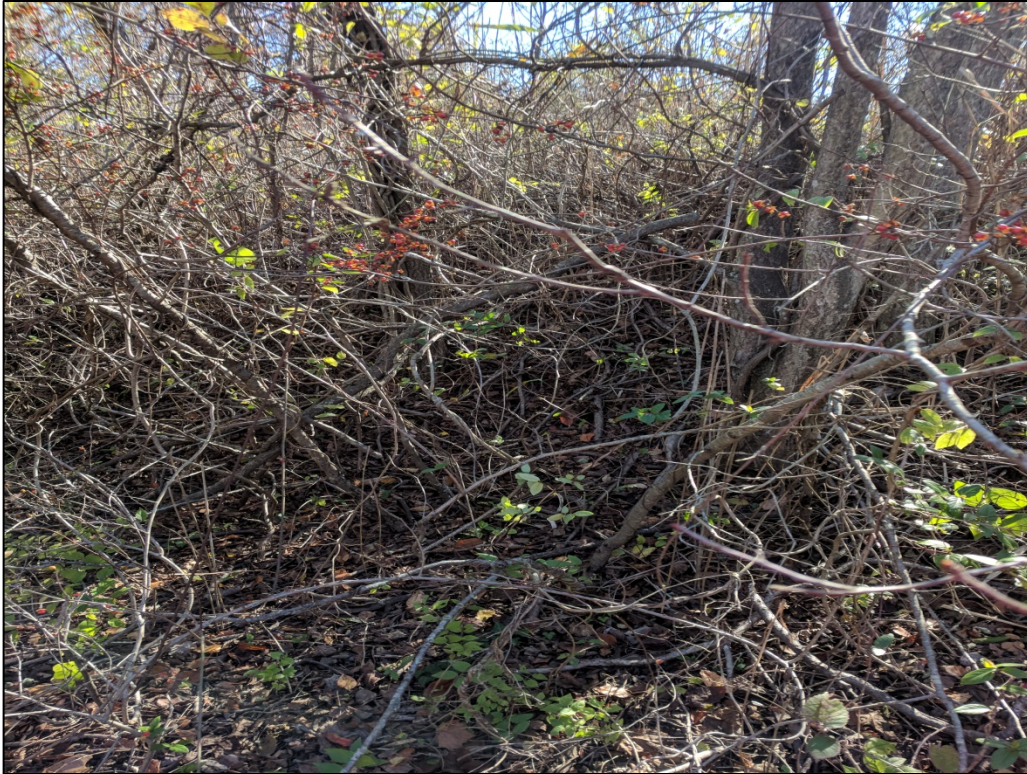
Photo 25: View of test pit at A7-010-TP before excavation.
No visible contamination is evident.

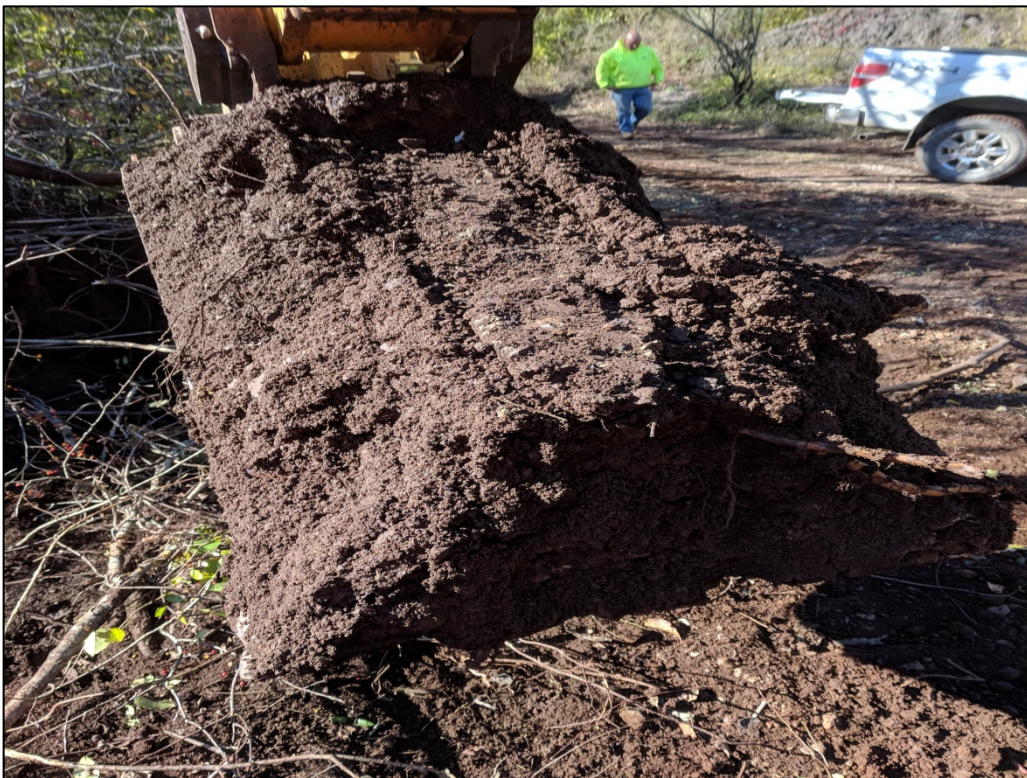
Photo 26: View of the soil observed during test pit activities at A7-010-TP.
Soils appear to consist of sandy silt. No visible contamination is evident.

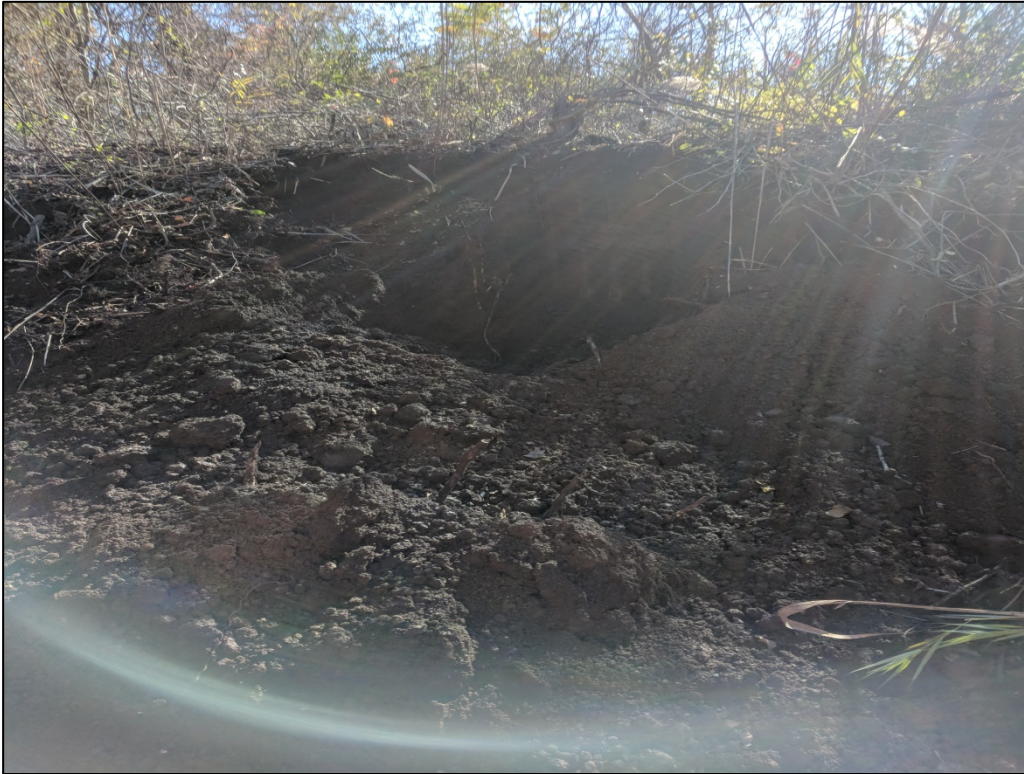
Photo 27: View of test pit at A7-010-TP after excavation.
No visible contamination is evident and PID reading equals 5.4.

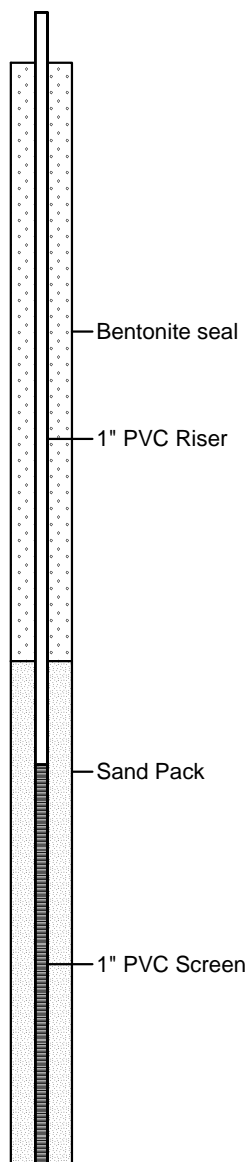
Drilling Company : Allied Drilling Co.
TOC Elevation : ---
0-Hr DTW : 14.3' TOC
48-Hr DTW : 14.6' TOC
ARM Representative : L. Perrin

Depth in Feet	Surf. Elev.	DESCRIPTION		REMARKS
0		Riser Type: PVC Riser Diameter: 1" Riser Stickup: 2.4' Riser Amount: 17.6'		Northing (US ft): 574579.00 Easting (US ft): 1460855.00 No LNAPL or DNAPL detected at 48 hours
1				
2				
3		Screen Type: PVC Screen Diameter: 1" Screen Amount: 10' Slot Size: 0.010"		
4				
5				
6		Sand Pack: Top: 15' bgs Bottom: 27.6' bgs Grain Size: WG #2		
7				
8		Bentonite Seal: Top: 0 (surface) Bottom: 15' bgs Grain Size: 3/8" chips		
9				
10				
11				
12				
13				
14				
15				
16				
17				
18				
19				
20				
21				
22				
23				
24				
25				
26				
27				
28		End of Boring

Total Depth: 27.6' bgs
