# PHASE II INVESTIGATION REPORT

AREA B: PARCEL B2  
TRADEPOINT ATLANTIC  
SPARROWS POINT, MARYLAND

ARM Project No. 150300M-6

Revision 1 – August 13, 2018

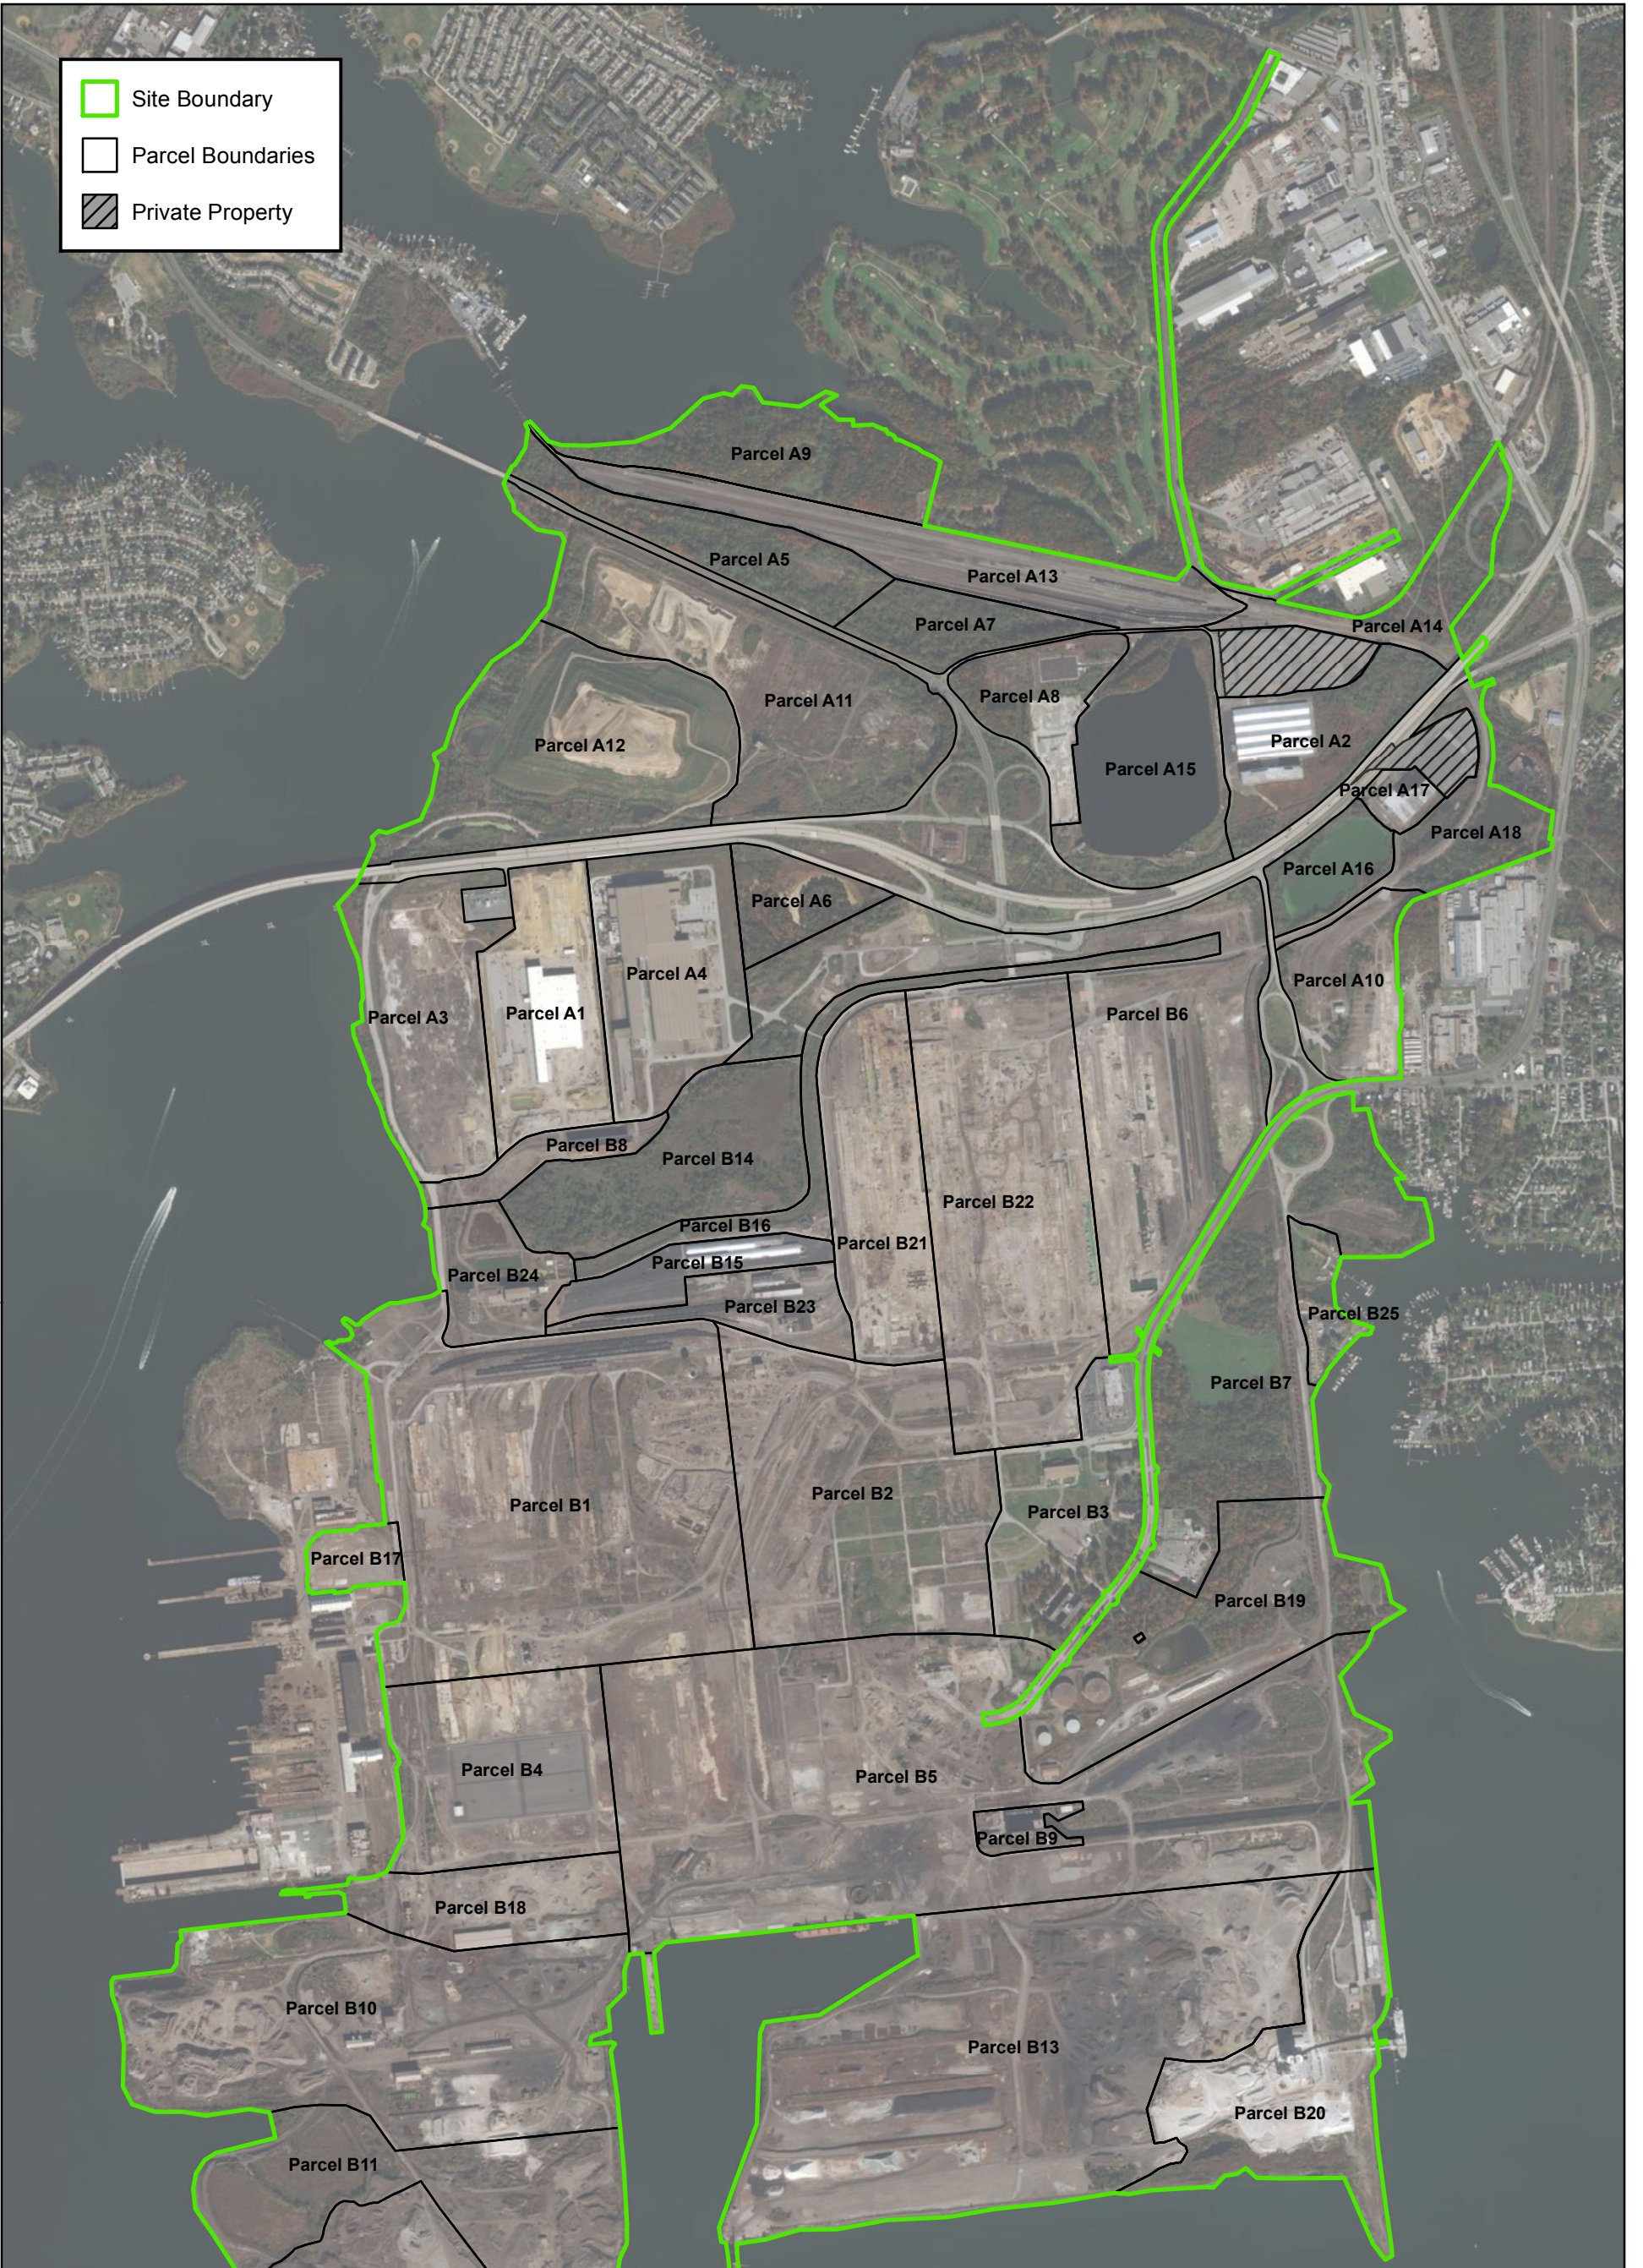
<b>Tradepoint Atlantic</b> <b>Area A and Area B Parcels</b> March 1, 2018		<b>Figure</b> <span style="font-size: 2em; font-weight: bold;">1</span>
 	 <b>ARM Group Inc.</b> Earth Resource Engineers and Consultants	Tradepoint Atlantic Baltimore County, MD EnviroAnalytics Group
	Area A: Project 150298M Area B: Project 150300M Development: Project 160443M

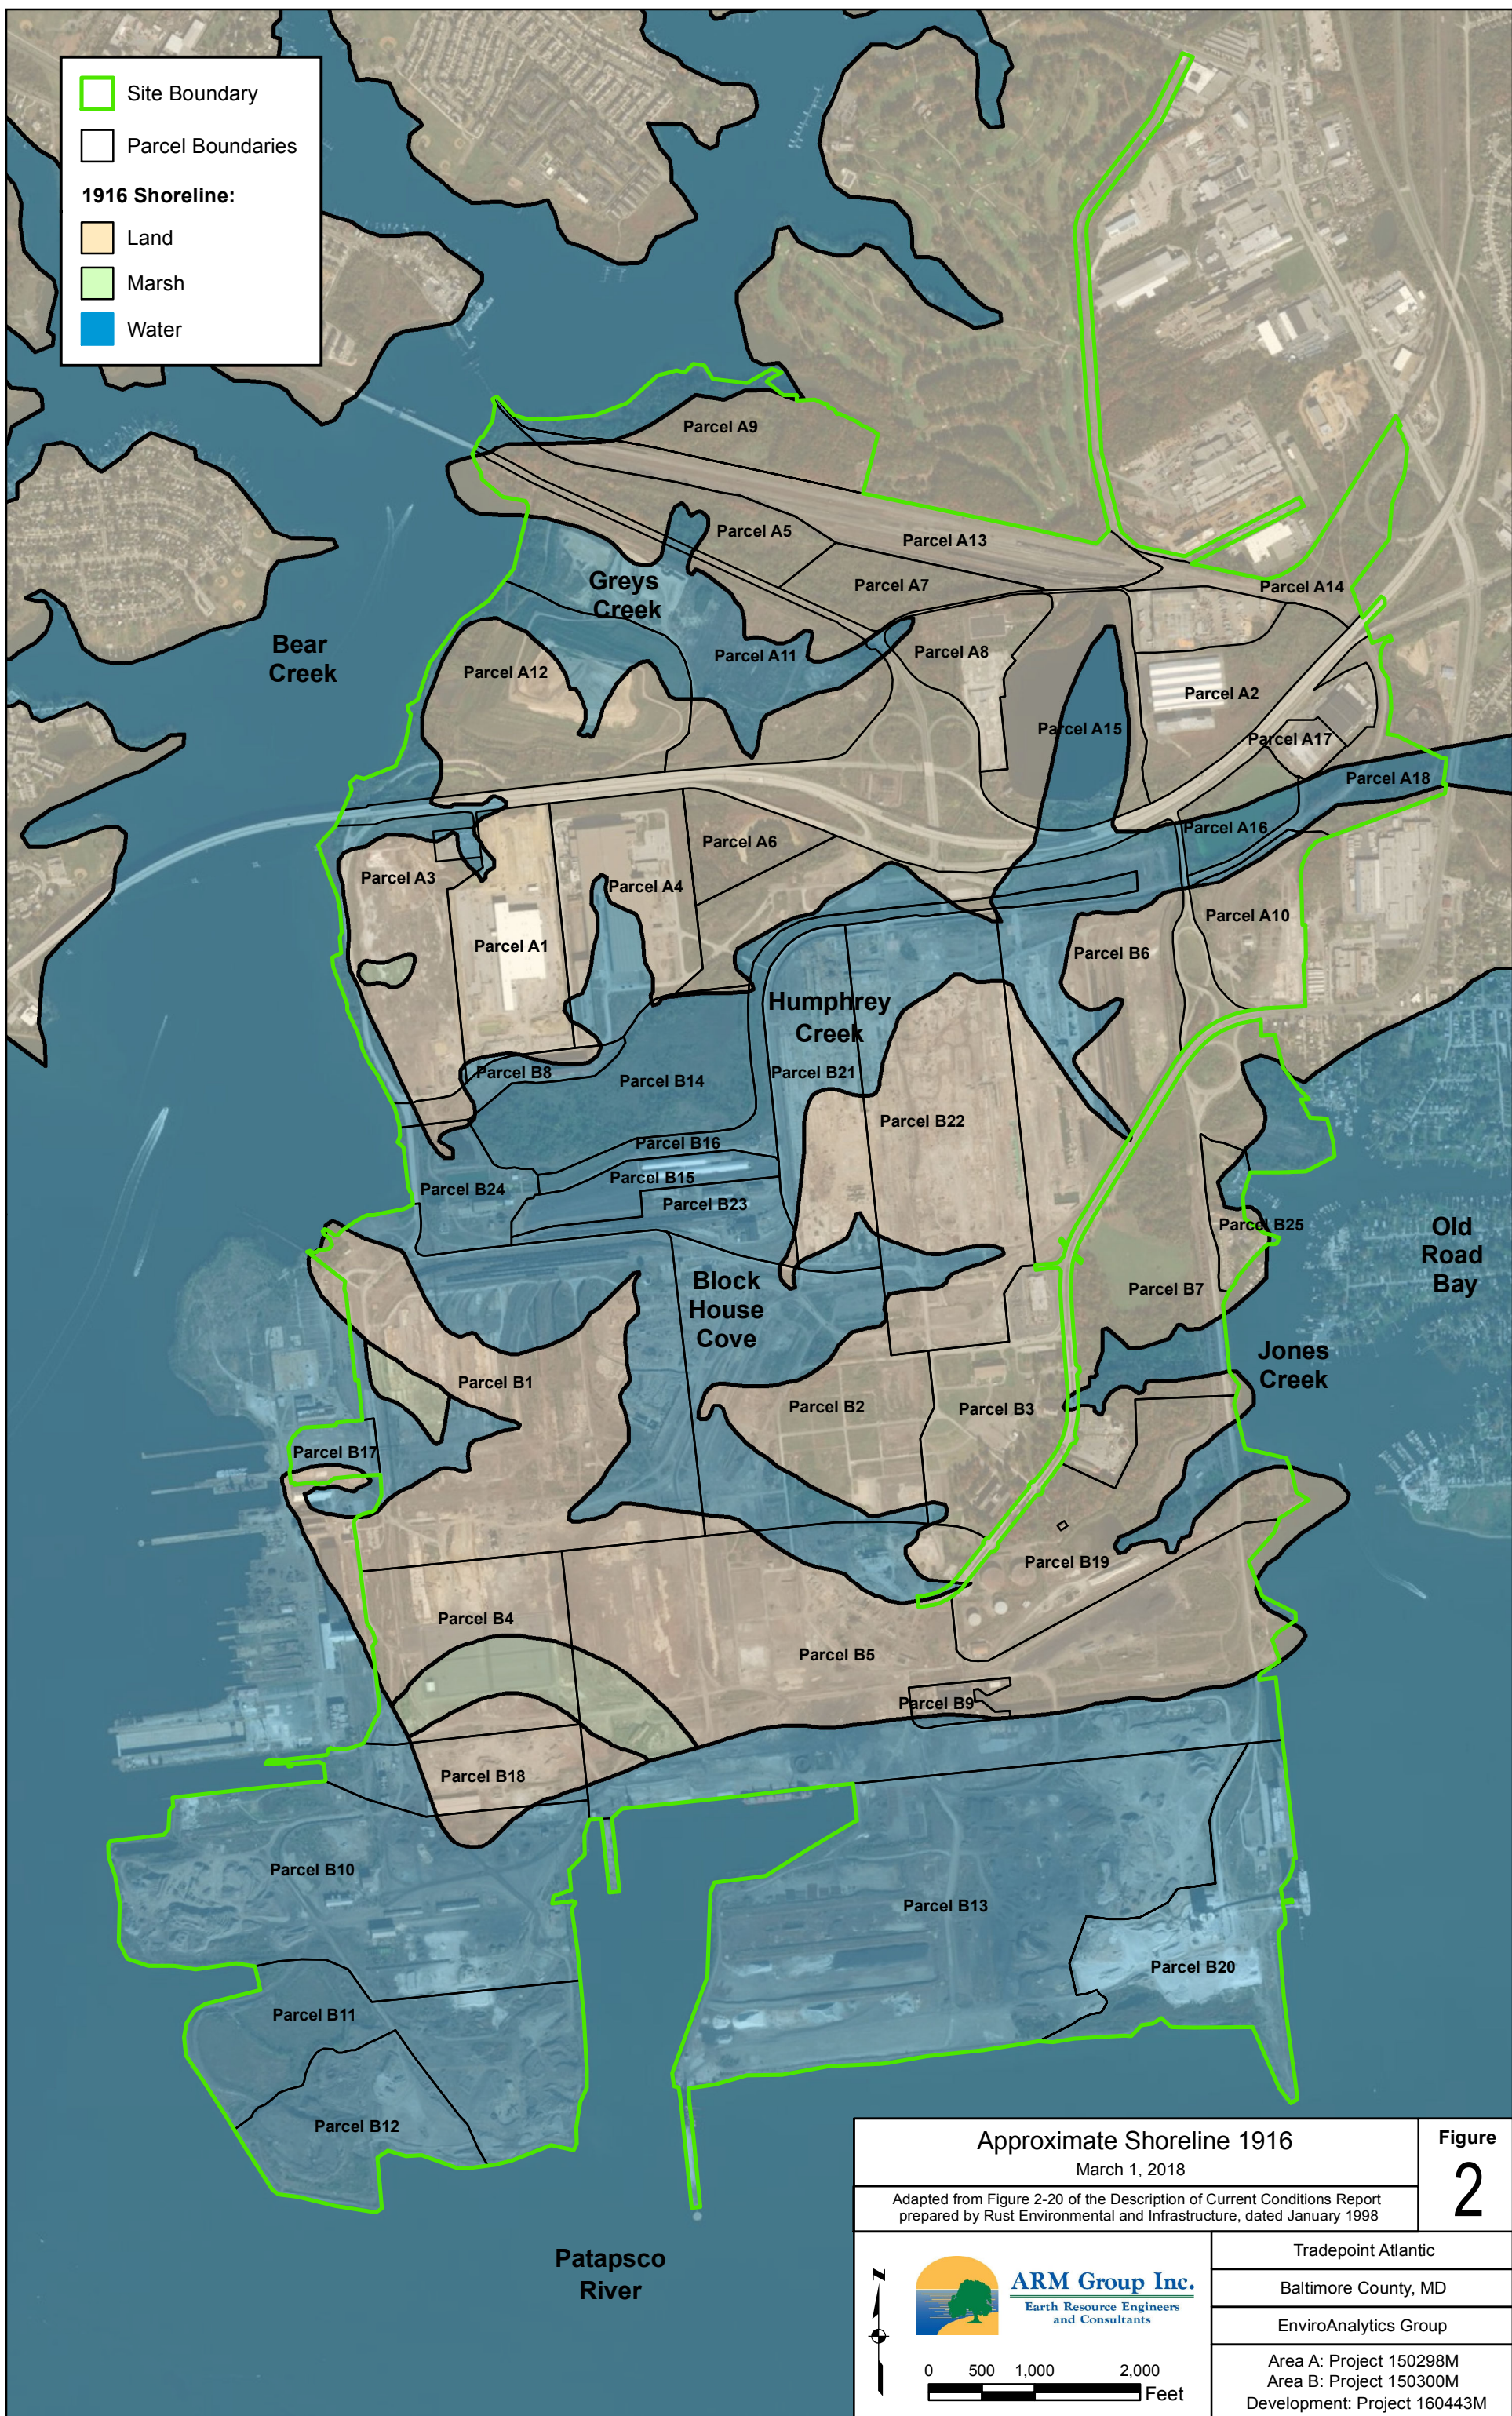
Site Boundary  
 Parcel Boundaries  
**1916 Shoreline:**  
 Land  
 Marsh  
 Water

Groundcover at the Site is comprised of approximately 45% natural soils and 55% fill materials based on the approximate shoreline of the Sparrows Point Peninsula in 1916, as shown on **Figure 2** (adapted from Figure 2-20 in the Description of Current Conditions (DCC) Report prepared by Rust Environment and Infrastructure dated January 1998).

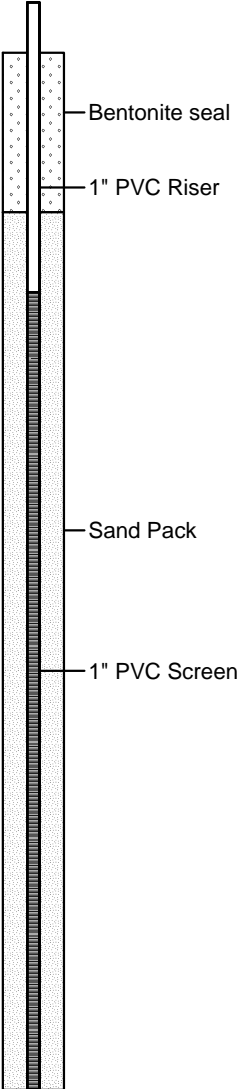
REMARKS
0		Riser Type: PVC Riser Diameter: 1" Riser Stickup: 2.3' Riser Amount: 3'		Northing (US ft): 566017.95 Easting (US ft): 1461361.10  No LNAPL or DNAPL detected at 48 hours
5		Screen Type: PVC Screen Diameter: 1" Screen Amount: 10' Slot Size: 0.010"		
10		Filter (sand) Pack: Top: 2' bgs Bottom: 13' bgs Grain Size: WG #2		
15		Bentonite Seal: Top: 0 (surface) Bottom: 2' bgs Grain Size: Granular (30/50 mesh)		
		End of Boring

Total Depth: 13'
