Re: Test Pit Completion Report
B6-066 Delineation Area
Area B: Parcel B6
Tradepoint Atlantic
Sparrows Point, MD 21219

ARM Group LLC (ARM), on behalf of Tradepoint Atlantic (TPA), has prepared this Completion Report to document the test pitting activities in Parcel B6 (the Site) on the TPA Property located in Sparrows Point, Maryland. This completion report is being provided to the Maryland Department of the Environment (MDE) and United States Environmental Protection Agency (USEPA) to present the observations of the test pitting investigation.

Test Pit Observations
Area B: Parcel B6 – B6-066 NAPL Area
Sparrows Point, Maryland

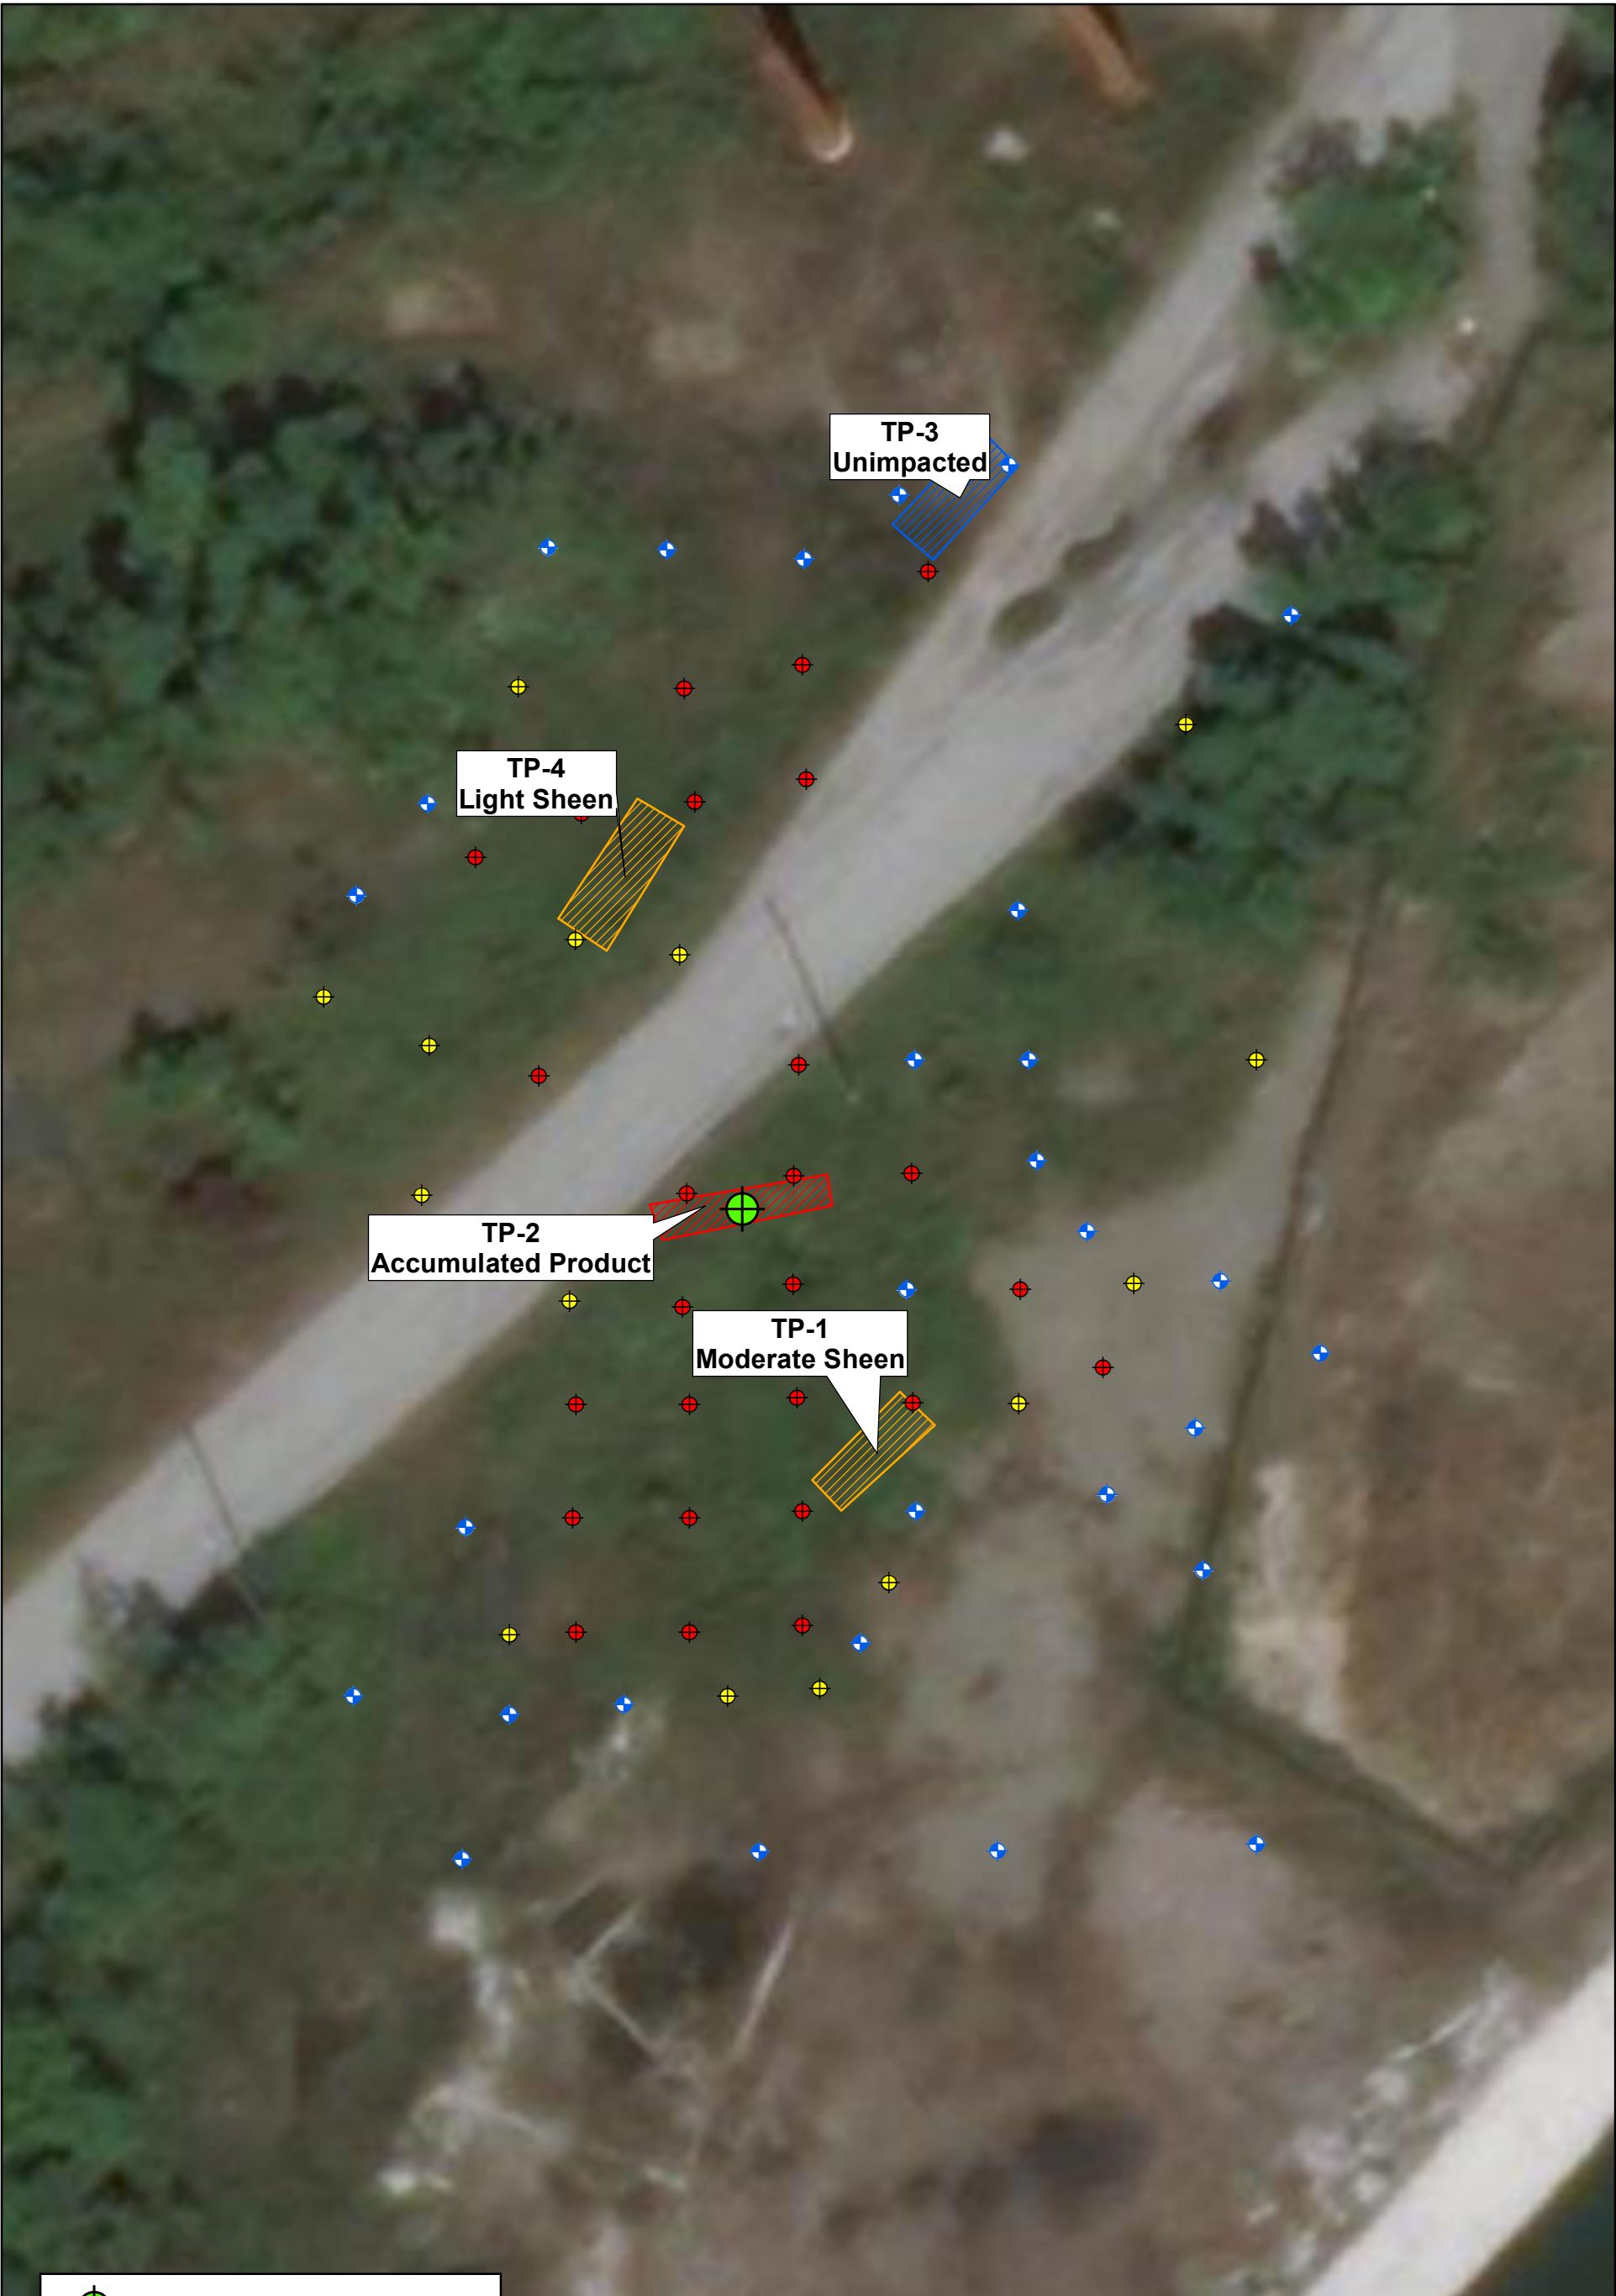
Figure
2

On July 8, 2021, in order to further assess the presence of NAPL on the site, an excavator was used to dig four test pits at the locations shown on **Figure 2**. Test pitting was conducted in accordance with the methods specified in QAPP Worksheet 21 – Field SOPs, SOP No. 015 – Test Pitting. Test pitting procedures were outlined in the B6-066 Test Pitting Work Plan and Piezometer Abandonment Completion Report (Revision 0 dated June 4, 2021).

Parcel B6: B6-066 NAPL Delineation
Test Pits
 August 24, 2021

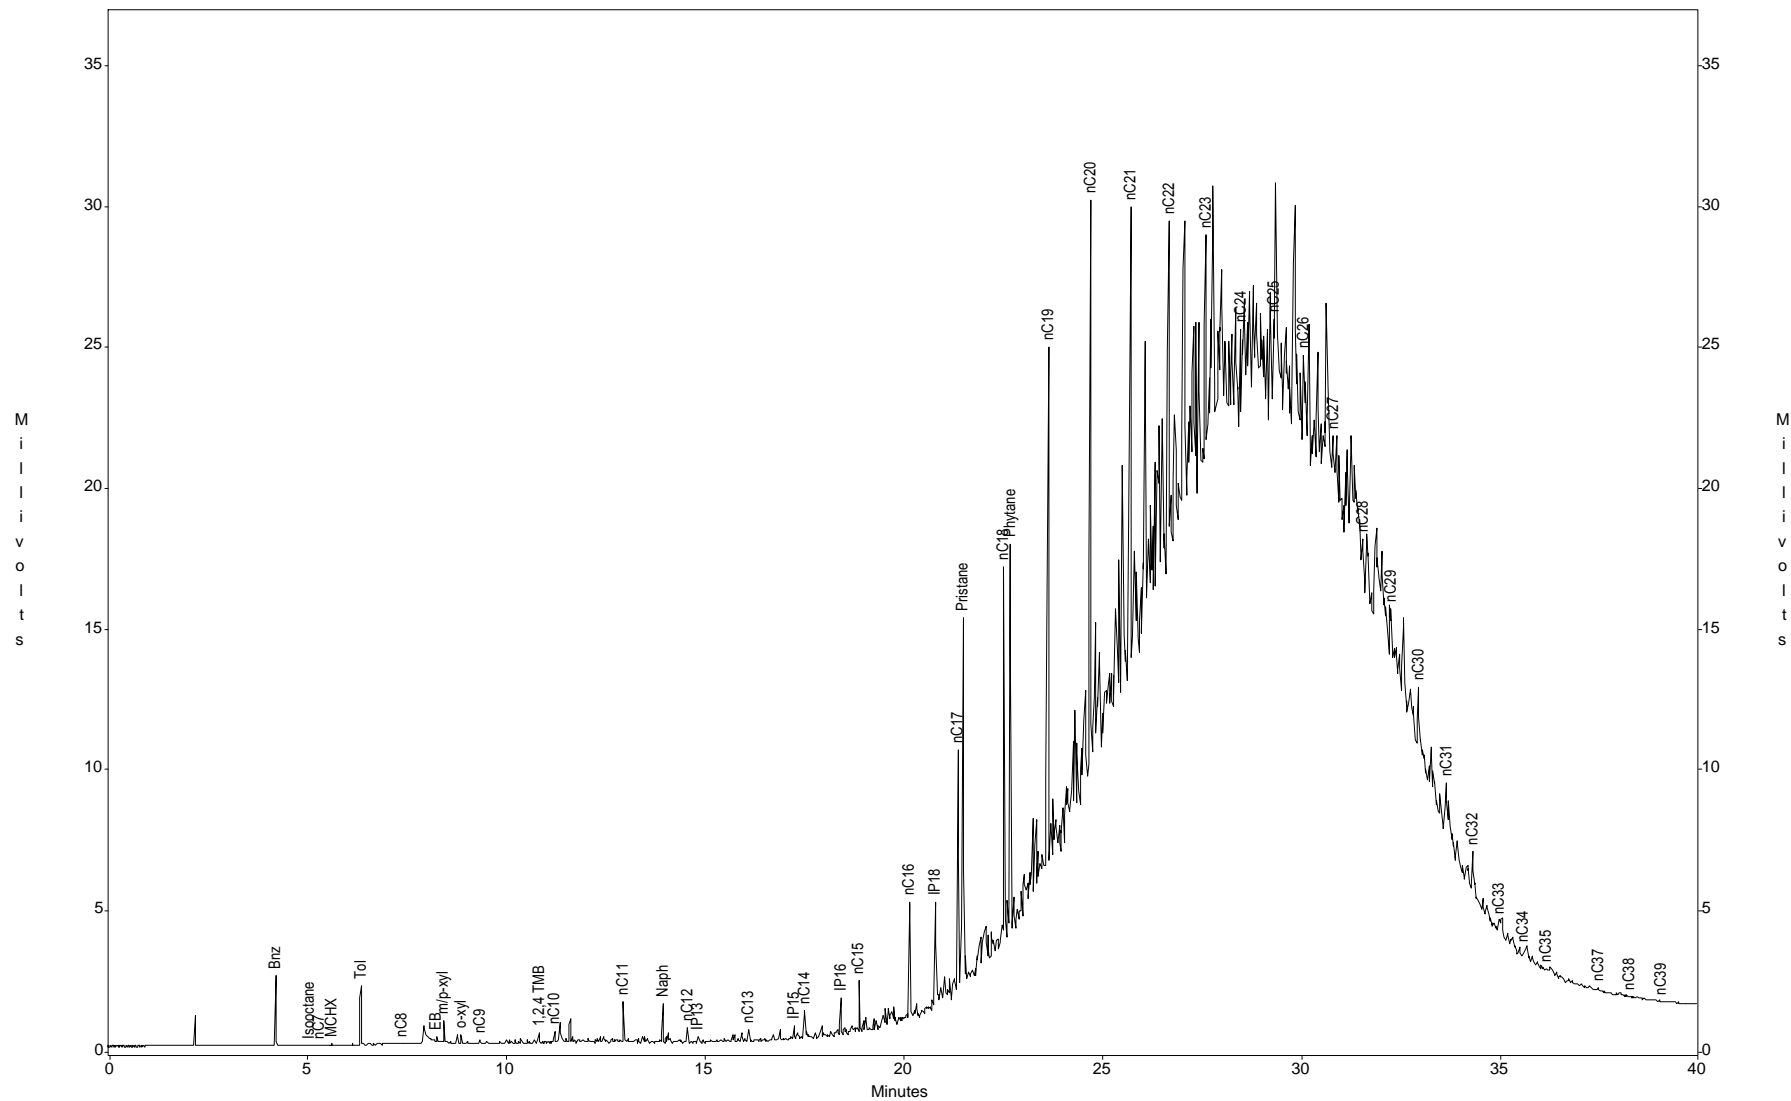
The B17 LNAPL sample appears to be a lubricating oil of some sort with a very small amount of unidentifiable light ends. The B17 LNAPL sample chromatogram (Figures 3 and 10) shows a series of peaks that starts at benzene (Bnz) and continues to the end of the chromatogram and an unresolved hump that starts at about nC13, reaches a maximum between nC24 and nC25 and continues to the end of the chromatogram. The large unresolved hump and associated peaks is most likely a lubricating oil of some sort. The identity of the very small amount of light ends in the benzene to nC14 range is not obvious.

Figure 3, Gas chromatogram of the B17 LNAPL sample.

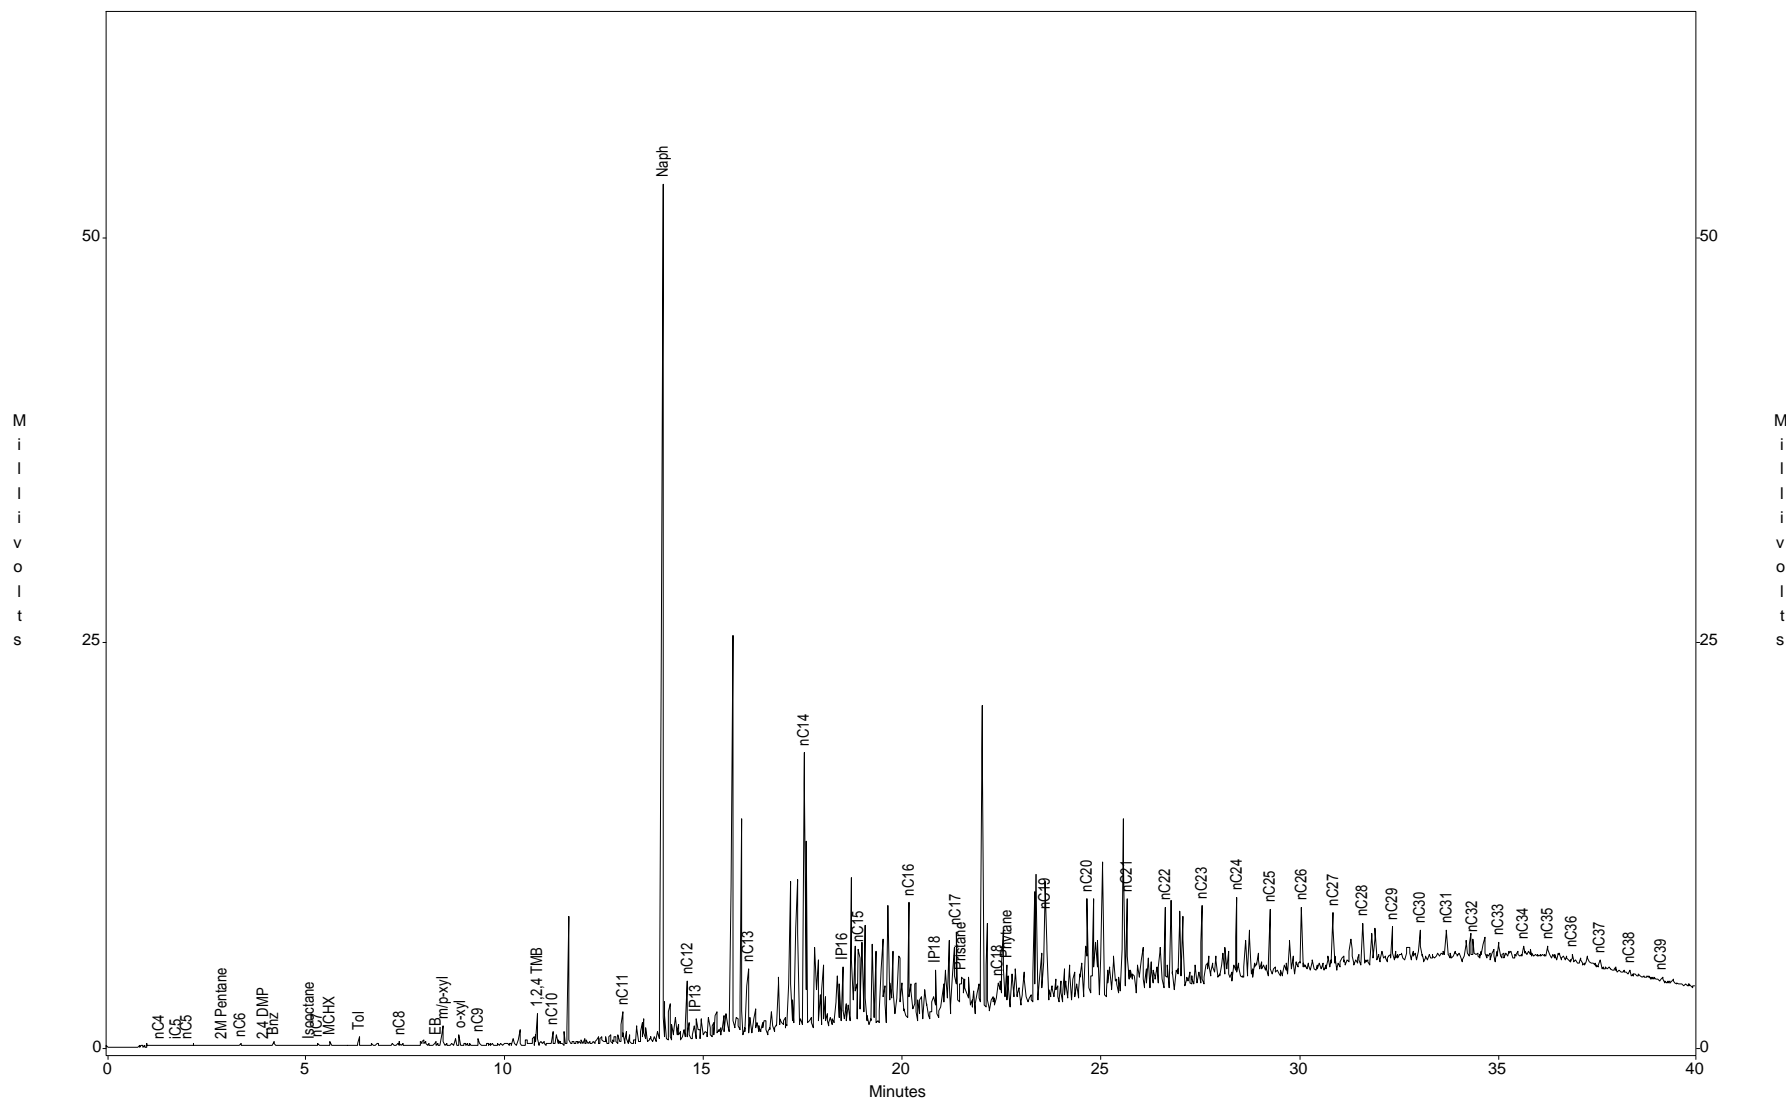
The B18 LNAPL sample appears to be a mixture of a heavy material, perhaps a #5 or #6 fuel oil and a smaller amount of coal tar. The B18 LNAPL sample chromatogram (Figures 4 and 11) shows a series of peaks that starts at benzene (Bnz) and continues to about the end of the chromatogram and a broad unresolved hump that starts at about nC10, reaches a maximum at about nC33 and continues to the end of the chromatogram. The broad unresolved hump and smaller peaks may be a heavy fuel oil such as #5 or #6. The naphthalene and larger unlabeled peaks are probably polynuclear aromatic compounds and are typical of a coal tar.

Figure 4, Gas chromatogram of the B18 LNAPL sample.

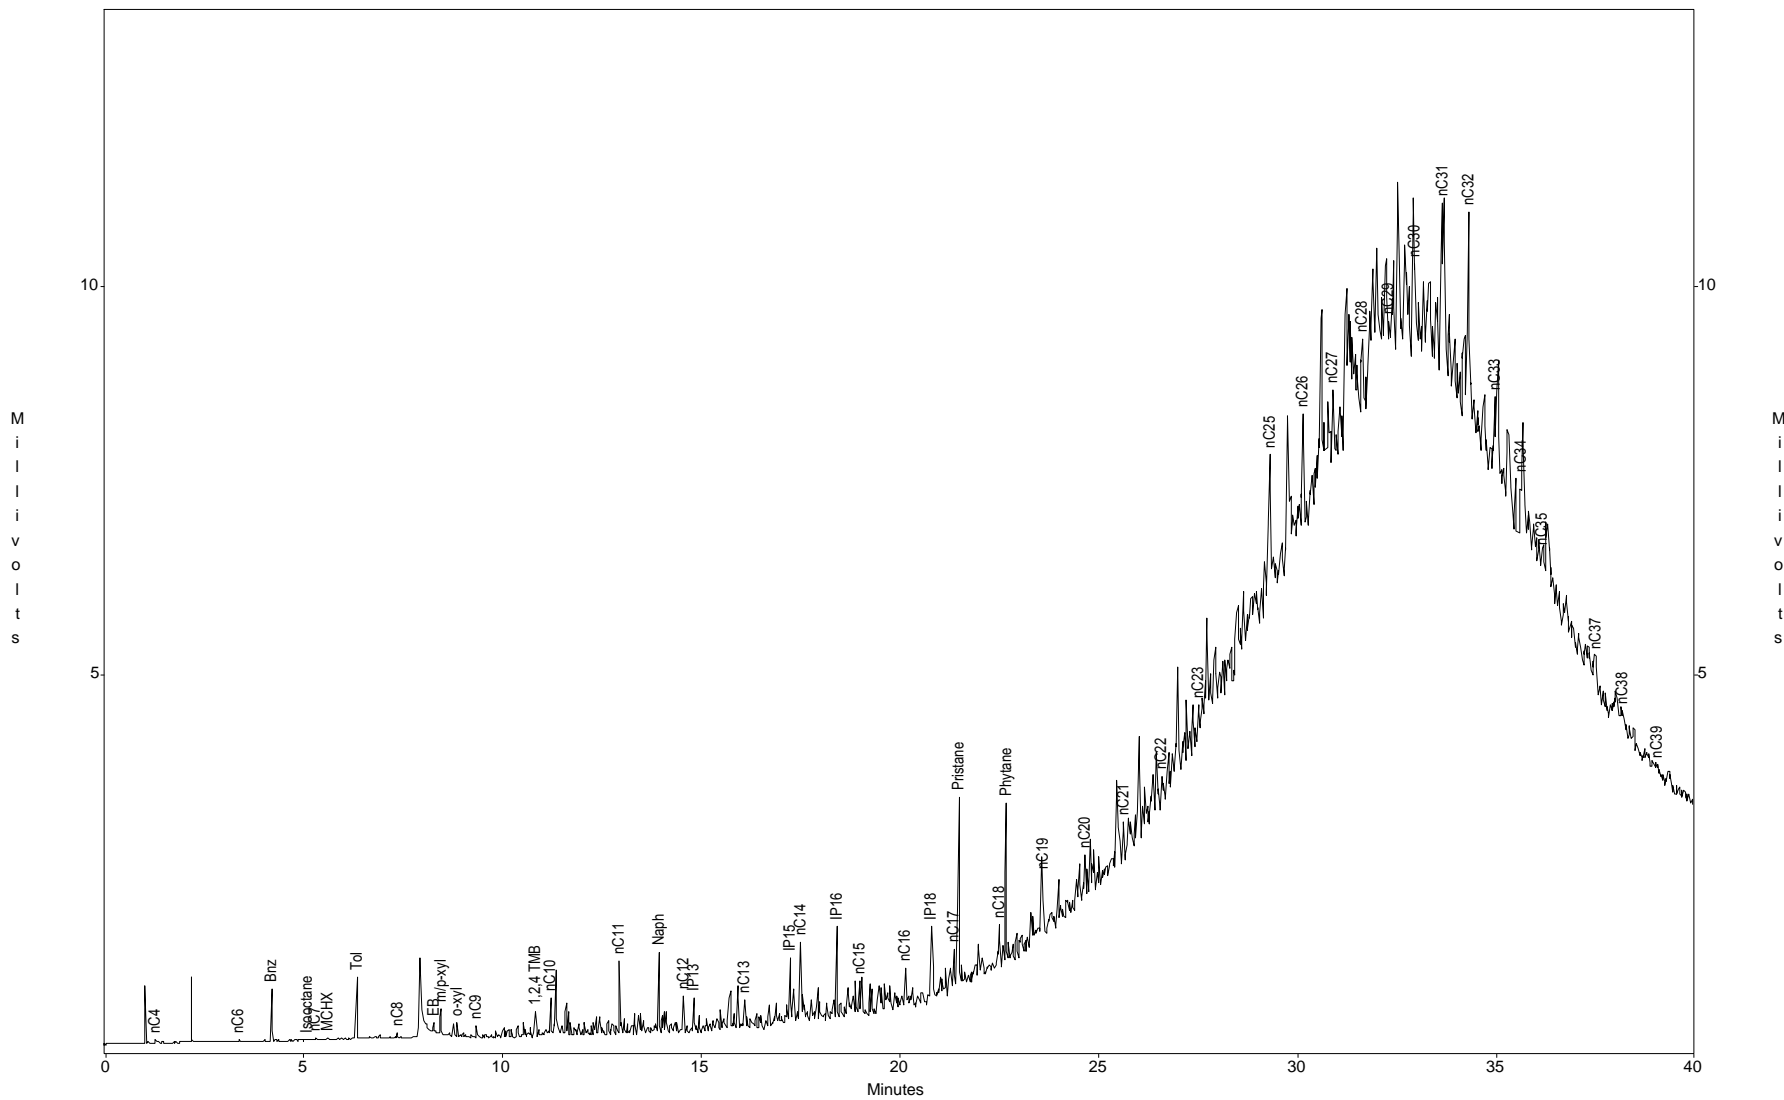
The B6-066 LNAPL sample appears to be a lubricating oil of some sort with a small amount of unidentifiable light ends. The B6-066 LNAPL sample chromatogram (Figures 5 and 12) shows a series of peaks that starts at normal butane (nC4) and continues to the end of the chromatogram and an unresolved hump that starts at about nC13, reaches a maximum at about nC30 and continues to the end of the chromatogram. The large unresolved hump and associated peaks is most likely a lubricating oil of some sort. The identity of the small amount of light ends in the nC4 to nC14 range is not obvious.

Figure 5, Gas chromatogram of the B6-066 LNAPL sample.

In March 2021, prior to piezometer network abandonment, a NAPL sample was collected from the delineation piezometers for hydrocarbon fingerprinting analysis. The hydrocarbon fingerprinting analysis determined that the NAPL is most likely a lubricating oil. Results of this analysis are included as **Attachment 1**.

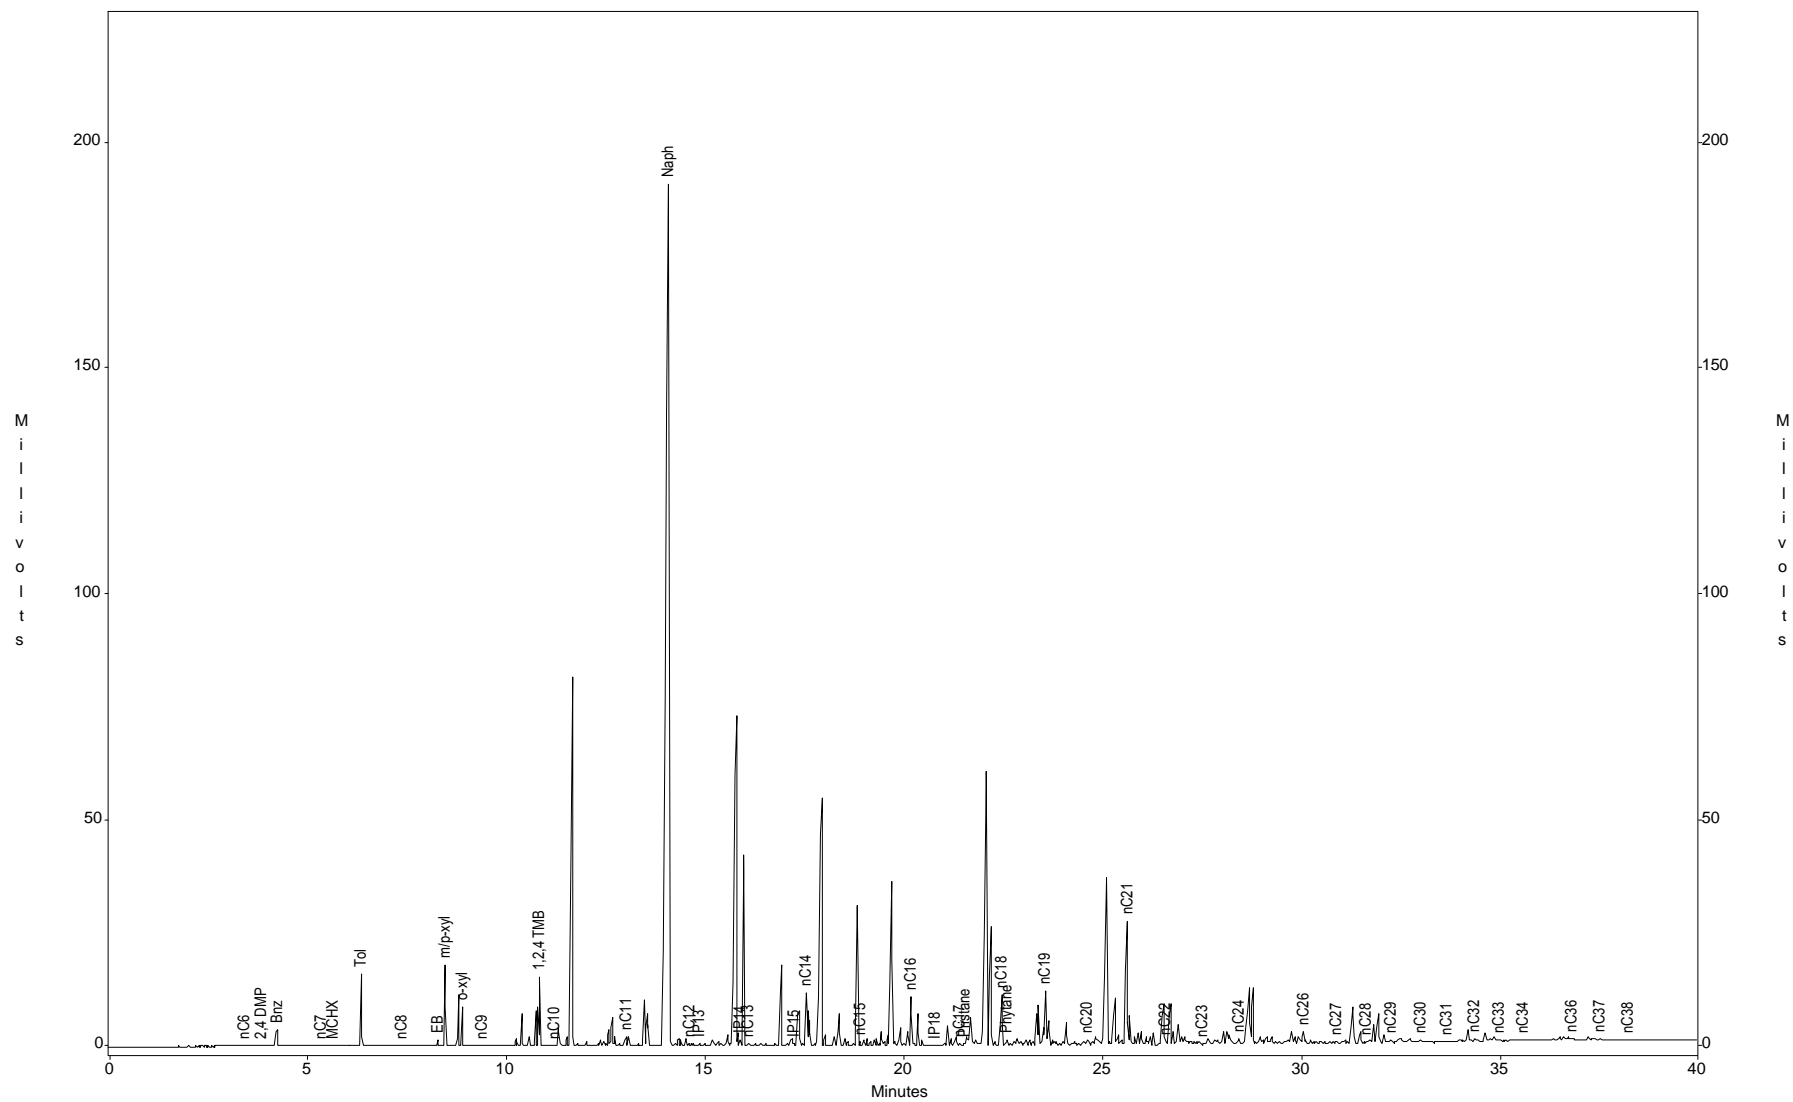
The CO124 DNAPL sample appears to be a coal tar. The CO124 DNAPL sample chromatogram (Figures 6 and 13) shows a series of peaks that starts at benzene (Bnz) and continues to about the end of the chromatogram. The larger unlabeled peaks are probably polynuclear aromatic compounds and are typical of a coal tar.

Figure 6, Gas chromatogram of the CO124 DNAPL sample.

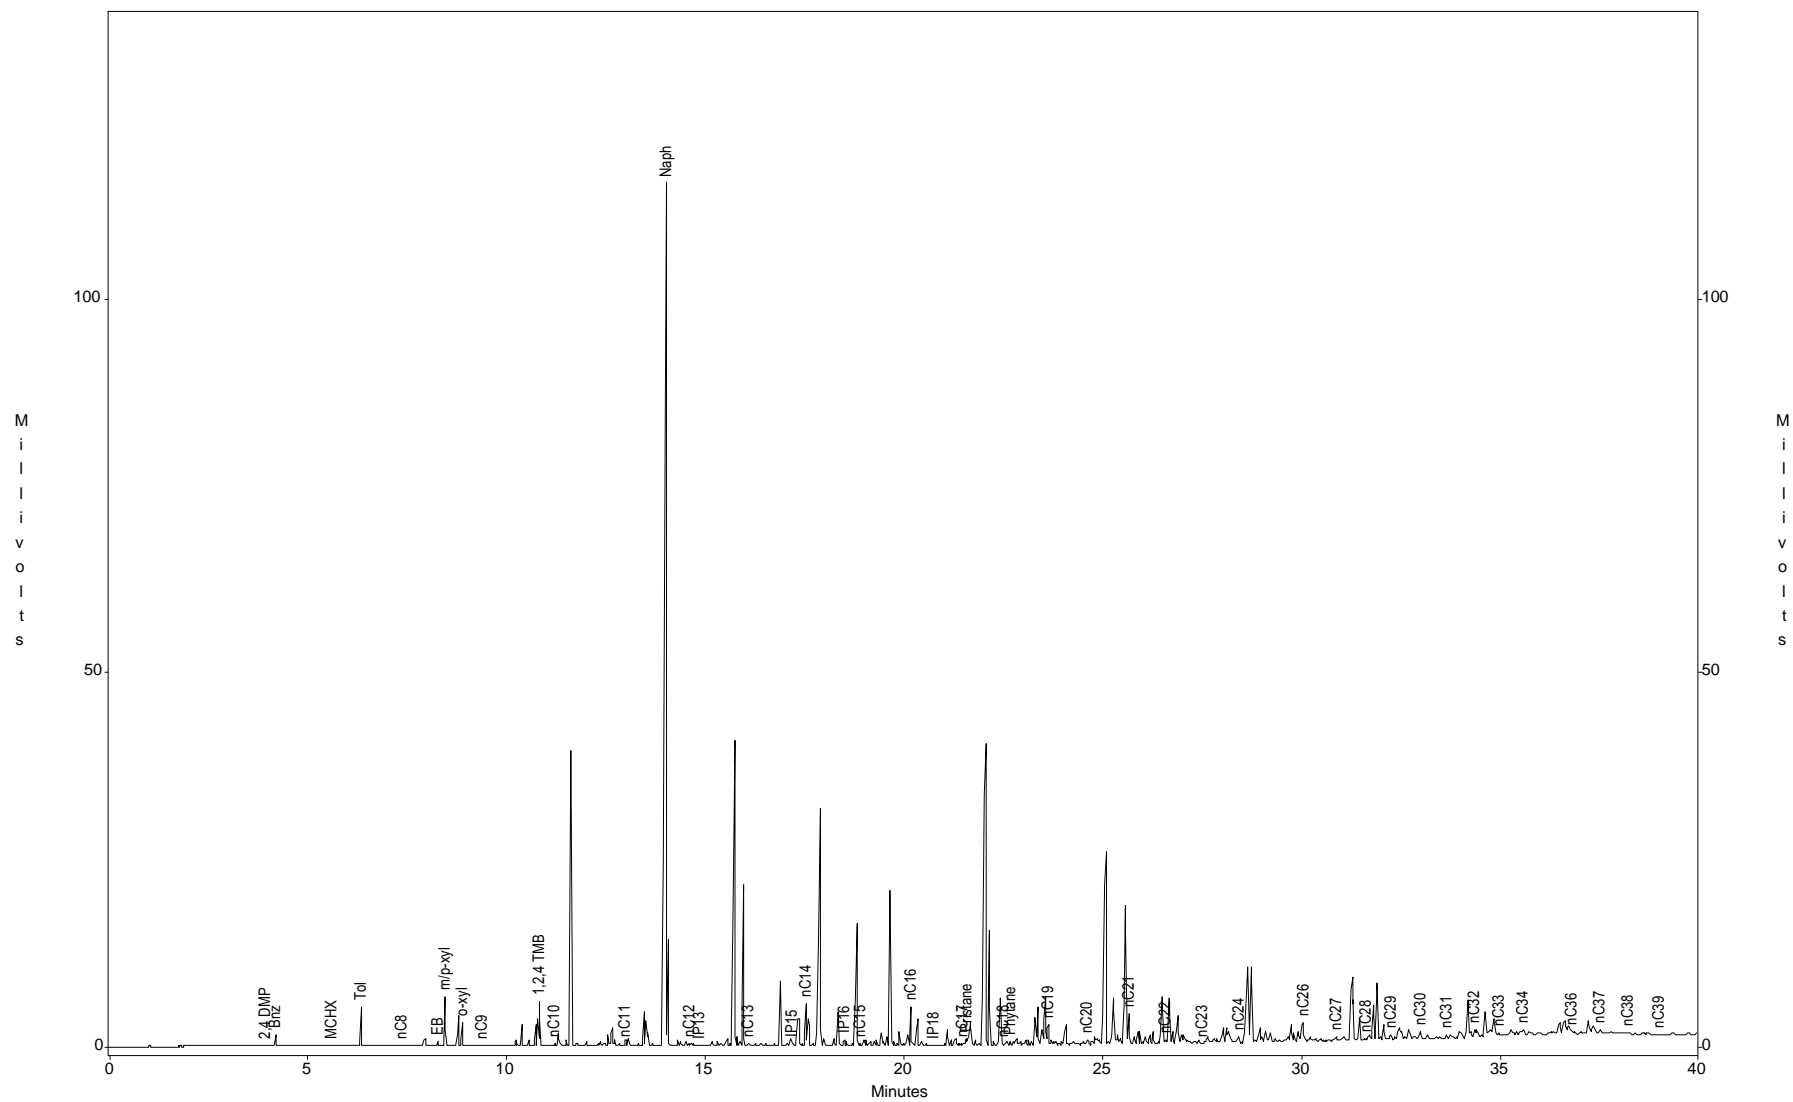
The CO125 DNAPL sample appears to be a coal tar. The CO125 DNAPL sample chromatogram (Figures 7 and 14) shows a series of peaks that starts at benzene (Bnz) and continues to about the end of the chromatogram. The larger unlabeled peaks are probably polynuclear aromatic compounds and are typical of a coal tar.

Figure 7, Gas chromatogram of the CO125 DNAPL sample.

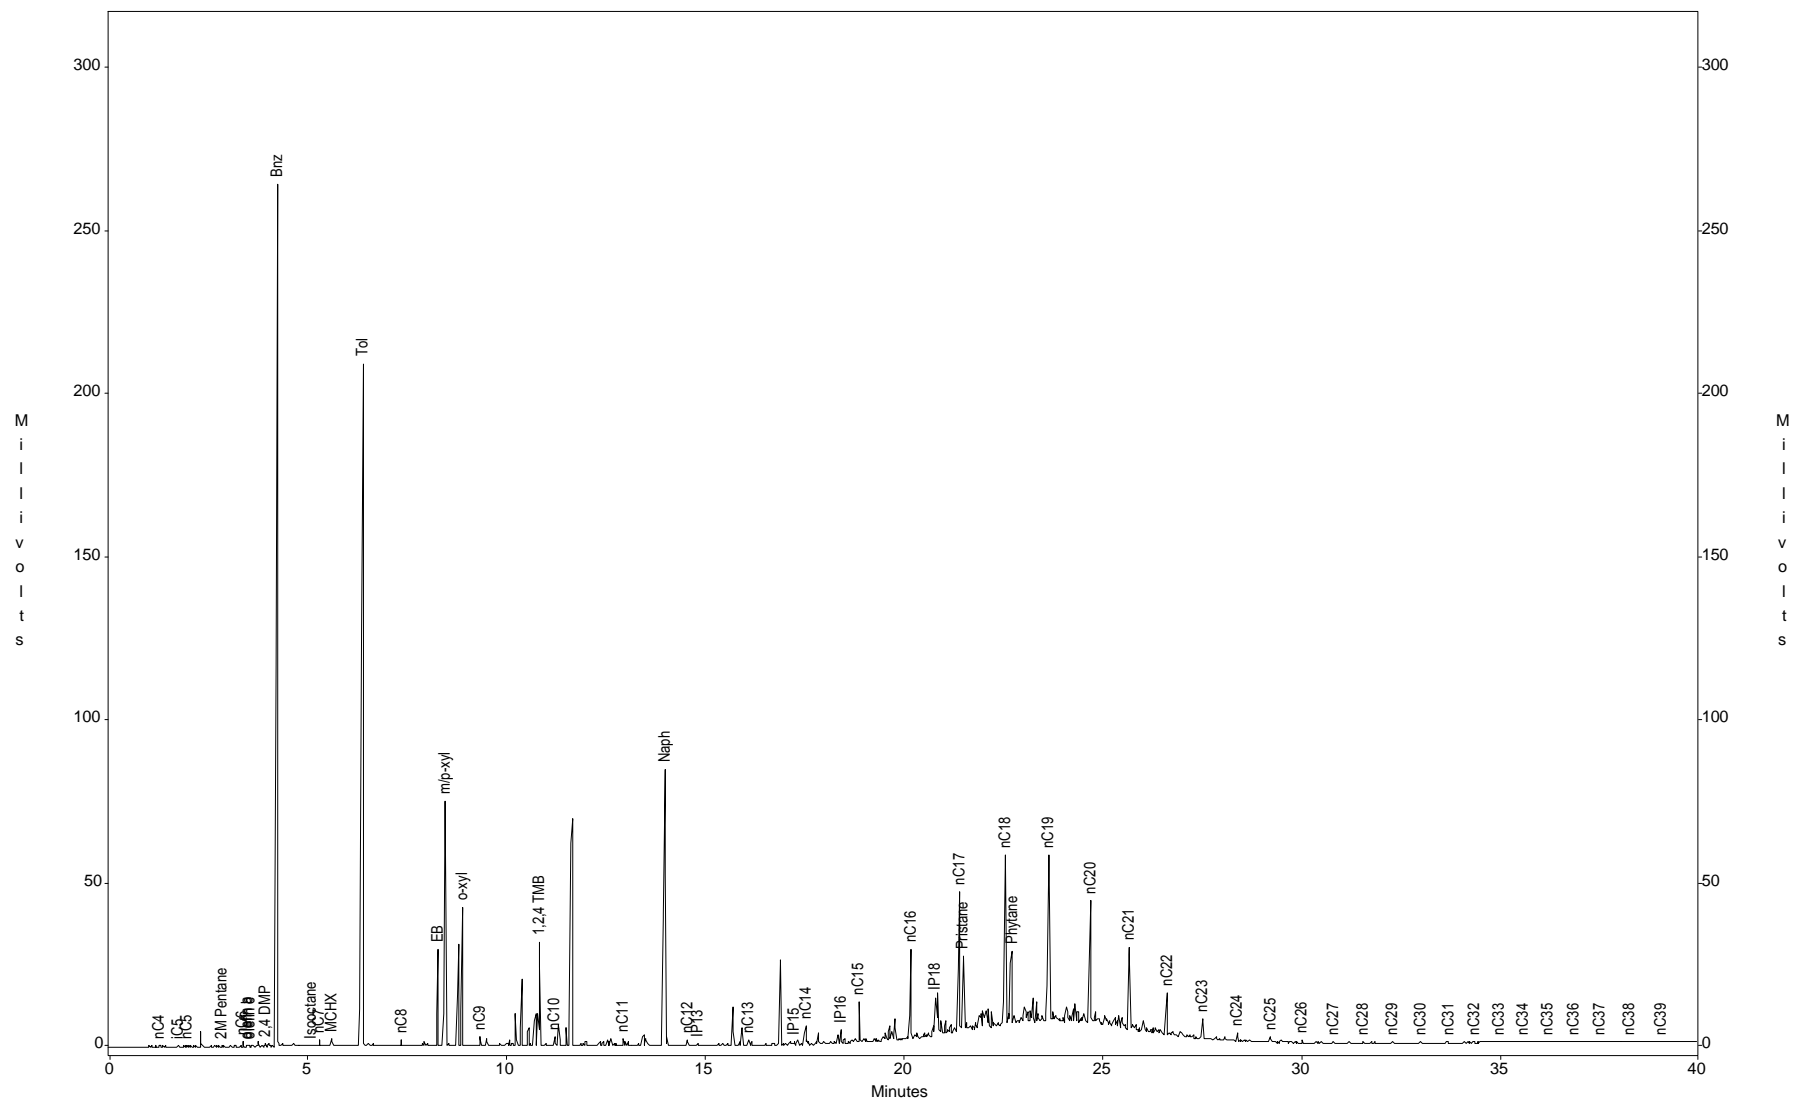
The identity of the CO173 LNAPL sample is not obvious but may be a mixture of two products. The CO173 LNAPL sample chromatogram (Figures 8 and 15) shows a series of peaks that starts at about normal butane (nC5) and continues to the end of the chromatogram. The early peaks from the beginning of the chromatogram to about nC12 are some sort of highly aromatic mixture. The heavier portion from about nC12 to the end of the chromatogram has some fairly large normal paraffin peaks but the identity of this material is not obvious.

Figure 8, Gas chromatogram of the CO173 LNAPL sample.

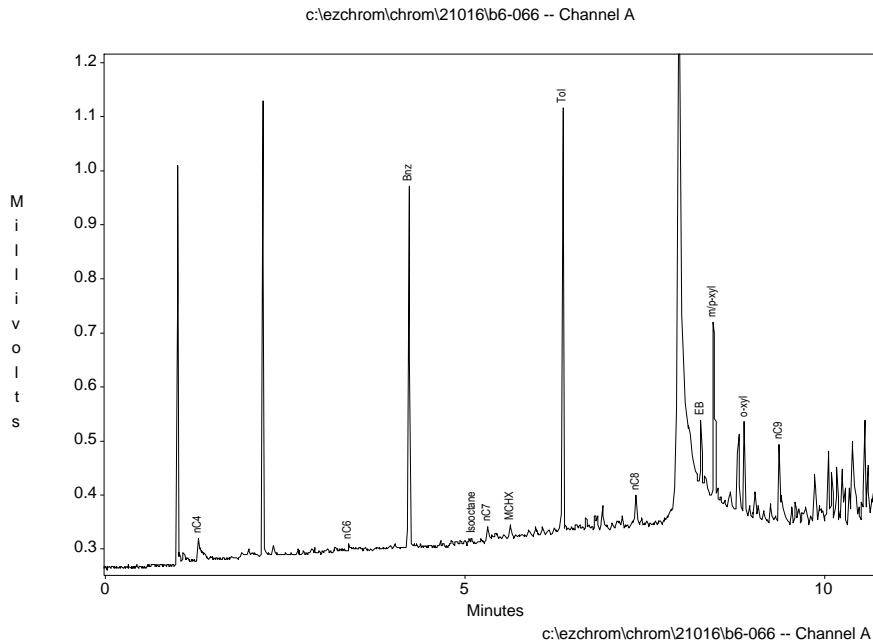
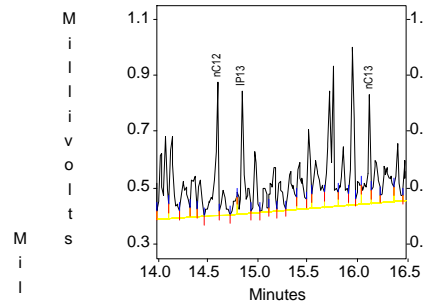
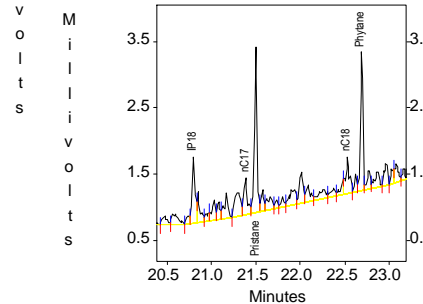
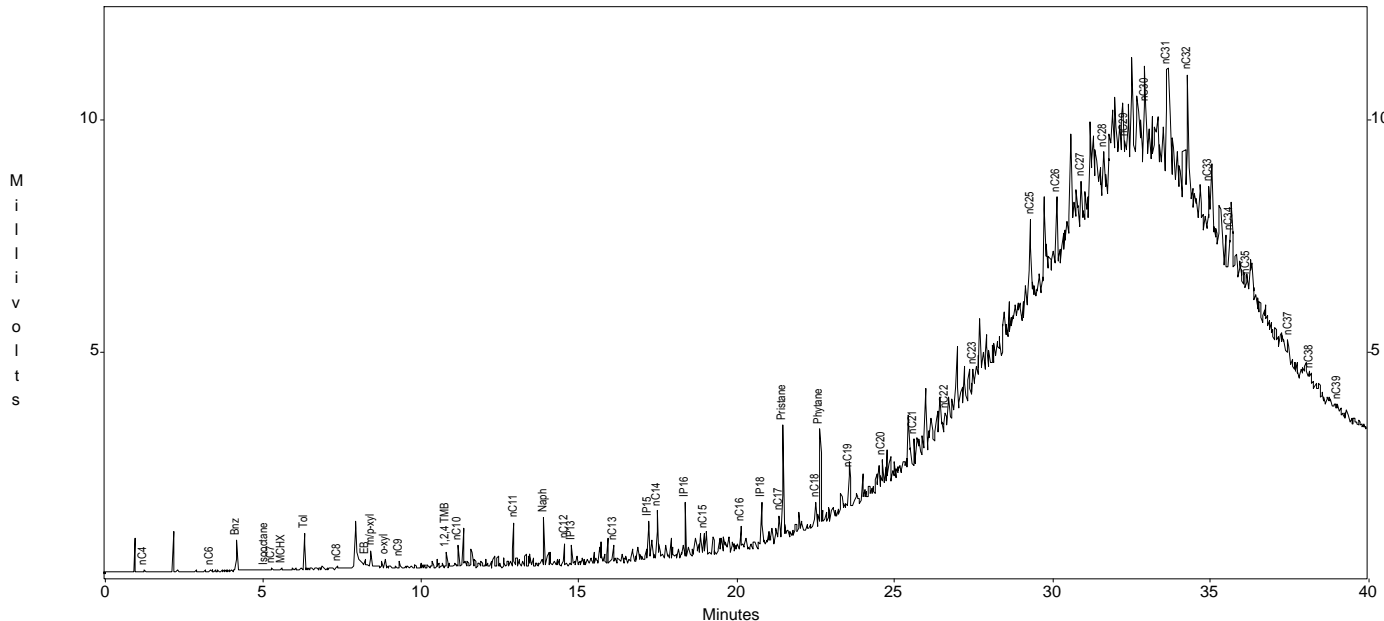
Figure 12, Multipanel display of gas chromatogram of the B6-066 LNAPL sample.

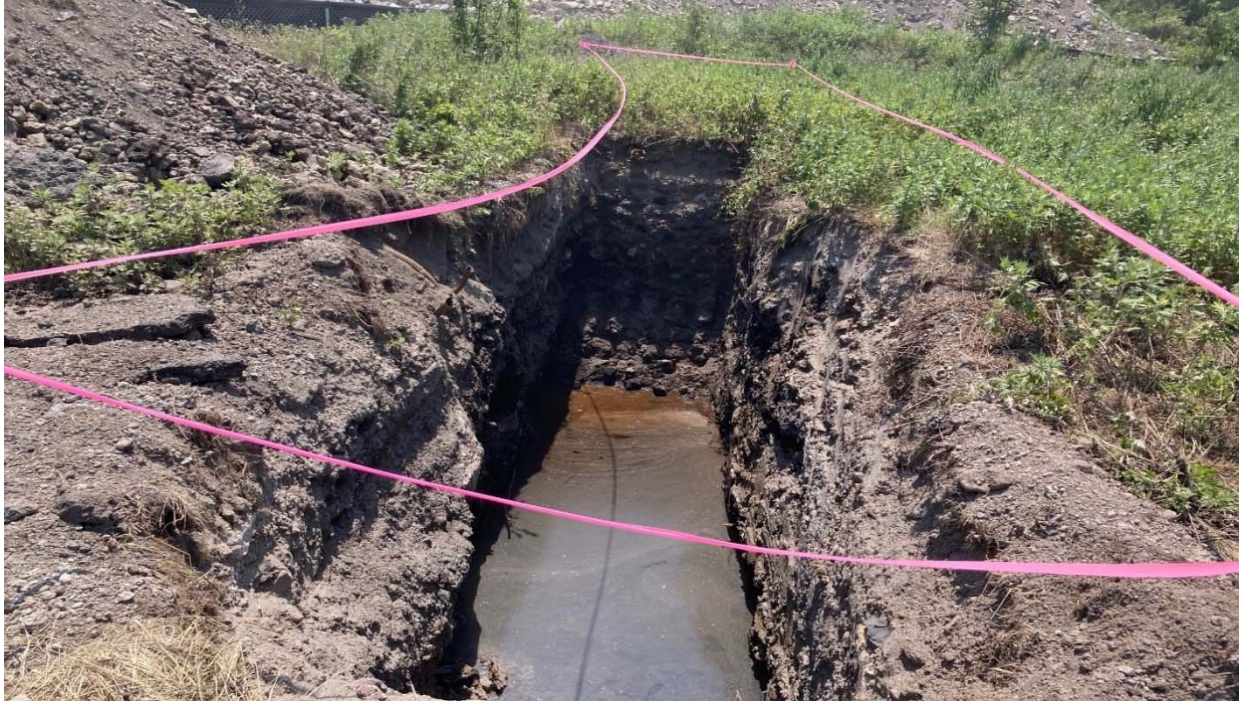
Groundwater in TP-1 was observed at approximately 6 feet below ground surface (bgs). TP-1 was excavated to a total depth of approximately 8 feet bgs. Material below the water table was dark, odorous, and appeared to have petroleum impacts. Material removed from below the water table in the test pit had PID readings of up to 80 parts per million (ppm). Dark material excavated from

070821-1: TP-1 – Test Pit following excavation

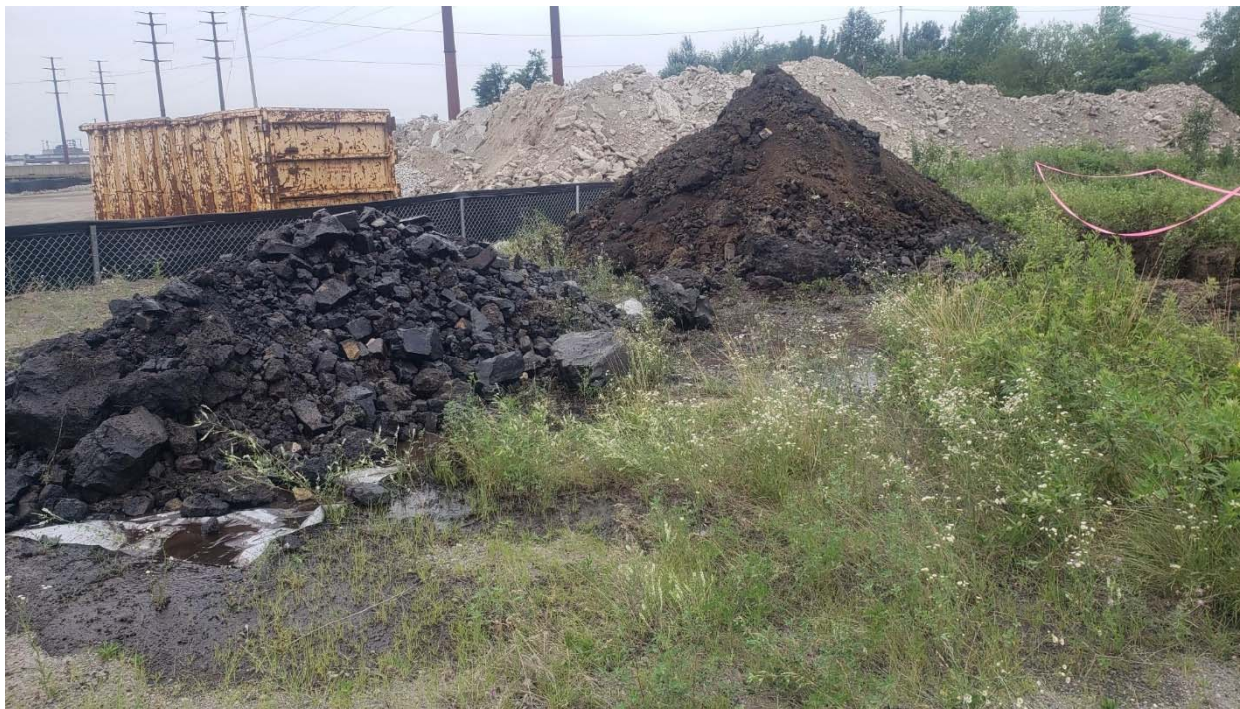
below the water table was placed in a designated stockpile and covered. The water surface within TP-1 showed a moderate LNAPL sheen.

070821-2: TP -1 – Excavated Material Stockpiles

Three test pits (TP-1, TP-2, and TP-4) contained material below the water table that showed visible evidence of petroleum impacts when stockpiled at the surface. Material removed from TP-1 and TP-2 also had high (80-100 ppm) PID readings. Impacted material was segregated based on evidence of contamination and placed on and covered with plastic sheeting adjacent to each test pit. The segregated material will be sampled and properly disposed of in accordance with its sample results. Unimpacted material (including all material removed from TP-3) was utilized as backfill. Details on the post-closure monitoring are described in the designated section below.

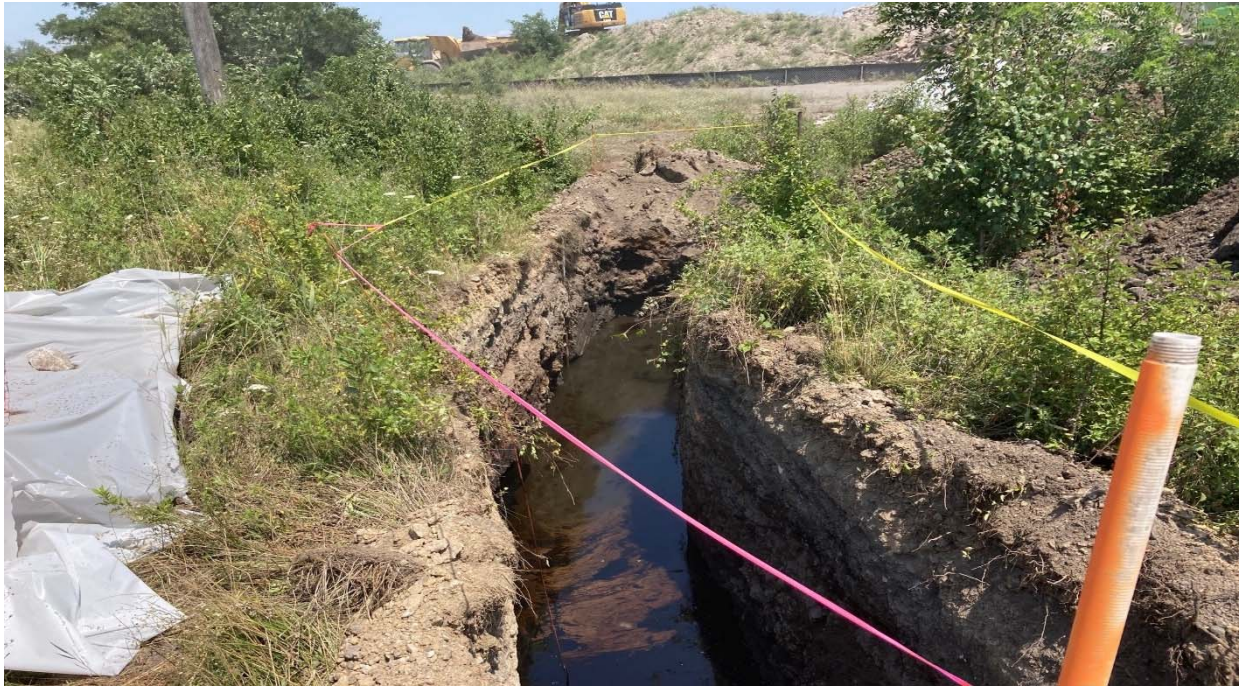
Groundwater in TP-2 was observed at approximately 6 feet bgs. TP-2 was excavated to a total depth of approximately 10 feet bgs. Material below the water table was dark, odorous, and appeared to have petroleum impacts. Material removed from below the water table in the test pit had PID readings of up to 100 ppm. Dark material excavated from below the water table was placed in a designated covered stockpile at the surface. The water surface within TP-2 showed LNAPL accumulation of less than 1 inch. TP-2 showed the most LNAPL accumulation of the four test pits. Due to the observed NAPL accumulation, an observation point was installed in TP-2 during backfilling. Details of the observation point's construction are further described in the trailing sections.

071221-1: TP-2 – Test Pit following extraction

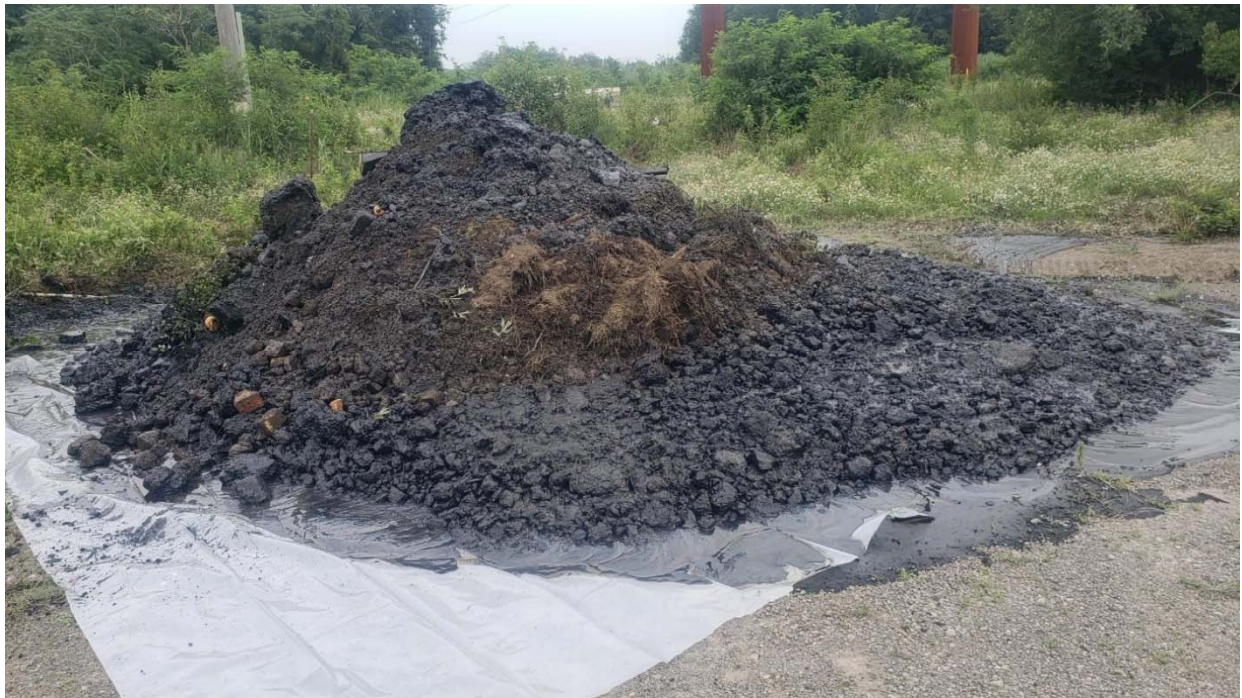
070821-3: TP-2 – Excavated Material Stockpile
