Re: Test Pit Completion Report
B6-066 Delineation Area
Area B: Parcel B6
Tradepoint Atlantic
Sparrows Point, MD 21219

ARM Group LLC (ARM), on behalf of Tradepoint Atlantic (TPA), has prepared this Completion Report to document the test pitting activities in Parcel B6 (the Site) on the TPA Property located in Sparrows Point, Maryland. This completion report is being provided to the Maryland Department of the Environment (MDE) and United States Environmental Protection Agency (USEPA) to present the observations of the test pitting investigation.

Test Pit Observations
Area B: Parcel B6 – B6-066 NAPL Area
Sparrows Point, Maryland

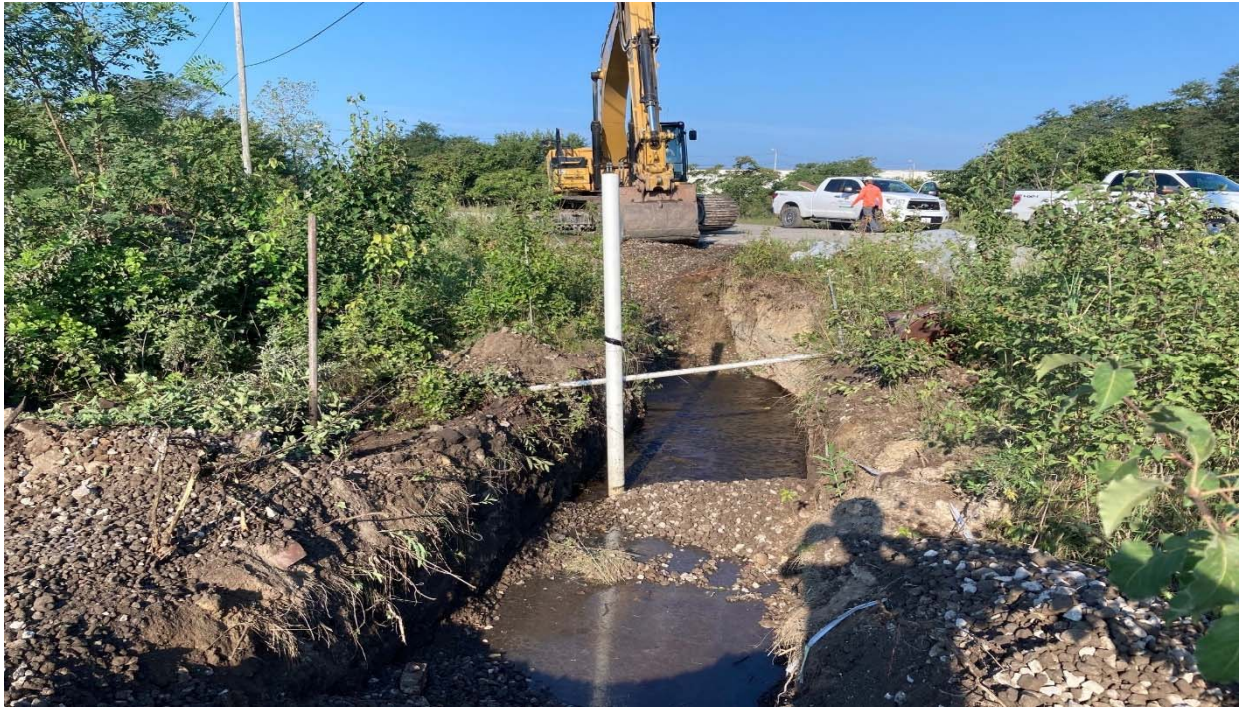
080621-1: TP-2 – Observation Point (While Backfilling)

The four test pit locations were backfilled on August 6, 2021. Prior to backfilling, one temporary observation point was constructed in the most impacted test pit, TP-2, by installing 4-inch diameter PVC screen and riser. This observation point will serve as a temporary monitoring location. The observation point was installed with 5 feet of screen and 10 feet of riser that extends above the surface. The screen was placed at the bottom of the test pit to screen across the groundwater table. Self-compacting recycled aggregate (#57 stone) was used to backfill from the bottom of TP-2 to approximately 1 foot above the water table. The remainder of the test pit was backfilled using the unimpacted excavated and stockpiled material. The material was placed in 1-foot lifts and compacted with an excavator bucket. The PVC was secured at the surface and backfill material was placed around the PVC with extra precaution taken to not damage the screen or riser. The observation point was left in place for future monitoring. The remaining three test pits (TP-1, TP-3, -TP-4) were backfilled with the unimpacted material removed from each test pit.

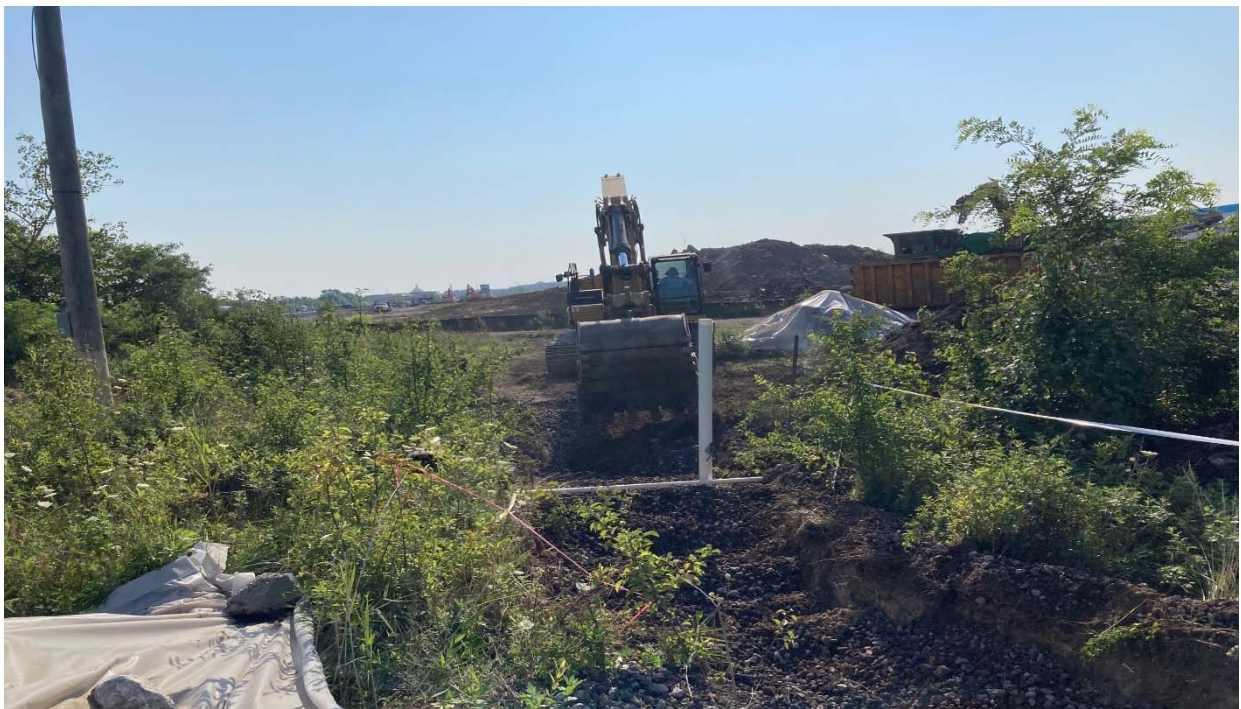
The 4-inch observation point was installed during backfilling and subsequently monitored for the accumulation of NAPL. The monitoring point did not show evidence of NAPL accumulation after 30 days of equilibration. At this time, TPA is requesting approval to remove the observation point.

080621-2: TP-2 – Temporary Monitoring Point (Backfilled)

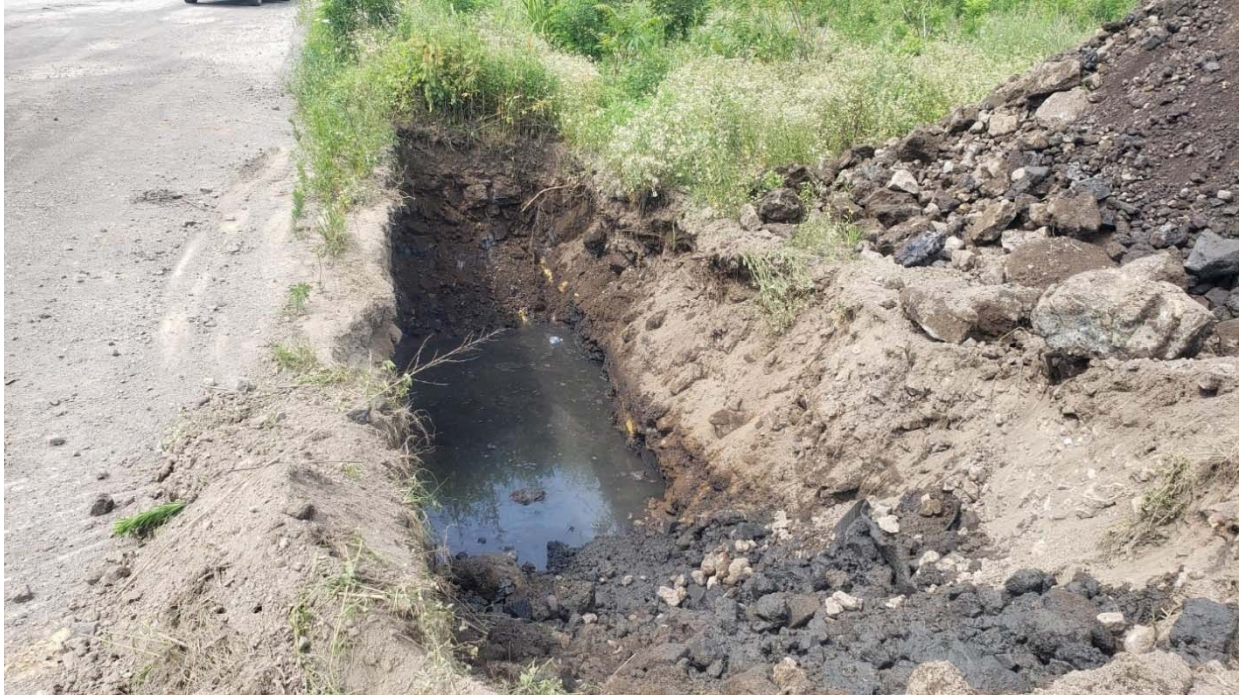
Groundwater in TP-3 was observed at approximately 4 feet bgs. TP-3 was excavated to a total depth of approximately 6 feet bgs. TP-3 had no elevated PID readings or evidence (visual or olfactory) of petroleum impacts. Material from TP-3 was not separated into segregated stockpiles at the surface and the water surface did not show signs of LNAPL sheen or accumulation.

070821-4: TP-3 – Test Pit following excavation

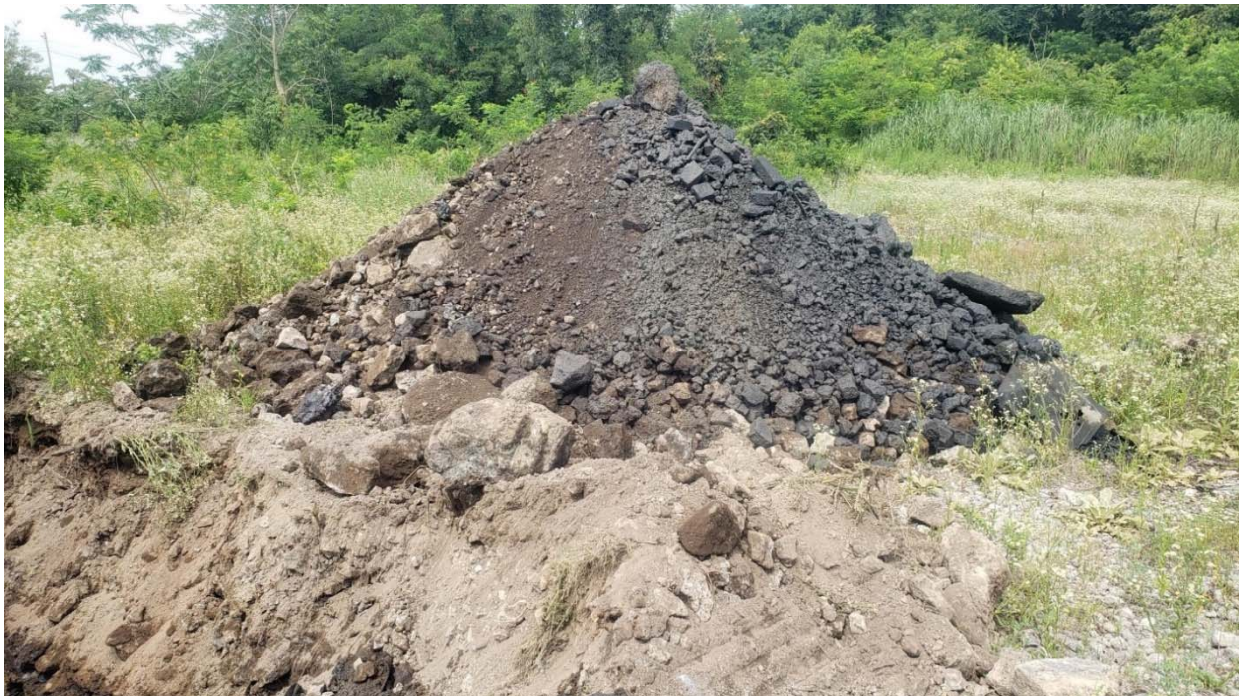
070821-5: TP-3 – Excavated Material Stockpile

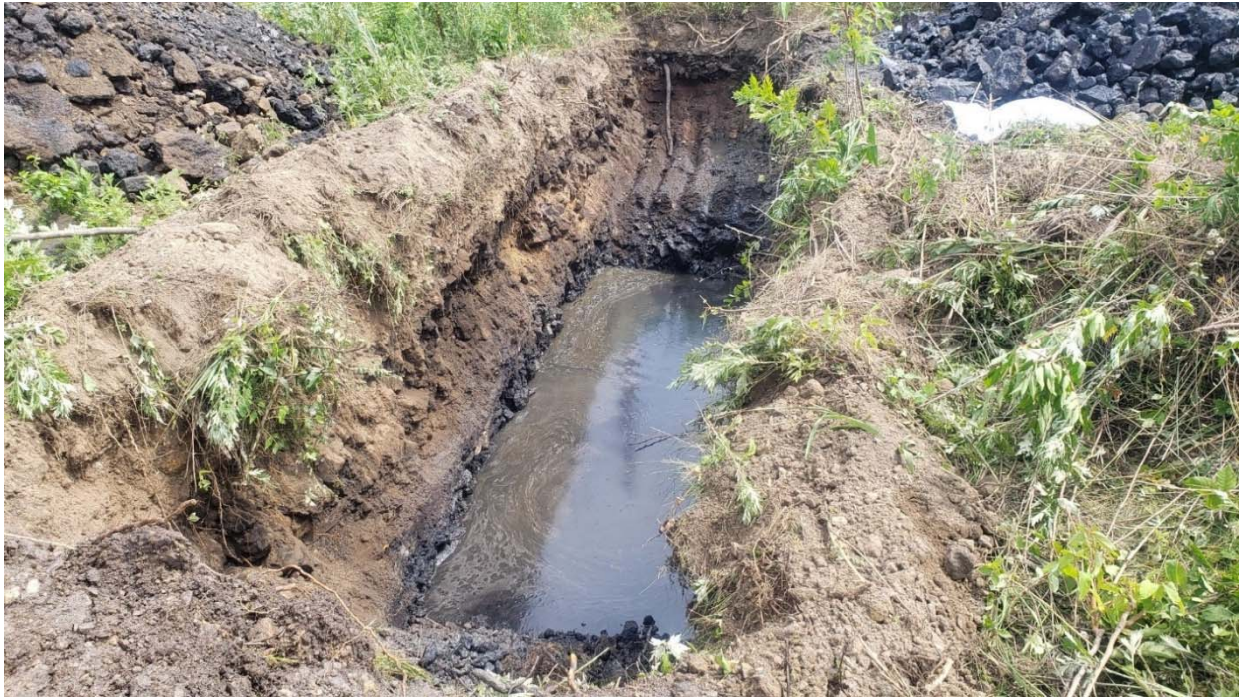
Groundwater in TP-4 was observed at approximately 5 feet bgs. TP-4 was excavated to a total depth of approximately 7 feet bgs. Material removed from below the water table was dark and appeared to have petroleum impacts, but did not have odors or PID readings above 10 ppm. Dark material excavated from below the water table was placed in a designated stockpile and covered. The water table showed only a light LNAPL sheen.

070821-6: TP-4 – Test Pit following excavation

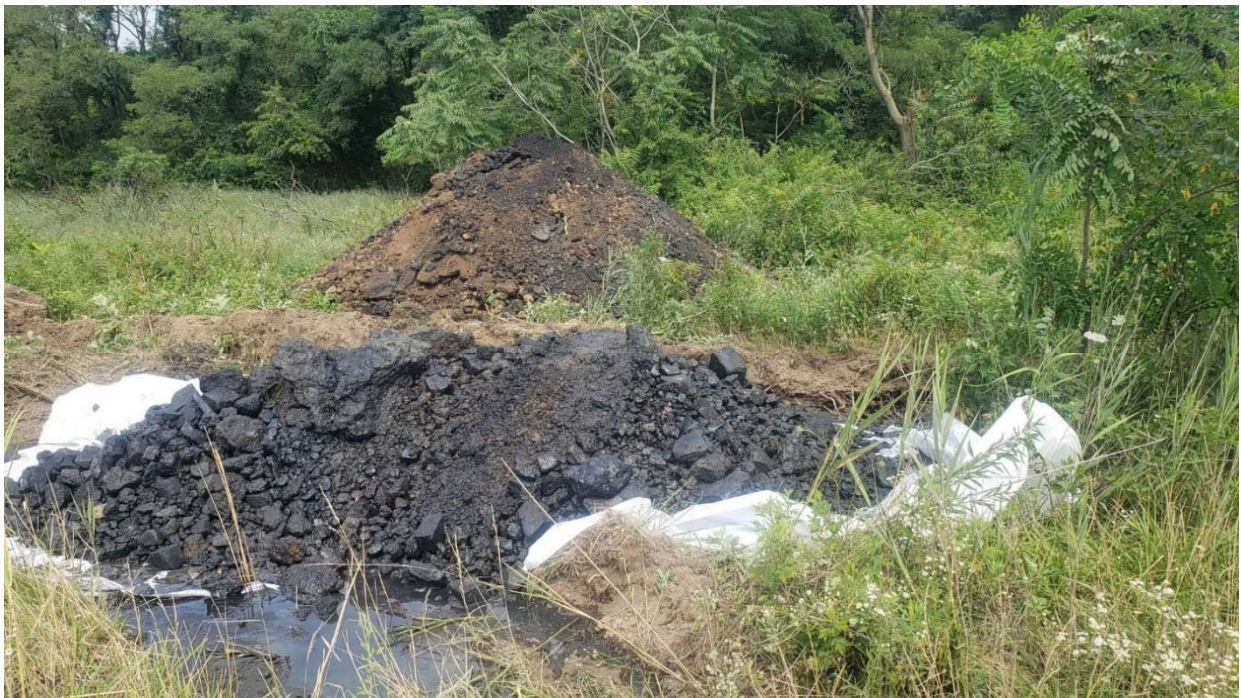
070821-7: TP-4 – Excavated Material Stockpile

Three test pits (TP-1, TP-2, and TP-4) contained material below the water table that showed visible evidence of petroleum impacts when stockpiled at the surface. Material removed from TP-1 and TP-2 also had high (80-100 ppm) PID readings. Impacted material was segregated based on evidence of contamination and placed on and covered with plastic sheeting adjacent to each test pit. The segregated material will be sampled and properly disposed of in accordance with its sample results. Unimpacted material (including all material removed from TP-3) was utilized as backfill. Details on the post-closure monitoring are described in the designated section below.
