# The 2017 Oroville Dam Spillway Incident – Incident Management and Recovery Program

John W. France, PE, D.GE, D.WRE  
JWF Consulting LLC

Maryland Dam Safety Training  
14 November 2018

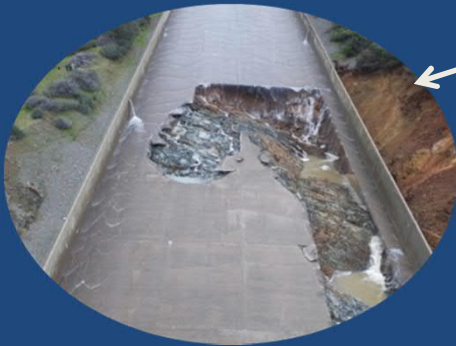
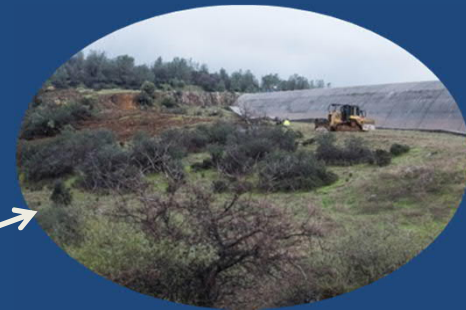
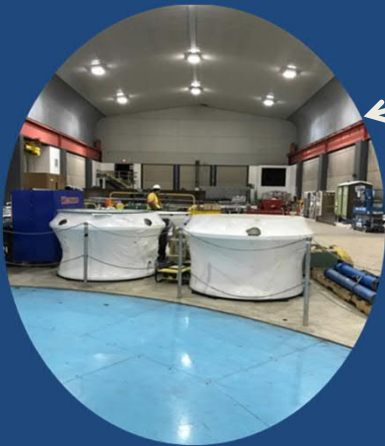
Additional SS Damage

Emergency Spillway Operation

Powerplant Flooding

Power Transmission Towers

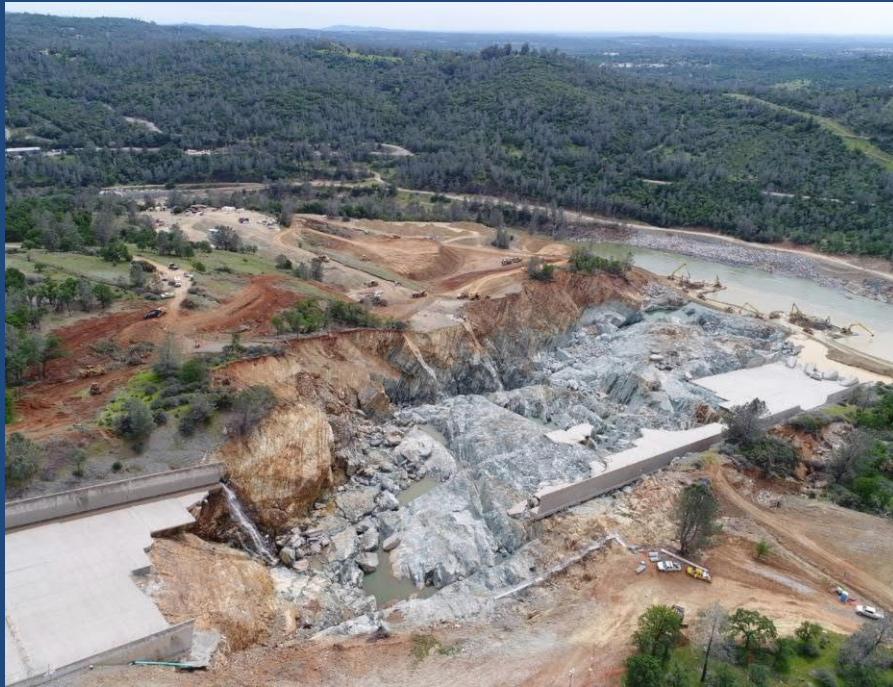
Scour Holes

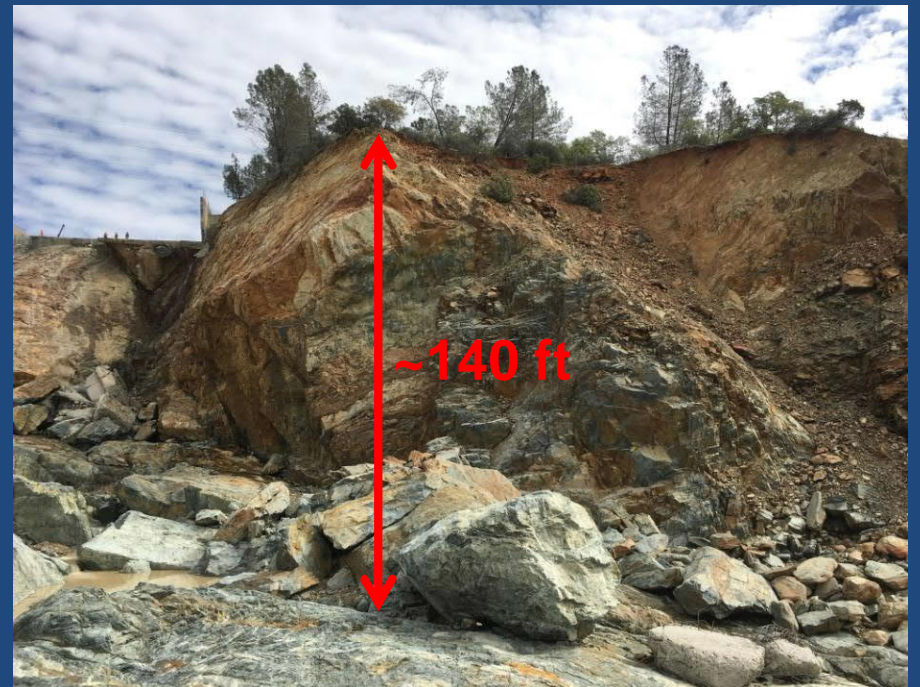
Overhanging Rock Faces

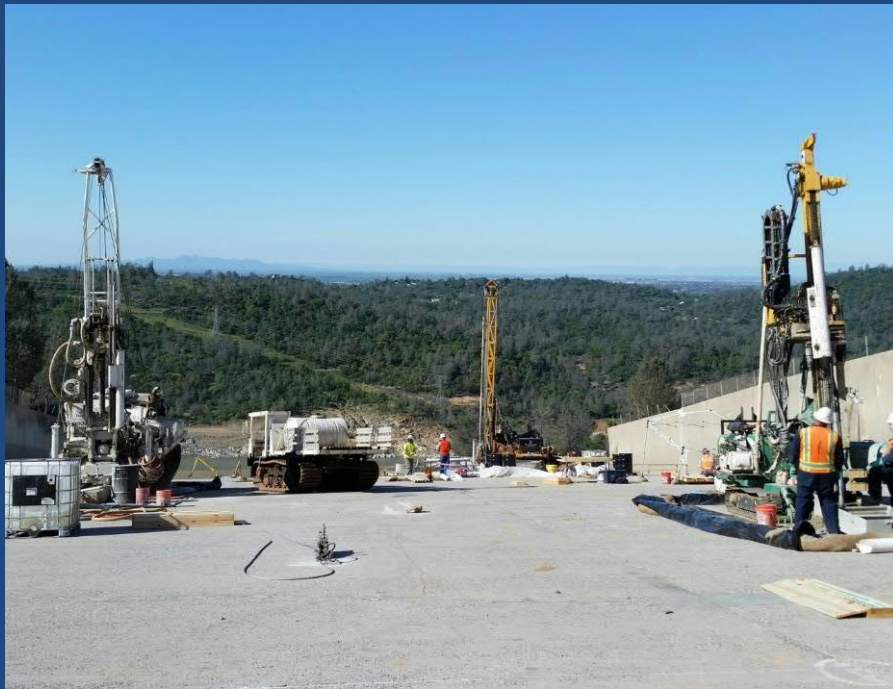
Condition of Remaining Chute

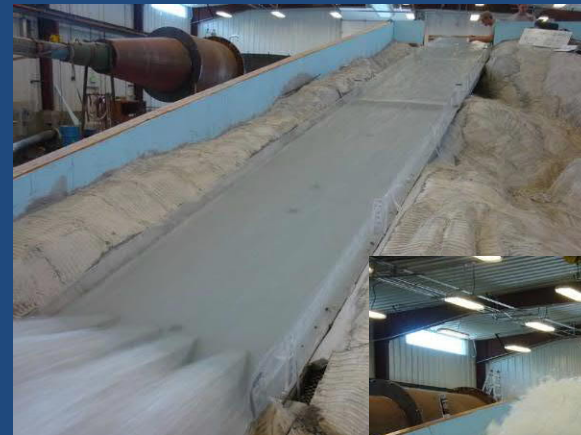
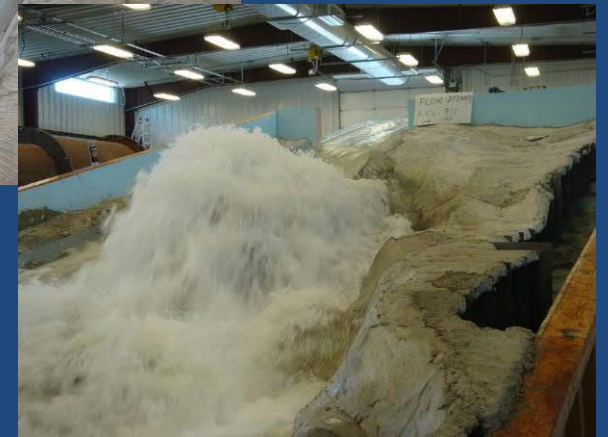
Hydraulics

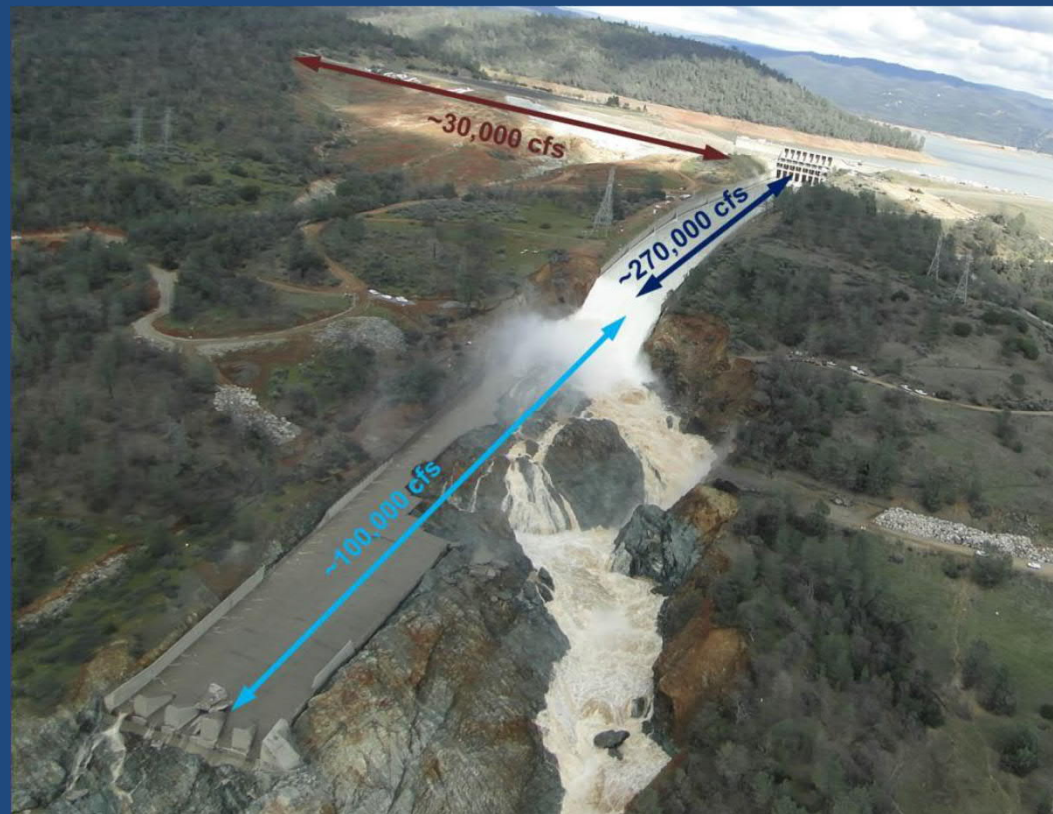
# 2017 Target Flows for Design

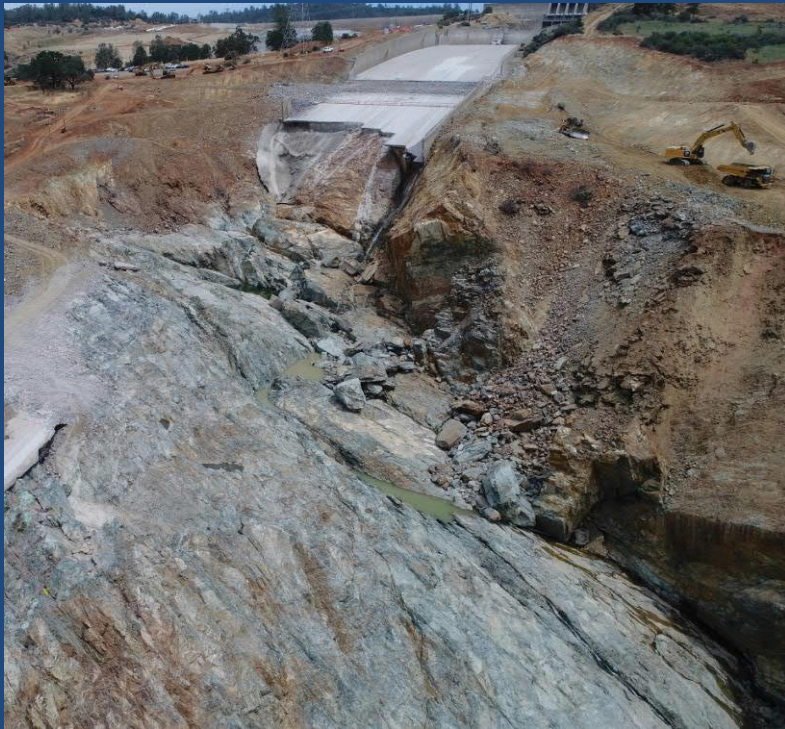
May 30, 2017

# Upper Scour Hole

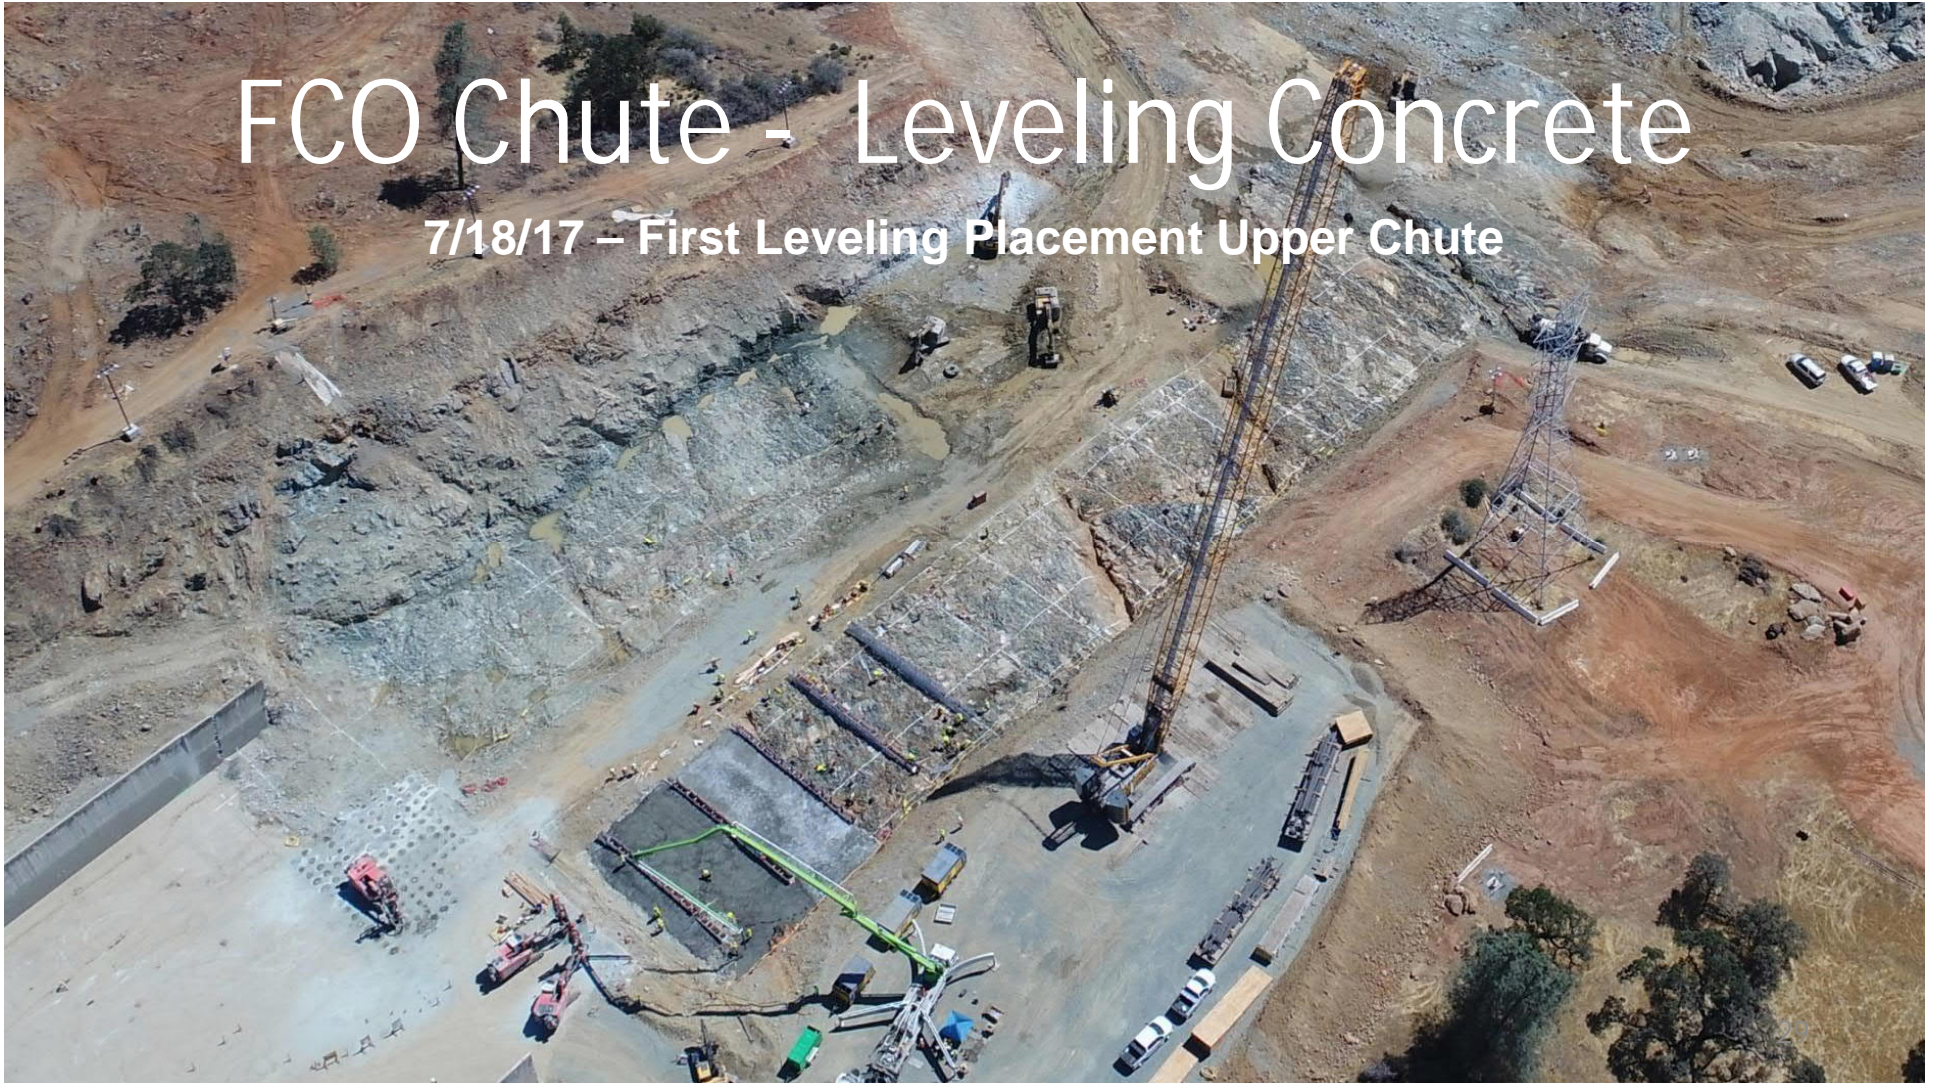
# FCO Chute - Leveling Concrete

7/18/17 – First Leveling Placement Upper Chute

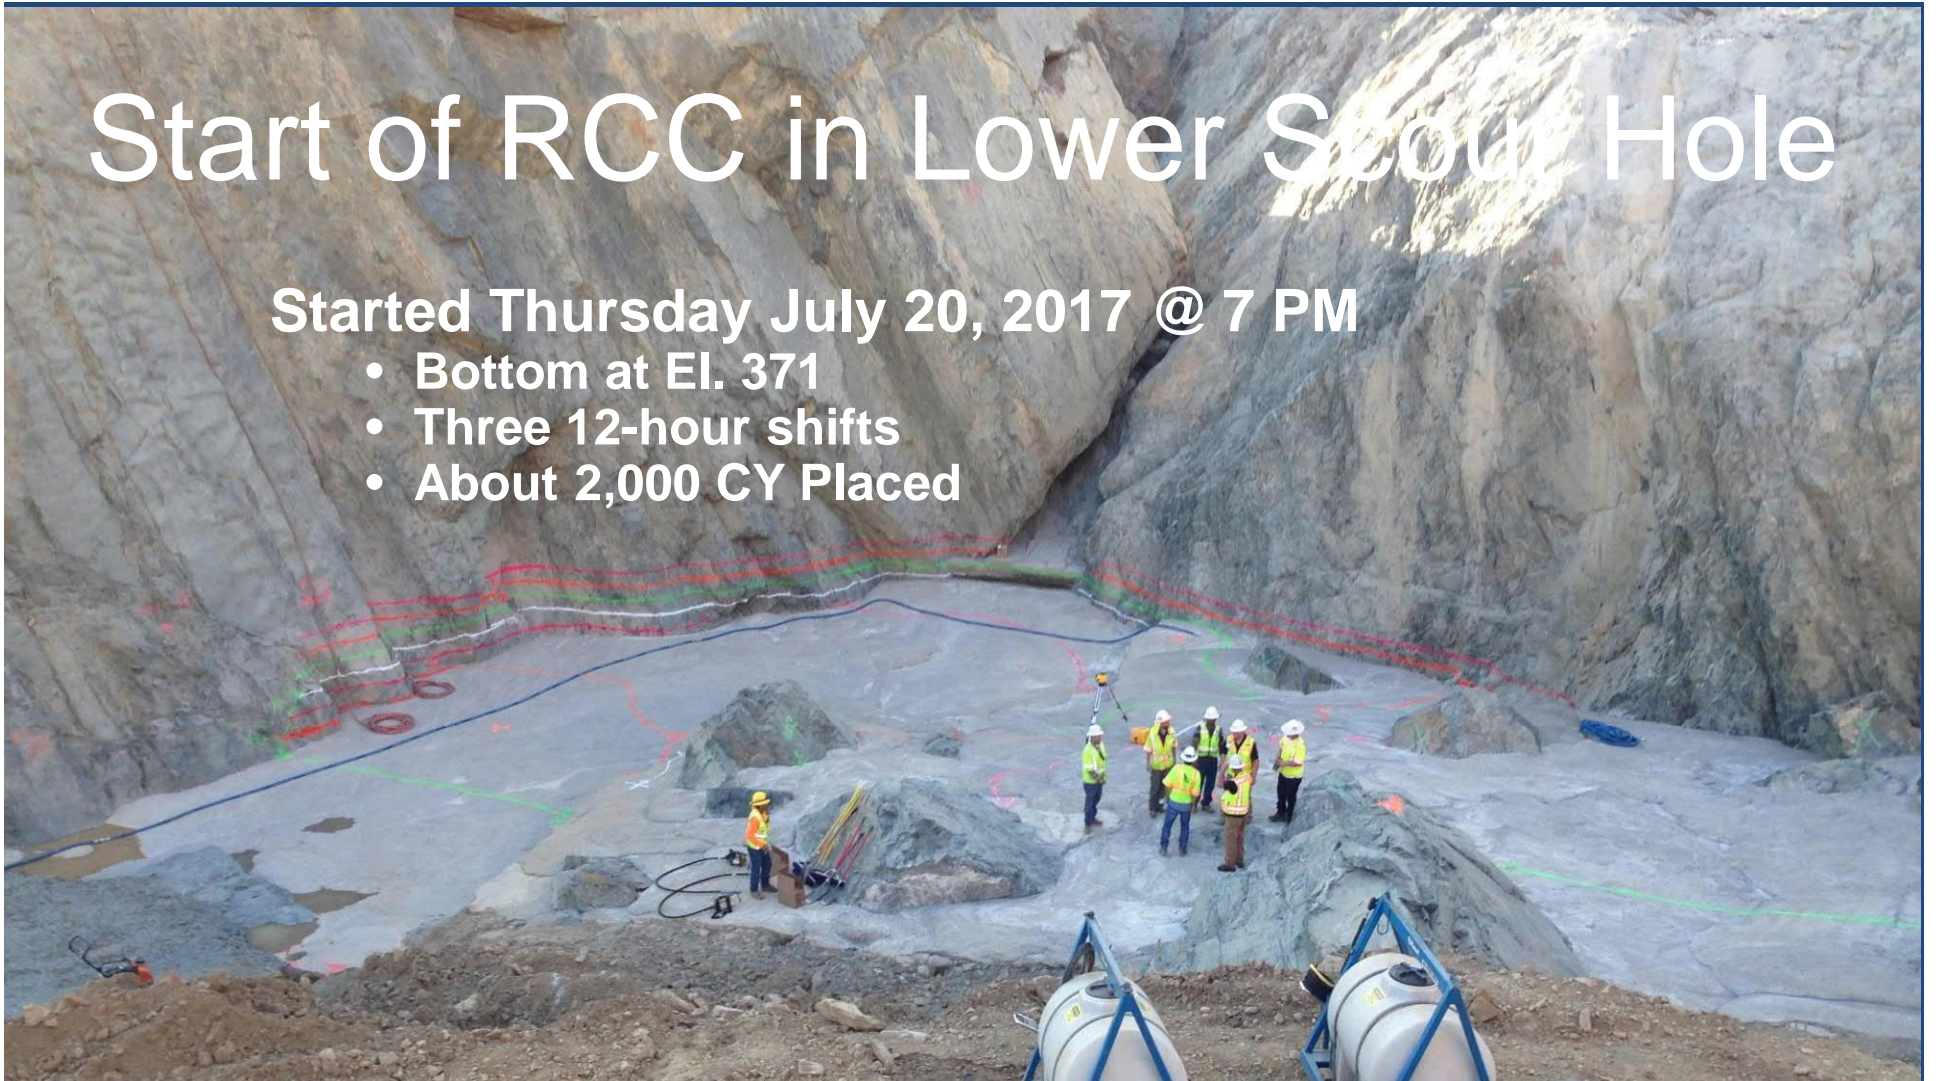
# Start of RCC in Lower Scout Hole

Started Thursday July 20, 2017 @ 7 PM

- Bottom at El. 371
- Three 12-hour shifts
- About 2,000 CY Placed

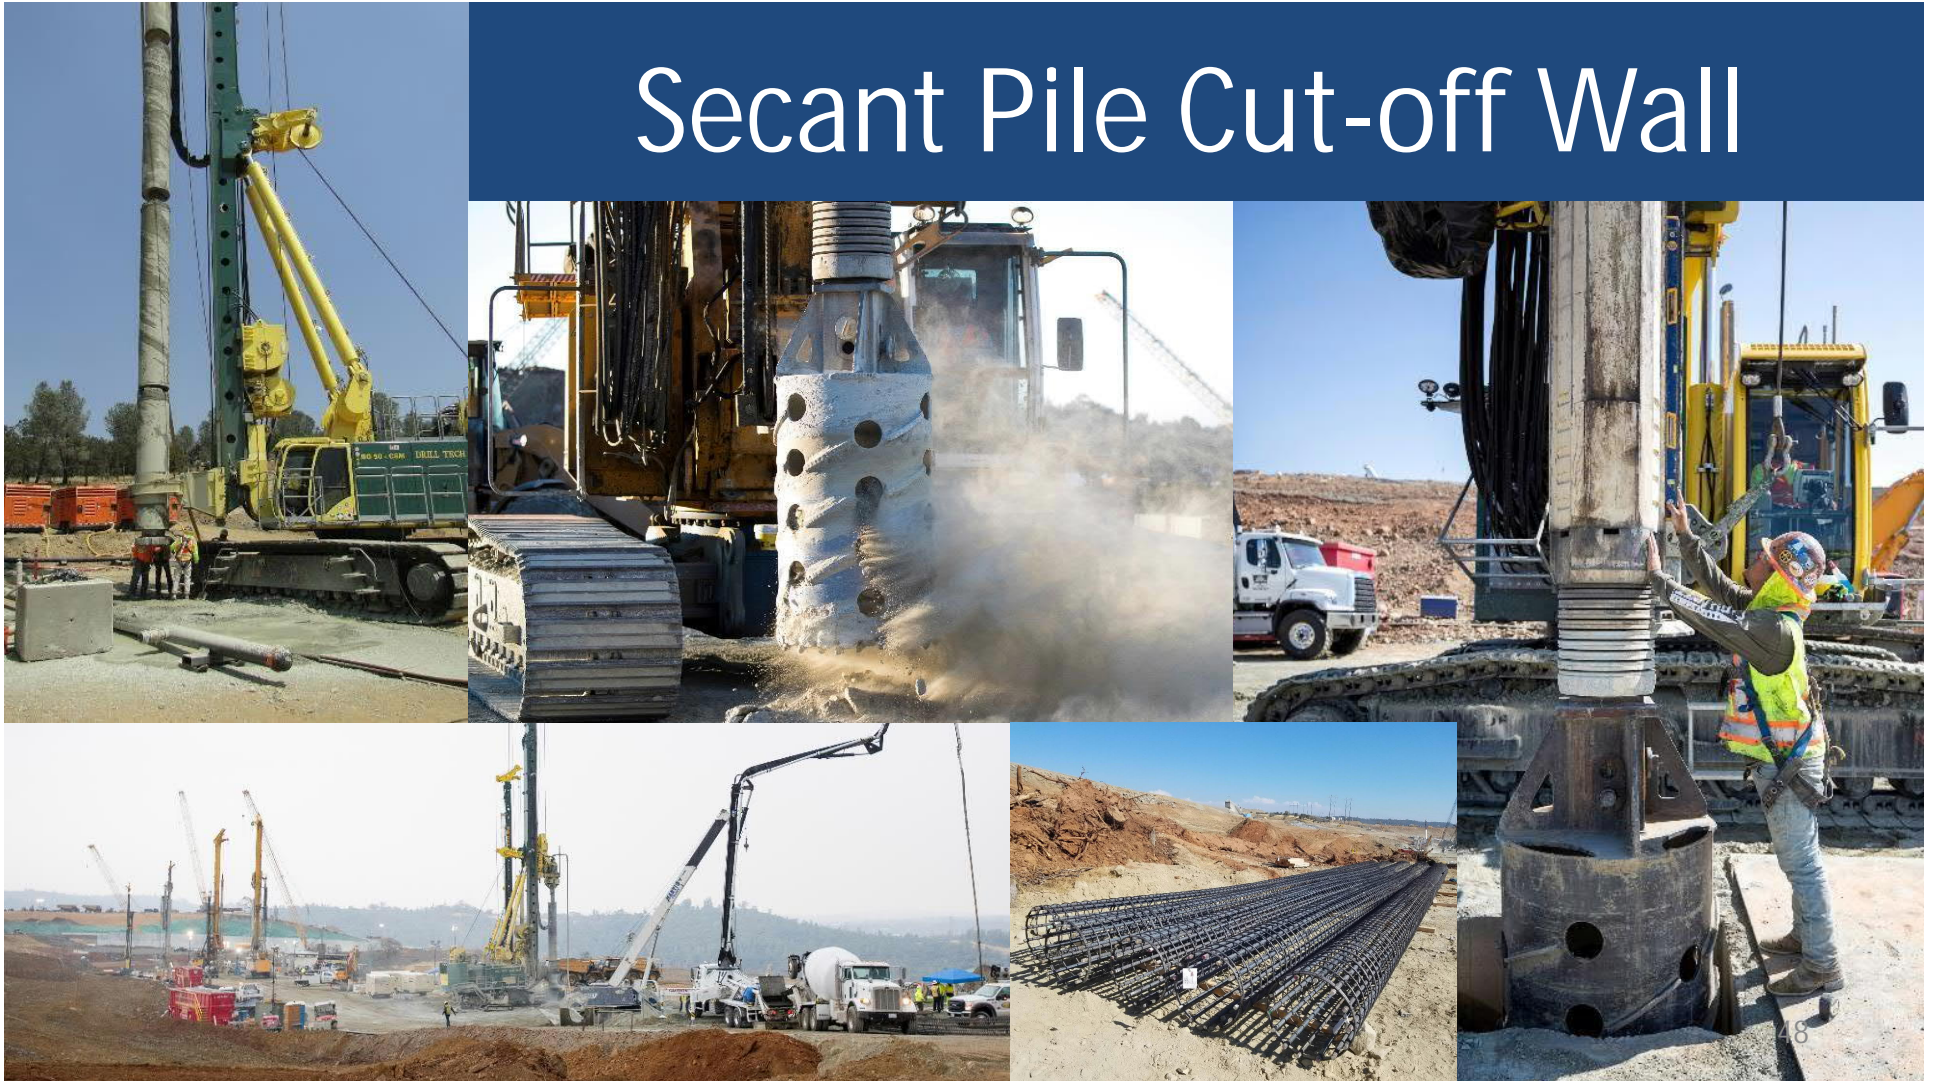
# Secant Pile Cut-off Wall
