Carsins Runs I-95 Section 200 Stream Restoration Site

Natural Resources Inventory

Prepared for
MDTA

KCI Technologies, Inc.
February 2018
KCI Project No. 22145228.36

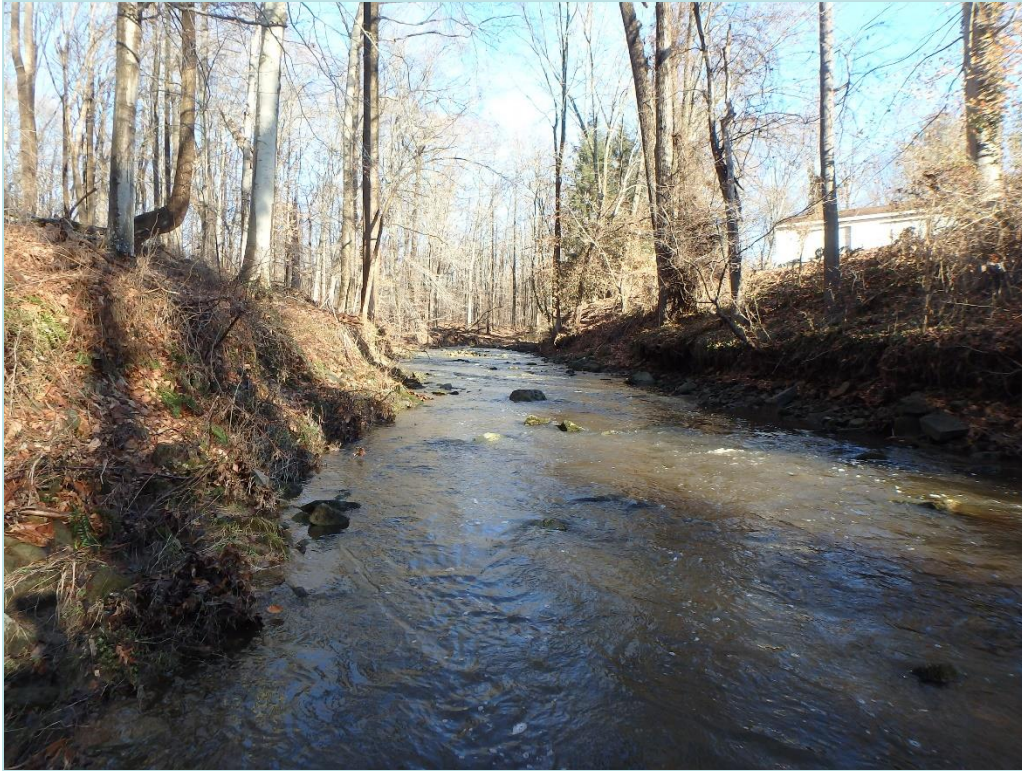
Photographer: K. Myers
Date: 2/5/18
Frame No. 1
Direction: North
Comments: View of WUS
WL001 facing upstream from
flag WL001-002

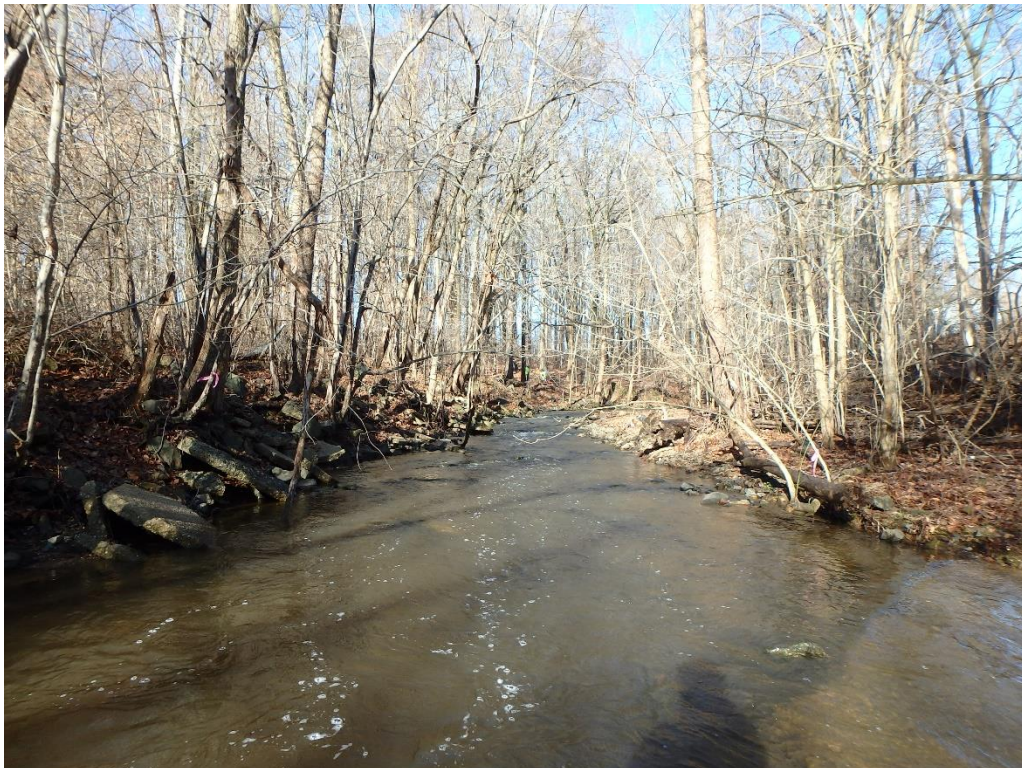
Photographer: K. Myers
Date: 2/5/18
Frame No. 2
Direction: North
Comments: View of WUS
WL001 facing upstream between
flags WL001-008 and WL001-
009.

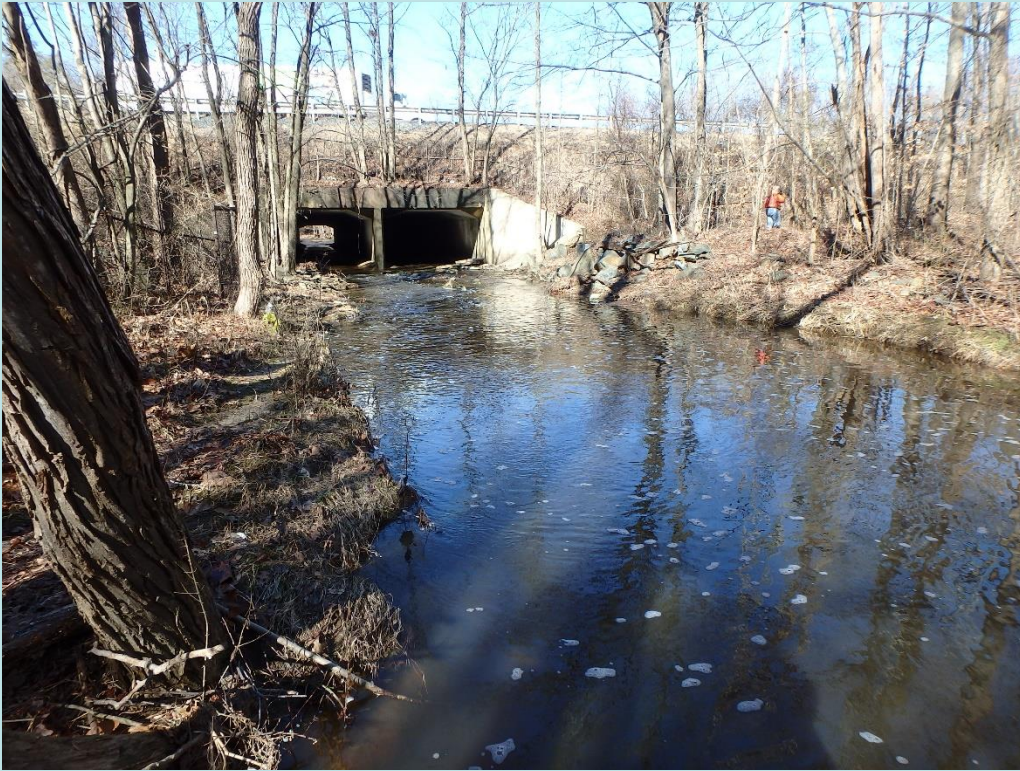
Photographer: K. Myers
Date: 2/5/18
Frame No. 3
Direction: North
Comments: View of WUS
WL001 facing upstream from
flag WL001-011.

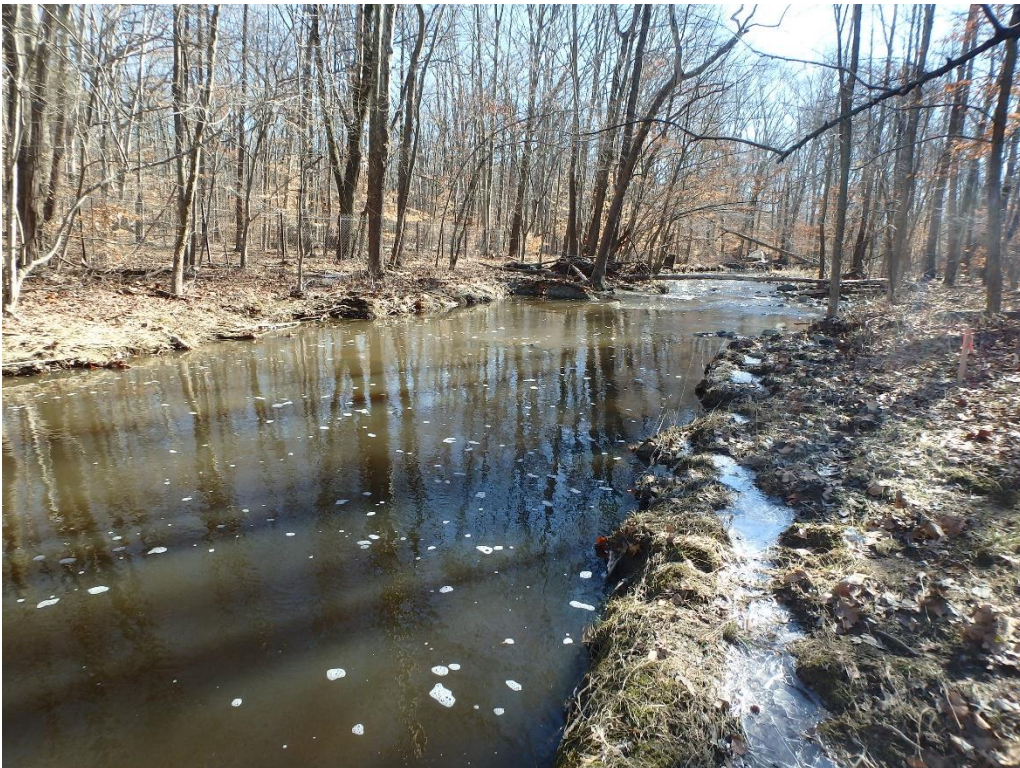
Photographer: K. Myers
Date: 2/5/18
Frame No. 4
Direction: Southeast
Comments: View of WUS
WL001 facing downstream from
flag WL001-011.

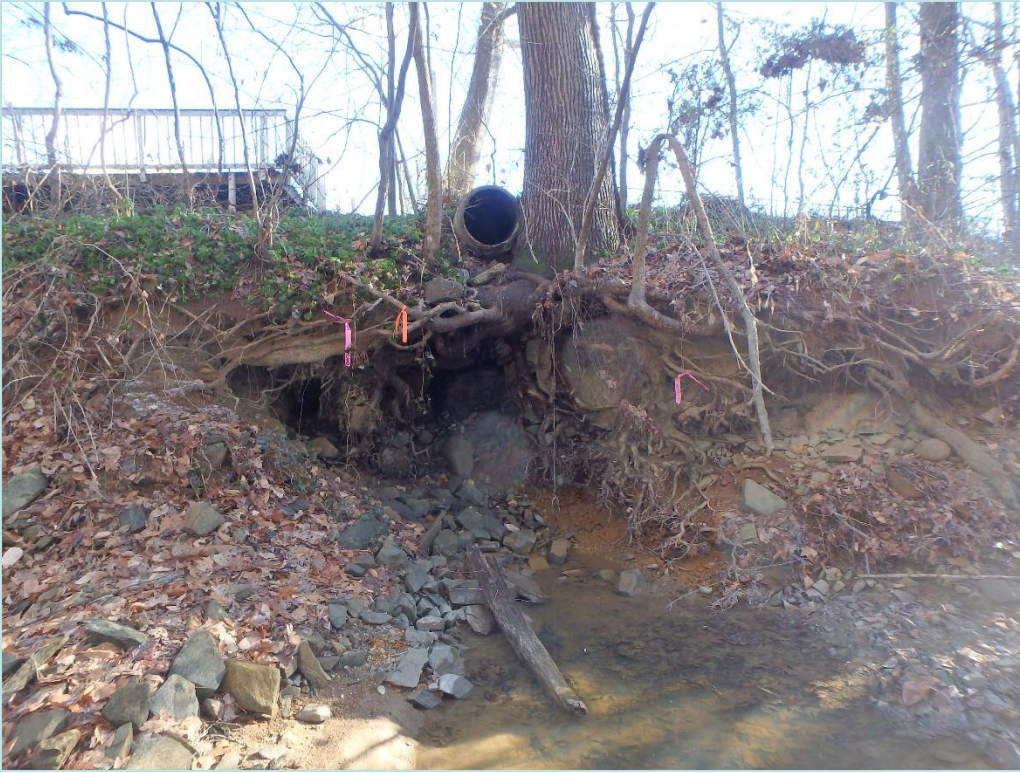
Photographer: K. Myers
Date: 2/5/18
Frame No. 5
Direction: Northeast
Comments: View of Waterway
WL002 facing upstream from
flag WL002-002.

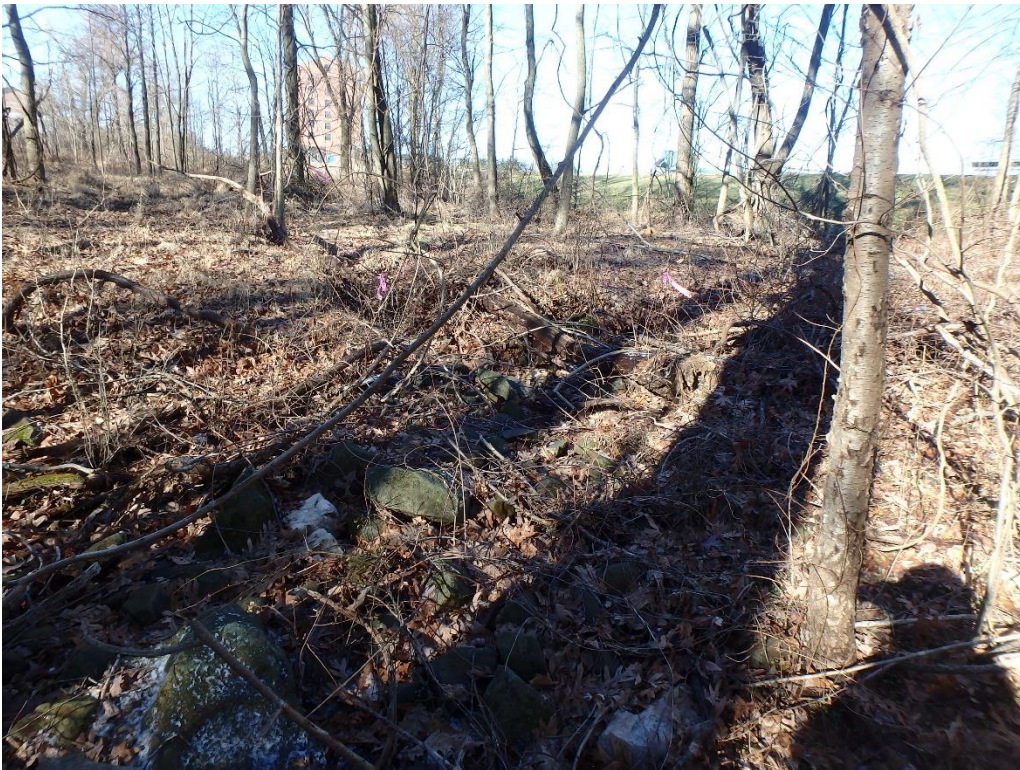
Photographer: K. Myers
Date: 2/5/18
Frame No. 6
Direction: West
Comments: View of WUS
WL003 facing upstream from
flag WL003-003.

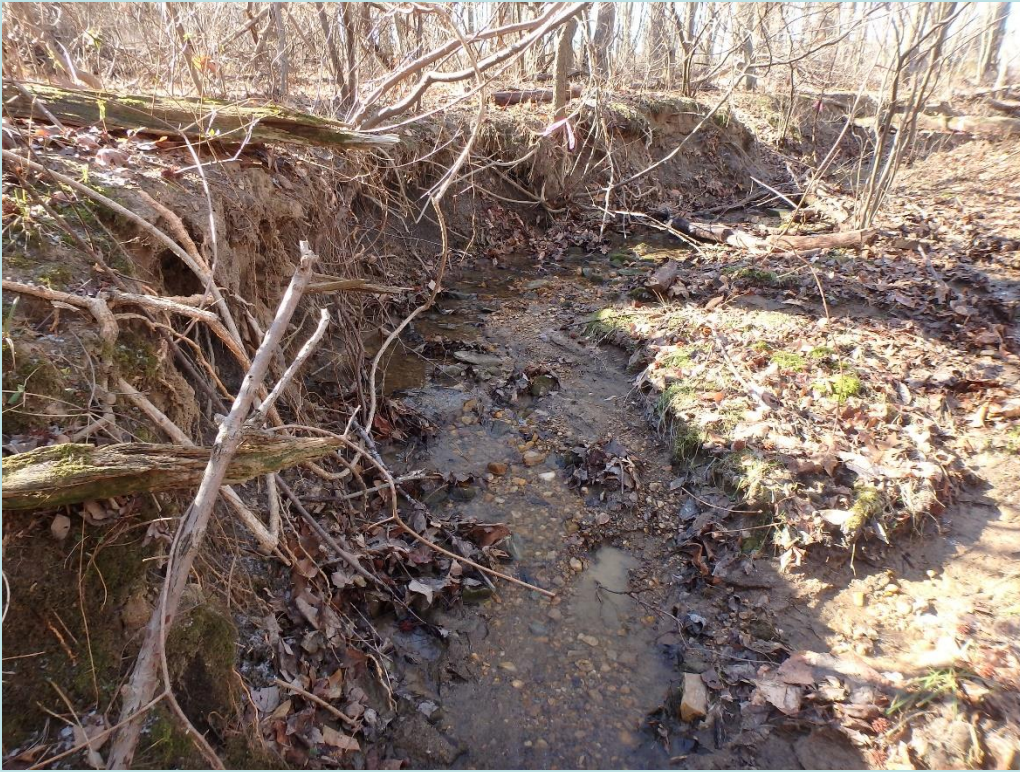
Photographer: K. Myers
Date: 2/5/18
Frame No. 7
Direction: West
Comments: View of Waterway
WL003 facing upstream from
flag WL003-007.

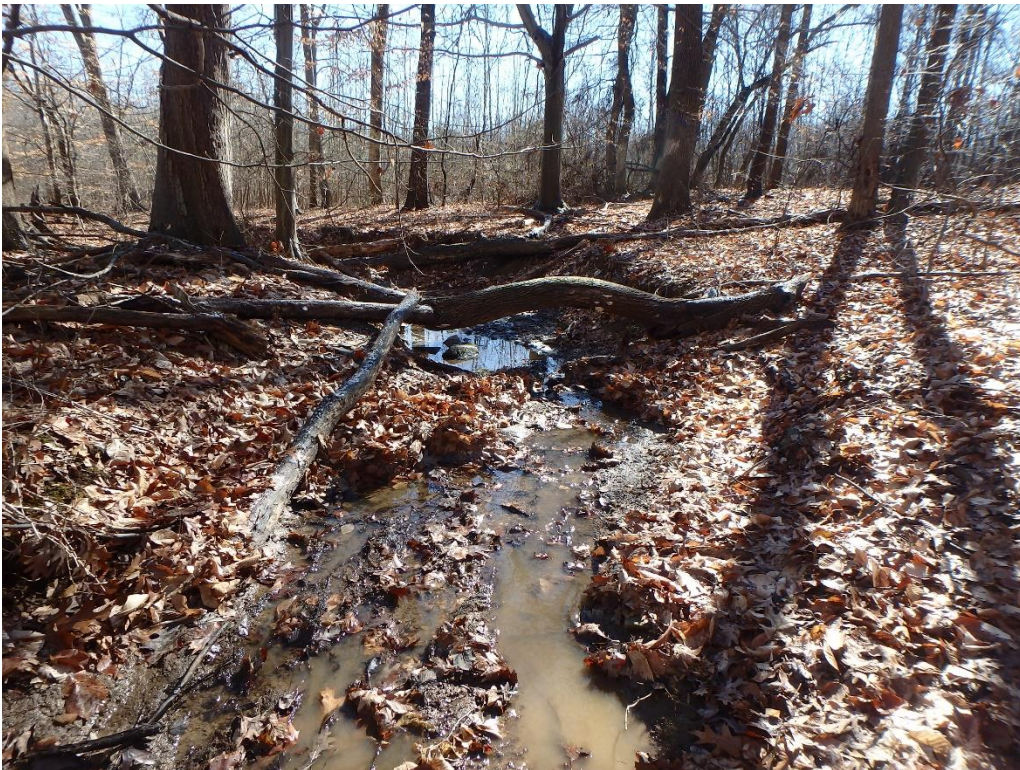
Photographer: K. Myers
Date: 2/5/18
Frame No. 8
Direction: East
Comments: View of WUS
WL003 facing downstream from
flag WL003-032.

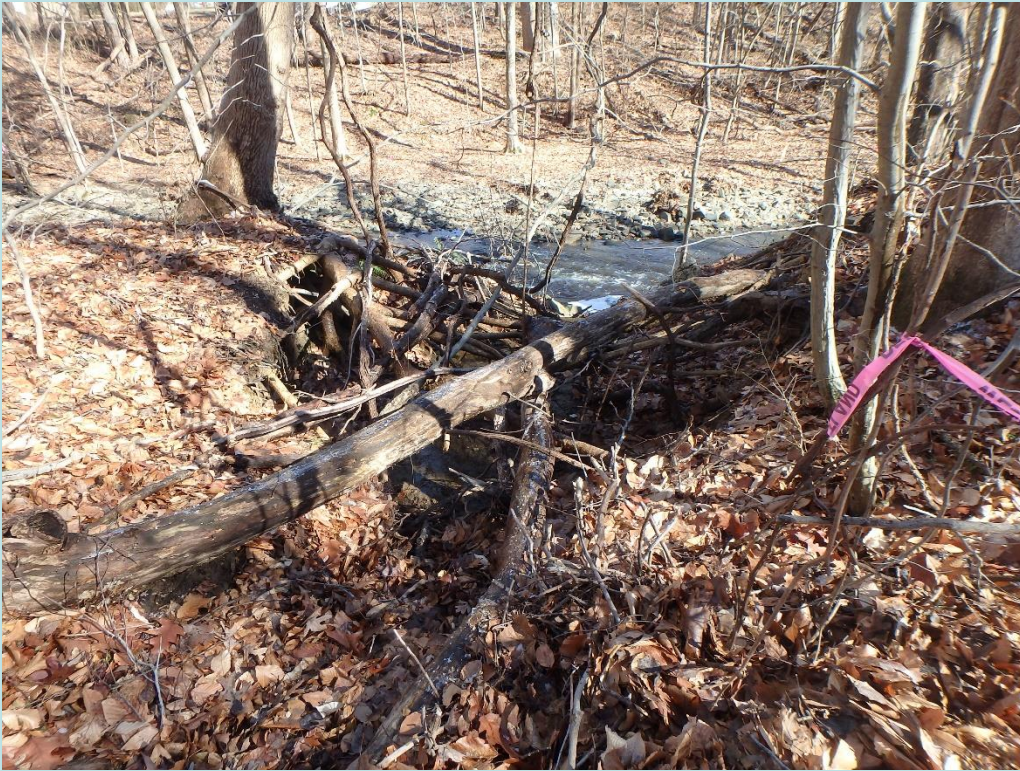
Photographer: K. Myers
Date: 2/5/18
Frame No. 9
Direction: East
Comments: View of Waterway
WL003 facing downstream from
flag WL003-037.

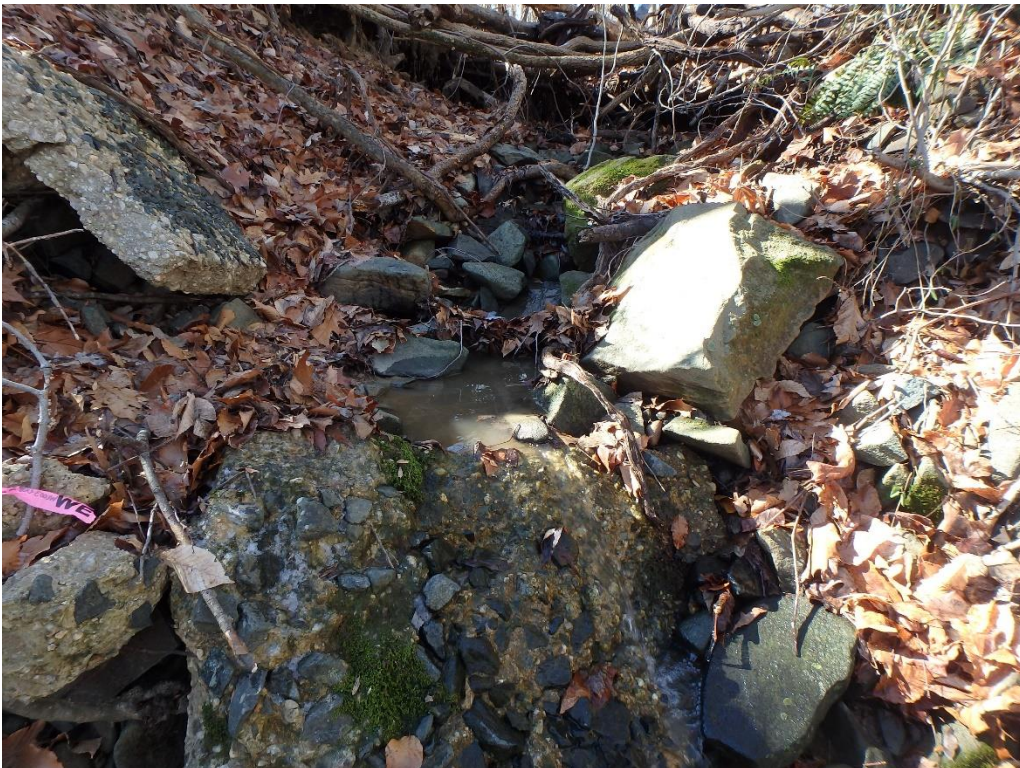
Photographer: K. Myers
Date: 2/5/18
Frame No. 10
Direction: West
Comments: View of WUS
WL003 facing upstream from
flag WL003-038.

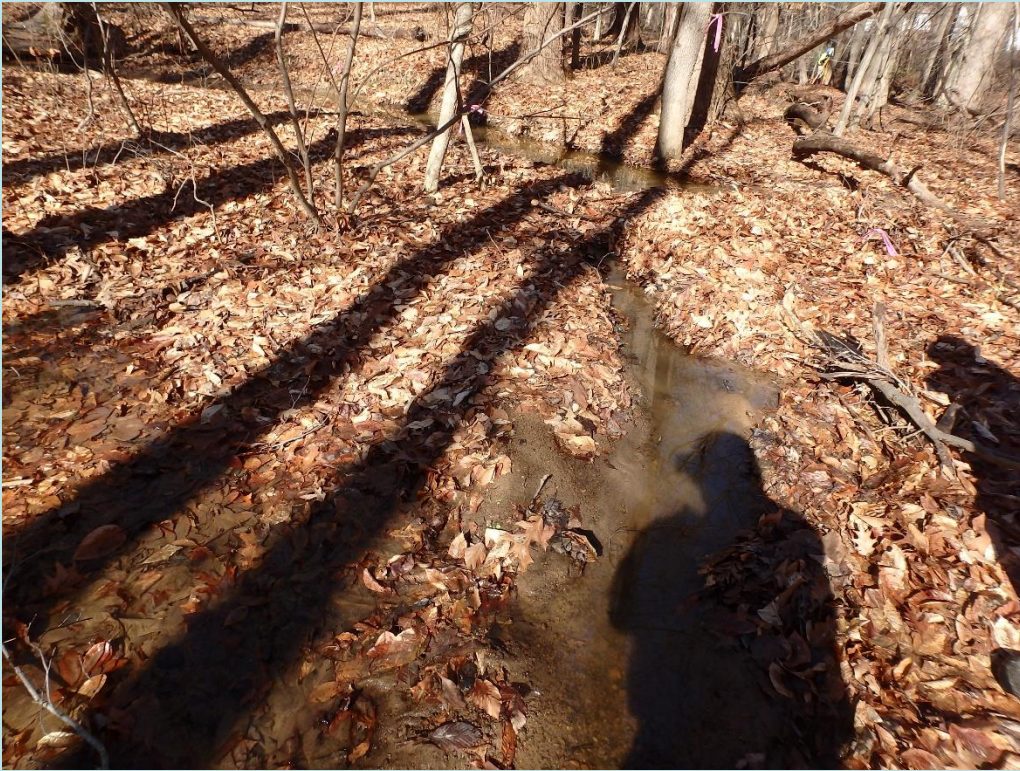
Photographer: K. Myers
Date: 2/5/18
Frame No. 11
Direction: Northwest
Comments: View of Waterway
WL004 facing upstream from
flag WL004-002.

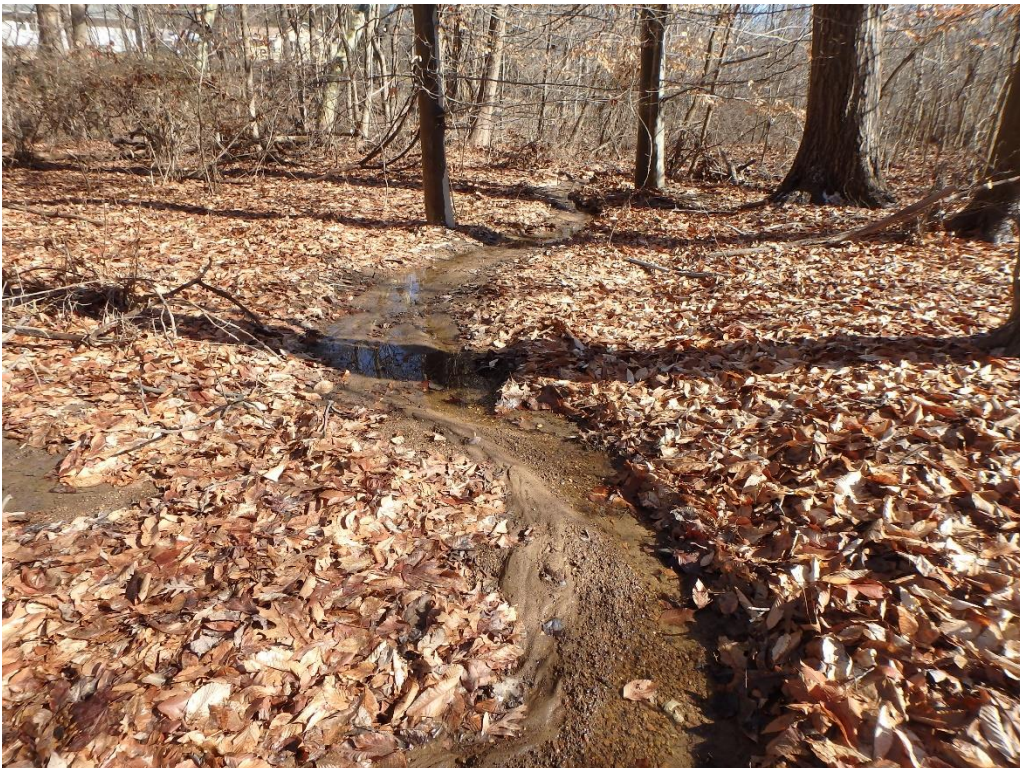
Photographer: K. Myers
Date: 2/5/18
Frame No. 12
Direction: Southeast
Comments: View of Waterway
WL004 facing downstream from
flag WL004-002.

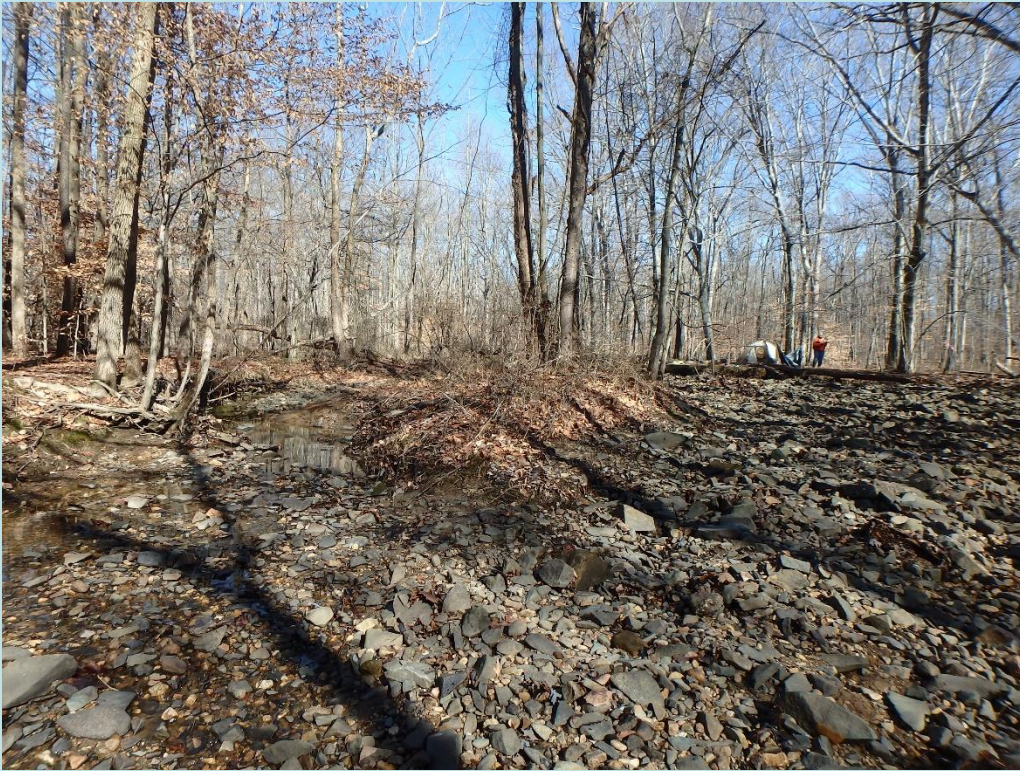
Photographer: K. Myers
Date: 2/5/18
Frame No. 13
Direction: South
Comments: View of WUS
WL001 facing upstream from
flag WL001-017.

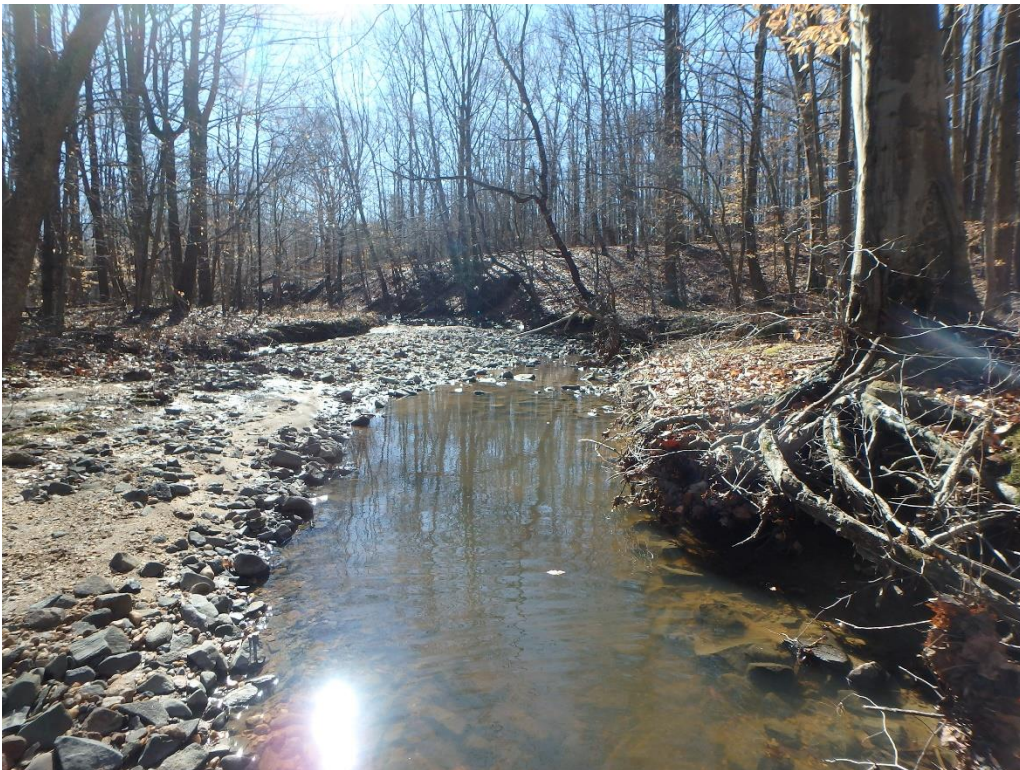
Photographer: K. Myers
Date: 2/5/18
Frame No. 14
Direction: North
Comments: View of WUS
WL005 facing downstream from
flag WL005-004.

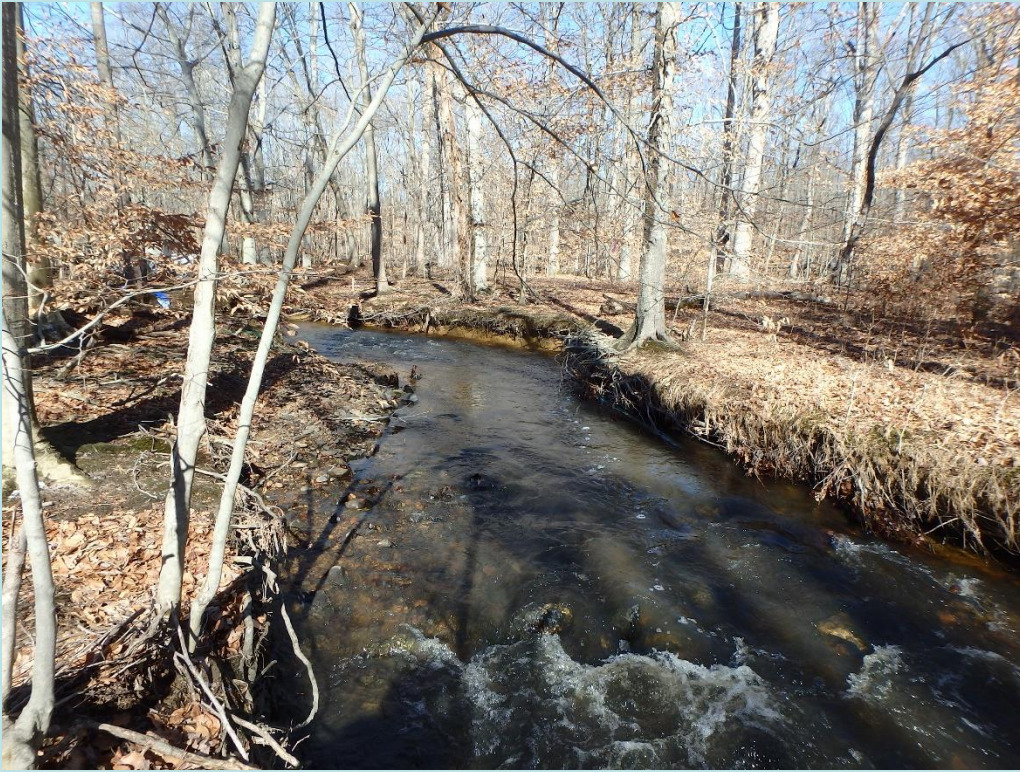
Photographer: K. Myers
Date: 2/5/18
Frame No. 15
Direction: South
Comments: View of WUS
WL001 facing upstream from
flag WL001-017.

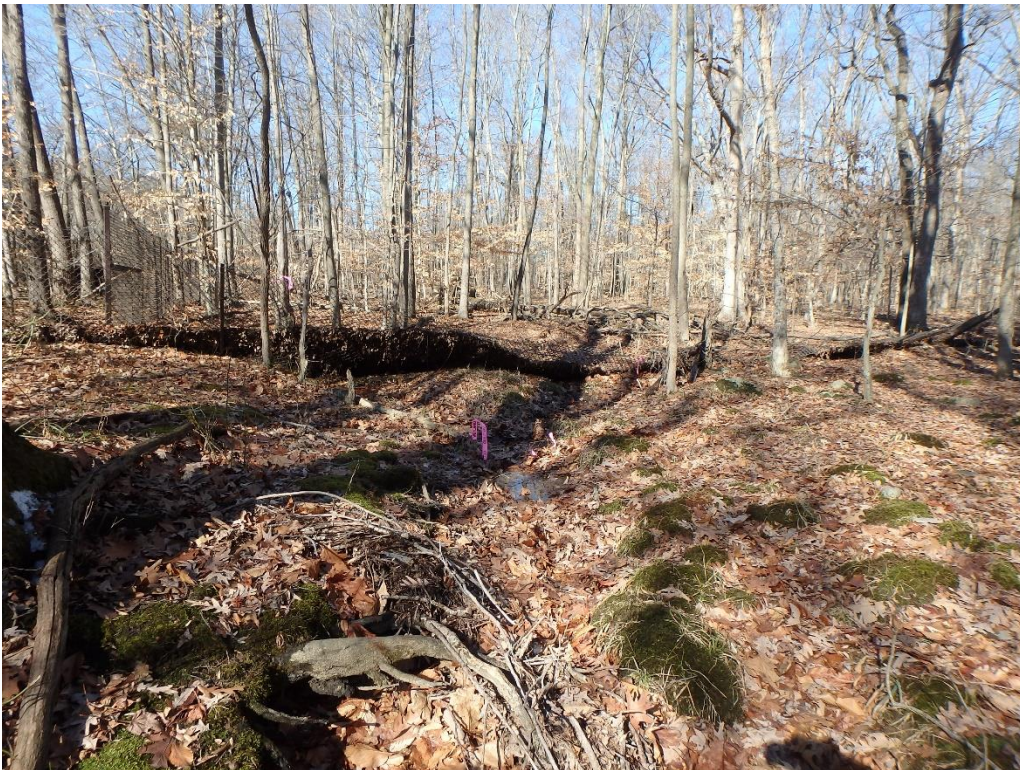
Photographer: K. Myers
Date: 2/5/18
Frame No. 16
Direction: North
Comments: View of Waterway
WL006 facing upstream from
flag WL006-003.

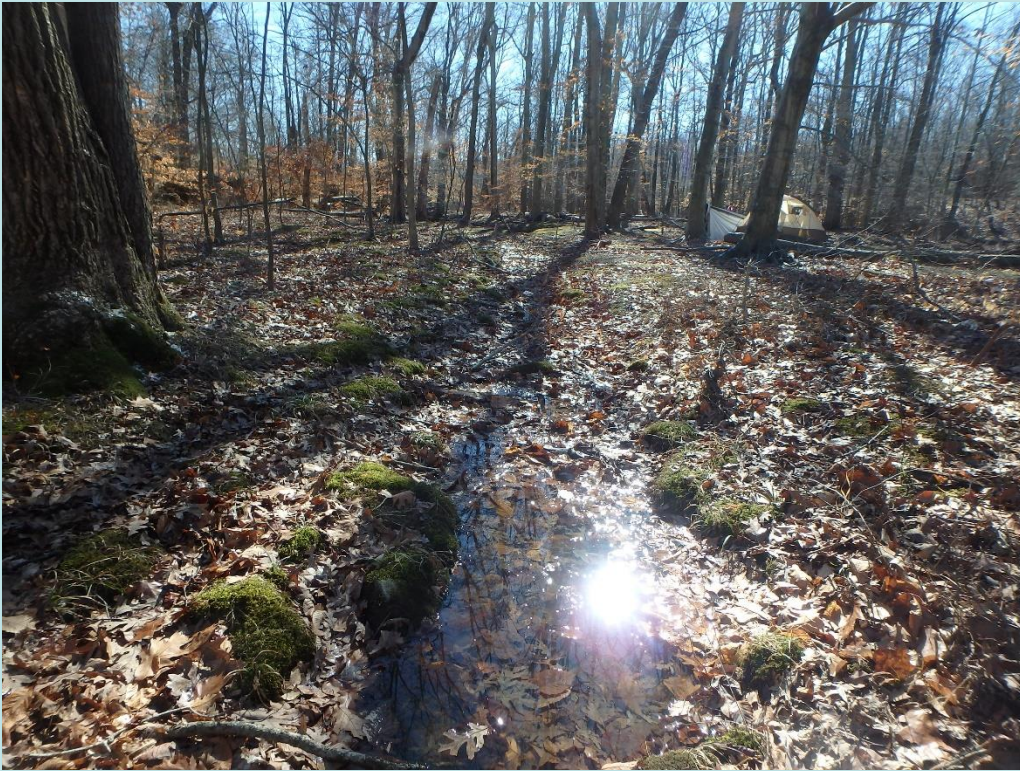
Photographer: K. Myers
Date: 2/5/18
Frame No. 17
Direction: South
Comments: View of Waterway
WL006 facing downstream from
flag WL006-006.

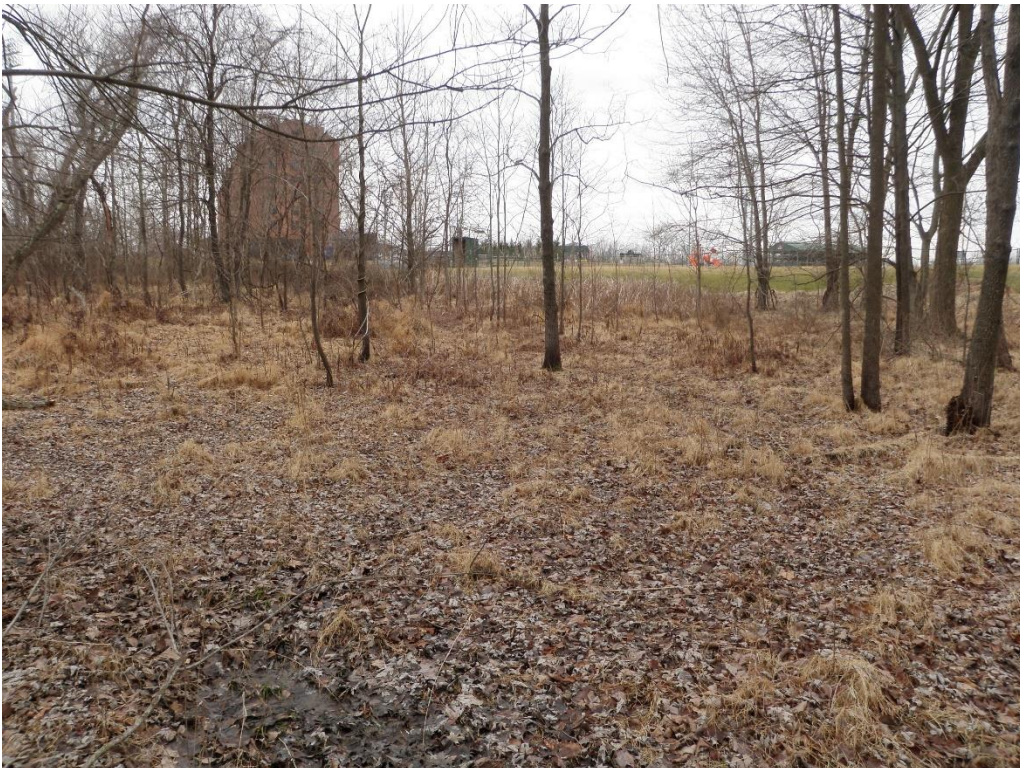
Photographer: A. Wagoner
Date: 2/6/18
Frame No. 18
Direction: Northwest
Comments: View of Wetland
Sample Plot WL007-WET
towards Ripken Stadium
complex

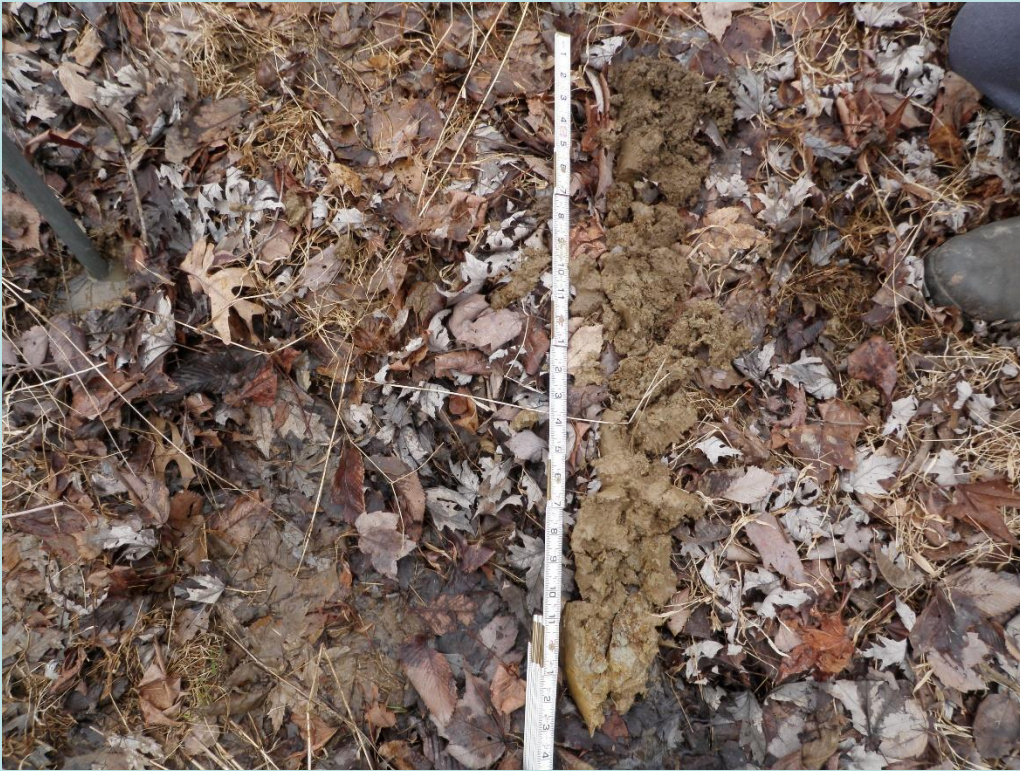
Photographer: A. Wagoner
Date: 2/6/18
Frame No. 19
Direction: N/A
Comments: View of Wetland
Sample Plot WL007-WET soils.

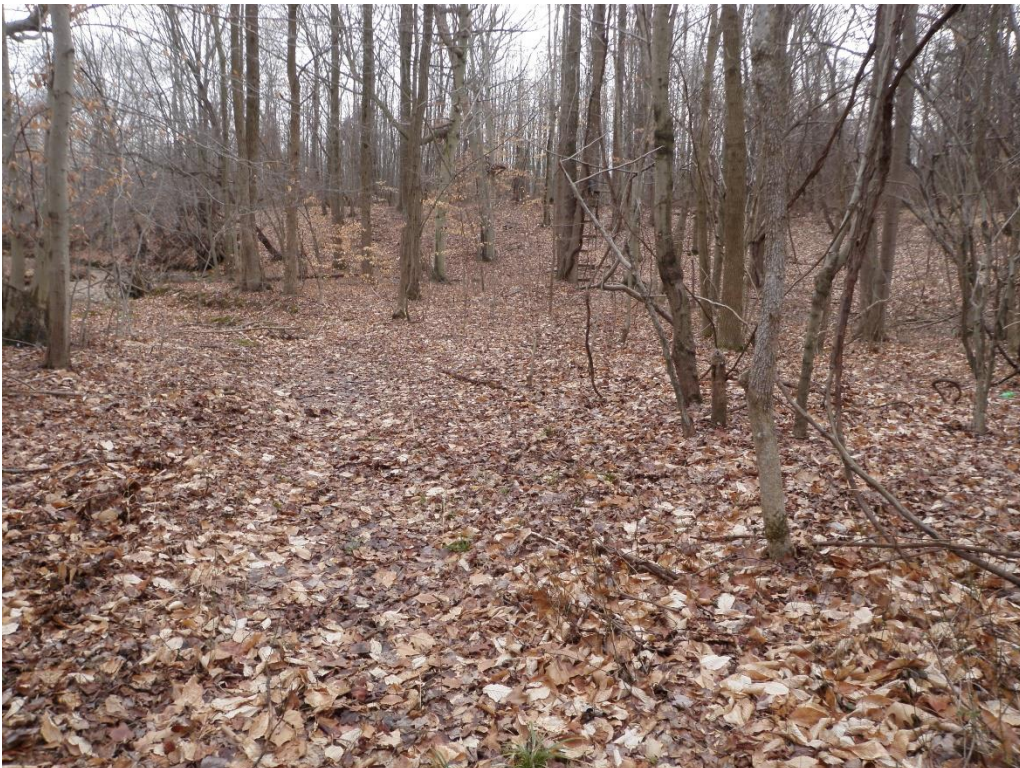
Photographer: A. Wagoner
Date: 2/6/18
Frame No. 20
Direction: South
Comments: View of Wetland
Sample Plot WL008-WET.

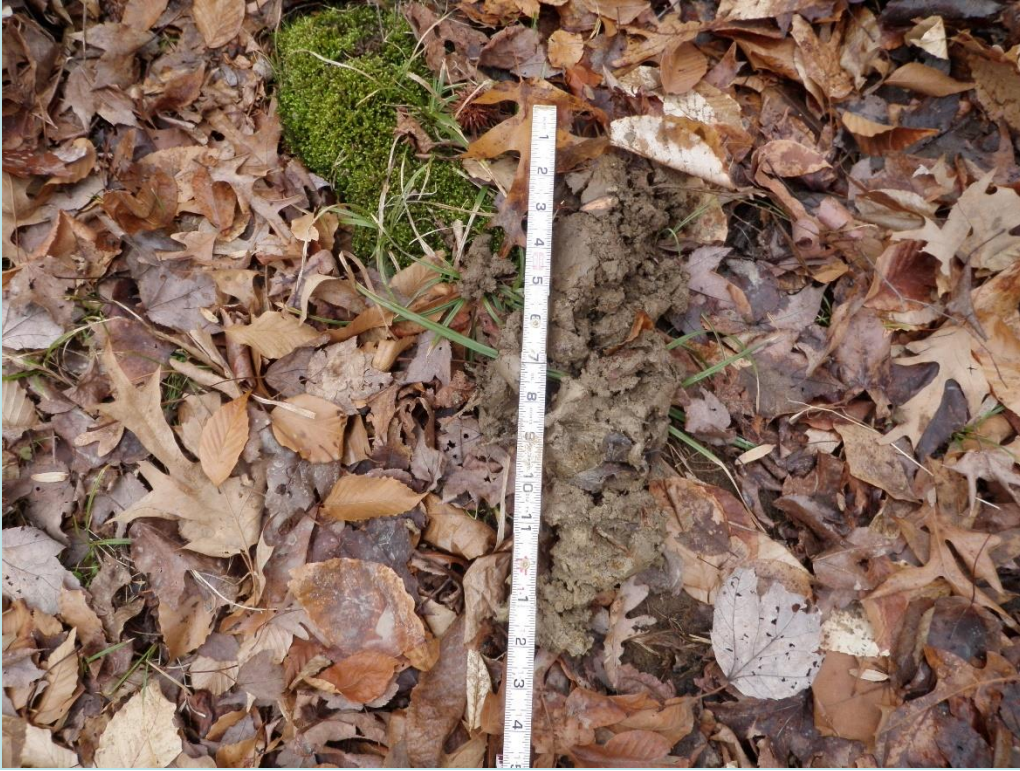
Photographer: A. Wagoner
Date: 2/6/18
Frame No. 21
Direction: N/A
Comments: View of Wetland
Sample Plot WL008-WET soils.

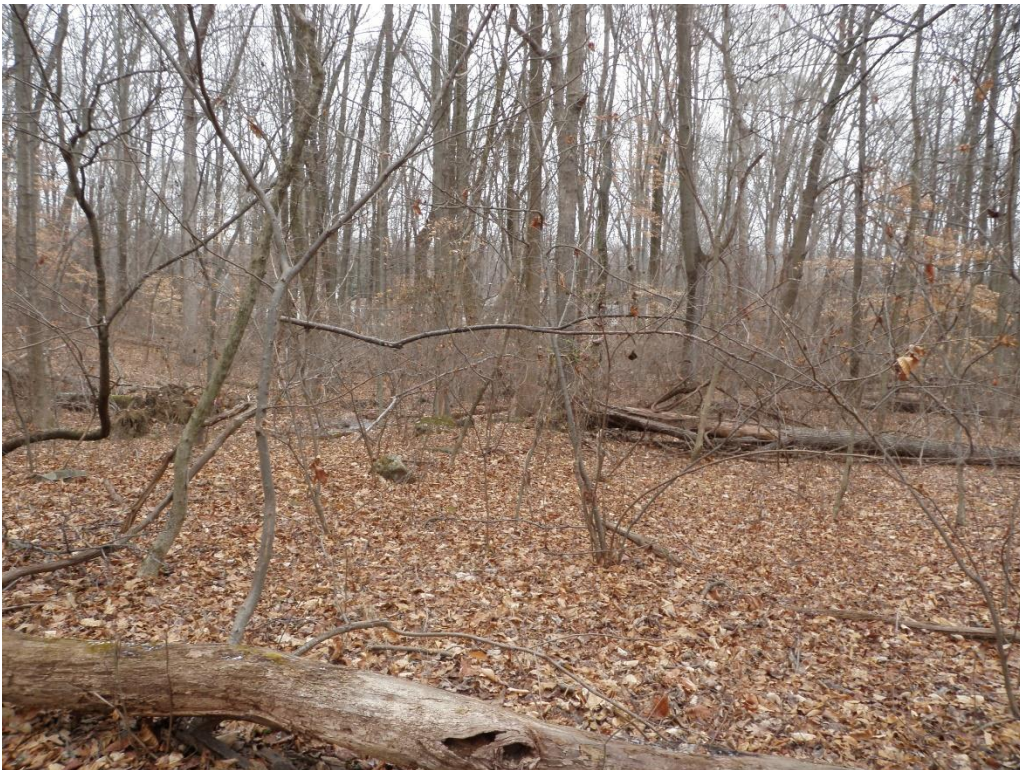
Photographer: A. Wagoner
Date: 2/6/18
Frame No. 22
Direction: North
Comments: View of Upland
Sample Plot UPL-1.

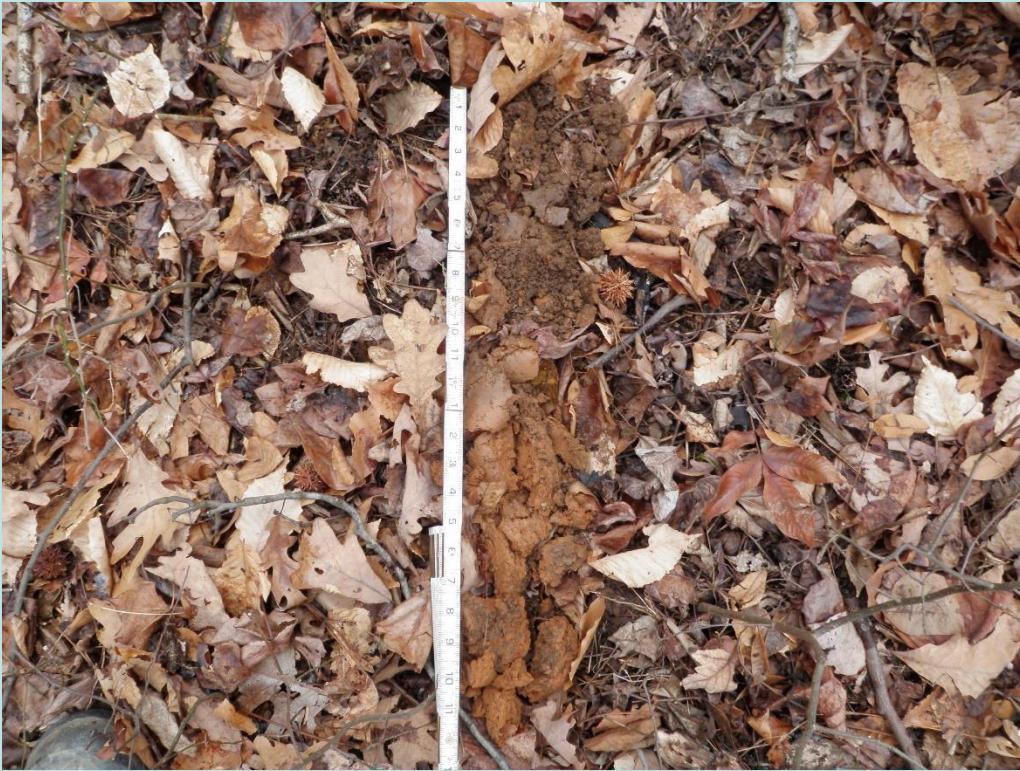
Photographer: A. Wagoner
Date: 2/6/18
Frame No. 23
Direction: N/A
Comments: View of Upland
Sample Plot UPL-1 soils.

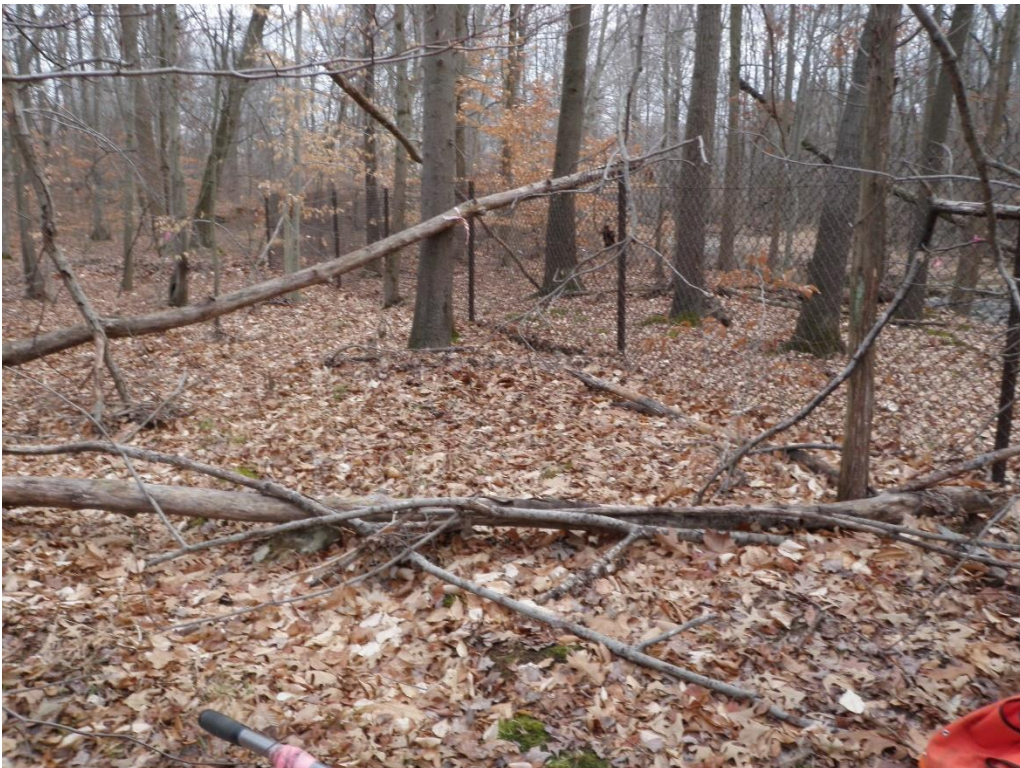
Photographer: A. Wagoner
Date: 2/6/18
Frame No. 24
Direction: Southwest
Comments: View of Upland
Sample Plot UPL-2.

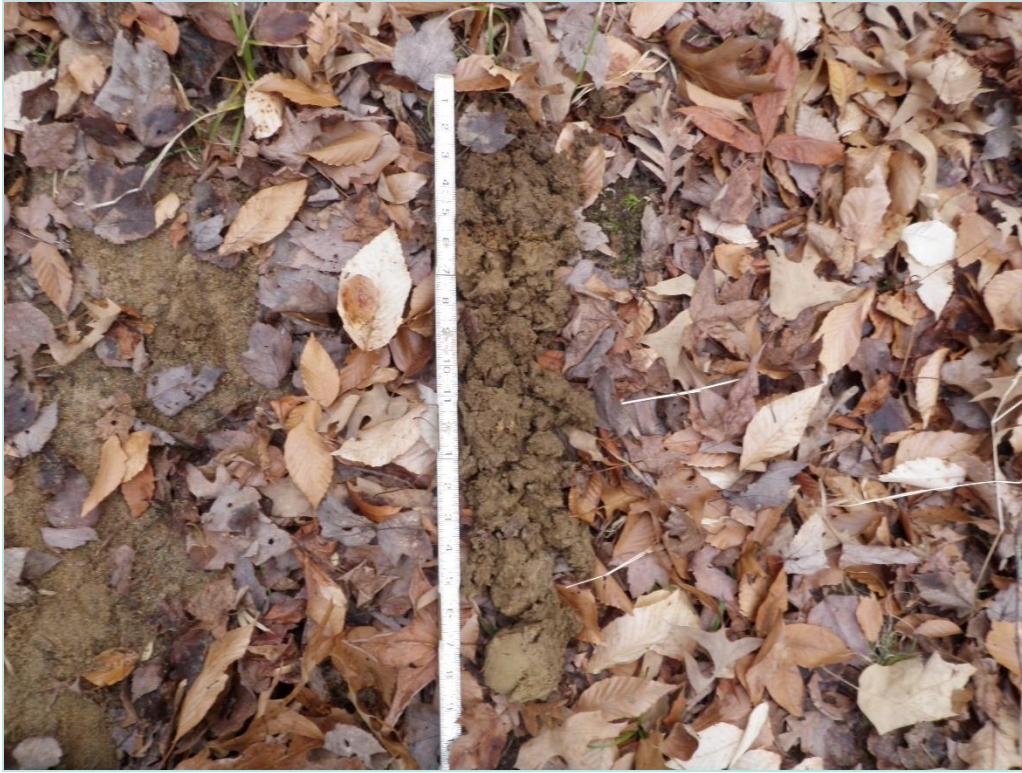
Photographer: A. Wagoner
Date: 2/6/18
Frame No. 25
Direction: N/A
Comments: View of Upland
Sample Plot UPL-2 soils.

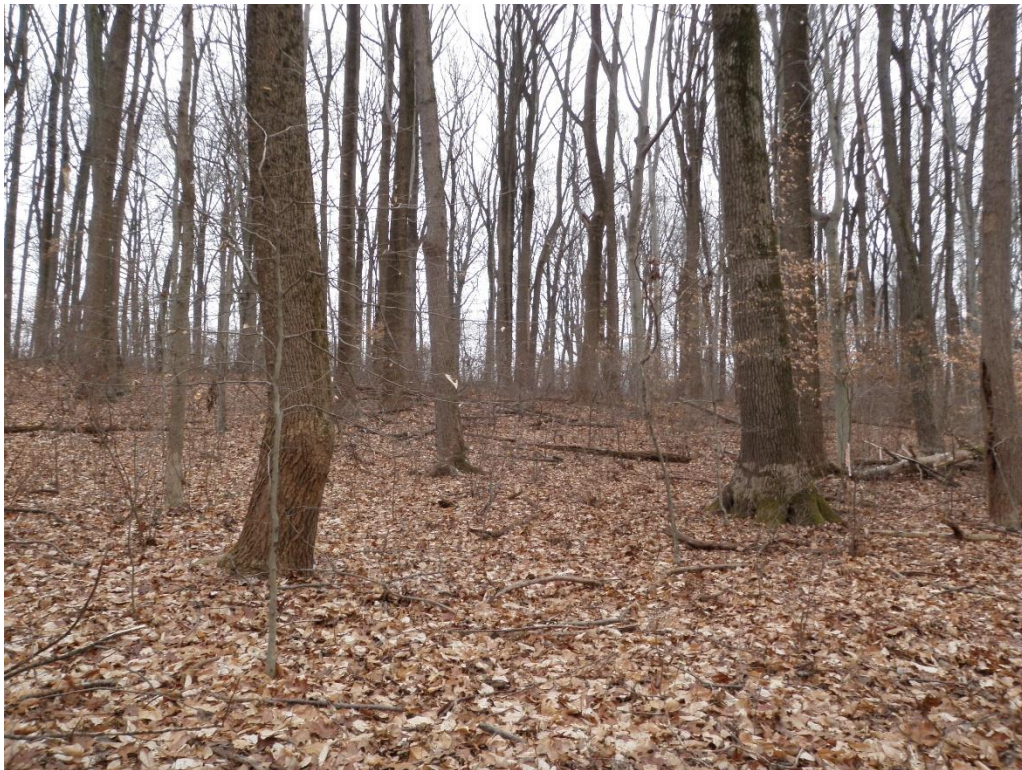
Photographer: A. Wagoner
Date: 2/6/18
Frame No. 26
Direction: West
Comments: View of Forest Stand
Delineation Sample Plot FSD A-
1 from center.

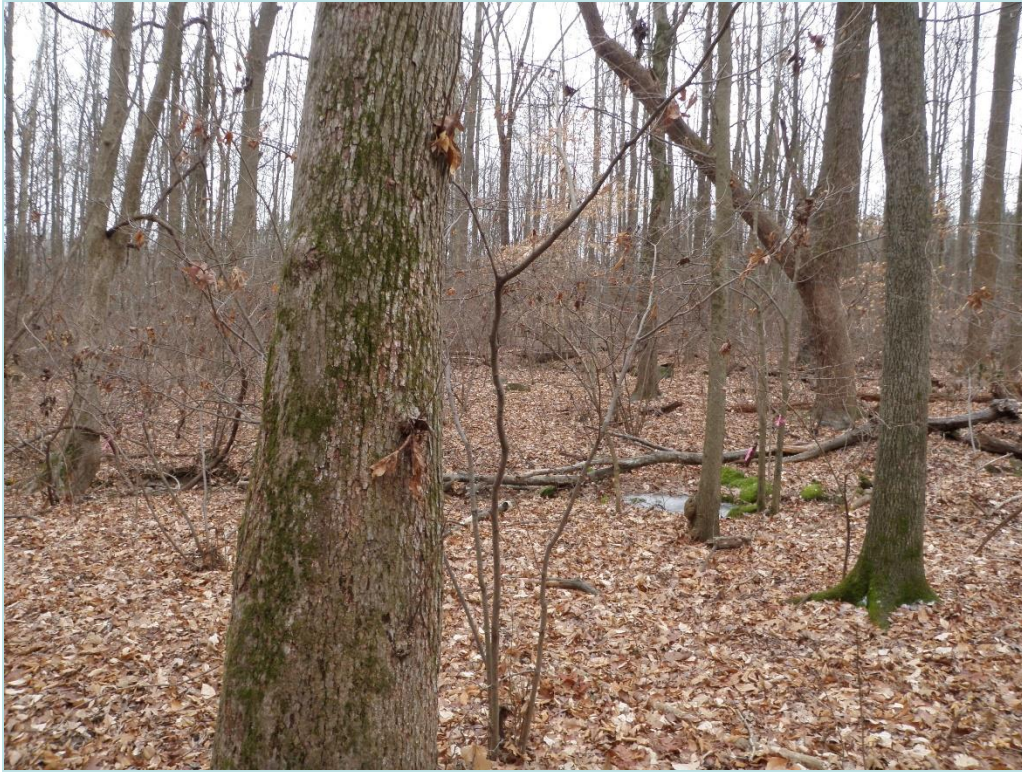
Photographer: A. Wagoner
Date: 2/6/18
Frame No. 27
Direction: East
Comments: View of Forest Stand
Delineation Sample Plot FSD A-
2 from center.

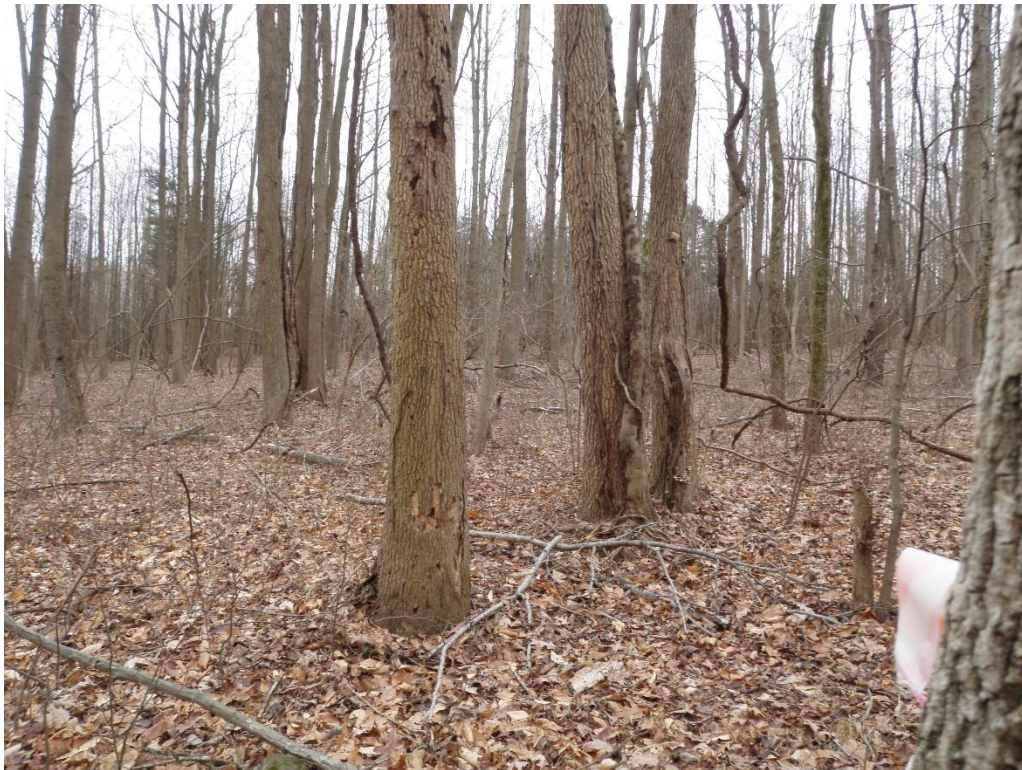
Photographer: A. Wagoner
Date: 2/6/18
Frame No. 28
Direction: East
Comments: View of Forest Stand
Delineation Sample Plot FSD A-
3 from center.
