Carsins Runs I-95 Section 200 Stream Restoration Site

Natural Resources Inventory

Prepared for
MDTA

KCI Technologies, Inc.
February 2018
KCI Project No. 22145228.36

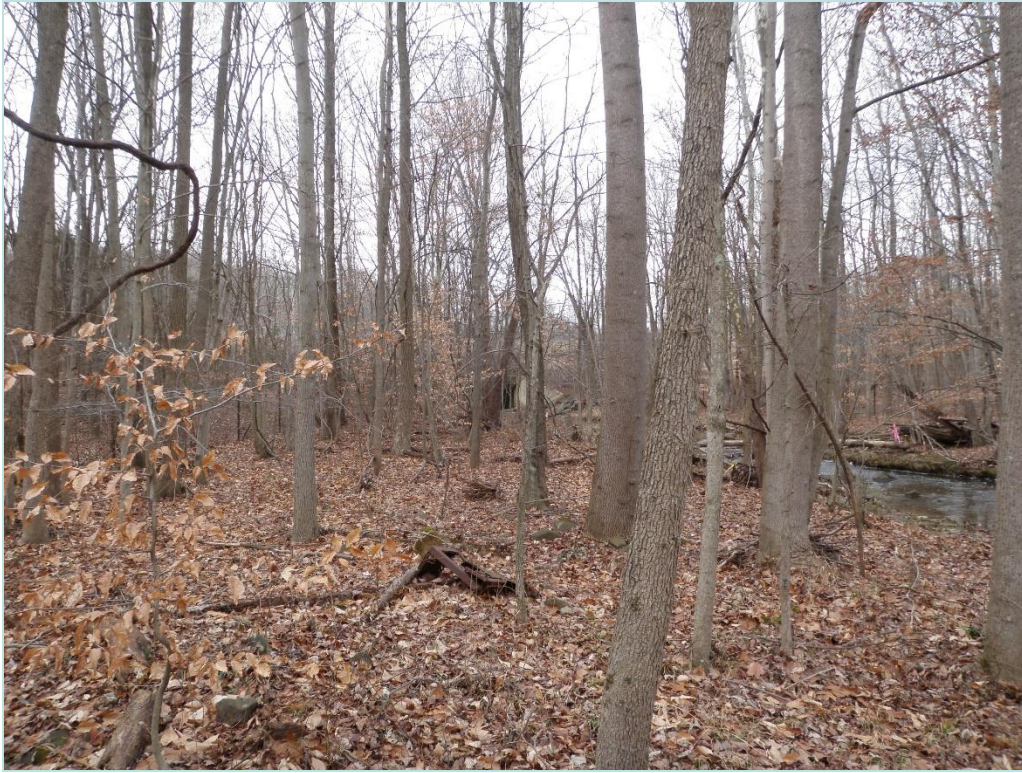
Photographer: A. Wagoner
Date: 2/6/18
Frame No. 29
Direction: North
Comments: View of Forest Stand
Delineation Sample Plot FSD B-
1 from center.

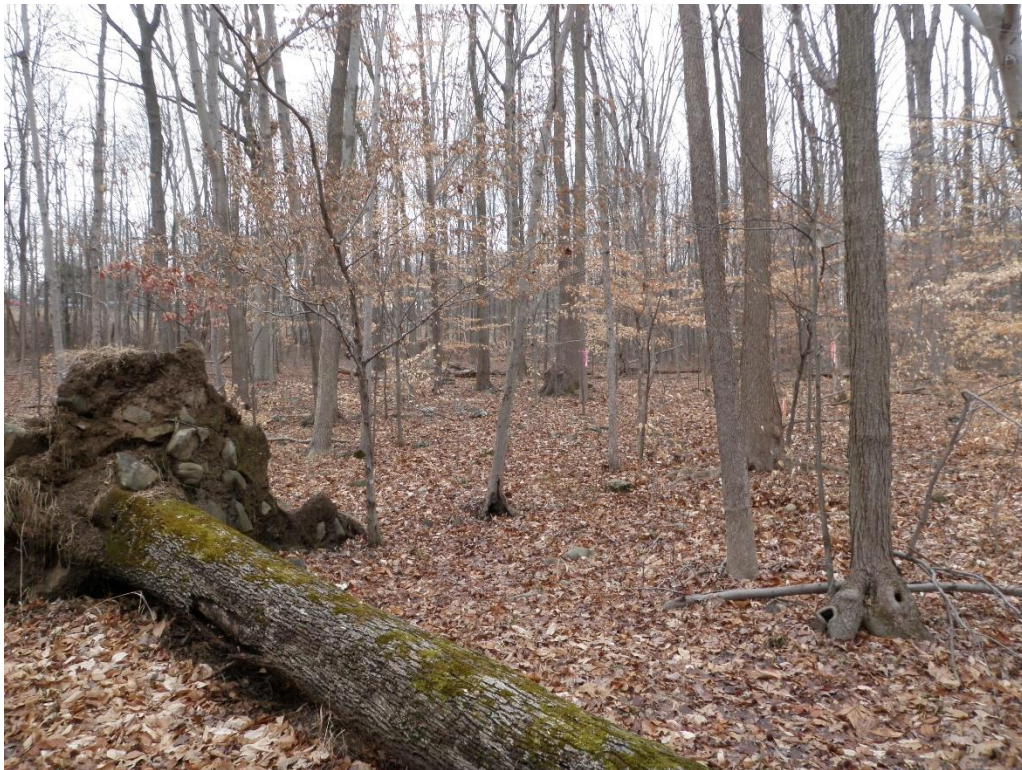
Photographer: A. Wagoner
Date: 2/6/18
Frame No. 30
Direction: North
Comments: View of Forest Stand
Delineation Sample Plot FSD B-
2 from center.
