Lessons Learned from Concrete Dam Failures

Gannett Fleming

Maryland
Department of
the Environment

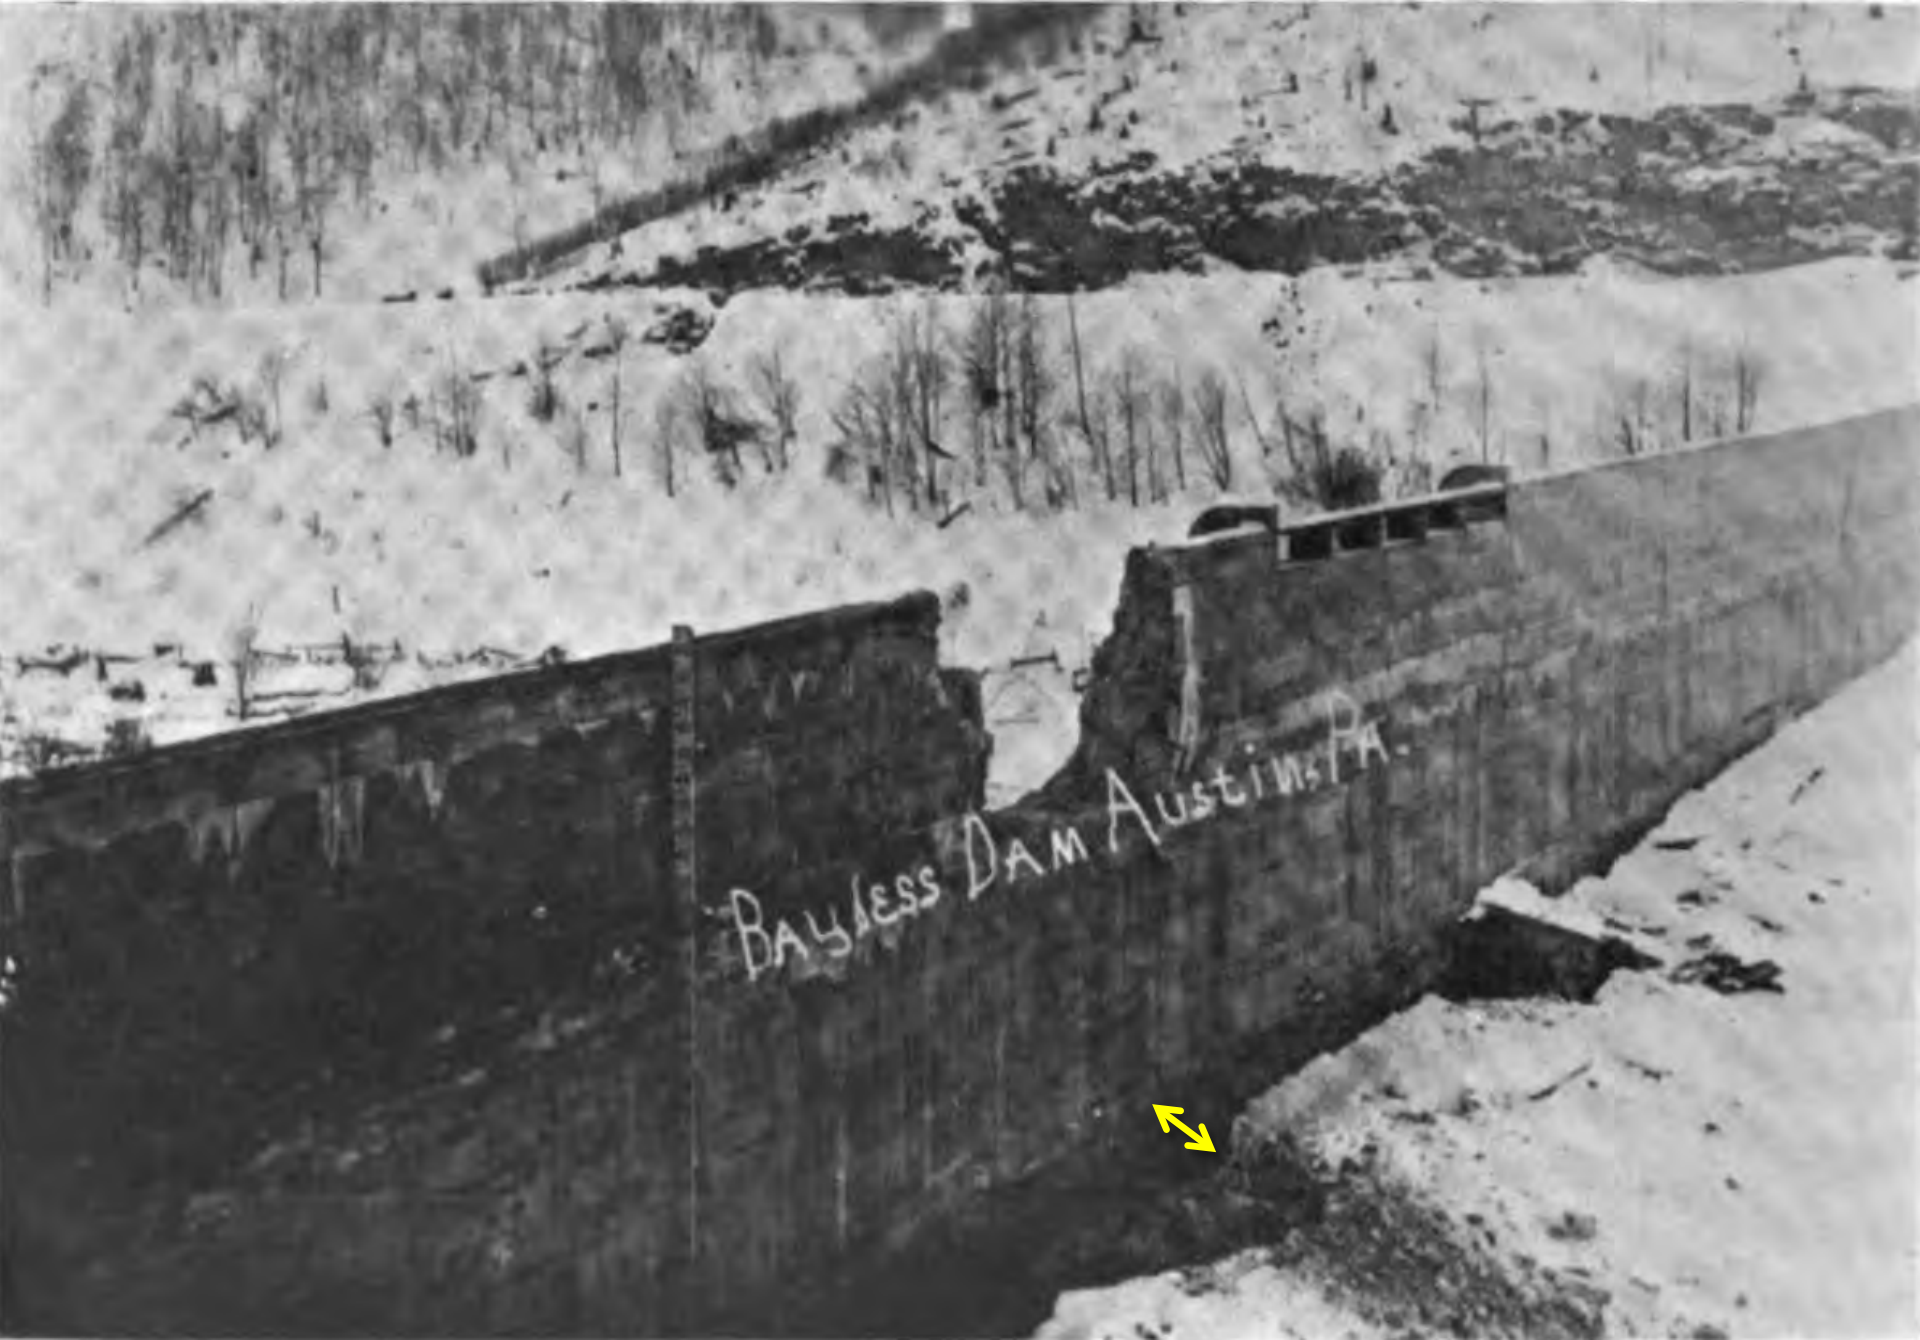
Bayless Dam, Austin, PA
January 23, 1910
Max. Horizontal Displacement:
Crest: 31 inches
Base: 18 inches
