DAM SAFETY
POLICY MEMORANDUM #1

SUBJECT: Maintenance and Repair: Trees and Woody Vegetation

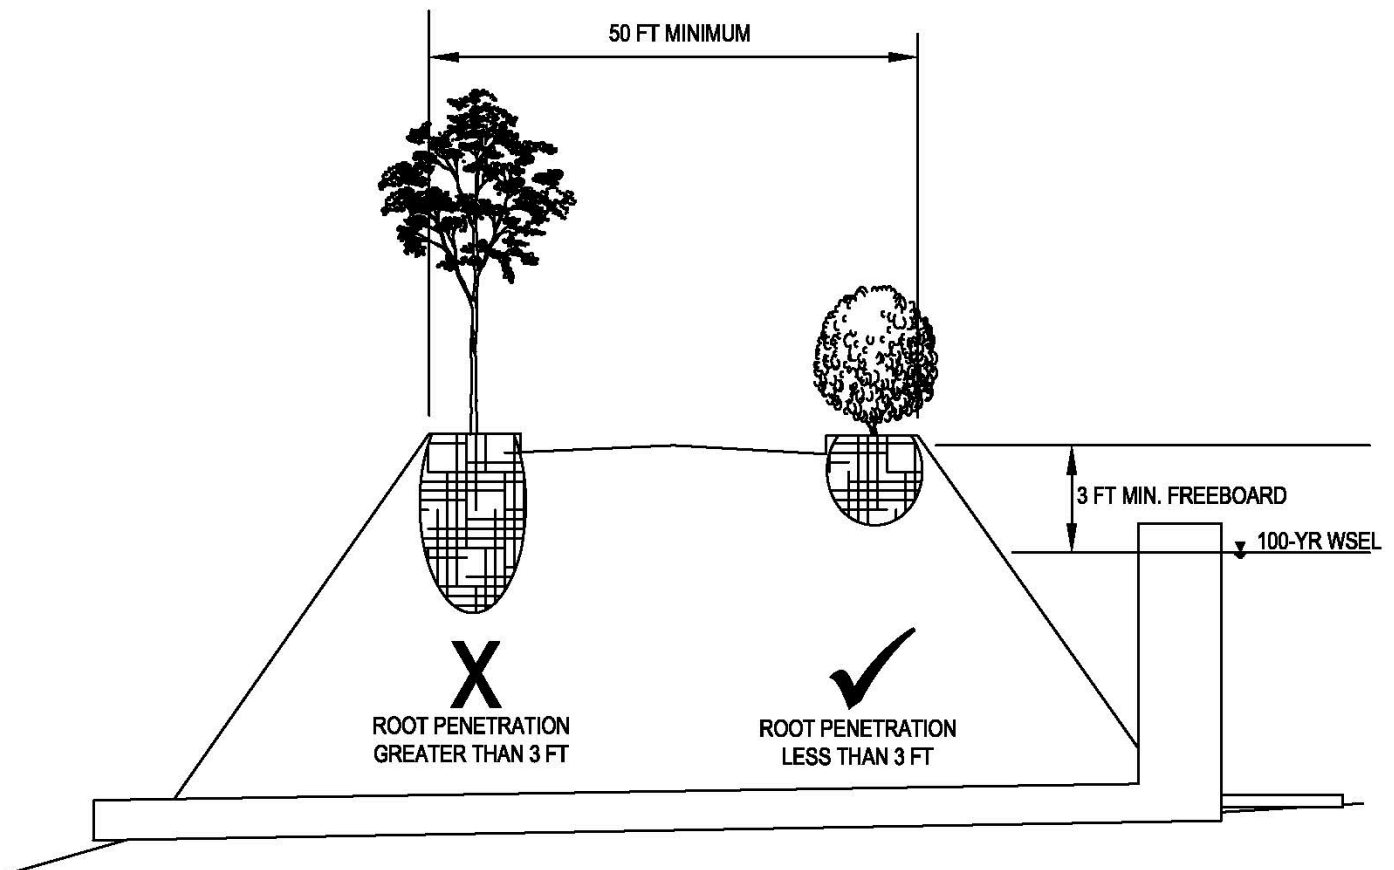
Figure 2: Plantings on Dams Used as Roadway

Figure 2 illustrates acceptable and unacceptable applications of this policy exemption.

The Department allows a limited exception to this policy for planting of certain trees or similar woody vegetation along the crest of roadway embankments used as dry stormwater management structures (i.e., those structures that act as dams, rather than culverts) where required per local ordinances. While planting trees on roadway embankments is discouraged, the following conditions must be met to allow limited woody vegetation plantings:

1. The structure shall have no permanent wet pool.
2. The dam shall be classified as low hazard only.
3. The structure shall have a minimum of three (3) feet of freeboard between the peak 100-year water surface elevation (WSEL) and the lowest point on the crest of the dam.
4. The width of the dam embankment measured three (3) feet above the peak 100-year WSEL shall be no less than 50 feet.
5. Woody vegetation planting is acceptable only on the top of the dam along the edge of the roadway. Woody vegetation planting shall not be permitted on the side slopes.
6. Woody vegetation planting is not permitted within 15 feet from the spillway, toe, or abutments of the dam.
7. Planting may consist only of trees or shrubs with a shallow root system (less than three (3)

feet depth) when mature. A landscape plan showing the type and location of plantings shall be submitted for review and approval by the appropriate authority. The plan shall be prepared by a Maryland registered landscape architect with a note certifying that the proposed plantings have a shallow root system. Planting must be intentional. Volunteer tree growth is not acceptable.
