# Spring Branch Subwatershed - Small Watershed Action Plan

(Addendum to the Water Quality Management Plan for Loch Raven Watershed)

Prepared by  
**Baltimore County**  
Department of Environmental Protection and Resource Management  
401 Bosley Avenue, Suite 416, Towson, MD 21204

March 17, 2008

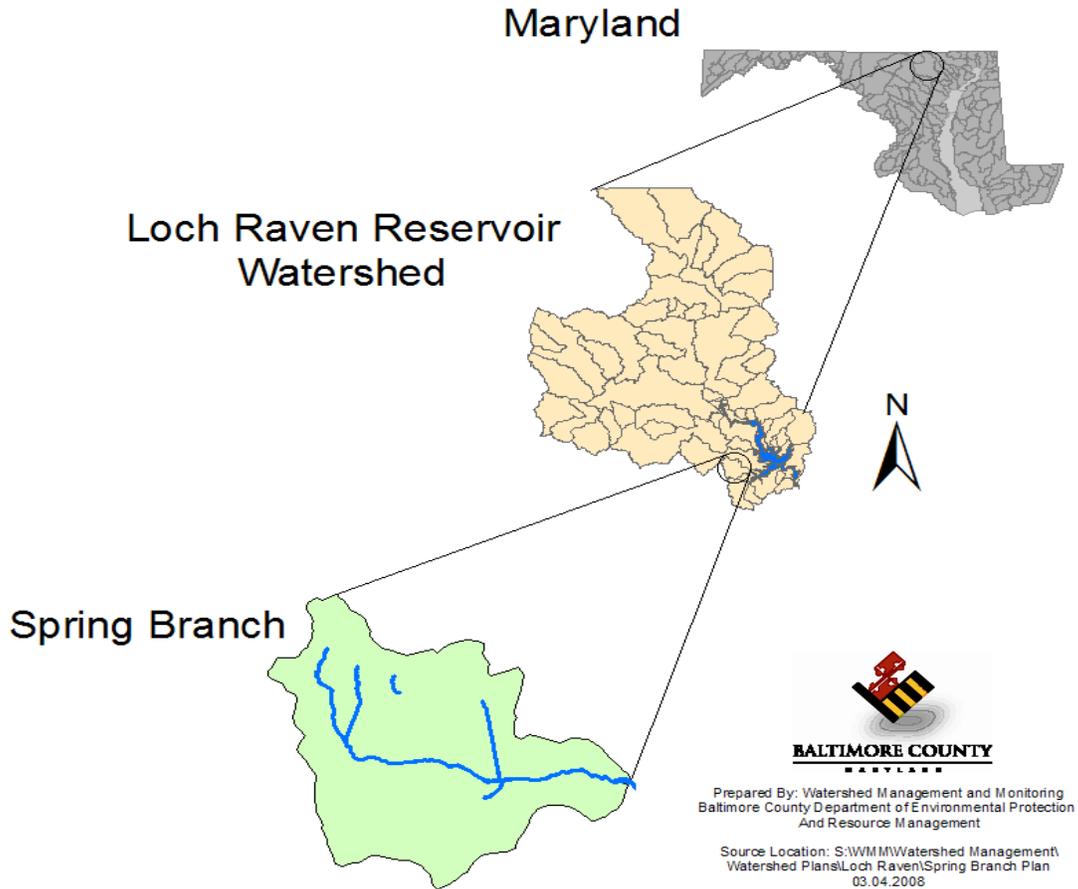
Figure 1-1: Location of the Spring Branch Subwatershed.

The Spring Branch is a 1,005-acre subwatershed located in the Loch Raven Reservoir watershed (Basin No. 02130805), which in turn is located in the Gunpowder River Basin (Figure 1-1). The Spring Branch subwatershed is in the Piedmont region of Maryland. The subwatershed drains directly to southwestern portion of the Loch Raven Reservoir. It was primarily developed in the 1950-1970 time period and predates the environmental regulations that are currently in place. The controlled storm water discharge resulted in severe stream erosion within the subwatershed.

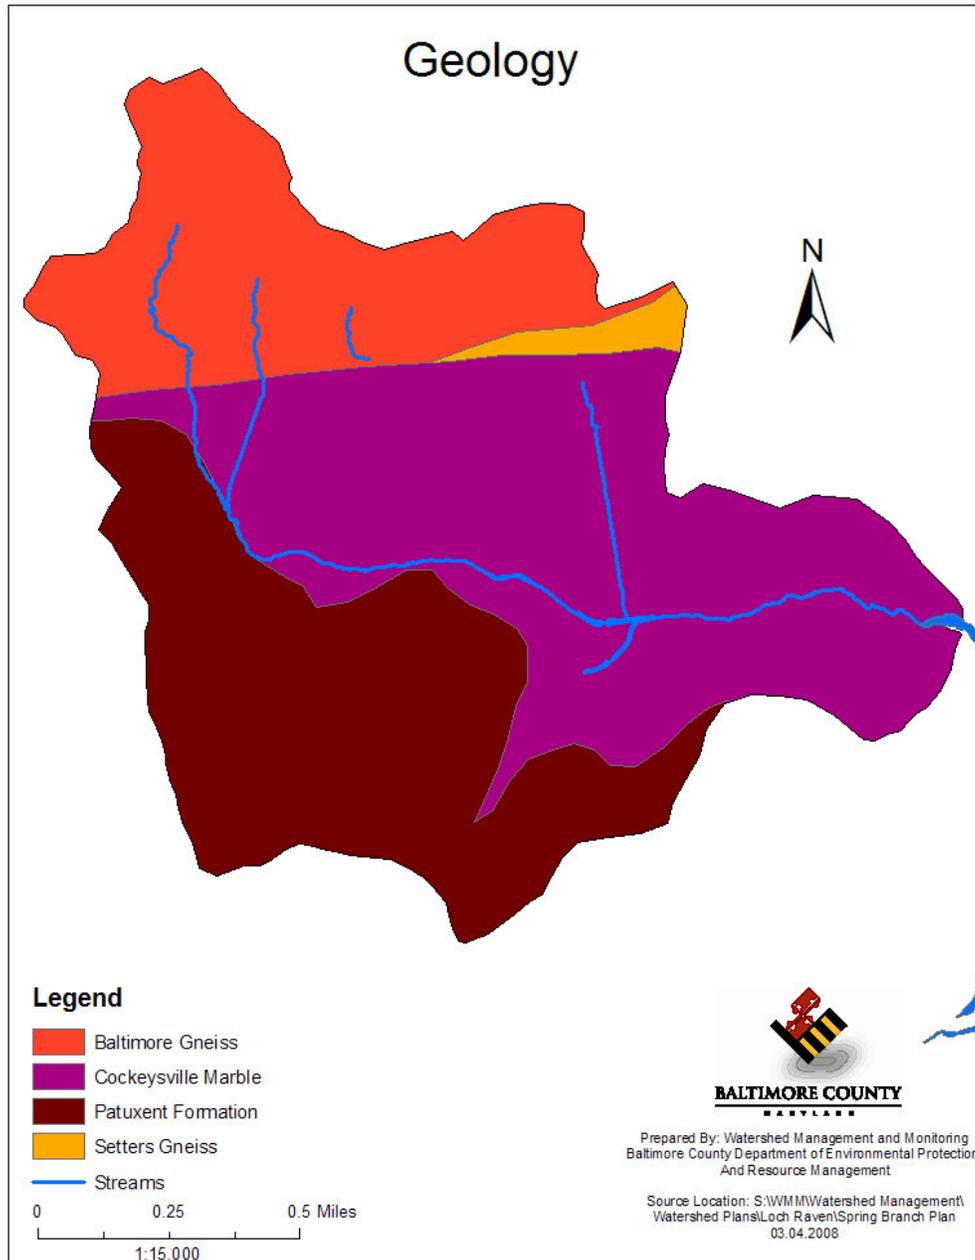
Figure 2-2: Spring Branch Subwatershed Geology

The headwaters of Spring Branch subwatershed are located at the top of a geological feature known as the Texas Dome. This is an area of local uplifting characterized by a relatively flat top and steep sides. The geological formations of the Spring Branch subwatershed are shown in Figure 2-2, with the acres and percentage of each geological type shown in Table 2-1. These formations affect the chemical composition of surface and groundwater, as well as the recharge rate to groundwater. They are also key to soil formation. As such, the geology is closely correlated with water quality in pristine systems, and affects the buffering of pollution to stream systems in developed areas.

Cockeysville marble underlies 44% of the Spring Branch subwatershed. This rock type provides buffering capacity and due to solution of the bedrock generally provides a greater infiltration capacity for the overlying soil. Approximately a quarter of the underlying bedrock is gneiss. This bedrock type is metamorphic. The density and distribution of cracks in this rock type control the amount of water holding capacity of the bedrock. This may be limited. The Patuxent Formation, an unconsolidated formation, underlies one-third of the subwatershed. This unconsolidated formation is associated with the Coastal Plain Physiographic Province. At this location we have the interface of the Coastal Plain with the Piedmont, where the unconsolidated sediments of the Coastal Plain overlap the bedrock formations of the Piedmont.

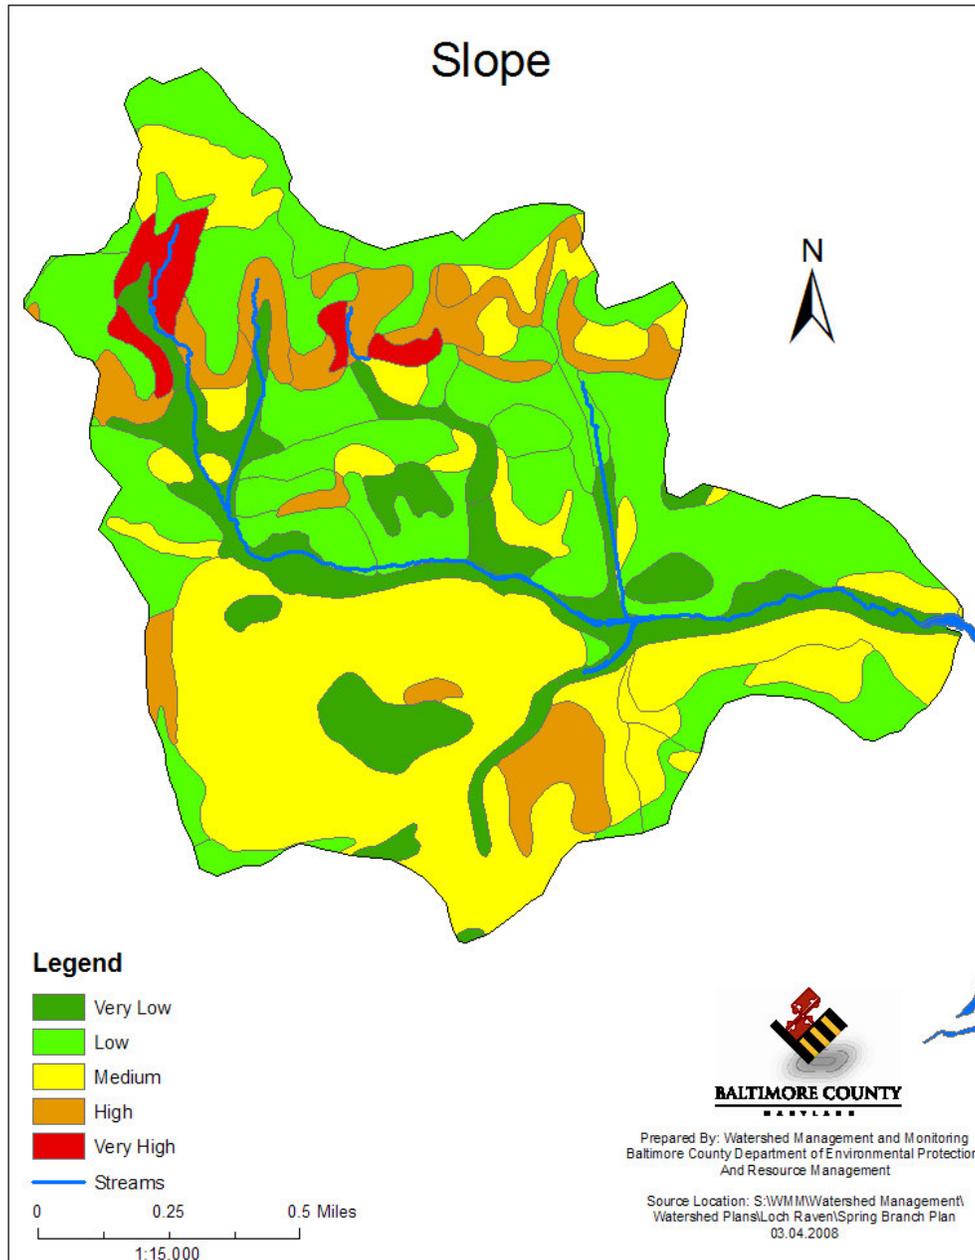
Figure 2-2. Spring branch Subwatershed Topography

The shape of the land, including its steepness and degree of concavity, affect surface water flows and soil erosion, as well as the suitability for development. The Piedmont Region is characterized by rolling hills of varying steepness. Steep slopes are more prone to overland flow and soil erosion, and therefore have a greater potential for generation of pollutants. Table 2-2 displays the results for Spring Branch based on the Baltimore County Soil Survey. Figure 2-2 displays the distribution of the slope categories.

The Spring Branch subwatershed is characterized by moderate to steep slopes throughout most of the subwatershed. A band of high to very high slopes occurs in the upper portion of the subwatershed (Figure 2-2). This is a result of the uplifting associated with the Texas Dome geological feature. The top of the dome (above the band of steep slopes) is relatively flat, as is the base of the dome. The steeper slopes in the upper portion of the watershed provide additional energy to the stream flow due to the steeper nature of the stream channel. This can result in greater erosion of the channel after development has occurred.

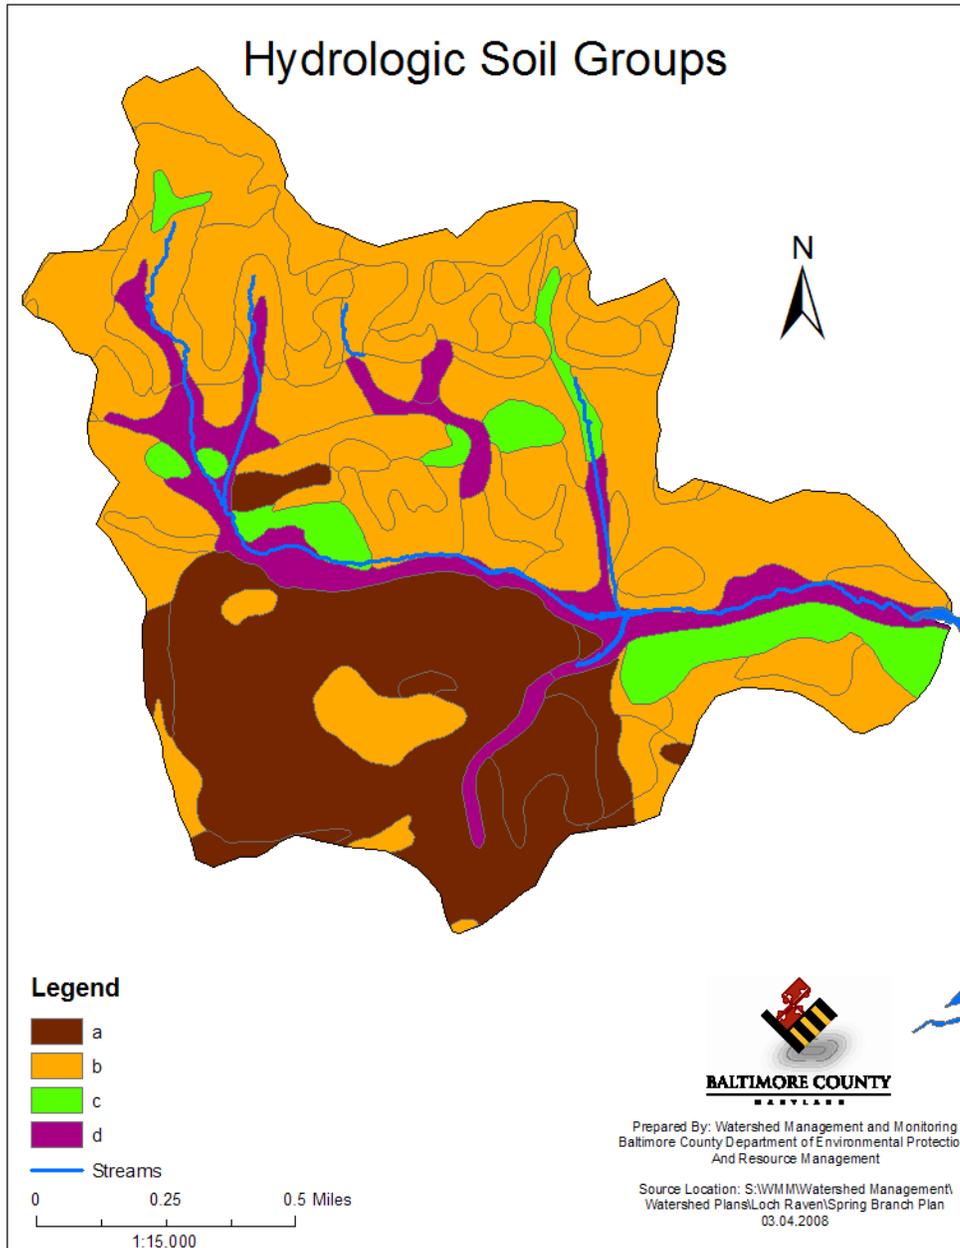
**Figure 2-3. Spring Branch Subwatershed - Hydrological Soil Groups**

Spring Branch subwatershed hydrologic soil group distribution is displayed in Figure 2-3 and in Table 2-3. Spring Branch soils are dominated by soil types that provide high to moderate infiltration rates. The low to very low infiltration rates are associated with soils that lie along the stream system where the high water table limits infiltration rates.

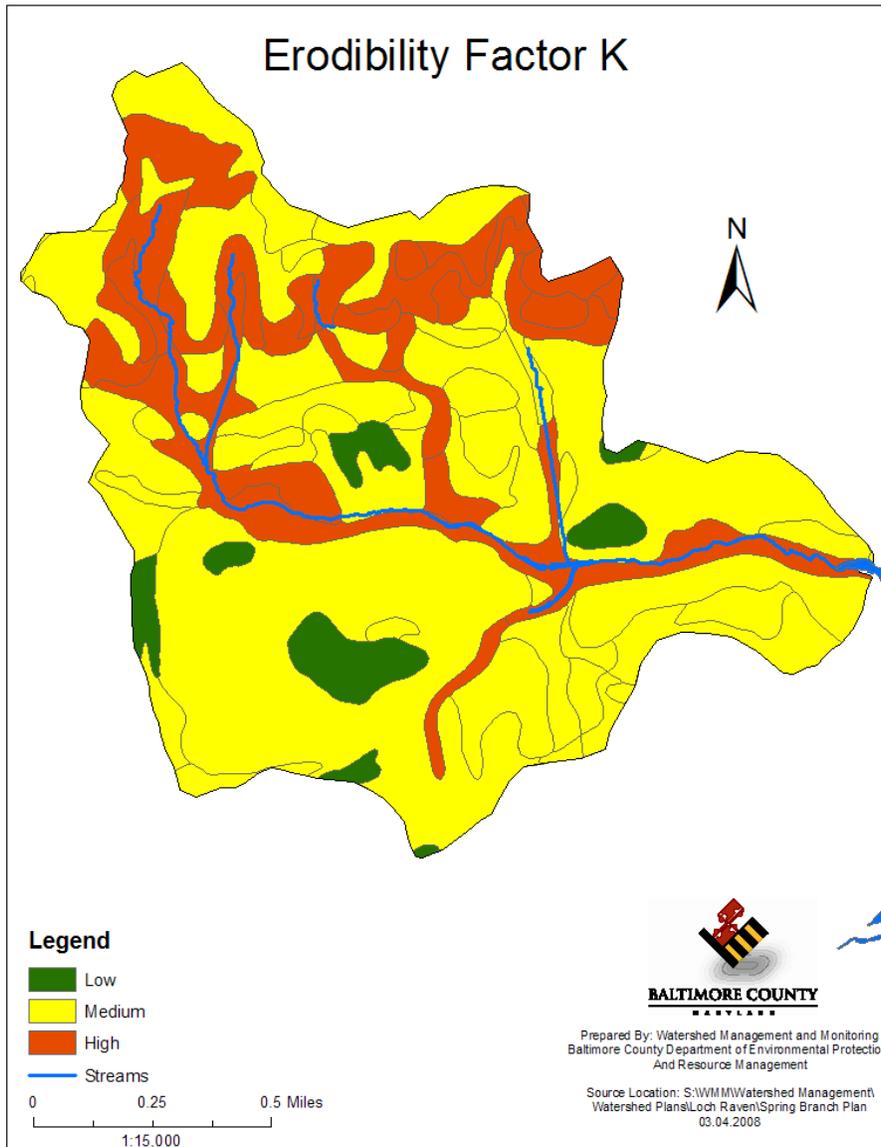
**Figure 2-4. Soil Erodibility based on the K factor**

The erodibility of the soil is its intrinsic susceptibility to erosion. It is one factor (known as the K factor) in the Universal Soil Loss Equation, which estimates the rate of erosion at an actual site. Erodibility is based on the physical and chemical properties of the soil, which determine how strongly soil particles cohere with one another. Figure 2-4 shows soil erodibility in the Spring Branch subwatershed, and Table 2-4 is the summary erodibility factor. Low erodibility is defined as a K factor <0.24, medium is K between 0.24 and 0.32, and high is K >0.32. These classes are based on groupings in the data that resulted in three classes. They also represent the

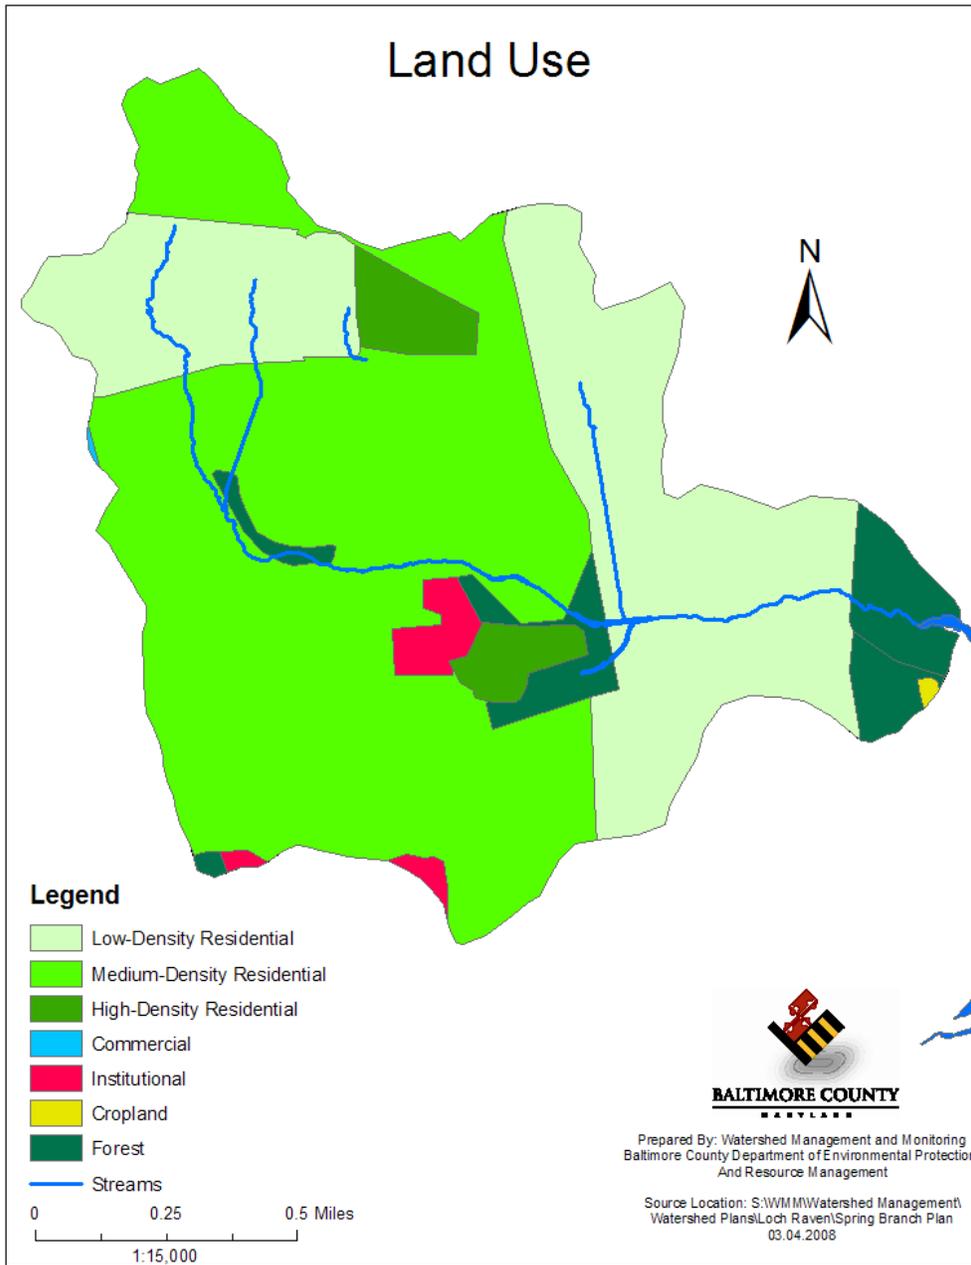
Figure 2-5. Spring Branch Subwatershed – Land Use

Based on MDP 2002 GIS land use data, the Spring Branch subwatershed is predominately urban in nature. Table 2-5 tabulates the acreage by land use category, while Figure 2-5 displays the distribution within the subwatershed.

As can be seen from Table 2-5 the majority of Spring Branch is residential (91.5%) of varying degrees of density, but the bulk of the residential in is the medium density residential category. Forest cover accounts for only 6.7% of the land use, with the majority in the lower portion of the watershed. Forest cover is underestimated based on the land use. There exists an extensive canopy cover as can be seen in Figure 2-6.

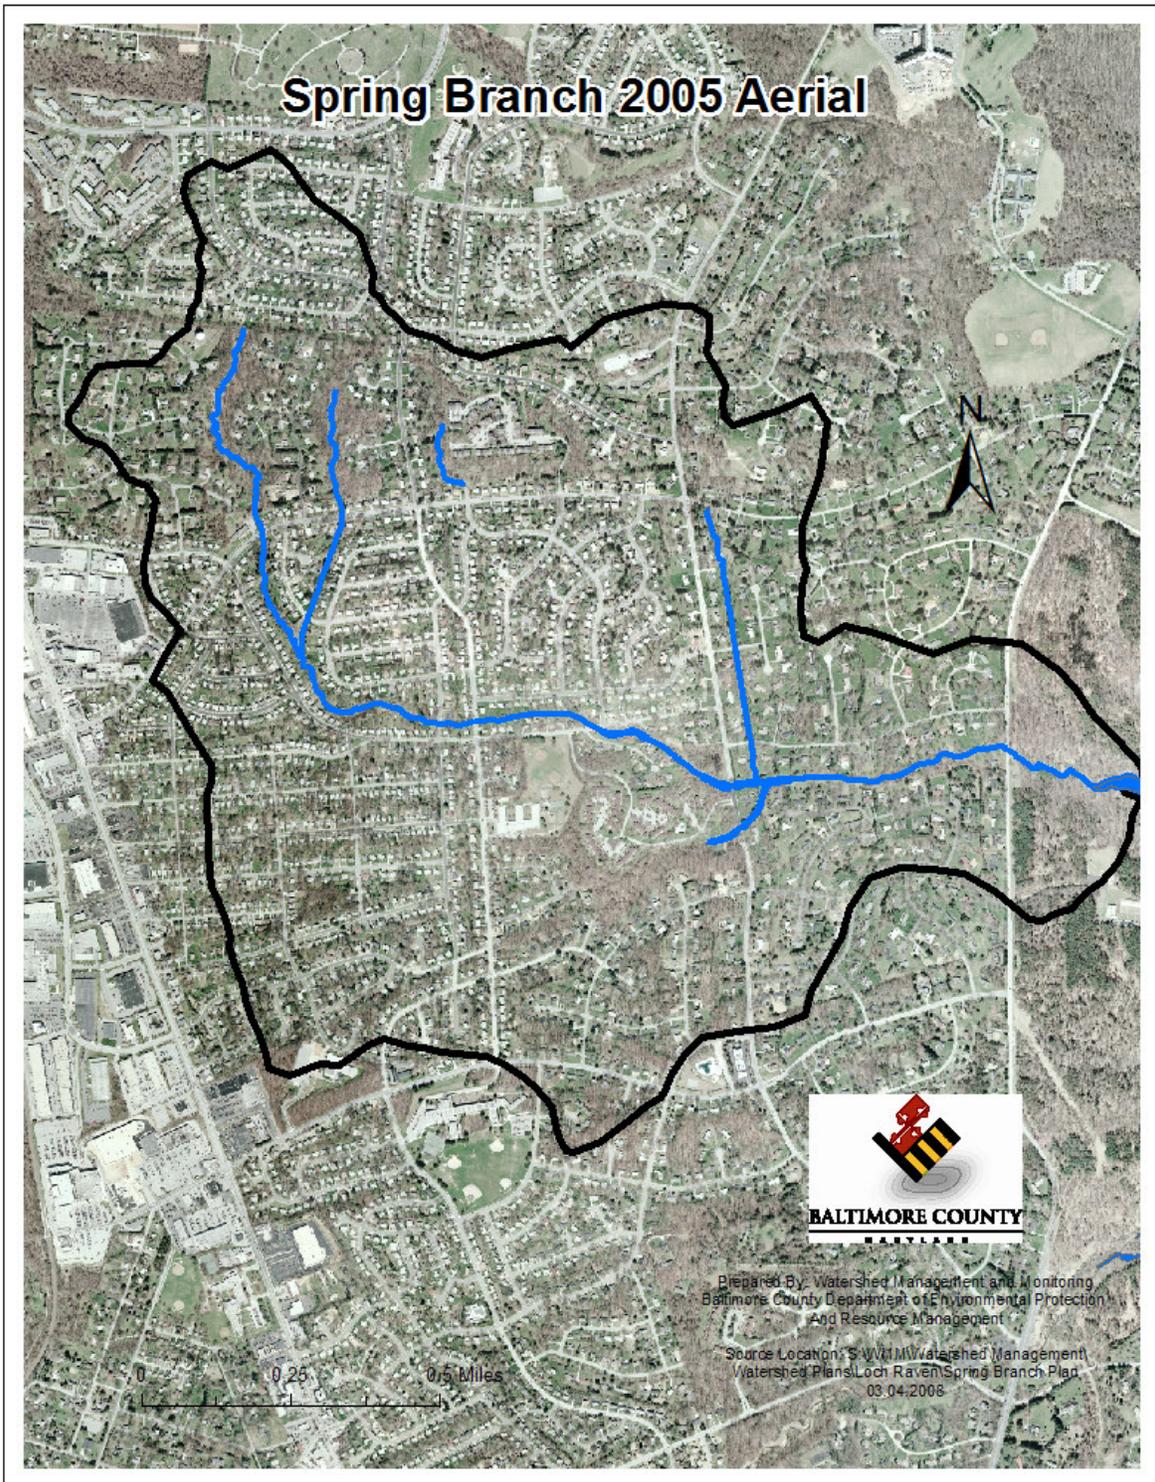
Figure 2-6: Spring Branch Aerial

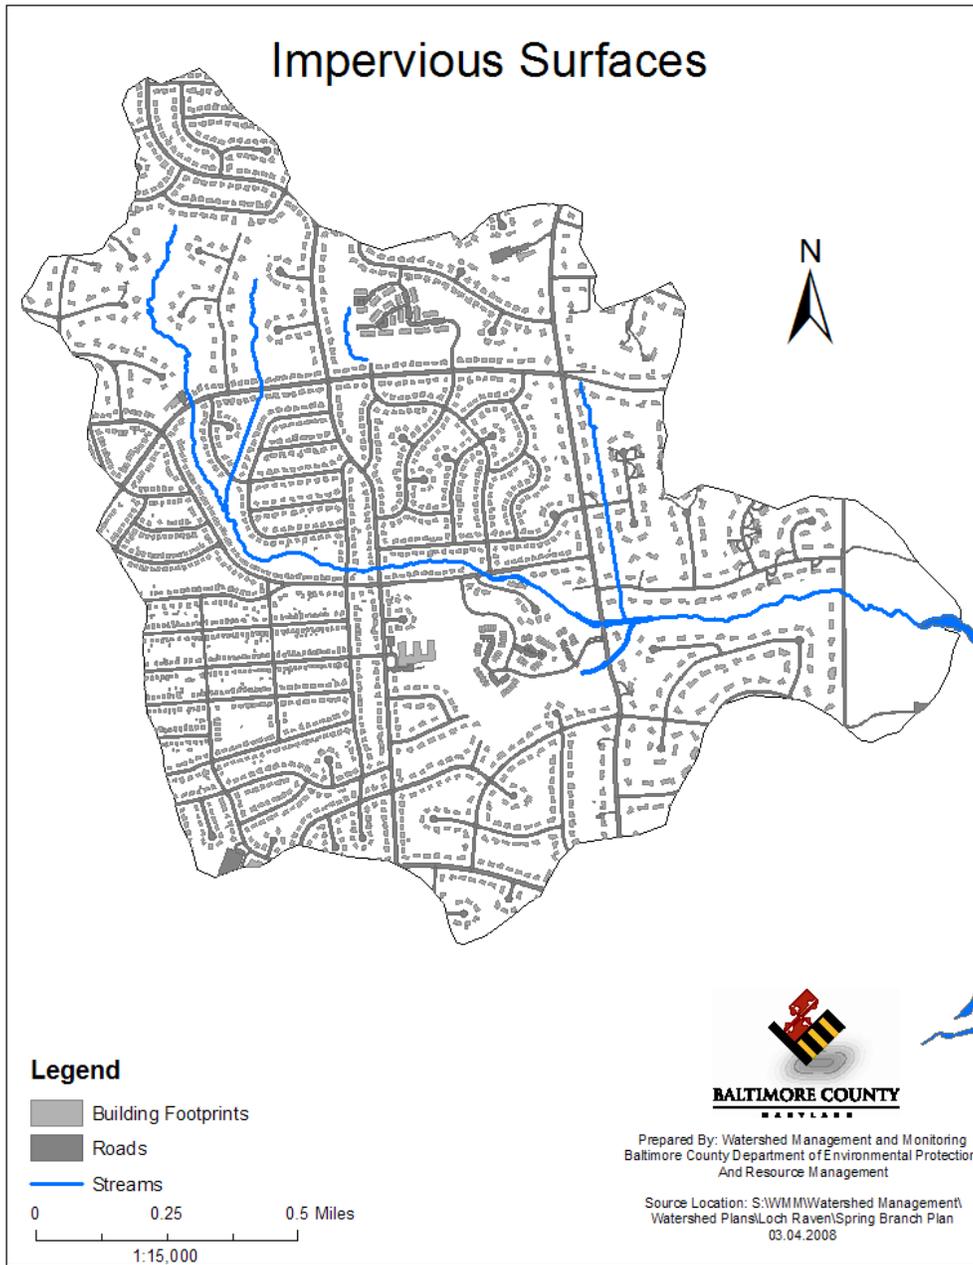
Figure 2-7: Spring Branch Impervious Cover

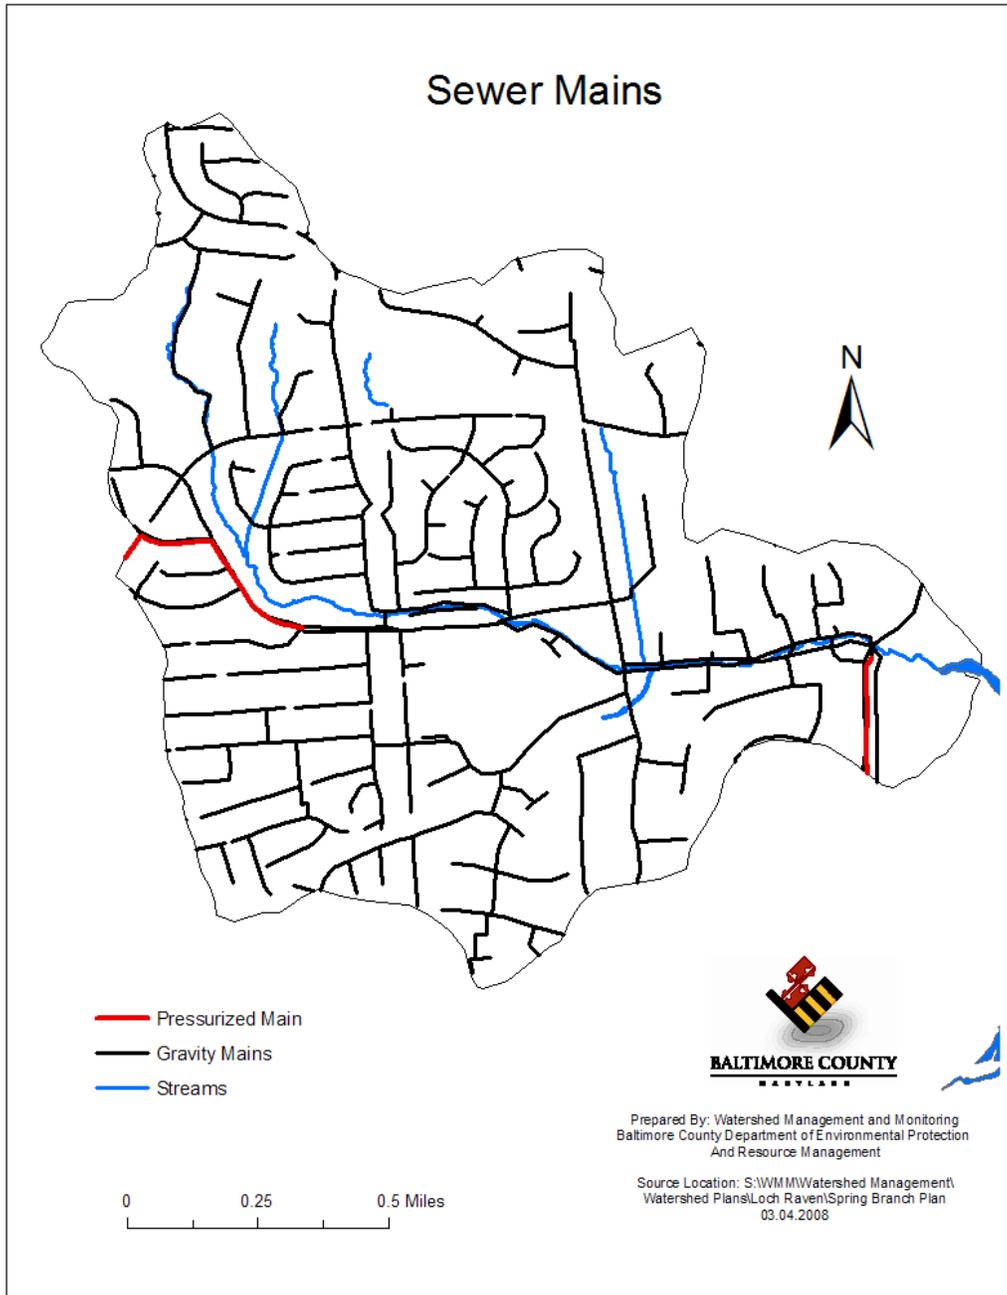
Figure 2-8: Spring Branch Subwatershed Public Sanitary Sewer Line Locations

Within Spring Branch subwatershed there are 22.8 miles of public gravity sewer lines and 0.67 miles of force mains. The locations of these lines are displayed in Figure 2-8. While many of the lines are located in the street right-of-way, there are also lines that parallel the streams system. The lines adjacent to streams are subject of exposure and damage from stream erosion. Prior to the Phase I – Spring Branch stream restoration project, a number of lateral lines were exposed by stream erosion and were leaking sewage into the stream channel. A review of our Sanitary Sewer Overflow (SSO) database indicated that no sanitary sewer overflows occurred in Spring Branch in the time period of 2001 through 2007.

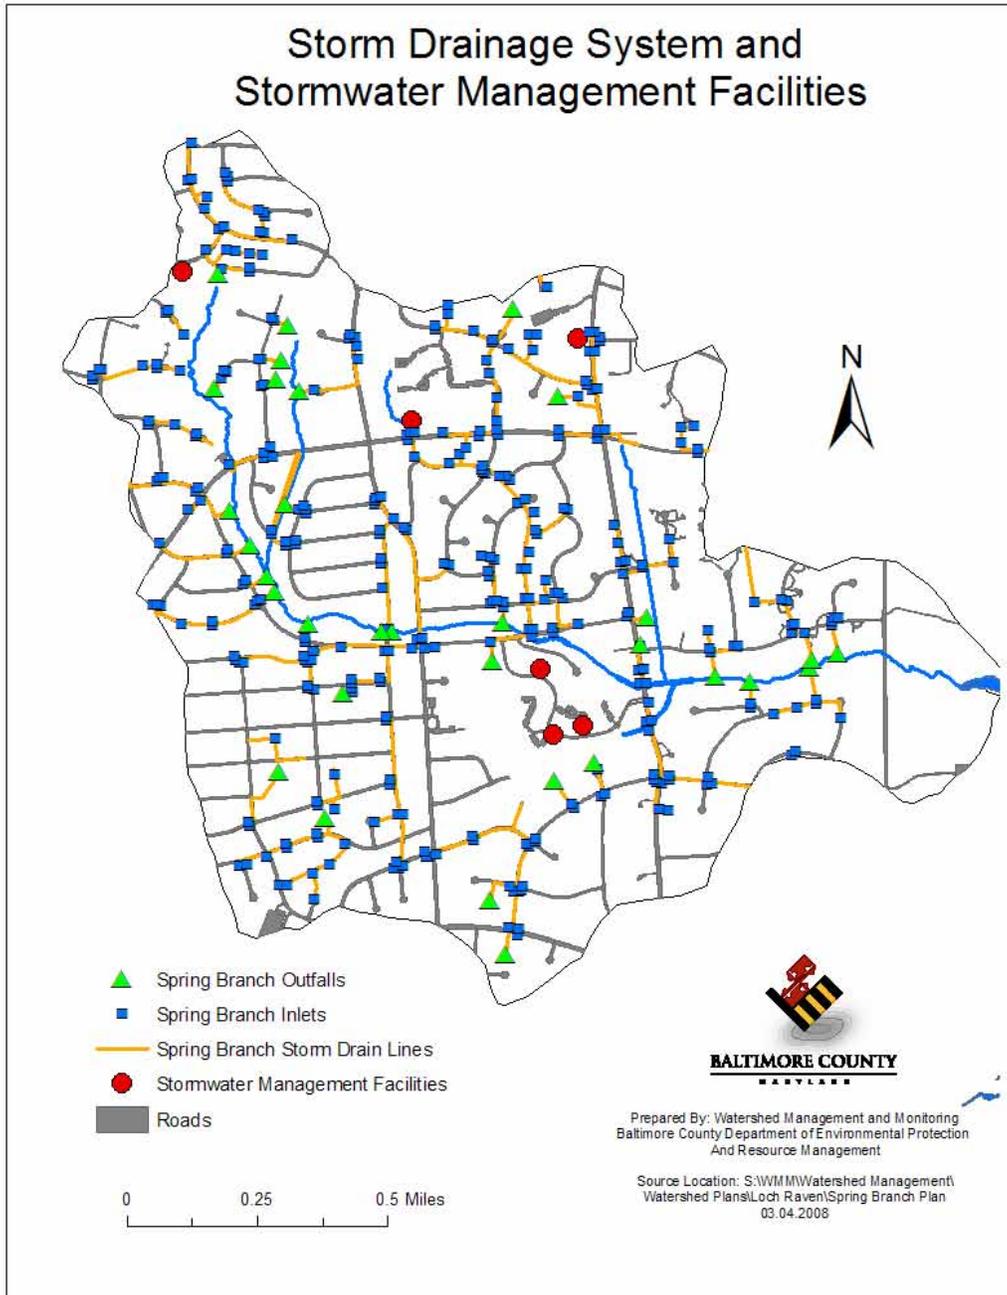
Figure 2-9: Spring Branch Subwatershed Storm Drain System and Stormwater Management

Table 2-7 characterizes the storm drain system within the Spring Branch subwatershed, while Table 2-8 summarizes the information the stormwater management facilities present in the subwatershed. Figure 2-9 shows the distribution of both the storm drain system and the stormwater management facilities.

Drainage to the storm drain system covers 61% of the subwatershed drainage area. This storm drain conveyance provides fast delivery of runoff to the stream during storm events resulting in a quick response to the stream system.

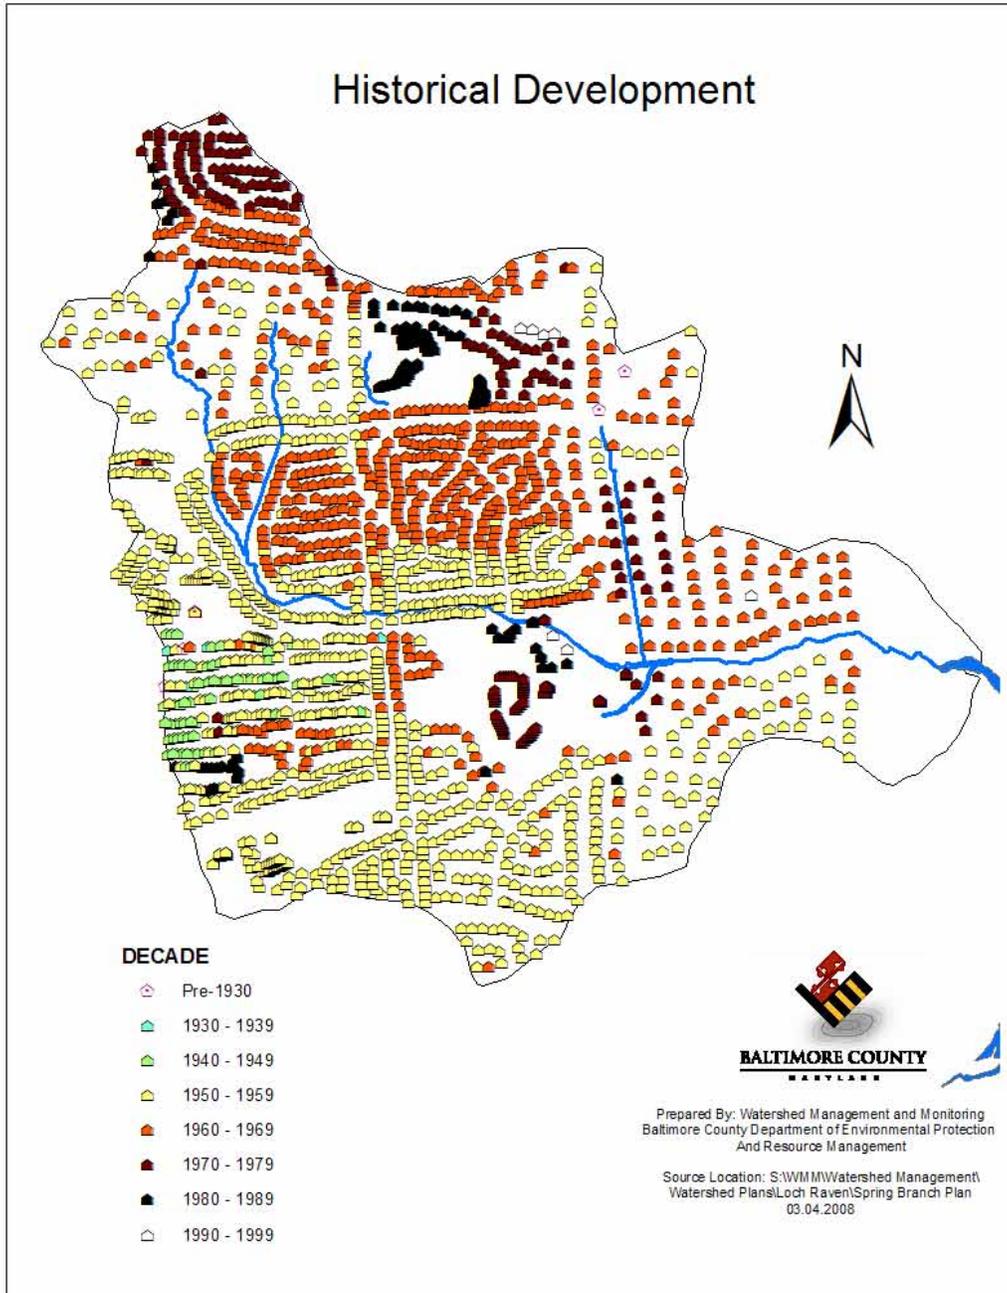
Figure 2-10: Spring Branch Historical Development

Using the tax parcel Geographic Information System data layer, the decade of lot improvement can be determined. Table 2-9 presents the information on when residential development occurred in Spring Branch and Figure 2-10 displays the distribution of residential development by decade.

As can be seen from Table 2-9, the majority of the residential development in Spring Branch occurred in the 1950’s and 1960’s with 79% of the development occurring in those two decades. The 1970’s experienced a decrease in residential development with only 201 units built.

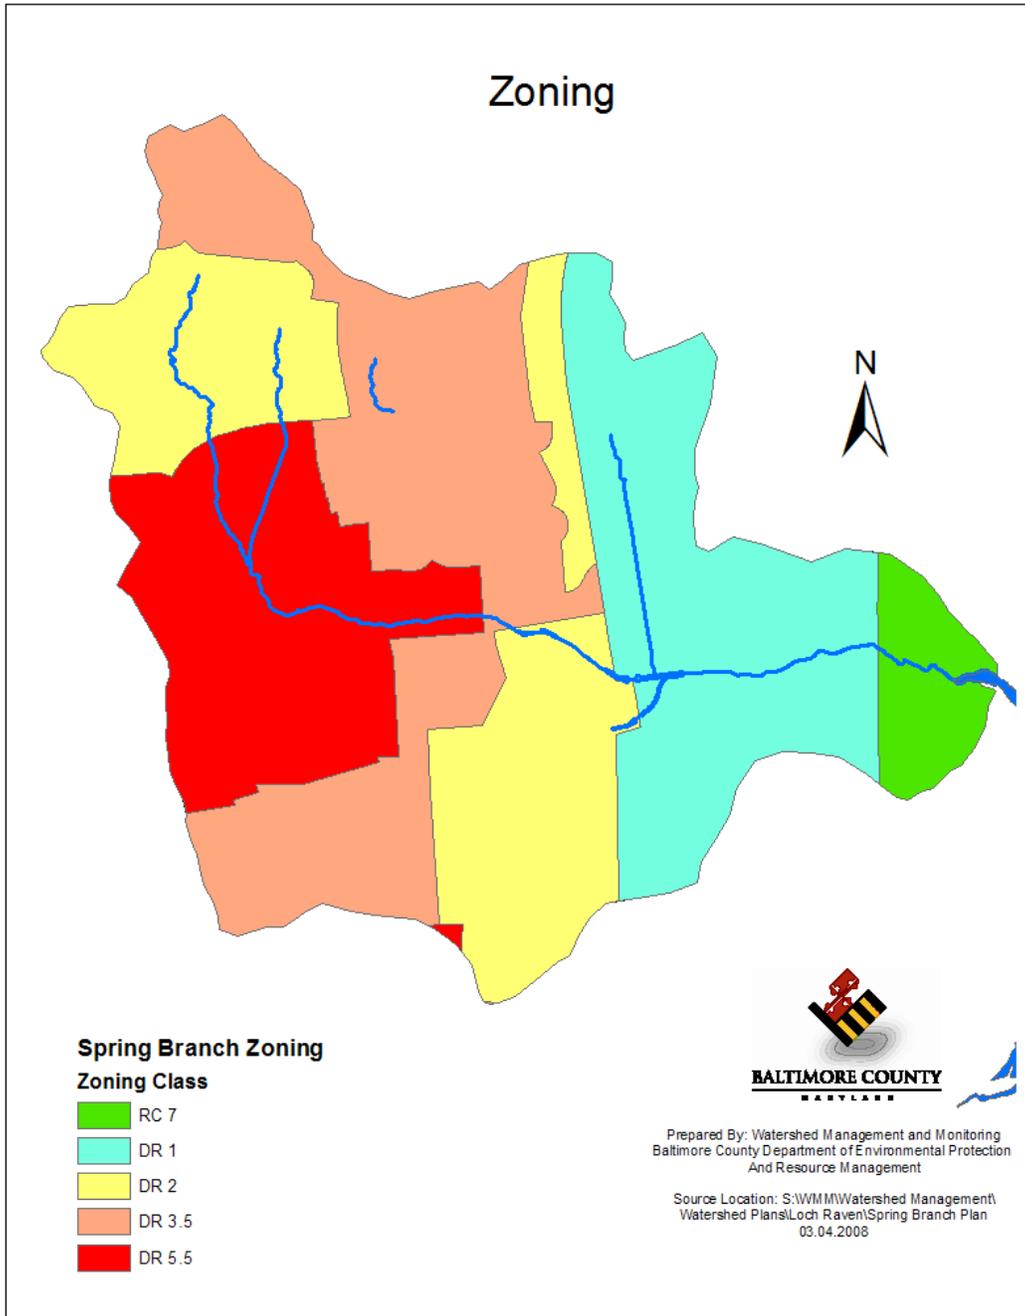
**Figure 2-11. Zoning in the Spring Branch Subwatershed**

The zoning for the Spring Branch subwatershed is strictly residential with varying allowable densities. Table 2-10 presents the acreage by zoning category and the number of allowable residential units based on the acreage. Figure 2-11 displays the distribution of the zoning categories.

Approximately 52% of the subwatershed is zoned for low density residential (DR1, DR2, RC7), while the balance is zoned for medium density residential (DR3.5, DR5.5). A comparison with Table 2-9 on historical development would indicate that an additional 773 residential units can be developed within the subwatershed.

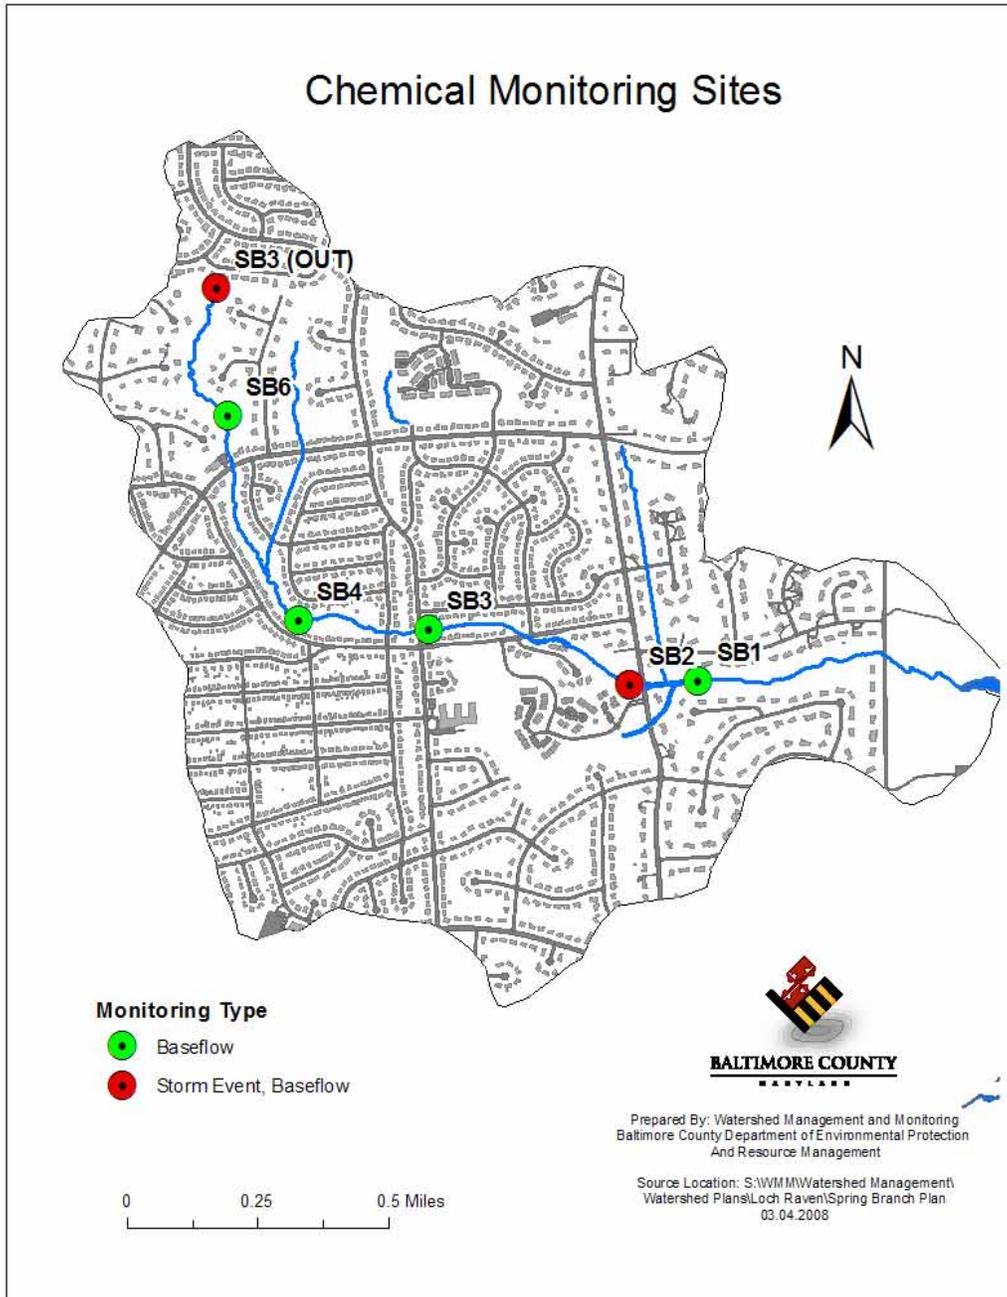
Figure 2-12: Spring Branch Monitoring Locations

time period only the Spring Branch data was used for the comparisons of pollutant load reduction. The Spring Branch monitoring locations are shown in Figure 2-12.

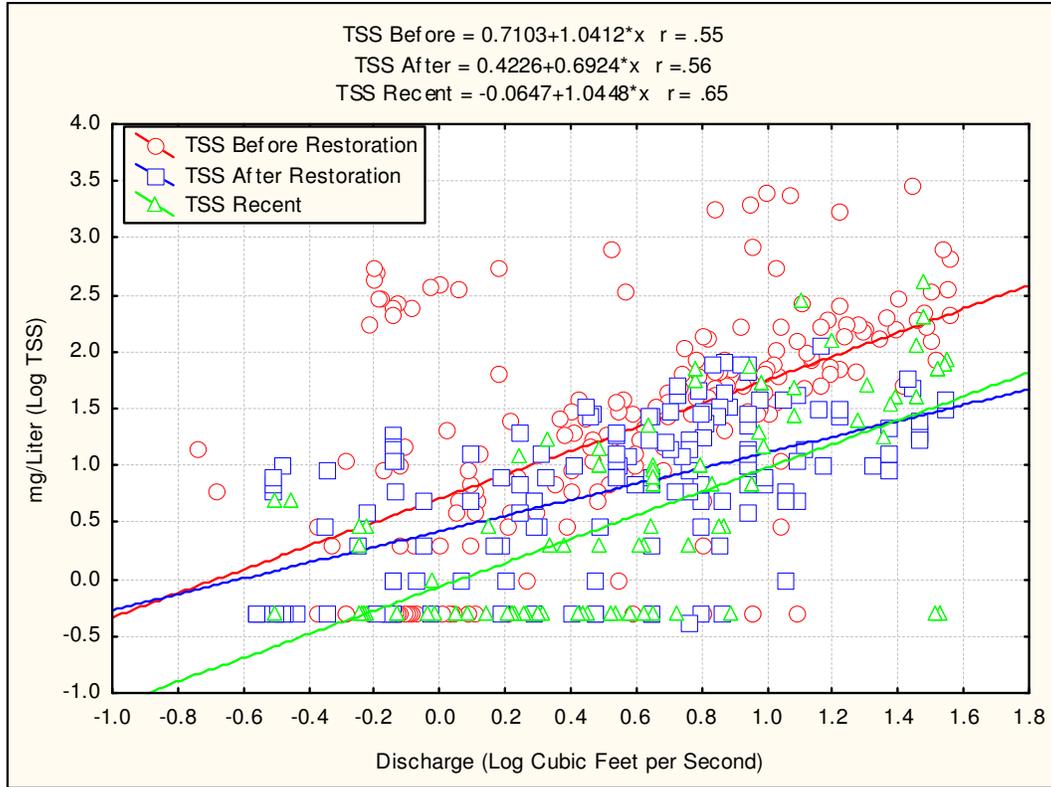
Figure 2-13: Total Suspended Solids (TSS) Data and Regressions for the Three Time Periods.

The analysis included the creation of linear regression equations based on the  $\log_{10}$  transformations of the discharge, suspended sediment, and nutrient data. This resulted in the development of a linear regression equation for each pollutant and each time period. The equations are presented in Table 2-12. The data points and the regressions are shown in Figures 2-13 (Total Suspended Solids), 2-14 (Total Nitrogen), and 2-15 (Total Phosphorus). Each Figure displays three graphs representing the three time periods used in the analysis (pre-restoration, immediate post-restoration, and seven years post-restoration).

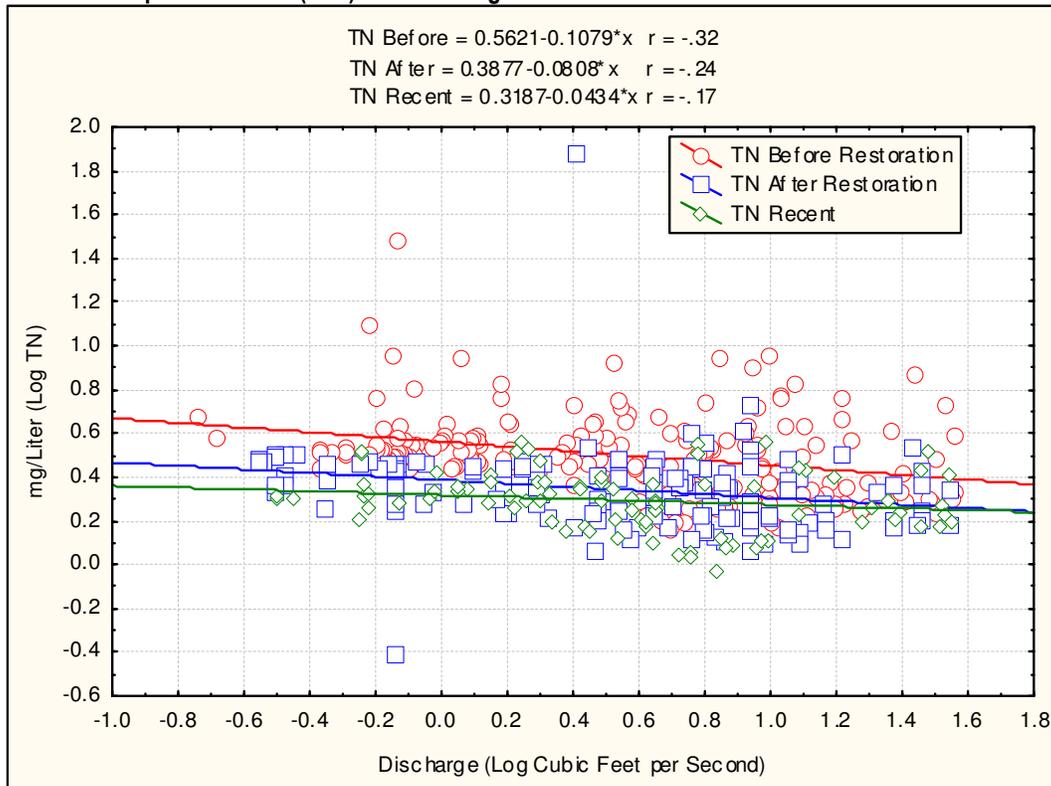
Figure 2-15: Total Nitrogen (TN) Data and Regressions for the Three Time Periods

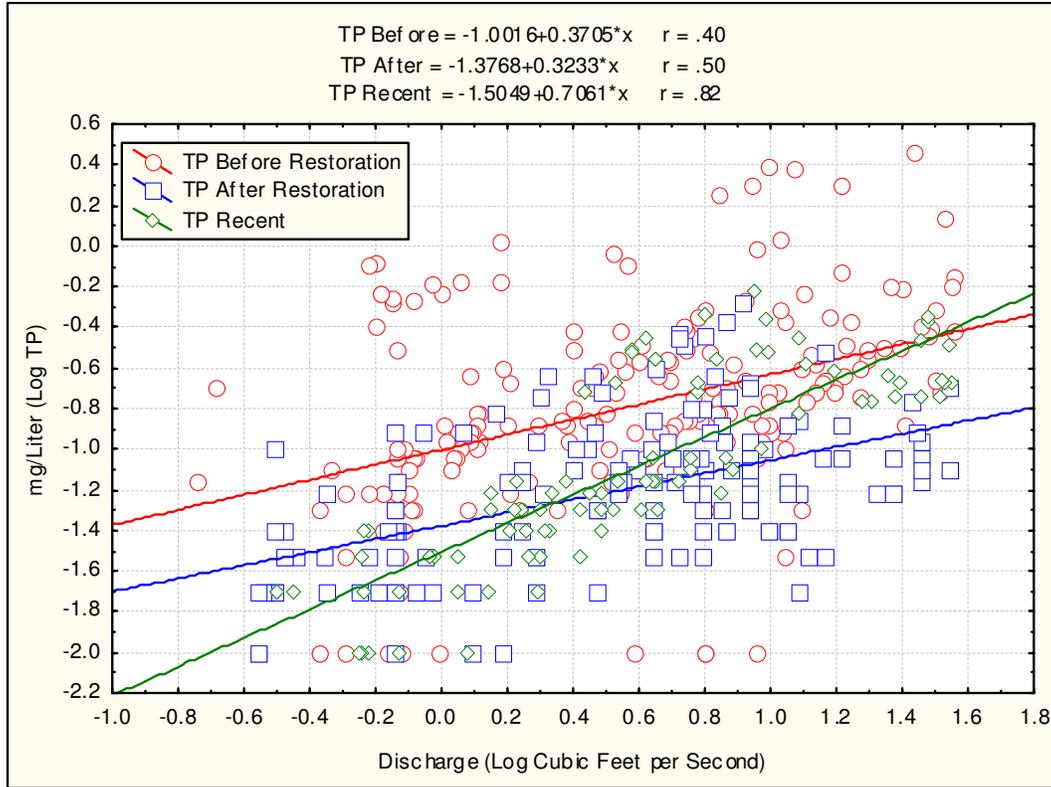
Figure 2-14: Total Phosphorus (TP) Data and Regressions for the Three Time Periods.

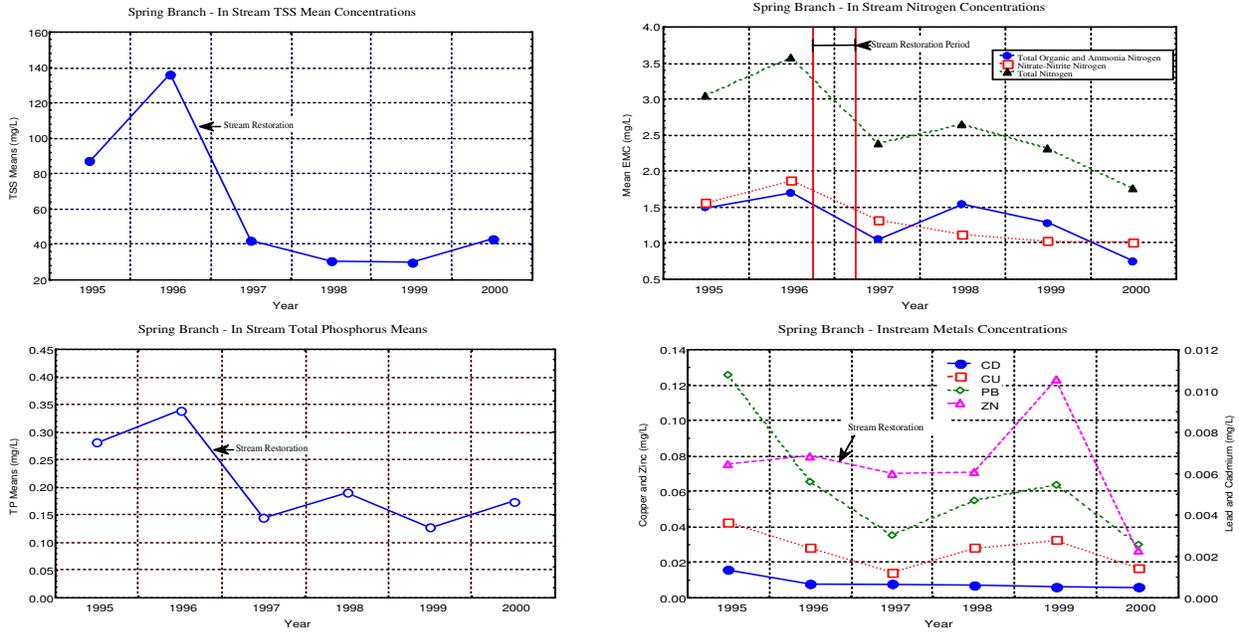
**Figure 2-16: Yearly mean EMCs for the Spring Branch in-stream monitoring site.**

Mean EMC concentration were calculated for the 1995-2000 time period for Total Suspended Solids, Total Nitrogen, Total Phosphorus, and metals (Cd, Cu, Zn, Pb). The results are displayed in Figure 2-16. In the case of TSS, TN, and TP there was a clear decrease in the mean EMC's after stream restoration compared to prior to restoration, while for metals the pattern is not as clear-cut.
