# Spring Branch Subwatershed - Small Watershed Action Plan

(Addendum to the Water Quality Management Plan for Loch Raven Watershed)

Prepared by  
**Baltimore County**  
Department of Environmental Protection and Resource Management  
401 Bosley Avenue, Suite 416, Towson, MD 21204

March 17, 2008

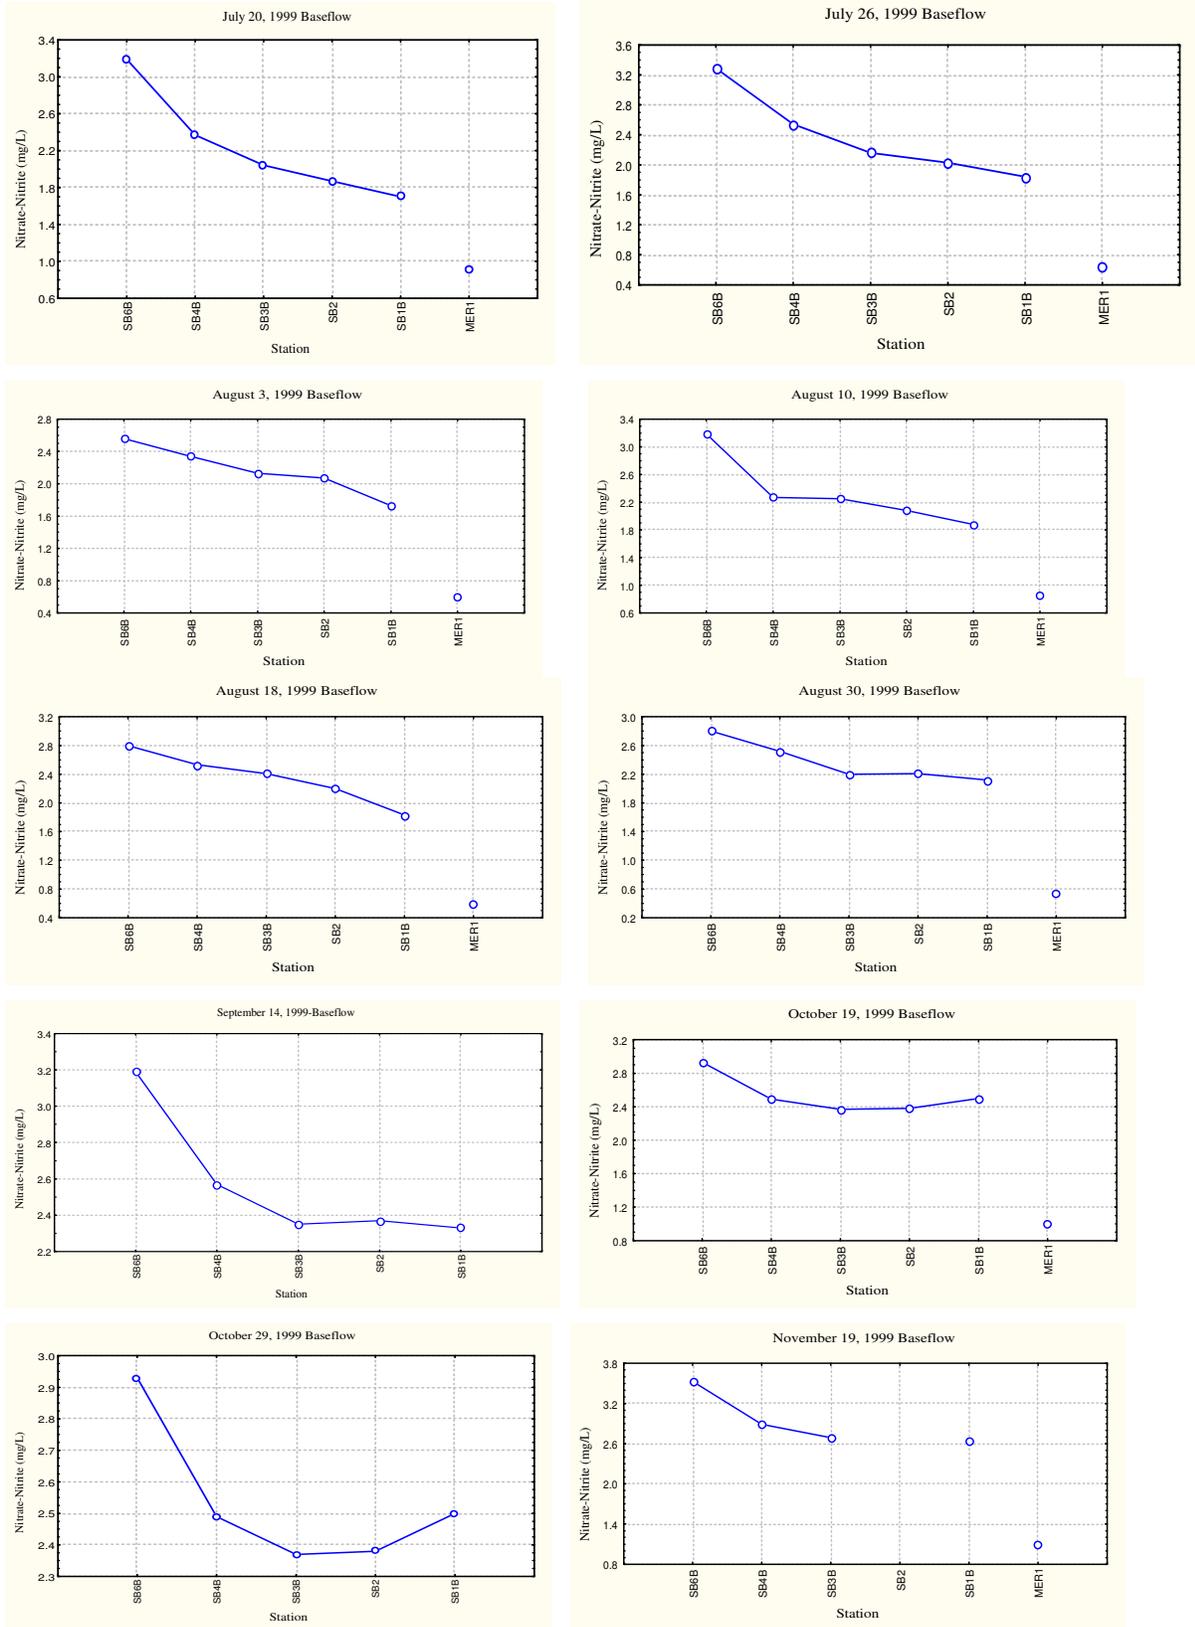
Figure 2-17: Longitudinal Spring Branch Stream profiles for nitrate-nitrite nitrogen concentrations

In 1999, a baseflow analysis was conducted to look at nitrate/nitrite concentrations changes longitudinally as one proceeded down stream. A total of five sites within Spring Branch were sampled on ten different dates. An adjacent subwatershed (Merryman’s Branch) was sampled to provide an outside reference point. The results are displayed in Figure 2-17.

As can be seen from Figure 2-17, the concentration of nitrate/nitrite nitrogen decreased downstream in almost every sampling period. There are several possibilities for the decrease:

Due to staffing limitations, the determination of which mechanism is resulting in lower nitrate/nitrite nitrogen concentrations was not made. The Merryman’s Branch subwatershed site results indicate that the concentration of nitrite/nitrite nitrogen was lower for each sampling date. Merryman’s Branch has high-density urban residential development in the headwaters, but the lower half is forested and in pasture. As with the Spring Branch sites the much lower Merryman’s Branch concentrations could be due to either processing of nitrogen within the stream channel or dilution by input of lower concentration groundwater.

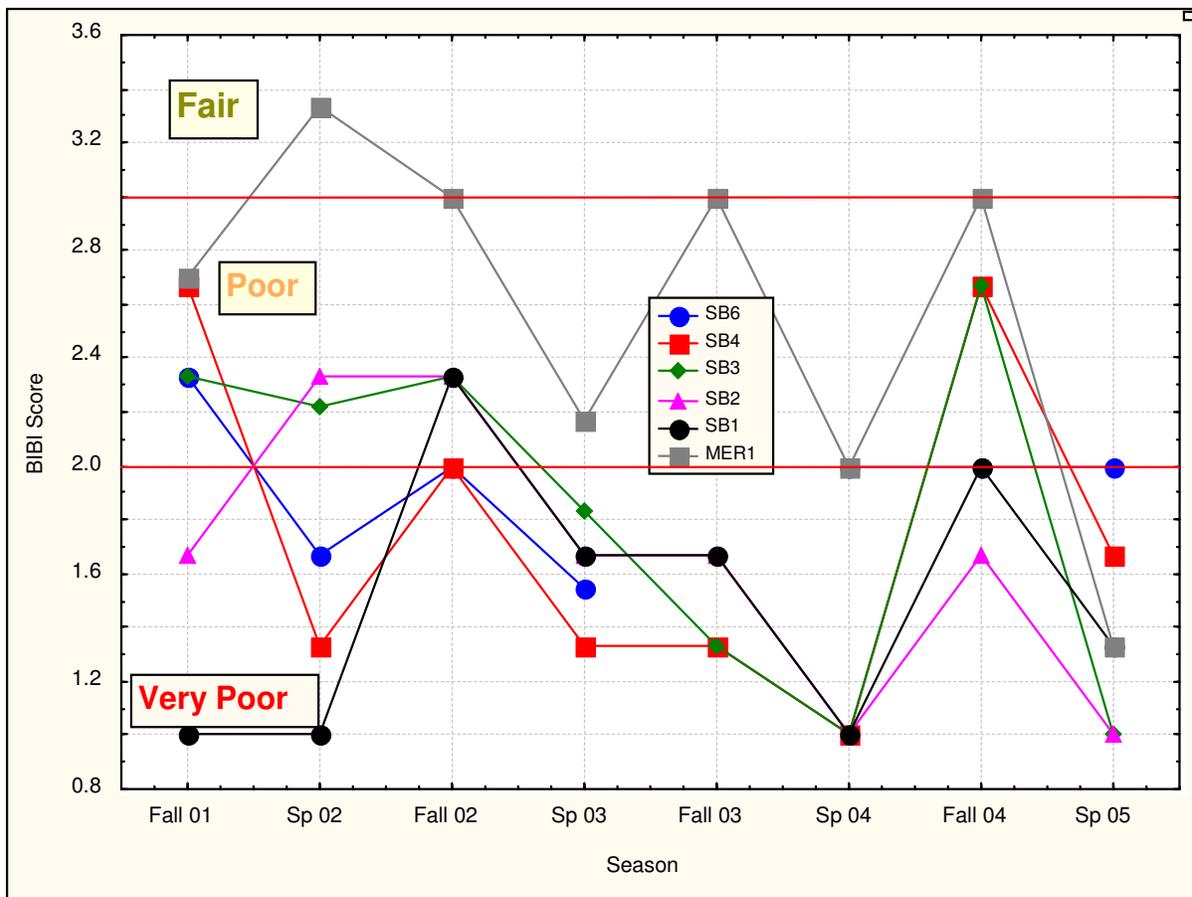
**Figure 2-18: Spring Branch BIBI Scores, Site by Season.**

Figure 2-18 shows BIBI results for each station by the sampling season. The figure shows that there is no consistent pattern of improvement at any of the sites. Merryman’s Branch, the reference site is the only site to achieve a fair rating during the monitoring period, but even that site had excursions into poor ratings. The drought of 2001 and 2002 followed by the third wettest year on record in 2003 could have masked any recovery in the biological community due to stream restoration. The samples from the spring of 2005 were all in the very poor range.

The focus of the Spring Branch biological monitoring project was on improvements in the benthic macroinvertebrate community as a result of the stream restoration that was completed in February 1997. The research design includes three stations within the restoration area, one site below the restoration area and a reference site in Merryman’s Branch (Figure 2-12). Samples have been collected since the spring of 1997 until the spring of 2005. Until Fall 2003 sampling was conducted using a Surber sampler with three replicates collected at each riffle station. For the Fall 2003 monitoring and subsequent monitoring seasons sampling was conducted using the MBSS sampling protocols using a D-net. One D-net sample was collected at each of the monitoring sites, where previously three replicate Surber samples were collected. This change was necessitated by the amount of staff time needed to sort each individual Surber sample. Greater detail on the research design has been included in earlier reports. The results for the time period of 2001 through 2005 are displayed graphically in Figure 2-18 and 2-19.

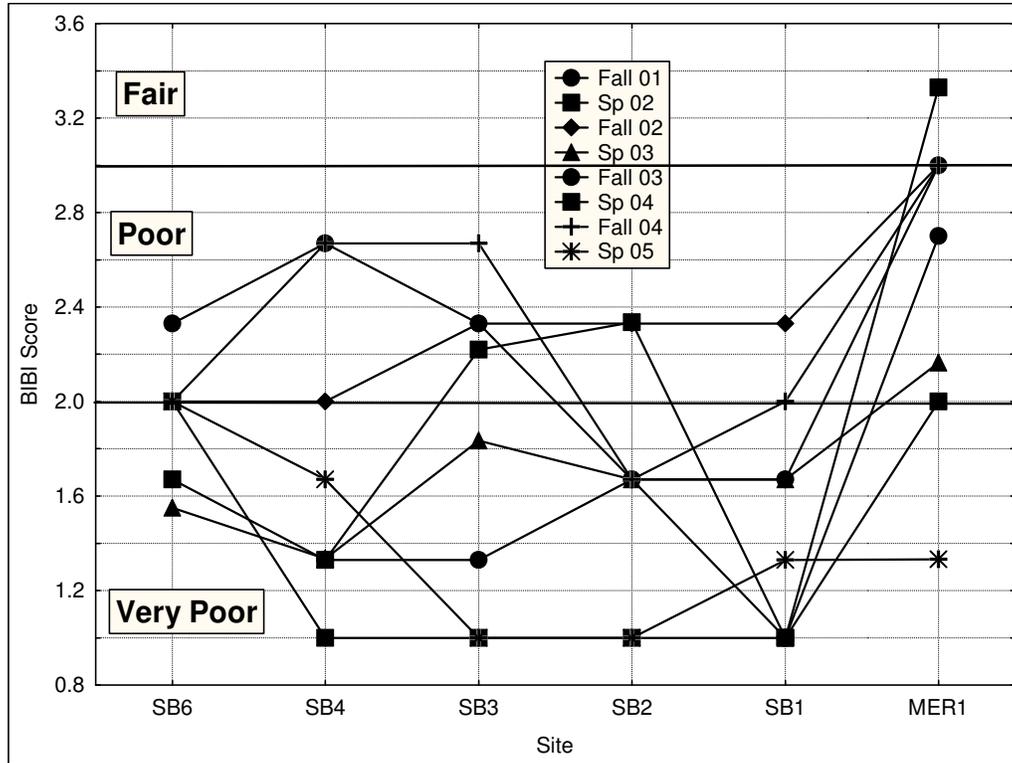
Figure 2-19 displays the changes at each site over the sampling period. SB1, the site below the restored reach was consistently rated as very poor by the BIBI scores. Sites within the restored reach ranged from poor to very poor, but scored better than SB1 with the exception of spring 2003. Merryman’s Branch was rated higher during most seasons, but was below SB6 in the fall of 2001.

Figure 2-19: Spring Branch BIBI Scores, Season by Site.

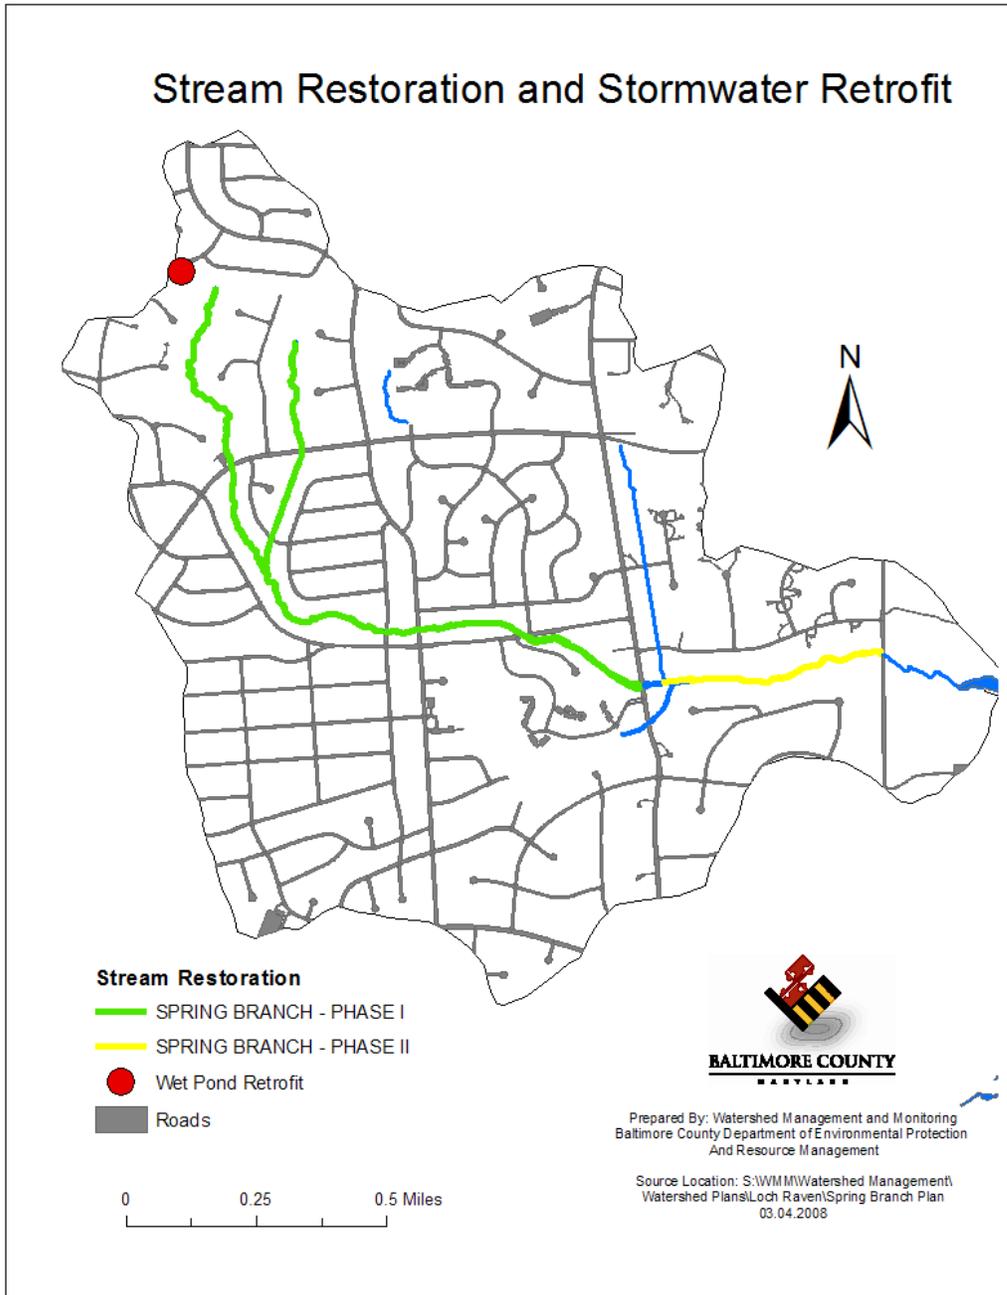
Figure 4-1: Spring Branch Subwatershed Restoration Projects

In early 1997 the Baltimore County Department of Environmental Protection and Resource Management (DEPRM) completed the restoration of approximate two miles of Spring Branch (Phase I) along with the creation of associated wetlands and construction of storm drain outfall retrofits to provide storm flow attenuation and water quality enhancement. In 2008, the Lower Spring Branch Stream Restoration Project (Phase II) will be completed. Phase II will restore approximately 2,500 linear feet of Spring Branch between Dulaney Valley Road and Pot Spring Road by creating a stable channel using natural stabilization techniques.

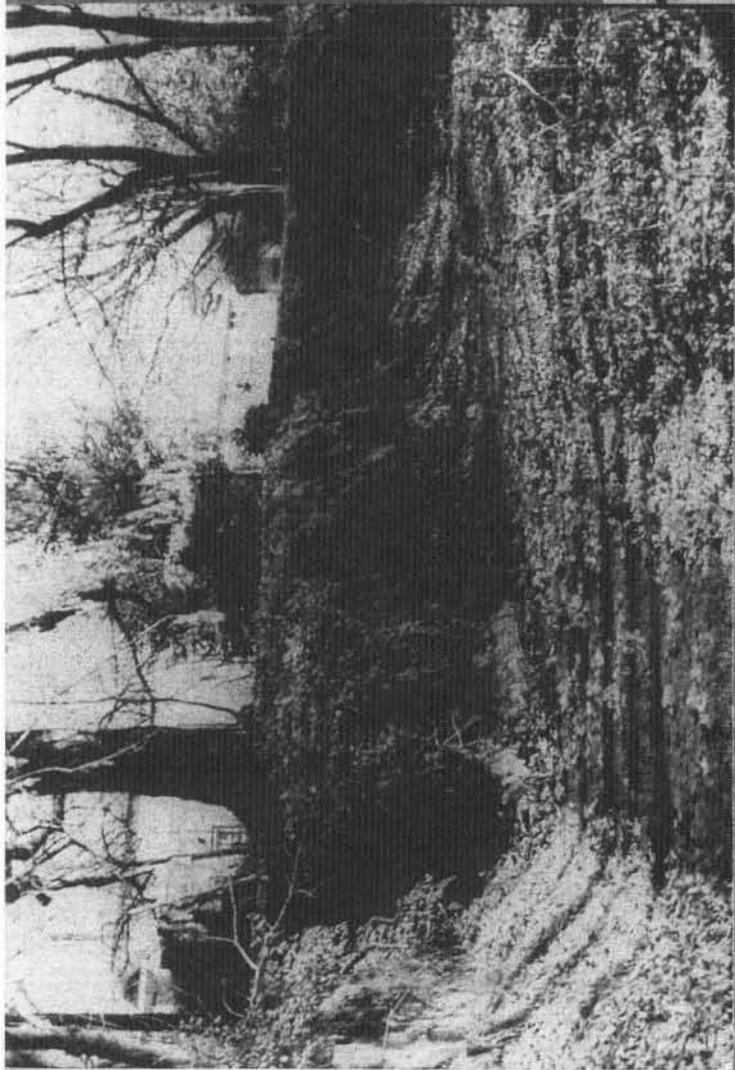
**MAIN STEM AT  
CONFLUENCE**

**BEFORE AND AFTER**

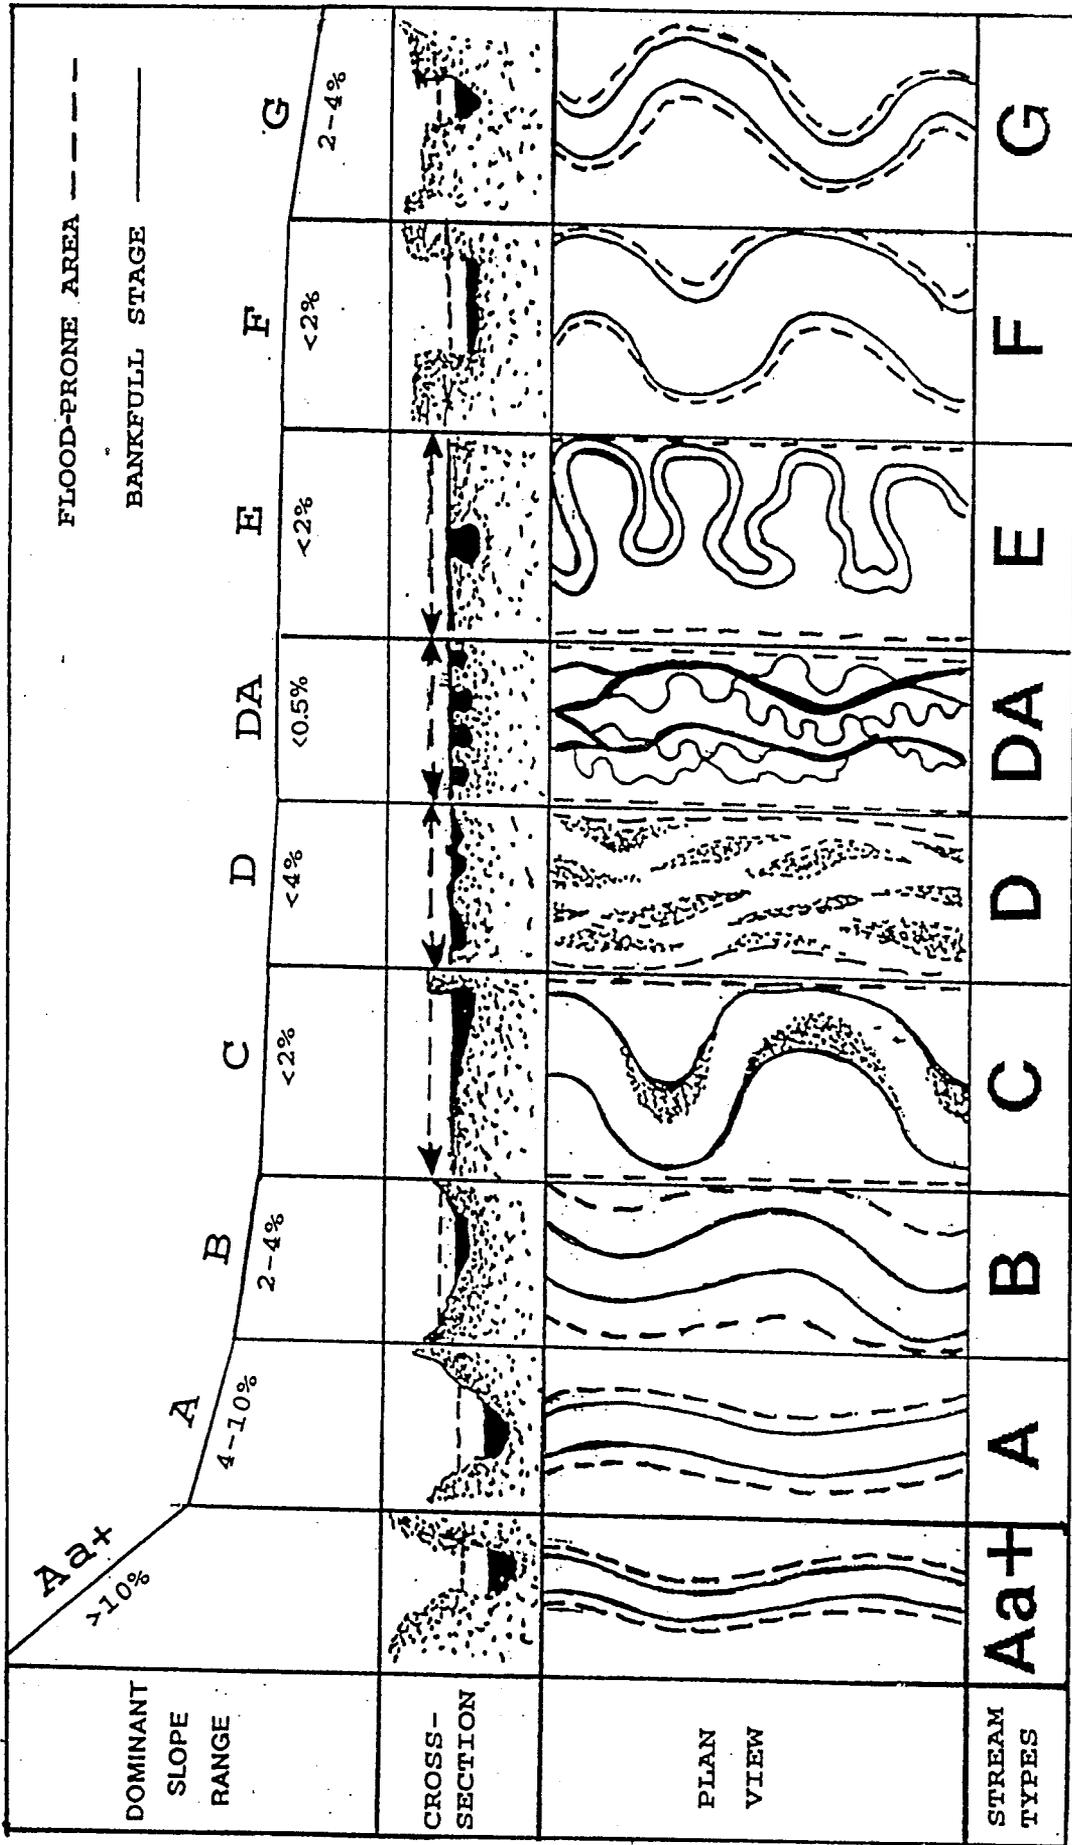
# STREAM CHANNEL TYPES

SOURCE: ROSGEN, 1993

Figure 1.1	Project Location .....	3
Figure 2.1	Stream Channel Types .....	6
Figure 2.2	Bank Erodibility Factors .....	9
Figure 3.1	Study Area .....	16
Figure 3.2	Erosion Potential Ratings .....	25
Figure 3.3	Sequence of Channel Changes .....	26
Figure 4.1	Proposed Sewer Lateral Restoration .....	39

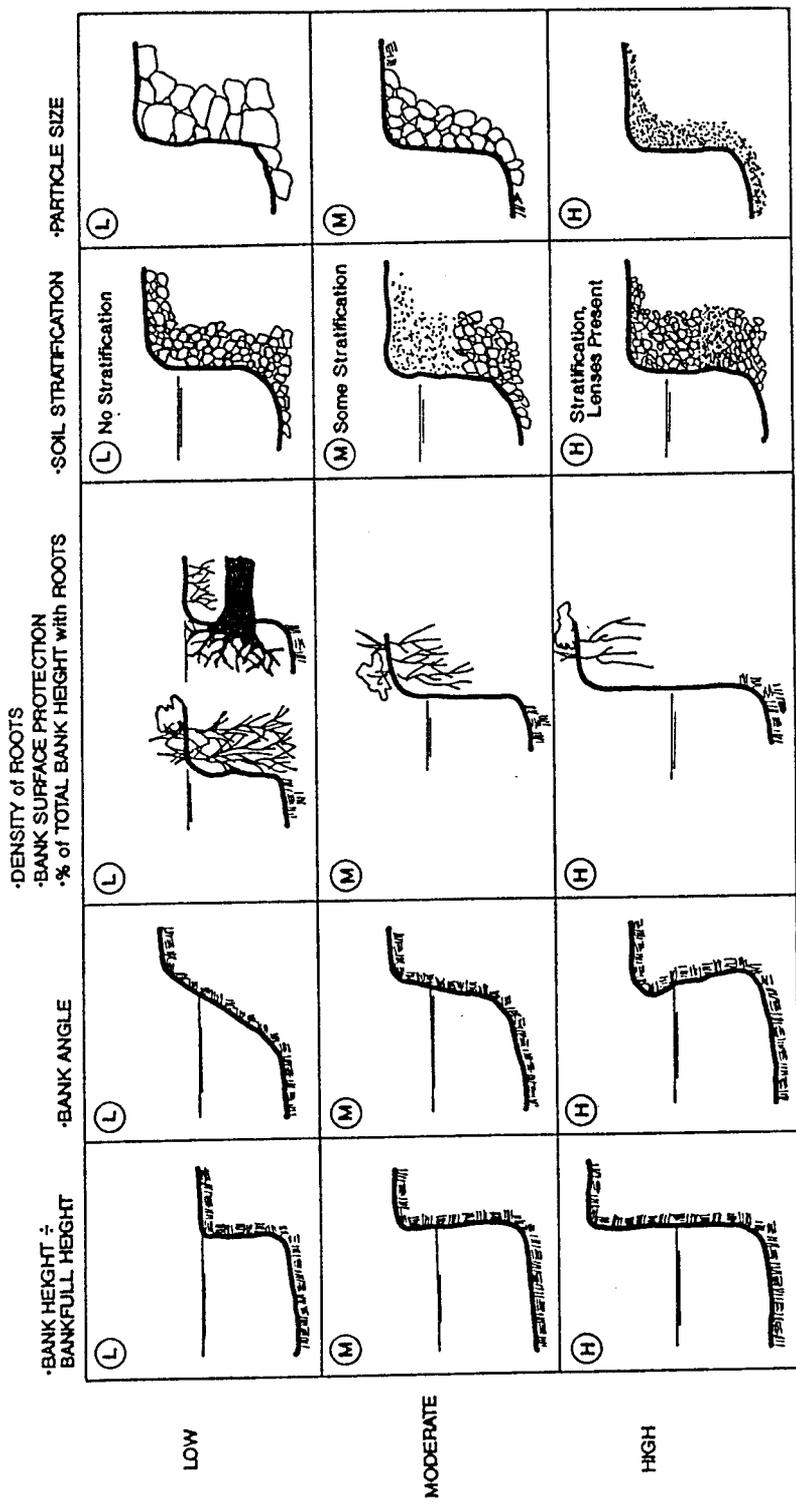
SOURCE: ROSGEN, 1993

Stream channel banks and outfall areas were assessed to identify areas of top of bank, toe, and full bank erosion. A visual assessment of bank conditions was performed using stream bank erodibility factors and erosion potential ratings after Pfankuch (1975) and Rosgen (1993) and are shown in detail in Figure 2.2. - Bank Erodibility Factors. Field data sheets documenting bank erosion are contained in Appendix E - Field Data Sheets,

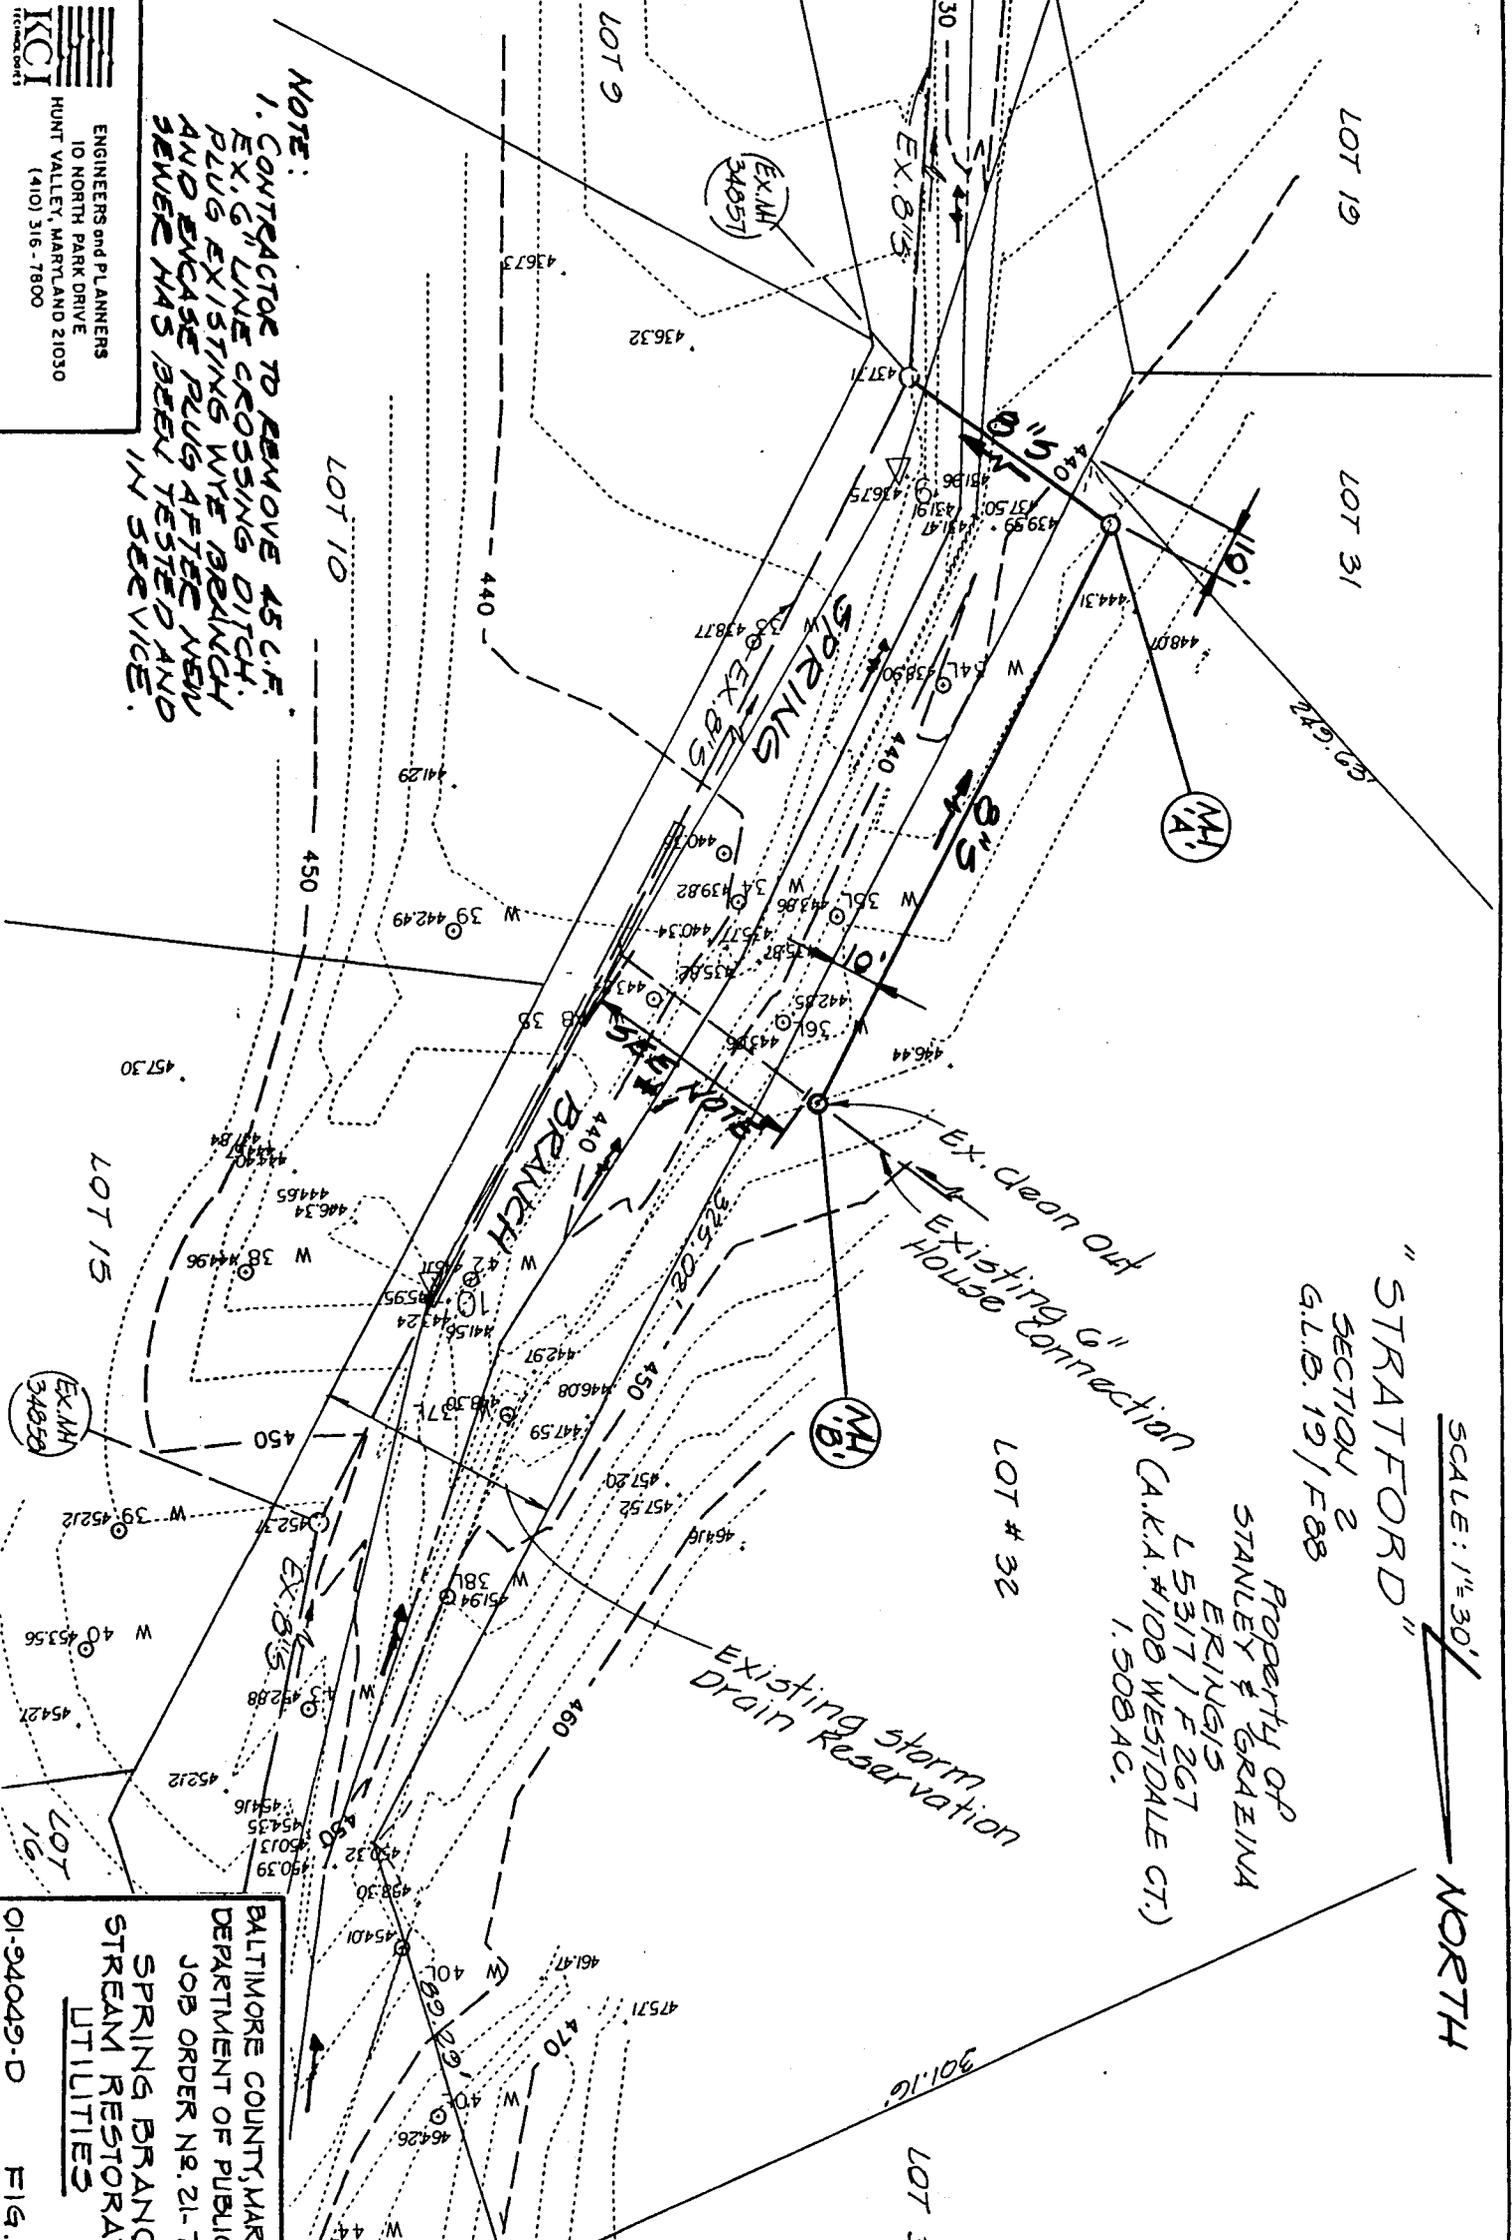
1. CONTRACTOR TO REMOVE 45 C.F. EX. G<sup>1</sup> LINE CROSSING DITCH. PLUG EXISTING WYE BRANCH AND ENCASE PLUG AFTER NEW SEWER HAS BEEN TESTED AND IN SERVICE.

An existing sanitary lateral connection serving Stratford Lot #32, 108 Westdale Court, is located between sanitary manholes 34857 and 34858. This sanitary lateral connection is an aerial crossing which impedes the stream flow by catching storm debris. The force of the stream acting on the lateral connection has caused several pipe joints to open, resulting in sanitary discharge to the stream. Temporary shoring of this line is required to eliminate the discharge. Permanent solutions are proposed in Section 4.0.

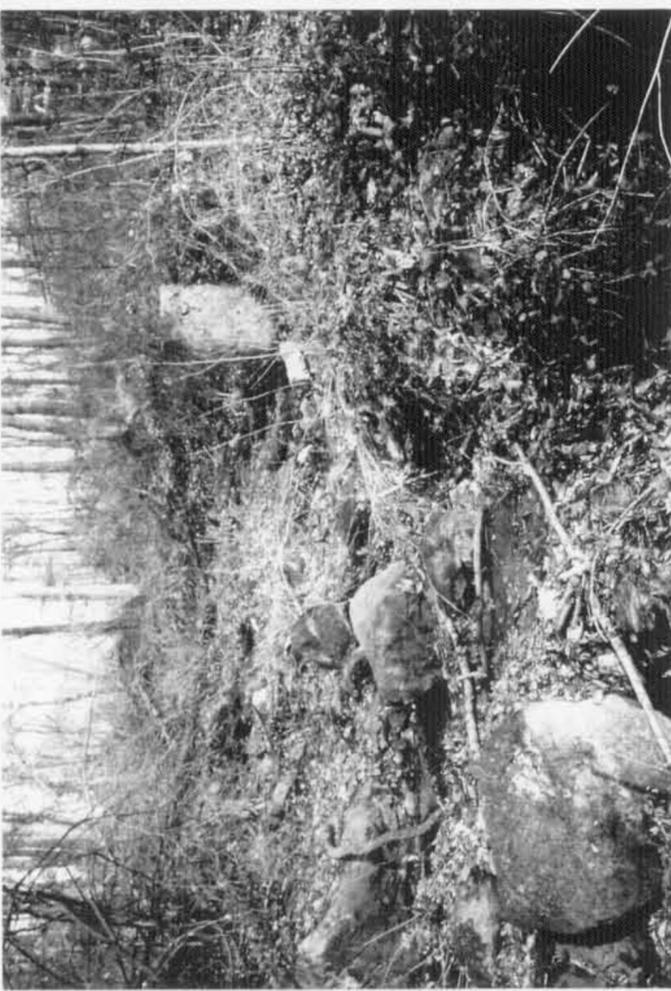
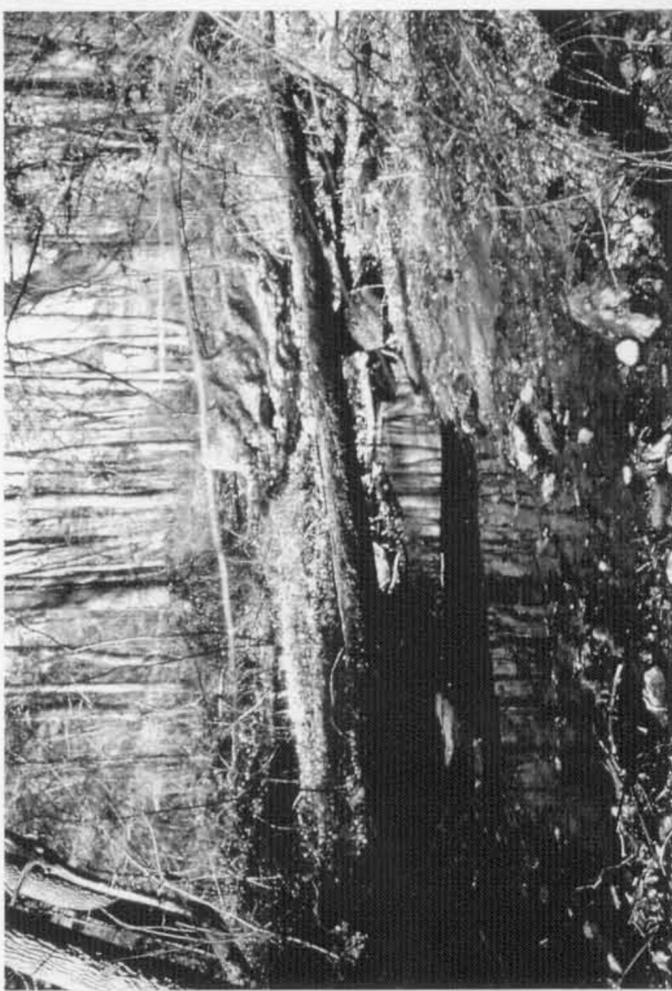
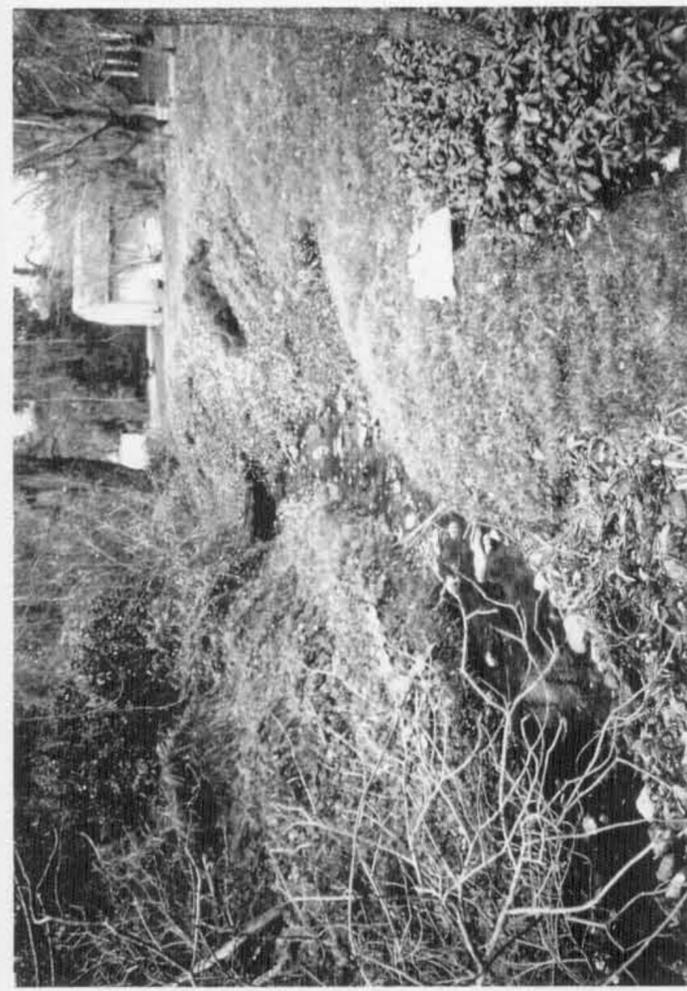
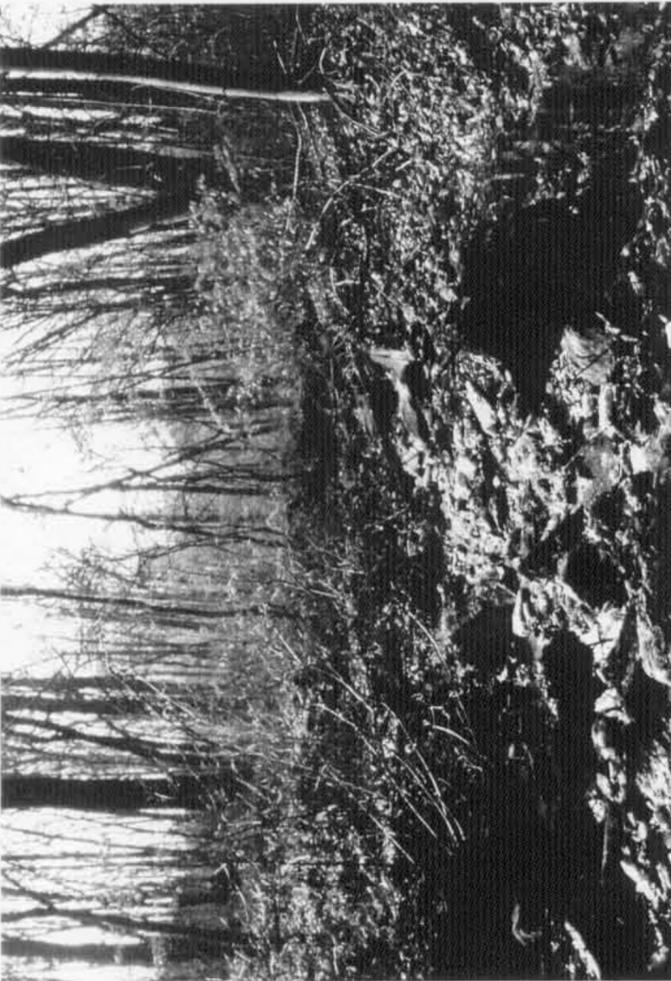
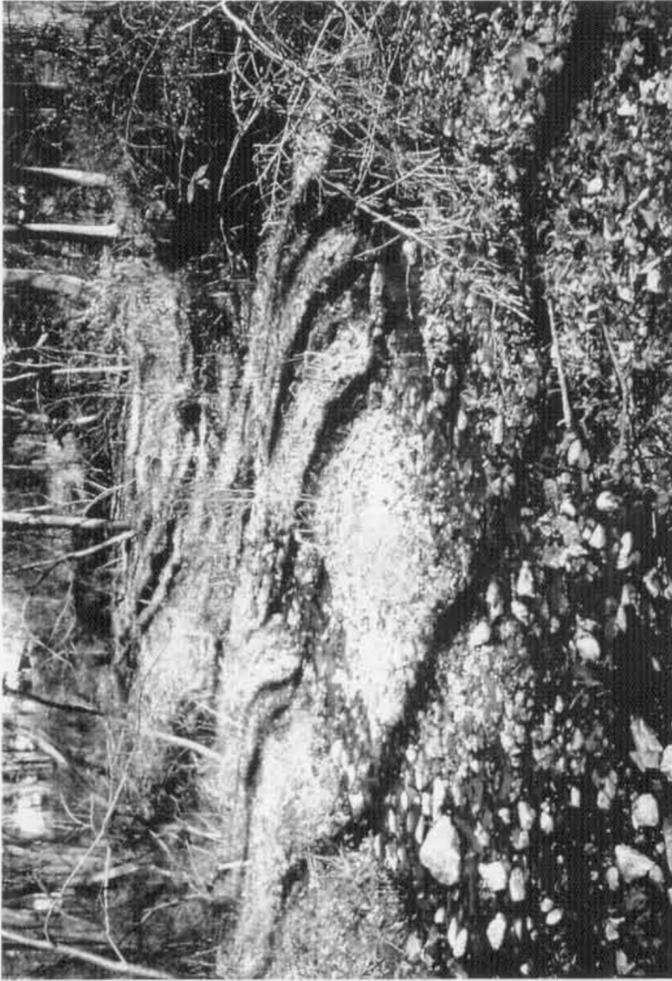
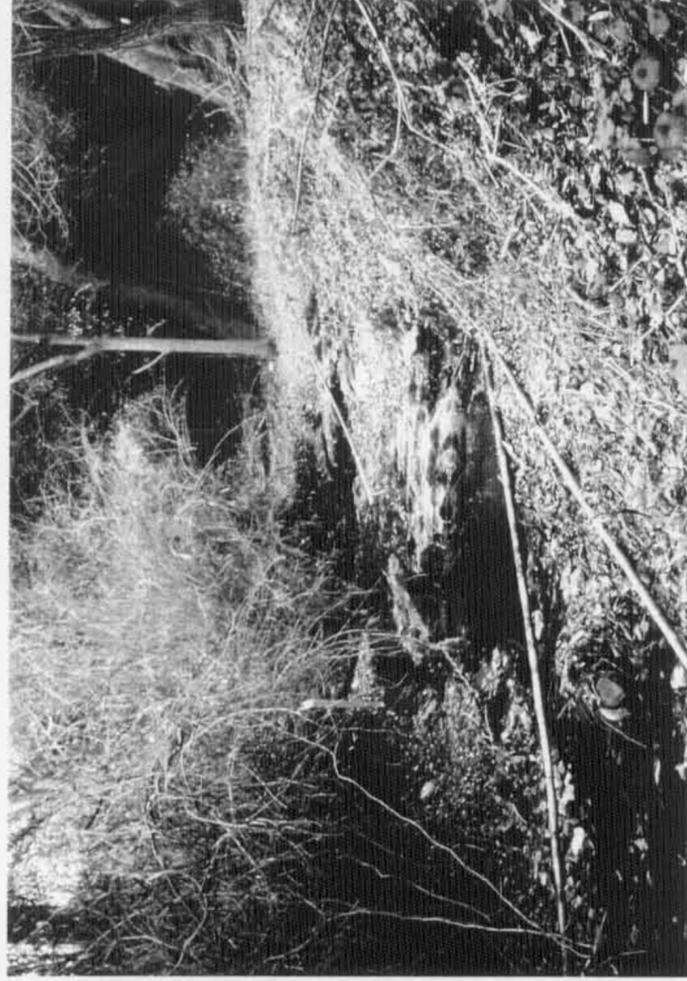
1. KILLORAN ROAD - TIMONIUM ROAD SECTOR AT TRAVERSE POINT 10 (G).
2. KILLORAN ROAD - TIMONIUM ROAD SECTOR BELOW KILLORAN ROAD OUTFALL (F).
3. KILLORAN ROAD - TIMONIUM ROAD SECTOR UPSTREAM FROM TRAVERSE POINT 4 (F).
4. KILLORAN ROAD - TIMONIUM ROAD SECTOR BETWEEN TRAVERSE POINTS 3 & 4. NOTE MID-CHANNEL BAR (C).
5. TIMONIUM ROAD - CONFLUENCE SECTOR AT TRAVERSE POINT 29 (C).
6. TIMONIUM ROAD - CONFLUENCE SECTOR ABOVE TRAVERSE POINT 27 (B1).

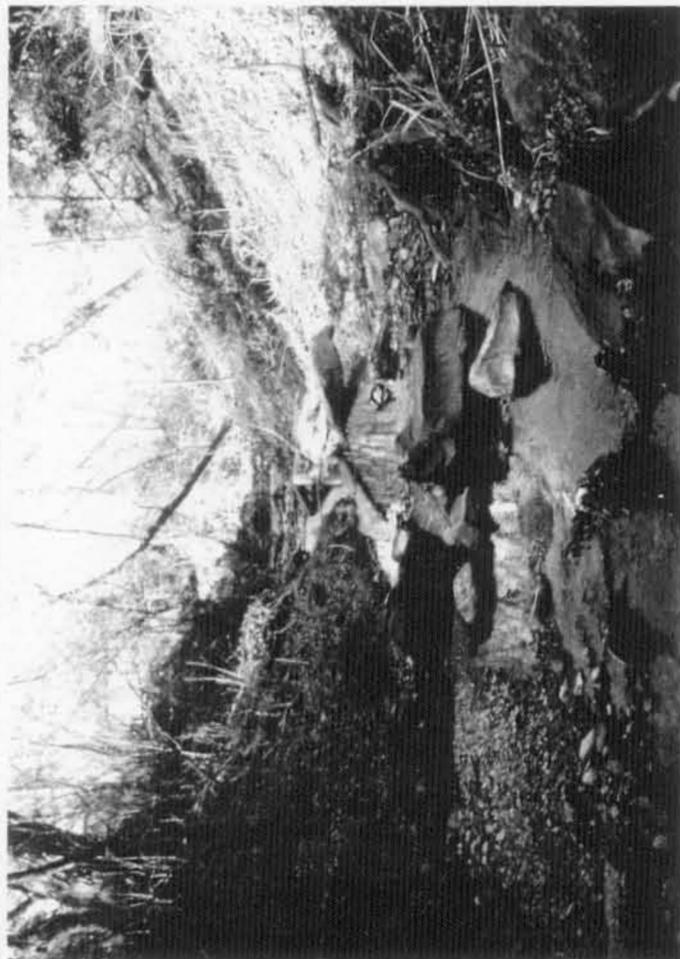
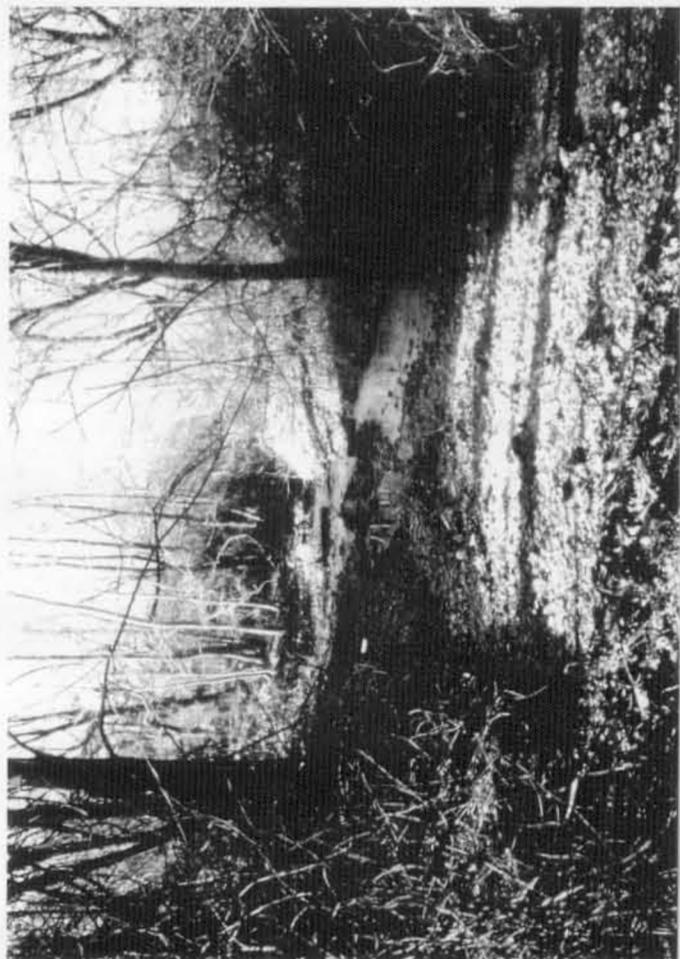
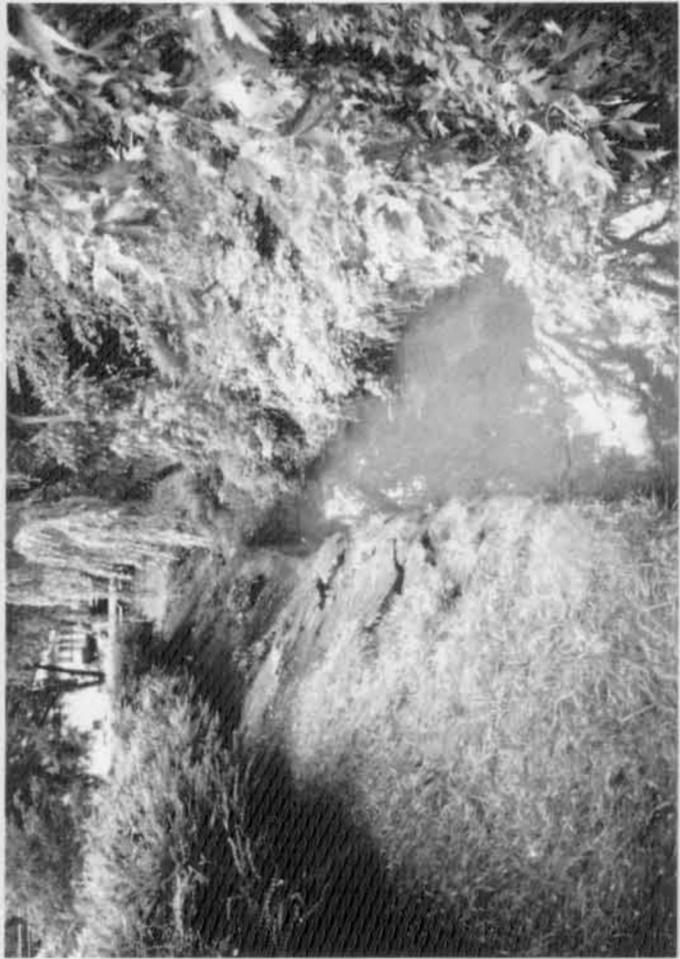
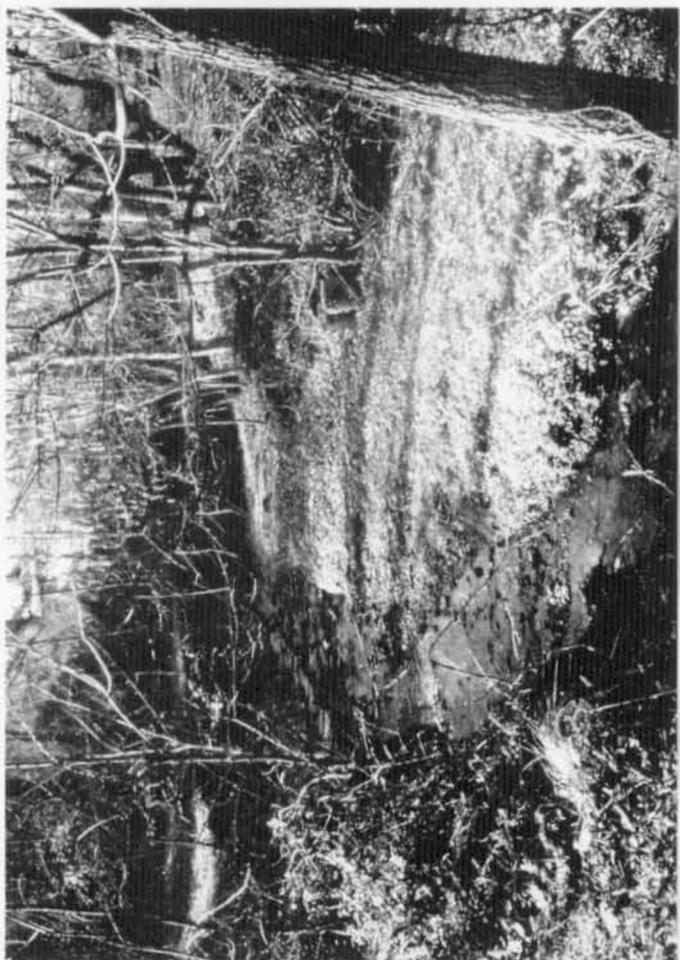
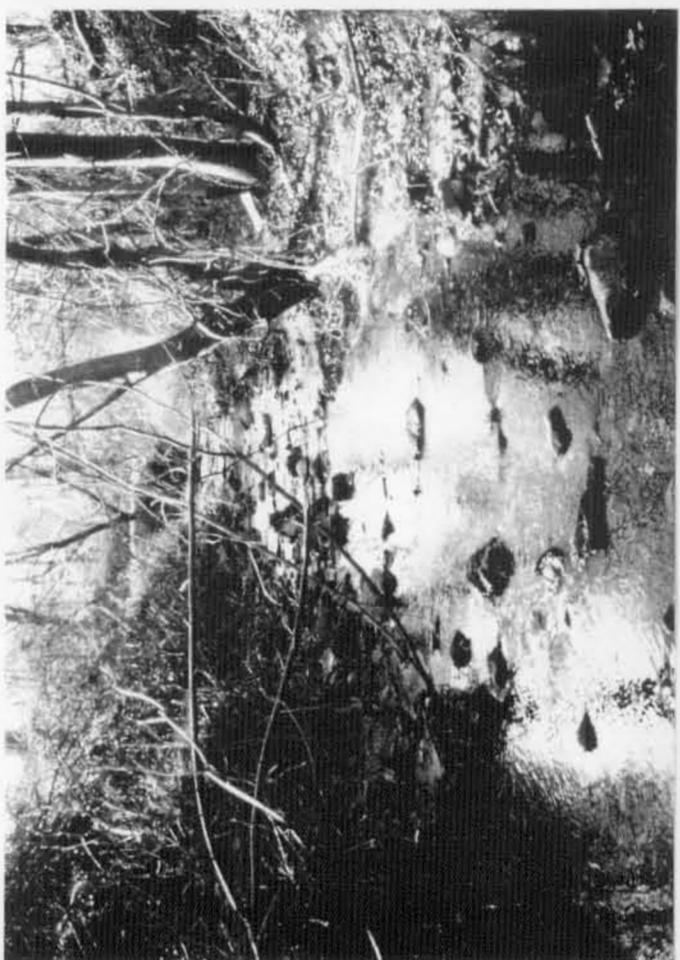
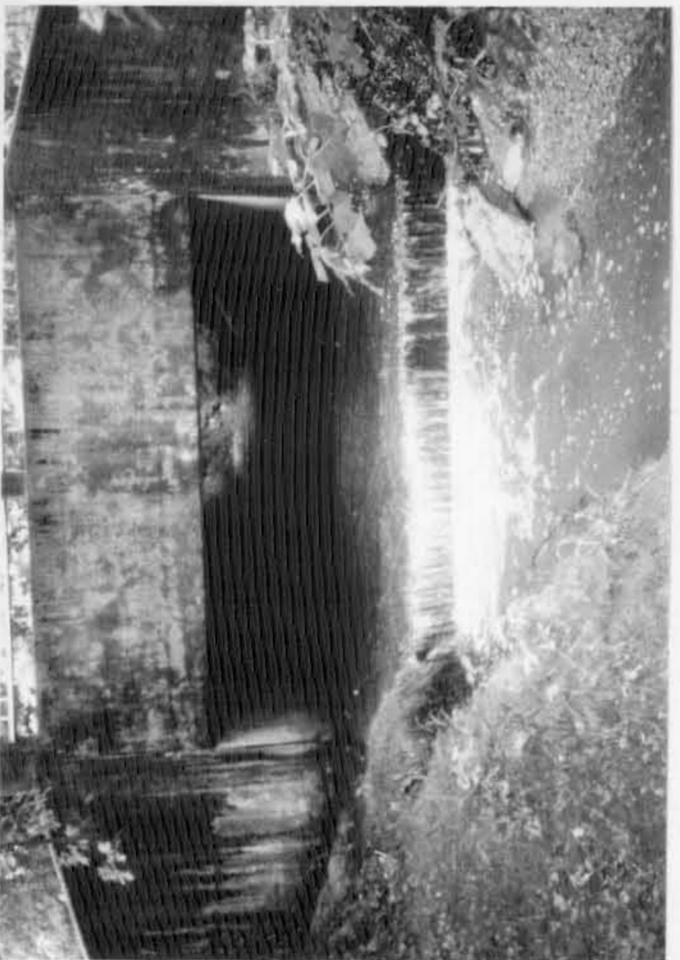
CHANNEL TYPES

1. CONFLUENCE - REUTER ROAD SECTOR BELOW HATHAWAY ROAD OUTFALL (G).
2. CONFLUENCE - REUTER ROAD SECTOR DOWN-STREAM OF TRAVERSE POINT 35 (C).
3. CONFLUENCE - REUTER ROAD SECTOR NEAR TRAVERSE POINT 38 (C).
4. CONFLUENCE - REUTER ROAD SECTOR BETWEEN TRAVERSE POINTS 36 & 37 (F).
5. REUTER ROAD - CINDER ROAD SECTOR UPSTREAM VIEW BETWEEN REUTER AND EASTRIDGE ROADS.(C)
6. REUTER ROAD CULVERT.(F)

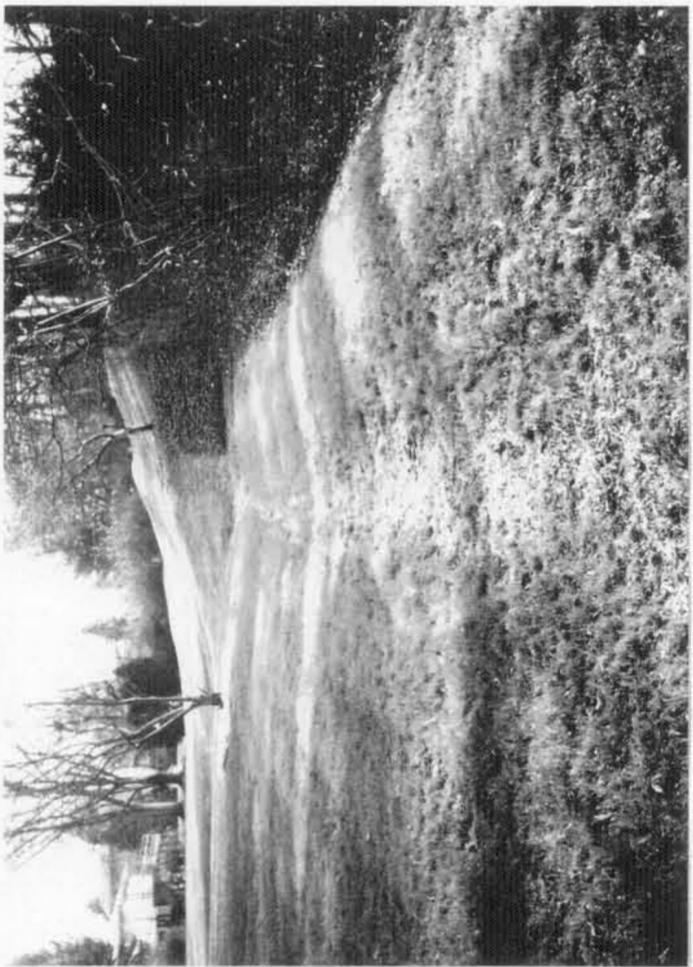
①

1. REUTER ROAD - CINDER ROAD SECTOR AT TRAVERSE POINT 46 (F).
