# Spring Branch Subwatershed - Small Watershed Action Plan

(Addendum to the Water Quality Management Plan for Loch Raven Watershed)

Prepared by  
**Baltimore County**  
Department of Environmental Protection and Resource Management  
401 Bosley Avenue, Suite 416, Towson, MD 21204

March 17, 2008

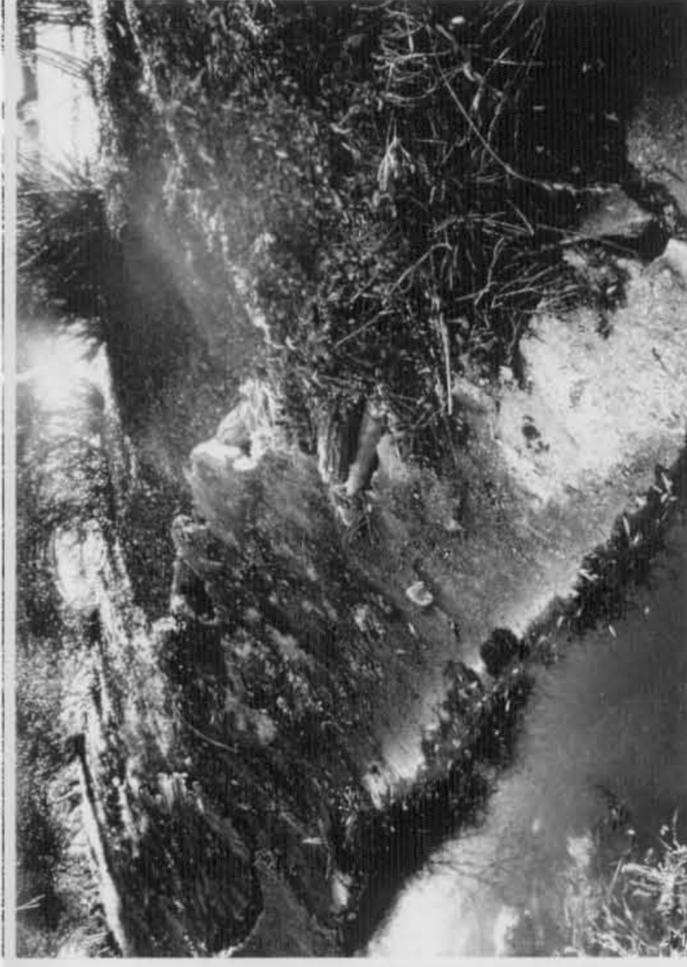
⑥

6. HOLLOWBROOK TRIBUTARY CONCRETE FLUME. (ATYPICAL)

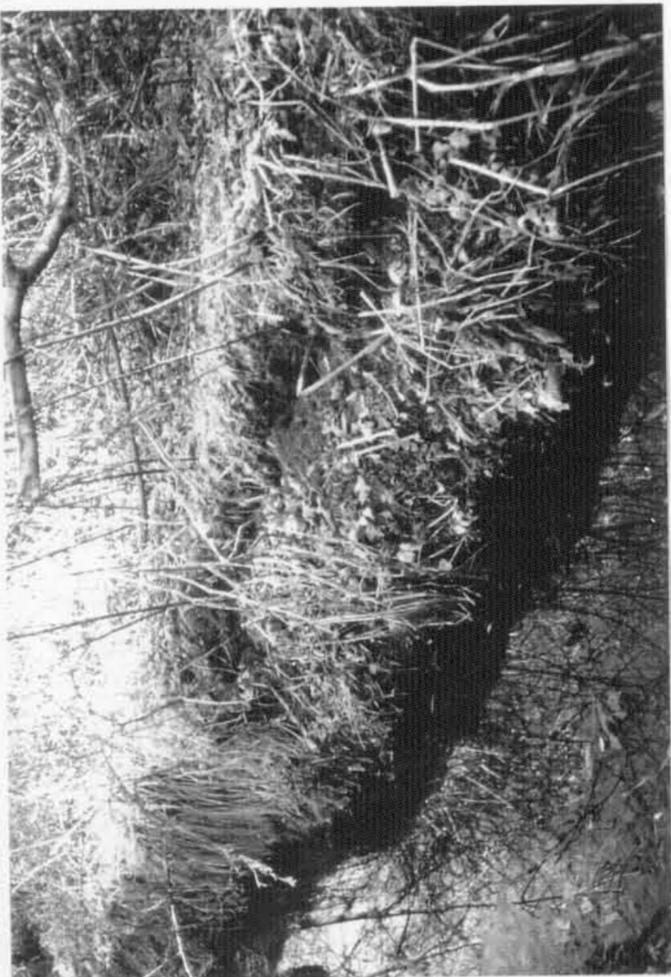
①

1. CONCENTRATED OVERLAND FLOW ABOVE KILLORAN ROAD OUTFALL.
2. EXPOSED SEWER TRUNK LINE CROSSING IN REUTER ROAD - CINDER ROAD SECTOR ABOVE TRAVERSE POINT 46.
3. BROKEN SEWER LATERAL IN KILLORAN ROAD - TIMONIUM ROAD SECTOR.
4. EROSION AT KILLORAN ROAD OUTFALL.
5. DEBRIS DAM IN CONFLUENCE - REUTER ROAD SECTOR ABOVE TRAVERSE POINT 35.
6. FAILED CONCRETE BANK REPAIR ABOVE EASTRIDGE ROAD CULVERT.

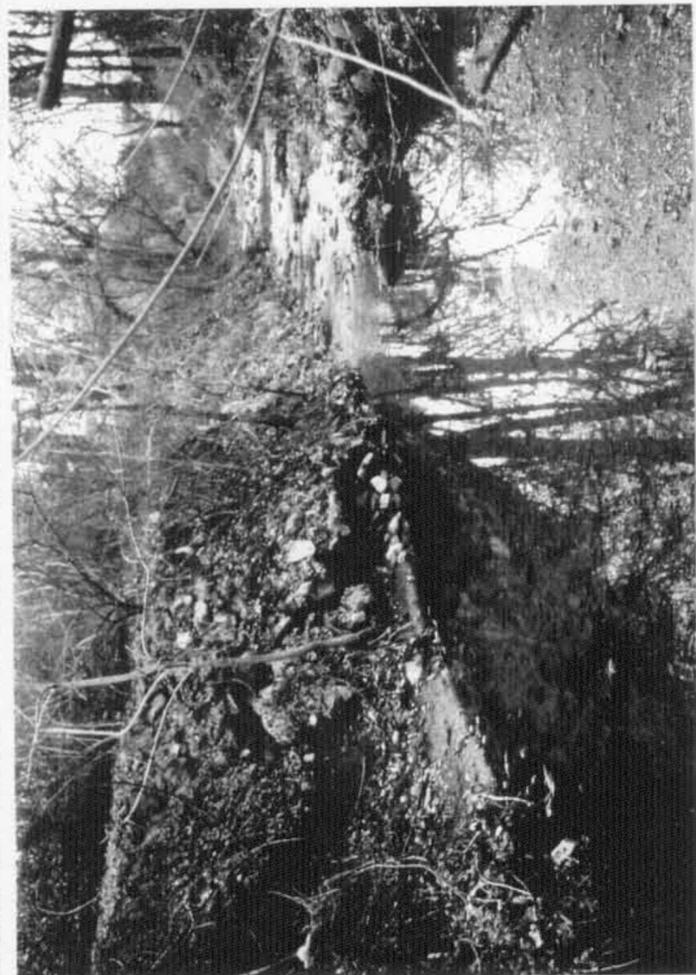
②

1. RIGHT BANK OF HOLLOWBROOK TRIBUTARY.

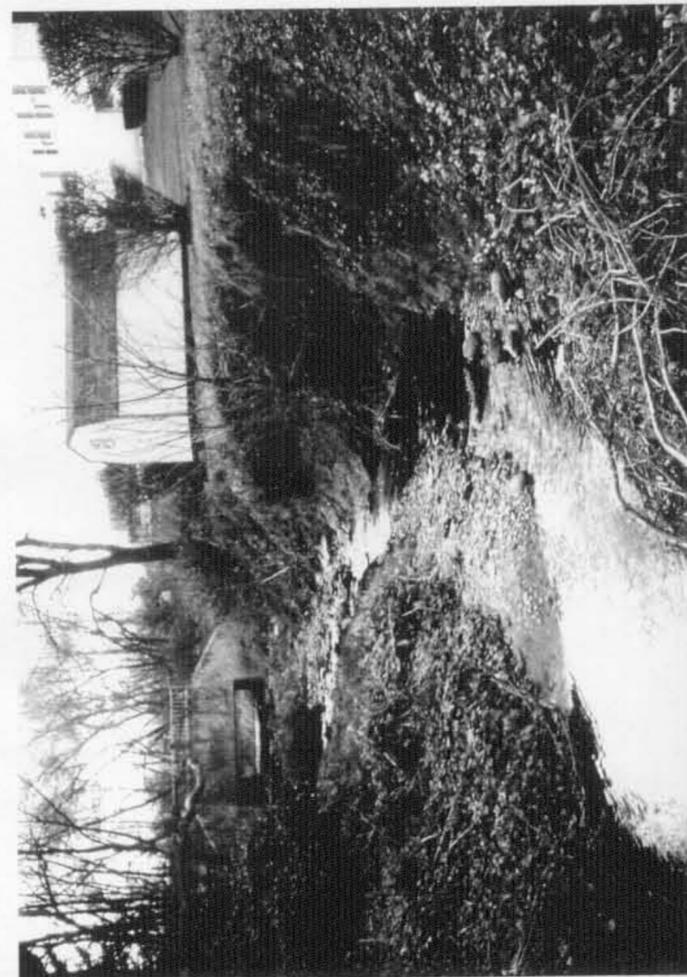
④

5. LEFT BANK BELOW REUTER ROAD CULVERT.

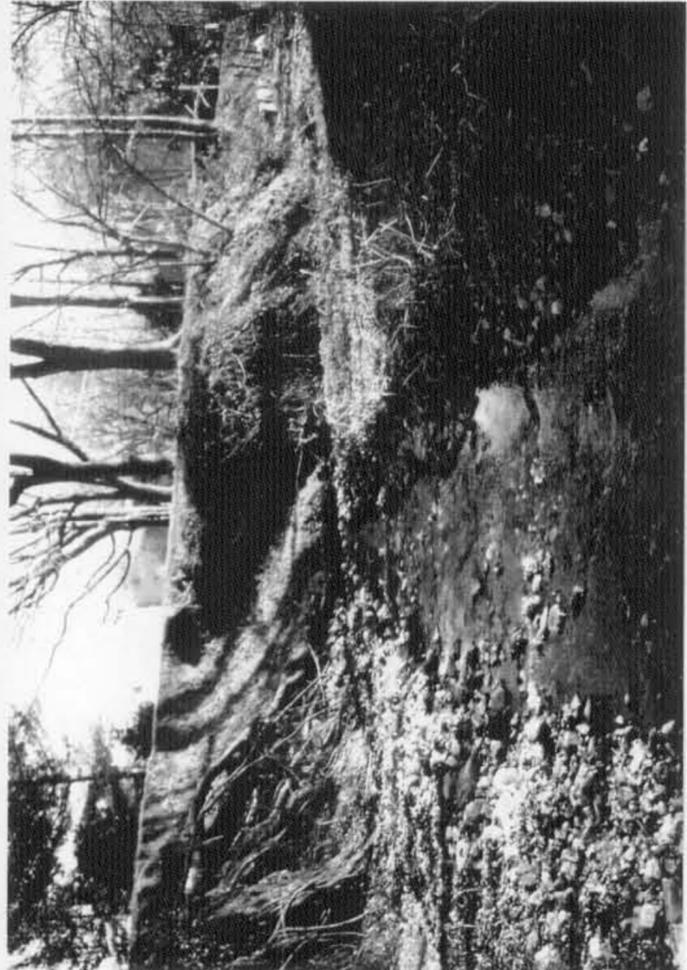
⑥

6. RIGHT BANK AT AND BELOW SPRINGSIDE DRIVE PIPE OUTFALL.

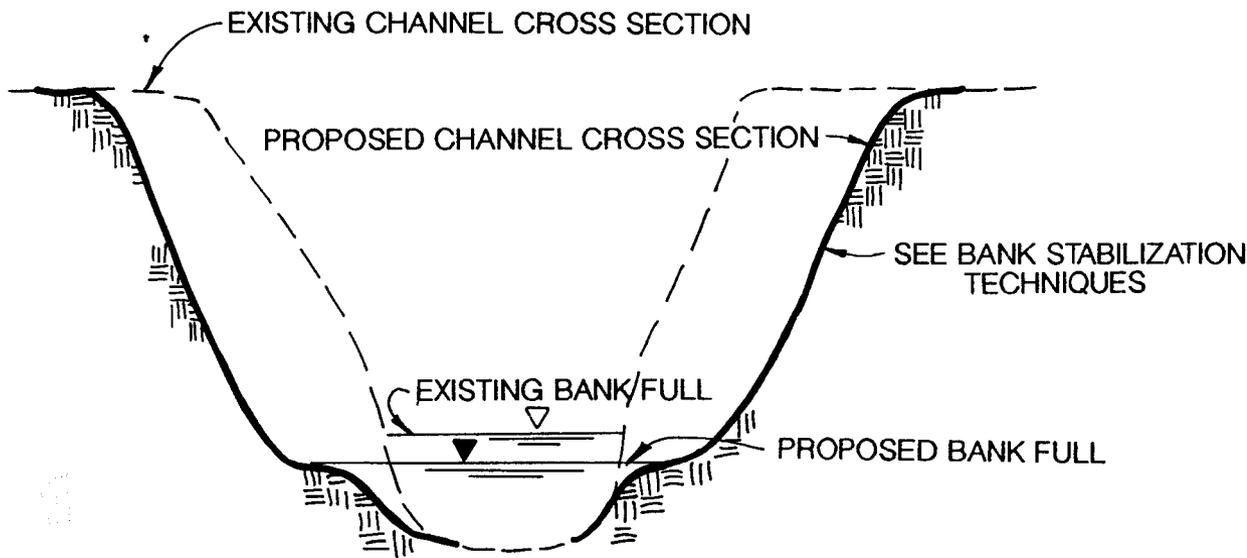
CHANNEL GEOMETRY MODIFICATION

"B" WITHIN A "G"

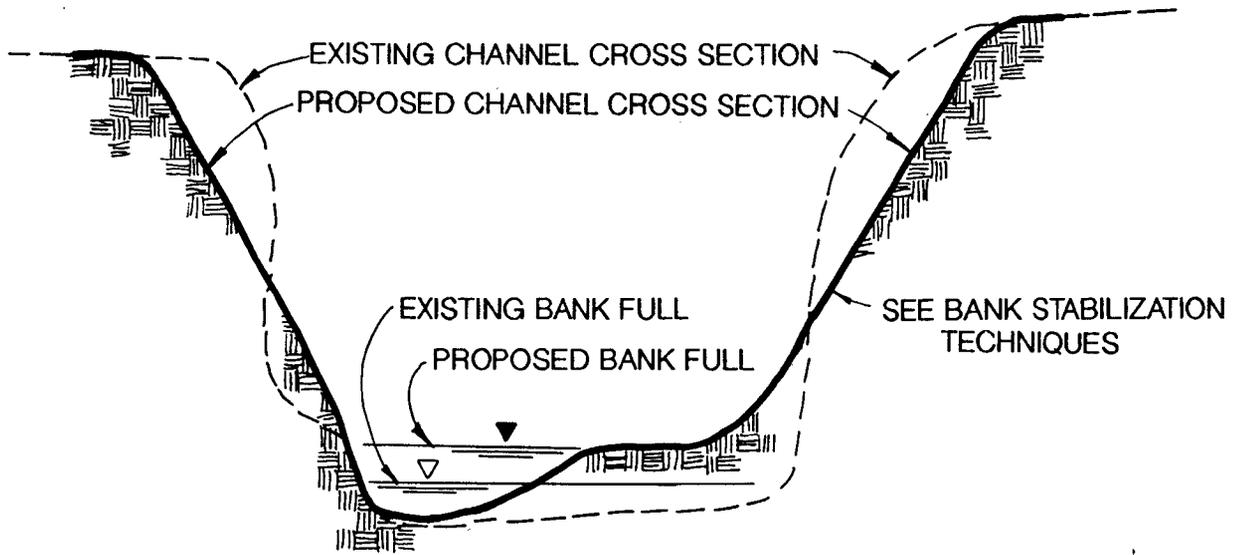
# CHANNEL GEOMETRY MODIFICATION

"C" WITHIN AN "F"

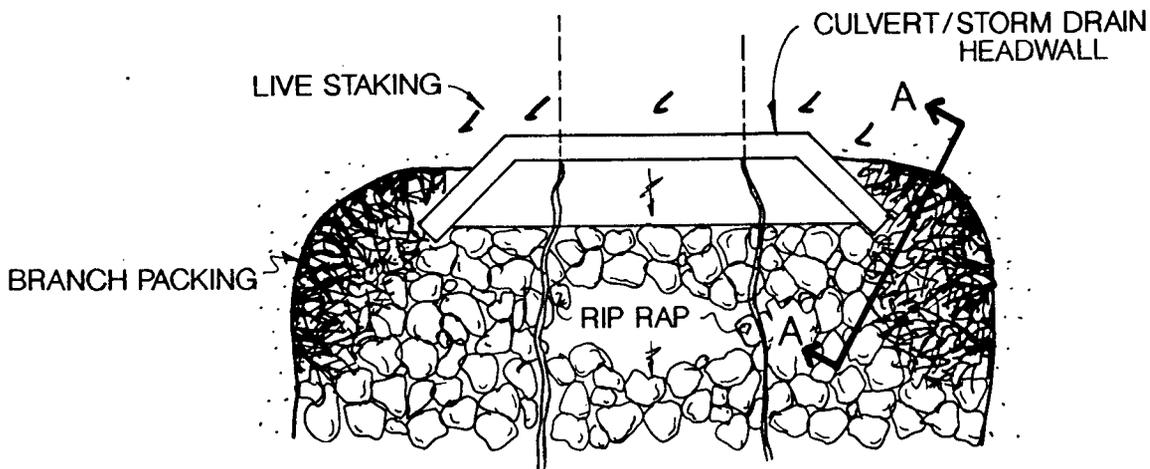
PLAN  
NTS

**CULVERT/STORM DRAIN HEADWALL**  
**BRANCH PACKING/BRANCH LAYERING** NTS

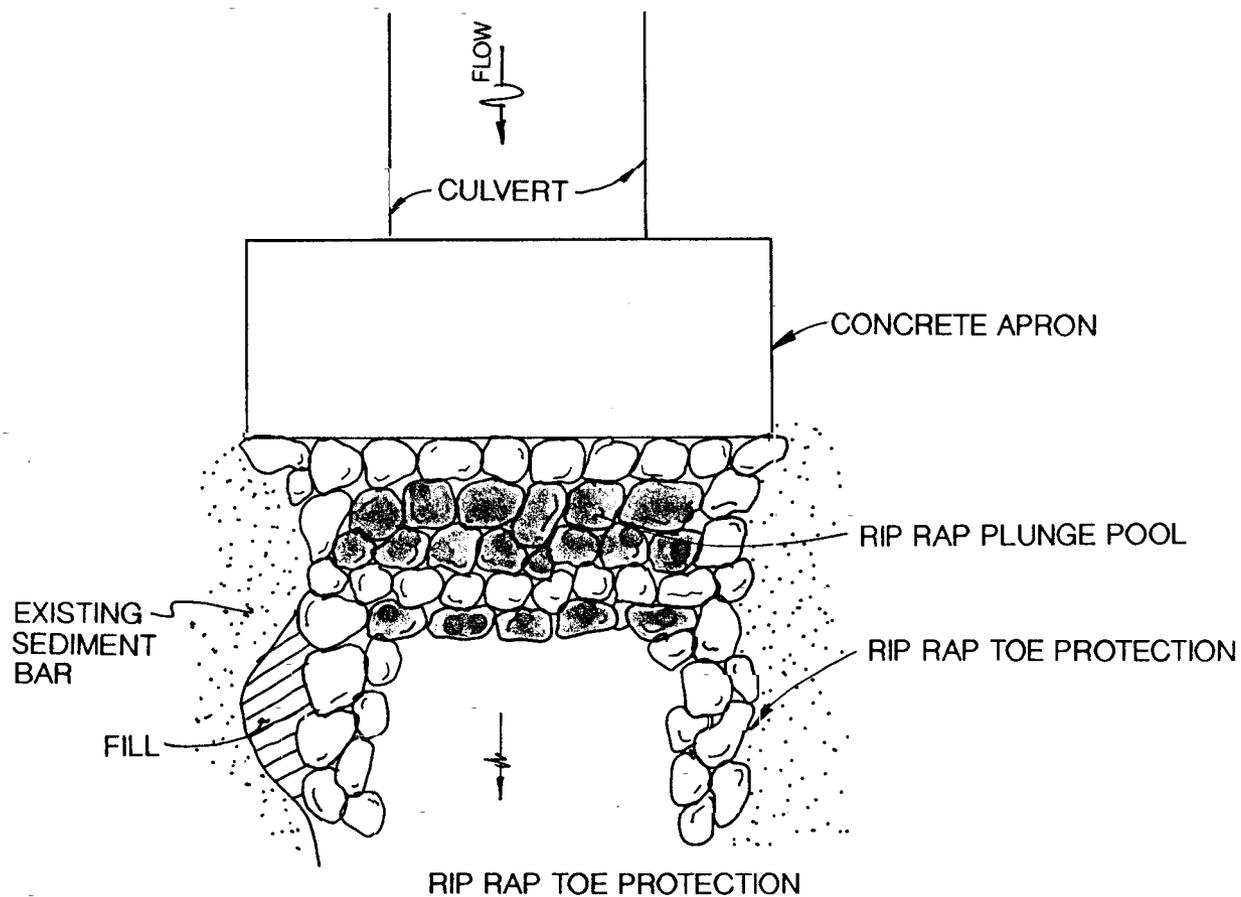
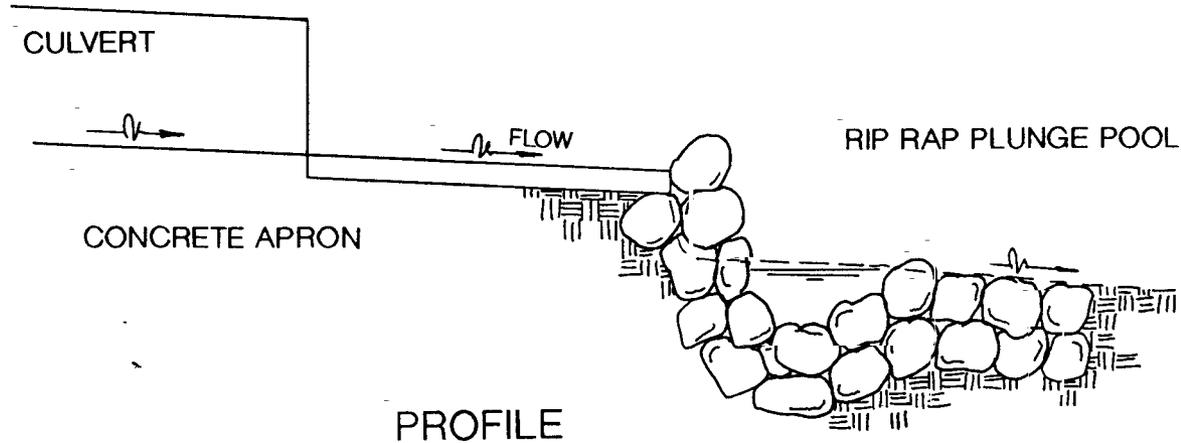
# CULVERT OUTFALL RETROFIT

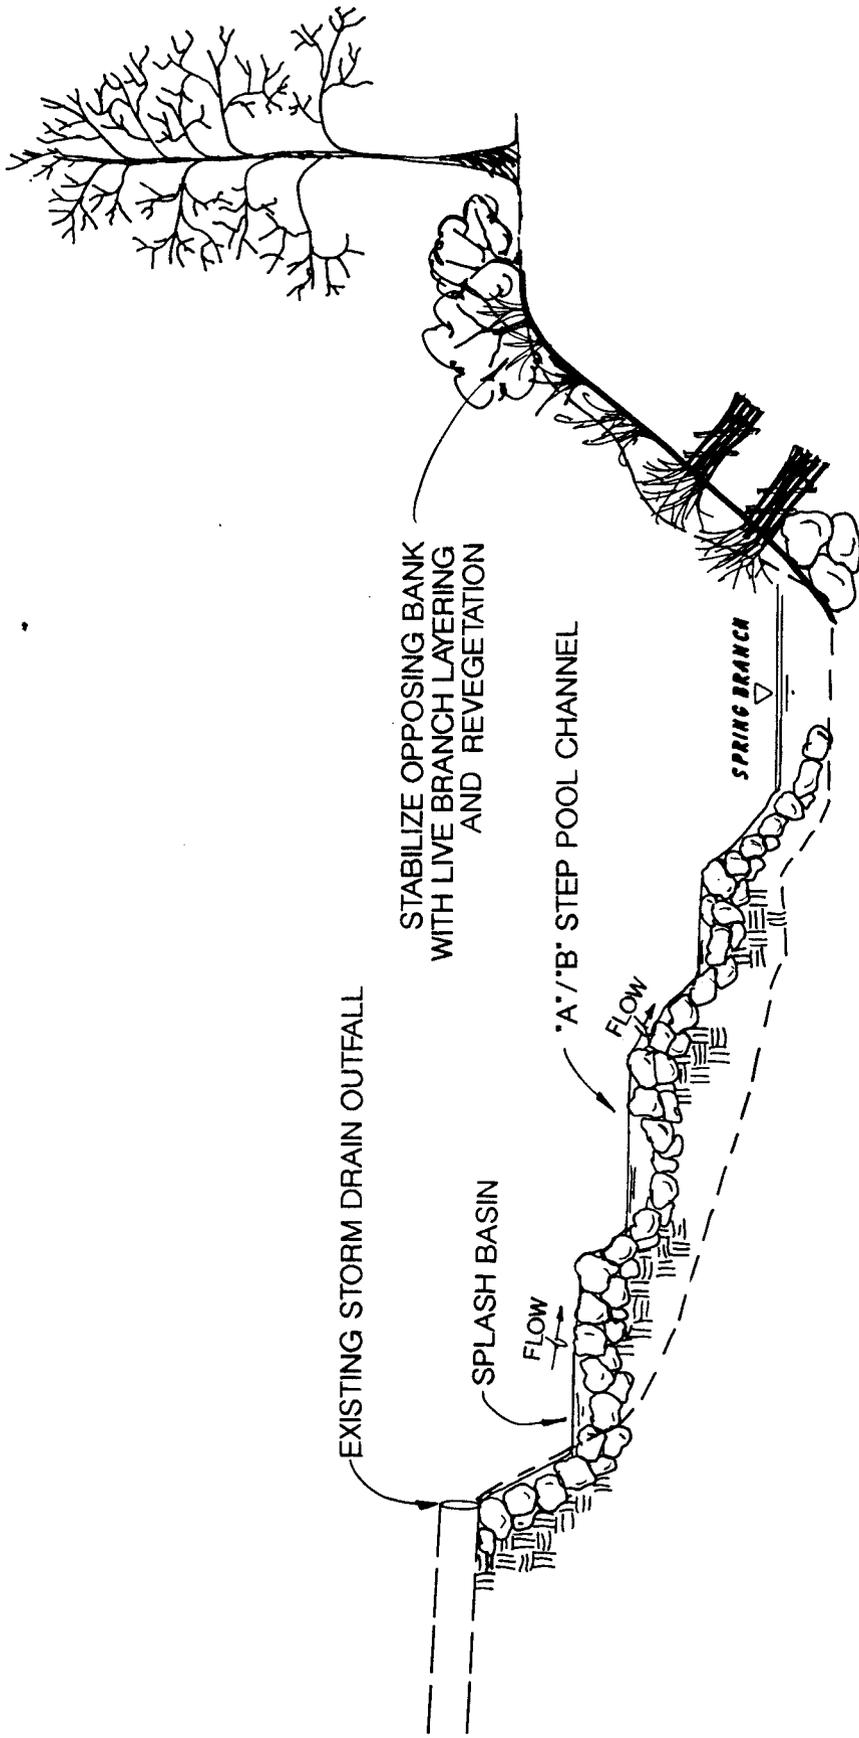
○ STORM DRAIN OUTFALL RETROFIT  
PROFILE

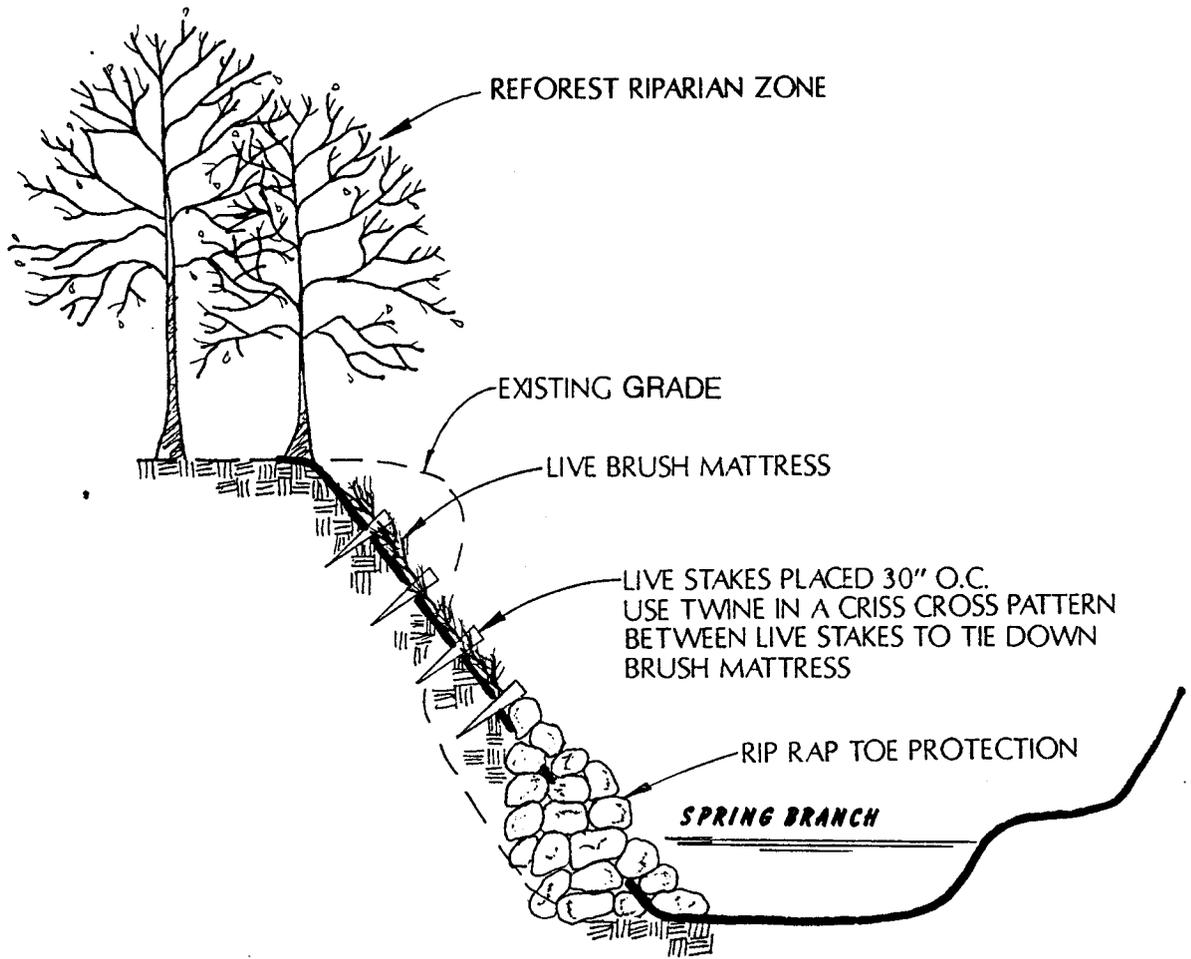
LIVE BRUSH MATTRESS

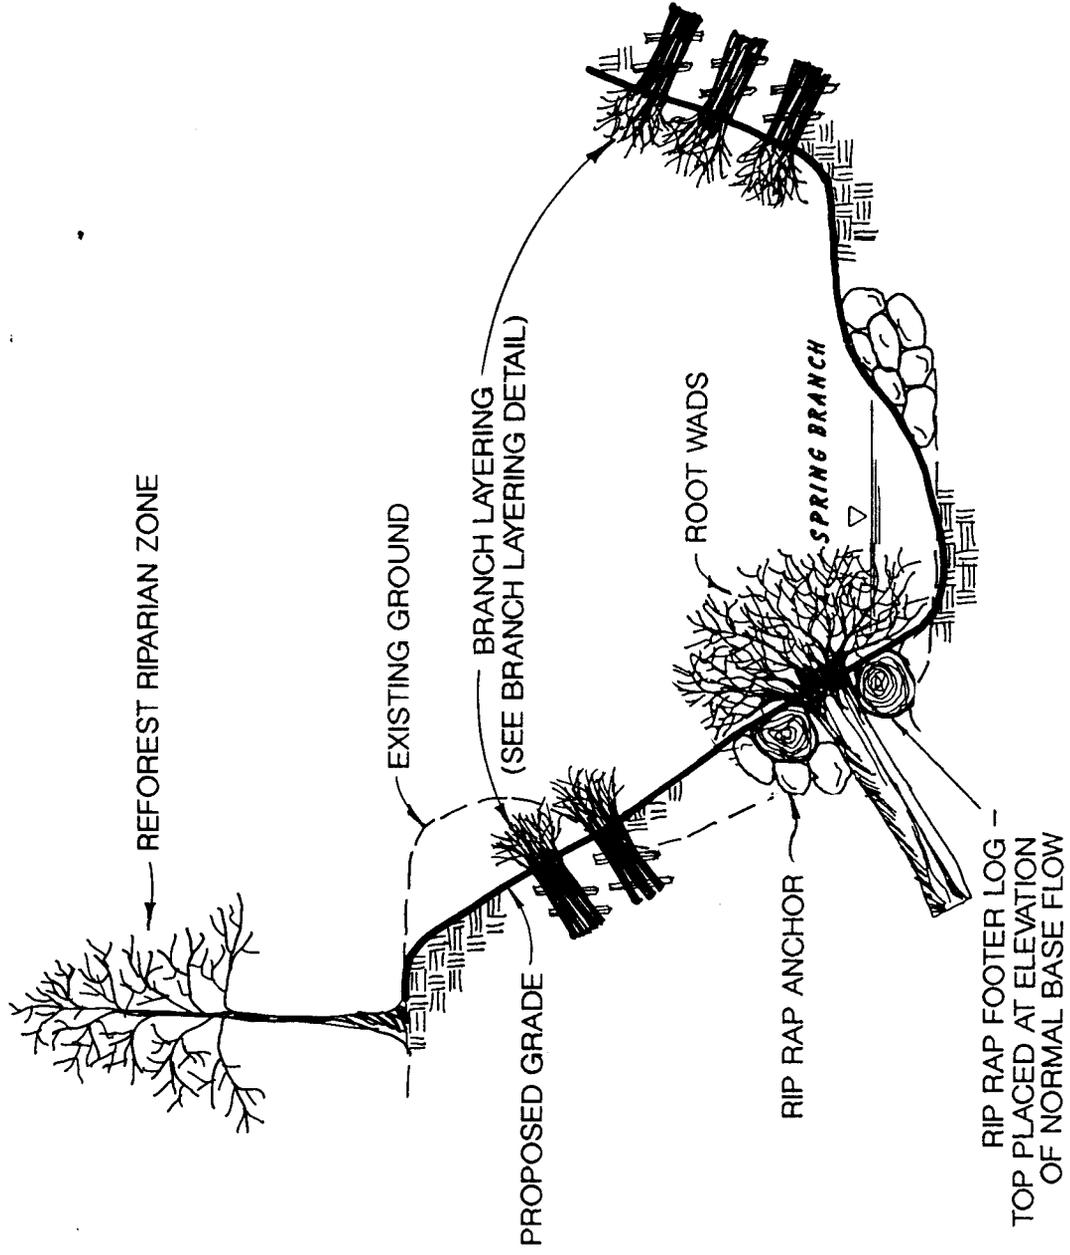
# ROOT WAD WITH BRANCH LAYERING

Similar to In-Channel Structures, bank stabilization structures should also be regularly inspected to ensure that the structures are in place and functioning properly. Riprap toe protection, root wads, live fascines, and live branch packing should be examined on a semi-annual basis. Undermining, increased erosion noted downstream, plant mortality, and structural integrity should all be inspected and in-kind repairs made as soon as possible. Minor reconfiguration and realignment of certain structures, over a period of time, may be necessary to ensure the ultimate success of the project.

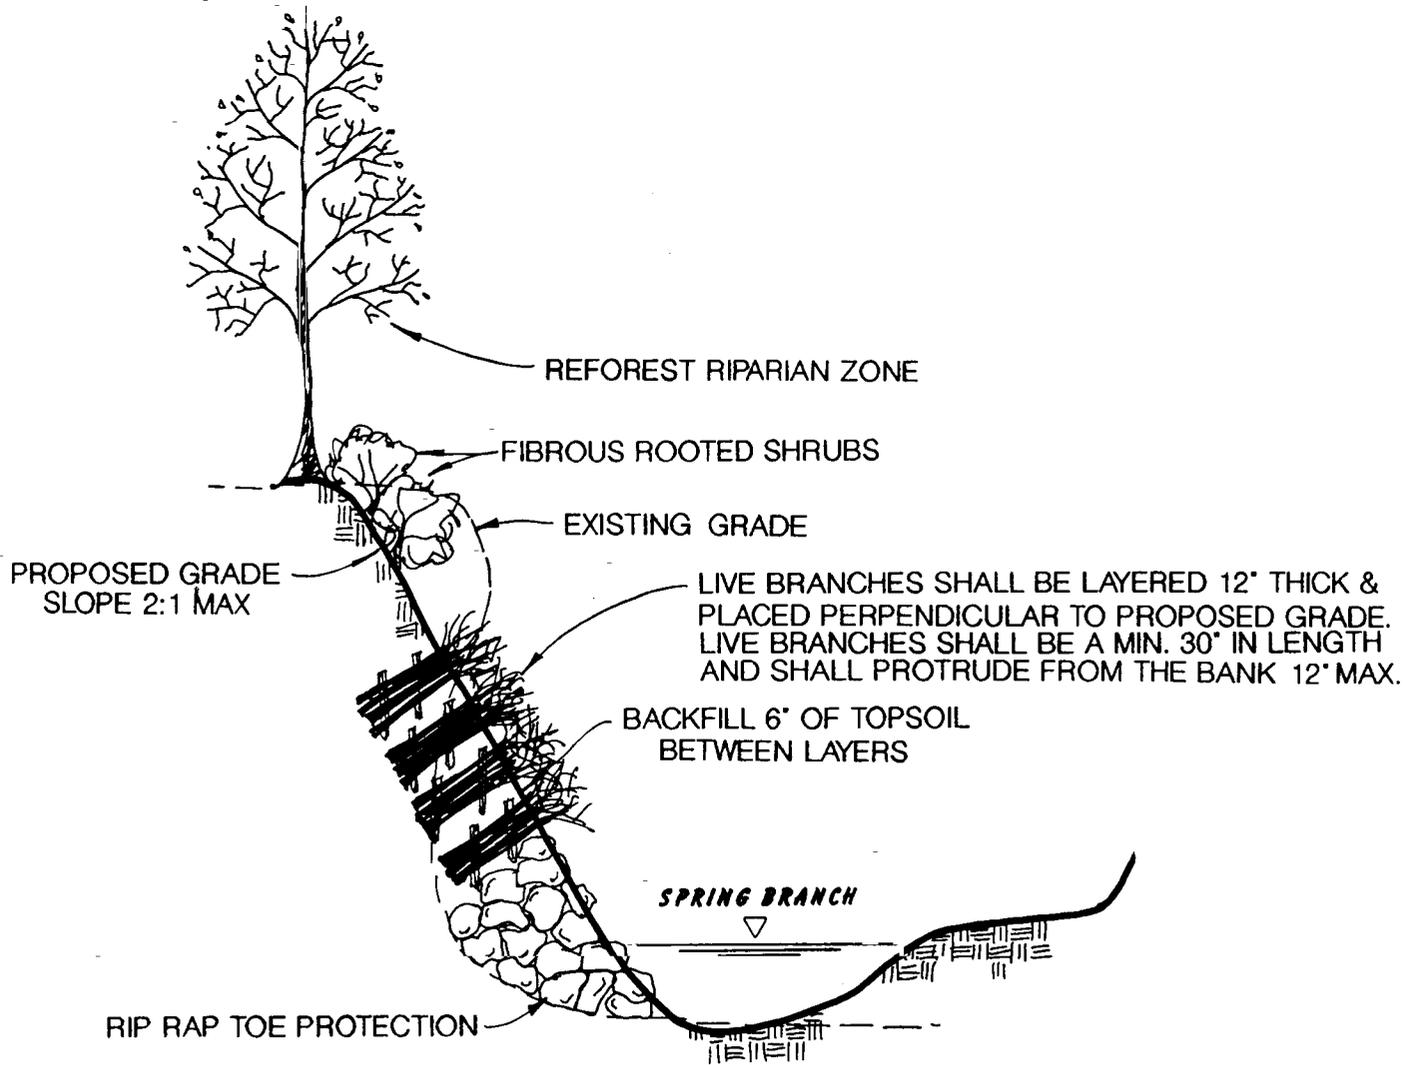
# BRANCH LAYERING WITH RIP RAP TOE

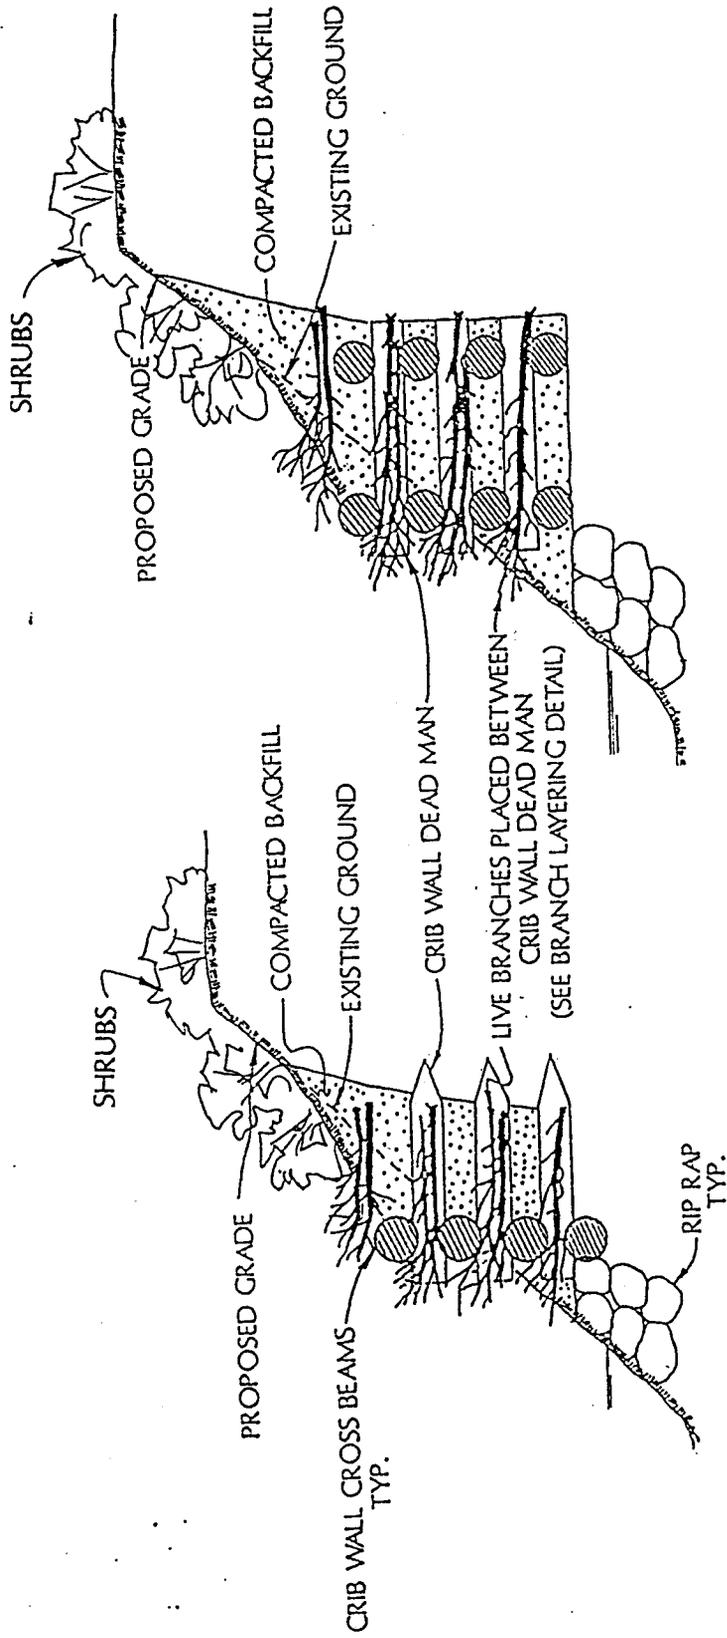
**LIVE CRIB WALL W/LIVE BRANCH LAYERING NTS**

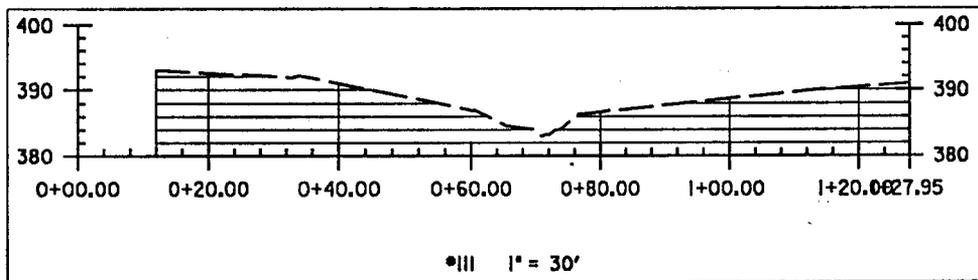
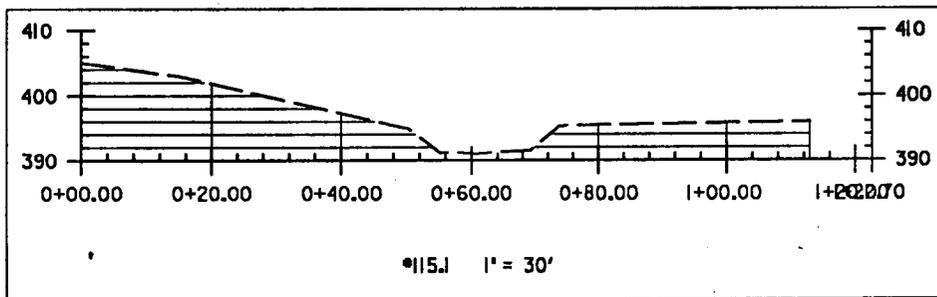
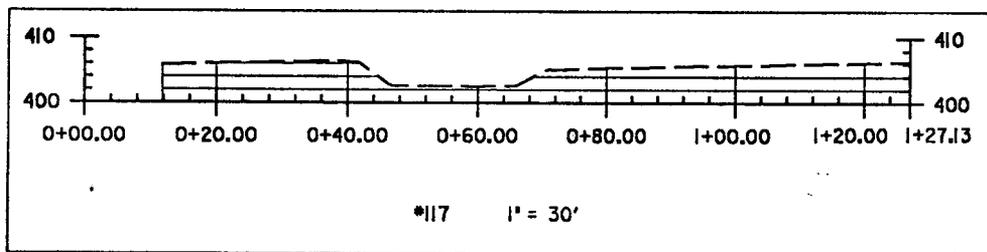
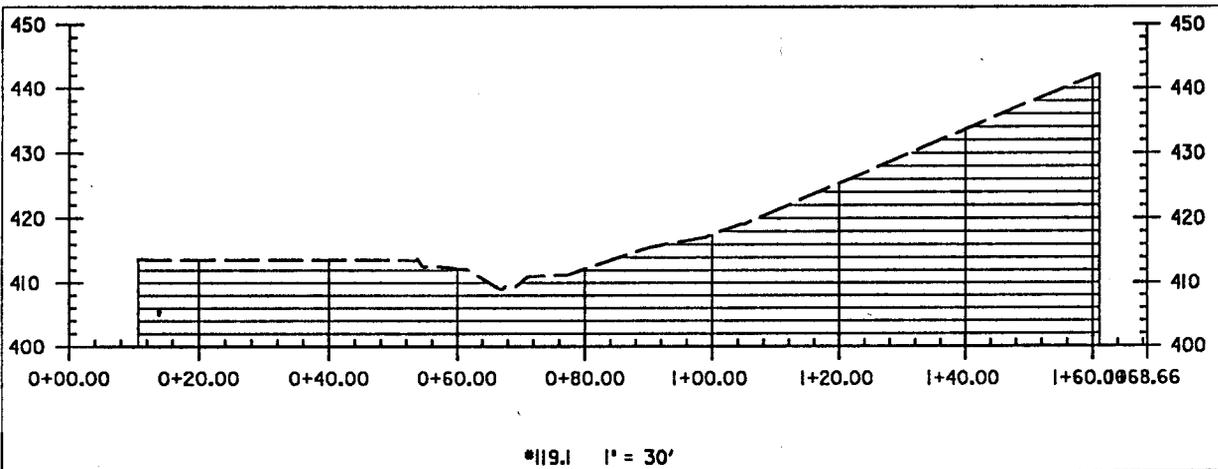
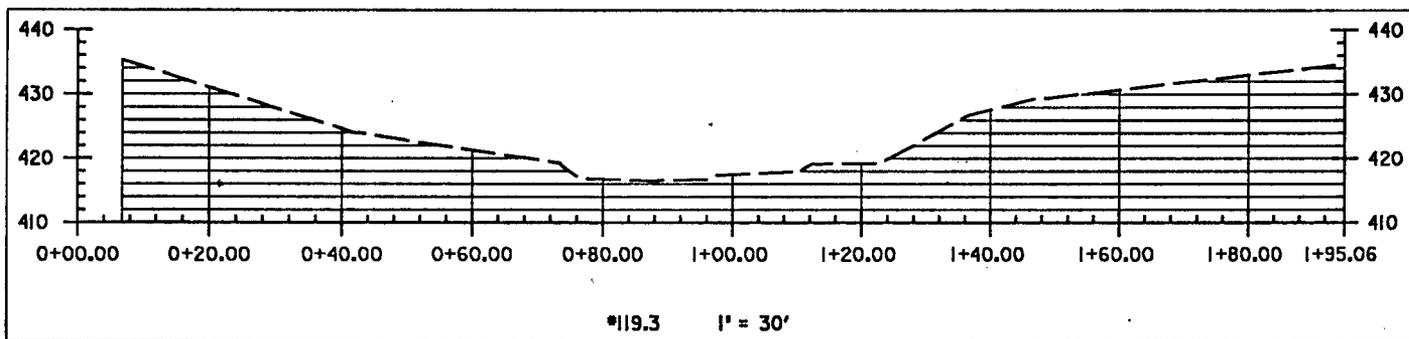
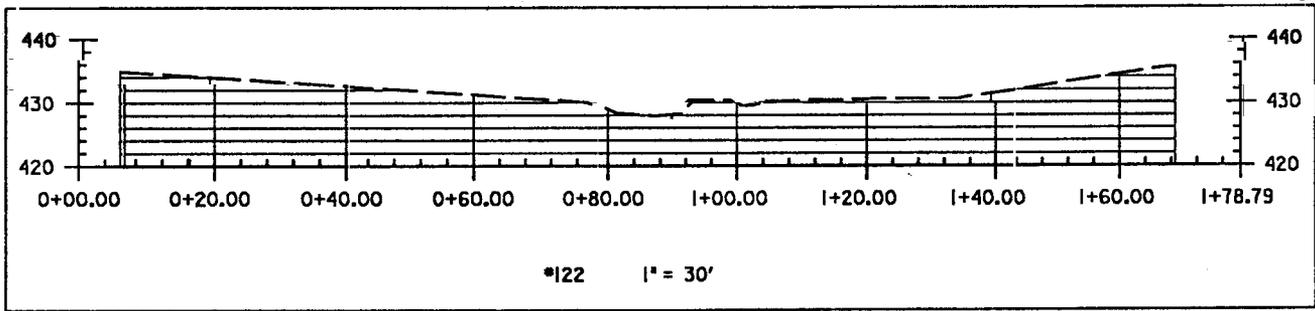
# APPENDIX C: SELECT FIELD SURVEYED CROSS SECTIONS

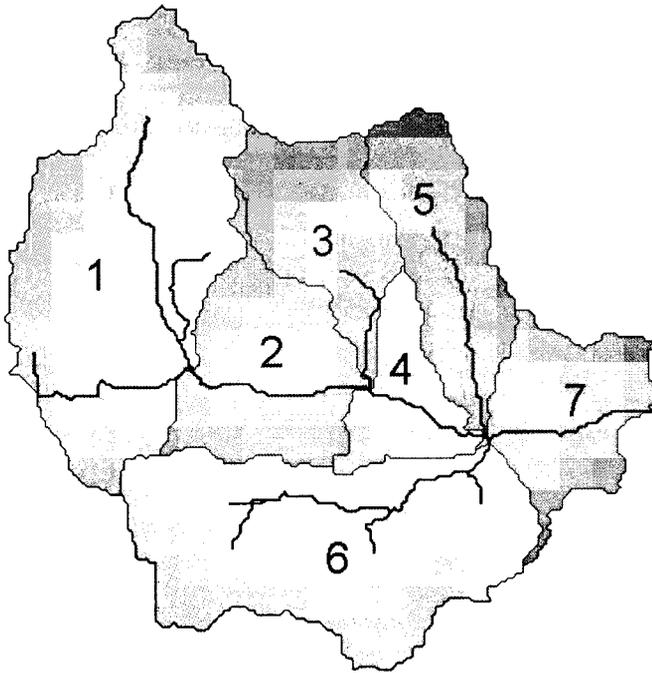
**Figure 2.1. Spring Branch Sub-basin Watershed Map.**

The Lower Spring Branch watershed was delineated by interpolating a Digital Elevation Model (DEM) from a 2-foot contour GIS layer provided by Baltimore County using ArcGIS 8.3. The watershed was divided into seven sub-basins by importing the layer into TauDEM and Arcview 8.3 programs and run through preprocessing routines to determine exact watershed and sub-basin boundaries (Figure 2.1).

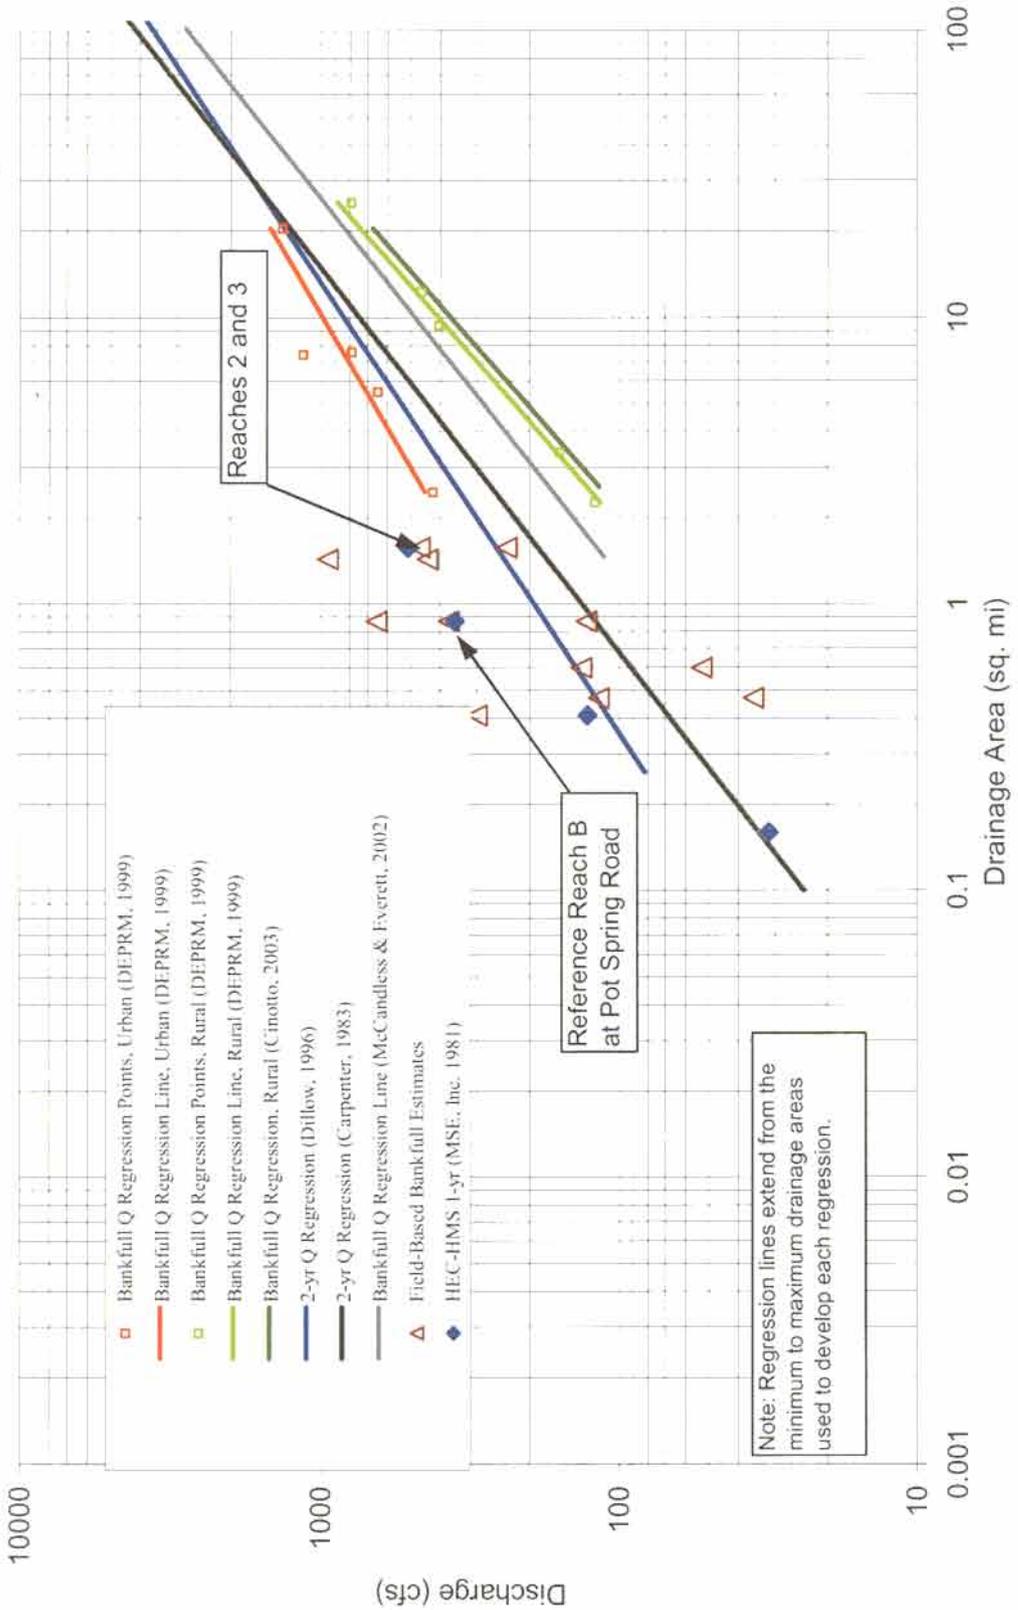
Figure 3.1. Comparison of Field Bankfull Estimates, HEC-HMS Results, and Regional Regressions.

Results from the regional regressions in comparison to the field based bankfull discharges and the HEC-HMS model are wide ranging, however important patterns can be extracted from the values which point to a realistic design discharge (Figure 3.1). A group of the field based estimates appear to correspond well with the Dillow (1996) and Carpenter (1983) regressions. However, the regression results are based on a two-year discharge. This is likely not the return interval that corresponds to the bankfull indicators in the more urbanized conditions of Lower Spring Branch.

As previously noted, the best bankfull indicators were located on the reference reaches and within Reaches 2 and 3. The field based discharge values calculated for these reaches fall in line with the DEPRM Urban (1999) regression; however, the drainage areas used for the regression are out of the range of the drainage area of our study (Figure 3.1). More support for these values can be found in the results of the 1-year discharge from the HEC-HMS model. The high bankfull discharge calculated for reference Reach B (375.1 CFS) near Pot Spring Road corresponds very well with the value returned for the HEC-HMS model (359 CFS) at the same location (Tables 3.3 and 3.5). In addition, the value (516 CFS) modeled for the downstream end of the site at Dulaney Valley Road corresponds well with the bankfull measurements for Reaches 2 and 3 (443.8 and 471.9 respectively).

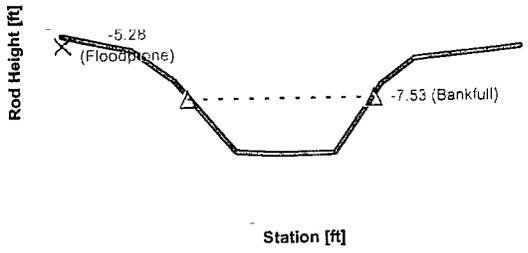
# Lower Spring Branch Xsection #1

*bf max depth:* 2.25 ft  
*bf avg depth:* 1.69 ft  
*entrenchment:* 2.21  
*width/depth ratio:* 12.82  
*hydraulic radius:* 1.66 ft  
*bankfull discharge:* 656.42 ft<sup>3</sup>/s      17.95 ft/s  
*floodprone discharge:* 2,172.32 ft<sup>3</sup>/s  
*Avg. shear stress at bankfull stage:* 1.101 lb/ft<sup>2</sup>

<i>Benchmark Elevation</i>	<i>Bankfull Rod Height [ft]</i>	7.53	<i>measured wall</i>	<i>Floodprone Rod Height [ft]</i>	-5.28
<i>Benchmark Rod Height</i>	<i>channel slope</i>	1.06%		<i>rod height</i>	= (2 · max depth <sub>bf</sub> )
	<i>manning's 'n'</i>	0.012	<i>concrete channel</i>

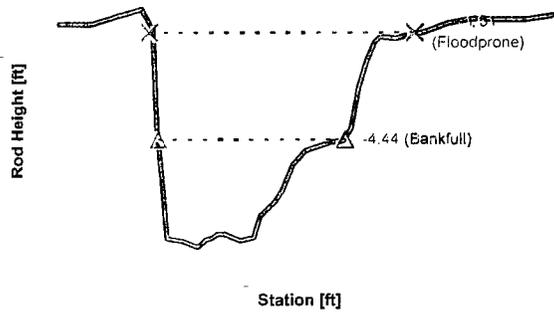
### Lower Spring Branch Xsection #3

*bf max depth:* 2.93 ft  
*bf avg depth:* 1.74 ft  
*entrenchment:* 1.42  
*width/depth ratio:* 20.58  
*hydraulic radius:* 1.67 ft  
*bankfull discharge:* 443.80 ft<sup>3</sup>/s      7.16 ft/s  
*floodprone discharge:* 2,014.50 ft<sup>3</sup>/s  
*Avg. shear stress at bankfull stage:* 1.489 lb/ft<sup>2</sup>

<i>Benchmark Elevation</i>	<i>Bankfull Rod Height [ft]</i>	4.44
<i>Benchmark Rod Height</i>	<i>channel slope</i>	1.43%
	<i>mannings's 'n'</i>	0.035

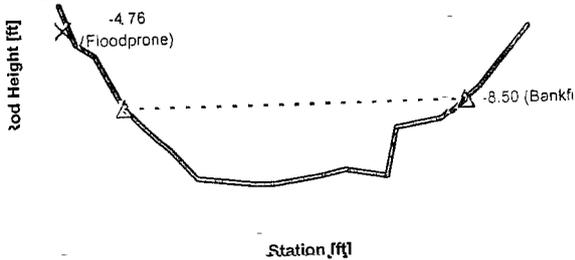
# Lower Spring Branch Xsection #4

*bf max depth:* 3.74 ft  
*bf avg depth:* 2.52 ft  
*entrenchment:* 1.34  
*width/depth ratio:* 13.00  
*hydraulic radius:* 2.36 ft  
*bankfull discharge:* 471.87 ft<sup>3</sup>/s      5.73 ft  
*floodprone discharge:* 2,031.47 ft<sup>3</sup>/s  
*Avg. shear stress at bankfull stage:* 0.900 lb/ft<sup>2</sup>

*Benchmark Elevation*      *Bankfull Rod Height [ft]*      8.50  
*Benchmark Rod Height*      *channel slope*      0.61%  
    *manning's 'n'*      0.036

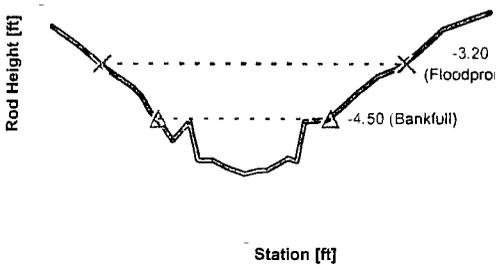
# Lower Spring Branch Reference Reach A Riffle

*bf max depth:* 1.30 ft  
*bf avg depth:* 0.74 ft  
*entrenchment:* 1.77  
*width/depth ratio:* 26.45  
*hydraulic radius:* 0.71 ft  
*bankfull discharge:* 53.19 ft<sup>3</sup>/s      3.64 ft/s  
*floodprone discharge:* 272.16 ft<sup>3</sup>/s  
*Avg. shear stress at bankfull stage:* 0.511 lb/ft<sup>2</sup>

<i>Benchmark Elevation</i>	<i>Bankfull Rod Height [ft]</i>	4.50
<i>Benchmark Rod Height</i>	<i>channel slope</i>	1.15%
	<i>manning's 'n'</i>	0.035

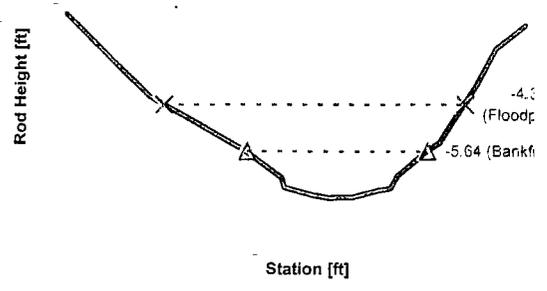
### Lower Spring Branch Xsection C Riffle

*bf max depth:* 1.26 ft  
*bf avg depth:* 0.83 ft  
*entrenchment:* 1.66  
*width/depth ratio:* 14.47  
*hydraulic radius:* 0.81 ft  
*bankfull discharge:* 35.74 ft<sup>3</sup>/s      3.56 ft/s  
*floodprone discharge:* 159.93 ft<sup>3</sup>/s  
*Avg. shear stress at bankfull stage:* 0.392 lb/ft<sup>2</sup>

<i>Benchmark Elevation</i>	<i>Bankfull Rod Height [ft]</i>	5.64
<i>Benchmark Rod Height</i>	<i>channel slope</i>	0.78%
	<i>manning's 'n'</i>	0.032
