# Spring Branch Subwatershed - Small Watershed Action Plan

(Addendum to the Water Quality Management Plan for Loch Raven Watershed)

Prepared by  
**Baltimore County**  
Department of Environmental Protection and Resource Management  
401 Bosley Avenue, Suite 416, Towson, MD 21204

March 17, 2008

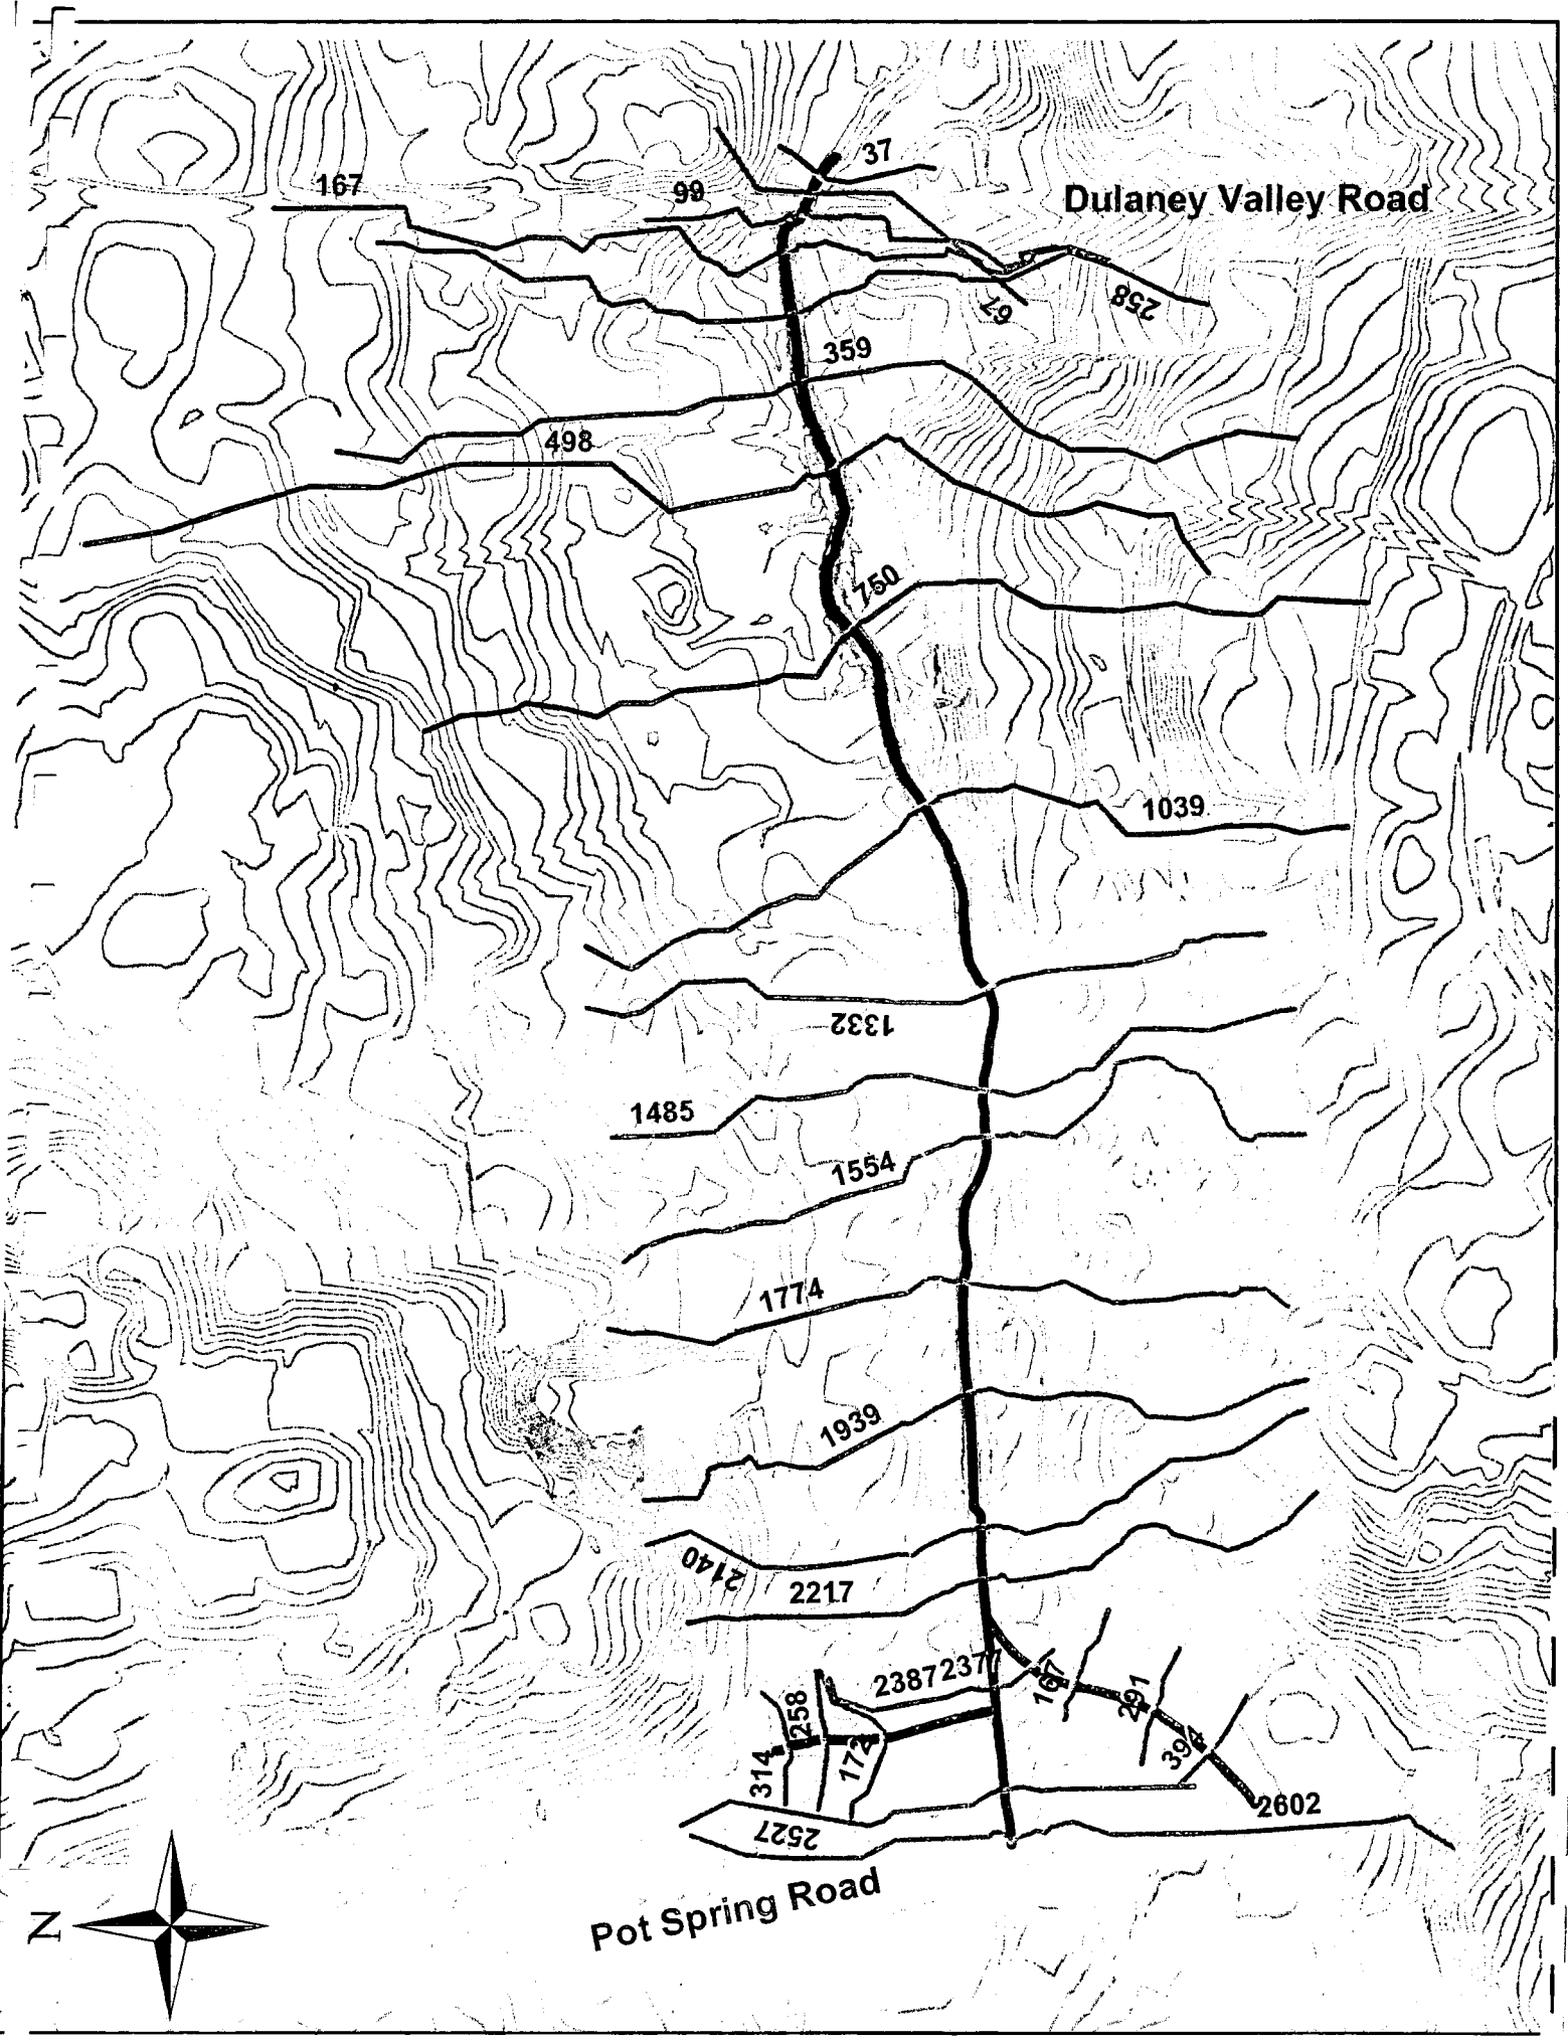
**RESULTS OF THE HYDRAULIC MODELING**

Dulaney Valley Road

Pot Spring Road

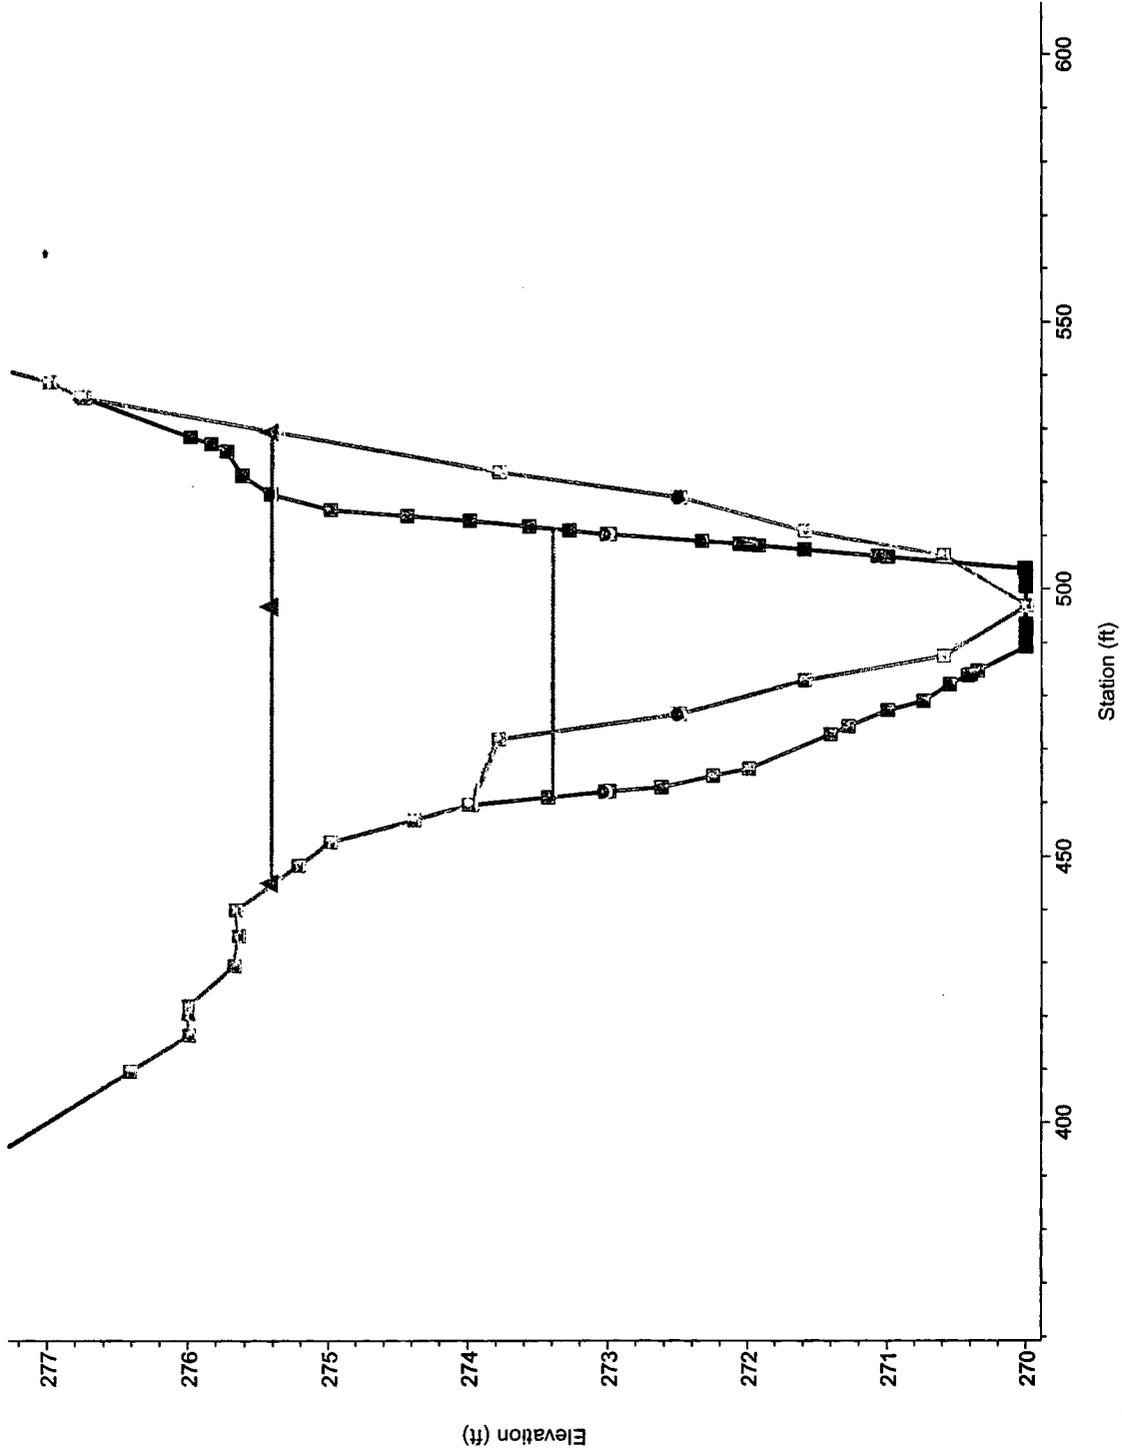
# Lower Spring Branch 100-YR WS Comparison

Reach: Mainstem Cross Section Station: 2602

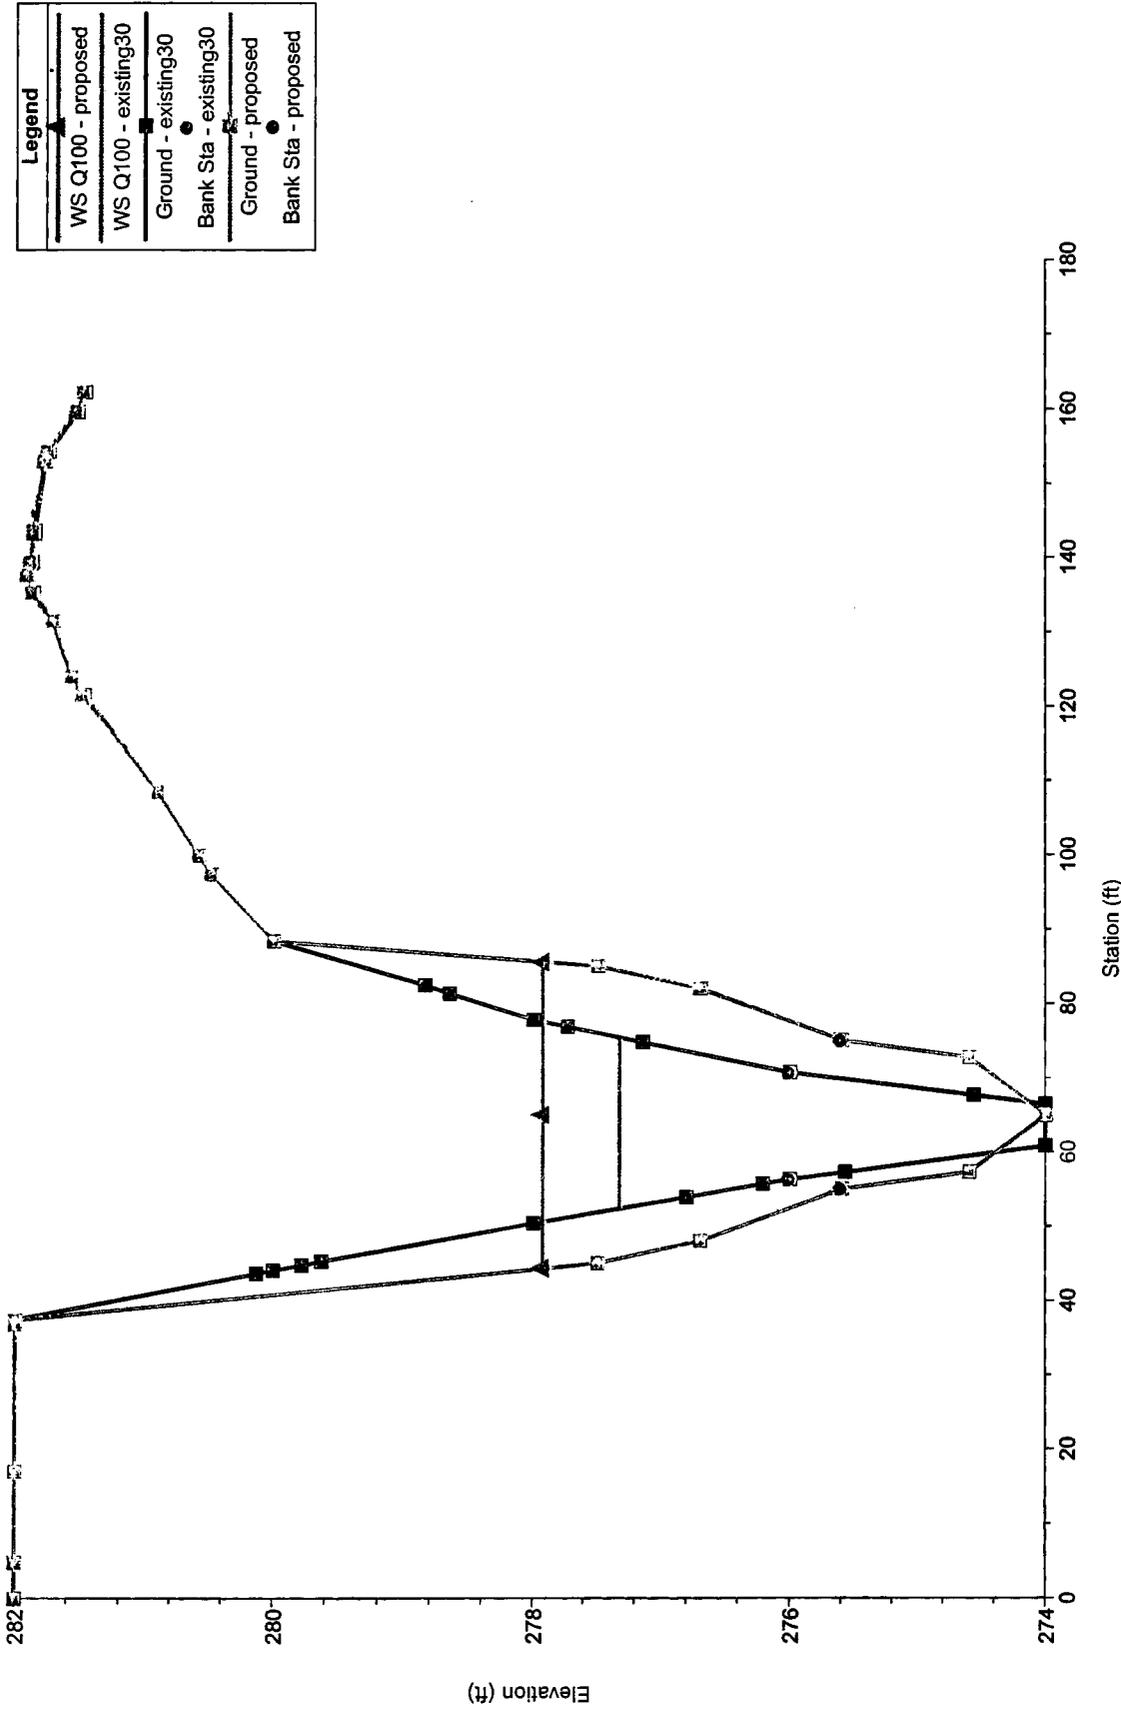
# Lower Spring Branch 100-YR WS Comparison

Reach: Tributary B Cross Section Station: 394

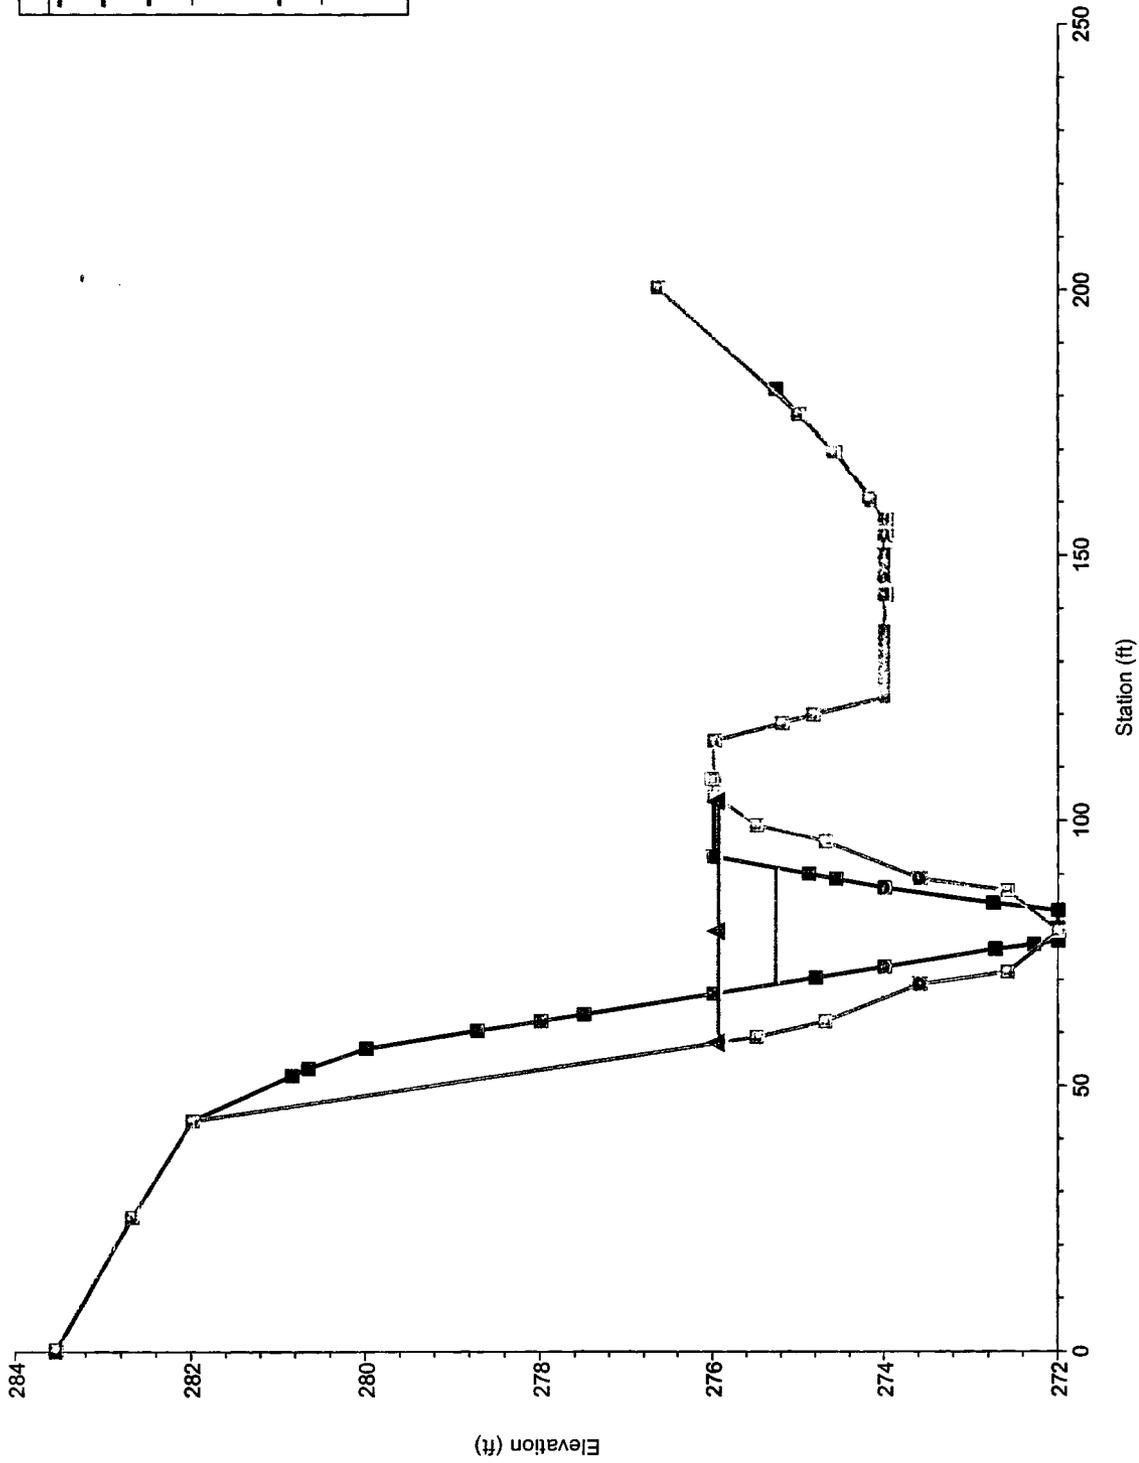
# Lower Spring Branch 100-YR WS Comparison

Reach: Tributary B Cross Section Station: 291

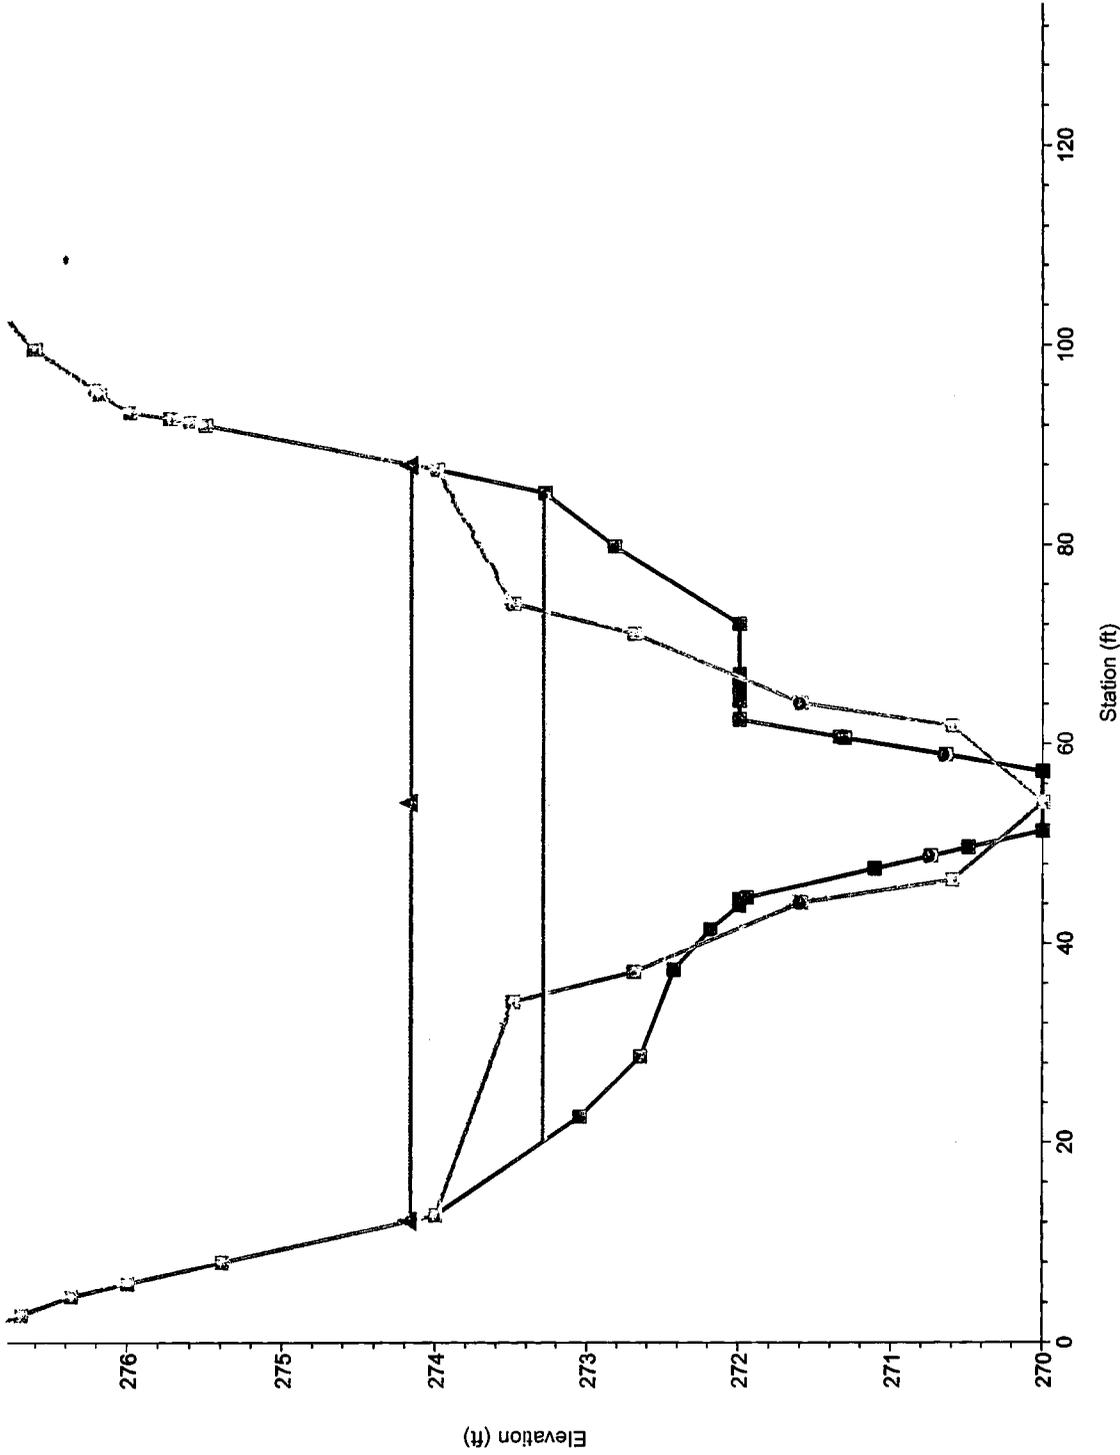
# Lower Spring Branch 100-YR WS Comparison

Reach: Tributary B Cross Section Station: 166

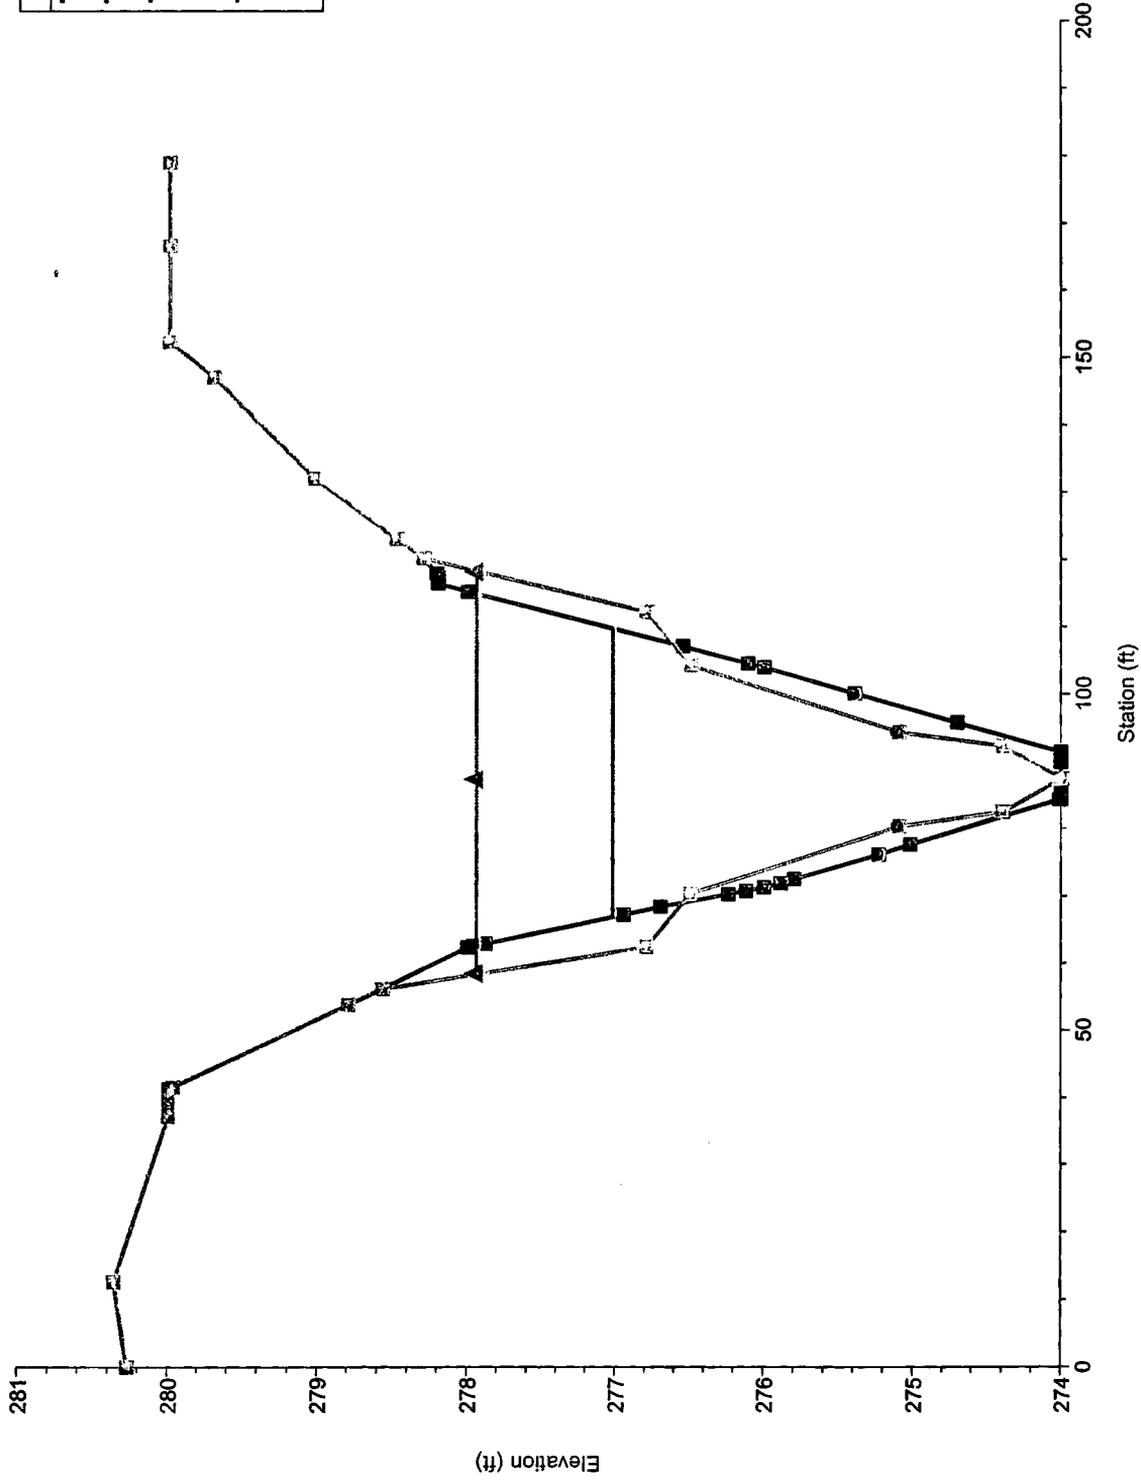
# Lower Spring Branch 100-YR WS Comparison

Reach: Tributary A Cross Section Station: 314

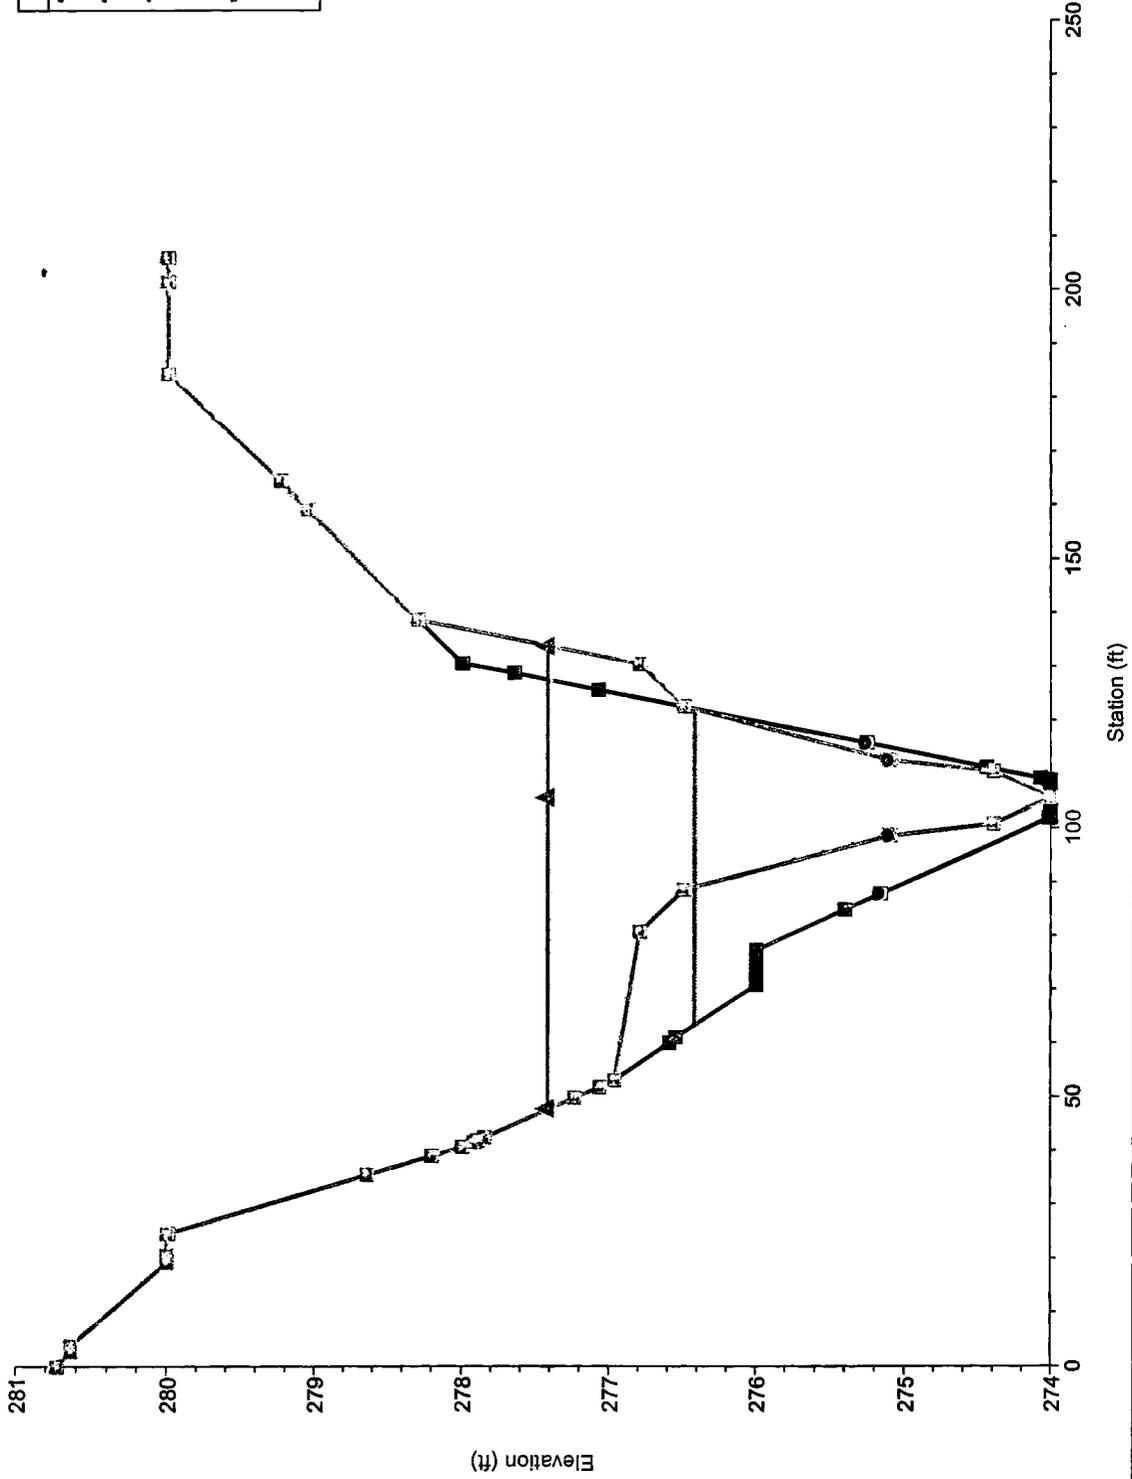
# Lower Spring Branch 100-YR WS Comparison

Reach: Tributary A Cross Section Station: 258

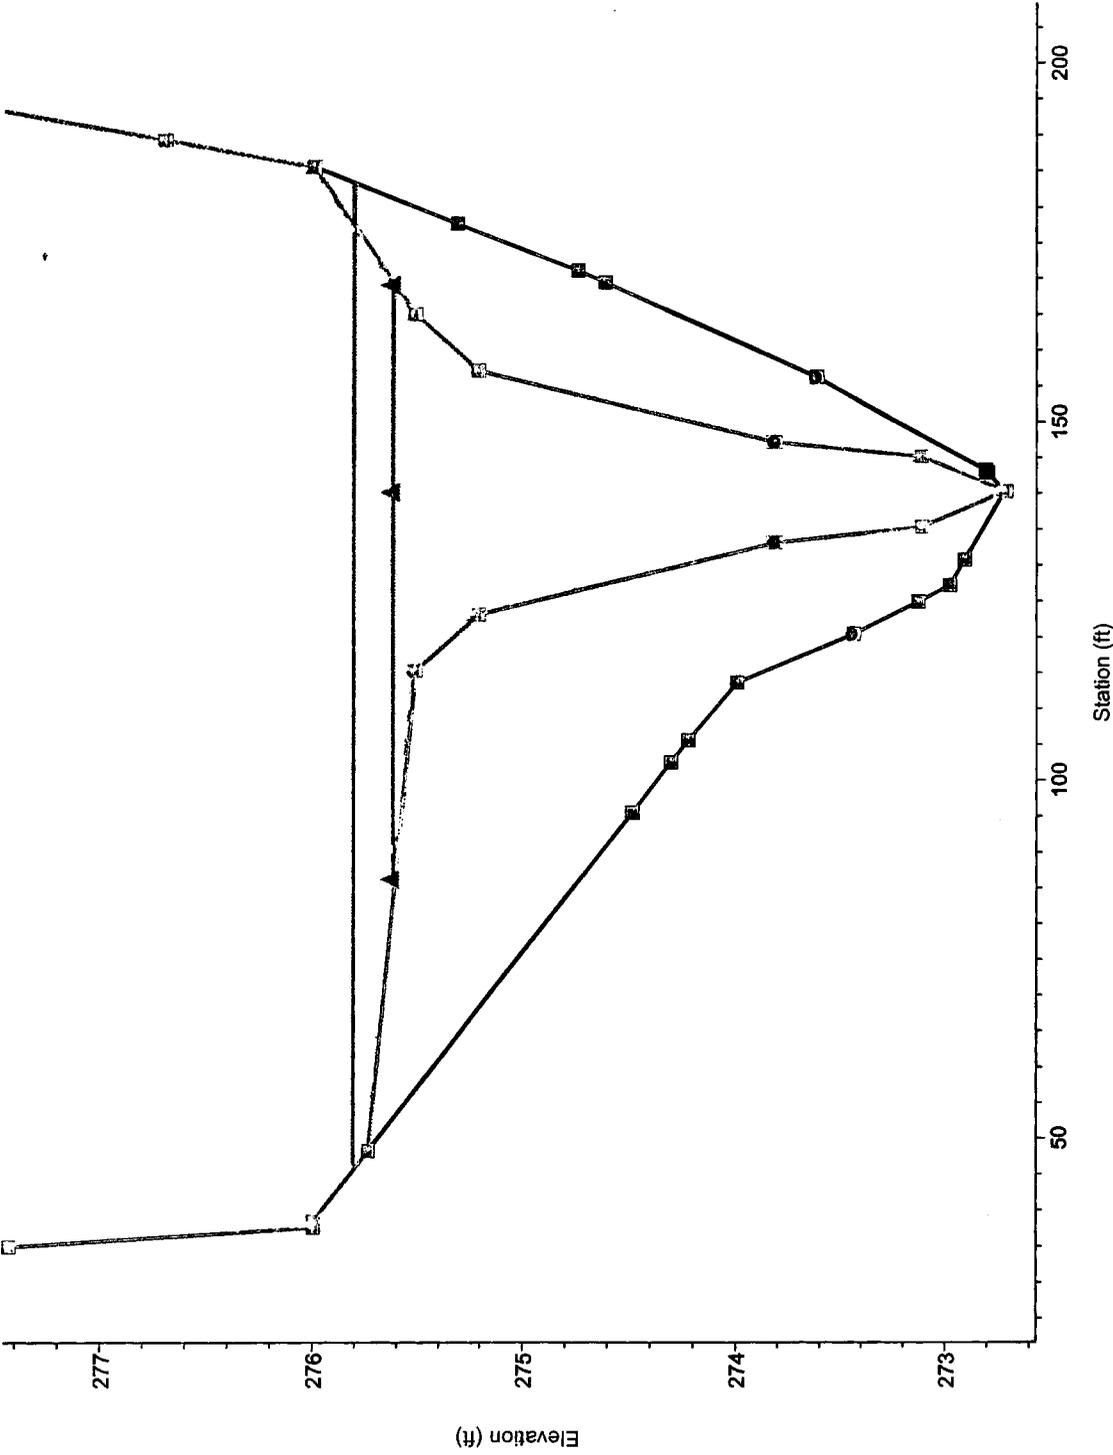
# Lower Spring Branch 100-YR WS Comparison

Reach: Tributary A Cross Section Station: 172

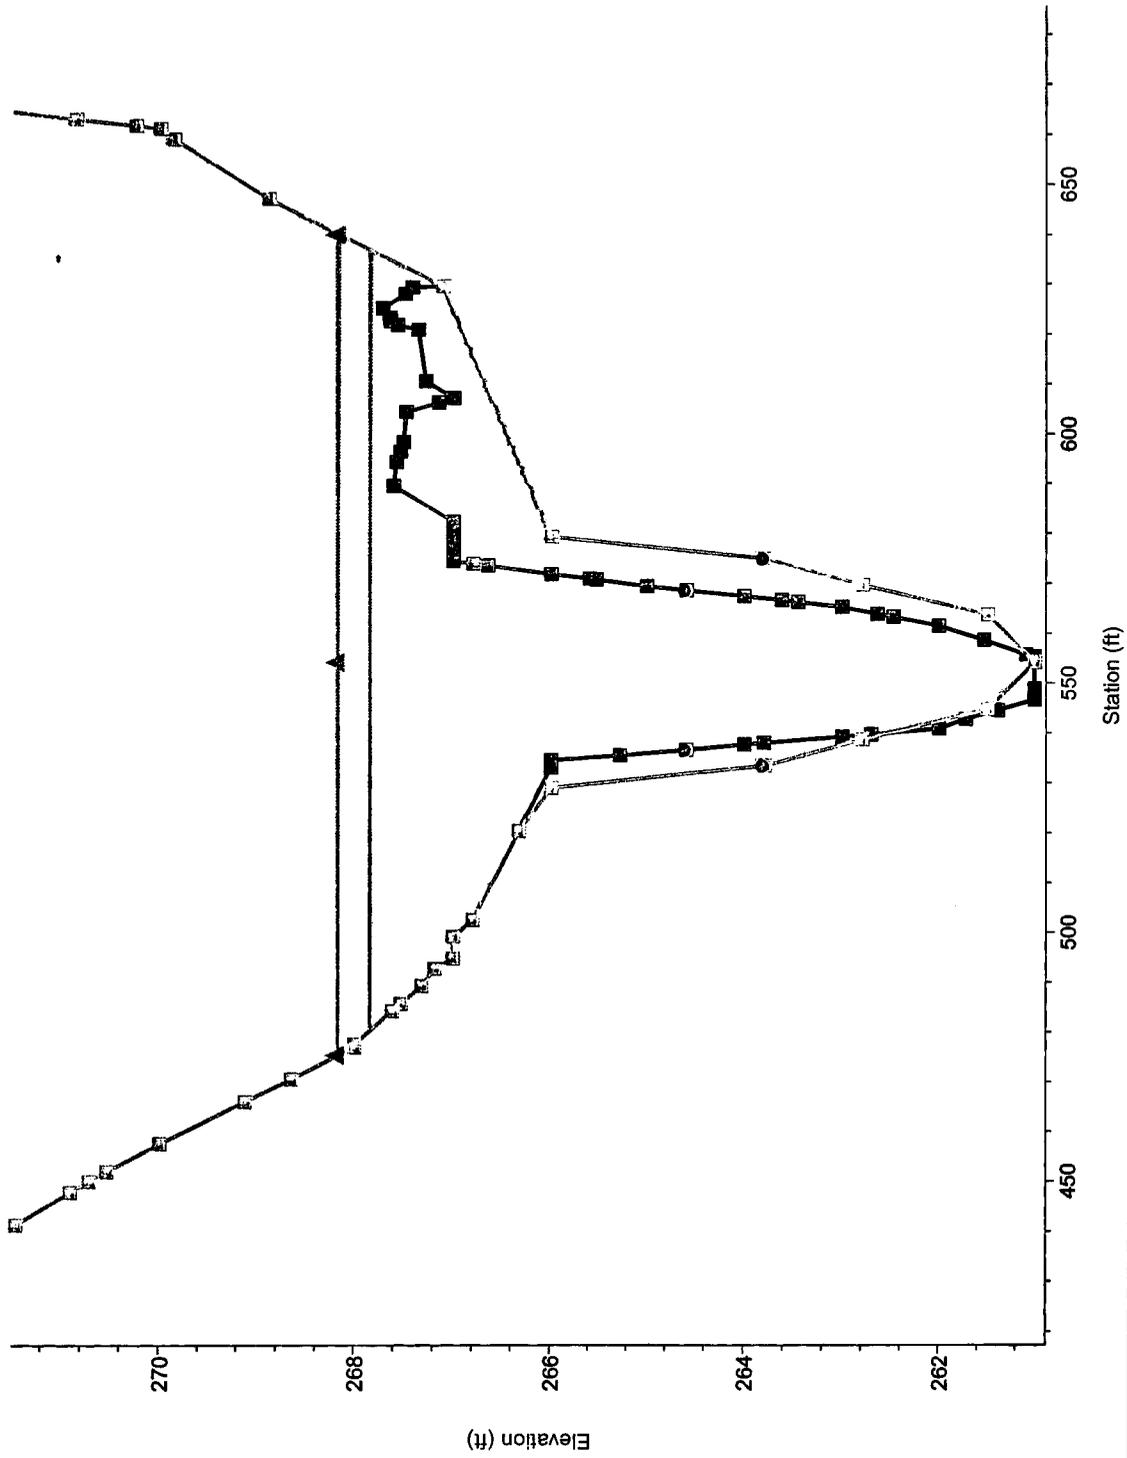
# Lower Spring Branch 100-YR WS Comparison

Reach: Mainstem Cross Section Station: 1939

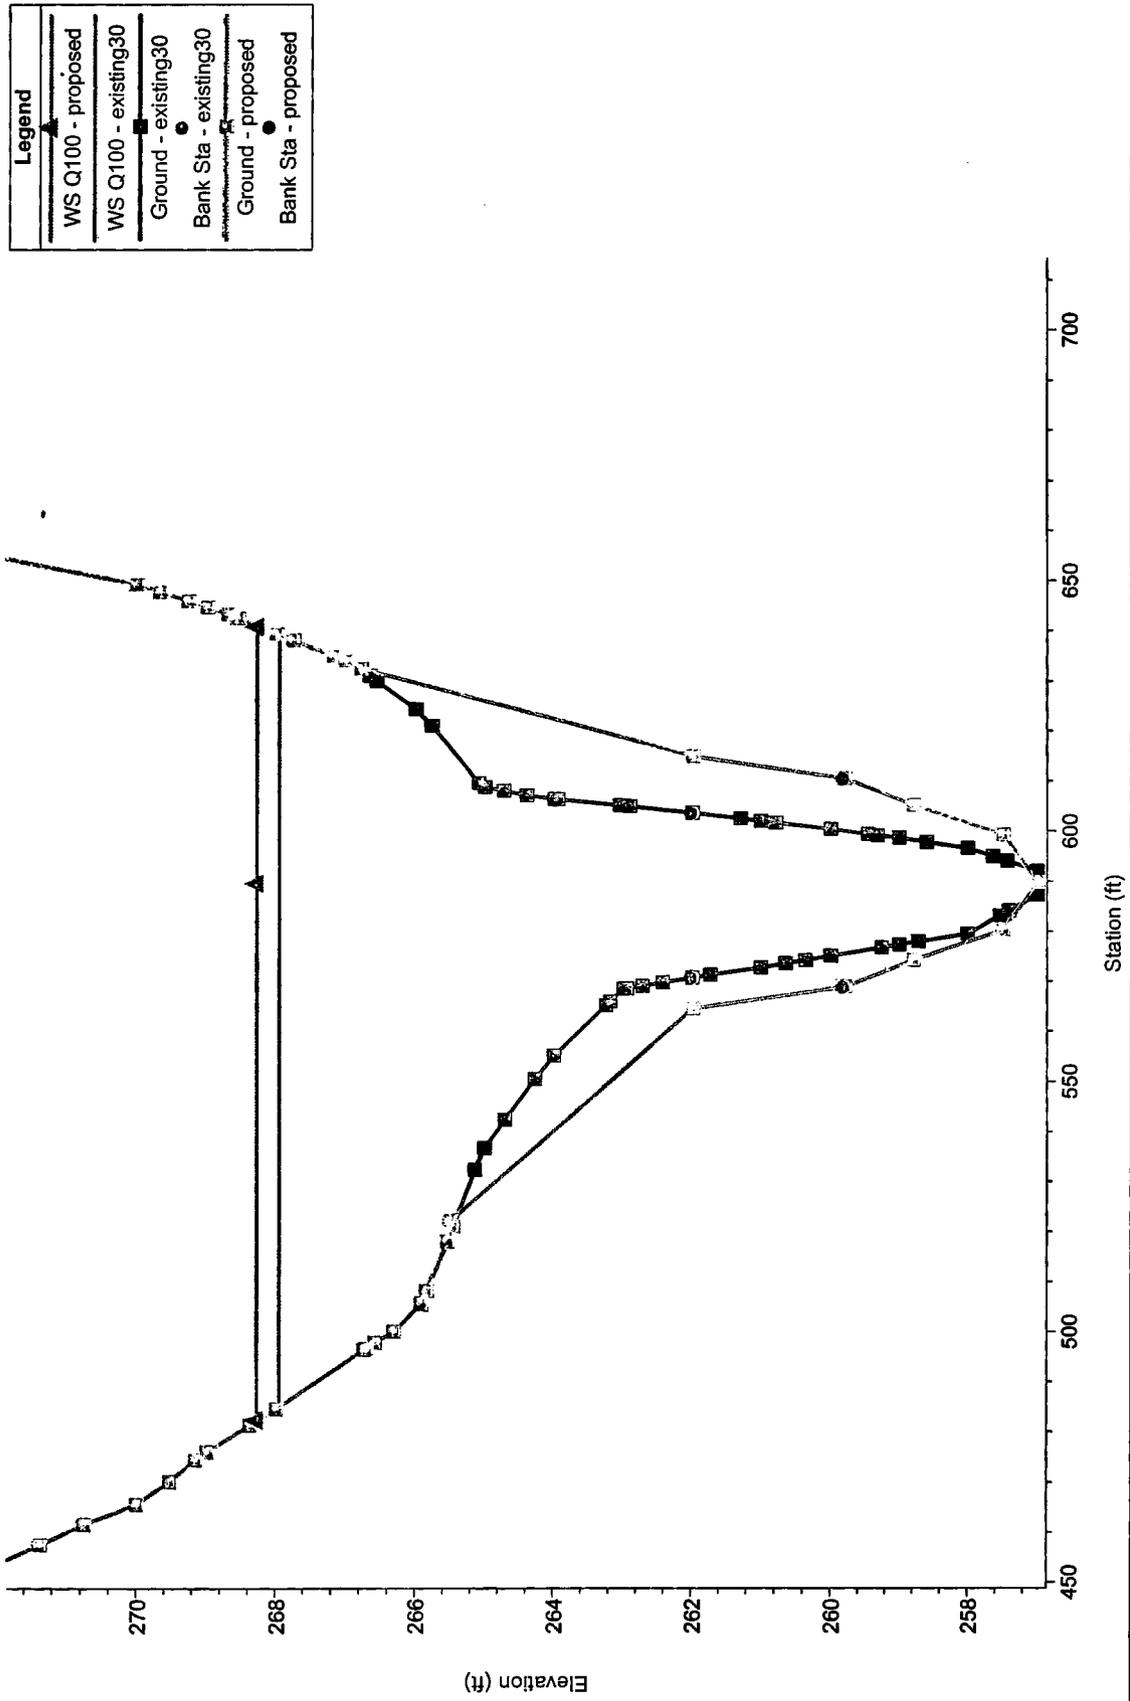
# Lower Spring Branch 100-YR WS Comparison

Reach: Mainstem Cross Section Station: 1554

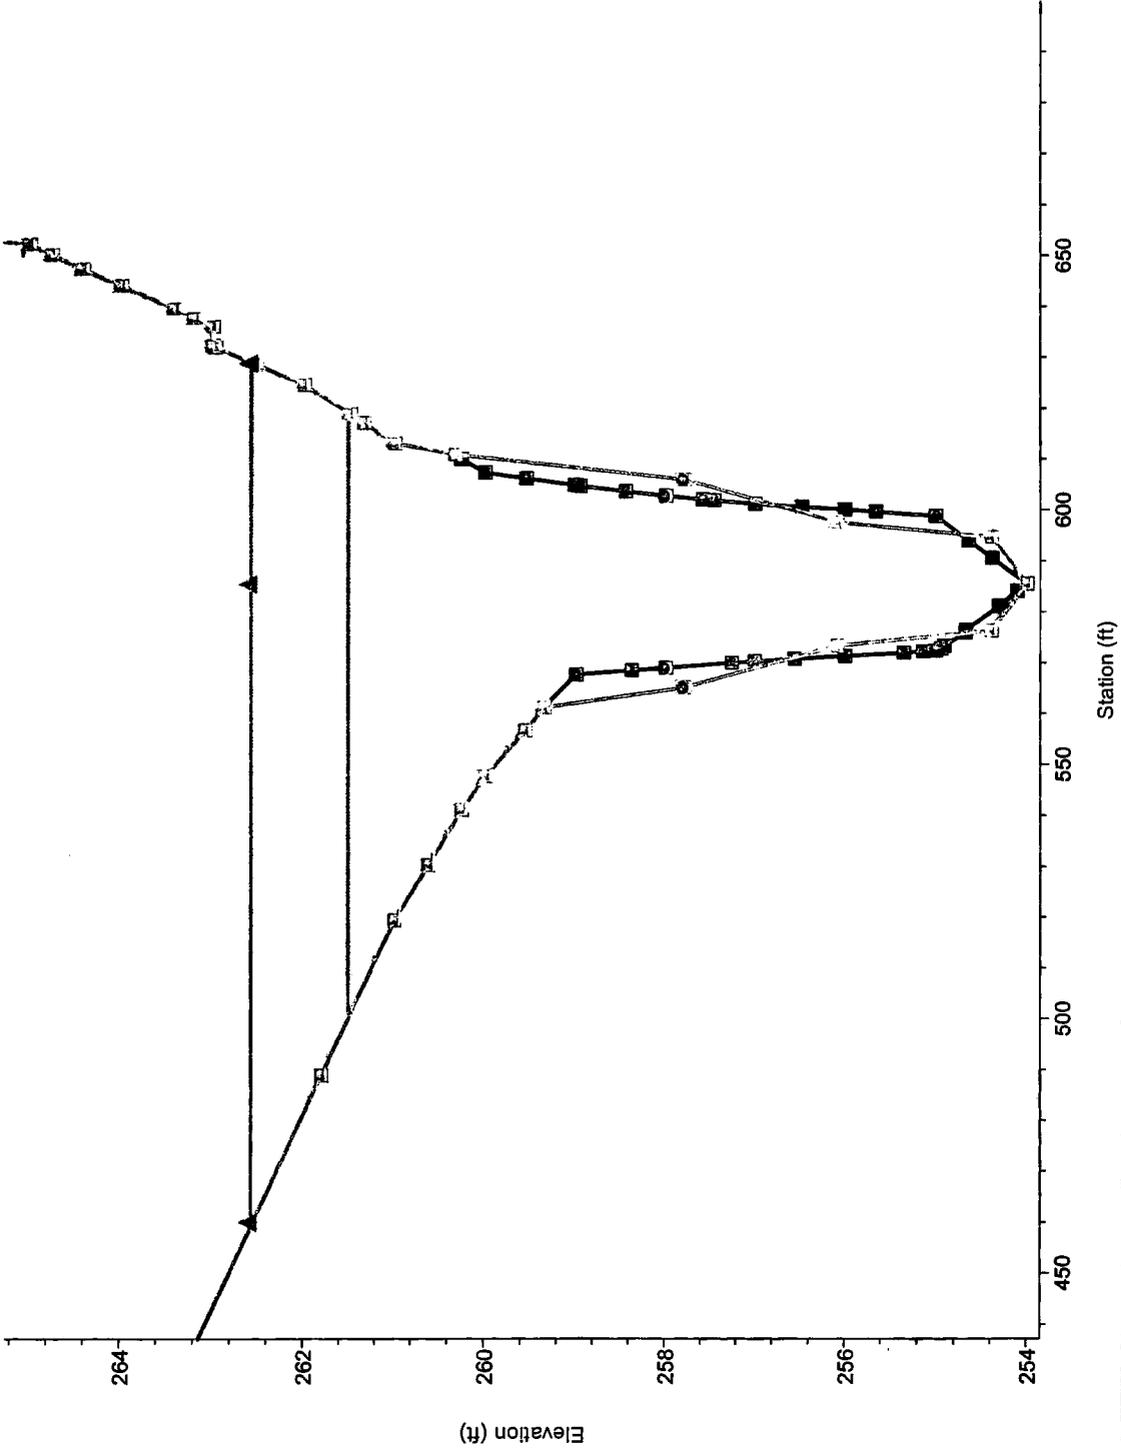
# Lower Spring Branch 100-YR WS Comparison

Reach: Mainstem Cross Section Station: 1038

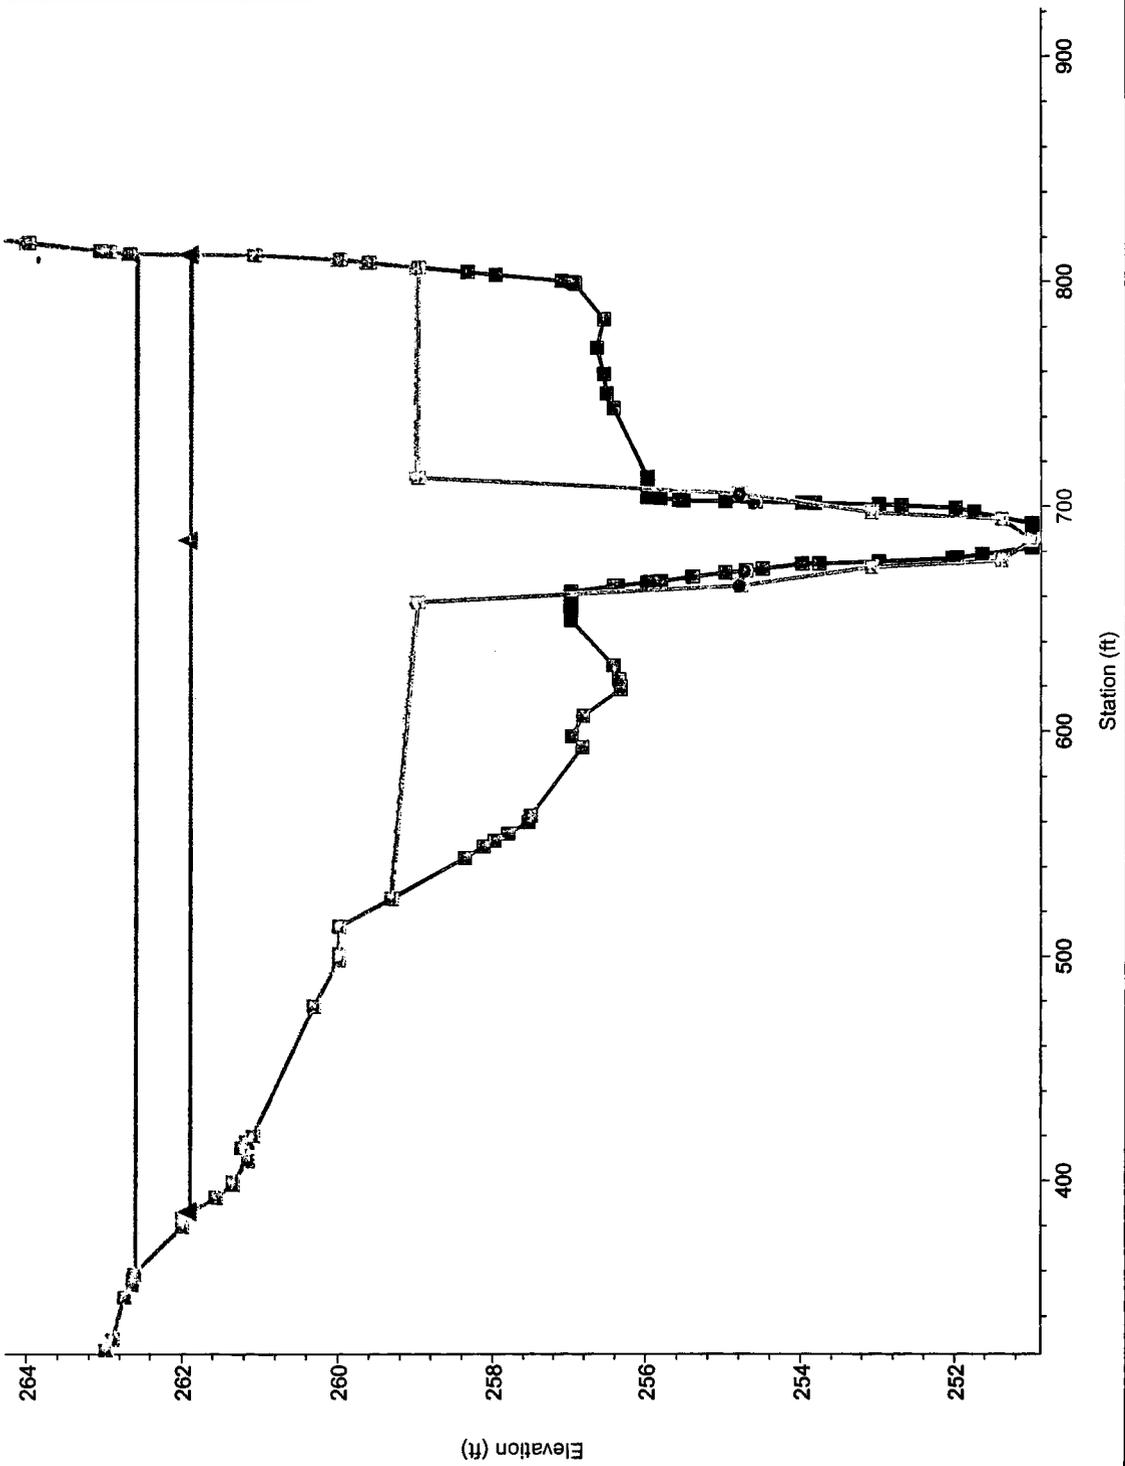
# Lower Spring Branch 100-YR WS Comparison

Reach: Mainstem Cross Section Station: 749
