# Spring Branch Subwatershed - Small Watershed Action Plan

(Addendum to the Water Quality Management Plan for Loch Raven Watershed)

Prepared by  
**Baltimore County**  
Department of Environmental Protection and Resource Management  
401 Bosley Avenue, Suite 416, Towson, MD 21204

March 17, 2008

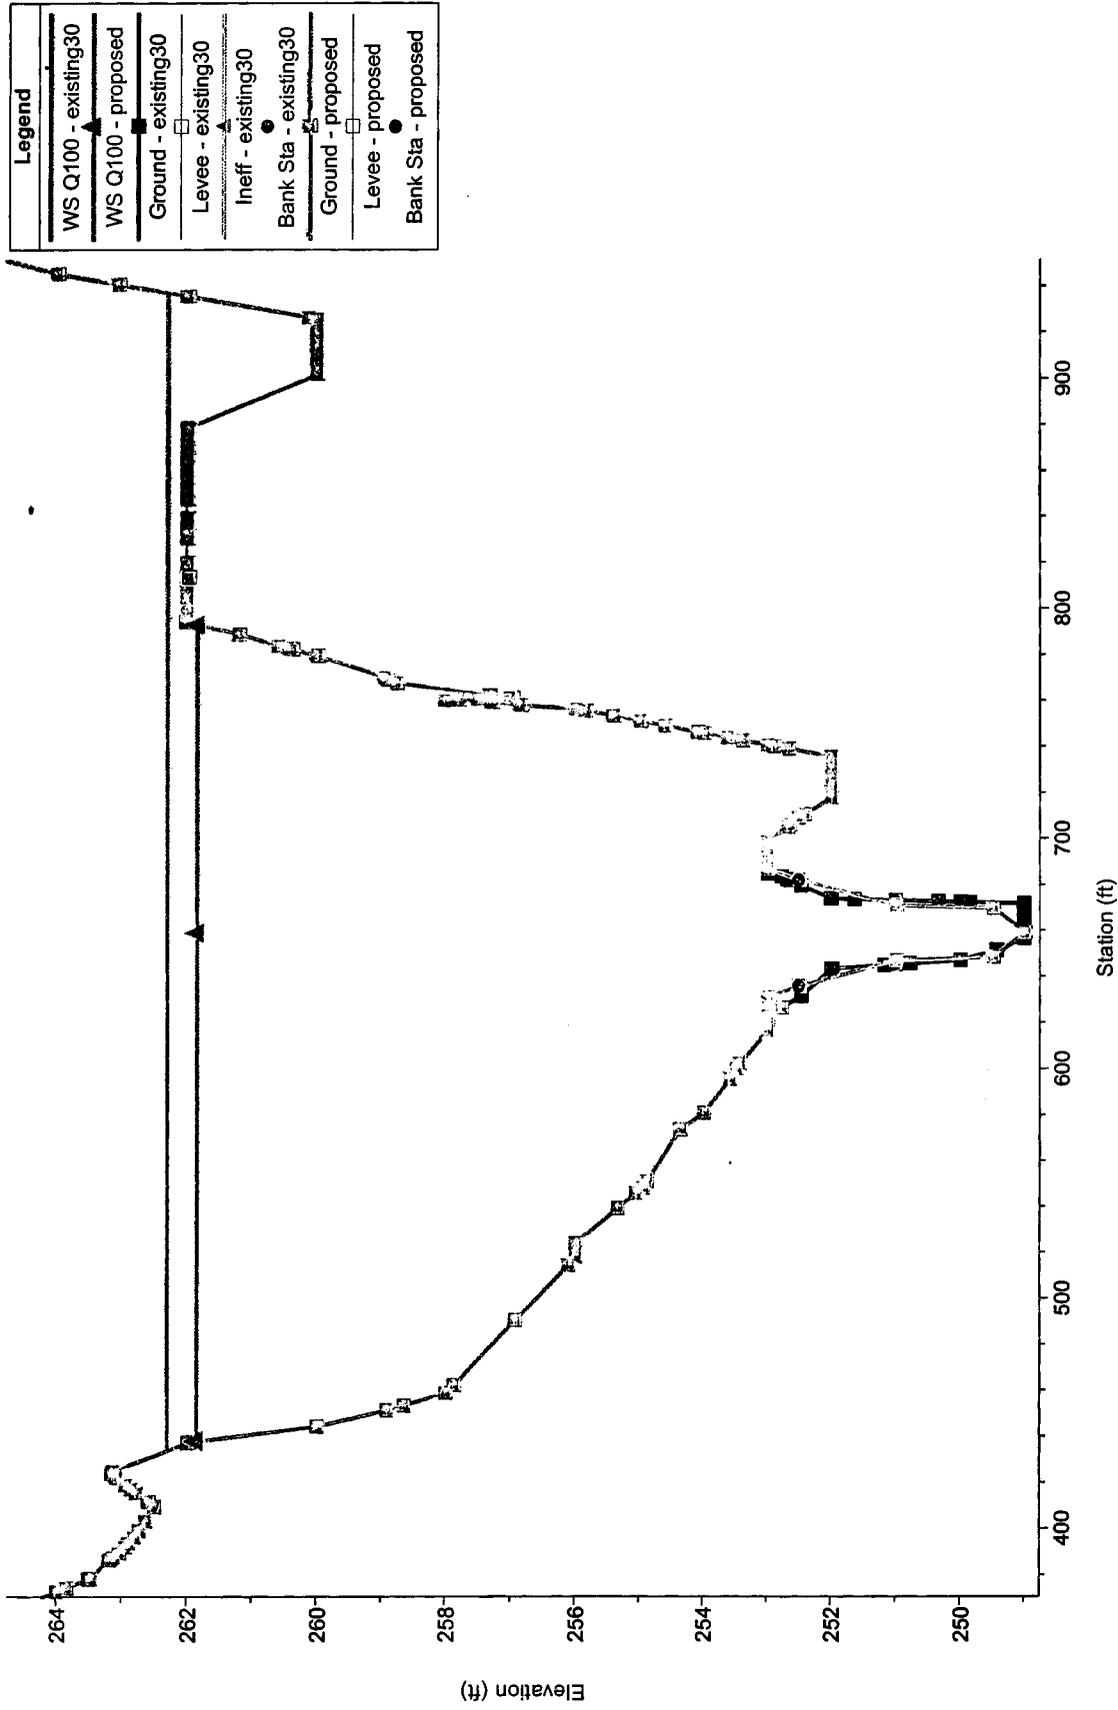
# Lower Spring Branch 100-YR WS Comparison

Reach: Mainstem Cross Section Station: 258

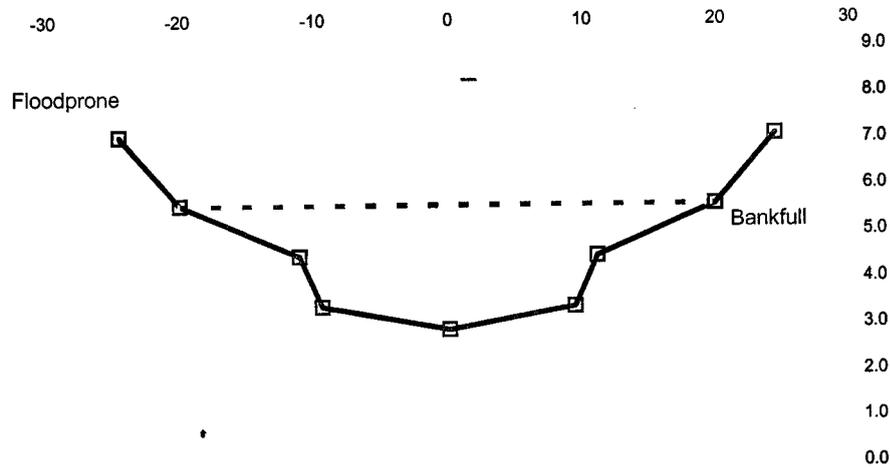
## Reach 1 High BKF UPS Trib A&B Bc Channel

<i>Bankfull</i>	<i>Floodprone</i>
<i>Max Depth</i>	2.70 ft.	5.40 ft.
<i>Manning's 'n'</i>	0.035	0.060
<i>slope</i>	1.14%	n/a
<i>Q</i>	367.04 ft <sup>3</sup> /s	1946.43 ft <sup>3</sup> /s
<i>V<sub>avg</sub></i>	5.98 ft/s	9.98 ft/s
<i>R<sub>h</sub></i>	1.51	0.28
<i>Entrenchment</i>	1.34	n/a
<i>W/D Ratio</i>	25.82	n/a
<i>Avg. Depth</i>	1.54 ft	3.66 ft
<i>Avg. Shear</i>	1.08 lbs/ft <sup>2</sup>

<i>Increment change</i>	<i>offset</i>	<i>elevation</i>	<b>40.61 ft</b>	<b>61.34 ft<sup>2</sup></b>	<b>39.80 ft</b>	<b>54.84 ft</b>	<b>195.10 ft<sup>2</sup></b>	<b>53.30 ft</b>
1								
0.1	-24.4	7.1	0.00 ft	0.00 ft <sup>2</sup>	0.00 ft	4.74 ft	8.77 ft	4.50 ft
	-19.9	5.6	0.00 ft	0.00 ft <sup>2</sup>	0.00 ft	4.74 ft	8.77	4.50 ft
<u><i>side slope</i></u>	-11.1	4.5	8.87 ft	4.84 ft <sup>2</sup>	8.80 ft	8.87 ft	28.59	8.80 ft
<b>1.55:1</b>	-9.4	3.4	2.02 ft	2.80 ft <sup>2</sup>	1.70 ft	2.02 ft	7.39	1.70 ft
<b>65%</b>	0.0	2.9	9.41 ft	23.03 ft <sup>2</sup>	9.40 ft	9.41 ft	48.40	9.40 ft
	9.4	3.4	9.41 ft	23.03 ft <sup>2</sup>	9.40 ft	9.41 ft	48.40	9.40 ft
	11.1	4.5	2.02 ft	2.80 ft <sup>2</sup>	1.70 ft	2.02 ft	7.39	1.70 ft
	19.9	5.6	8.87 ft	4.84 ft <sup>2</sup>	8.80 ft	8.87 ft	28.59	8.80 ft
	24.4	7.1	0.00 ft	0.00 ft <sup>2</sup>	0.00 ft	4.74 ft	8.77	4.50 ft

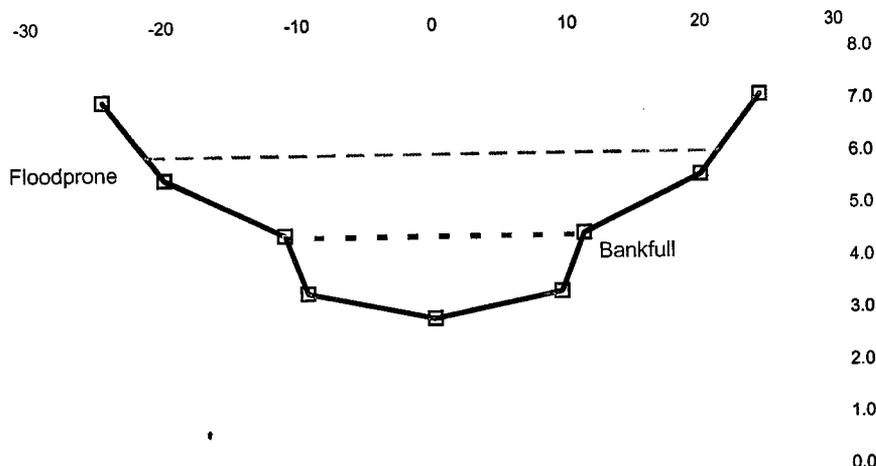
## Reach 1 Low BKF UPS Trib A&B Bc Channel

<i>Bankfull</i>	<i>Floodprone</i>
<i>Max Depth</i>	1.57 ft.	3.15 ft.
<i>Manning's 'n'</i>	0.035	0.060
<i>slope</i>	1.14%	n/a
<i>Q</i>	134.58 ft <sup>3</sup> /s	389.48 ft <sup>3</sup> /s
<i>V<sub>avg</sub></i>	5.05 ft/s	4.87 ft/s
<i>R<sub>h</sub></i>	1.17	0.56
<i>Entrenchment</i>	1.98	n/a
<i>W/D Ratio</i>	18.35	n/a
<i>Avg. Depth</i>	1.21 ft	1.83 ft
<i>Avg. Shear</i>	0.83 lbs/ft <sup>2</sup>

<b>22.78 ft</b>	<b>26.66 ft<sup>2</sup></b>	<b>22.12 ft</b>	<b>44.85 ft</b>	<b>80.03 ft<sup>2</sup></b>	<b>43.82 ft</b>
0.1	-24.4	7.1	0.00 ft	0.00 ft	0.00 ft	1.41 ft	0.30 ft	1.34 ft
	-19.9	5.6	0.00 ft	0.00 ft <sup>2</sup>	0.00 ft	1.41 ft	0.30	1.34 ft
<u>side slope</u>	-11.1	4.5	0.00 ft	0.00 ft <sup>2</sup>	0.00 ft	8.87 ft	8.77	8.80 ft
1.55:1	-9.4	3.4	1.98 ft	0.89 ft <sup>2</sup>	1.66 ft	2.02 ft	3.56	1.70 ft
65%	0.0	2.9	9.41 ft	12.44 ft <sup>2</sup>	9.40 ft	9.41 ft	27.23	9.40 ft
	9.4	3.4	9.41 ft	12.44 ft <sup>2</sup>	9.40 ft	9.41 ft	27.23	9.40 ft
	11.1	4.5	1.98 ft	0.89 ft <sup>2</sup>	1.66 ft	2.02 ft	3.56	1.70 ft
	19.9	5.6	0.00 ft	0.00 ft <sup>2</sup>	0.00 ft	8.87 ft	8.77	8.80 ft
	24.4	7.1	0.00 ft	0.00 ft <sup>2</sup>	0.00 ft	1.41 ft	0.30	1.34 ft

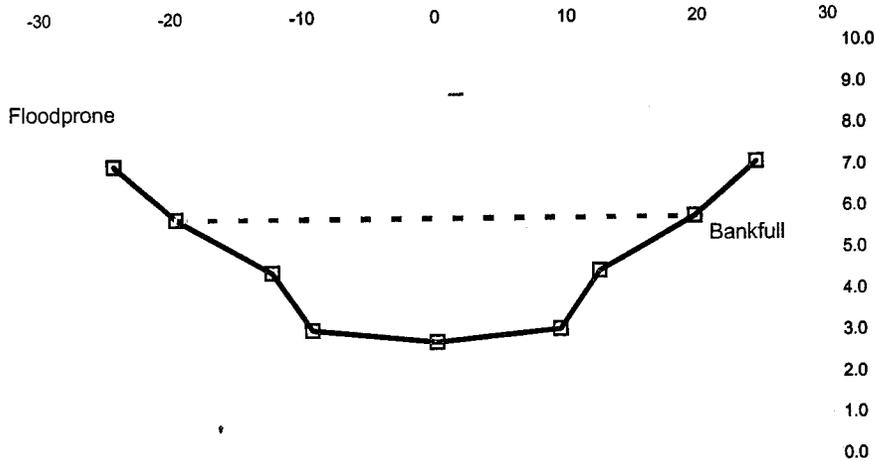
**Reach 2 High BKF**  
**UPS Trib A&B Bc Channel**

<b>Bankfull</b>	<b>Floodprone</b>
Max Depth	2.99 ft.	5.97 ft.
Manning's 'n'	0.035	0.060
slope	1.14%	n/a
Q	512.34 ft <sup>3</sup> /s	2386.38 ft <sup>3</sup> /s
V <sub>avg</sub>	6.87 ft/s	10.61 ft/s
R <sub>h</sub>	1.86	0.24
Entrenchment	1.36	n/a
W/D Ratio	20.67	n/a
Avg. Depth	1.90 ft	4.21 ft
Avg. Shear	1.32 lbs/ft <sup>2</sup>

<b>Increment change</b>	<b>offset</b>	<b>elevation</b>	<b>40.11 ft</b>	<b>74.56 ft<sup>2</sup></b>	<b>39.25 ft</b>	<b>54.89 ft</b>	<b>225.02 ft<sup>2</sup></b>	<b>53.50 ft</b>	
1	0.1	-24.4	7.1	0.00 ft	0.00 ft	0.00 ft	4.88 ft	10.92 ft	4.70 ft
		-19.7	5.8	0.00 ft	0.00 ft <sup>2</sup>	0.00 ft	4.88 ft	10.92	4.70 ft
<b>side slope</b>		-12.4	4.5	7.34 ft	4.65 ft <sup>2</sup>	7.23 ft	7.41 ft	26.46	7.30 ft
<b>2.14:1</b>		-9.4	3.1	3.31 ft	5.96 ft <sup>2</sup>	3.00 ft	3.31 ft	14.92	3.00 ft
<b>47%</b>		0.0	2.8	9.40 ft	26.67 ft <sup>2</sup>	9.40 ft	9.40 ft	54.75	9.40 ft
		9.4	3.1	9.40 ft	26.67 ft <sup>2</sup>	9.40 ft	9.40 ft	54.75	9.40 ft
		12.4	4.5	3.31 ft	5.96 ft <sup>2</sup>	3.00 ft	3.31 ft	14.92	3.00 ft
		19.7	5.8	7.34 ft	4.65 ft <sup>2</sup>	7.23 ft	7.41 ft	26.46	7.30 ft
		24.4	7.1	0.00 ft	0.00 ft <sup>2</sup>	0.00 ft	4.88 ft	10.92	4.70 ft

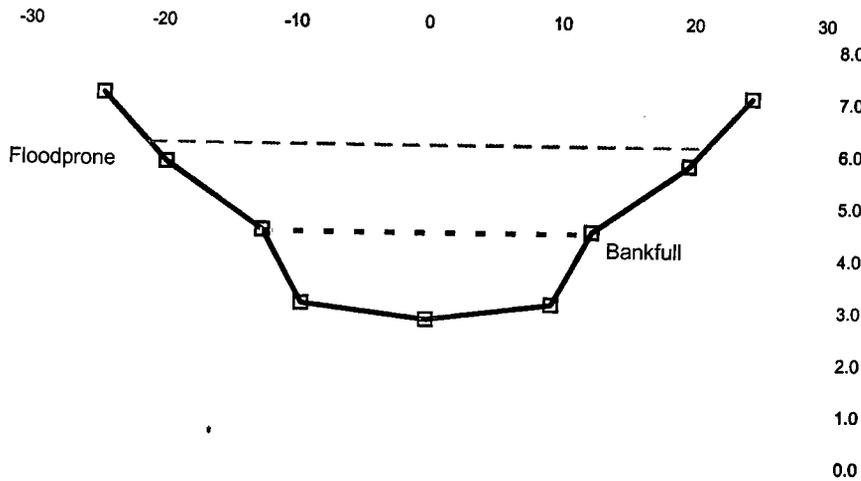
## Reach 2 Low BKF UPS Trib A&B Bc Channel

<b>Bankfull</b>	<b>Floodprone</b>
<i>Max Depth</i>	1.68 ft.	3.36 ft.
<i>Manning's 'n'</i>	0.035	0.060
<i>slope</i>	1.14%	n/a
<i>Q</i>	177.53 ft <sup>3</sup> /s	493.25 ft <sup>3</sup> /s
<i>V<sub>avg</sub></i>	5.40 ft/s	5.48 ft/s
<i>R<sub>h</sub></i>	1.30	0.49
<i>Entrenchment</i>	1.75	n/a
<i>W/D Ratio</i>	18.60	n/a
<i>Avg. Depth</i>	1.33 ft	2.08 ft
<i>Avg. Shear</i>	0.92 lbs/ft <sup>2</sup>

<b>Bankfull</b>			<b>Floodprone</b>		
	<i>Wetted Perimeter</i>	<i>Cross Sectional Area</i>	<i>Top Width</i>	<i>Wetted Perimeter</i>	<i>Cross Sectional Area</i>	<i>Top Width</i>
<b>1</b>	<b>25.34 ft</b>	<b>32.85 ft<sup>2</sup></b>	<b>24.71 ft</b>	<b>44.31 ft</b>	<b>89.97 ft<sup>2</sup></b>	<b>43.31 ft</b>
<i>Increment change</i>	<i>offset</i>	<i>elevation</i>				
0.1	-24.4	7.1	0.00 ft	1.35 ft	0.23 ft	1.30 ft
	-19.7	5.8	0.00 ft	1.35 ft	0.23	1.30 ft
<i>side slope</i>	-12.4	4.5	0.00 ft	7.41 ft	7.38	7.30 ft
<b>2.14:1</b>	-9.4	3.1	3.26 ft	3.31 ft	7.08	3.00 ft
<b>47%</b>	0.0	2.8	9.40 ft	9.40 ft	30.18	9.40 ft
	9.4	3.1	9.40 ft	9.40 ft	30.18	9.40 ft
	12.4	4.5	3.26 ft	3.31 ft	7.08	3.00 ft
	19.7	5.8	0.00 ft	7.41 ft	7.38	7.30 ft
	24.4	7.1	0.00 ft	1.35 ft	0.23	1.30 ft

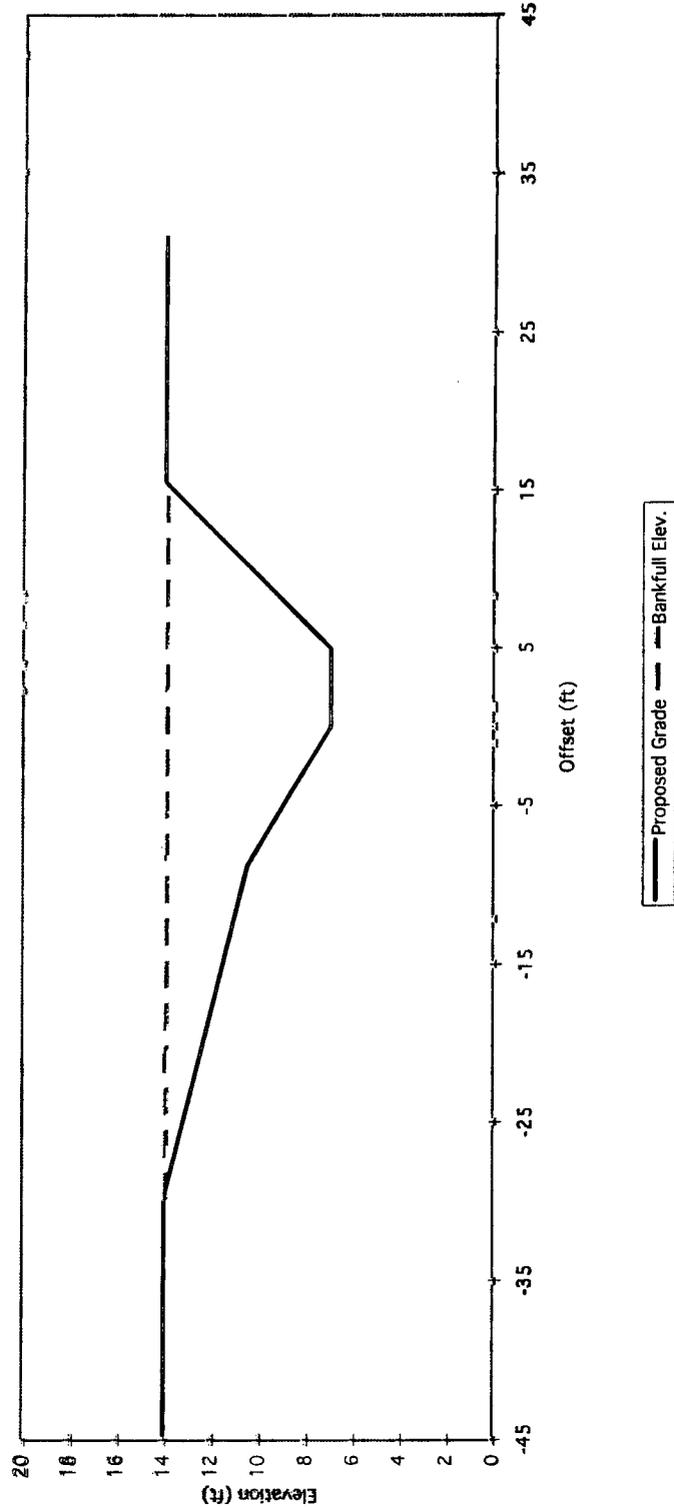
**Typical Meander Cross Section  
Reach 1 and 2**

Meander Channel Dimensions		
Meander Width	45.3 ft	Ratio to Riffle 3.38
Wetted Perimeter	48.3 ft	2.49
Hydraulic Radius	3.2 ft	1.29
Area	154.4 ft <sup>2</sup>	3.21
Max Pool Depth	7.0 ft	1
Bar Slope	6.0:1	
Bar Toe Slope	2.5:1	
Outer Bank Angle	1.50:1

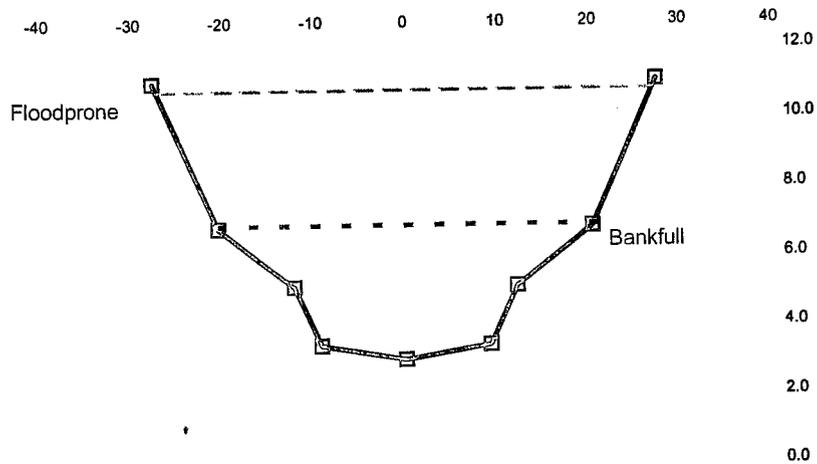
**Reach 3 High BKF**  
DS Trib A&B Bc Channel Entree

<b>Bankfull</b>	<b>Floodprone</b>
Max Depth	3.88 ft.	7.76 ft.
Manning's 'n'	0.035	0.060
slope	0.50%	n/a
Q	517.65 ft <sup>3</sup> /s	1983.43 ft <sup>3</sup> /s
V <sub>avg</sub>	5.26 ft/s	6.69 ft/s
R <sub>h</sub>	2.31	0.22
Entrenchment	1.48	n/a
W/D Ratio	17.26	n/a
Avg. Depth	2.39 ft	4.87 ft
Avg. Shear	0.72 lbs/ft <sup>2</sup>

Increment change	offset	elevation	<b>Bankfull</b>			<b>Floodprone</b>		
			Wetted Perimeter	Cross Sectional Area	Top Width	Wetted Perimeter	Cross Sectional Area	Top Width
1			<b>42.55 ft</b>	<b>98.36 ft<sup>2</sup></b>	<b>41.20 ft</b>	<b>65.40 ft</b>	<b>296.29 ft<sup>2</sup></b>	<b>60.87 ft</b>

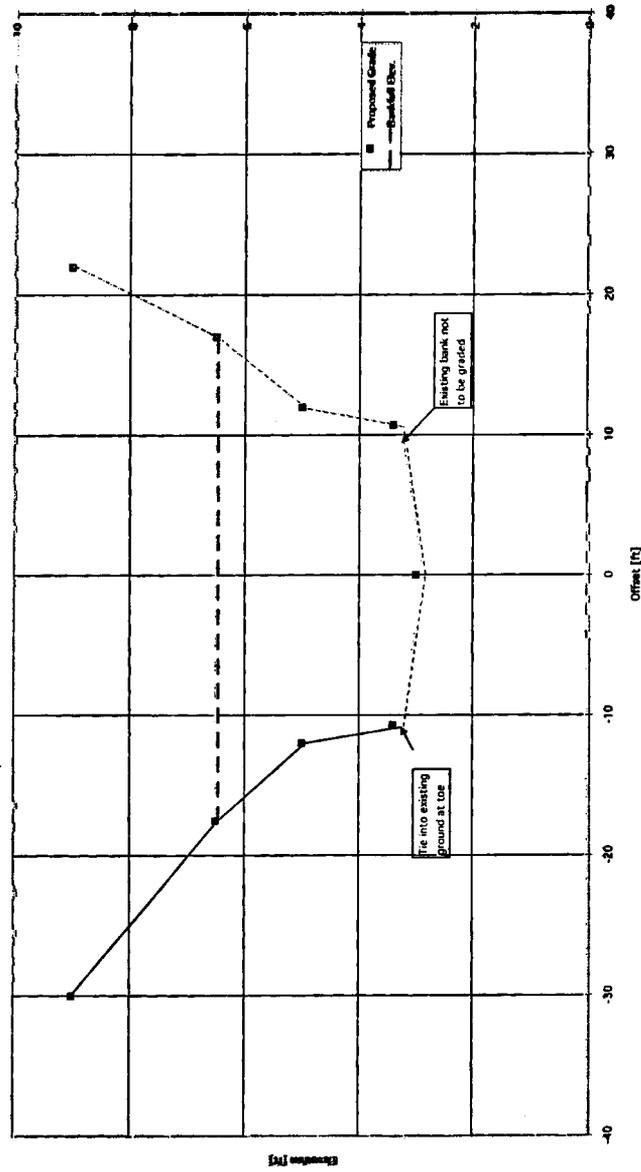
**Typical Riffle Cross Section**

Feature	Offset	Elevation	Cross Section Area [sq. ft.]	Wetted Perimeter [ft]
Floodprone	-30	9.0		
Bankfull	-12	6.5	2.99	2.06
		5.0	0.8	10.71
Max Depth	-10.7	3.4	35.31	10.71
	0	3.0	2.0	2.06
Bankfull	10.7	3.4	2.99	
Floodprone	12	6.5		
	17	9.0		
	22	9.0		
Total Area =			192.6	Wet Perimeter =
				54.80

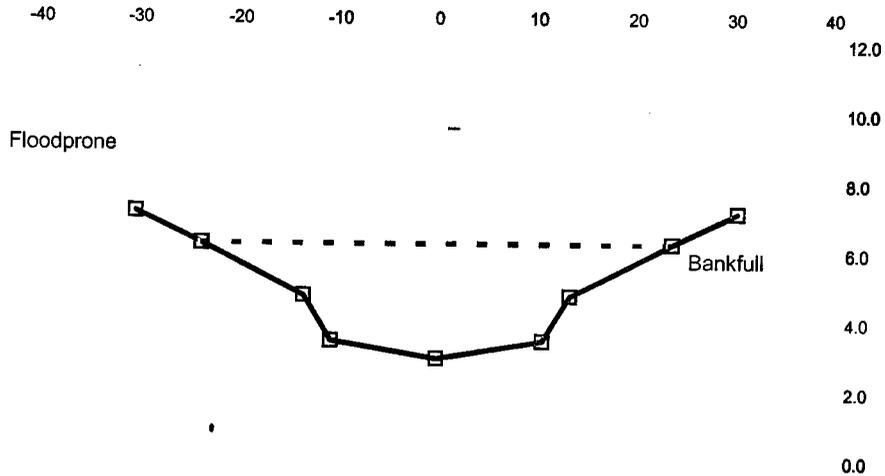
## Reach 4 High BKF DS Near Dulaney Valley C Channel

<b>Bankfull</b>	<b>Floodprone</b>
<i>Max Depth</i>	3.31 ft.	6.62 ft.
<i>Manning's 'n'</i>	0.035	0.060
<i>slope</i>	0.75%	n/a
<i>Q</i>	527.58 ft <sup>3</sup> /s	2774.26 ft <sup>3</sup> /s
<i>V<sub>avg</sub></i>	5.69 ft/s	9.05 ft/s
<i>R<sub>h</sub></i>	1.92	0.22
<i>Entrenchment</i>	1.41	n/a
<i>W/D Ratio</i>	24.43	n/a
<i>Avg. Depth</i>	1.95 ft	4.58 ft
<i>Avg. Shear</i>	0.90 lbs/ft <sup>2</sup>

<b>Bankfull</b>			<b>Floodprone</b>		
	<i>Wetted Perimeter</i>	<i>Cross Sectional Area</i>	<i>Top Width</i>	<i>Wetted Perimeter</i>	<i>Cross Sectional Area</i>	<i>Top Width</i>
<b>1</b>	<b>48.45 ft</b>	<b>92.79 ft<sup>2</sup></b>	<b>47.61 ft</b>	<b>68.22 ft</b>	<b>306.48 ft<sup>2</sup></b>	<b>67.20 ft</b>
<i>Increment change</i>	<i>offset</i>	<i>elevation</i>

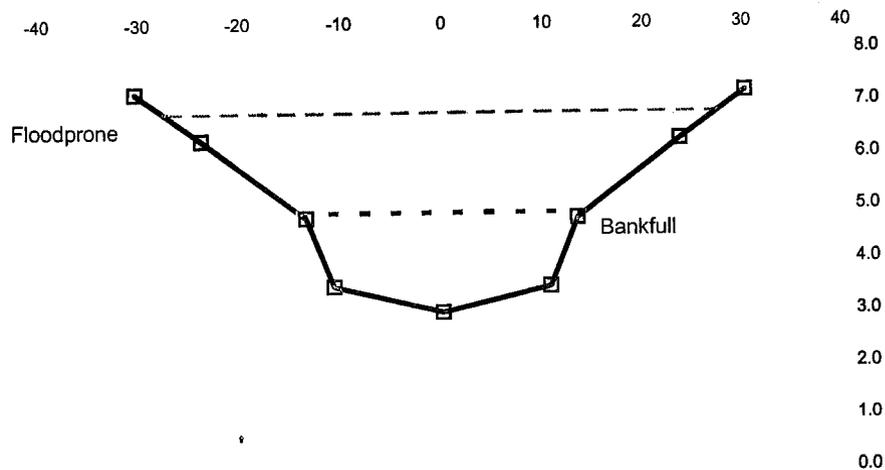
## Reach 4 Low BKF DS Near Dulaney Valley C Channel

<i>Bankfull</i>	<i>Floodprone</i>
<i>Max Depth</i>	1.91 ft.	3.81 ft.
<i>Manning's 'n'</i>	0.035	0.060
<i>slope</i>	0.75%	n/a
<i>Q</i>	180.27 ft <sup>3</sup> /s	505.48 ft <sup>3</sup> /s
<i>V<sub>avg</sub></i>	4.55 ft/s	4.23 ft/s
<i>R<sub>h</sub></i>	1.37	0.50
<i>Entrenchment</i>	2.08	n/a
<i>W/D Ratio</i>	20.17	n/a
<i>Avg. Depth</i>	1.40 ft	2.04 ft
<i>Avg. Shear</i>	0.64 lbs/ft <sup>2</sup>

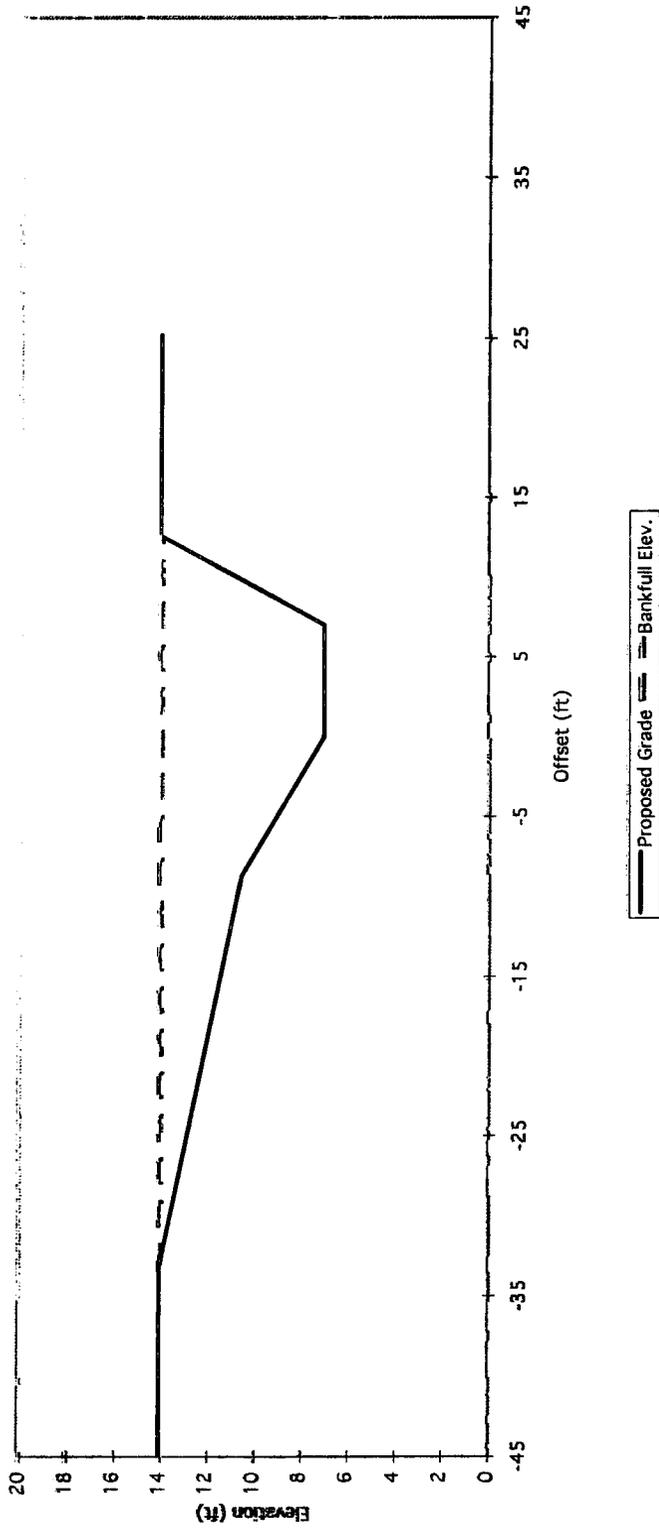
Typical Meander Cross Section  
Reach 4

Meander Channel Dimensions		
Meander Width	45.9 ft	Ratio to Riffle 3.42
Wetted Perimeter	50.1 ft	2.59
Hydraulic Radius	3.1 ft	1.27
Area	157.4 ft <sup>2</sup>	3.27
Max Pool Depth	7.0 ft	1
Bar Slope	7.0:1	
Bar Toe Slope	2.5:1	
Outer Bank Angle	.80:1

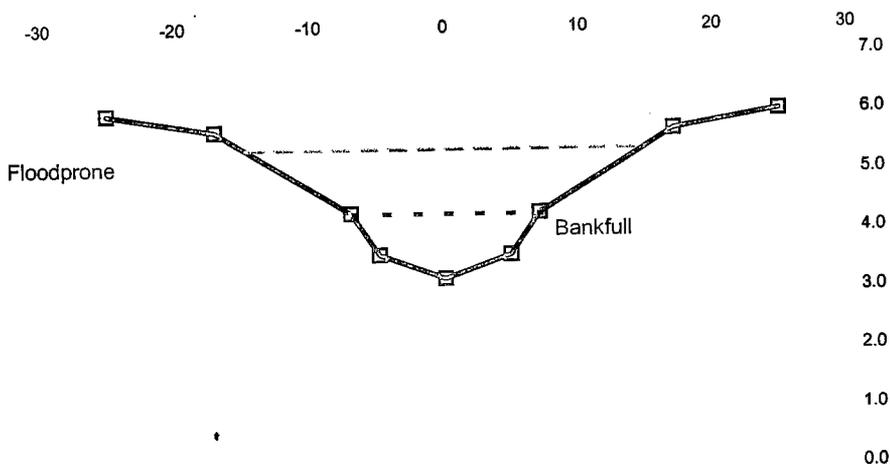
### Trib A Channel

<b>Bankfull</b>	<b>Floodprone</b>
Max Depth	1.09 ft.	2.19 ft.
Manning's 'n'	0.035	0.060
slope	1.14%	n/a
Q	37.19 ft <sup>3</sup> /s	120.19 ft <sup>3</sup> /s
V <sub>avg</sub>	3.64 ft/s	3.54 ft/s
R <sub>h</sub>	0.72	0.88
Entrenchment	2.12	n/a
W/D Ratio	19.11	n/a
Avg. Depth	0.73 ft	1.15 ft
Avg. Shear	0.51 lbs/ft <sup>2</sup>

1			14.22 ft	10.21 ft <sup>2</sup>	13.96 ft	29.96 ft	33.98 ft <sup>2</sup>	29.54 ft
<b>Increment change</b>	<b>offset</b>	<b>elevation</b>						
	0.1	-24.9	6.0	0.00 ft	0.00 ft	0.00 ft	0.00 ft	0.00 ft
		-17.0	5.7	0.00 ft	0.00 ft <sup>2</sup>	0.00 ft	0.00	0.00 ft
<b>side slope</b>		-7.0	4.3	0.00 ft	0.00 ft <sup>2</sup>	0.00 ft	7.85 ft	7.77 ft
		3.00:1	-4.9	3.6	2.19 ft	0.72 ft <sup>2</sup>	2.08 ft	2.10 ft
		33%	0.0	3.2	4.92 ft	4.38 ft <sup>2</sup>	4.90 ft	4.90 ft
			4.9	3.6	4.92 ft	4.38 ft <sup>2</sup>	4.90 ft	4.90 ft
			7.0	4.3	2.19 ft	0.72 ft <sup>2</sup>	2.08 ft	2.10 ft
			17.0	5.7	0.00 ft	0.00 ft <sup>2</sup>	0.00 ft	7.77 ft
			24.9	6.0	0.00 ft	0.00 ft <sup>2</sup>	0.00 ft	0.00 ft

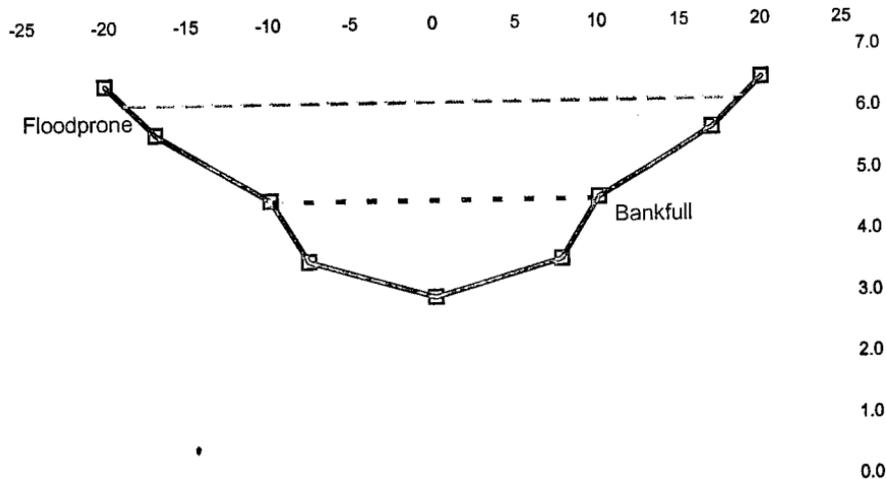
### Trib B Channel

<b>Bankfull</b>	<b>Floodprone</b>
<i>Max Depth</i>	1.59 ft.	3.18 ft.
<i>Manning's 'n'</i>	0.035	0.060
<i>slope</i>	1.90%	n/a
<i>Q</i>	136.76 ft <sup>3</sup> /s	427.75 ft <sup>3</sup> /s
<i>V<sub>avg</sub></i>	6.19 ft/s	6.15 ft/s
<i>R<sub>n</sub></i>	1.08	0.58
<i>Entrenchment</i>	1.97	n/a
<i>W/D Ratio</i>	18.01	n/a
<i>Avg. Depth</i>	1.11 ft	1.77 ft
<i>Avg. Shear</i>	1.28 lbs/ft <sup>2</sup>

<b>Increment change</b>	<b>offset</b>	<b>elevation</b>
0.1	-20.0	6.5
	-17.0	5.7
<b>side slope</b>	-10.0	4.6
<b>2.30:1</b>	-7.7	3.6
<b>43%</b>	0.0	3.0
	7.7	3.6
	10.0	4.6
	17.0	5.7
	20.0	6.5

<b>20.41 ft</b>	<b>22.10 ft<sup>2</sup></b>	<b>19.95 ft</b>	<b>40.20 ft</b>	<b>69.55 ft<sup>2</sup></b>	<b>39.38 ft</b>
0.00 ft	0.00 ft	0.00 ft	1.85 ft	0.43 ft	1.79 ft
0.00 ft	0.00 ft <sup>2</sup>	0.00 ft	1.85 ft	0.43	1.79 ft
0.00 ft	0.00 ft <sup>2</sup>	0.00 ft	7.09 ft	7.20	7.00 ft
2.48 ft	1.12 ft <sup>2</sup>	2.27 ft	2.51 ft	4.78	2.30 ft
7.72 ft	9.93 ft <sup>2</sup>	7.70 ft	7.72 ft	22.16	7.70 ft
7.72 ft	9.93 ft <sup>2</sup>	7.70 ft	7.72 ft	22.16	7.70 ft
2.48 ft	1.12 ft <sup>2</sup>	2.27 ft	2.51 ft	4.78	2.30 ft
0.00 ft	0.00 ft <sup>2</sup>	0.00 ft	7.09 ft	7.20	7.00 ft
0.00 ft	0.00 ft <sup>2</sup>	0.00 ft	1.85 ft	0.43	1.79 ft

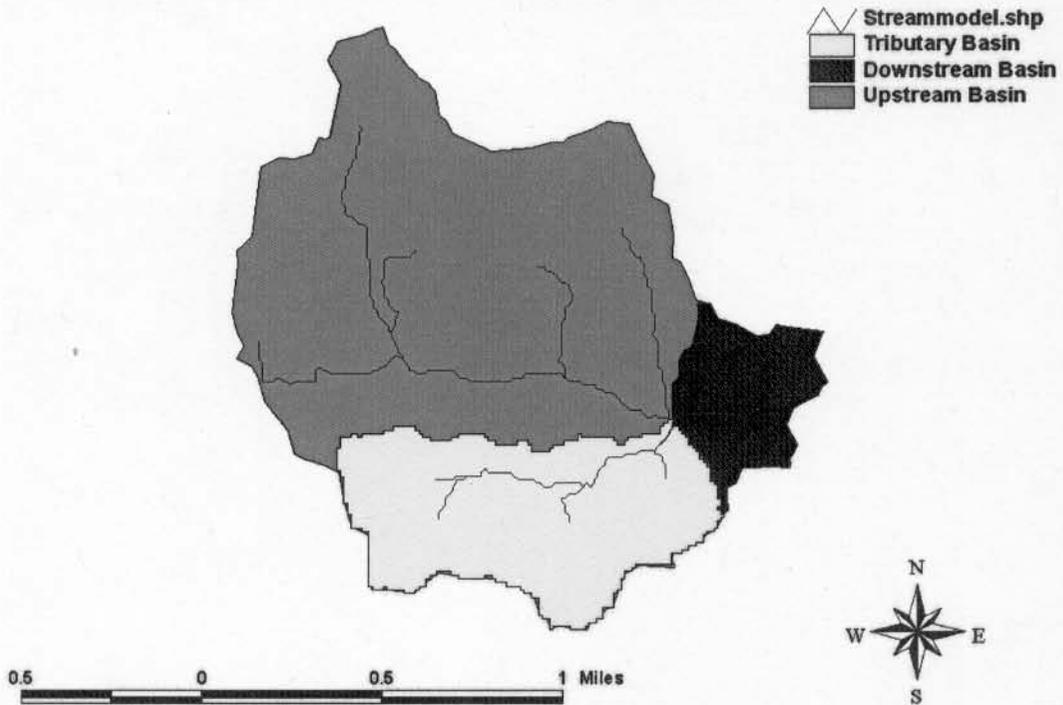
Figure 2.0. Spring Branch Sub-basin Watershed Map.

The HEC-HMS model was developed for existing land use conditions and soil types in the study area. Storm discharges were evaluated for the seven sub-basins within the watershed (Figure 2.0). The calculations of drainage area, time of concentration, and curve numbers were performed by MSE, Inc. (1981) for each sub-basin used in the model. Final input parameters can be located therein. The discharges of concern along the Spring Branch Channel are at Pot Spring Road, Tributary A, Tributary B, and at Dulaney Valley Road (Table 3.4). The sub-basins 1 through 4 were used to describe the discharge at Pot Spring Road, sub-basin 5 for Tributary A,

sub-basin 6 for Tributary B, and the downstream end of sub-basin 7 for the discharge at Dulaney Valley Road (Figure 2.0).

The Lower Spring Branch watershed was delineated by interpolating a Digital Elevation Model (DEM) from a 2-foot contour GIS layer provided by Baltimore County using ArcGIS 8.3. The watershed was divided into three sub-basins by importing the layer into TauDEM and HEC-GeoHMS programs and run through preprocessing routines to determine exact watershed and sub-basin boundaries. These are the Spring Branch mainstem above the confluence with the concrete-lined tributary that enters from the south (Mainstem Upstream), the concrete-lined tributary, and the mainstem just upstream of the Dulaney Valley Road culvert (Mainstem Downstream) (Figure 2.0).

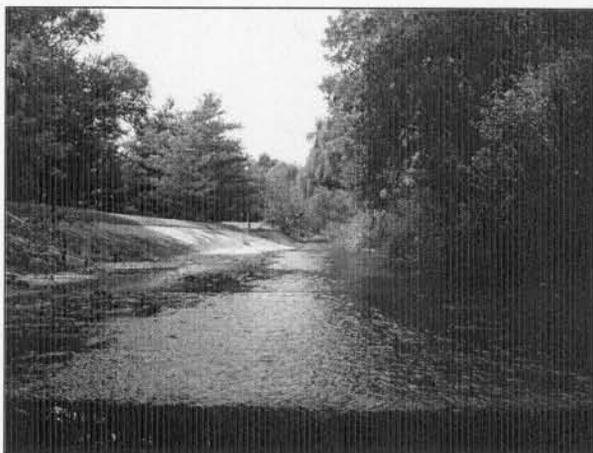
This reach is a trapezoidal concrete channel that begins at the downstream side of the Pot Spring Road double box culvert and extends approximately 450 feet to the end of the concrete section (Appendix C). This reach was channelized in the early 1970's to accommodate underground sewers and overhead utility lines on the south bank, and residential properties along both banks.

**Photo 1.** Reach 1 looking upstream from the end of the reach.

At the upstream end of this reach sandy debris and vegetation has blocked baseflow through the north side of the double box-culvert forcing baseflow through the south side of the culvert. Currently, only flows at bankfull or greater pass through the north side of the culvert. At approximately 70 feet downstream of the culvert, the concrete channel constricts down to 24.0 feet at the top of the channel. At approximately 140 feet downstream of the Pot Spring Road culvert, a perennial stream (Tributary A) enters the channel from the north (Appendix C). The last 20 feet of the channel enters Spring Branch through a small concrete channel. A dry concrete stormwater channel enters Spring Branch from the south approximately 340 feet downstream from the Pot Spring Road culvert. This reach will be further described below as Tributary B. After Tributary B enters the Spring Branch mainstem, the mainstem concrete channel widens to 34.0 feet at the top of the bank. This width continues until the end of the

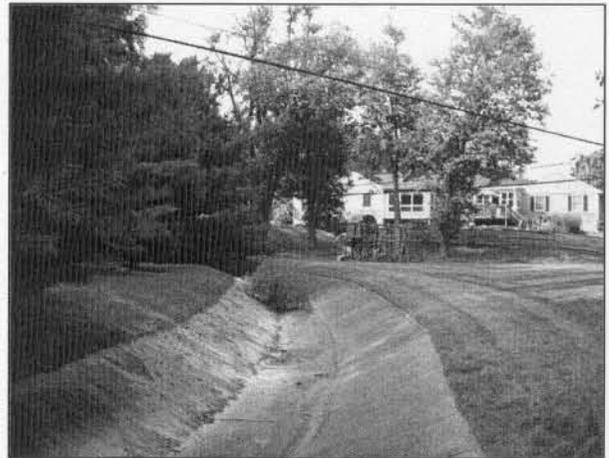
**Photo 2.** Tributary B looking upstream.

This reach enters Spring Branch from the south approximately 340 feet downstream of Pot Spring Road. It is a 14 foot wide (at the top of bank) trapezoidal concrete channel that carries no baseflow much of the year. It was constructed at the same time as the concrete armoring of Spring Branch. The reach begins from a single culvert downstream of Pot Spring Road and flows approximately 490 feet to Spring Branch. The slope within the downstream 100 feet of this reach is approximately 2%.

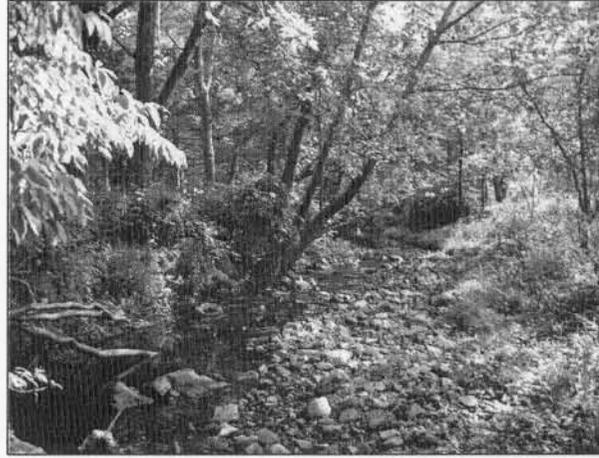
**Photo 3. Reach 2 Looking downstream from the upstream end of the reach.**

and riparian areas widen slightly. This reach has flat, extended riffles with a few shallow pools. The stream channel within this reach consists of a mix of small cobbles and boulders that appear to be moderately embedded and generally stable. They provide substantial habitat for macroinvertebrate fauna.

Much of the north bank of this reach is a four to six foot eroding vertical wall that flattens sharply at the top where maintained lawns meet the channel. On the north bank approximately 560 feet downstream of Pot Spring Road, about ten feet of 18 inch concrete pipe have fallen into the channel. This pipe drains a small pond north of Chapelwood Lane (Appendix C). The south bank is more gently sloping, and well vegetated until it reaches the top of bank, where the established stream buffer has been mown. At approximately 700 feet downstream of Pot Spring Road a perennial channel enters the stream from a small, spring-fed pond slightly outside of the Spring Branch floodplain. This small tributary is stable at its confluence with Spring Branch. The remainder of the channel to the end of the reach becomes slightly more incised and lined with boulders before entering Reach 3.

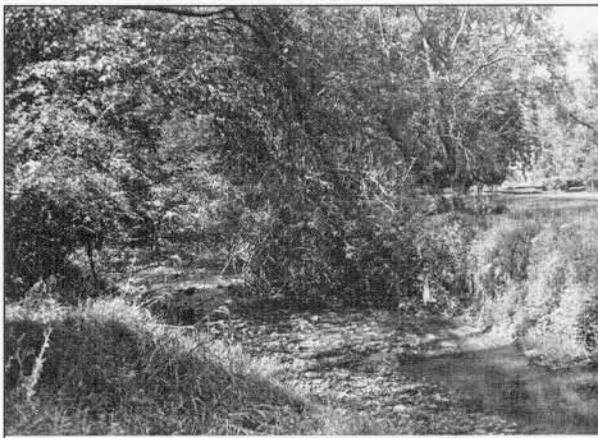
**Photo 5. Reach 4 looking upstream.**

Reach 4 begins where the floodplain and channel widen, the stream begins to meander, and the substrate changes to fine sand, gravel, and small cobble. The reach extends to the end of the study area at Dulaney Valley Road. Both the north and south banks within this reach are vertical and eroding along many of the outside meander bends. Two small intermittent drainage ditches enter the channel from the north at approximately stations 1,740 and 2,100

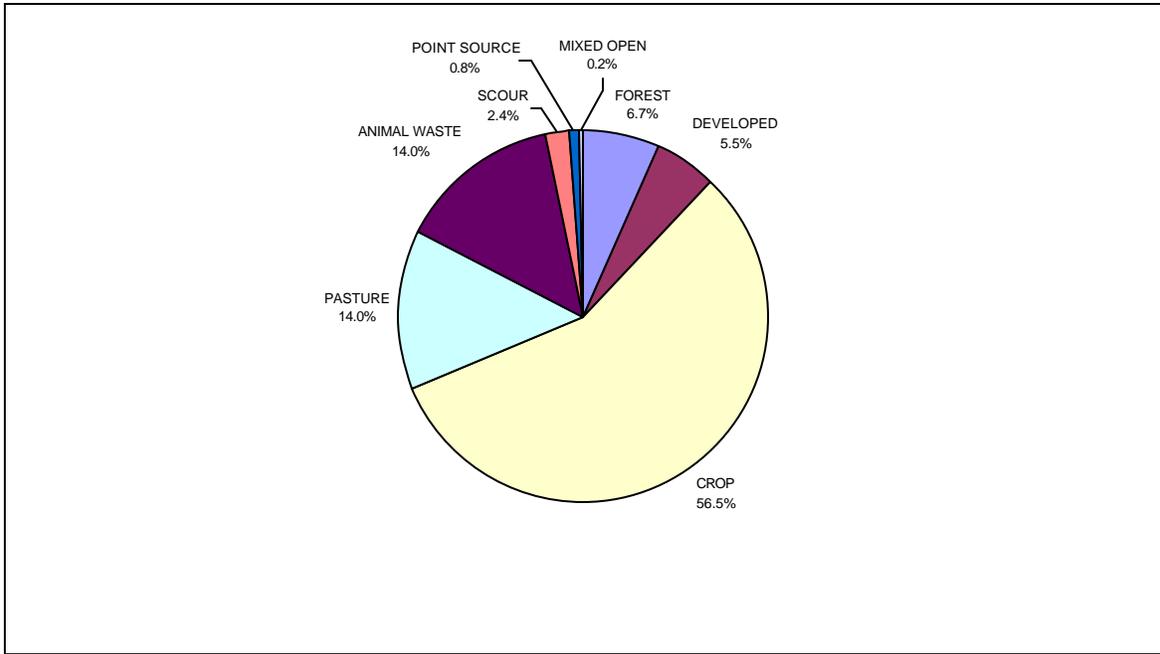
**Figure 5: Percent Contribution of Sources to Total Phosphorus Loads to Prettyboy Reservoir**

Figures 5 and 6 show the relative size of the contribution of point and nonpoint sources of total phosphorus to Prettyboy and Loch Raven Reservoirs, respectively, 1992-1997. Figure 7 shows the relative size of the contribution of sediment sources to Loch Raven Reservoir over the same period.

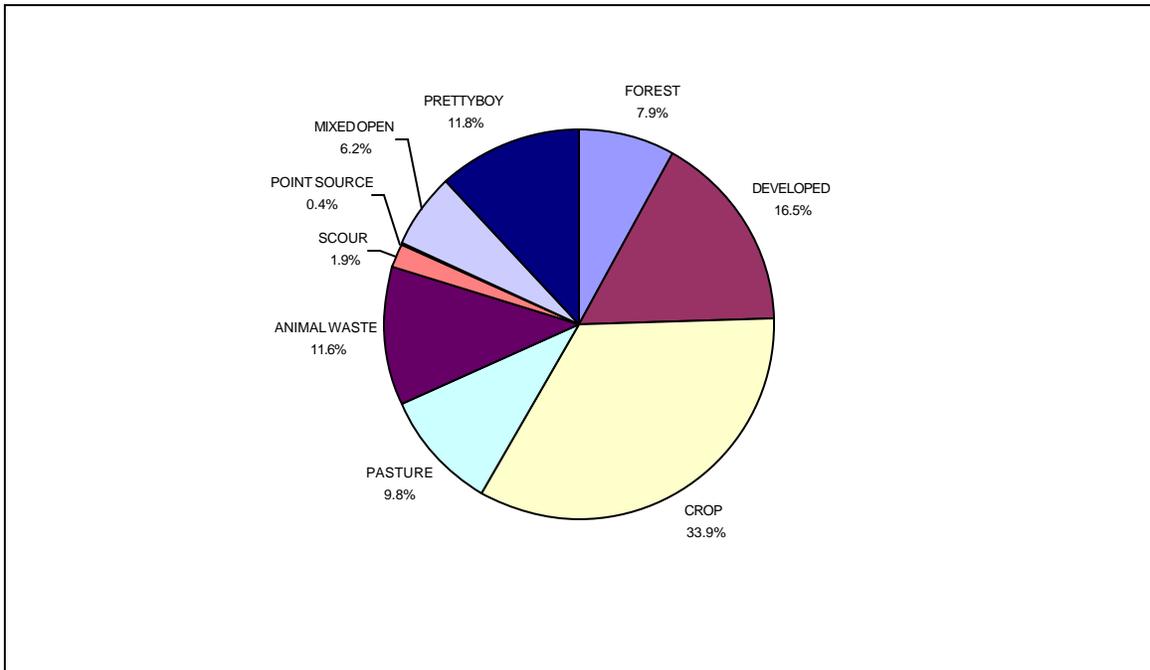
**Figure 6: Percent Contribution of Sources to Total Phosphorus Loads to Loch Raven Reservoir**

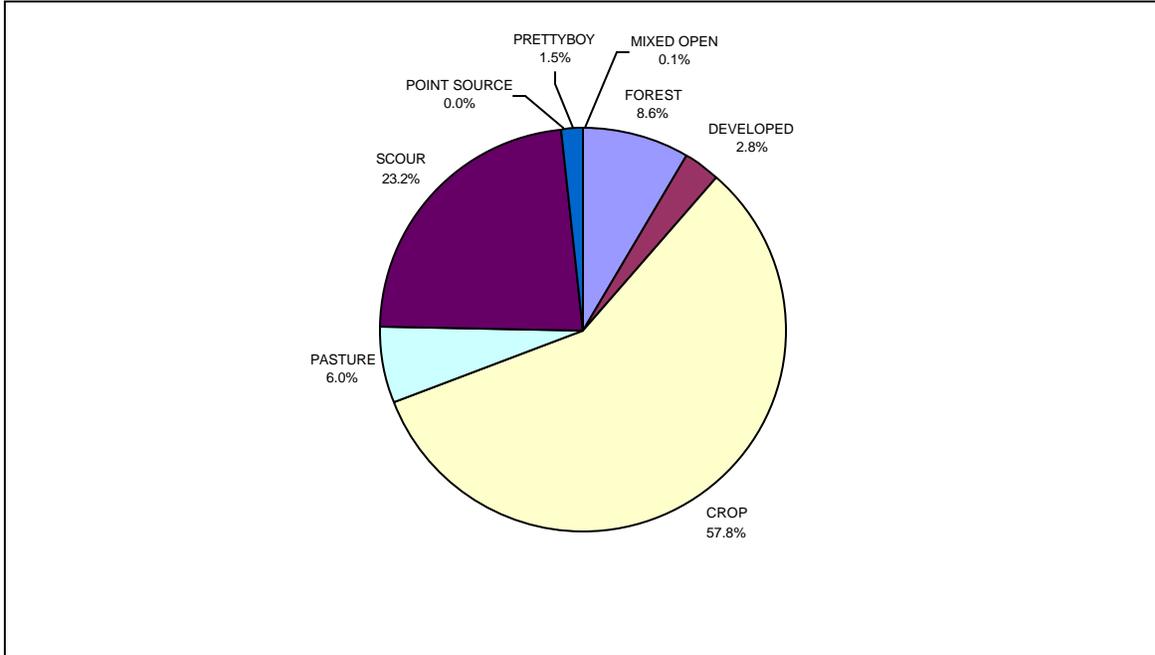
**Figure 7: Percent Contribution of Sources to Sediment Loads to Loch Raven Reservoir**

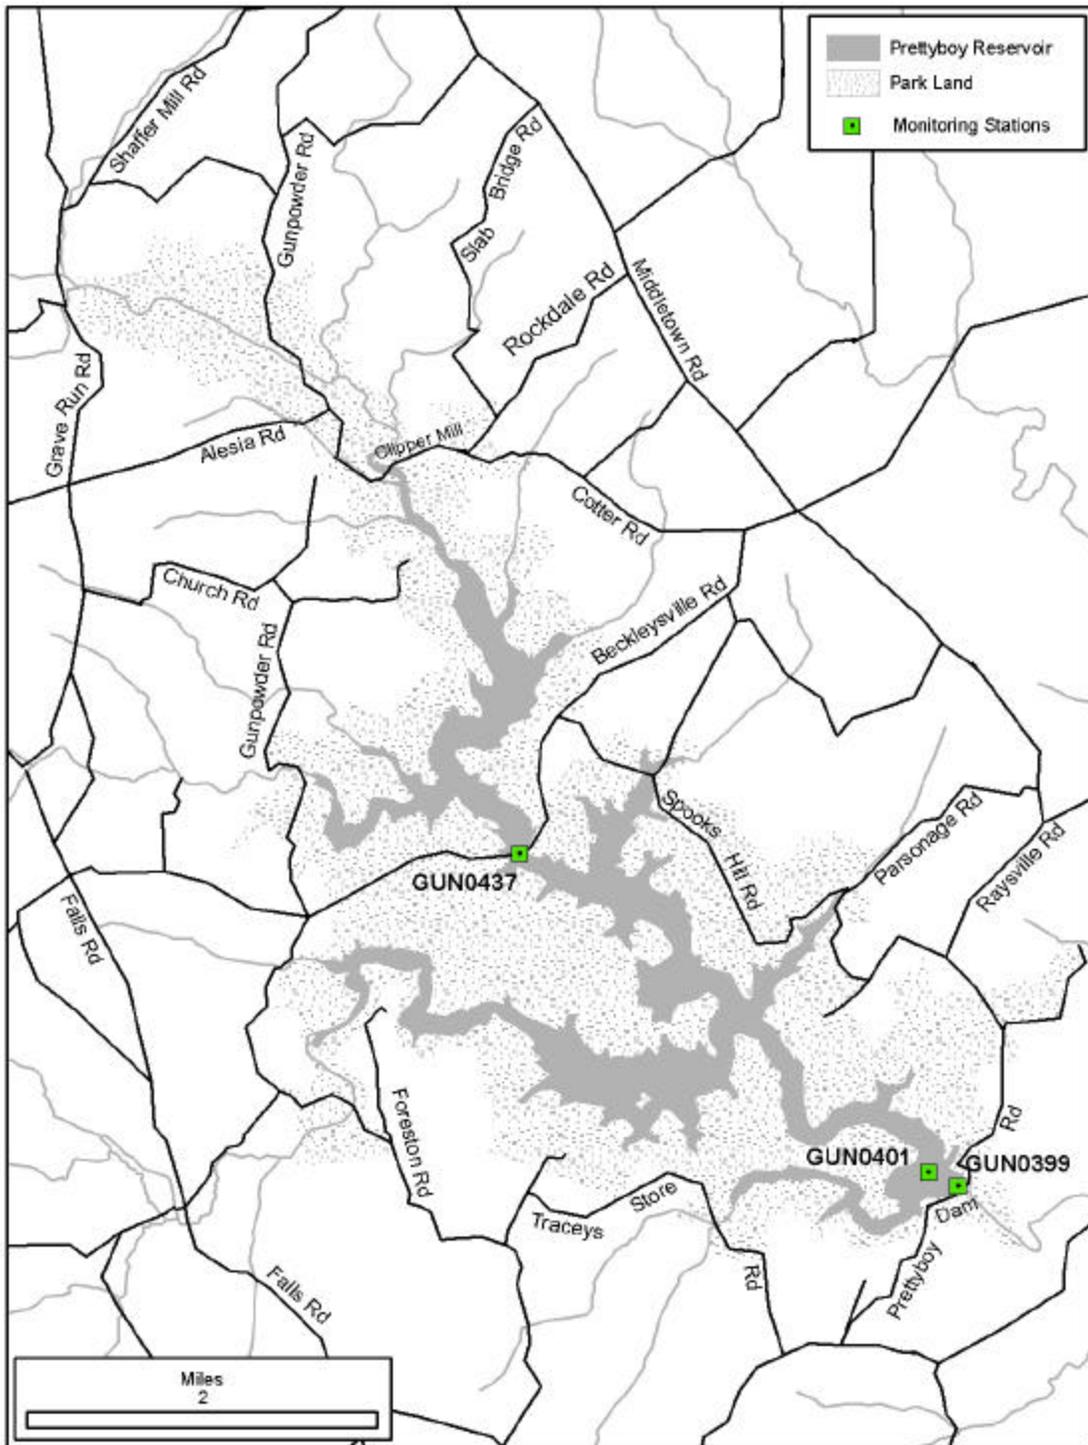
**Figure 8: Sampling Locations in Prettyboy Reservoir (from DPW)**

Baltimore City Department of Public Works (DPW) is the only agency that monitors water quality in the reservoirs. DPW samples at three locations in Prettyboy Reservoir, and at five locations in Loch Raven Reservoir. Figures 8 and 9 show the sites of these sampling locations. Not all locations are sampled at the same time. Sampling is performed by boat at locations GUN0401, GUN0171, and GUN0190 weather permitting; otherwise, in the winter months, sampling is at fixed locations GUN0399, GUN0156, and GUN0174. Sampling at GUN0142 and GUN0437 can occur either by boat or from a fixed platform.

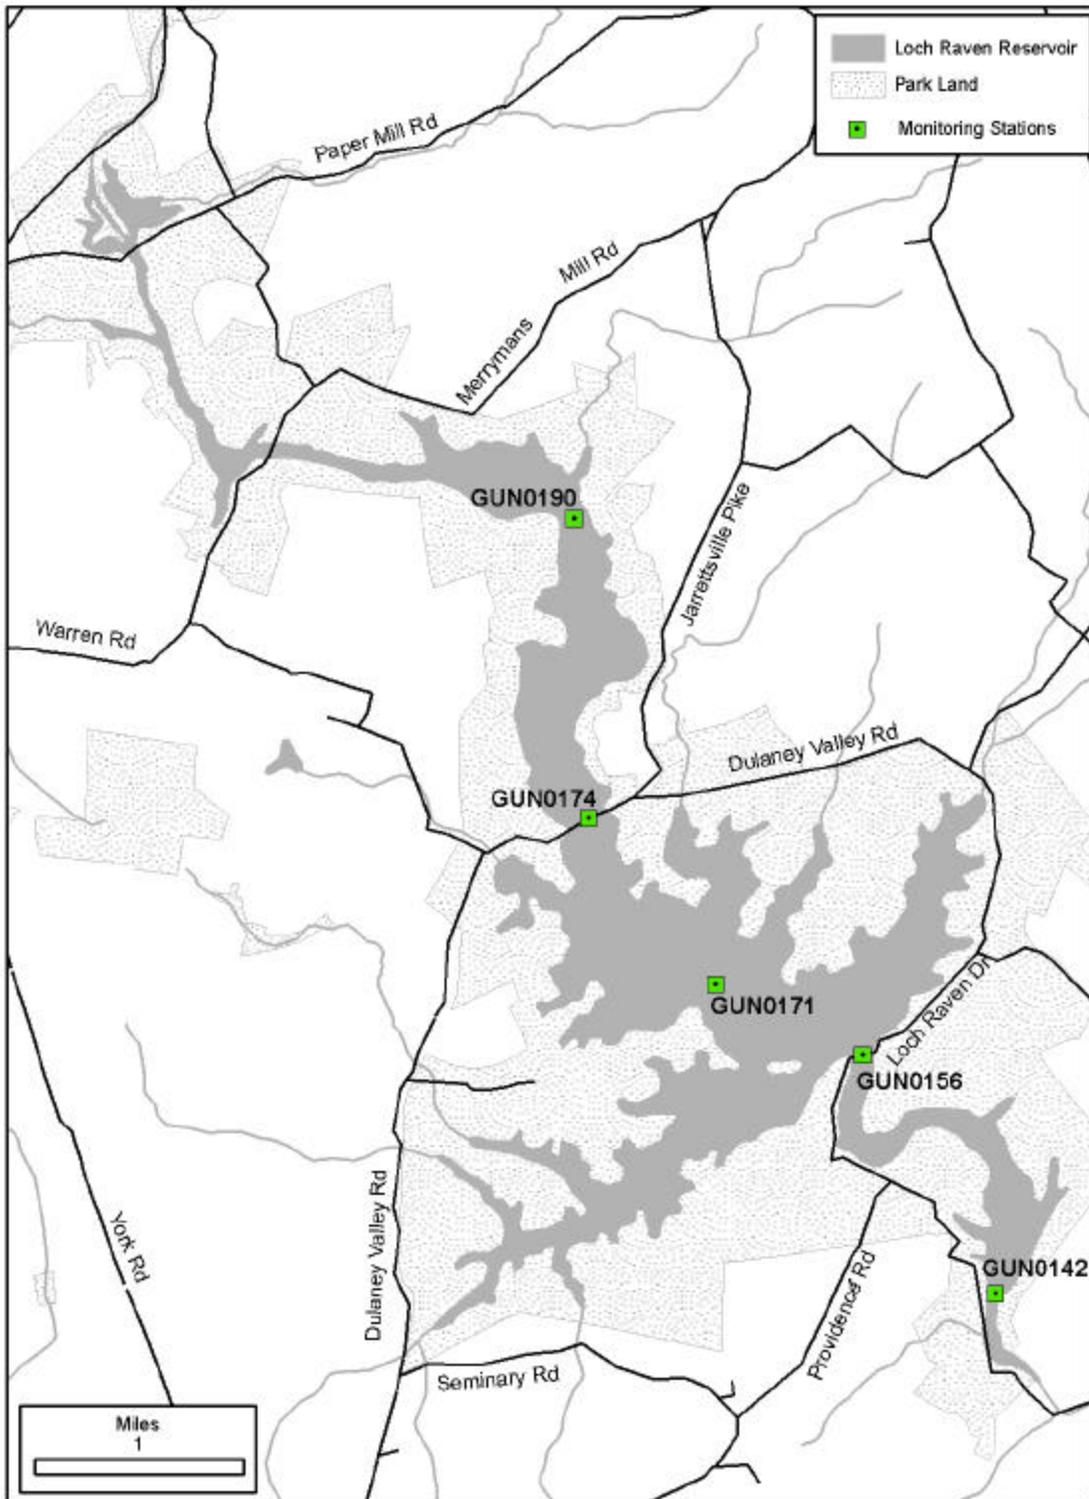
**Figure 9: Sampling Locations in Loch Raven Reservoir (from DPW)**

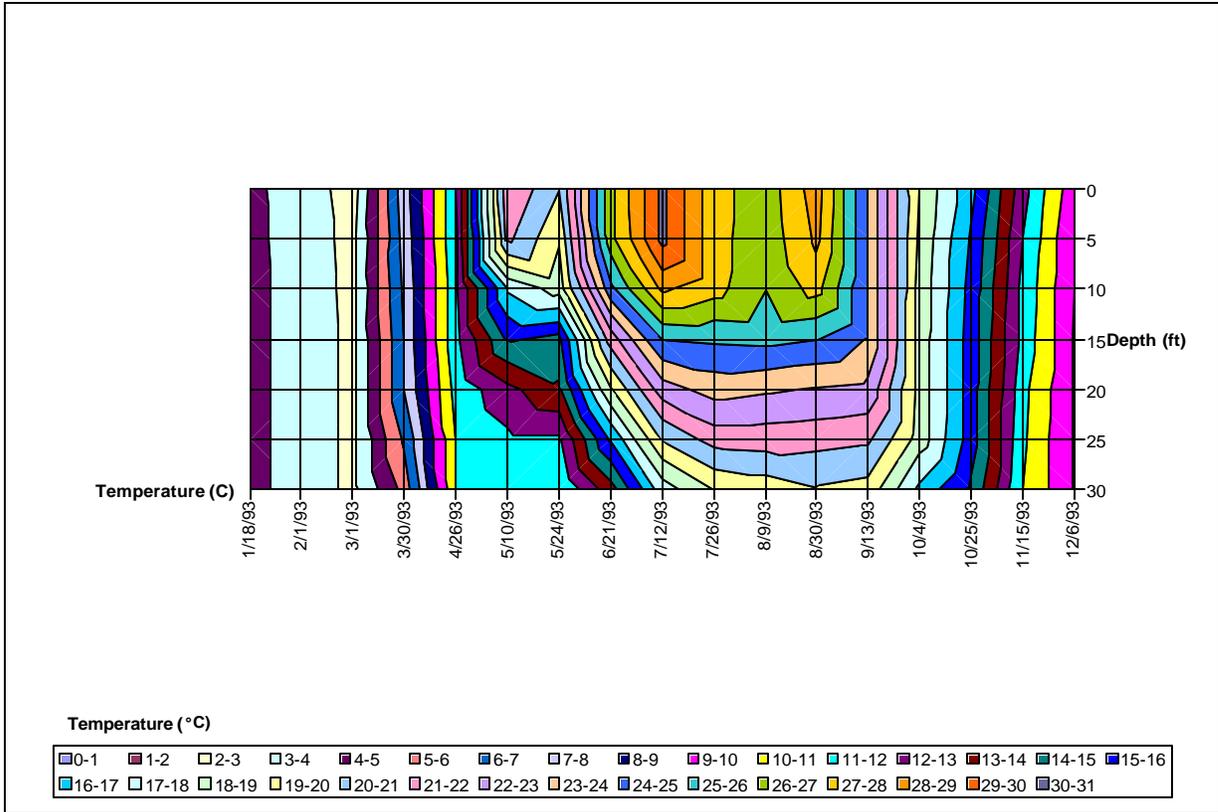
**Figure 10: Isothermal Contours, Loch Raven Reservoir, Middle Stations, 1993**

Contour plots of isotherms effectively illustrate seasonal position of the well-mixed surface layer or epilimnion. Figure 10 presents a contour plot of isothermals for GUN0142 in Loch Raven Reservoir for 1993, a representative year. Contours are shown only for the first 30 feet from the surface. In the winter, isothermal lines are vertical, showing that the reservoir has fairly uniform temperature over the first 30 feet of depth. In spring, isothermal lines begin to tilt away from the vertical, until by May, at depths greater than 15 to 20 feet, they are parallel to each other horizontally. At the surface, isothermal lines run vertically to a depth of 10 to 15 feet; this defines the epilimnion.

This is illustrated by the low DO reading recorded on September 13, 1993, in GUN0171, the middle of Loch Raven Reservoir. Figure 11 shows the DO contour at this location. Figure 10 in the previous section, shows the temperature contour. A comparison of the figures indicates that at the end of August the reservoir at this location was highly stratified, with the well-mixed layer extending to about 15 feet. Throughout September, the surface waters cooled and the epilimnion deepened. The layers with low oxygen concentrations in the summer were drawn into the epilimnion. By October, the epilimnion once again had fairly uniform DO concentrations, although the reservoir had not completely overturned.

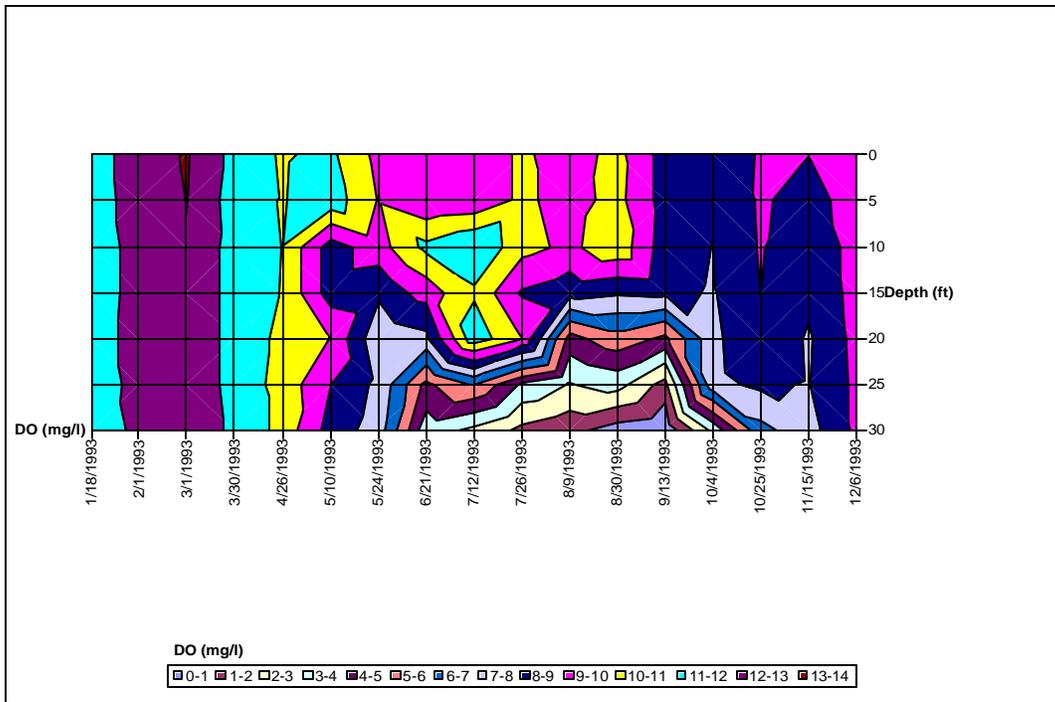
Figure 11: DO Contour, Loch Raven Reservoir, Middle Locations, 1993
