# Spring Branch Subwatershed - Small Watershed Action Plan

(Addendum to the Water Quality Management Plan for Loch Raven Watershed)

Prepared by  
**Baltimore County**  
Department of Environmental Protection and Resource Management  
401 Bosley Avenue, Suite 416, Towson, MD 21204

March 17, 2008

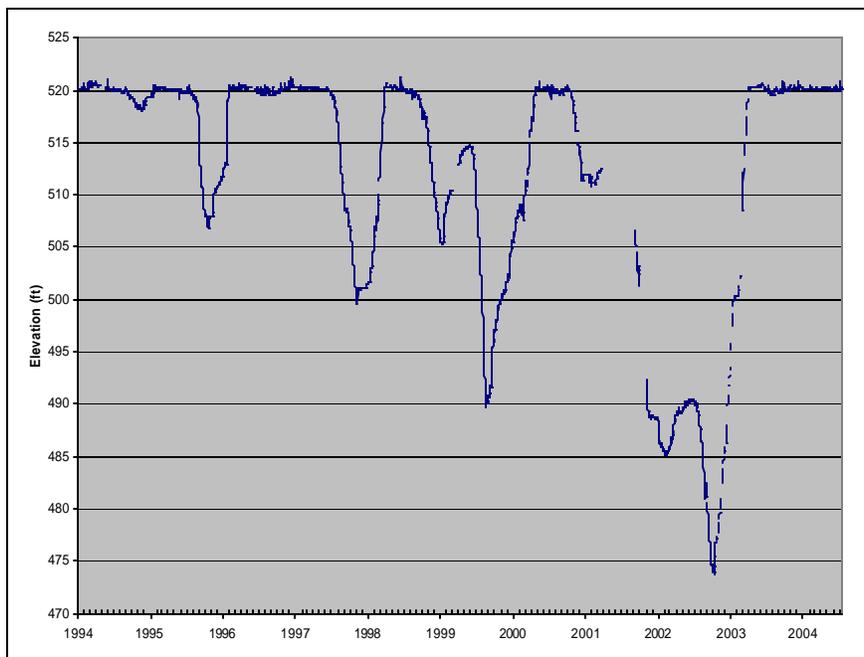
Figure 12: Surface Water Elevations in Prettyboy Reservoir, 1994-2004

Entrainment and overturning account for the other low DO oxygen observations in Loch Raven and Prettyboy as well. In Prettyboy, another factor also can influence entrainment: drawdown. Withdrawals from a reservoir can induce currents that enhance mixing. Figure 12 shows the surface elevation of Prettyboy Reservoir from 1994 through 2004. In 1999 and 2002 (drought years), releases from Prettyboy to fill Loch Raven dropped the surface elevation by 30 feet or more. These drawdowns are probably a contributing factor in mixing low DO concentrations into the surface levels of the reservoir.

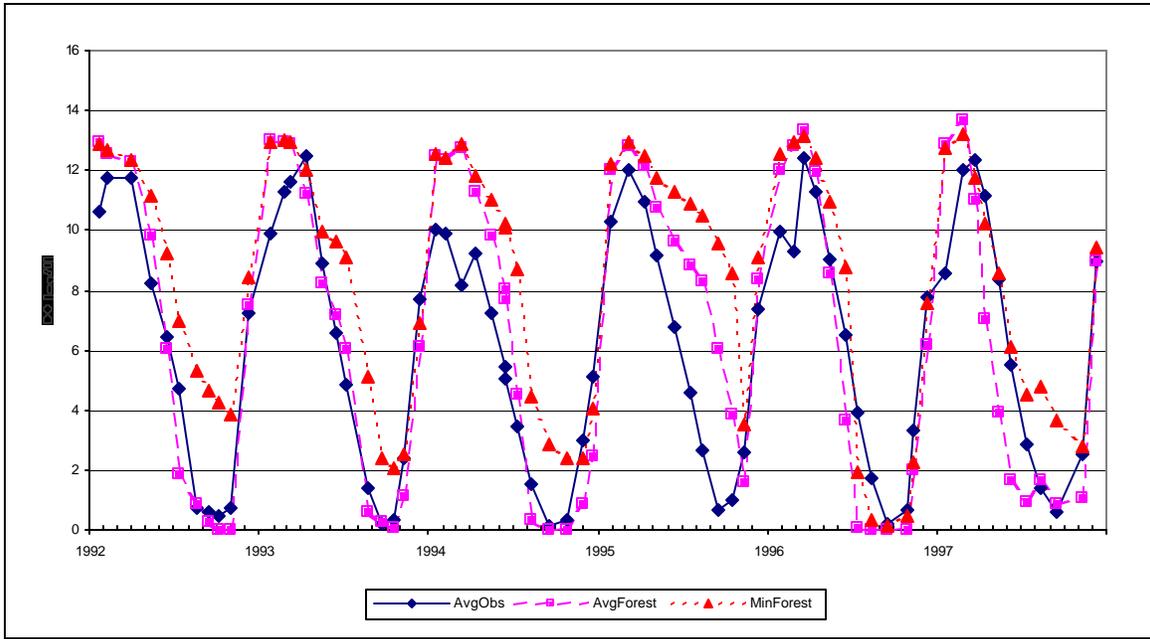
**Figure 13: Observed and Simulated Average Bottom DO Concentrations, Lower Stations, All-Forest Scenario, Prettyboy Reservoir**

Figures 13 and 14 below show the average bottom DO concentrations at lower sampling locations in the reservoirs under the All-Forest Scenario. Minimum concentrations at the sampling locations are also shown.

Average DO in the bottom layers of both reservoirs improves considerably under the All-Forest Scenario. The minimum DO concentration, however, frequently drops below 5.0 mg/l. Even under the All-Forest Scenario, the hypolimnion remains hypoxic in many (but not all) years of the simulation. The hypoxia tends to be worse in the lower stations of the reservoirs where the depths are greatest.

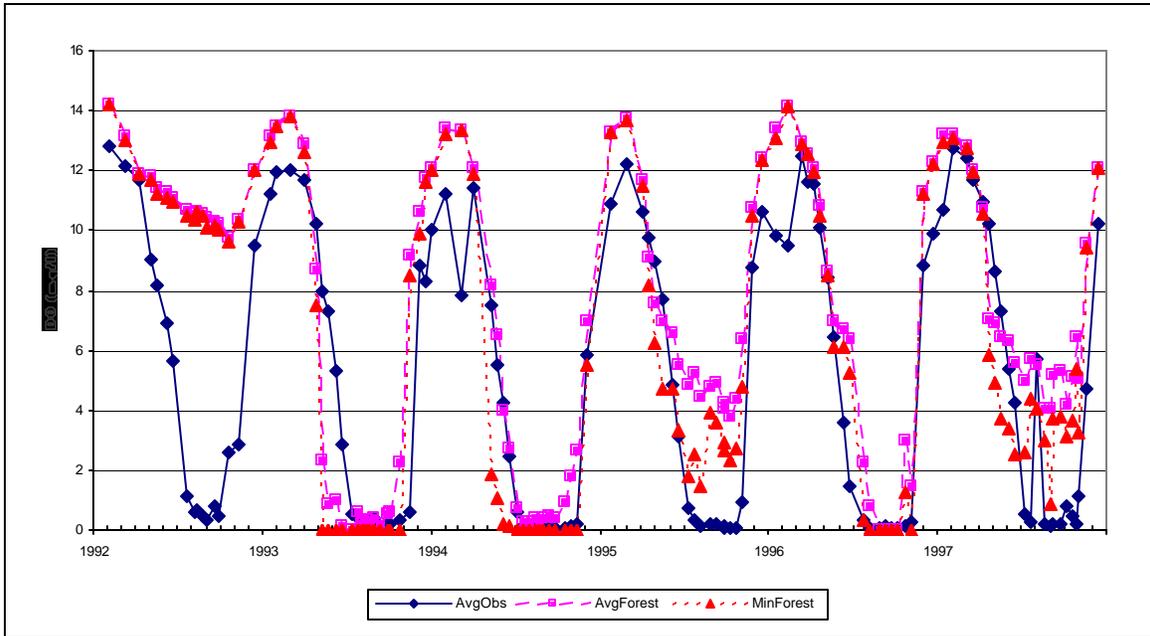
**Figure 14: Observed and Simulated Average Bottom DO Concentrations, Lower Stations, All-Forest Scenario, Loch Raven Reservoir**

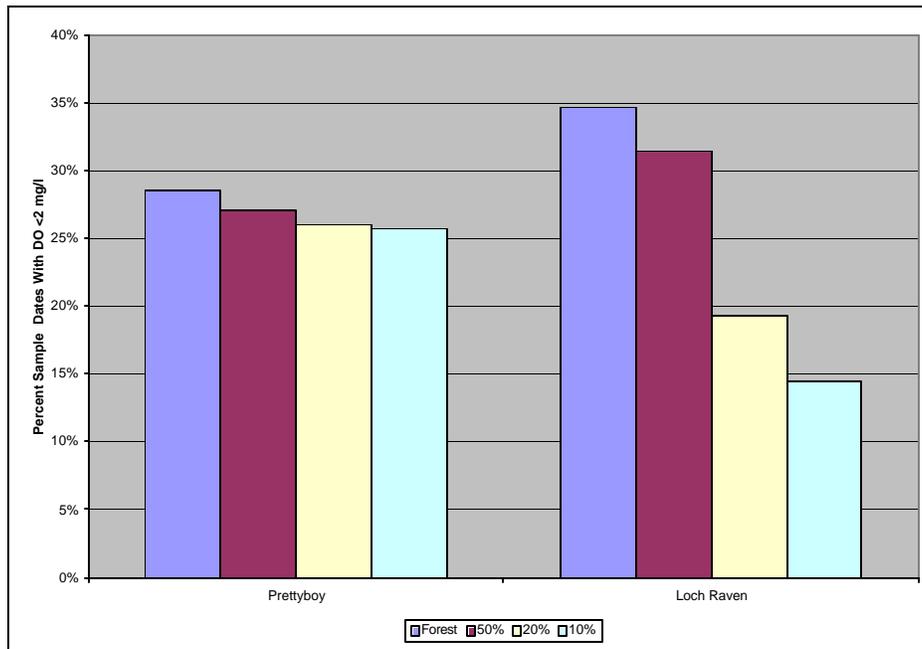
**Figure 15: Percent of Sampling Dates on which DO < 2.0 mg/l as a function of proportion of All-Forest Scenario**

A sensitivity analysis was performed to better determine how phosphorus and organic matter loading rates impact hypoxia in the hypolimnion. POM and TP loading rates were reduced to 50%, 20% and 10% of the loads of the All-Forest Scenario, and the percent of sampling dates where DO < 2.0 mg/l at the sampling locations was calculated. Figure 15 shows the results. Significant hypoxia persists even when loads are reduced to only 10% of the All-Forest Scenario, particularly in Prettyboy Reservoir, which is deeper than Loch Raven even though it has less volume. The sensitivity analysis shows that low DO in the bottom layers of the reservoirs is relatively insensitive to the particular assumptions used to determine organic matter loads in the models, and demonstrates that hypolimnetic hypoxia is primarily driven by stratification and reservoir morphology, rather than by external loads. The All-Forest Scenario demonstrates that current loads, and loads simulated under the TMDL Scenario, do not result in hypoxia that significantly exceeds that associated with natural conditions in the watershed. Low DO concentrations in the bottom layers of the reservoirs are therefore a naturally occurring condition, as described by the interim interpretation of Maryland’s water quality standards. The TMDL Scenario thus meets water quality standards for DO under the interim interpretation.
