SOURCE WATER ASSESSMENT
FOR TODD VILLAGE MOBILE HOME PARK
CARROLL COUNTY, MD

Prepared By
Water Management Administration
Water Supply Program
October 2002

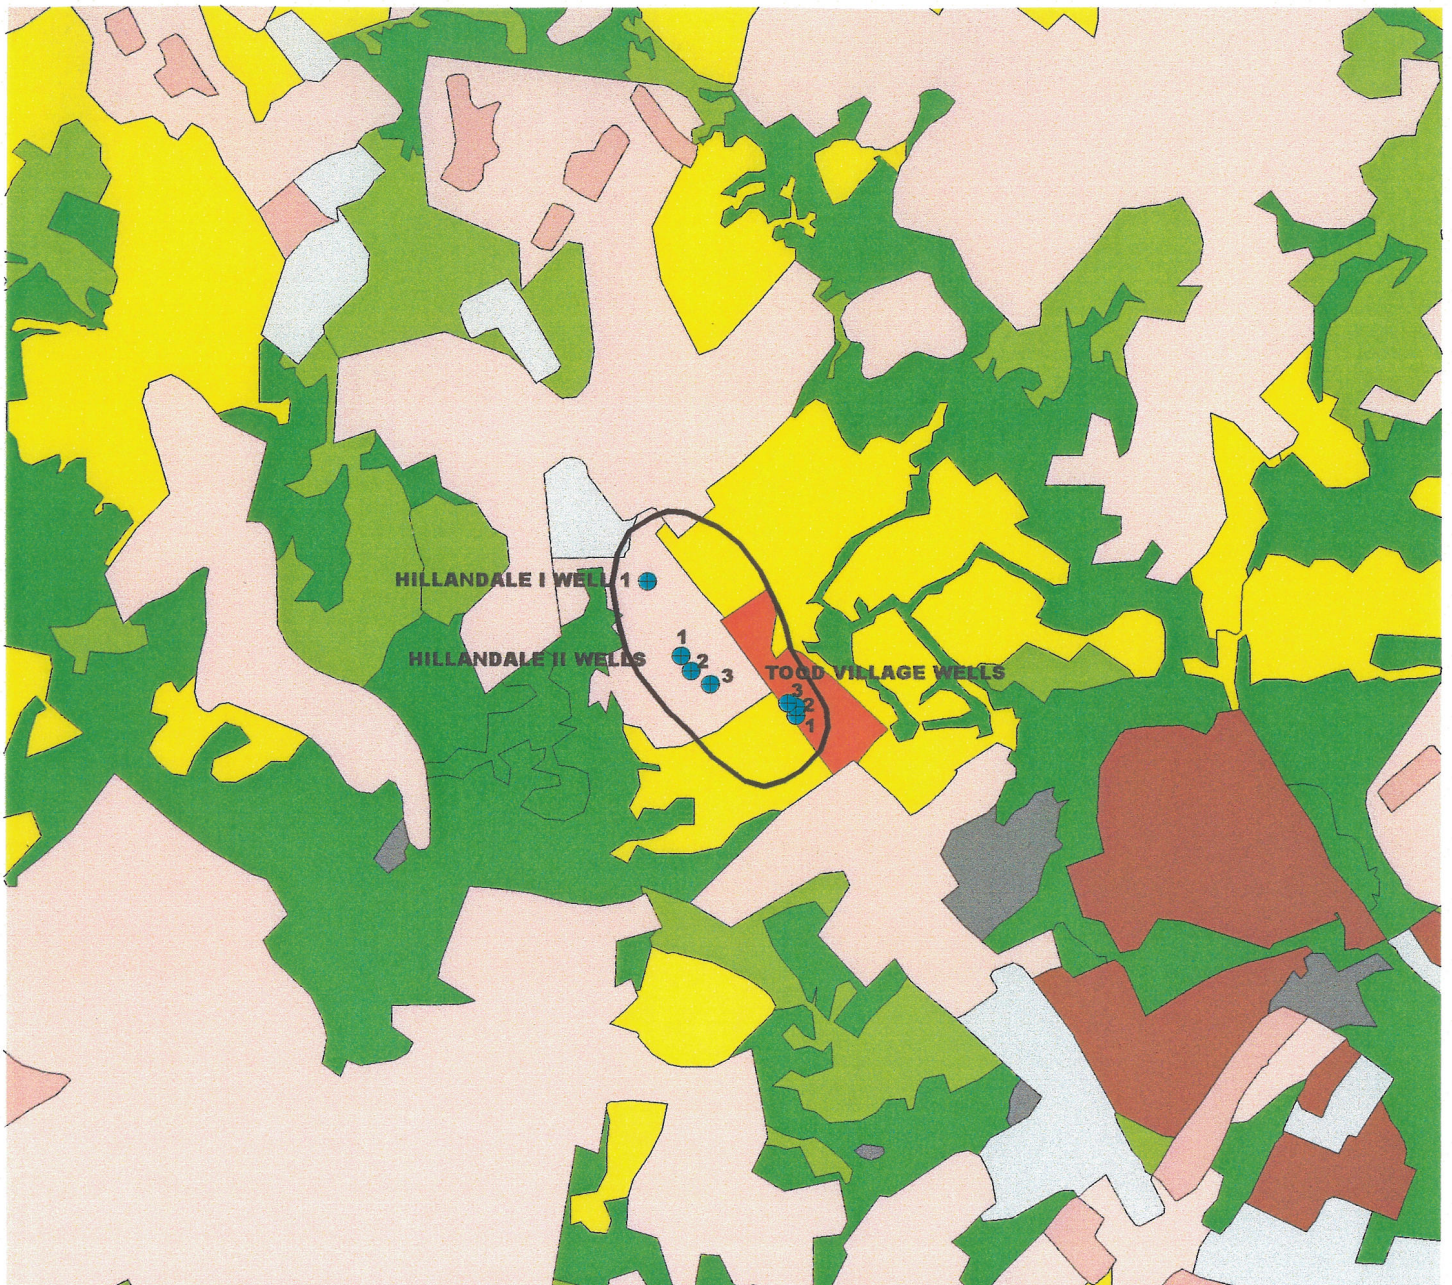
Figure 3. Land Use Map of the Todd Village and Hillandale Mobile Home Park Wellhead Protection Area

The Maryland Office of Planning's 2000 digital land use map for Carroll County was used to determine the predominant types of land use in the WHPA (figure 3). Table 3 shows the land use categories in the WHPA. A large portion of the WHPA is made of residential land (66%) followed by cropland (33%). It must be noted that about half the cropland is now part of a new school, Gerstell Academy that will be opening within six months.

LAND USE CATEGORIES	TOTAL AREA (acres)	PERCENTAGE OF WHPA
Low Density Residential	44.33	49.73
High Density Residential	14.30	16.05
Commercial	0.38	0.43
Cropland	30.05	33.72
Forest	0.06	0.07
Total	89.12	100.00

Table 3. Land Use Summary for the WHPA.
