Lessons Learned from Spillway Failures

Causes of Dam Incidents

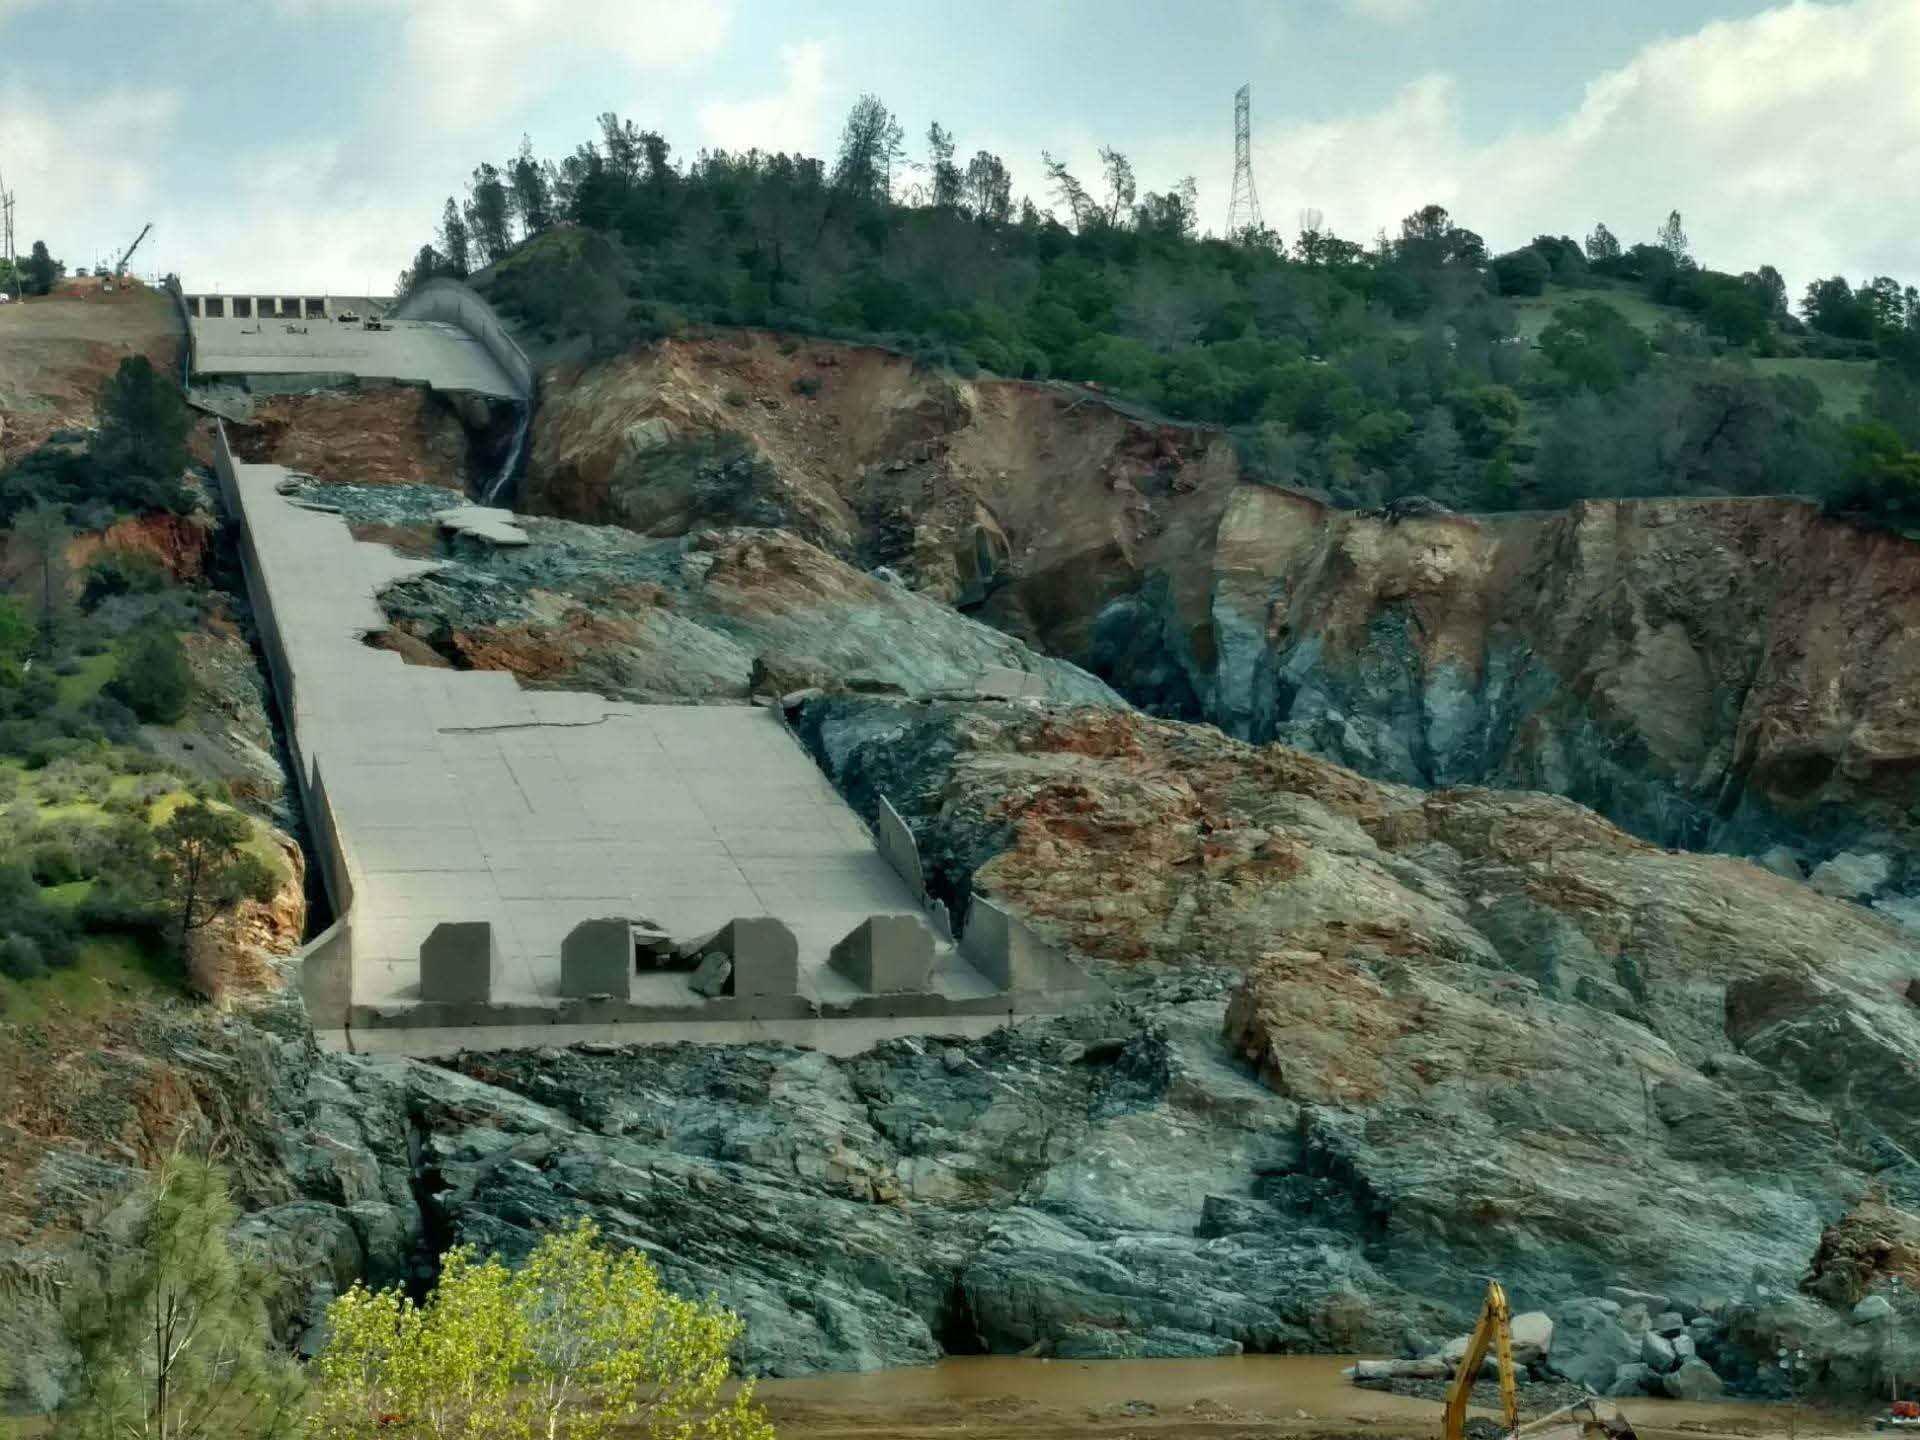
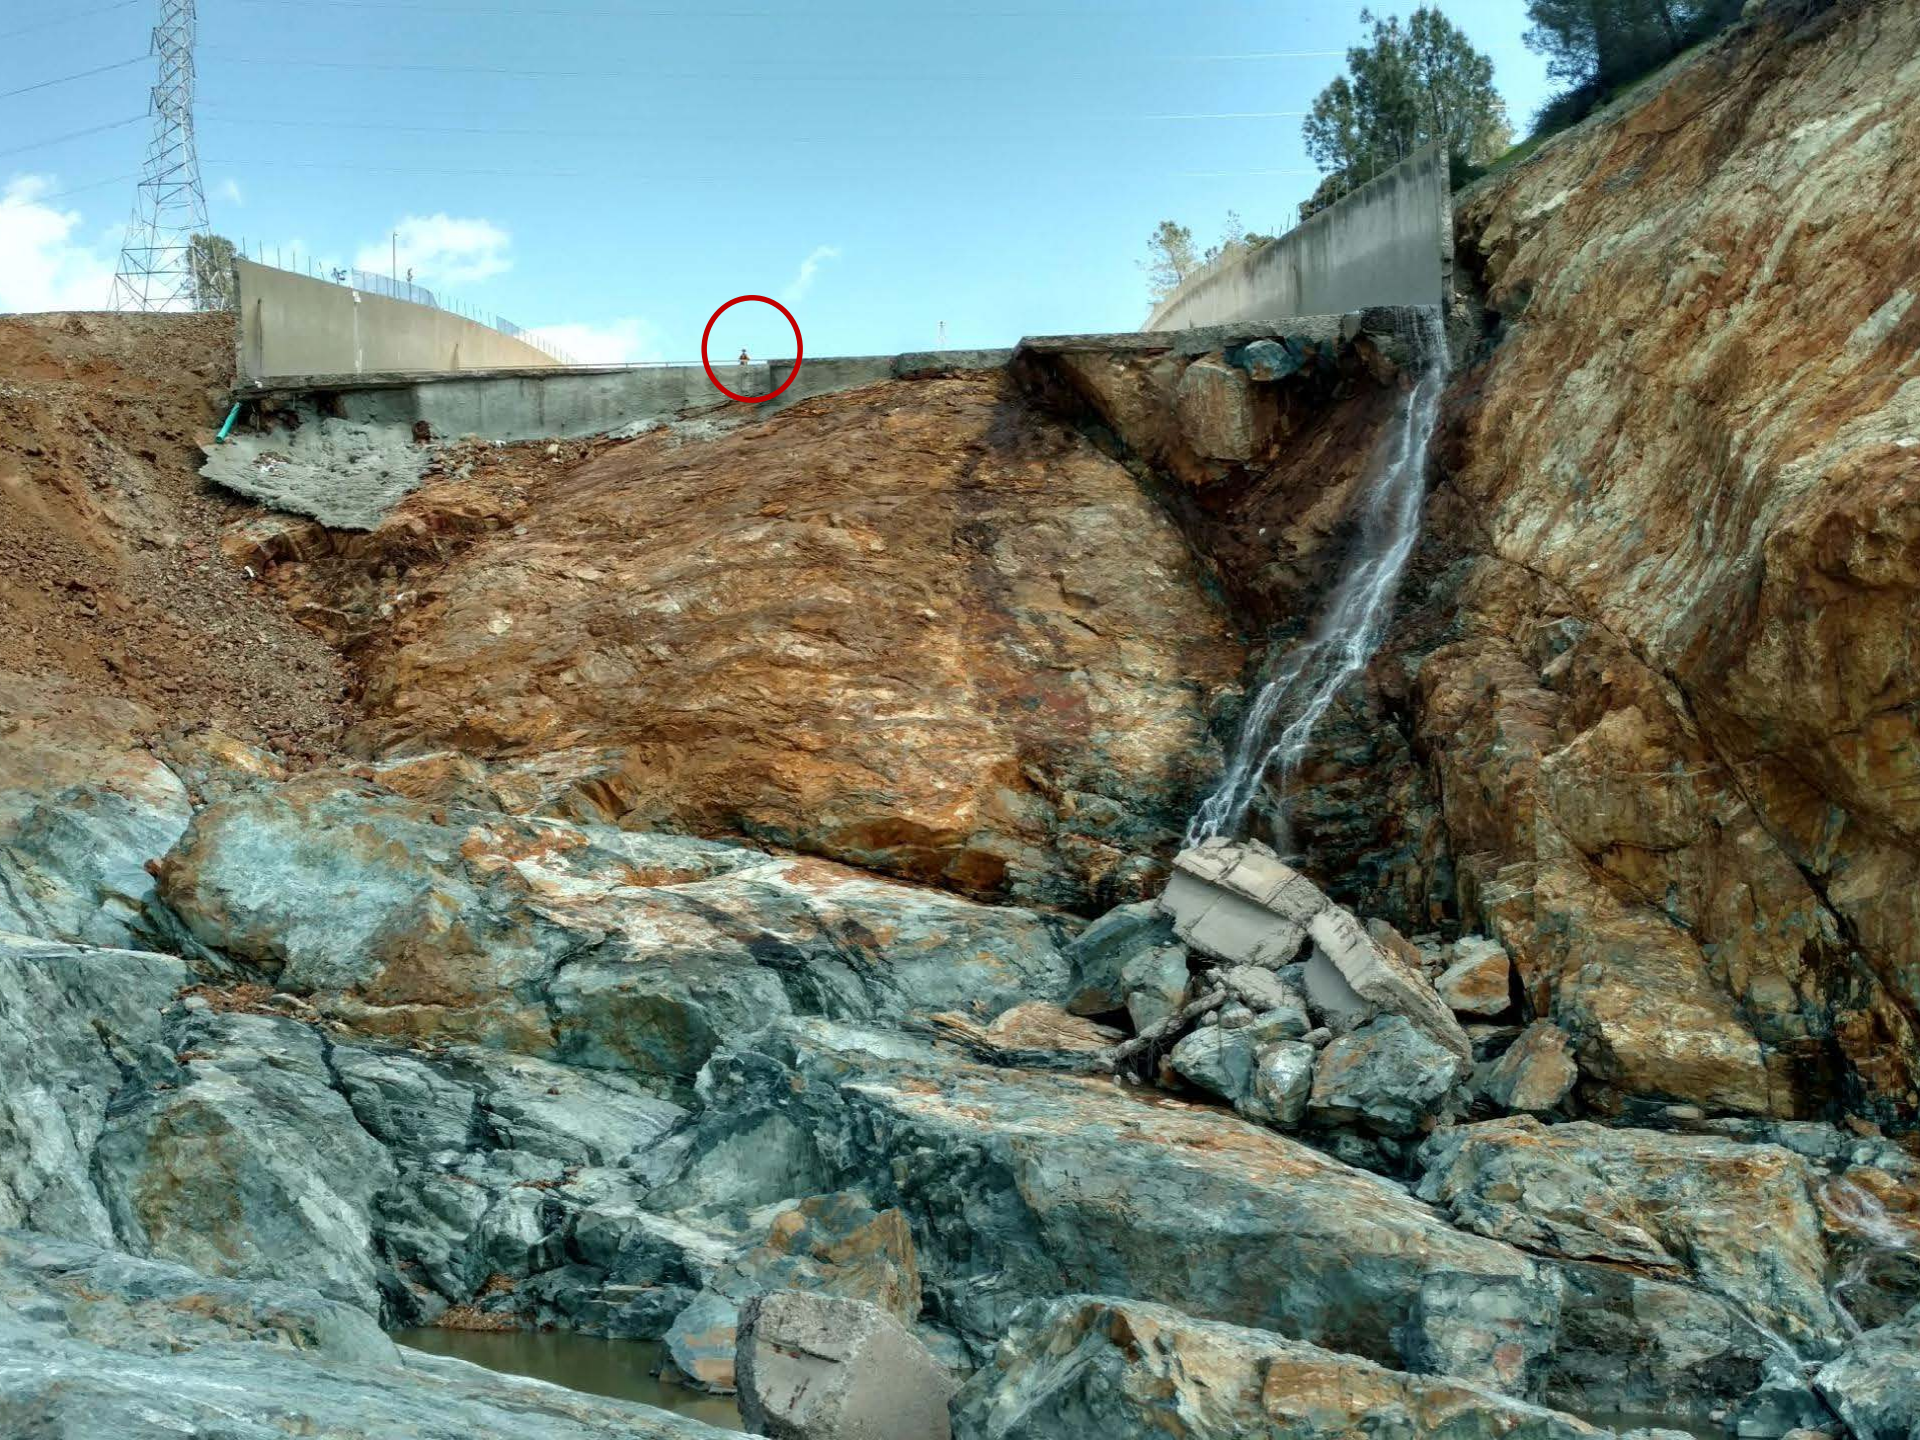
1997, Flow~160,000 cfs

Preliminary Factors Potentially Contributing to Failure

- 💧 Lack of waterstops in slab joints
- 💧 Concrete cracking and surface deterioration
- 💧 Plugging and collapse of underdrain pipes (roots)
- 💧 Unfiltered drains
- 💧 Soil-like erodible foundation in places
- 💧 Drought impacts on foundation materials
- 💧 Insufficient anchorage
- 💧 Large variations in slab thickness
- 💧 Limited slab reinforcement and joint restraint
- 💧 Cavitation?

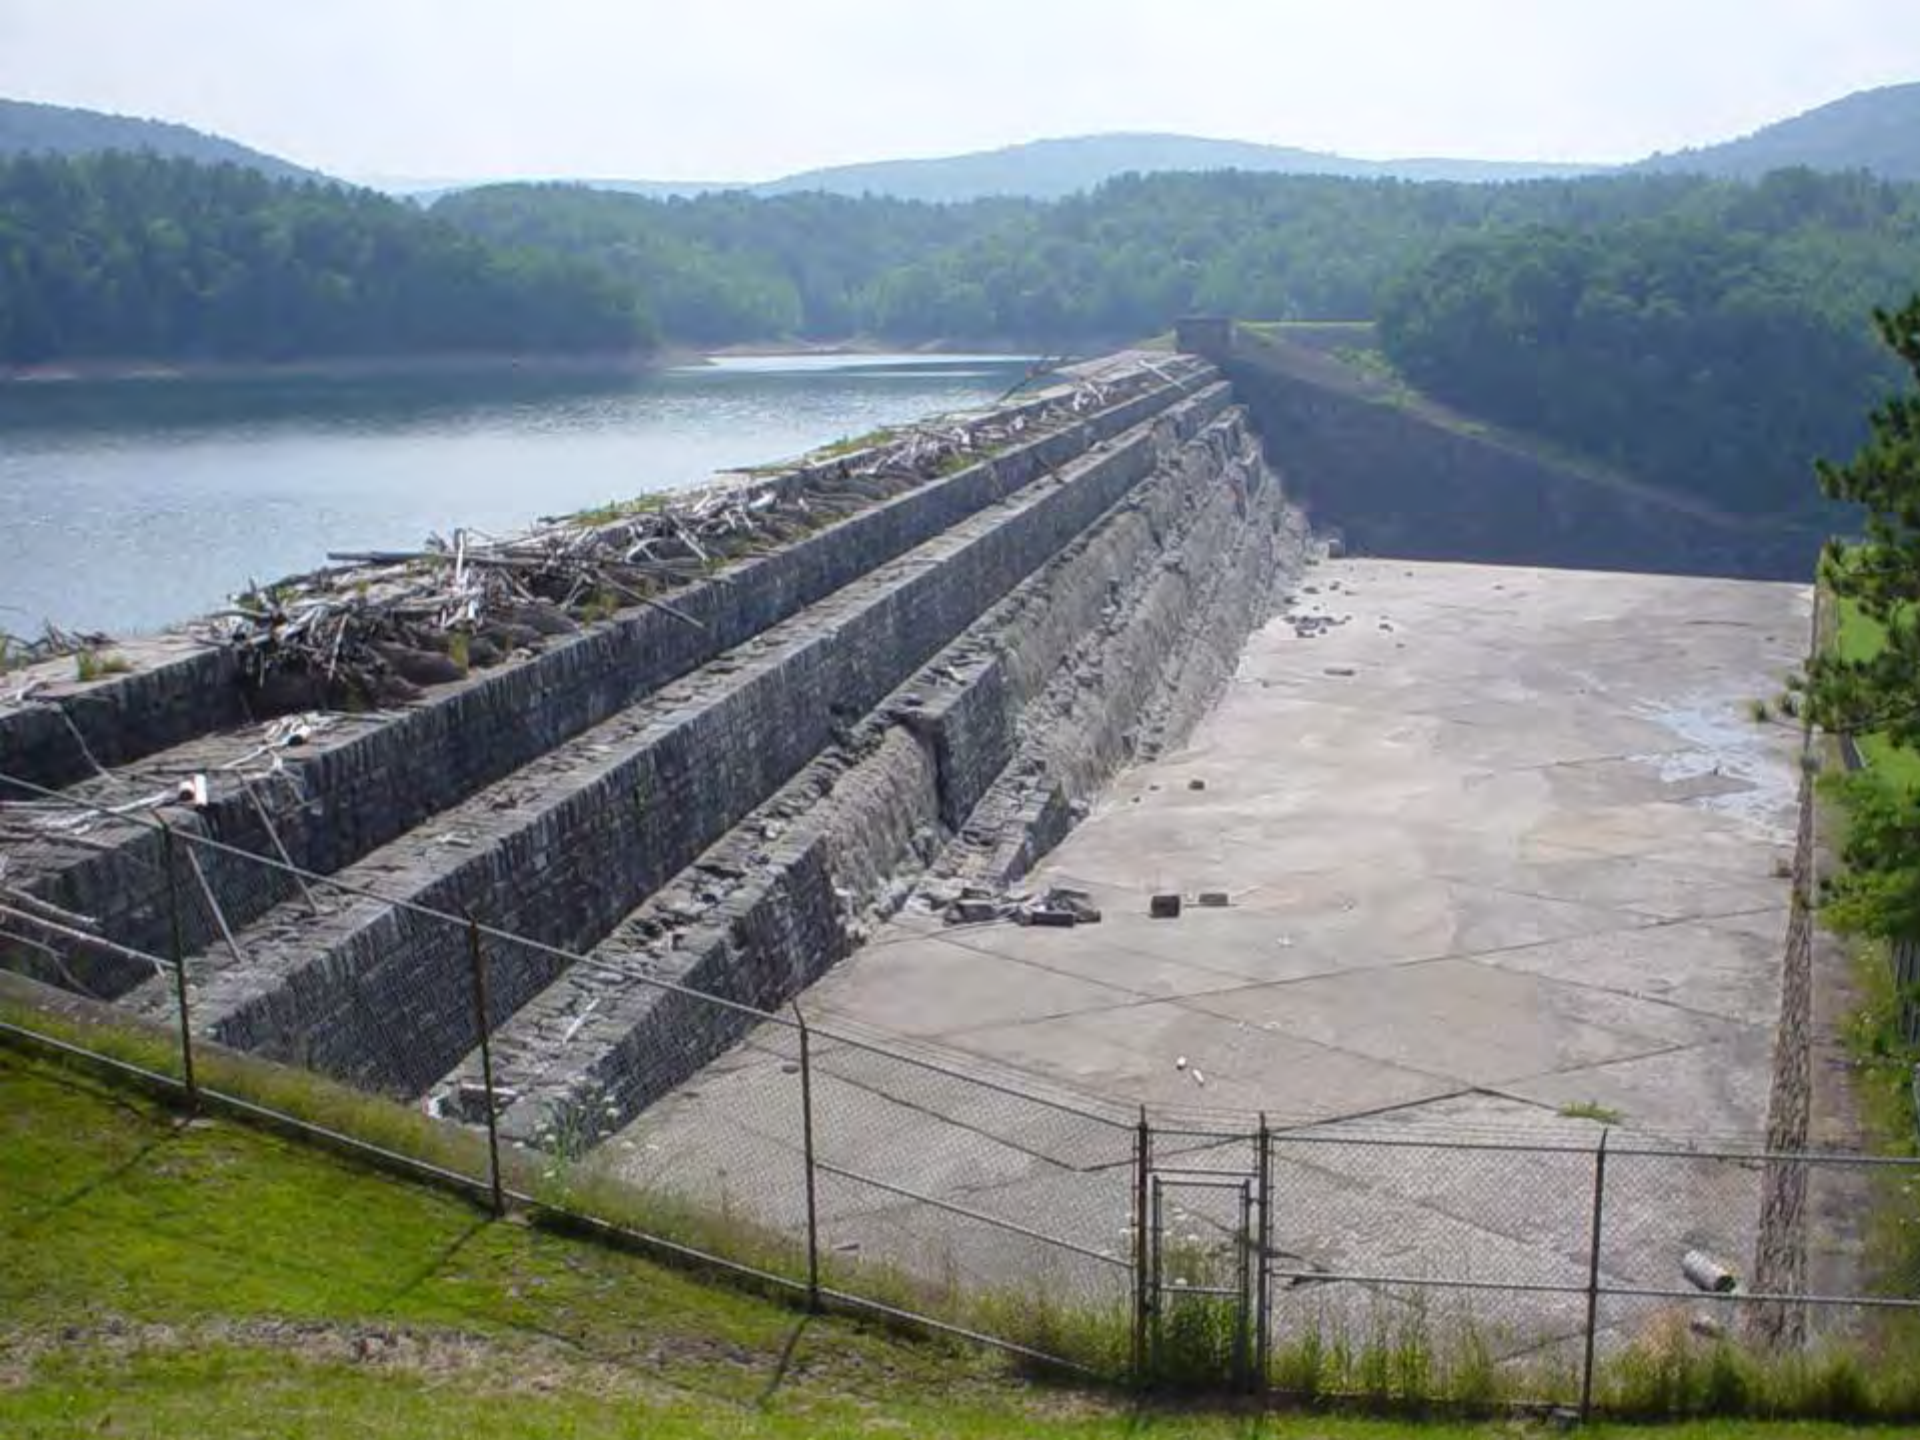
Flow Pattern Over Displacement

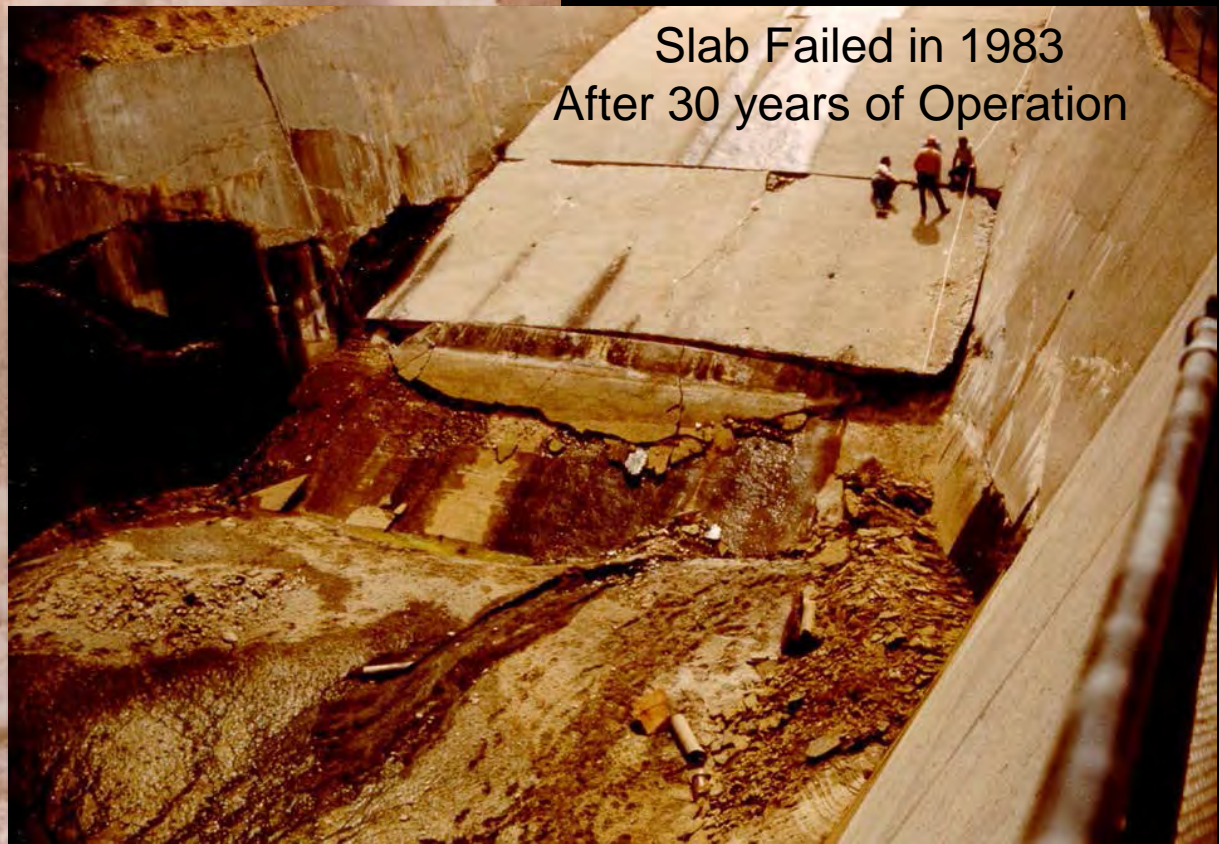
Slab Failed in 1983
After 30 years of Operation

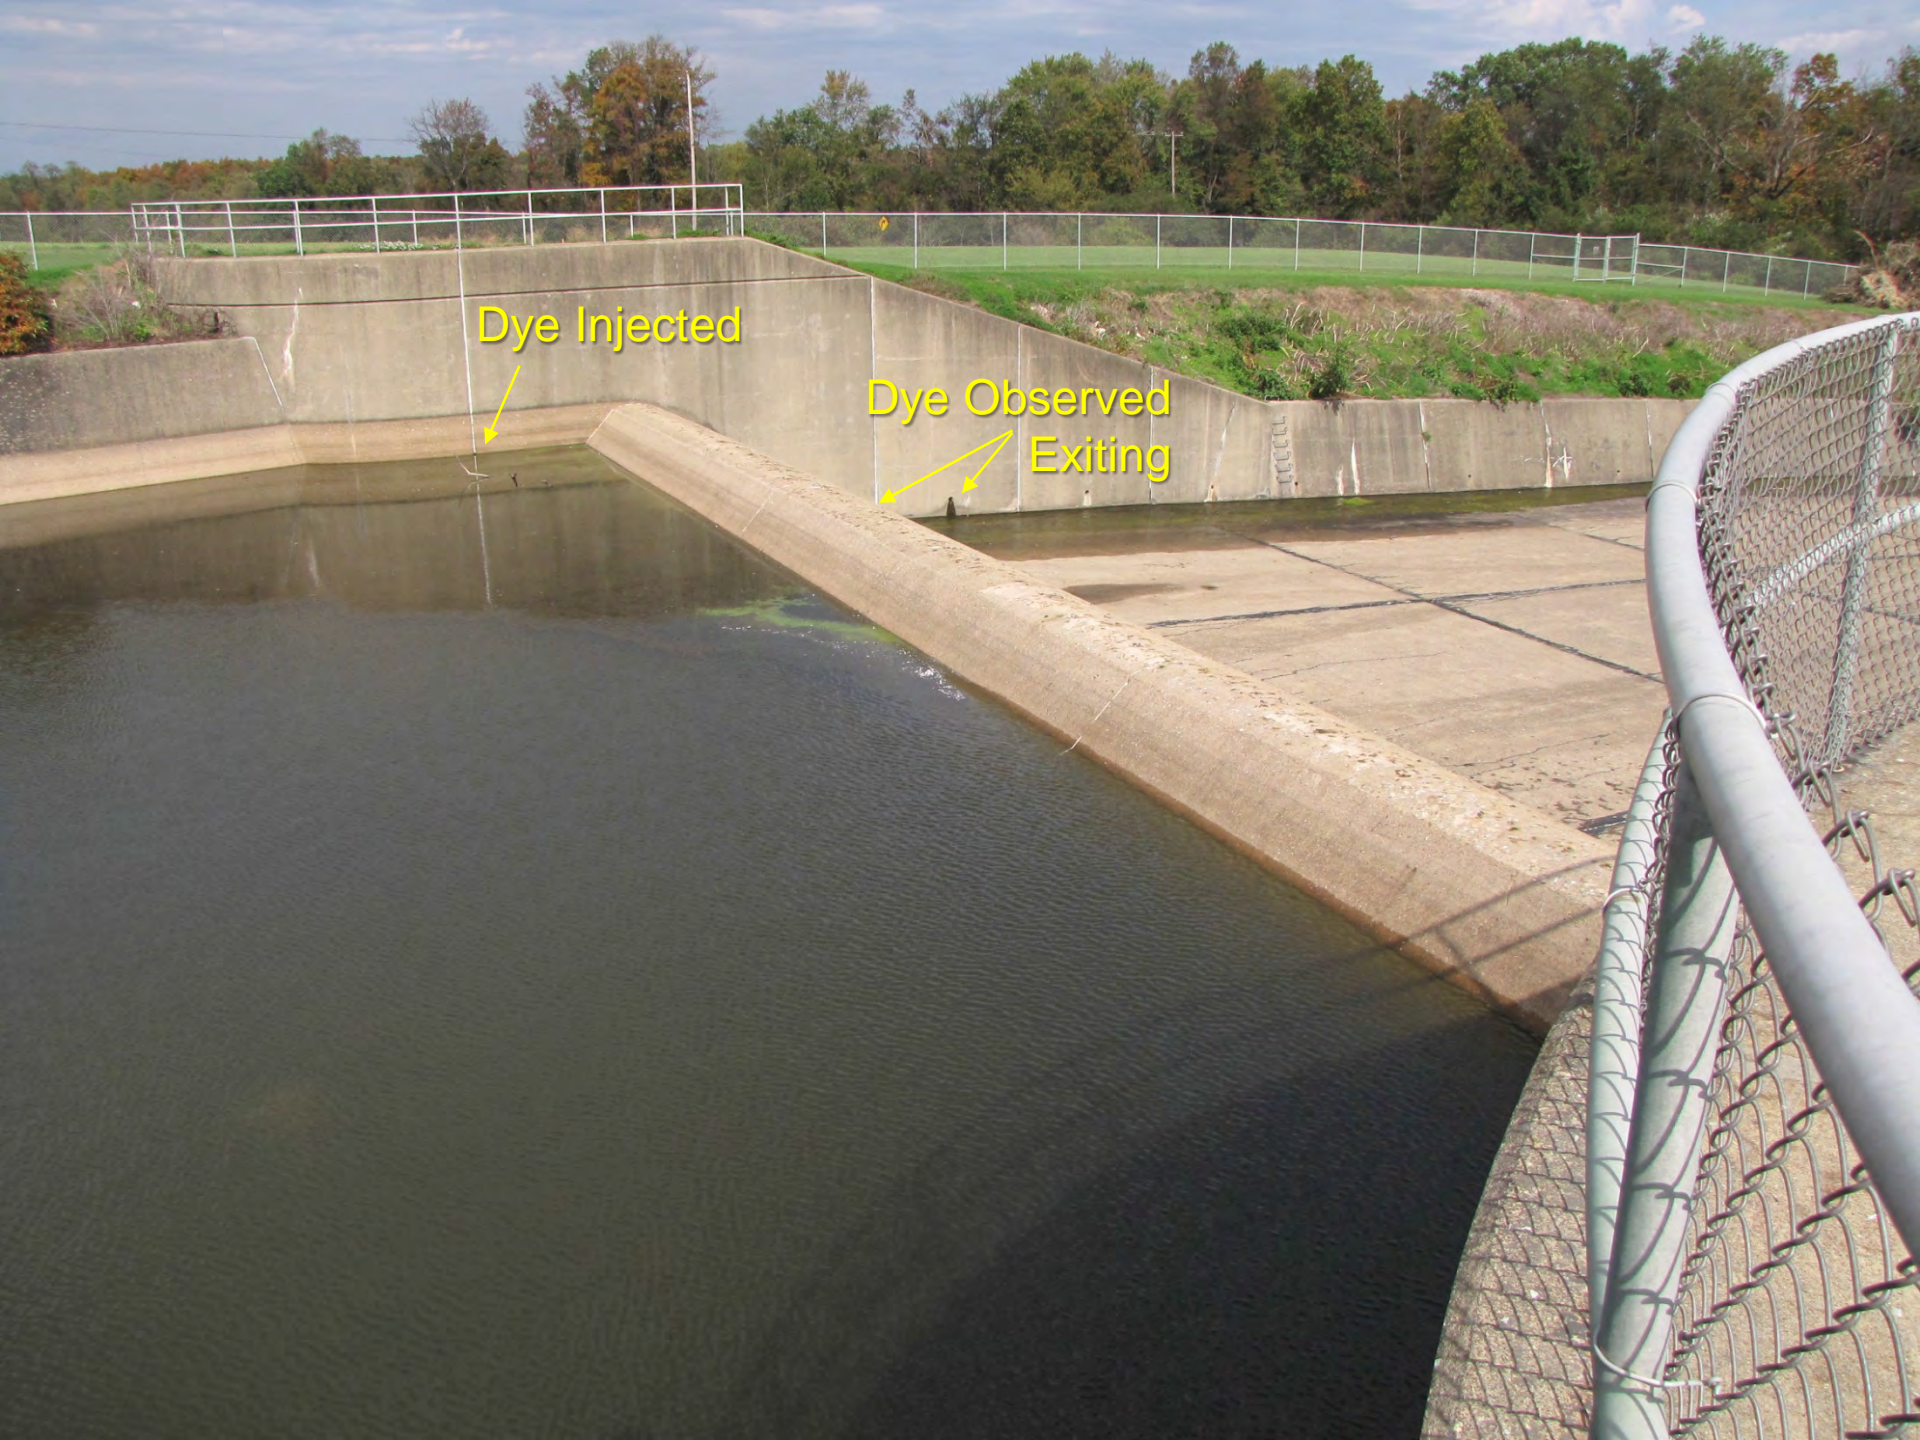
Dye Injected

Dye Observed
Exiting

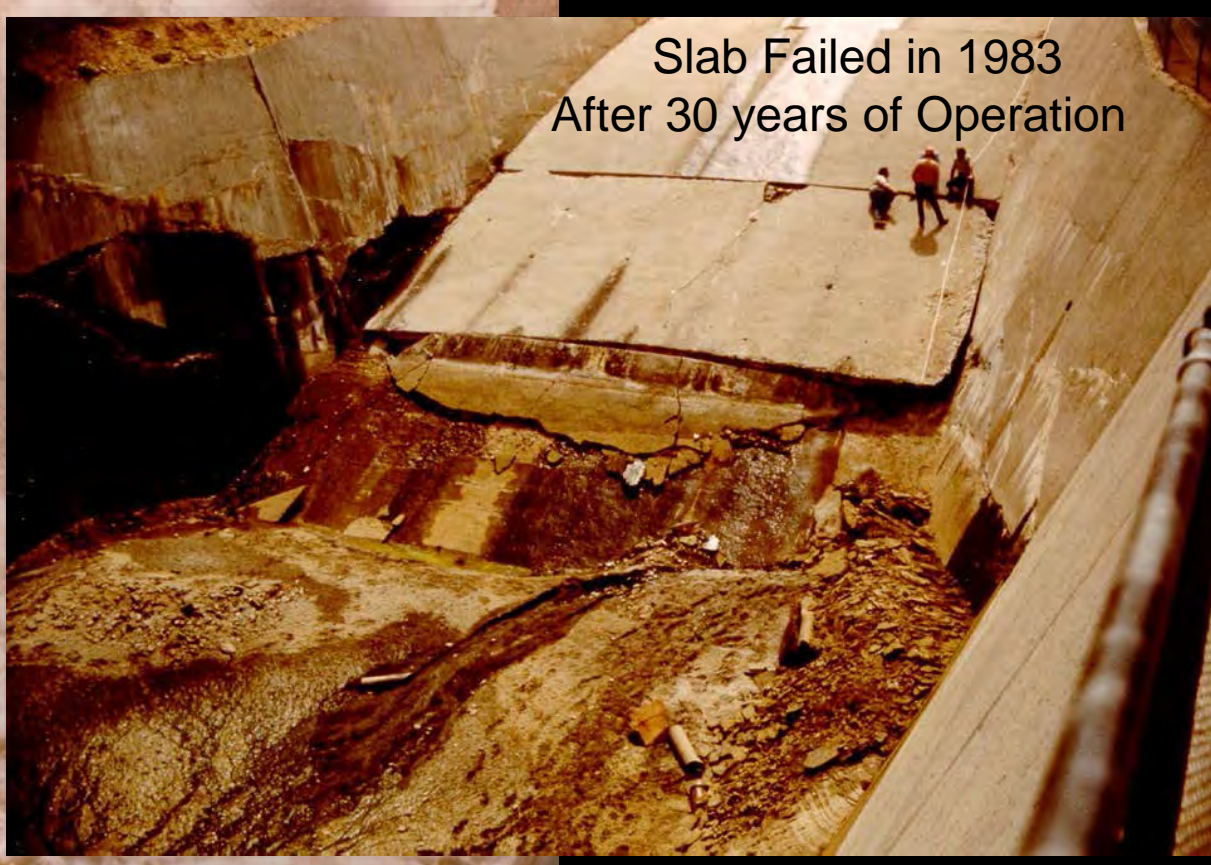
Foundation Erosion

Slab Failed in 1983
After 30 years of Operation

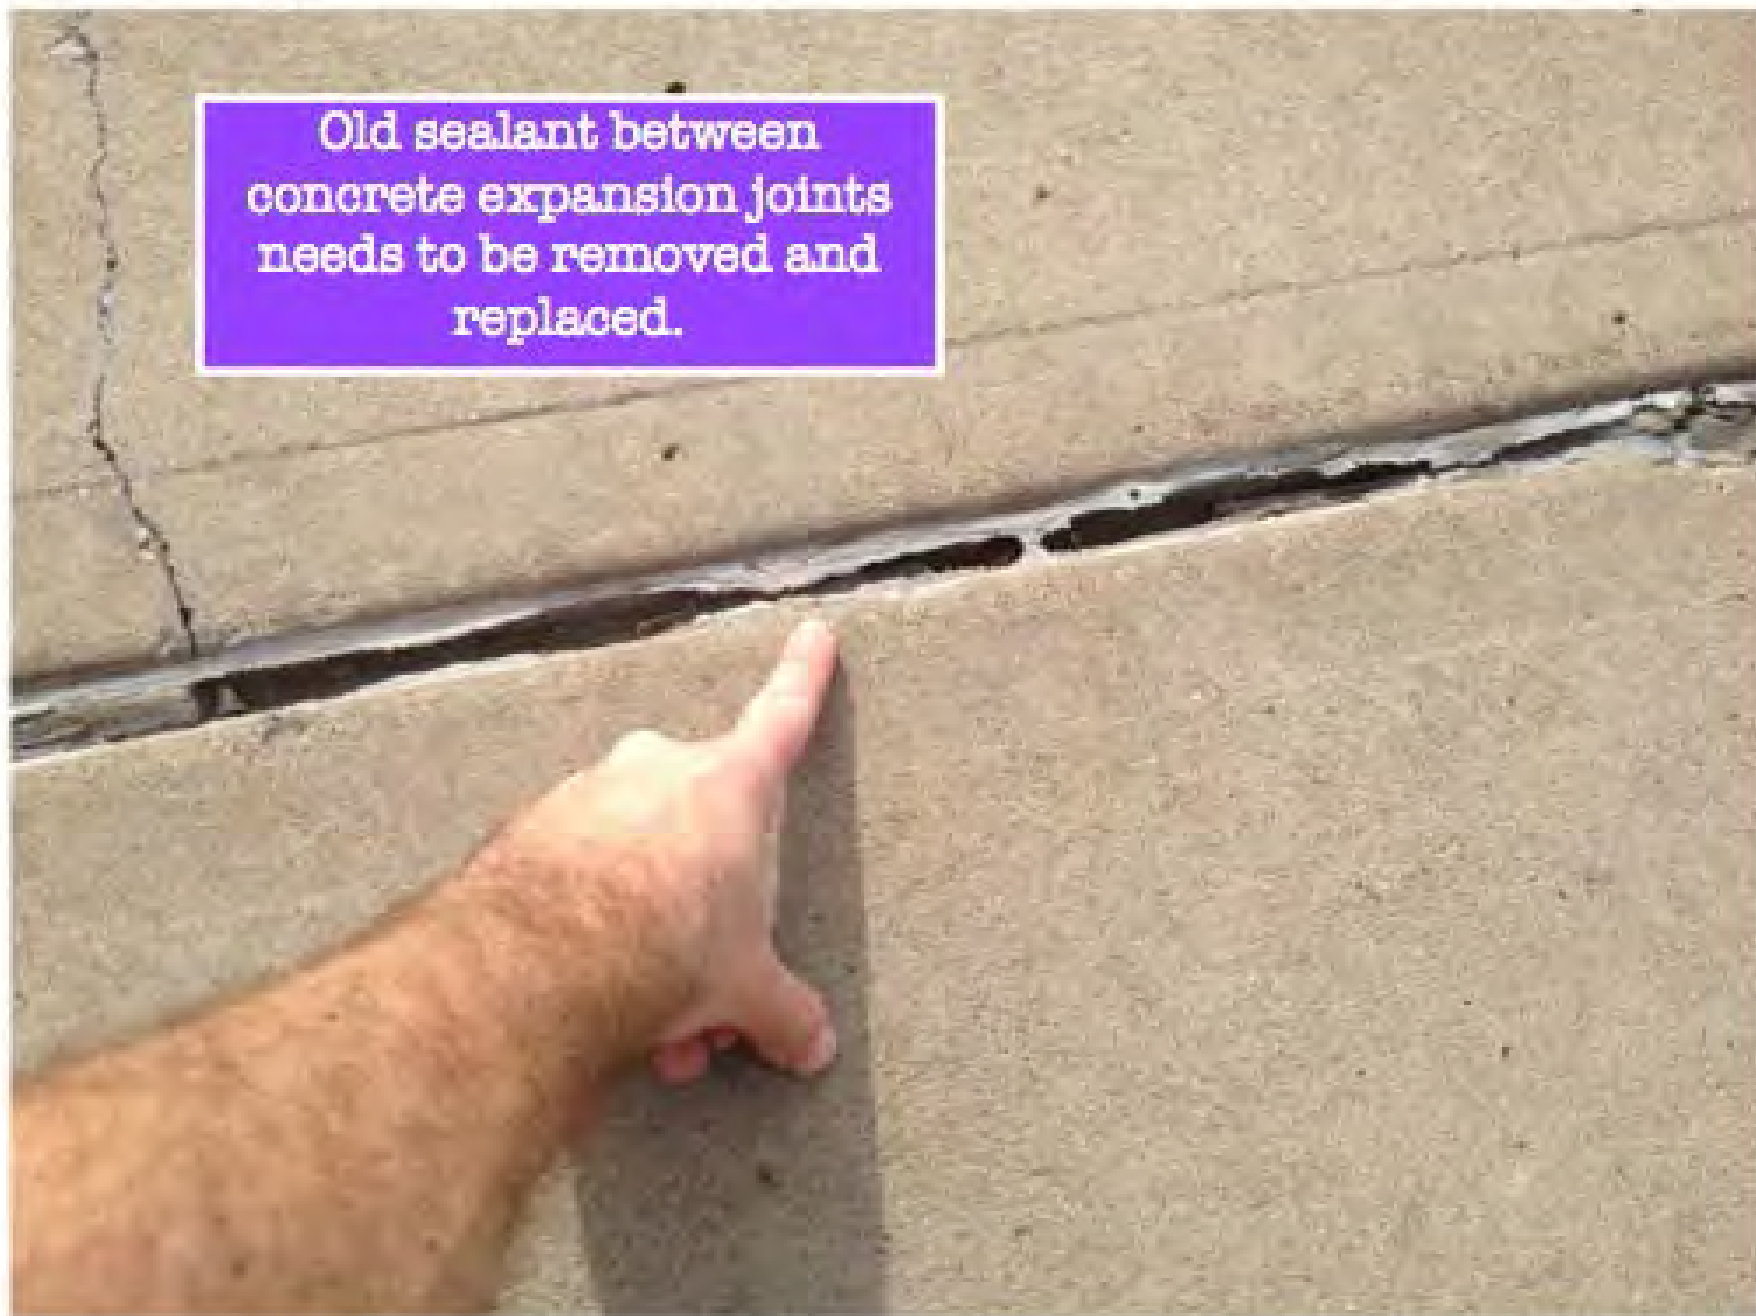
Old sealant between
concrete expansion joints
needs to be removed and
replaced.
