Lessons Learned from Spillway Failures

Causes of Dam Incidents

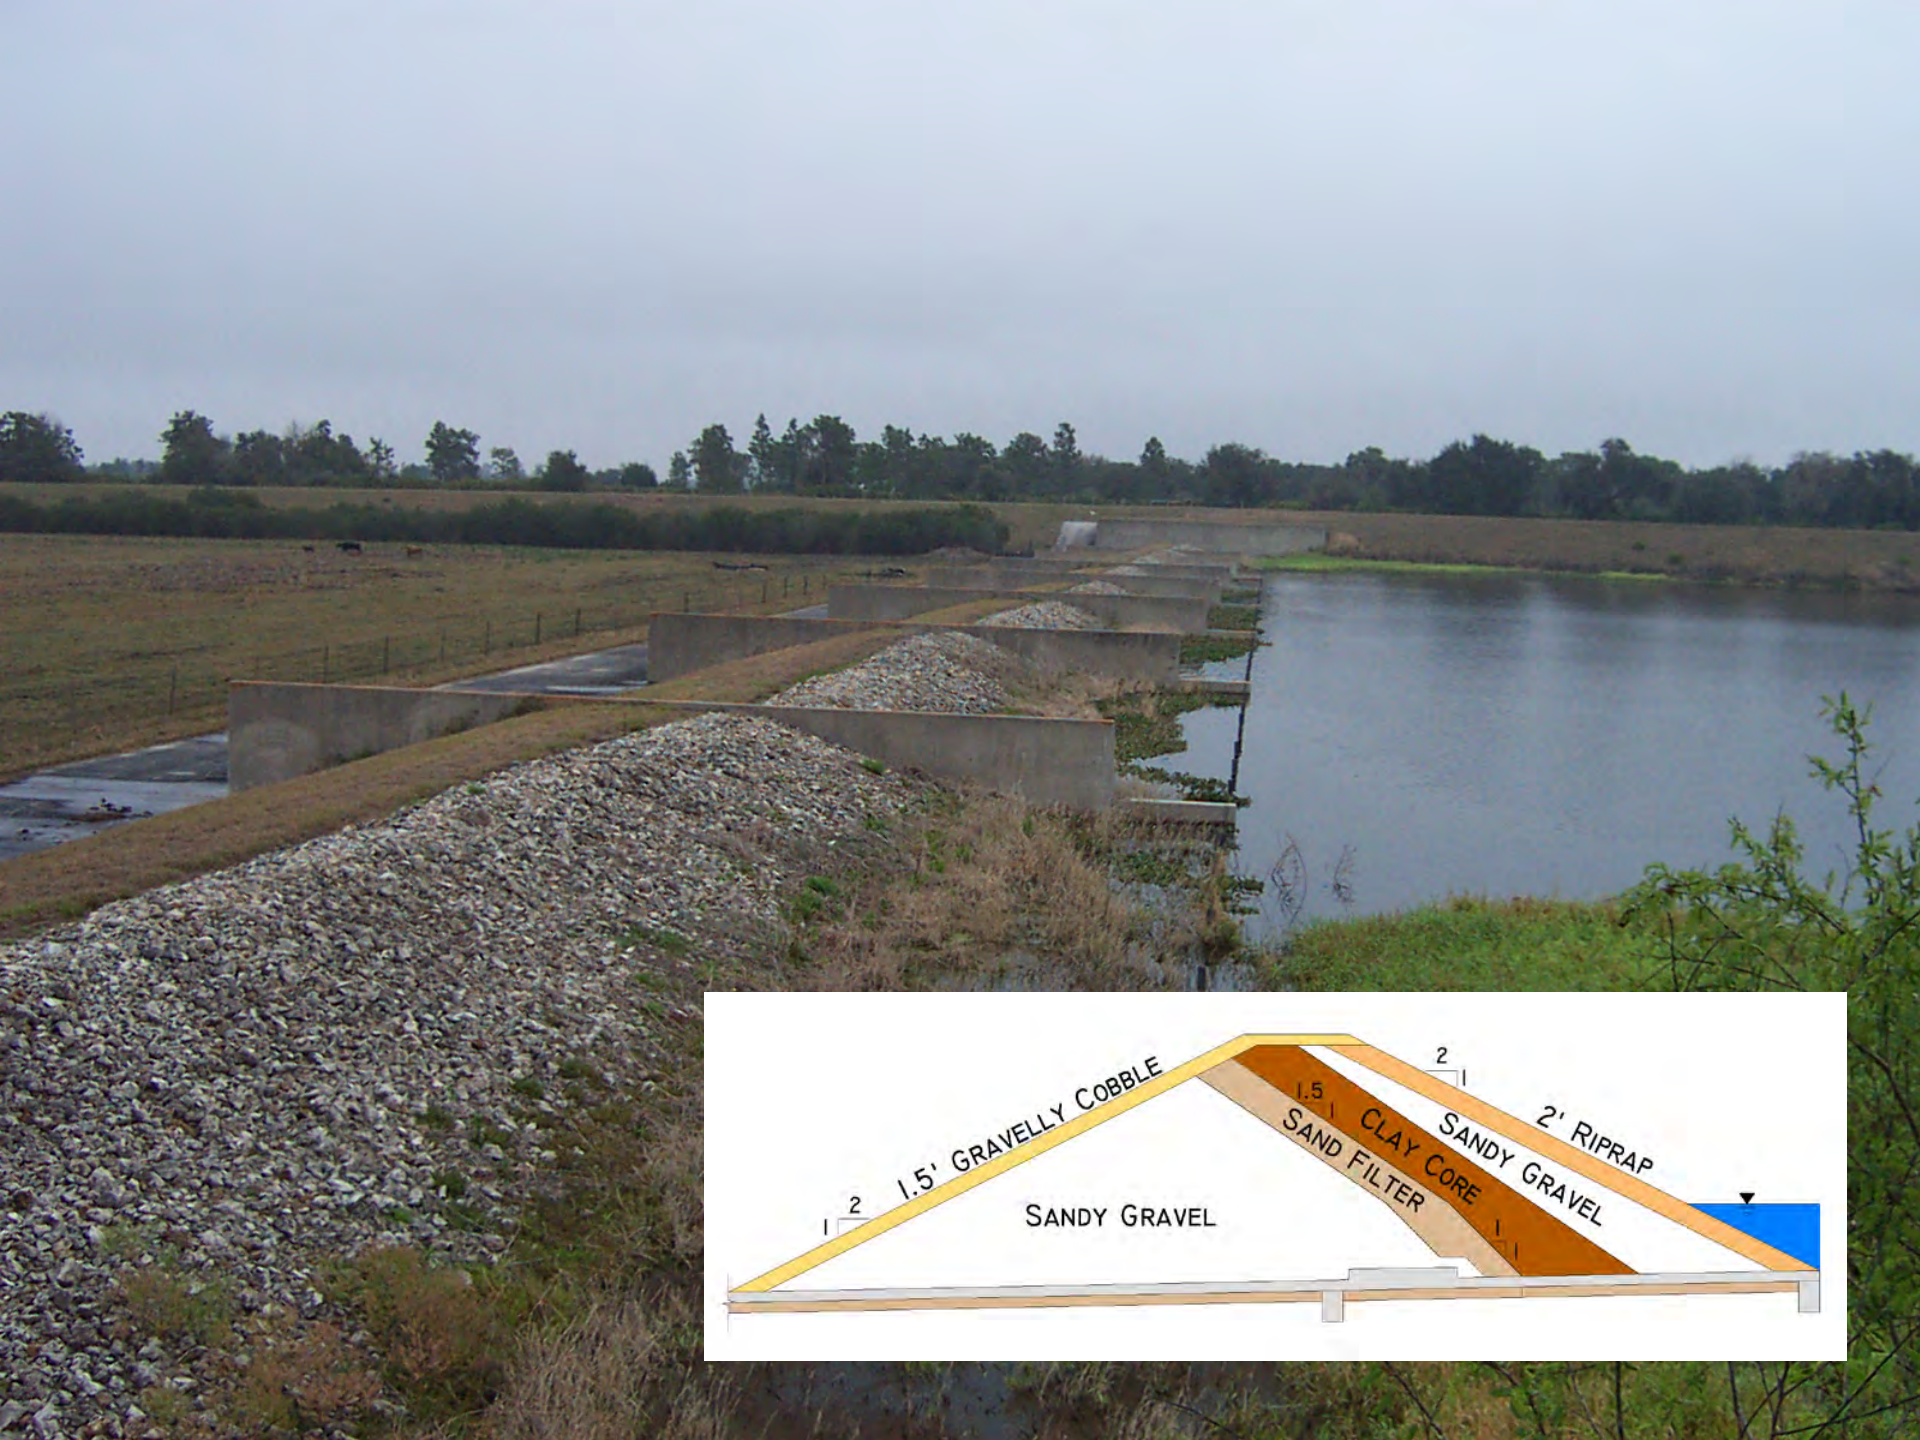
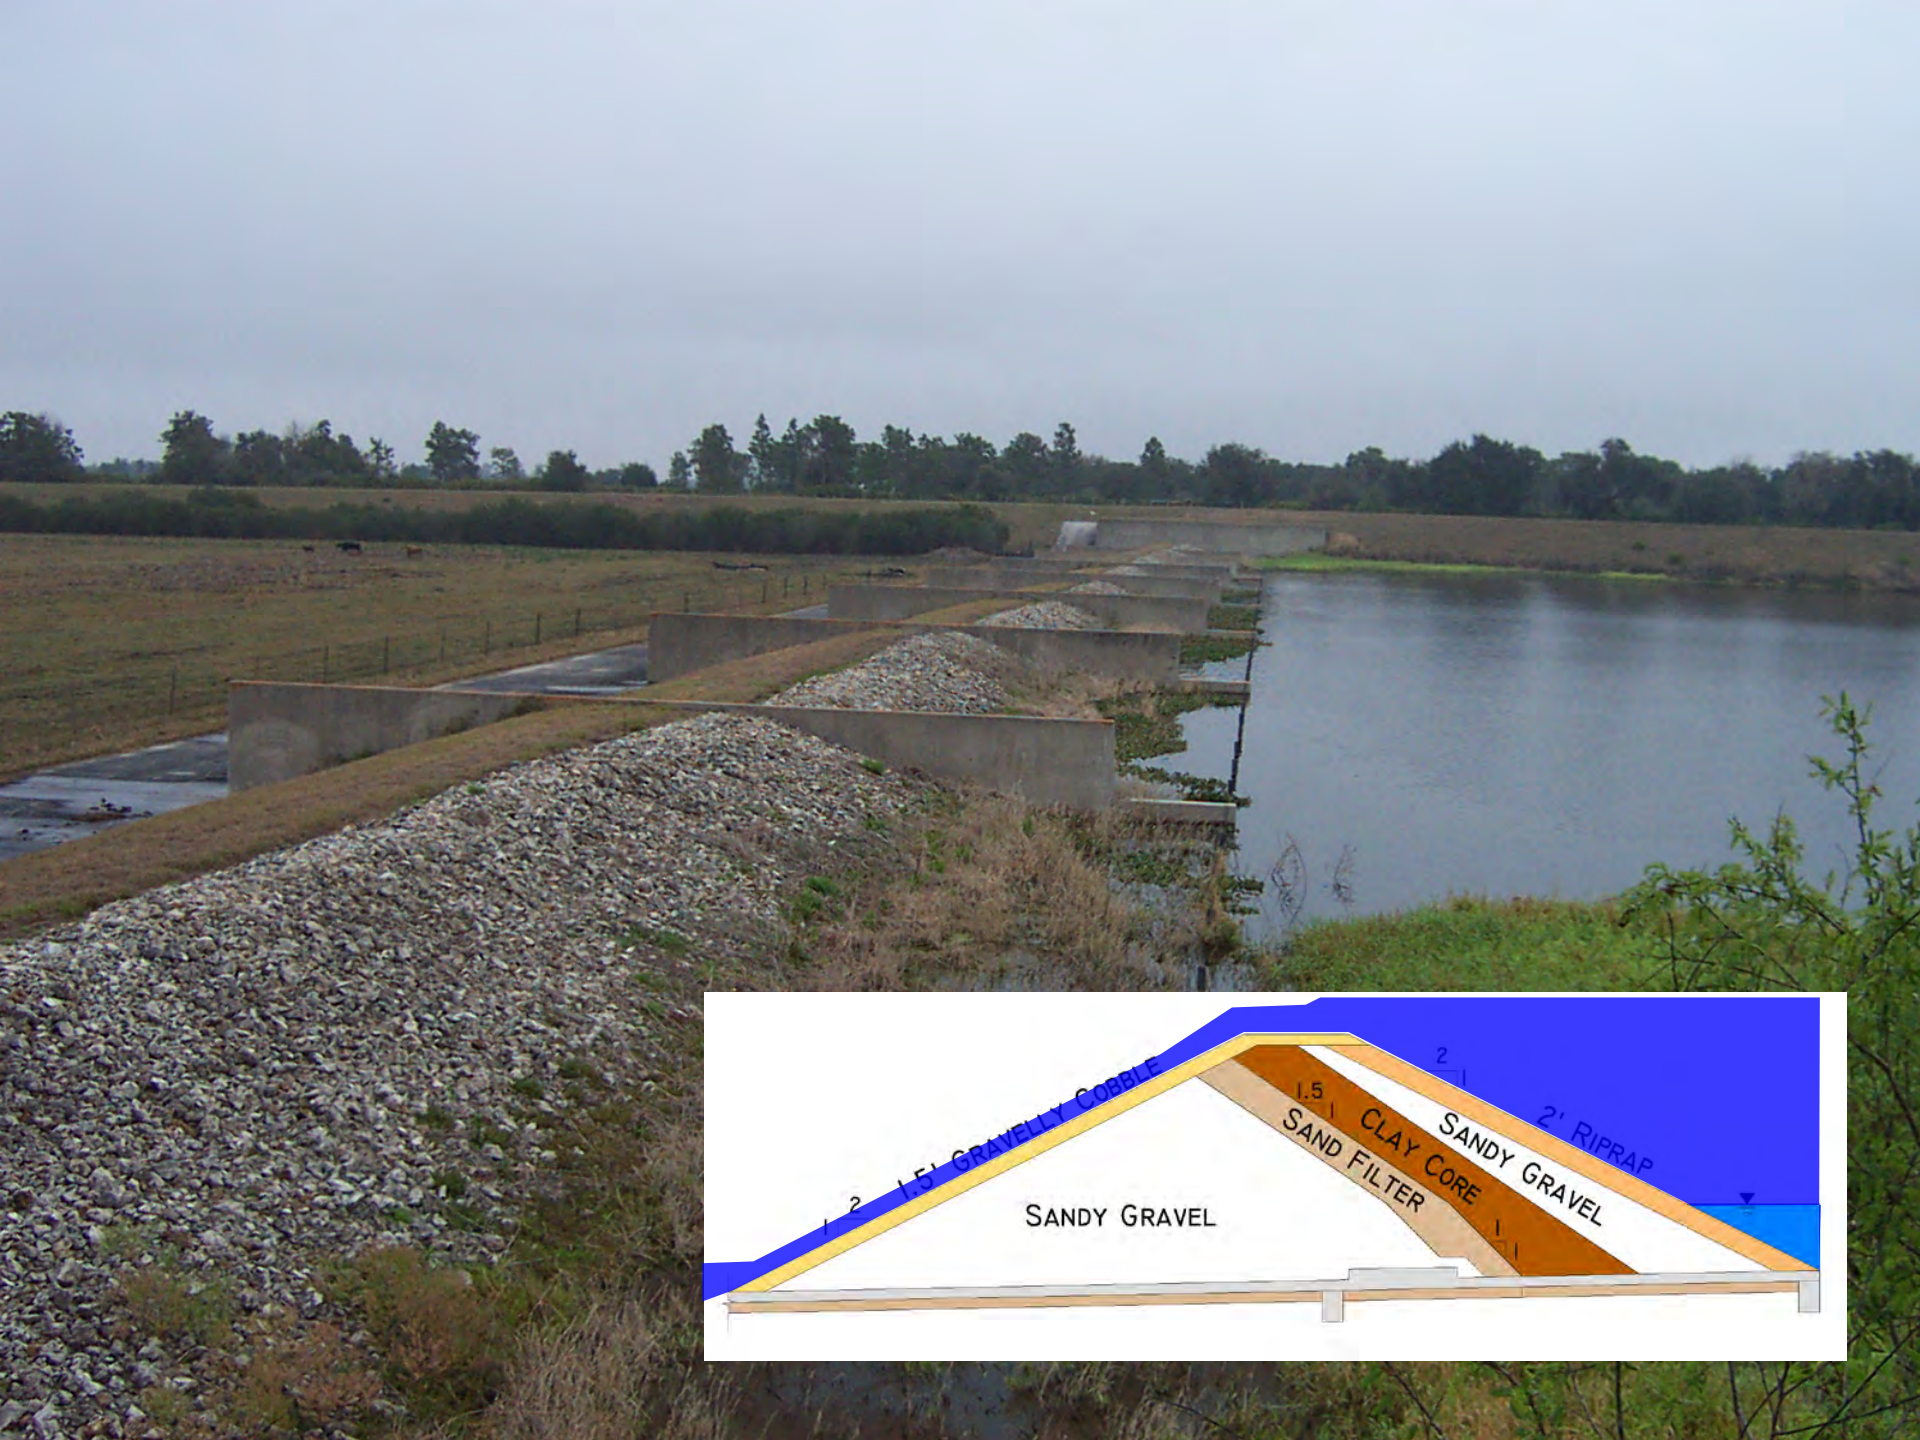
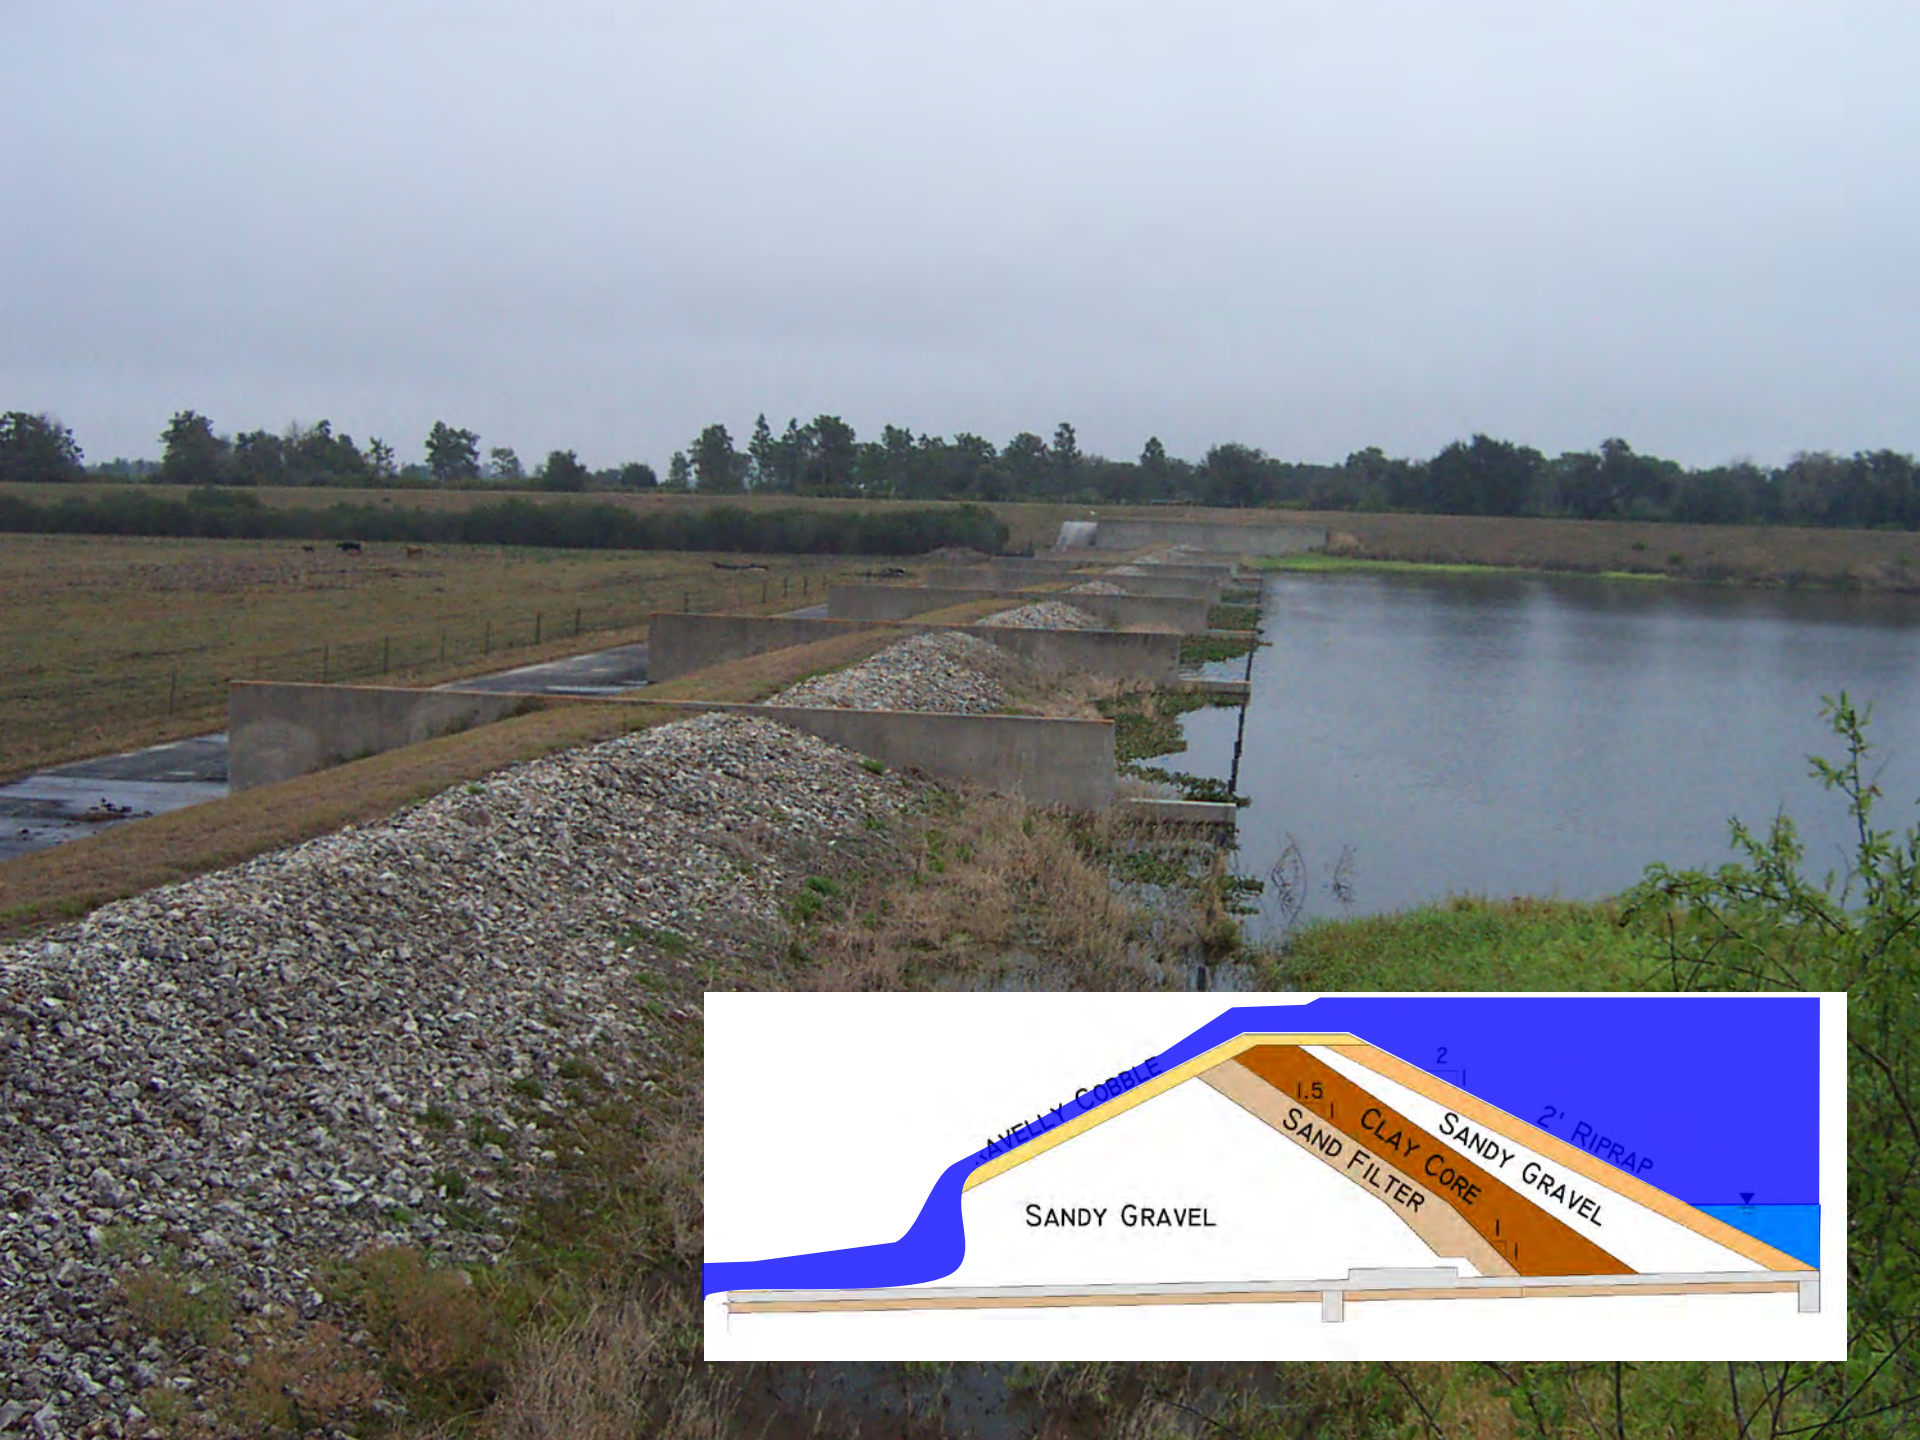
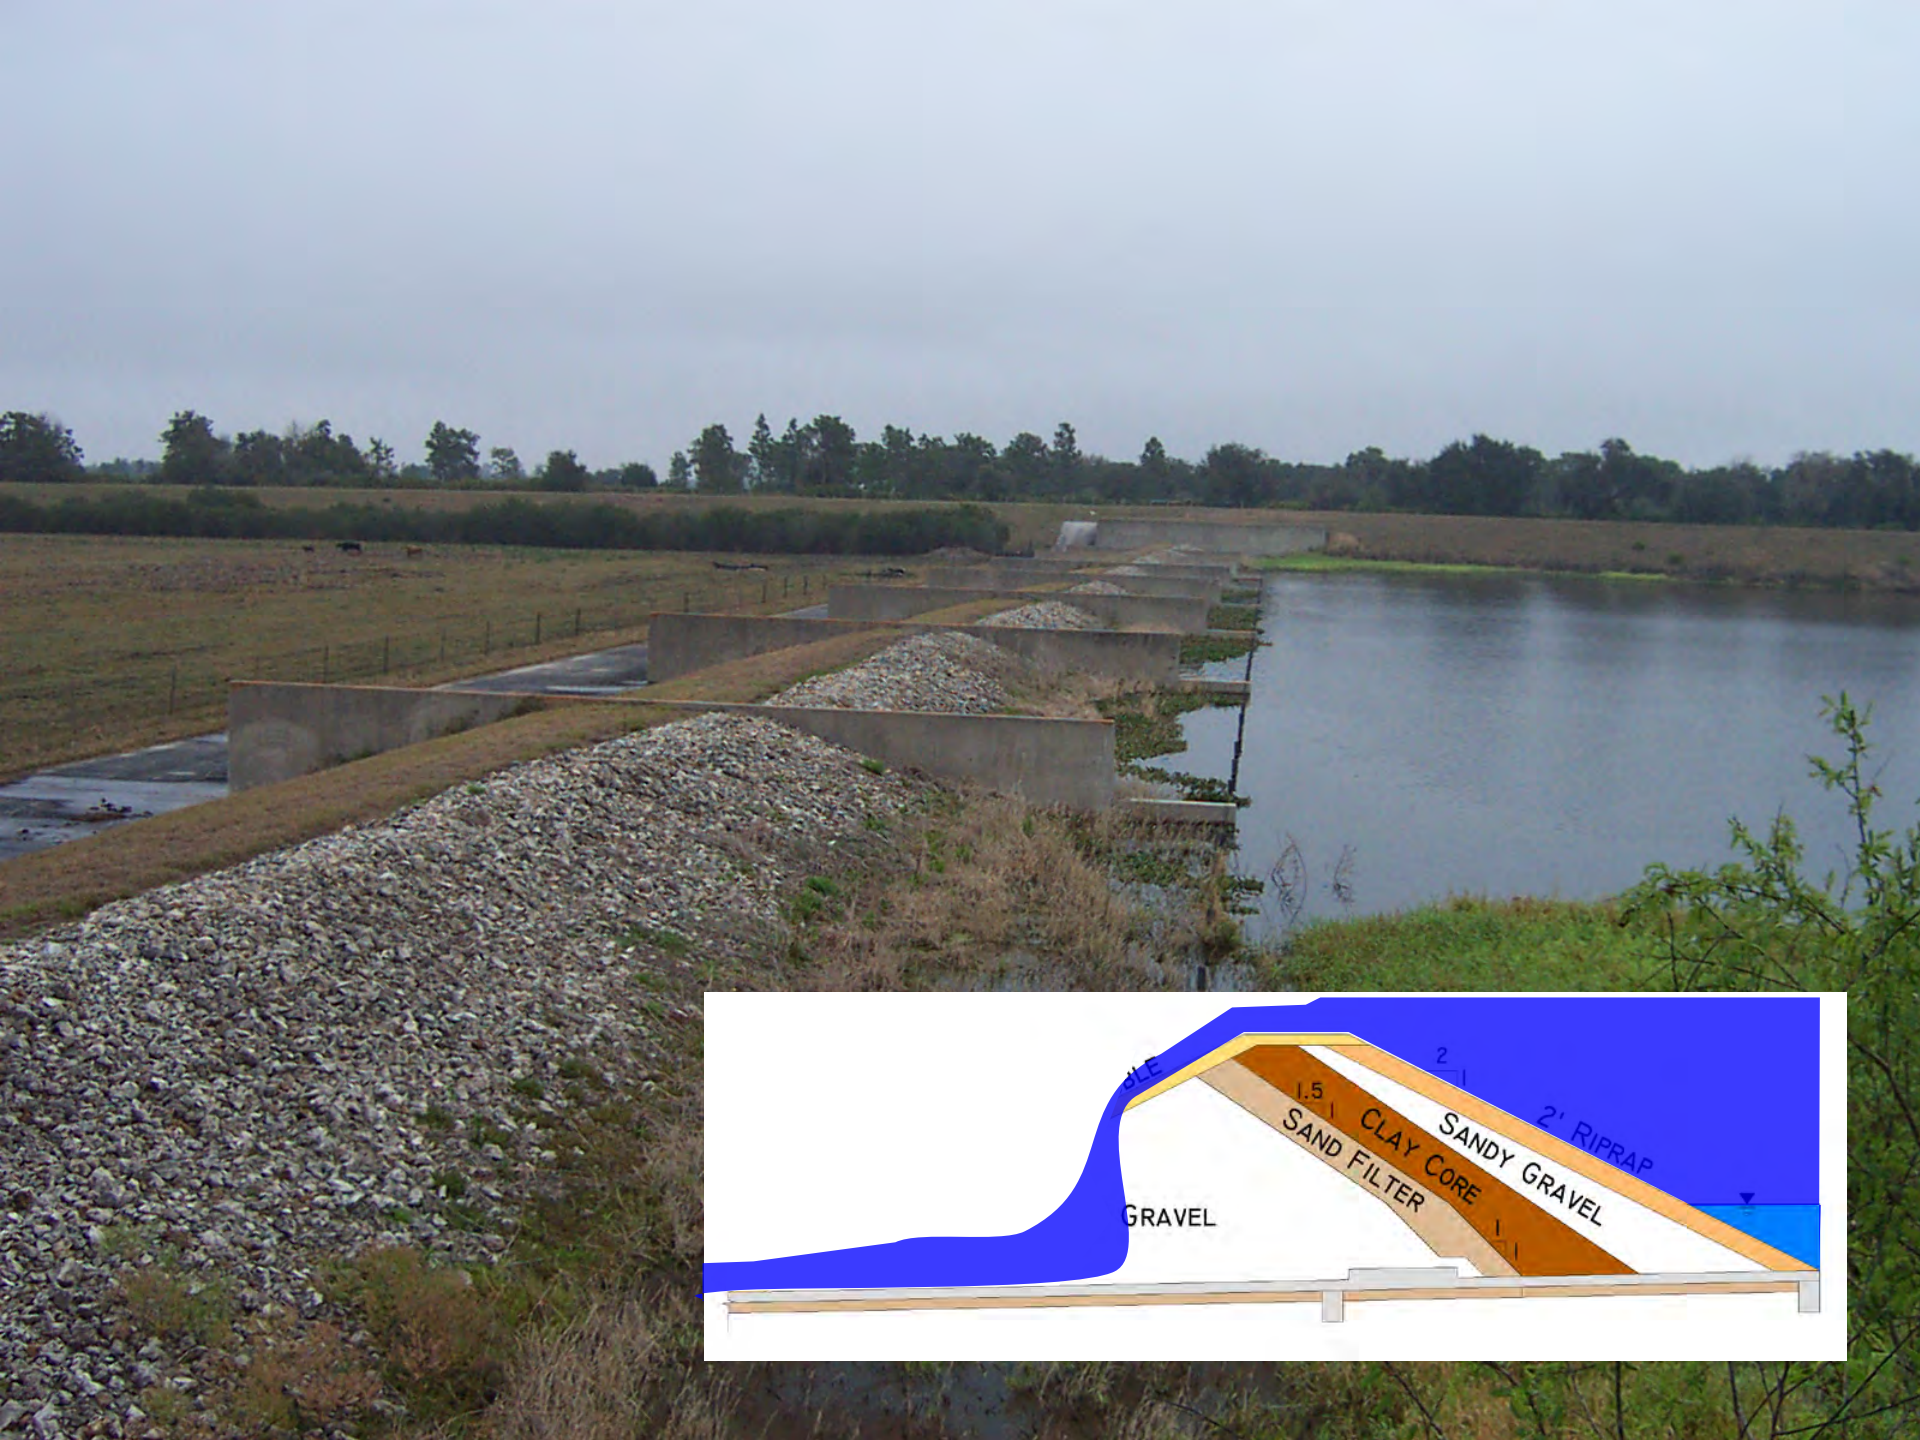
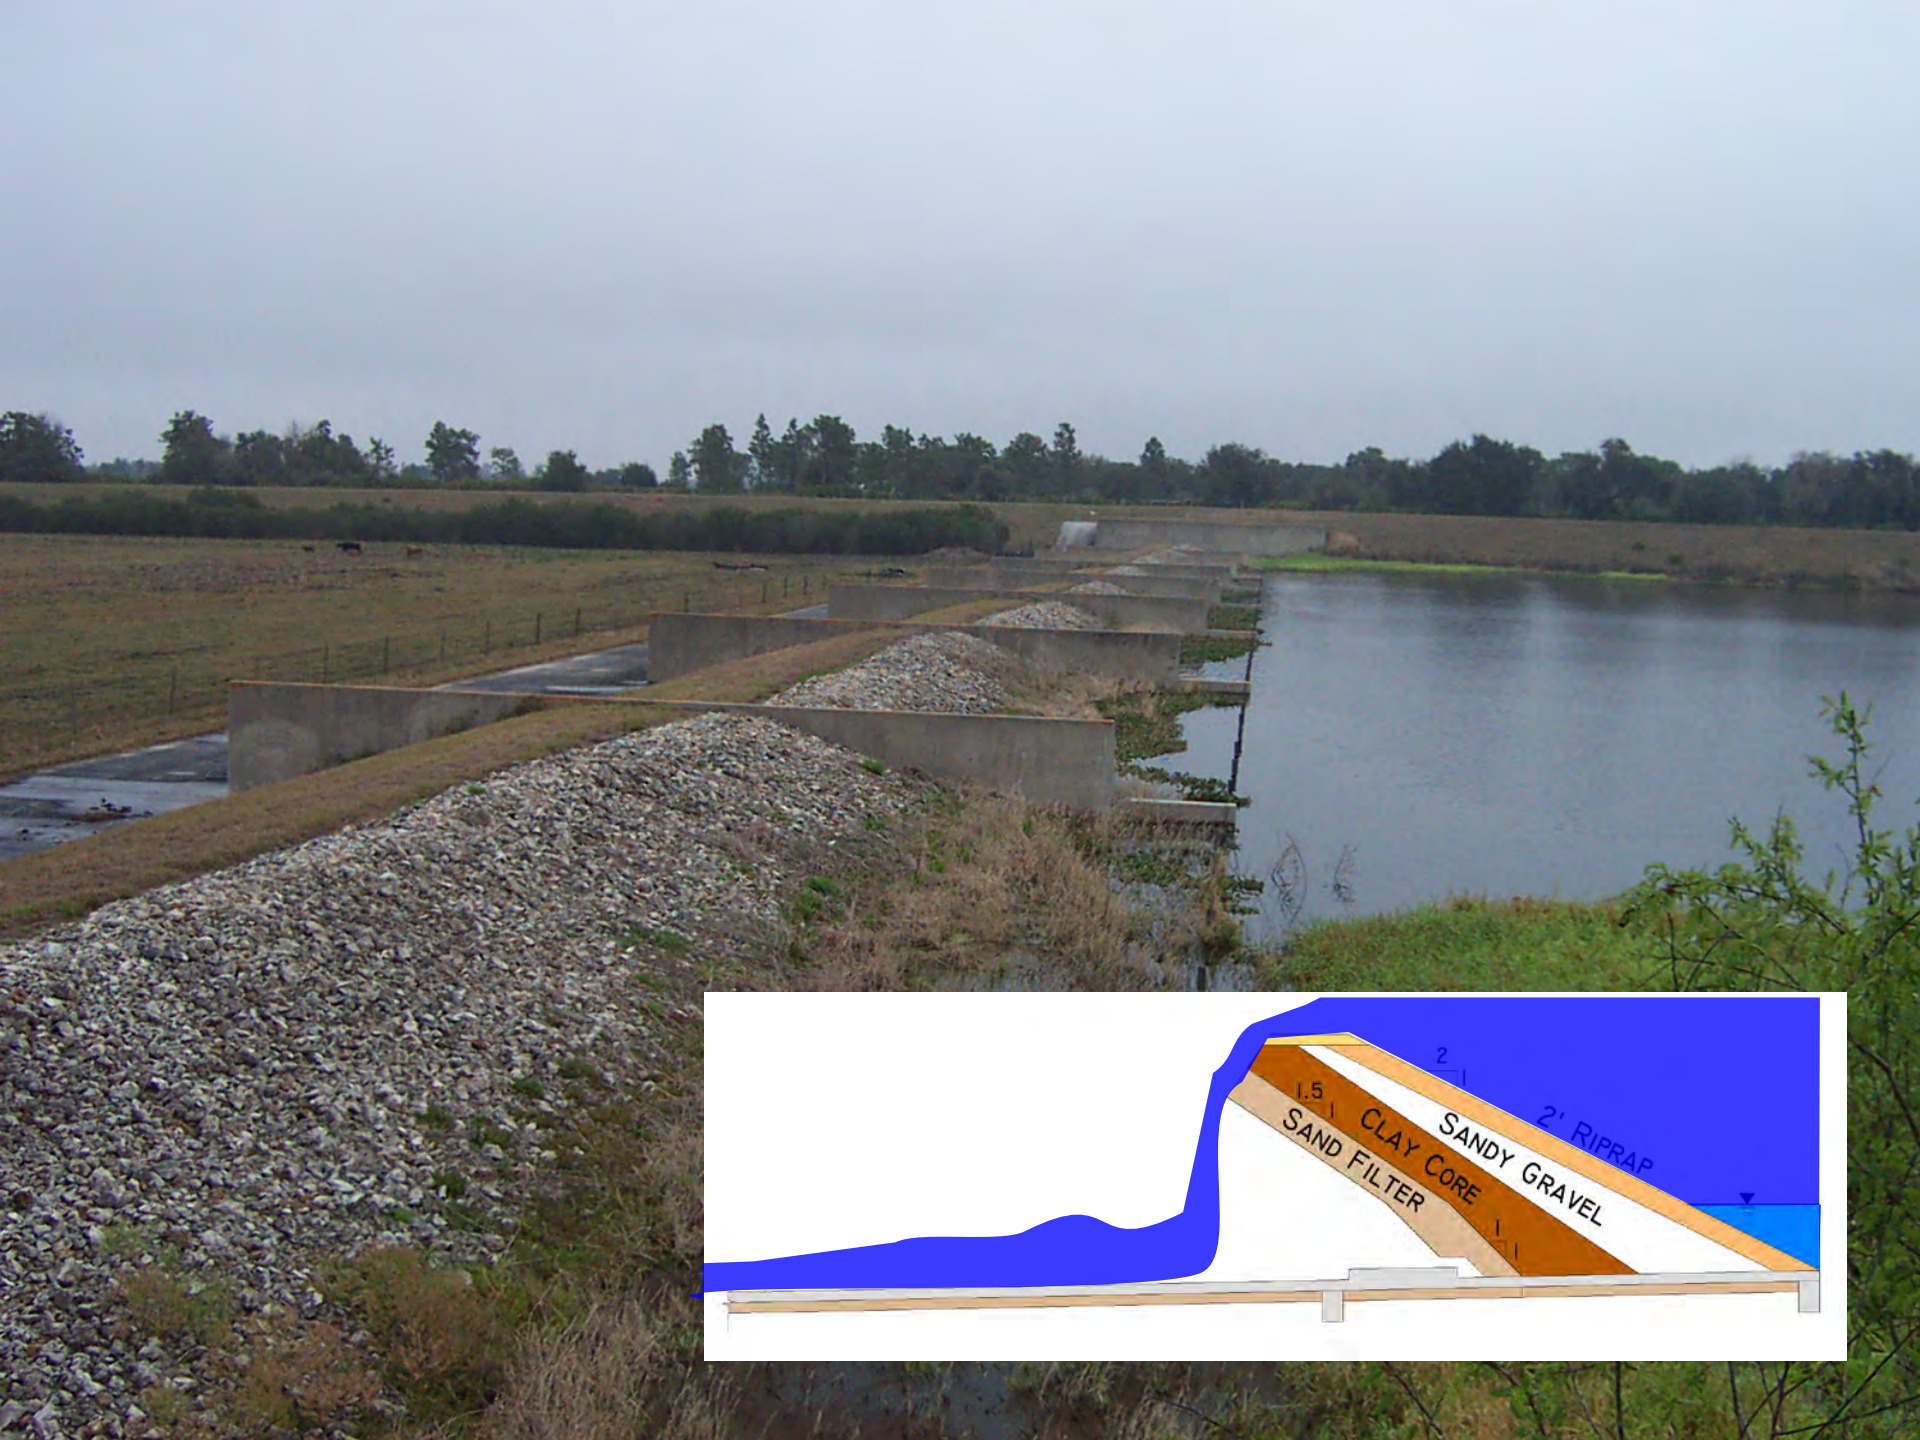
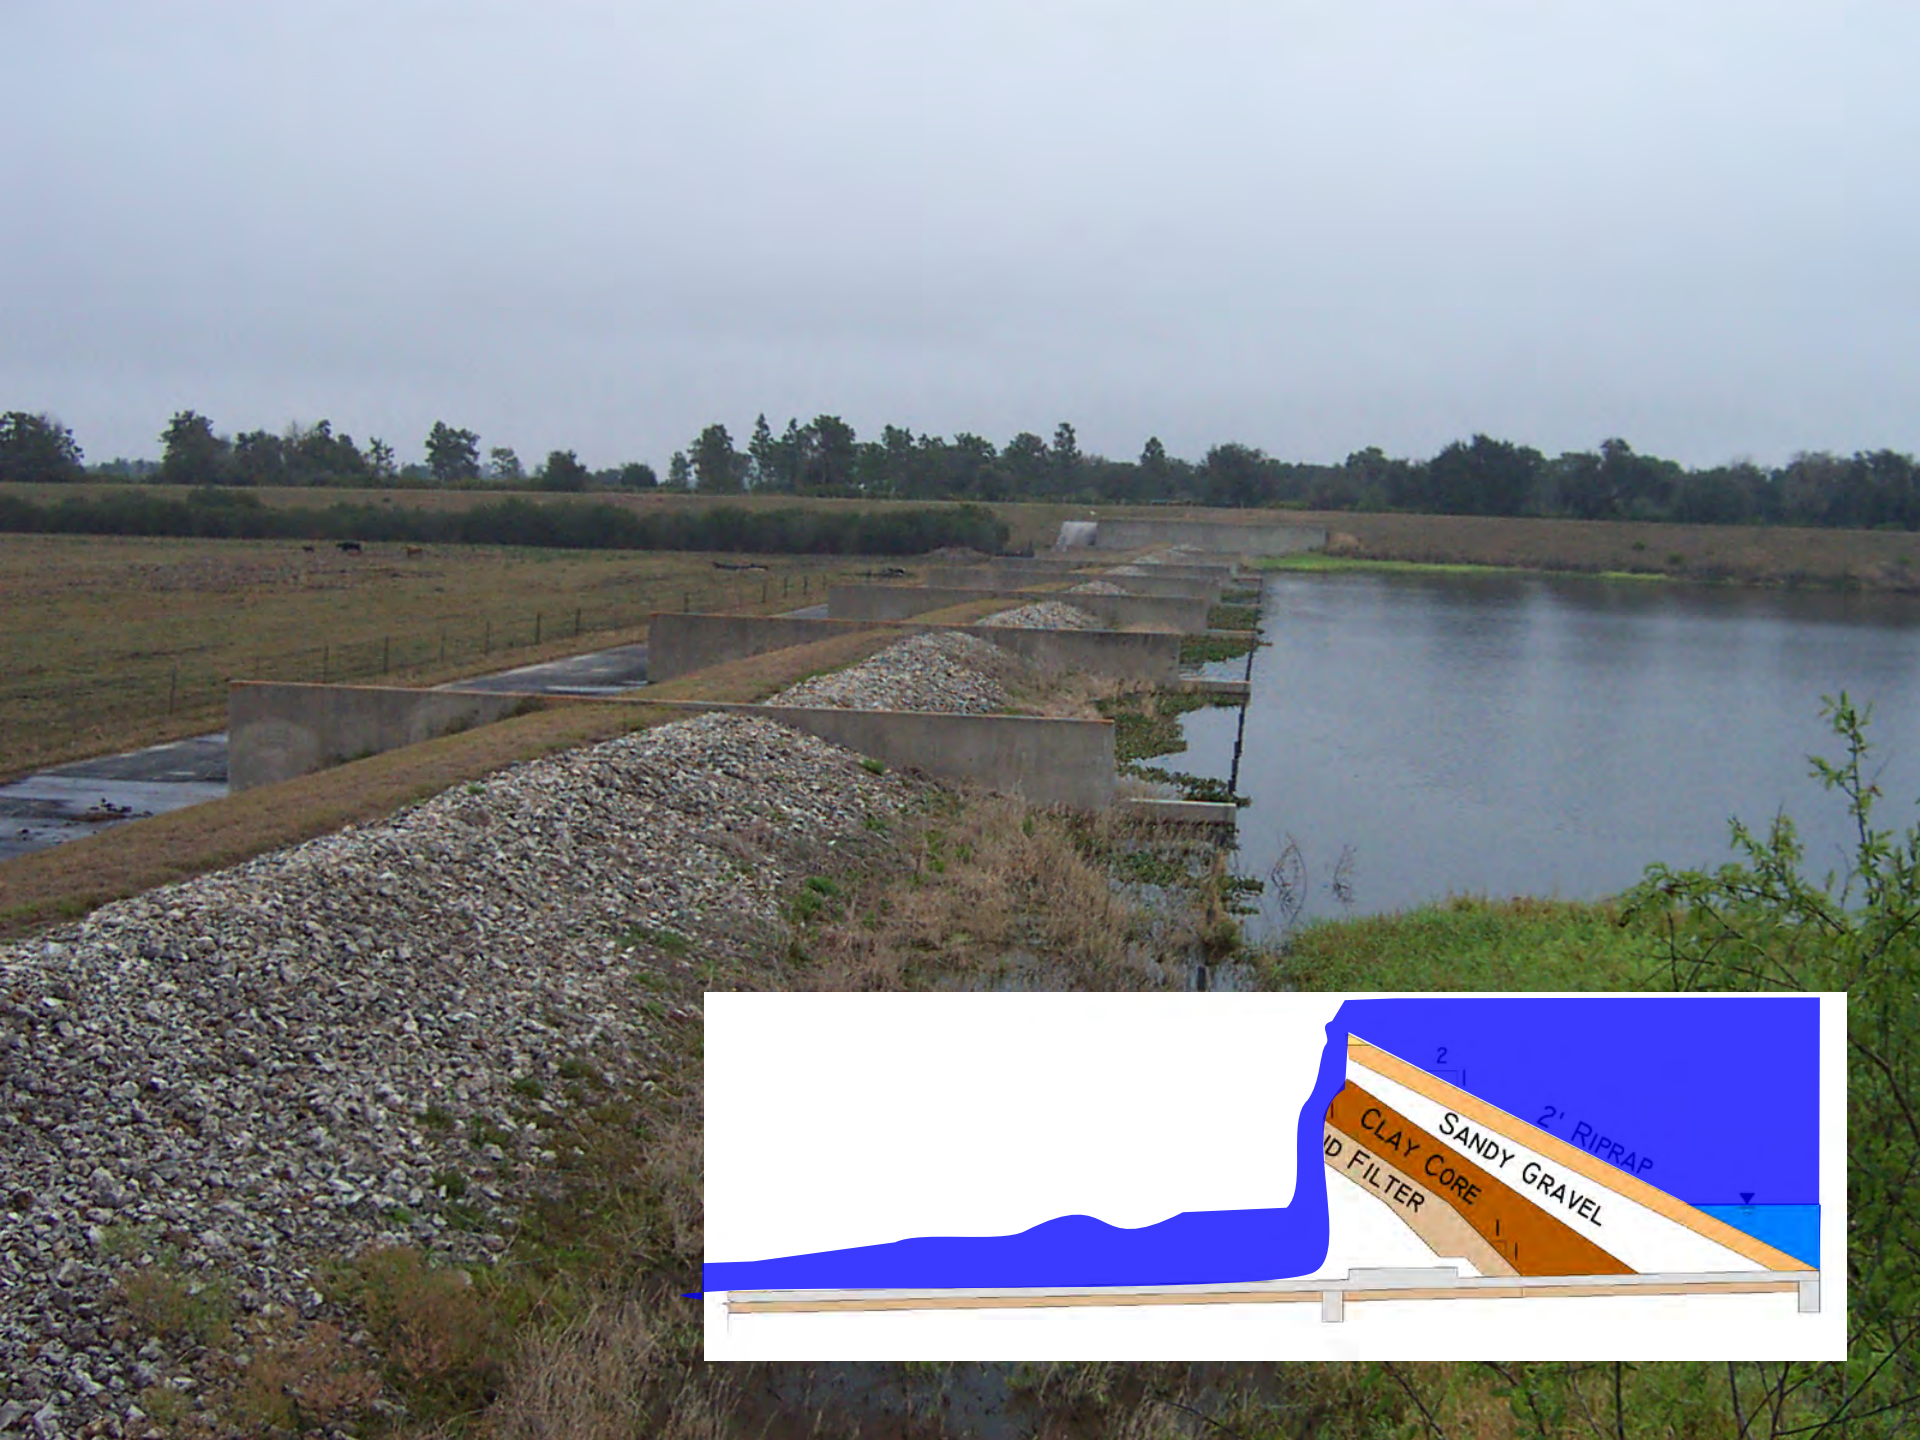
Silver Lake Dam, Mi

- 5-10 year flood event on May 14, 2003
- Fuse plug activated
- Spillway channel eroded well below fuse plug foundation
- Fuse plug 9" below service spillway crest
- Fuse plug foundation and channel susceptible to erosion
- Fuse plug flows 5,000 → 30,000 cfs ~PMF

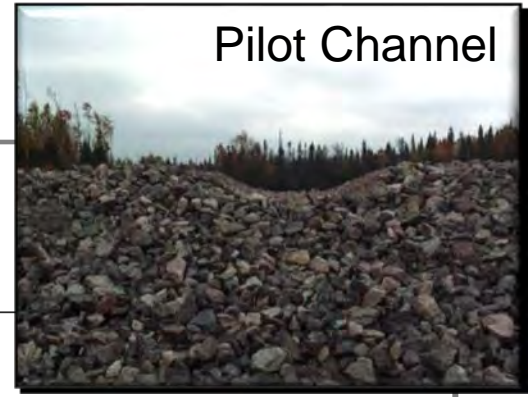
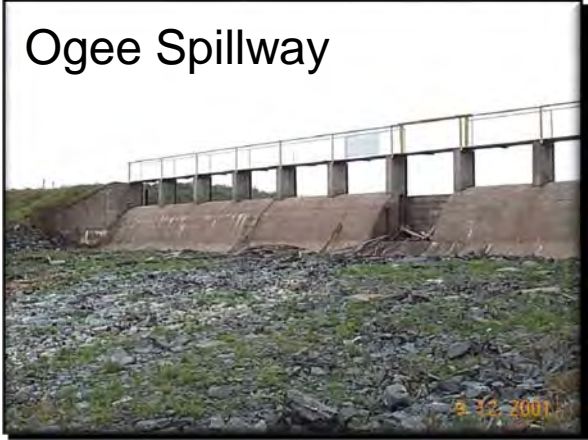
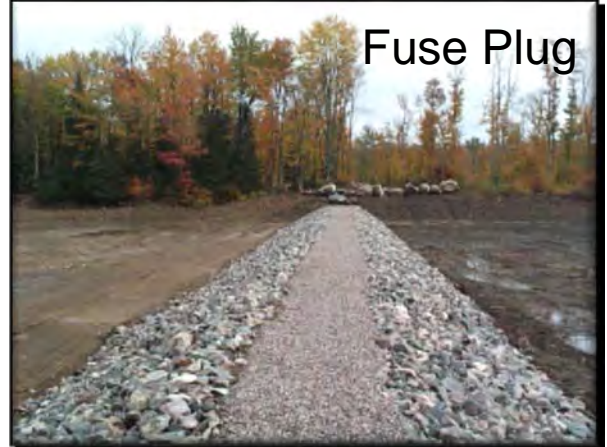
Final Eroded Fuse Plug Breach

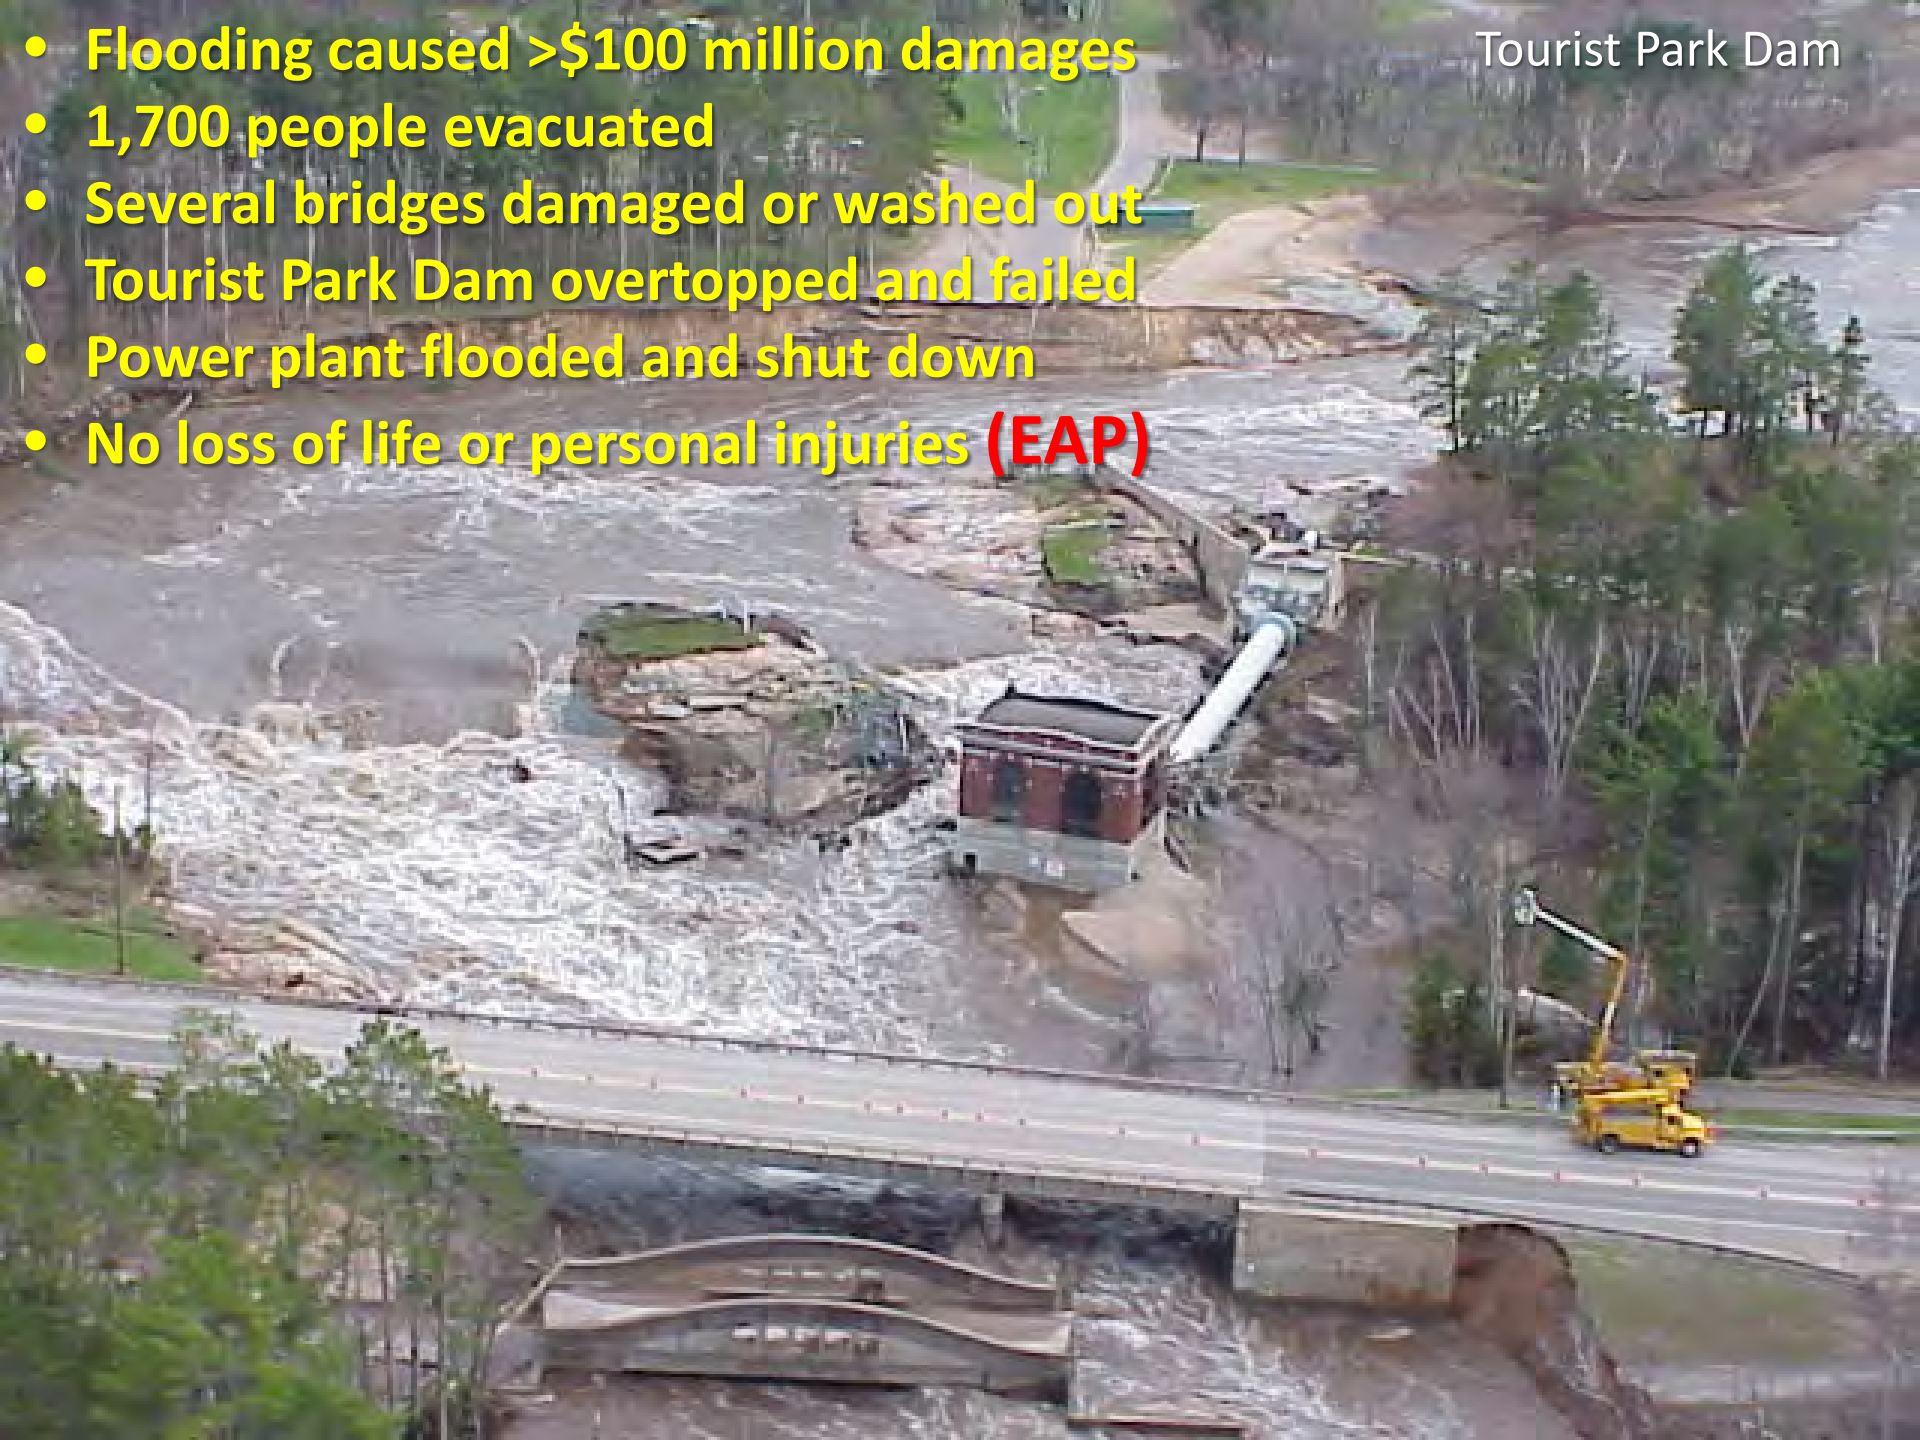
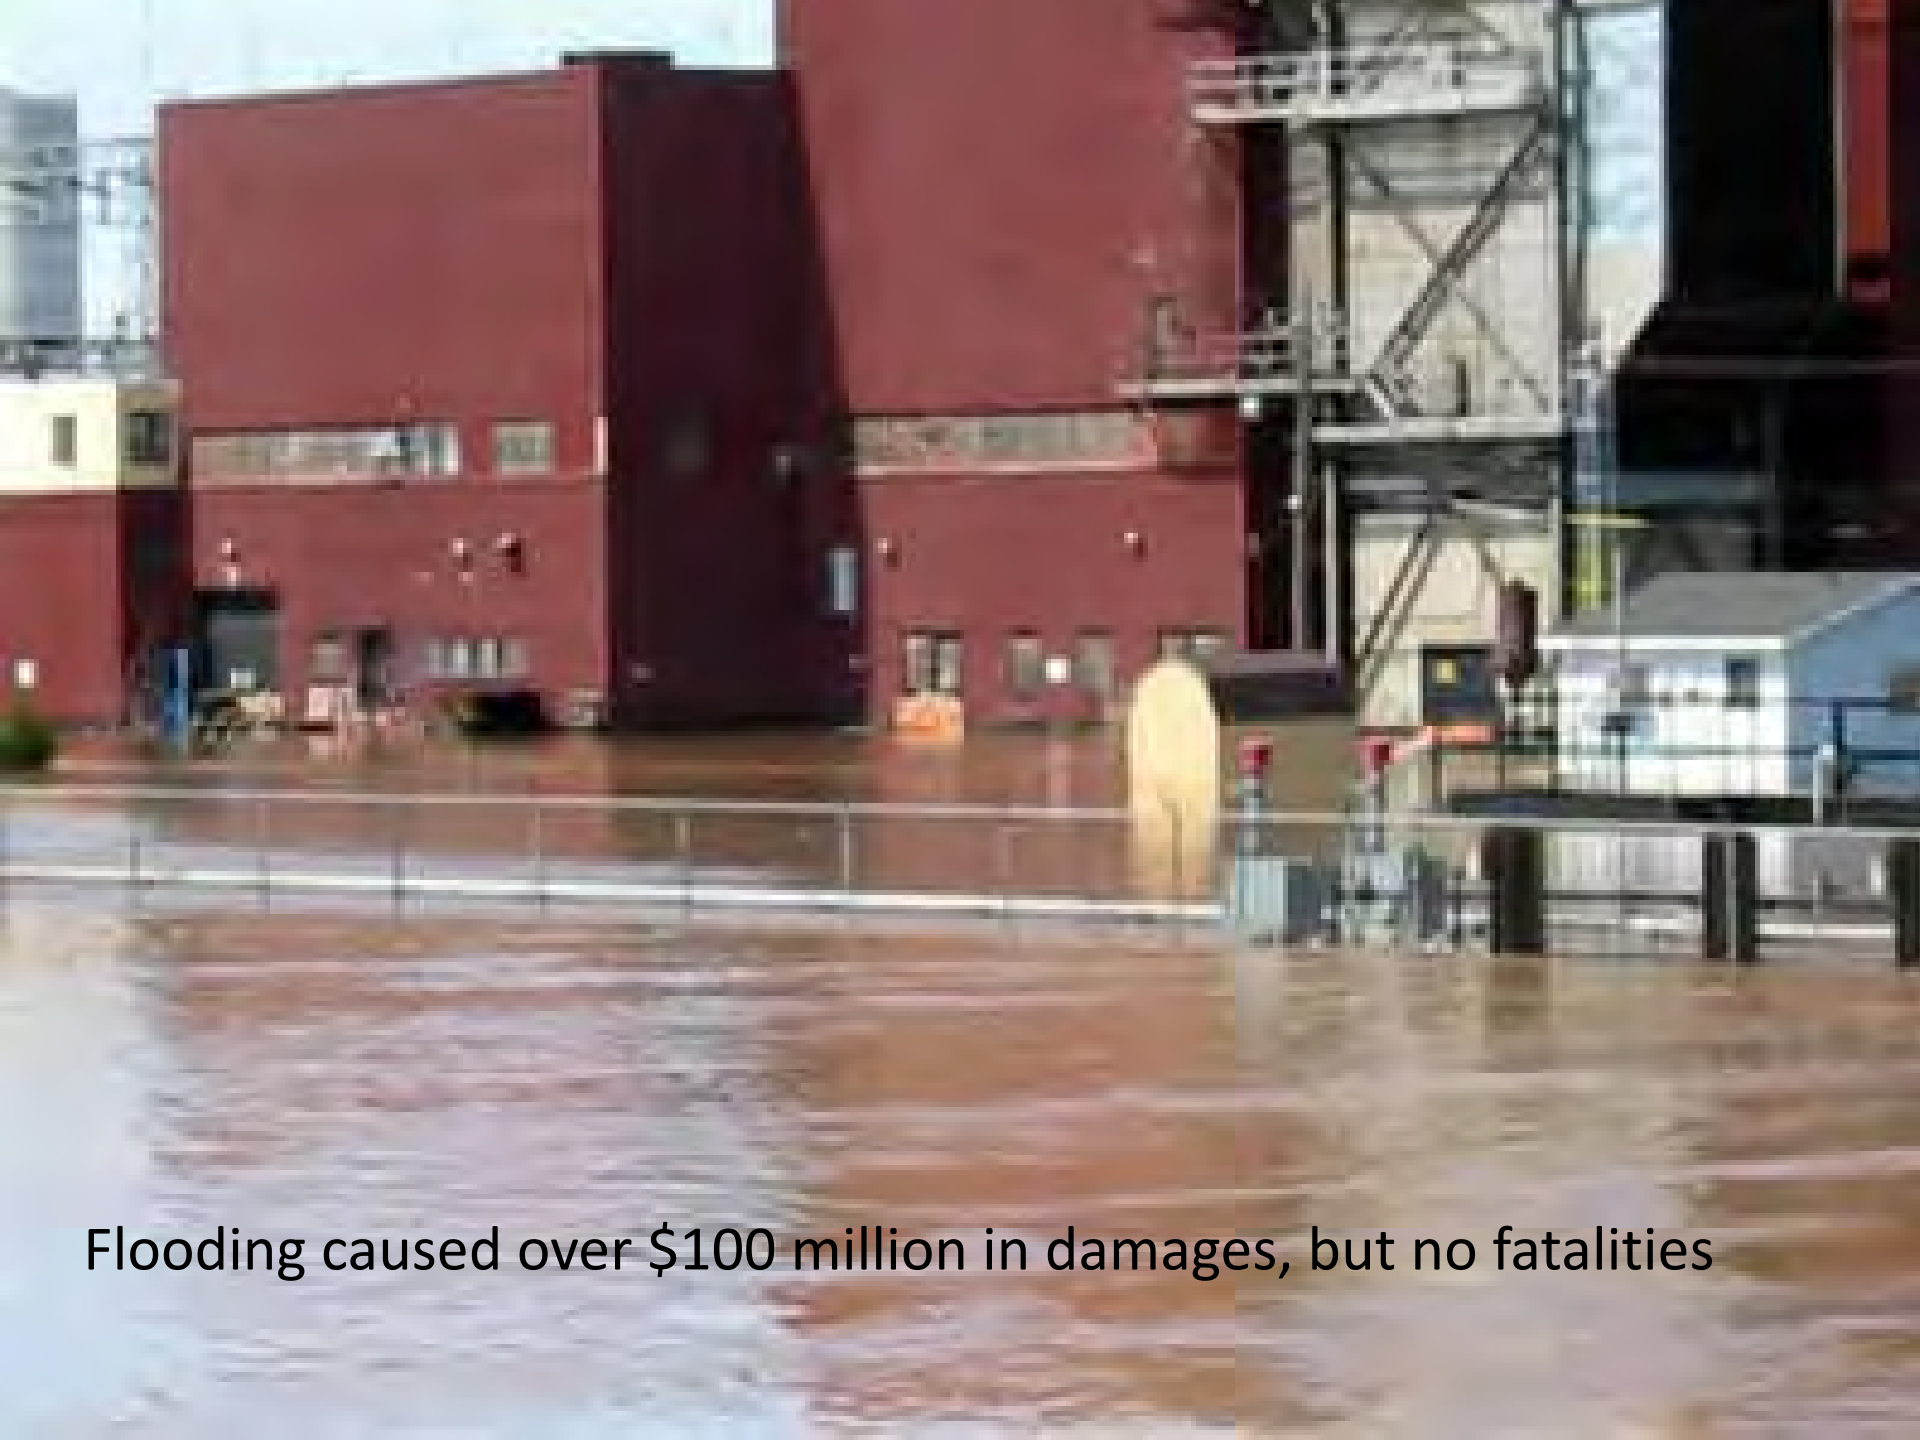
- Flooding caused >\$100 million damages
- 1,700 people evacuated
- Several bridges damaged or washed out
- Tourist Park Dam overtopped and failed
- Power plant flooded and shut down
- No loss of life or personal injuries (EAP)

Flooding caused over \$100 million in damages, but no fatalities
