Lessons Learned from Spillway Failures

Causes of Dam Incidents

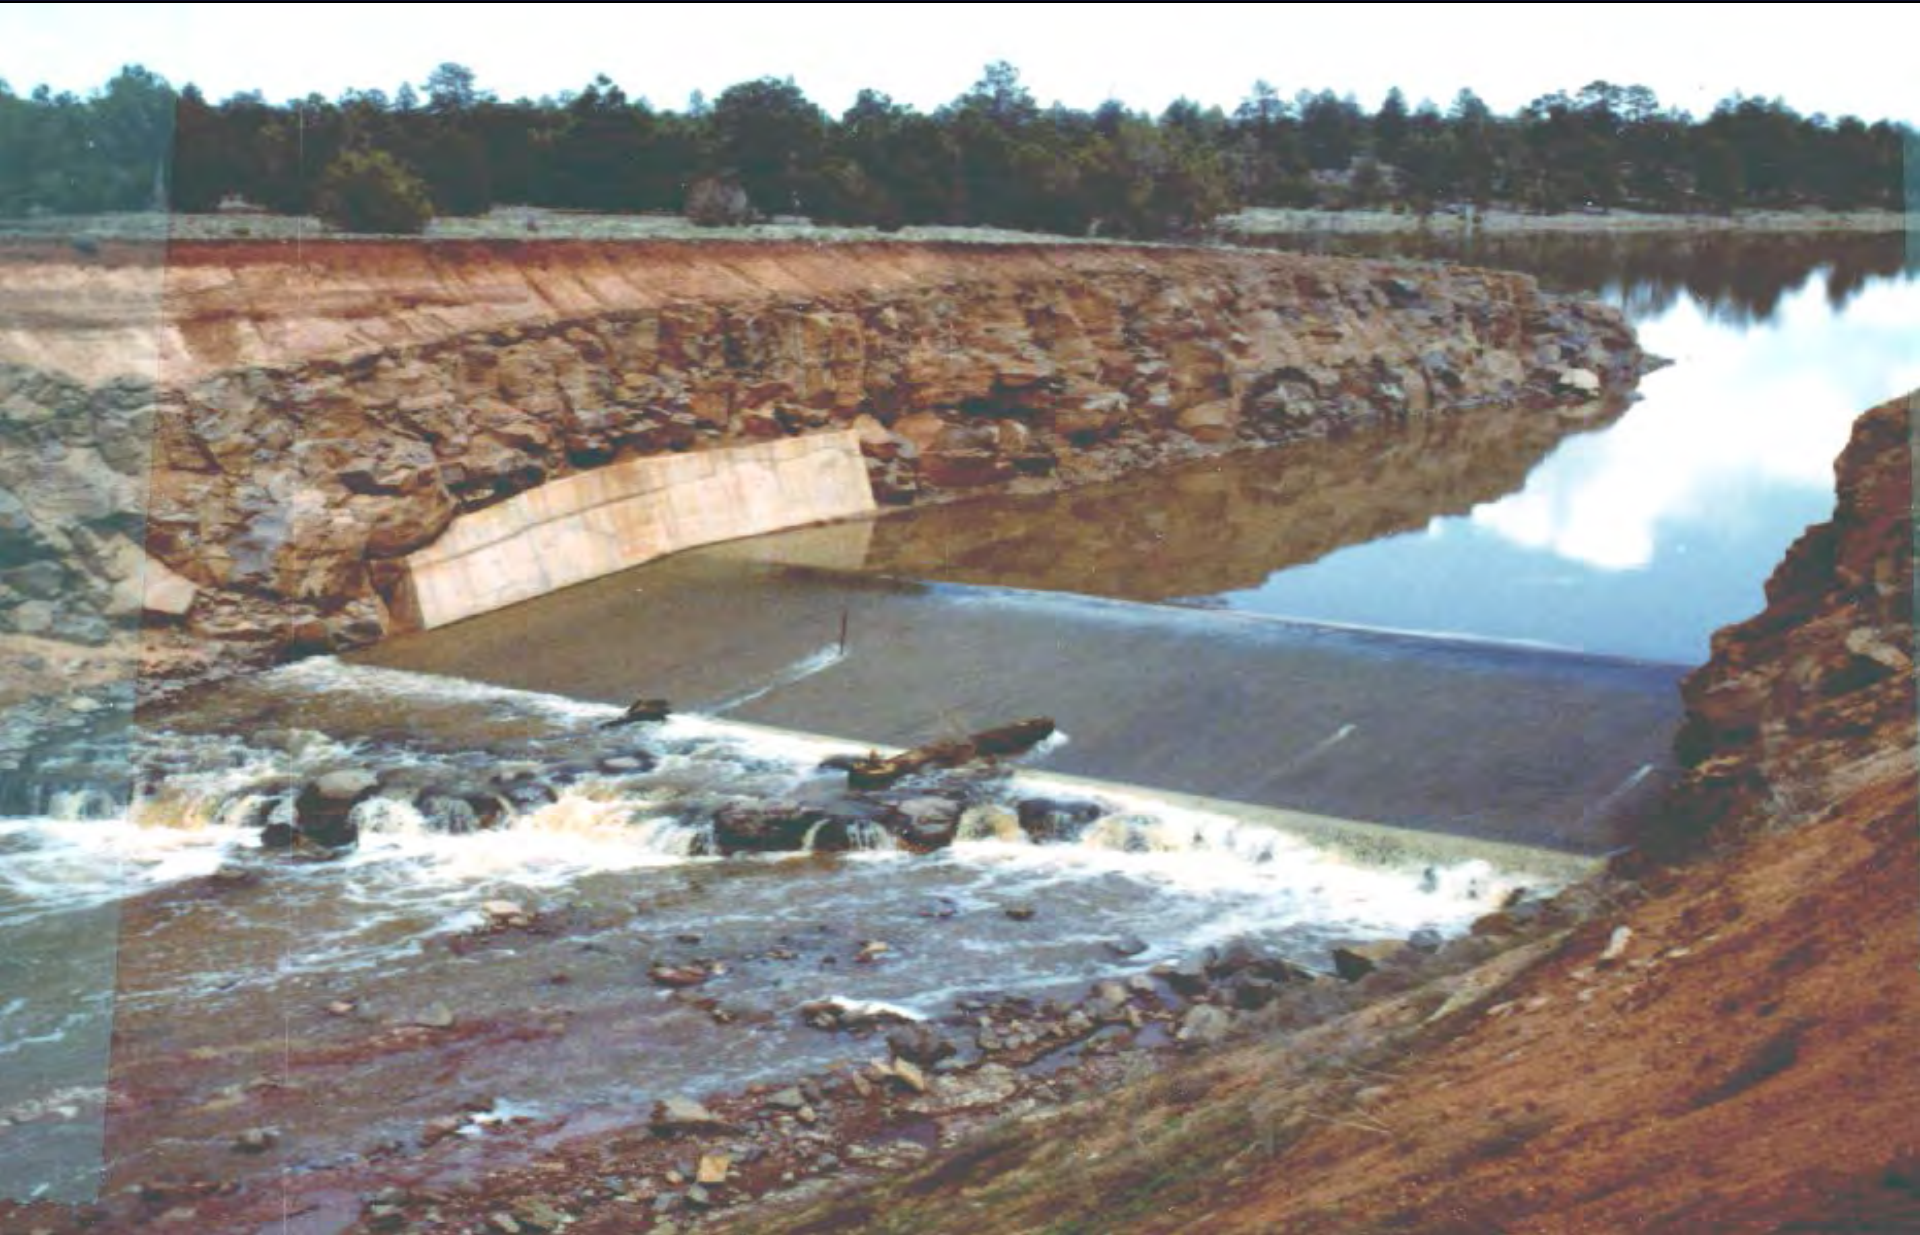
Earthen spillway scour/erosion

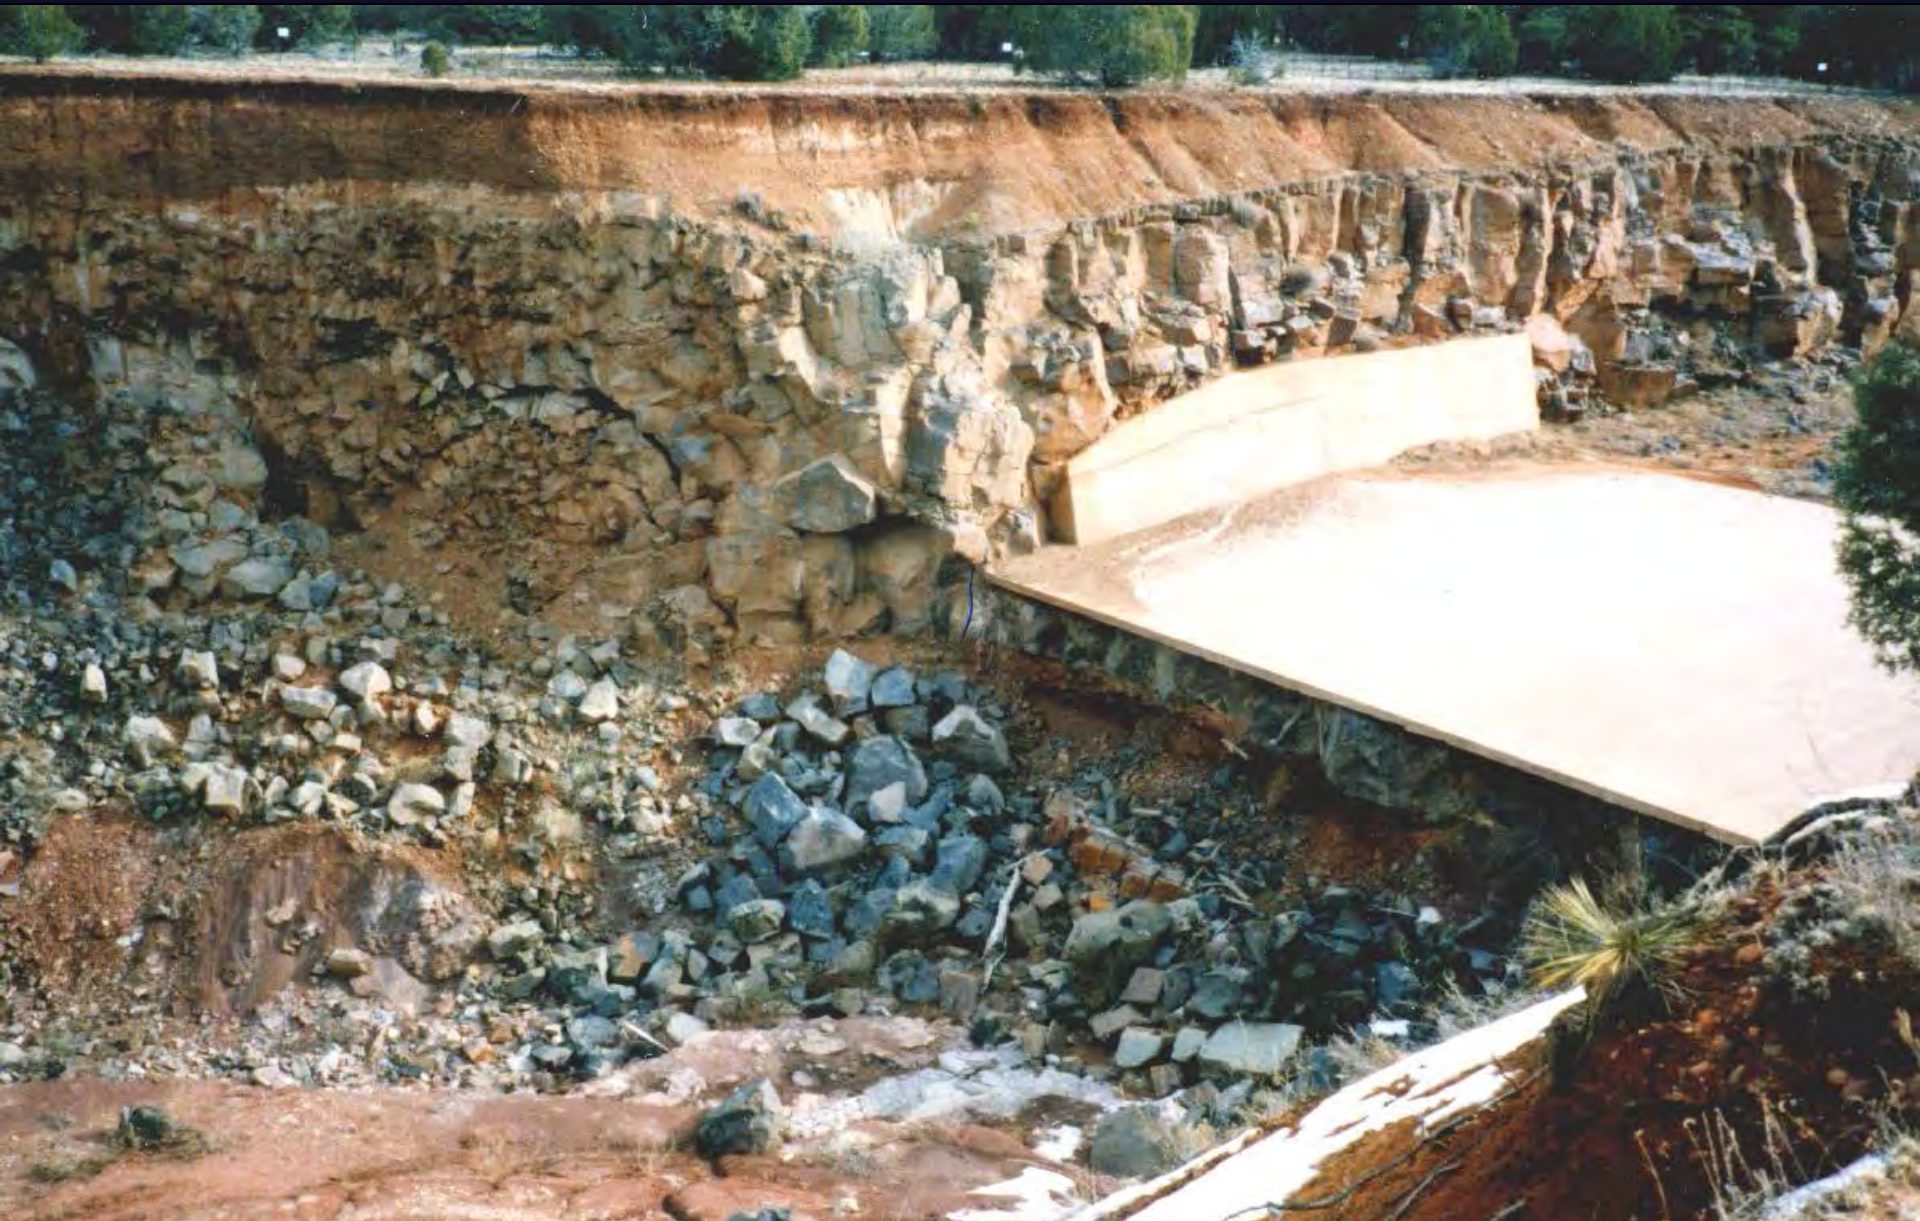
Earthen spillway scour/erosion

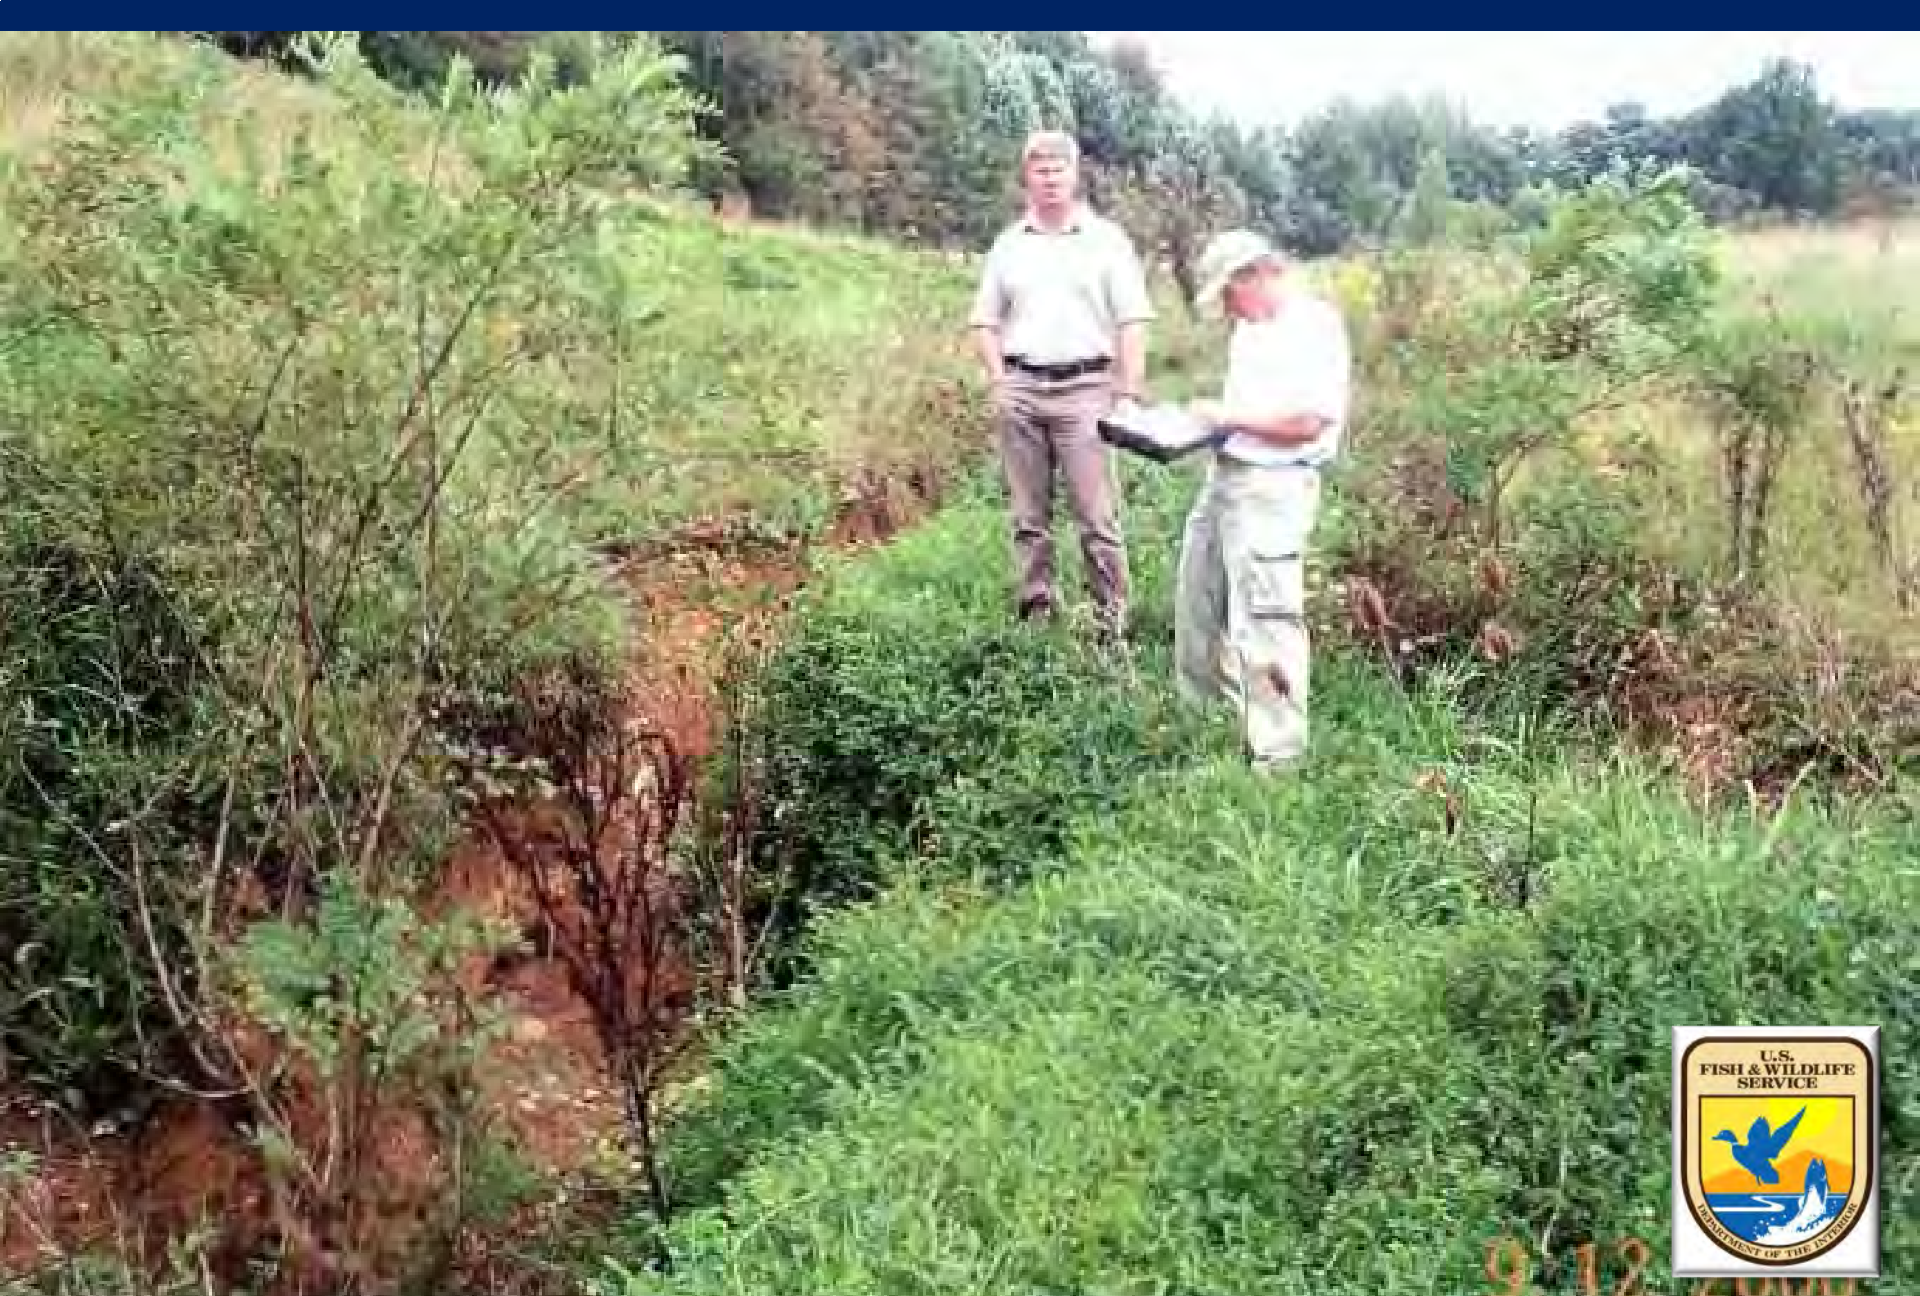
28. Erosion gully in downstream channel of emergency spillway, looking upstream.
Old Timbers Dam, Big Oaks NWR, Indiana

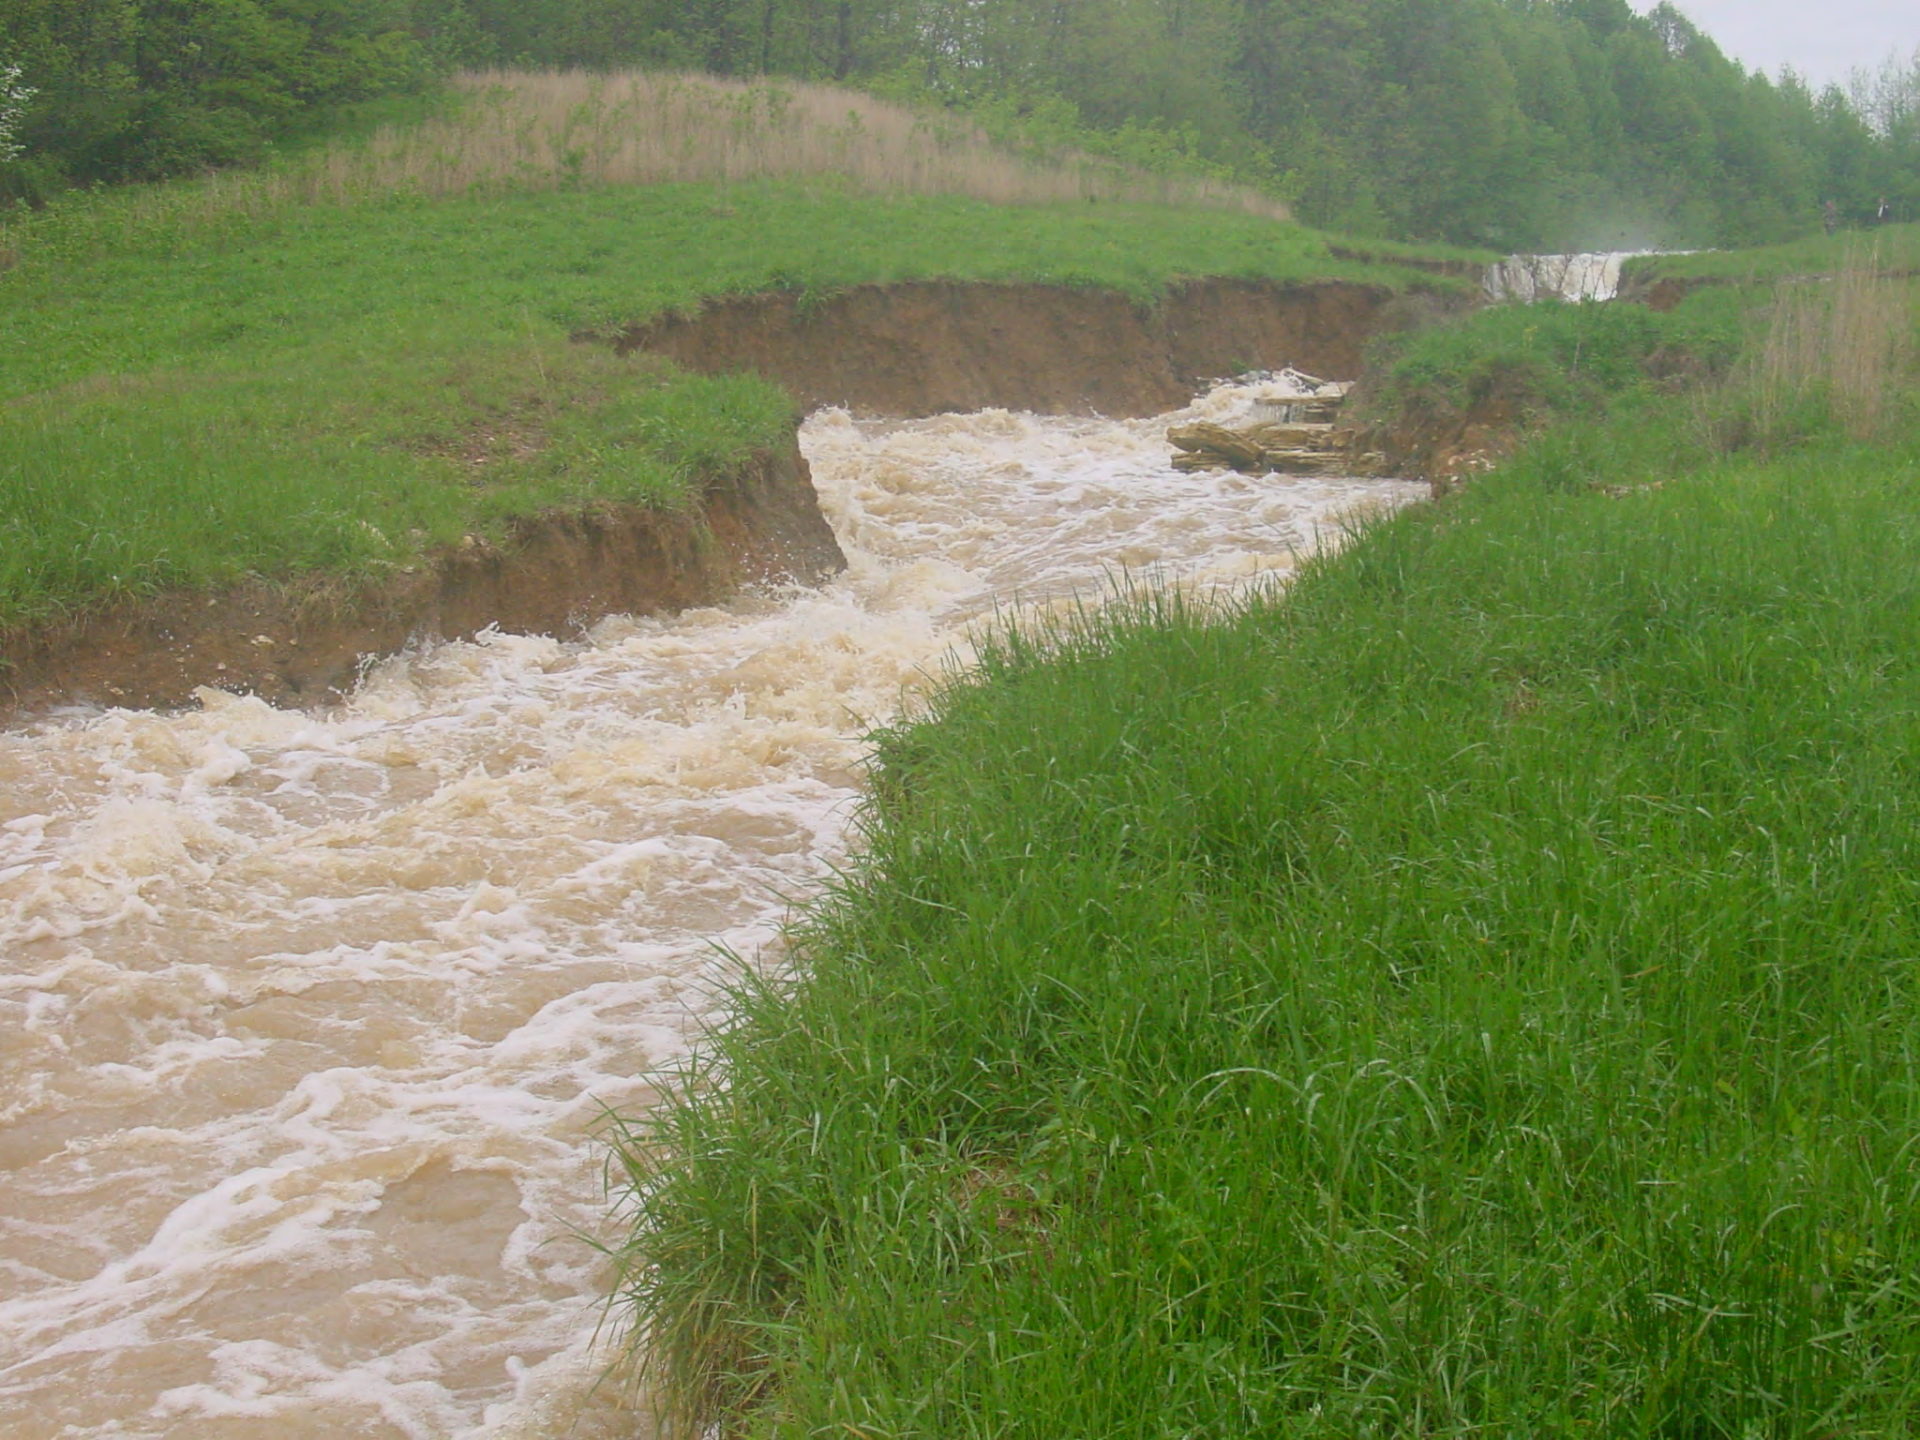
Breach

Black Creek, Mississippi

Flow Duration - 23 hr

Max Depth – 5.1 feet

Spillway Width – 100 feet

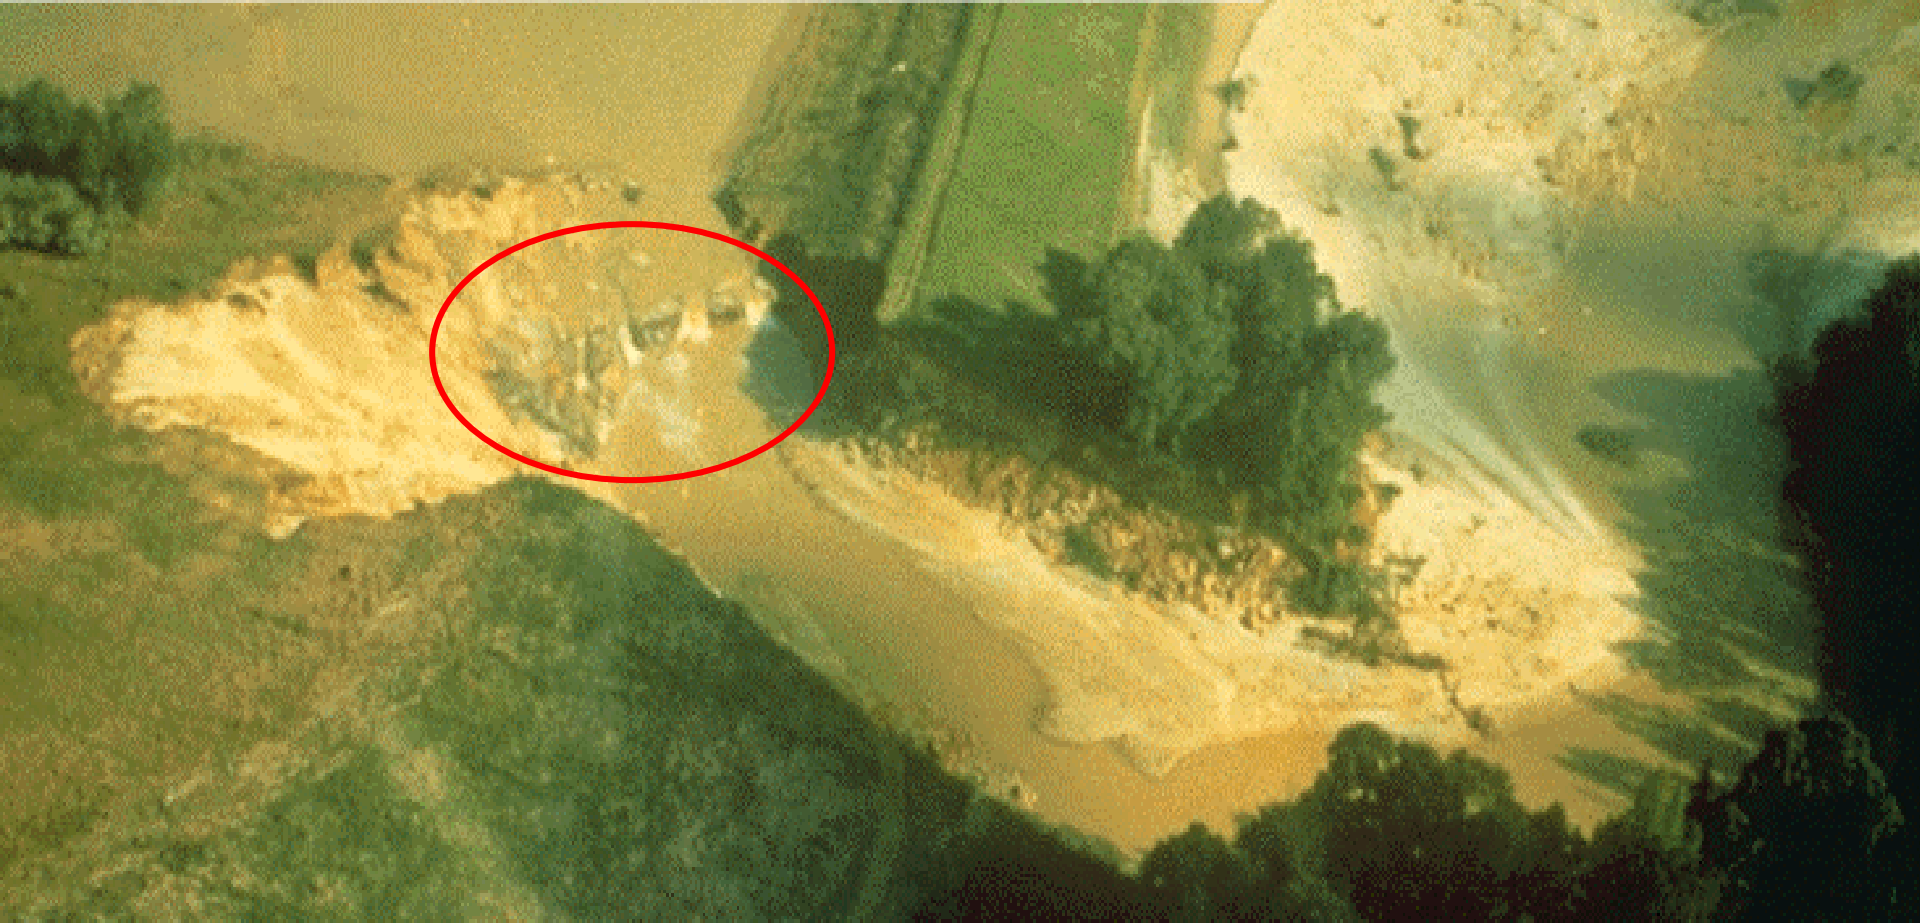
Black Creek Dam, Mississippi

Flow Duration - 23 hr

Max Depth - 5.1 feet

Spillway Width - 100 feet

~190,000 CY Eroded

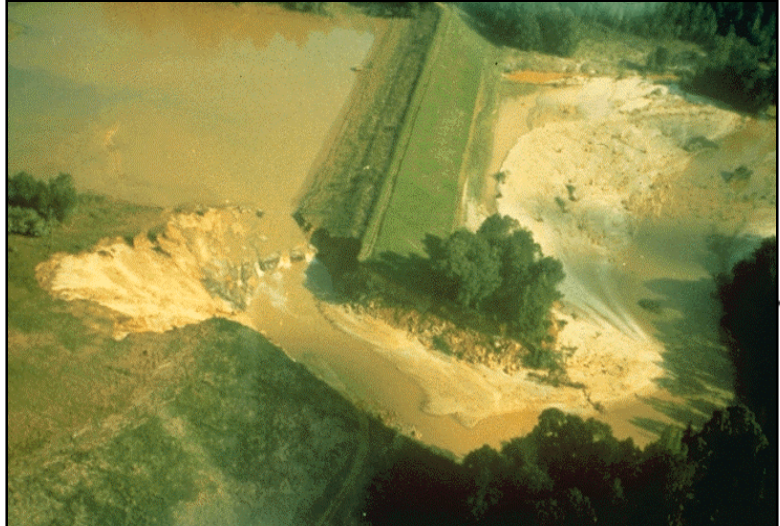
~190,000 CY Eroded

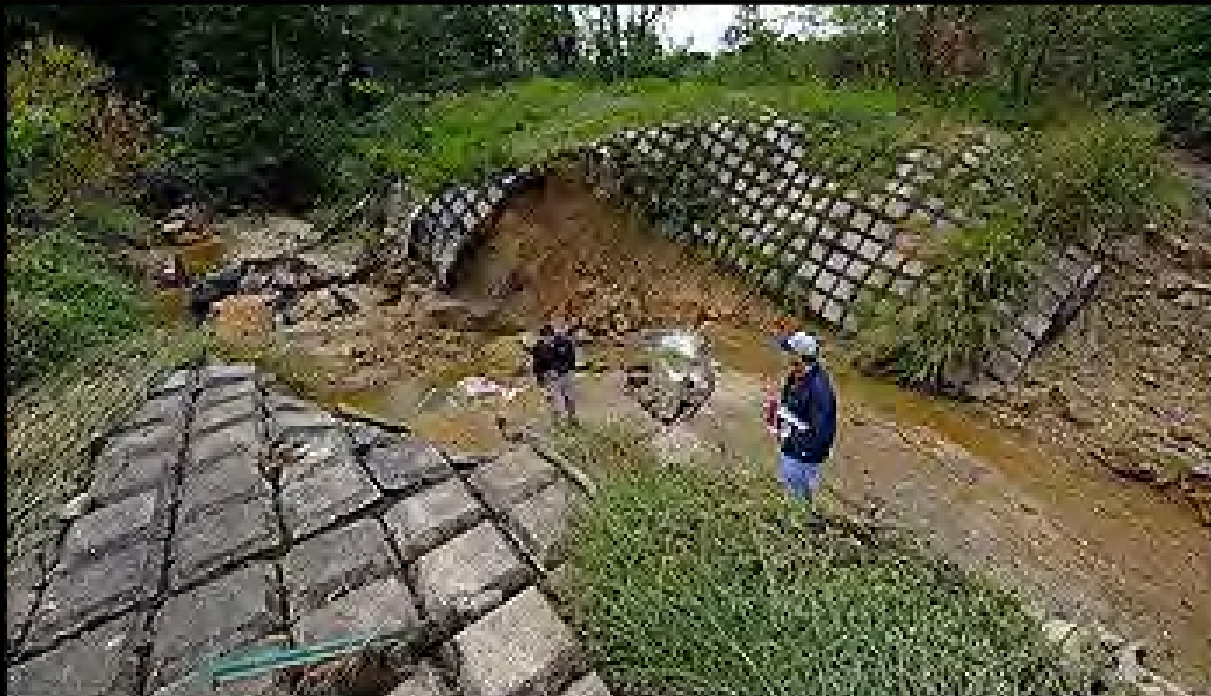
Dam failure drains Fairfax County lake, kills wildlife

During the heavy rains that drenched the Washington region Thursday, Kingstowne Park dam in Fairfax County's Alexandria section failed. It was a quick and quiet death,

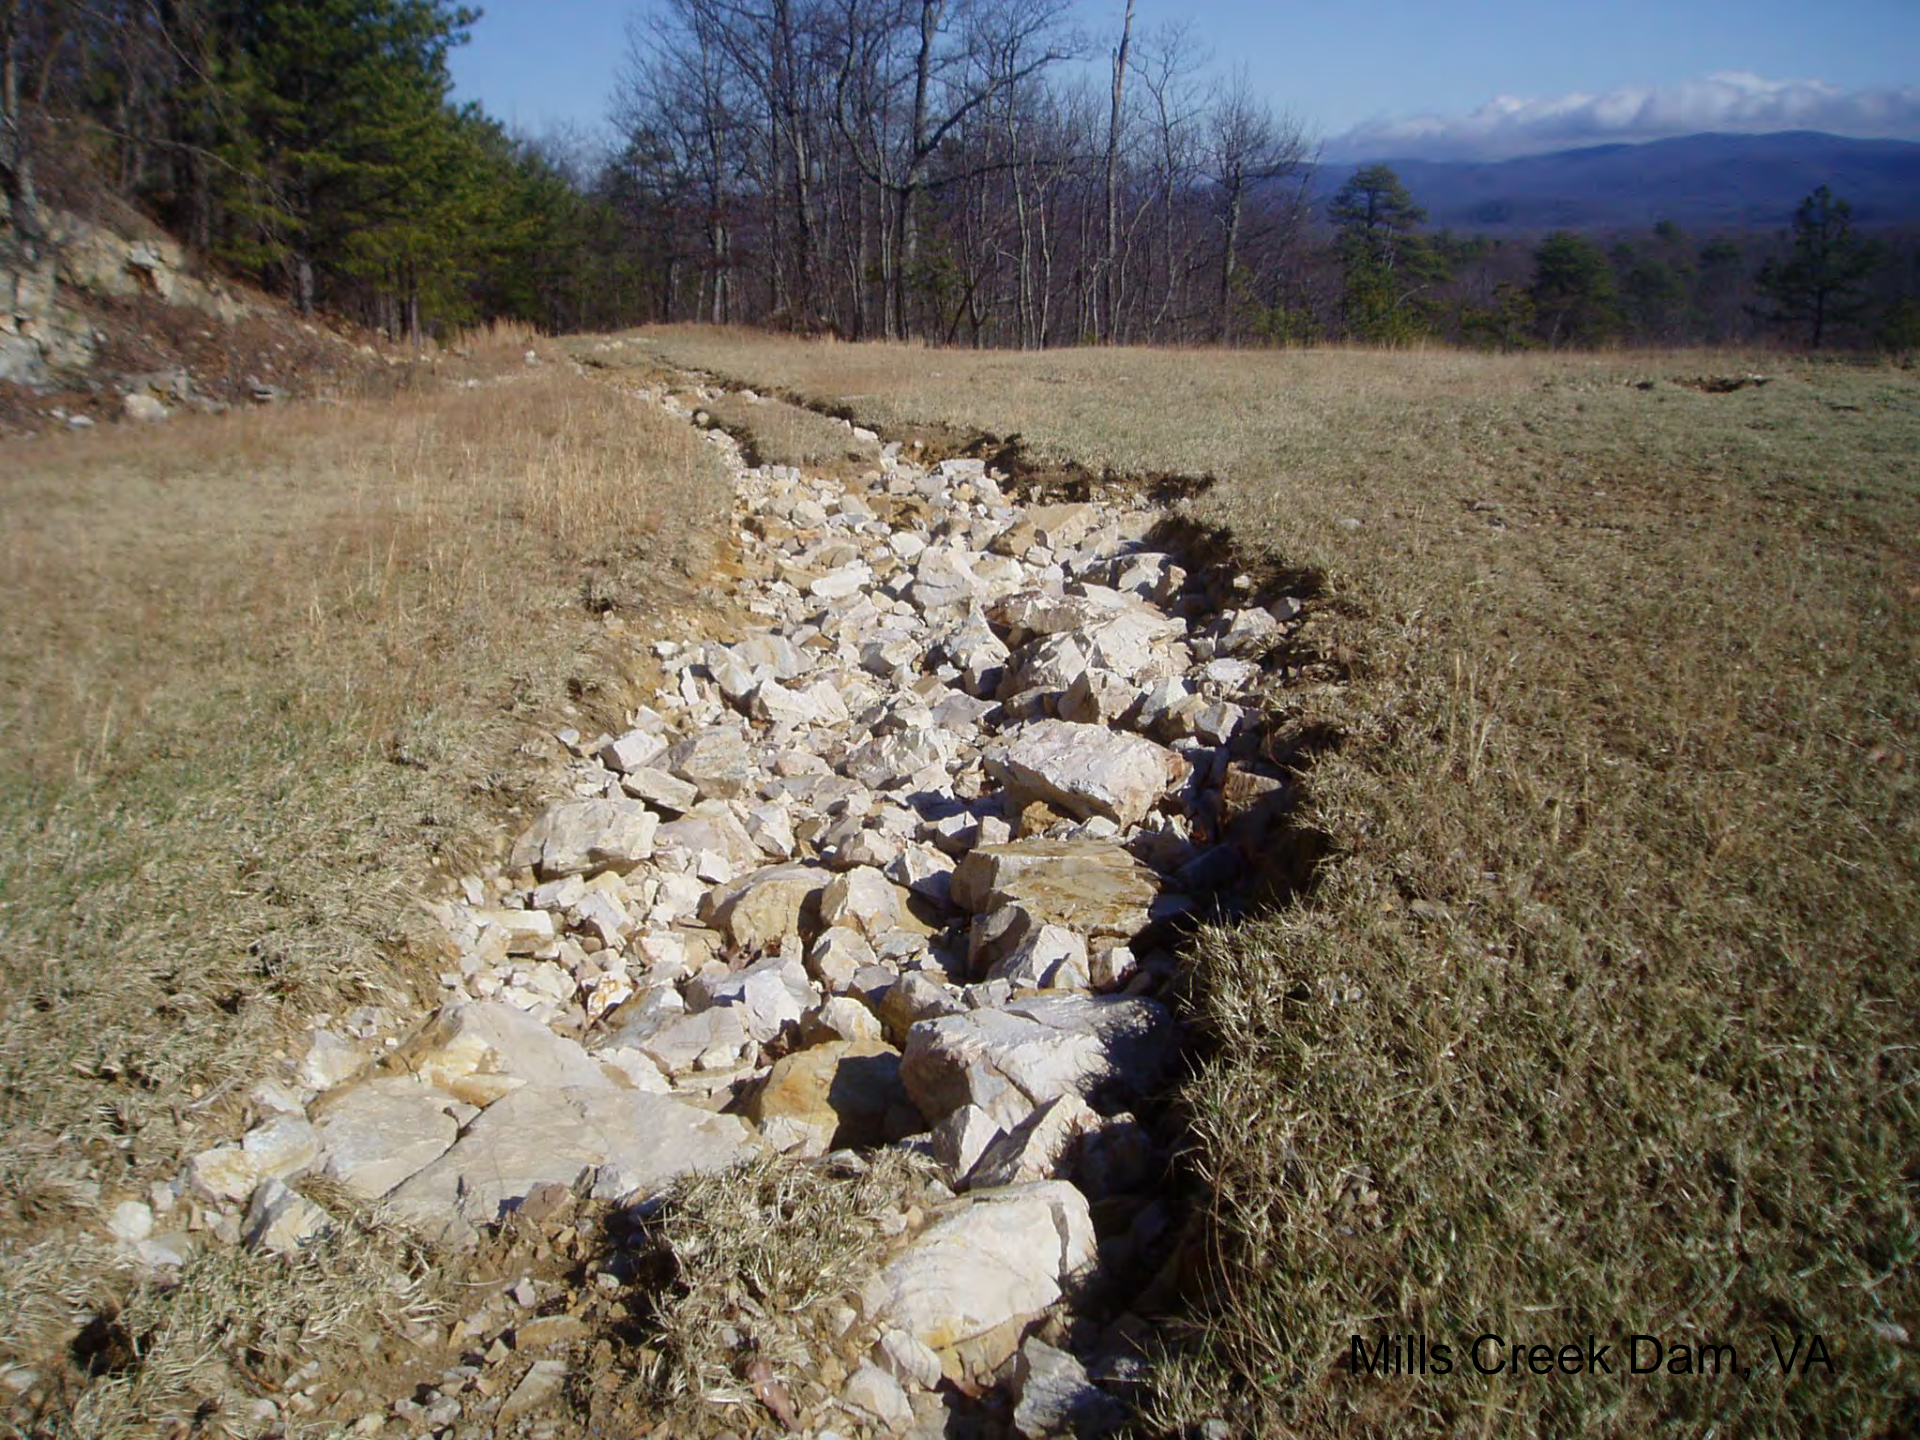
Mills Creek Dam, VA

Major discontinuities concentrate the flow where there is no vegetal cover and/or the surface is disturbed.

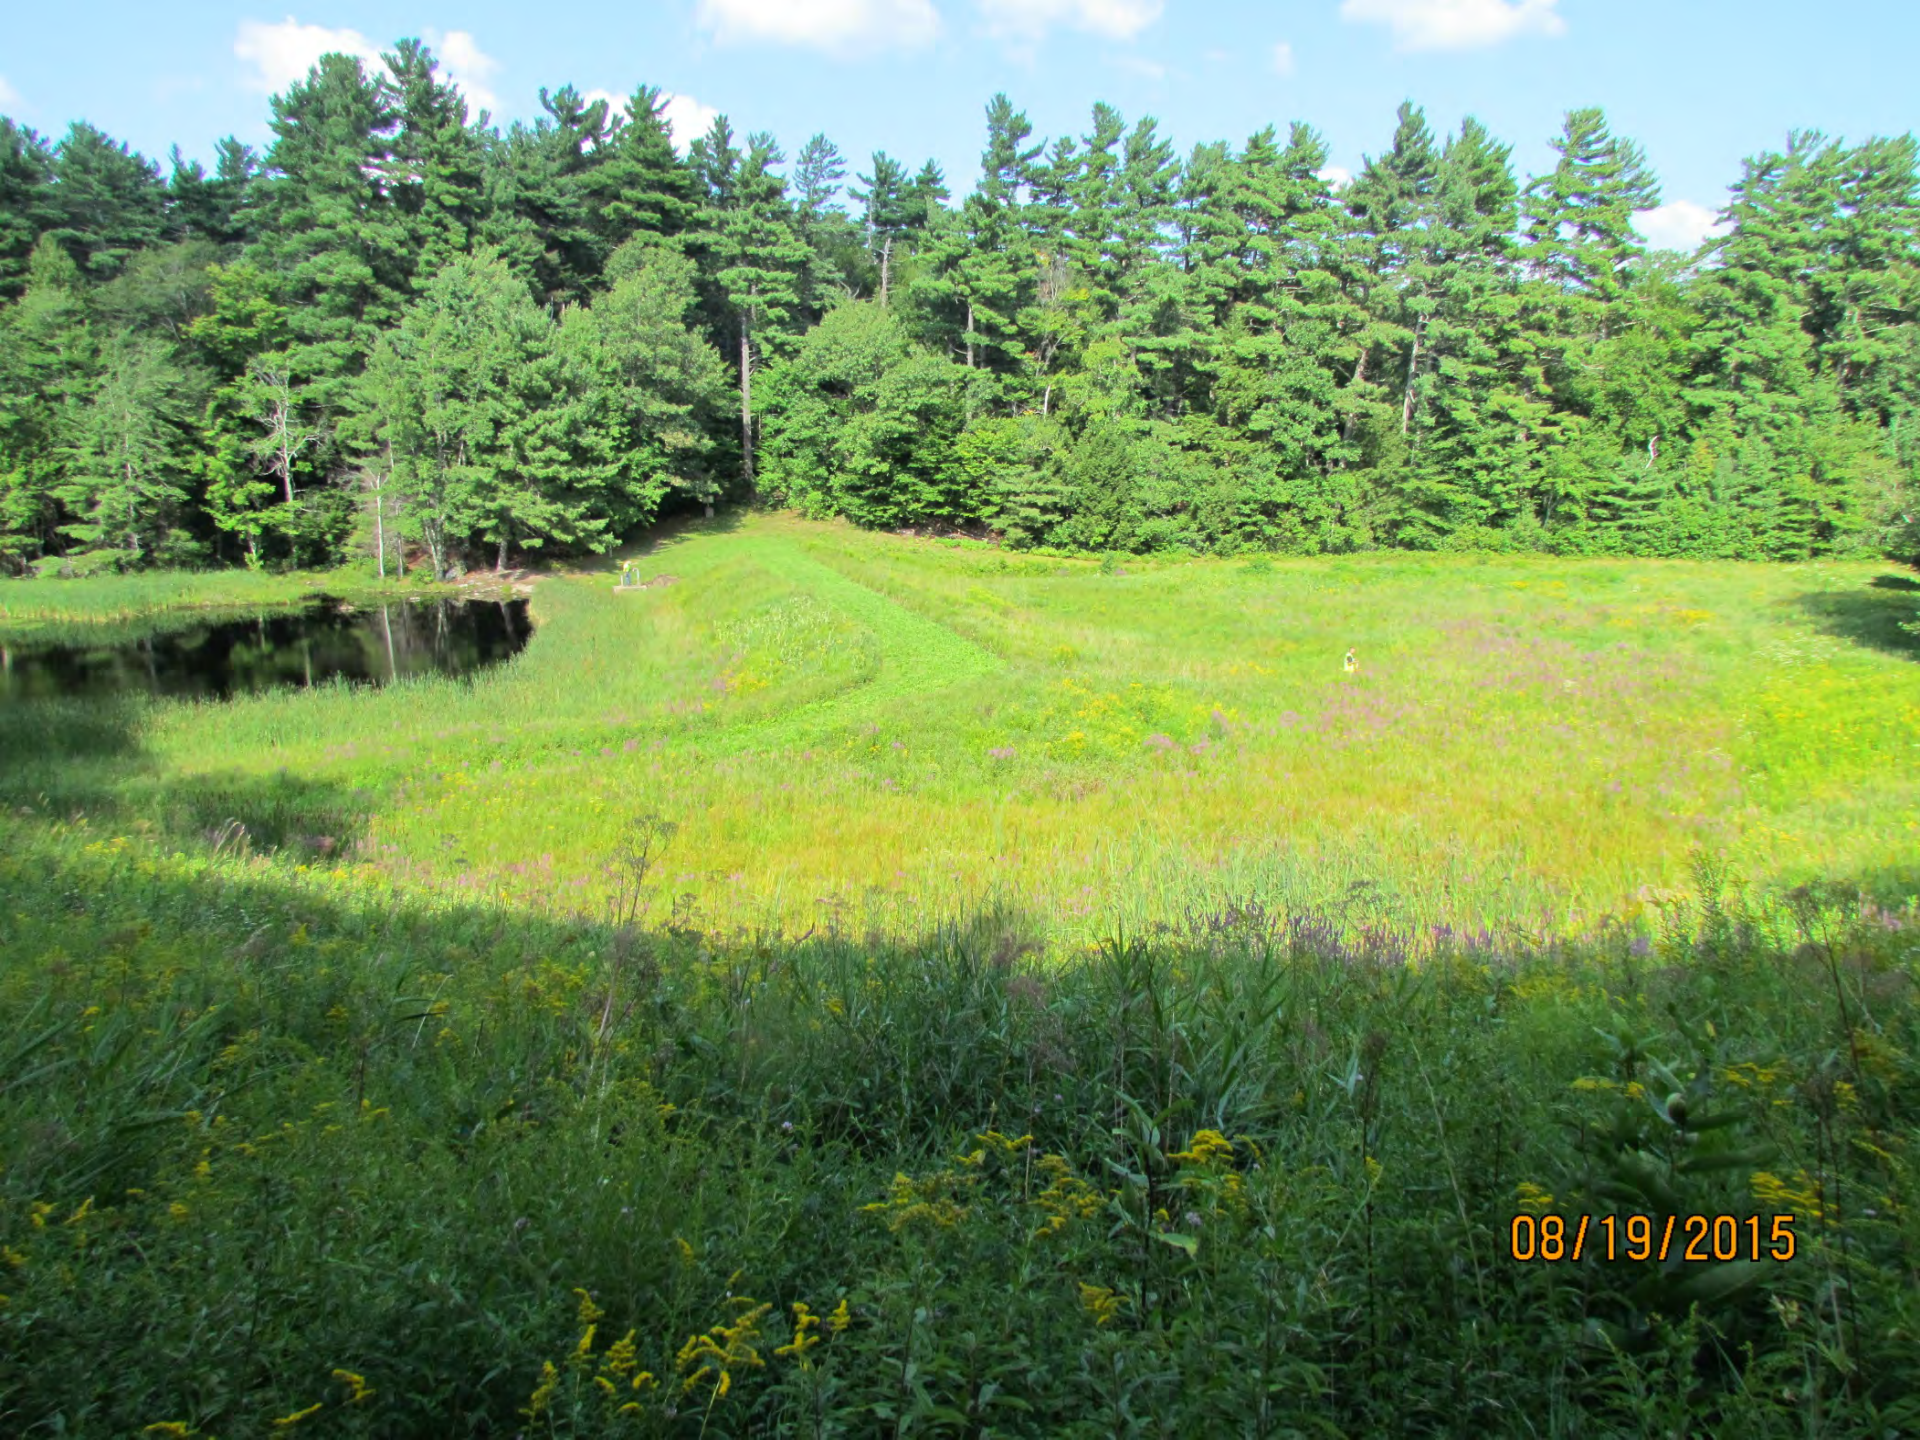
Souhegan Site 15

Aux. Spillway Erosion

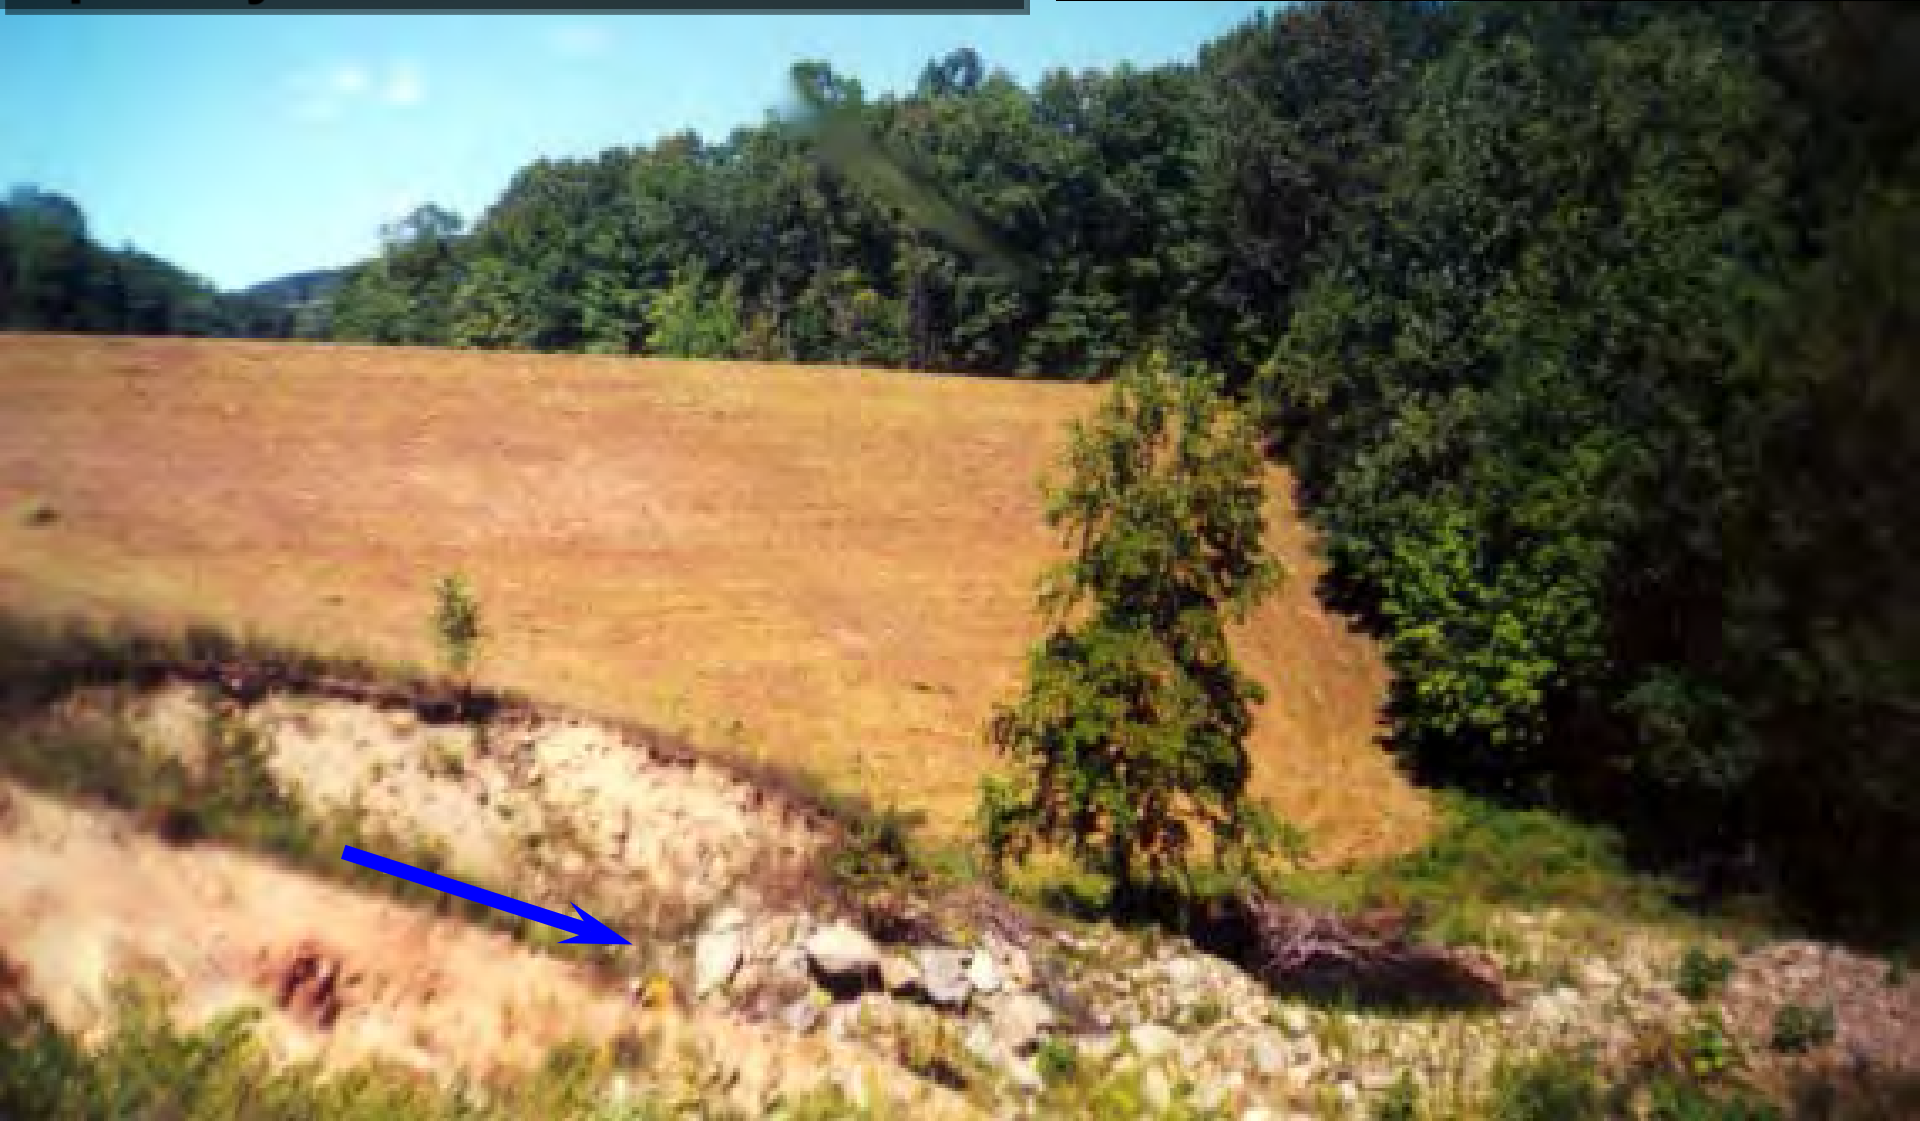
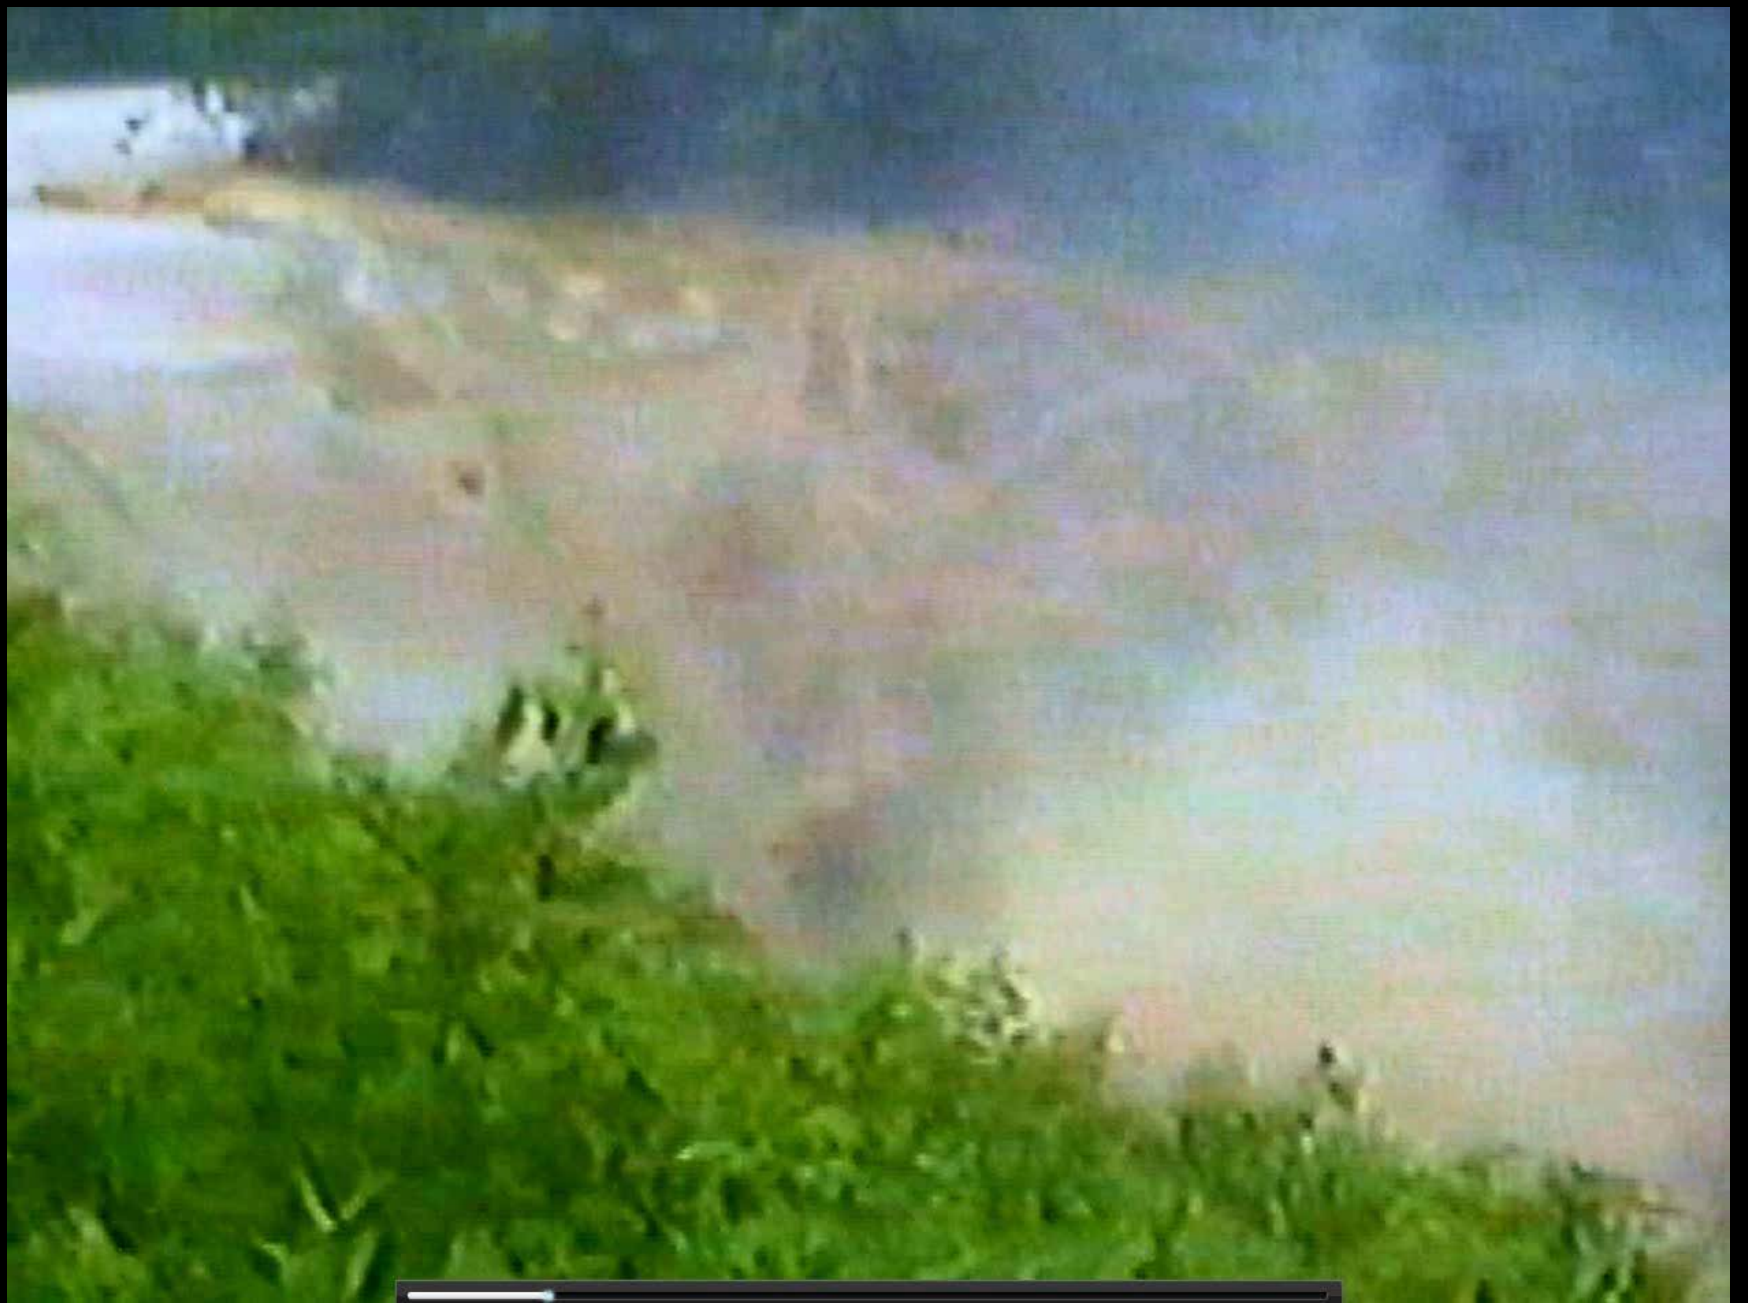
White Oak Dam

Maximum Head: 10 Feet

Max. Discharge: 7,000 cfs

Eroded: 10,500 C.Y.

Headcut Depth: 40 Feet

Headcut Length: 400 Feet
