Lessons Learned from Spillway Failures

Causes of Dam Incidents

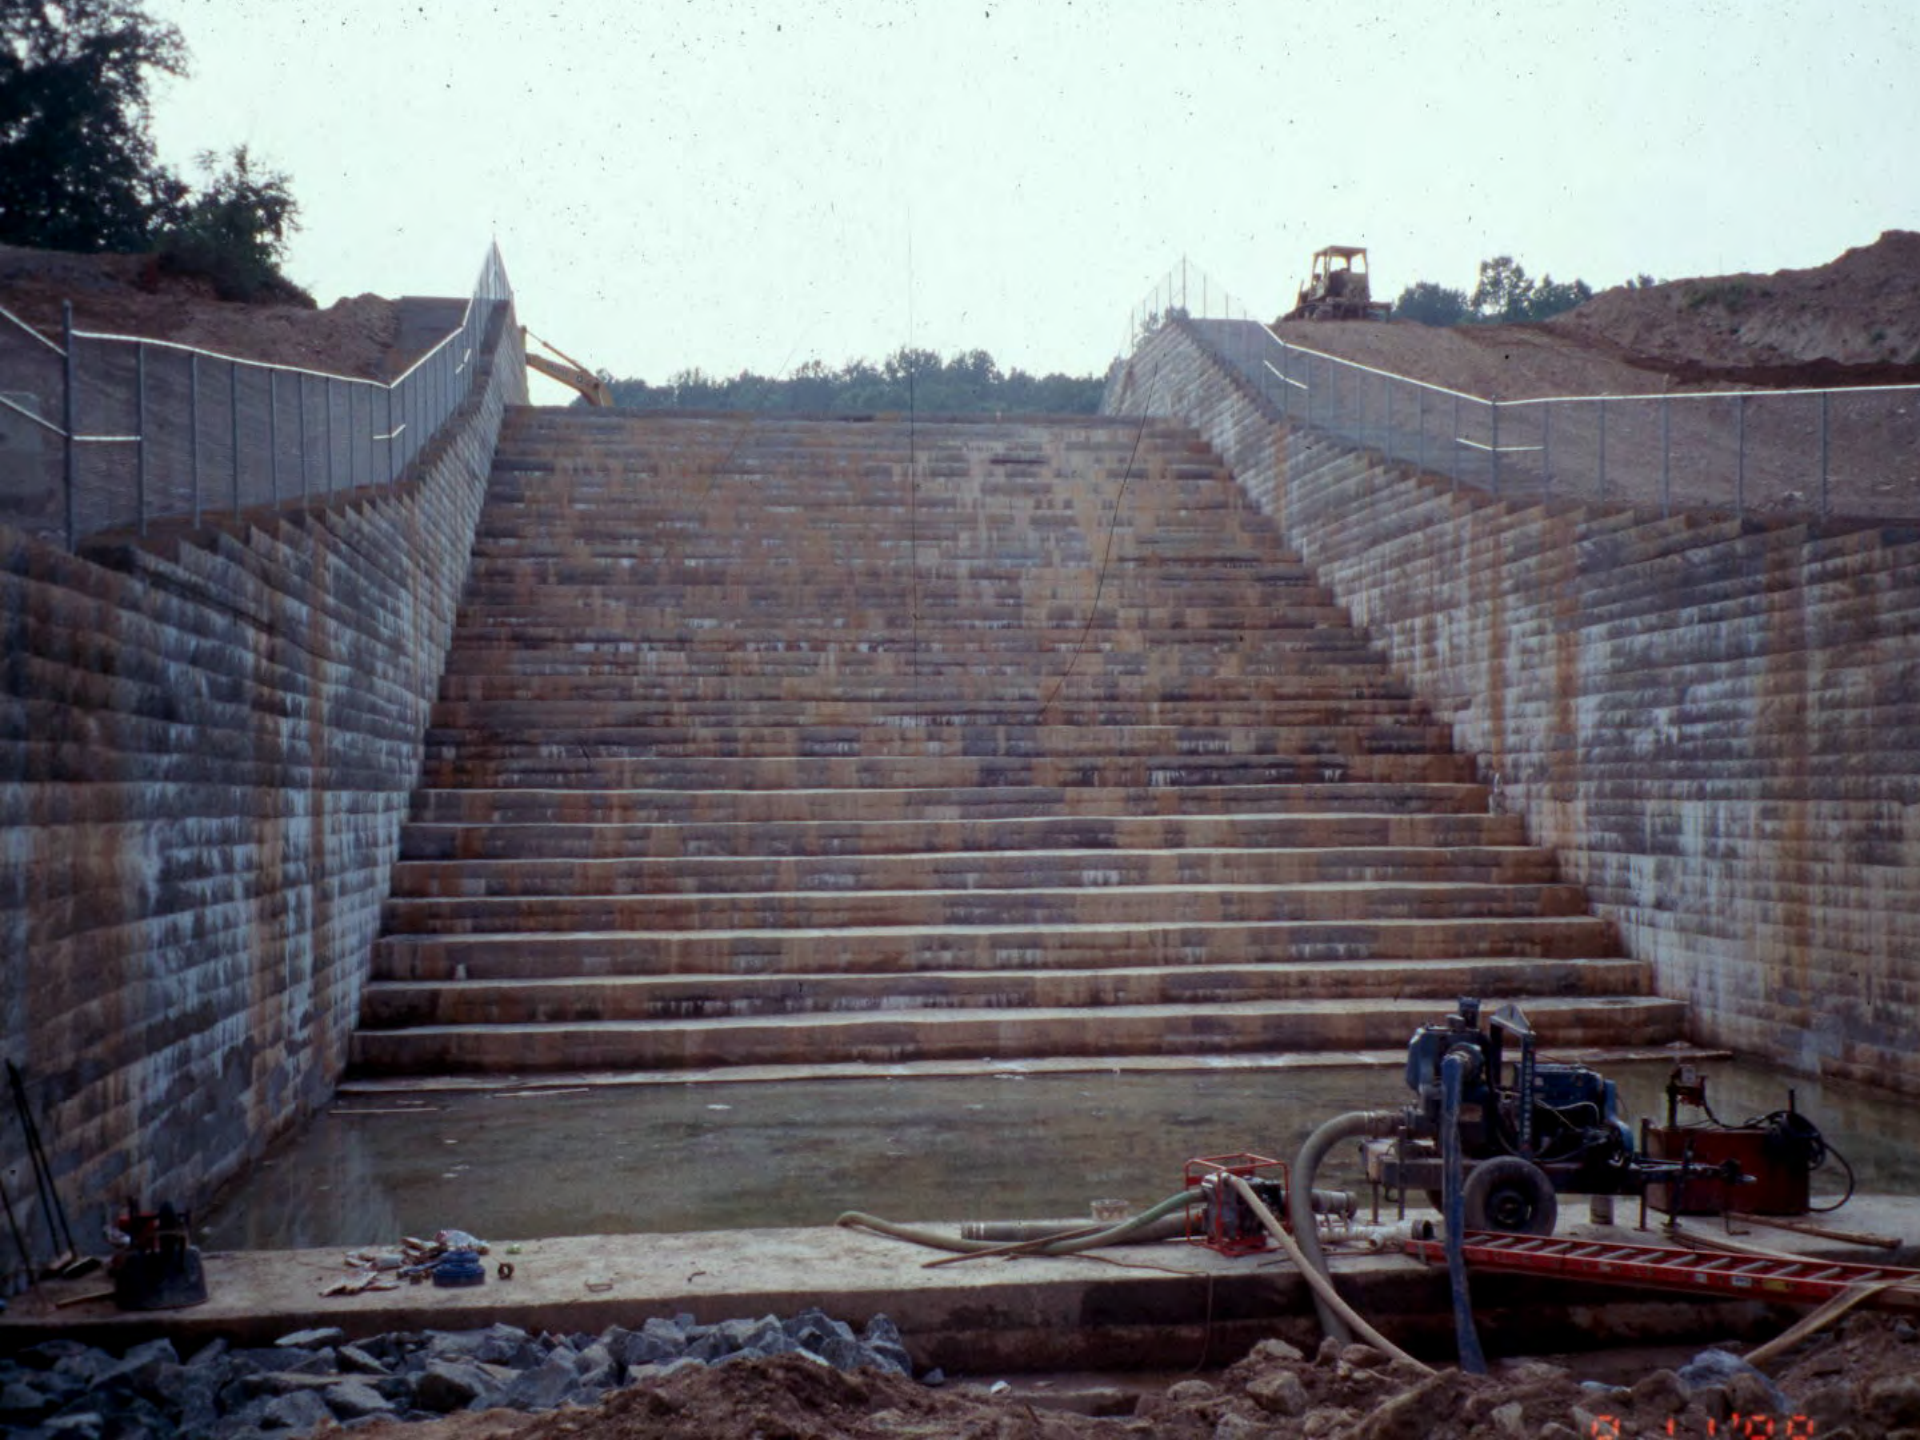
Auxiliary Spillway Discharge Channel
Before Activation of Spillway

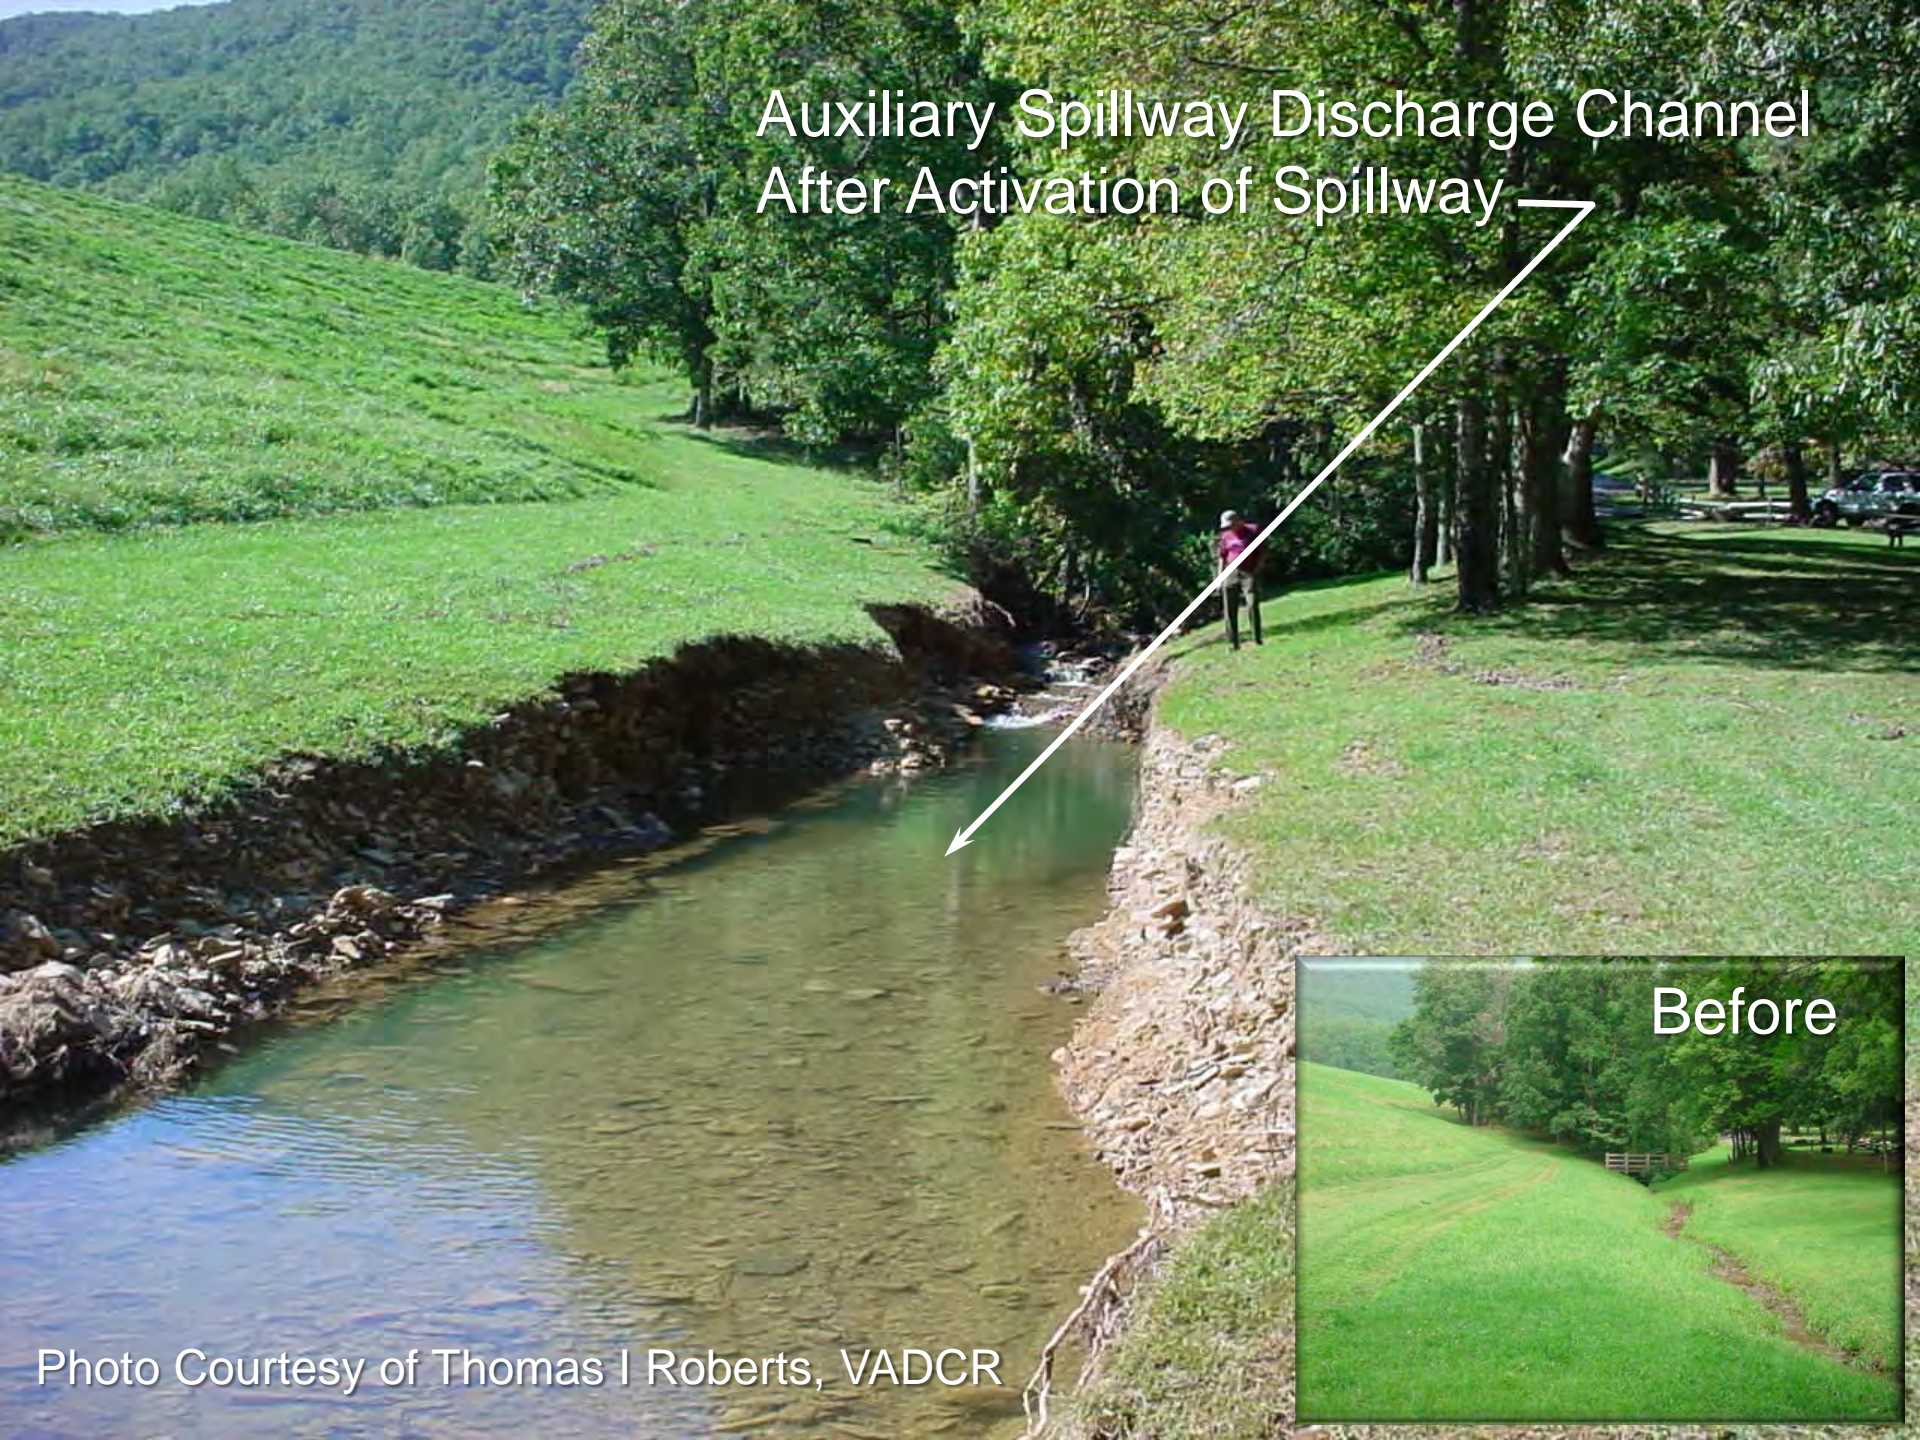
Auxiliary Spillway Discharge Channel After Activation of Spillway

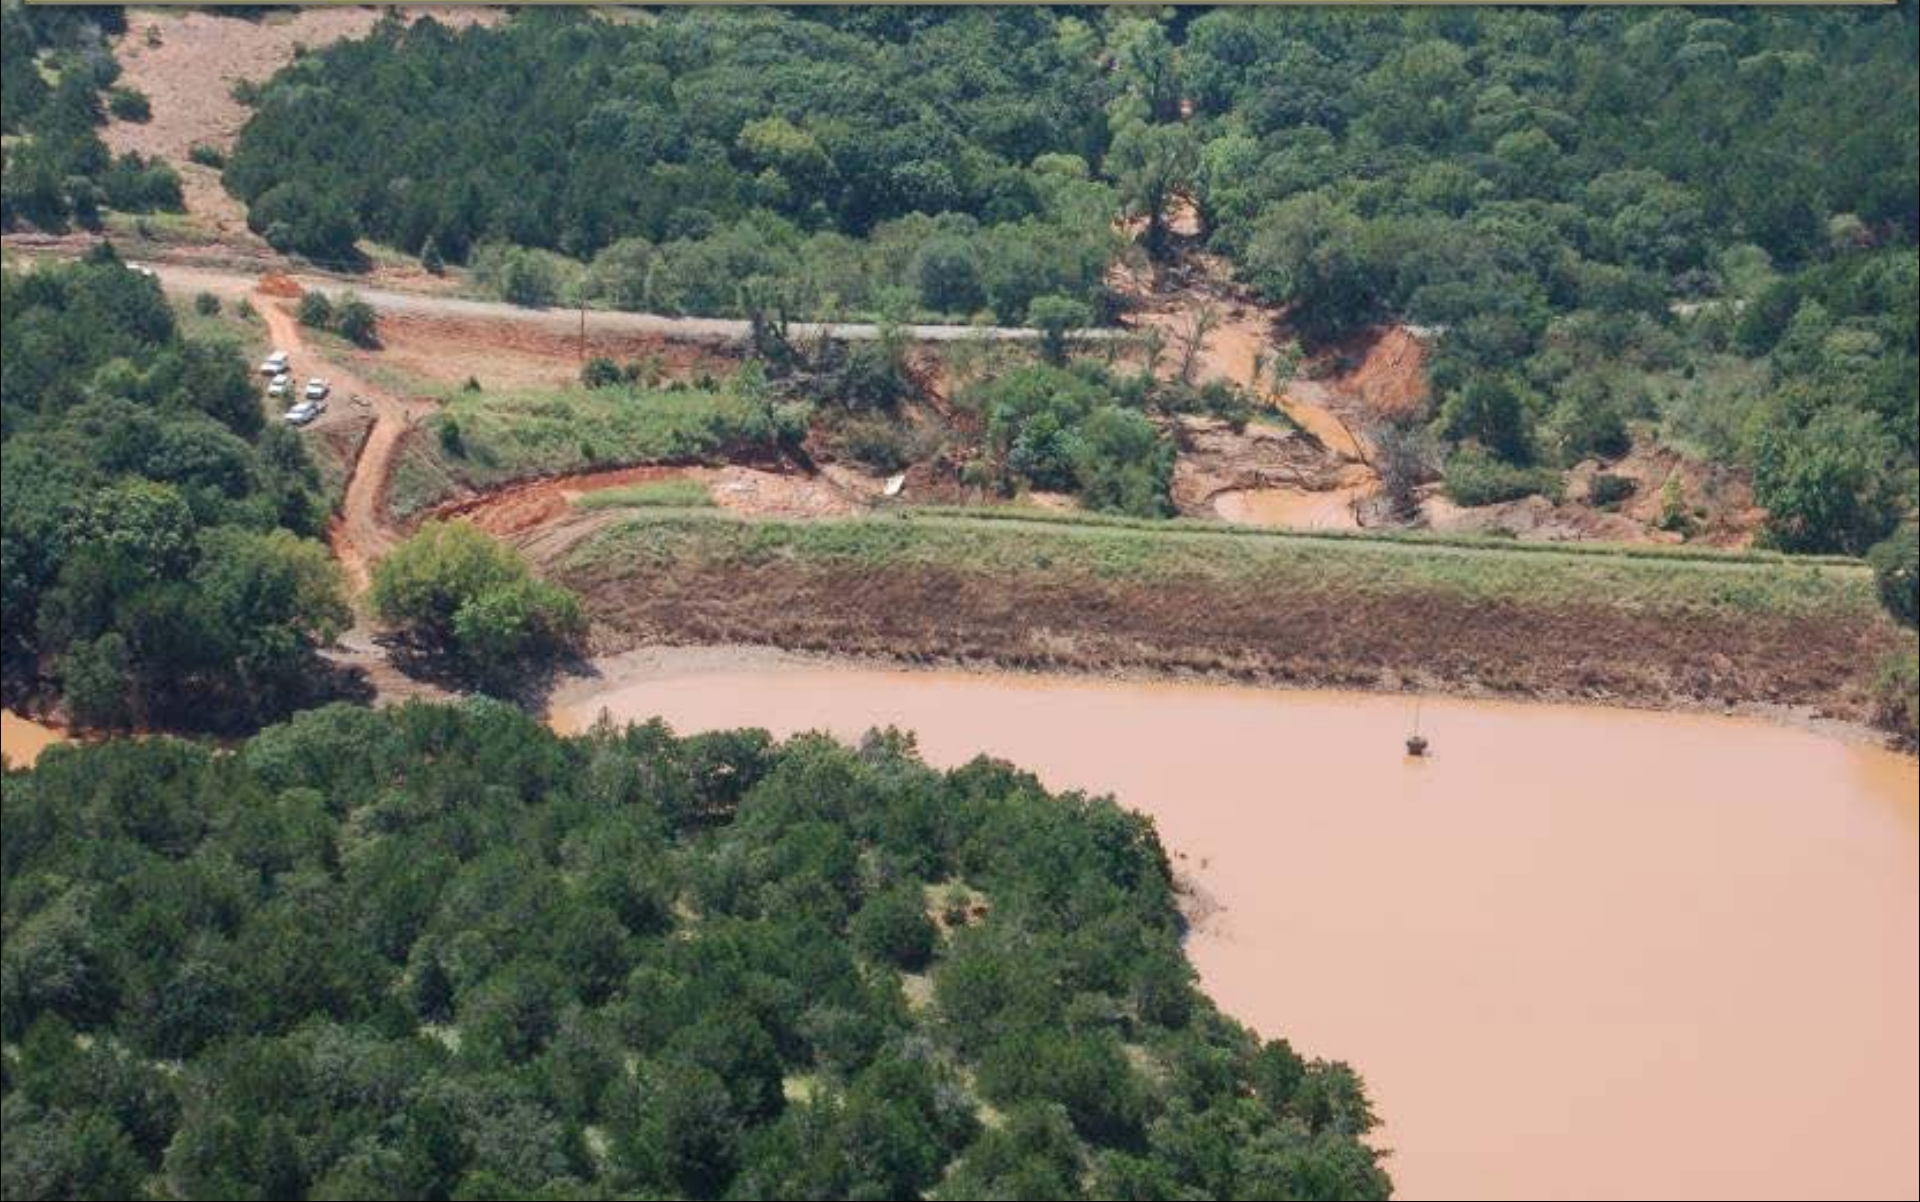
Sugar Creek Dam L-44, Caddo County Oklahoma

Tropical Depression Erin (Aug. 18-19, 2007)

>8" in less than 12 hours
