Lessons Learned from Concrete Dam Failures

Gannett Fleming

Maryland
Department of
the Environment

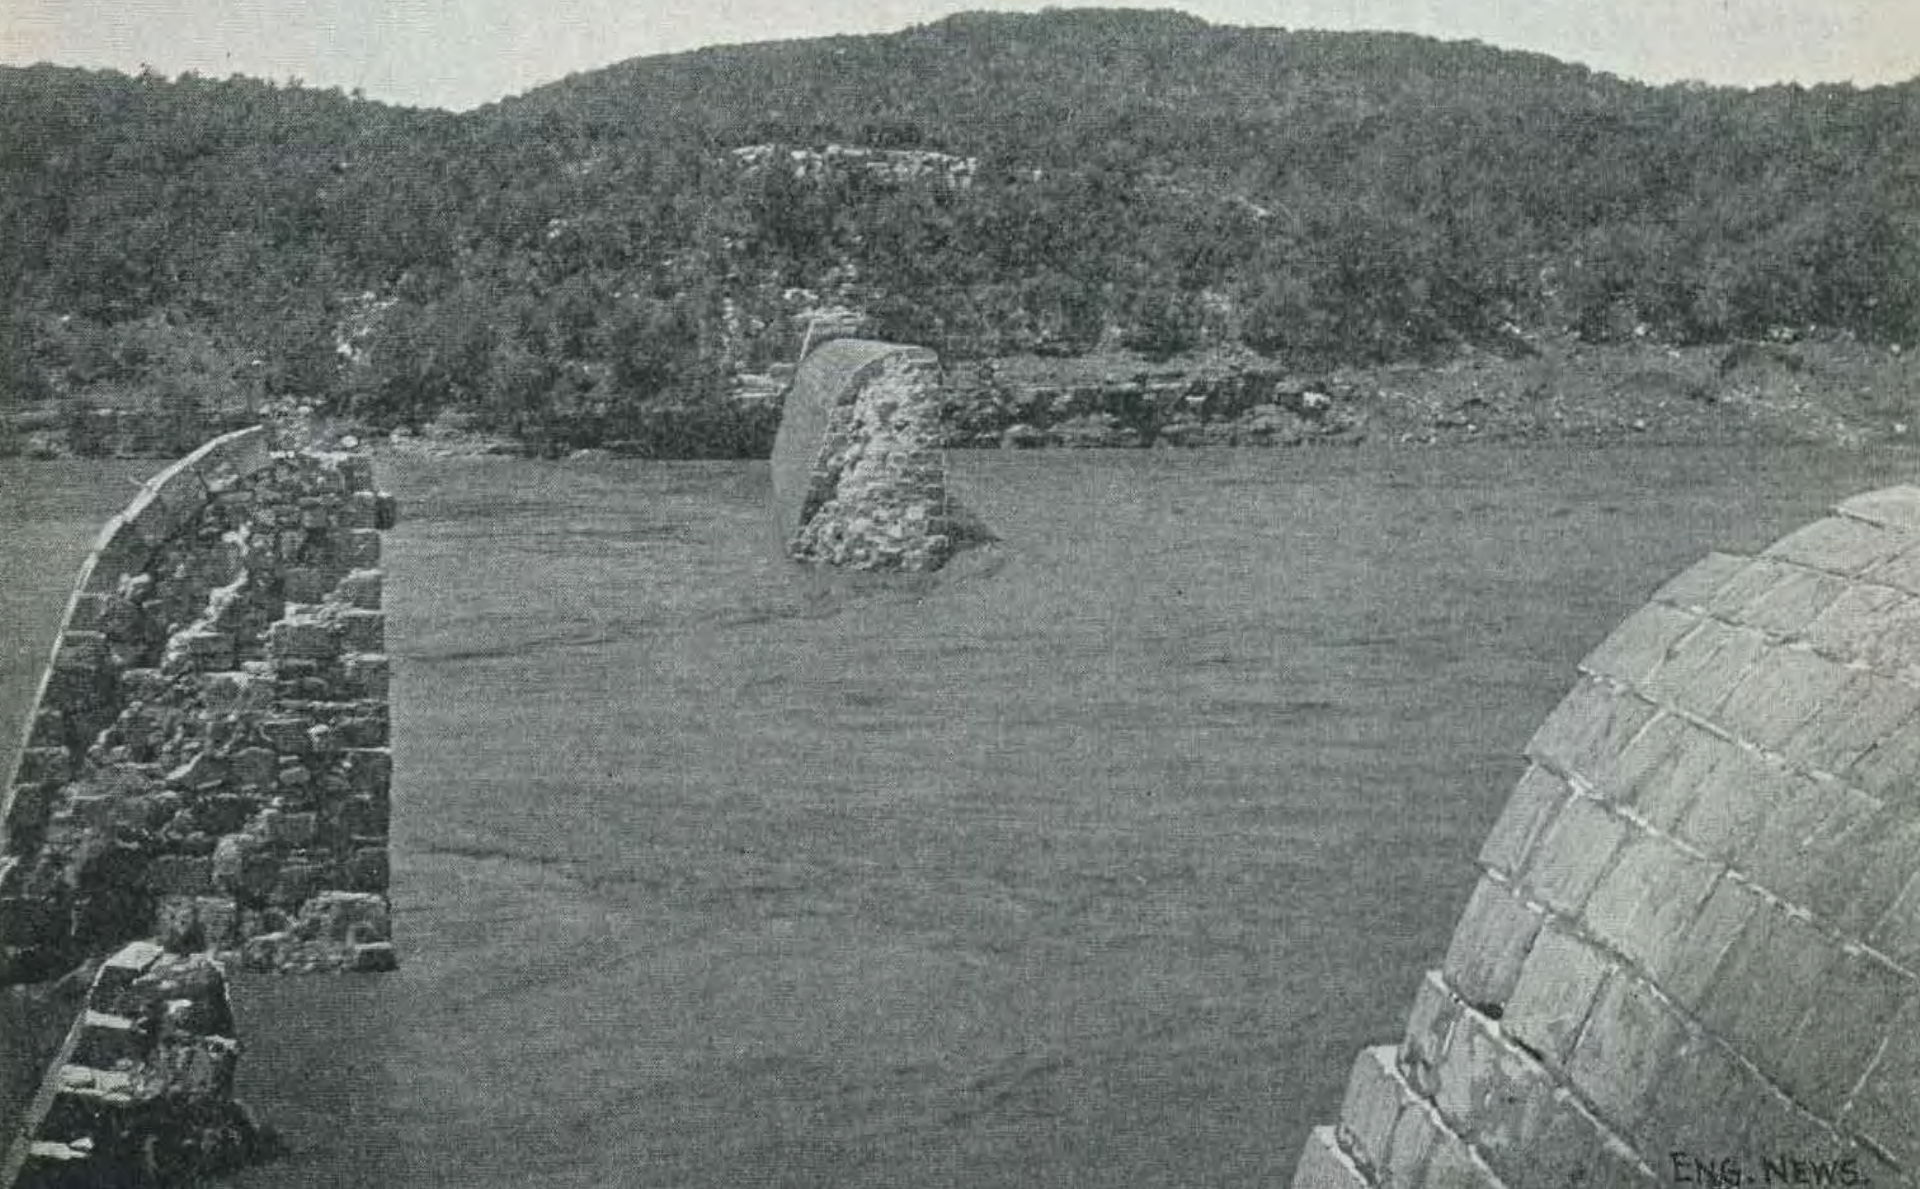
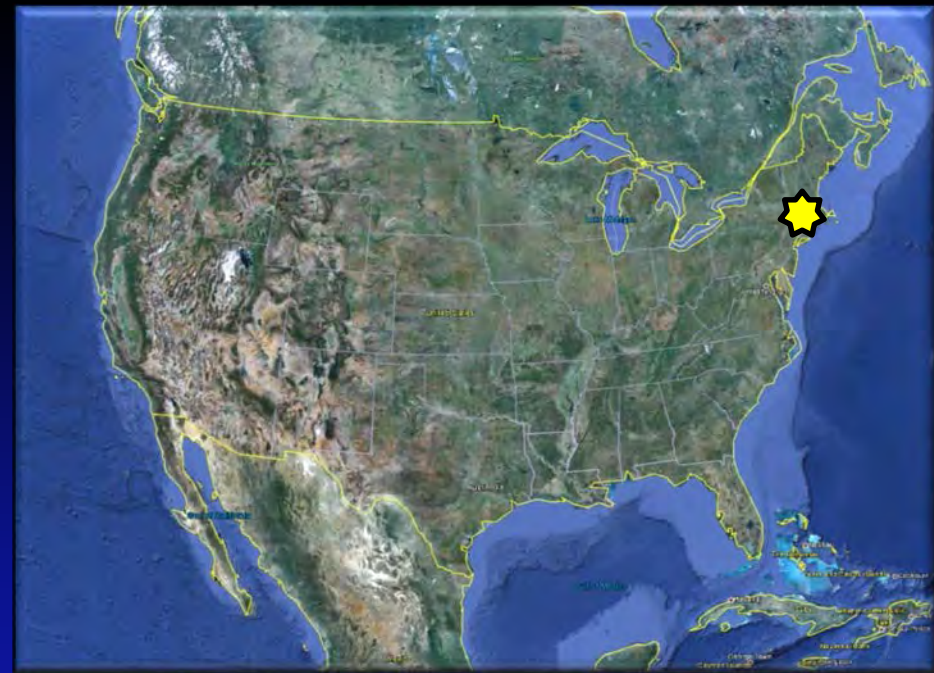
April 1900
Austin Dam
Austin, TX

Flood-Induced Failure
Peak Spillway Head: 11.07 ft

1. BROKEN DAM, SHOWING IN FOREGROUND SAND BAR LEFT IN MAIN CHANNEL.

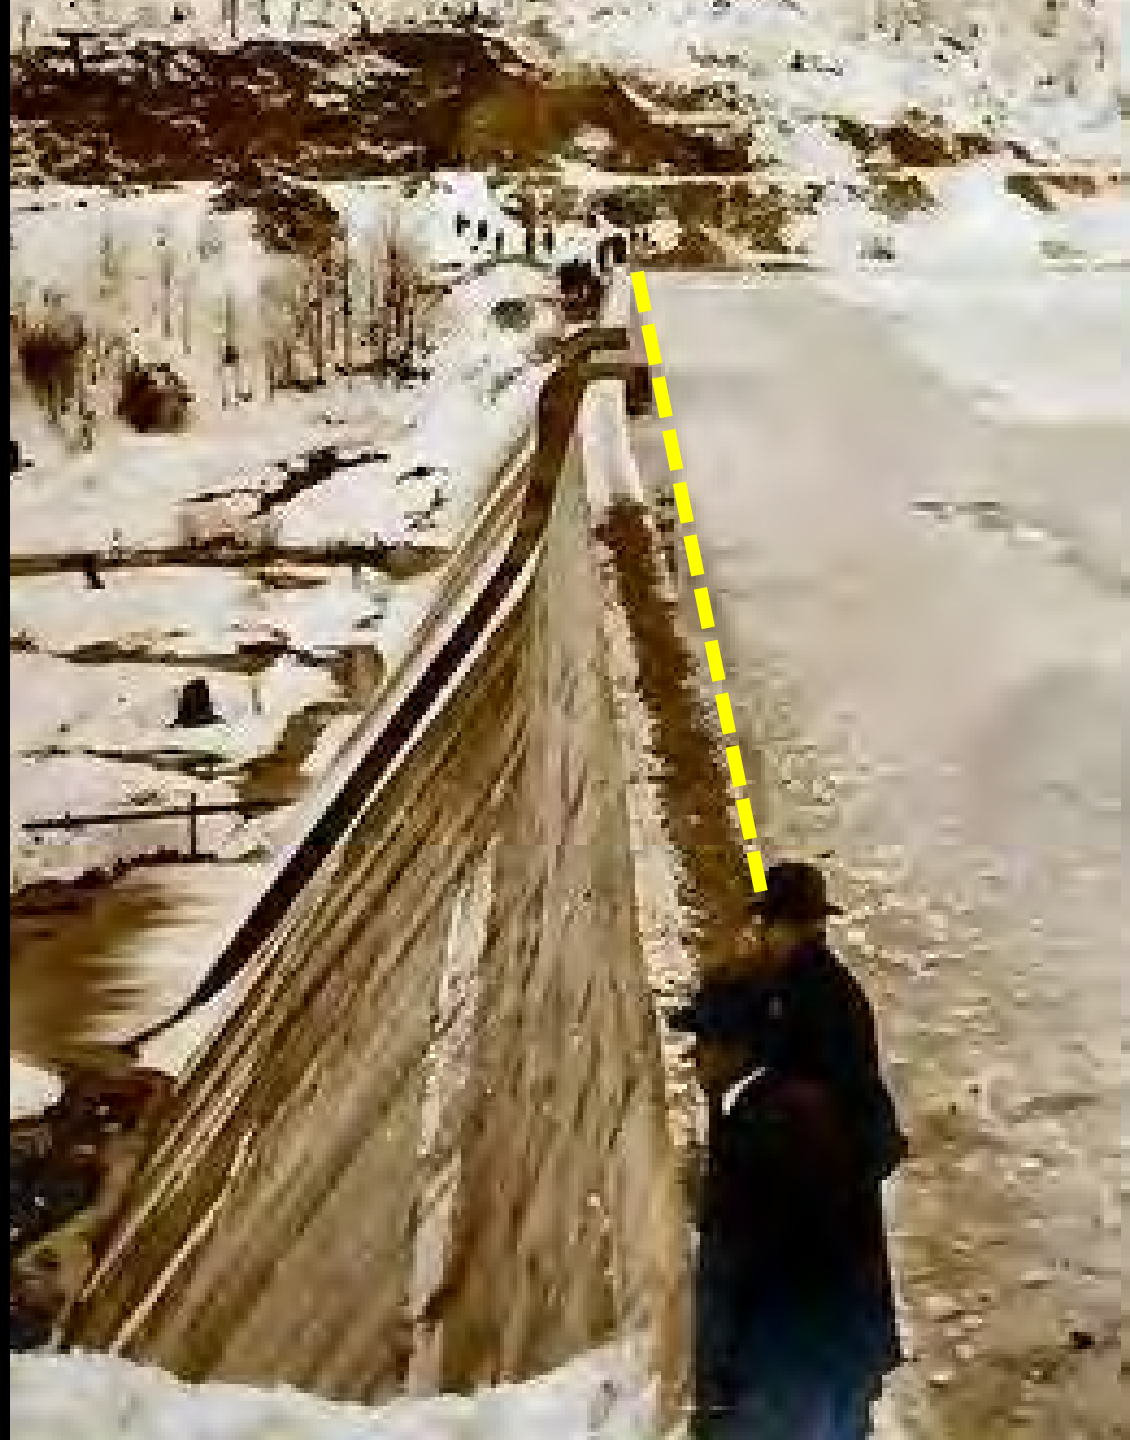
Bayless Dam, Austin, PA
January 23, 1910
Max. Horizontal Displacement:
Crest: 31 inches
Base: 18 inches

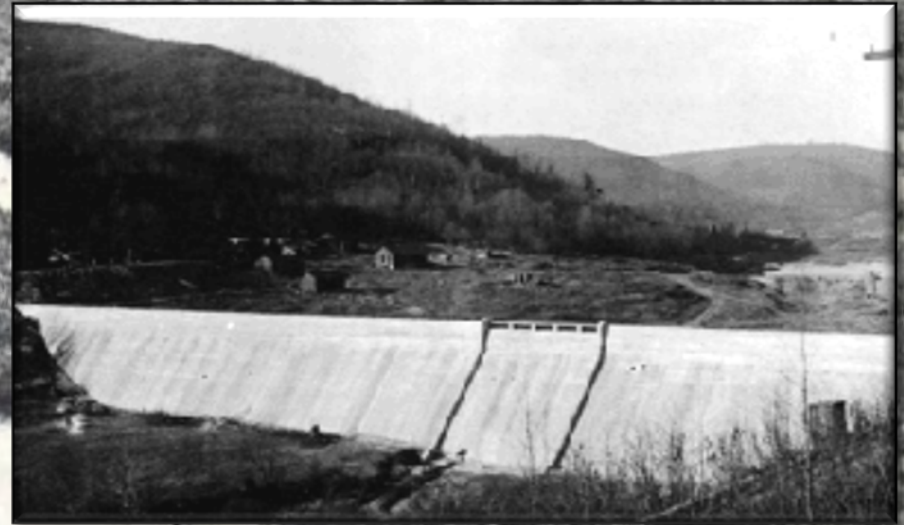
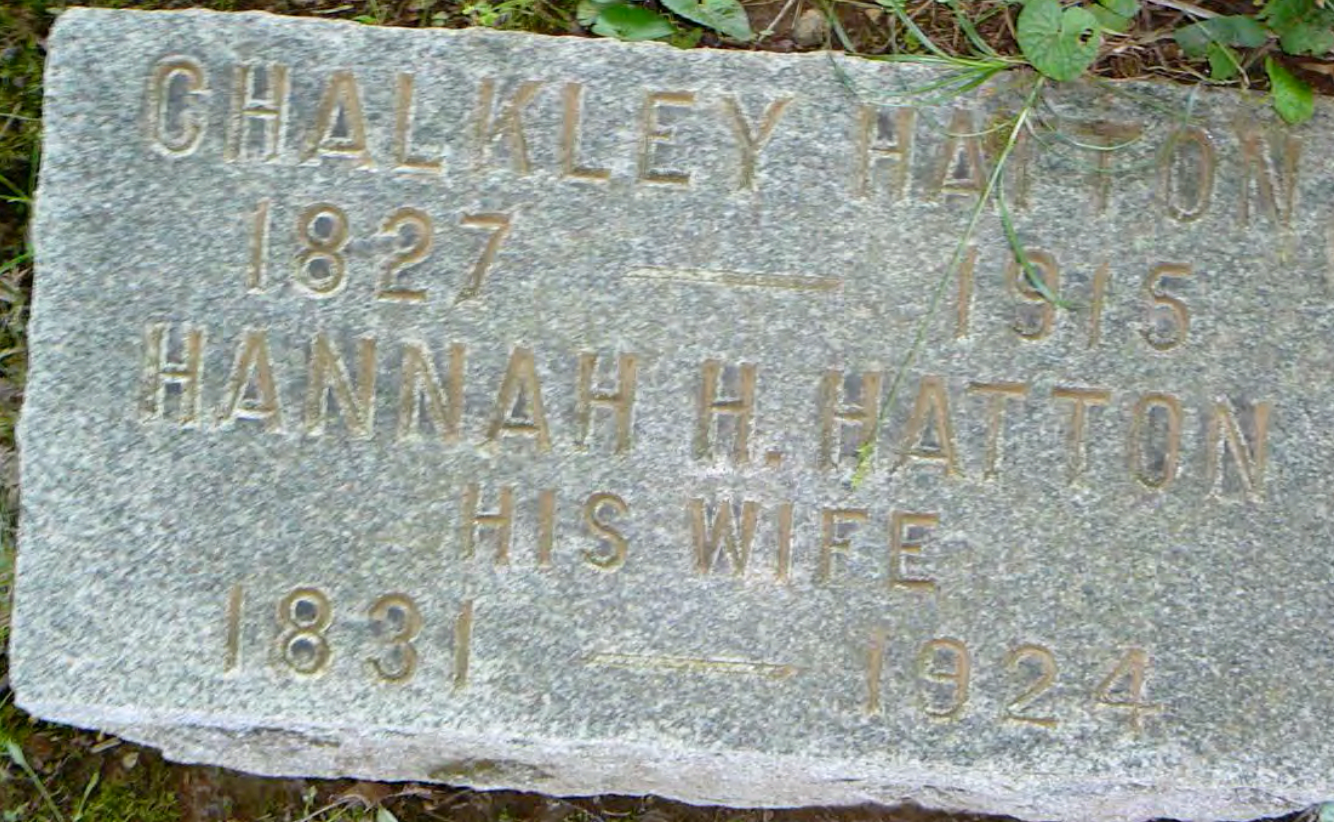
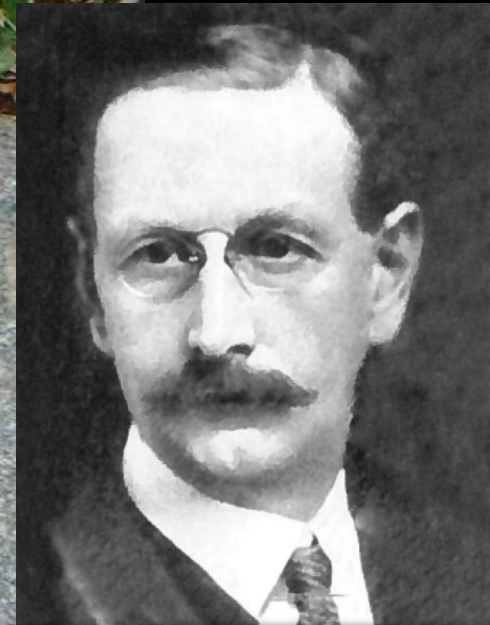
September 1911
Bayless Dam
Austin, PA

Loss of Life = 78 people

“The failure of this dam was not the result of poor workmanship, but poor judgment upon my part. I should have sought the advice of a man more skilled than I in determining foundations for dams. Had there been such a state officer it might have resulted in saving this dam and my reputation.”

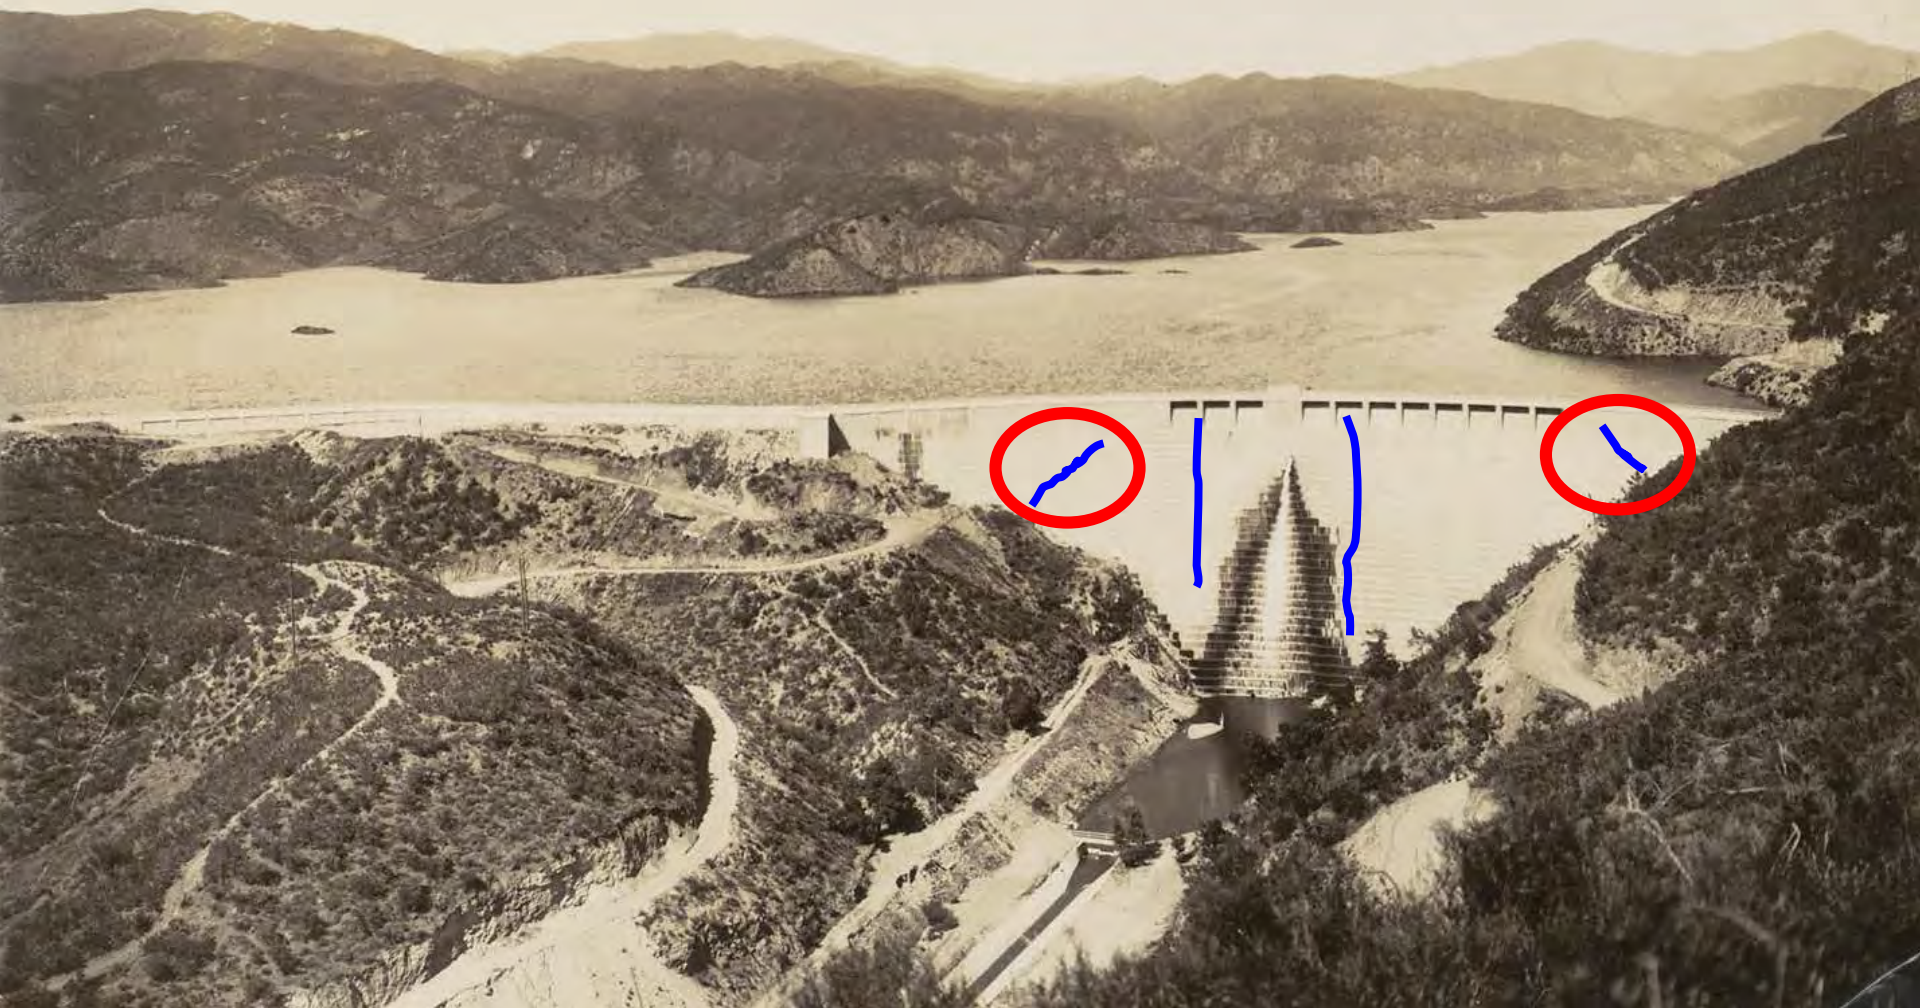
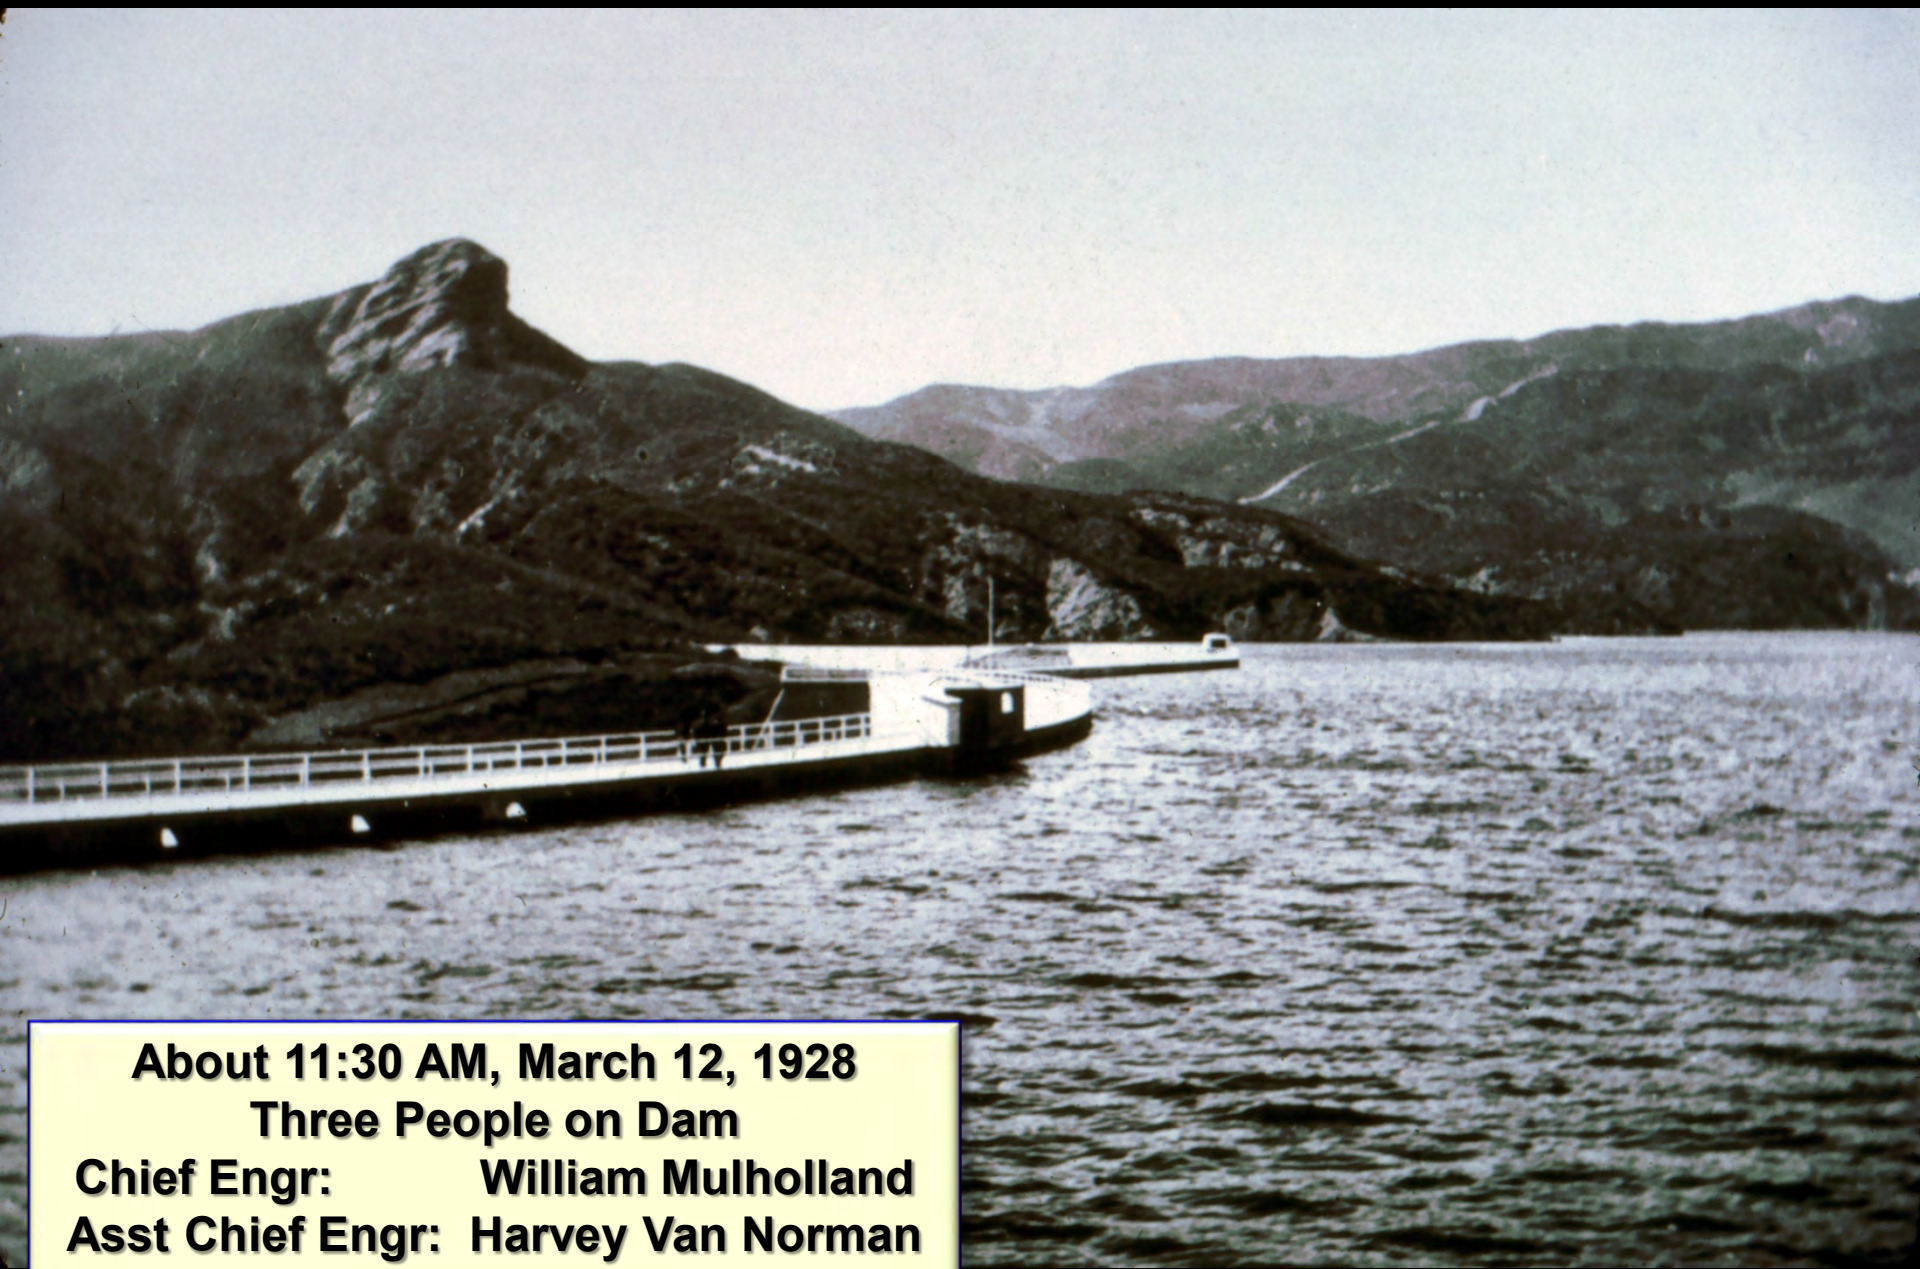
Saint Francis Dam Failure, CA 1928

Foundation Problems ...

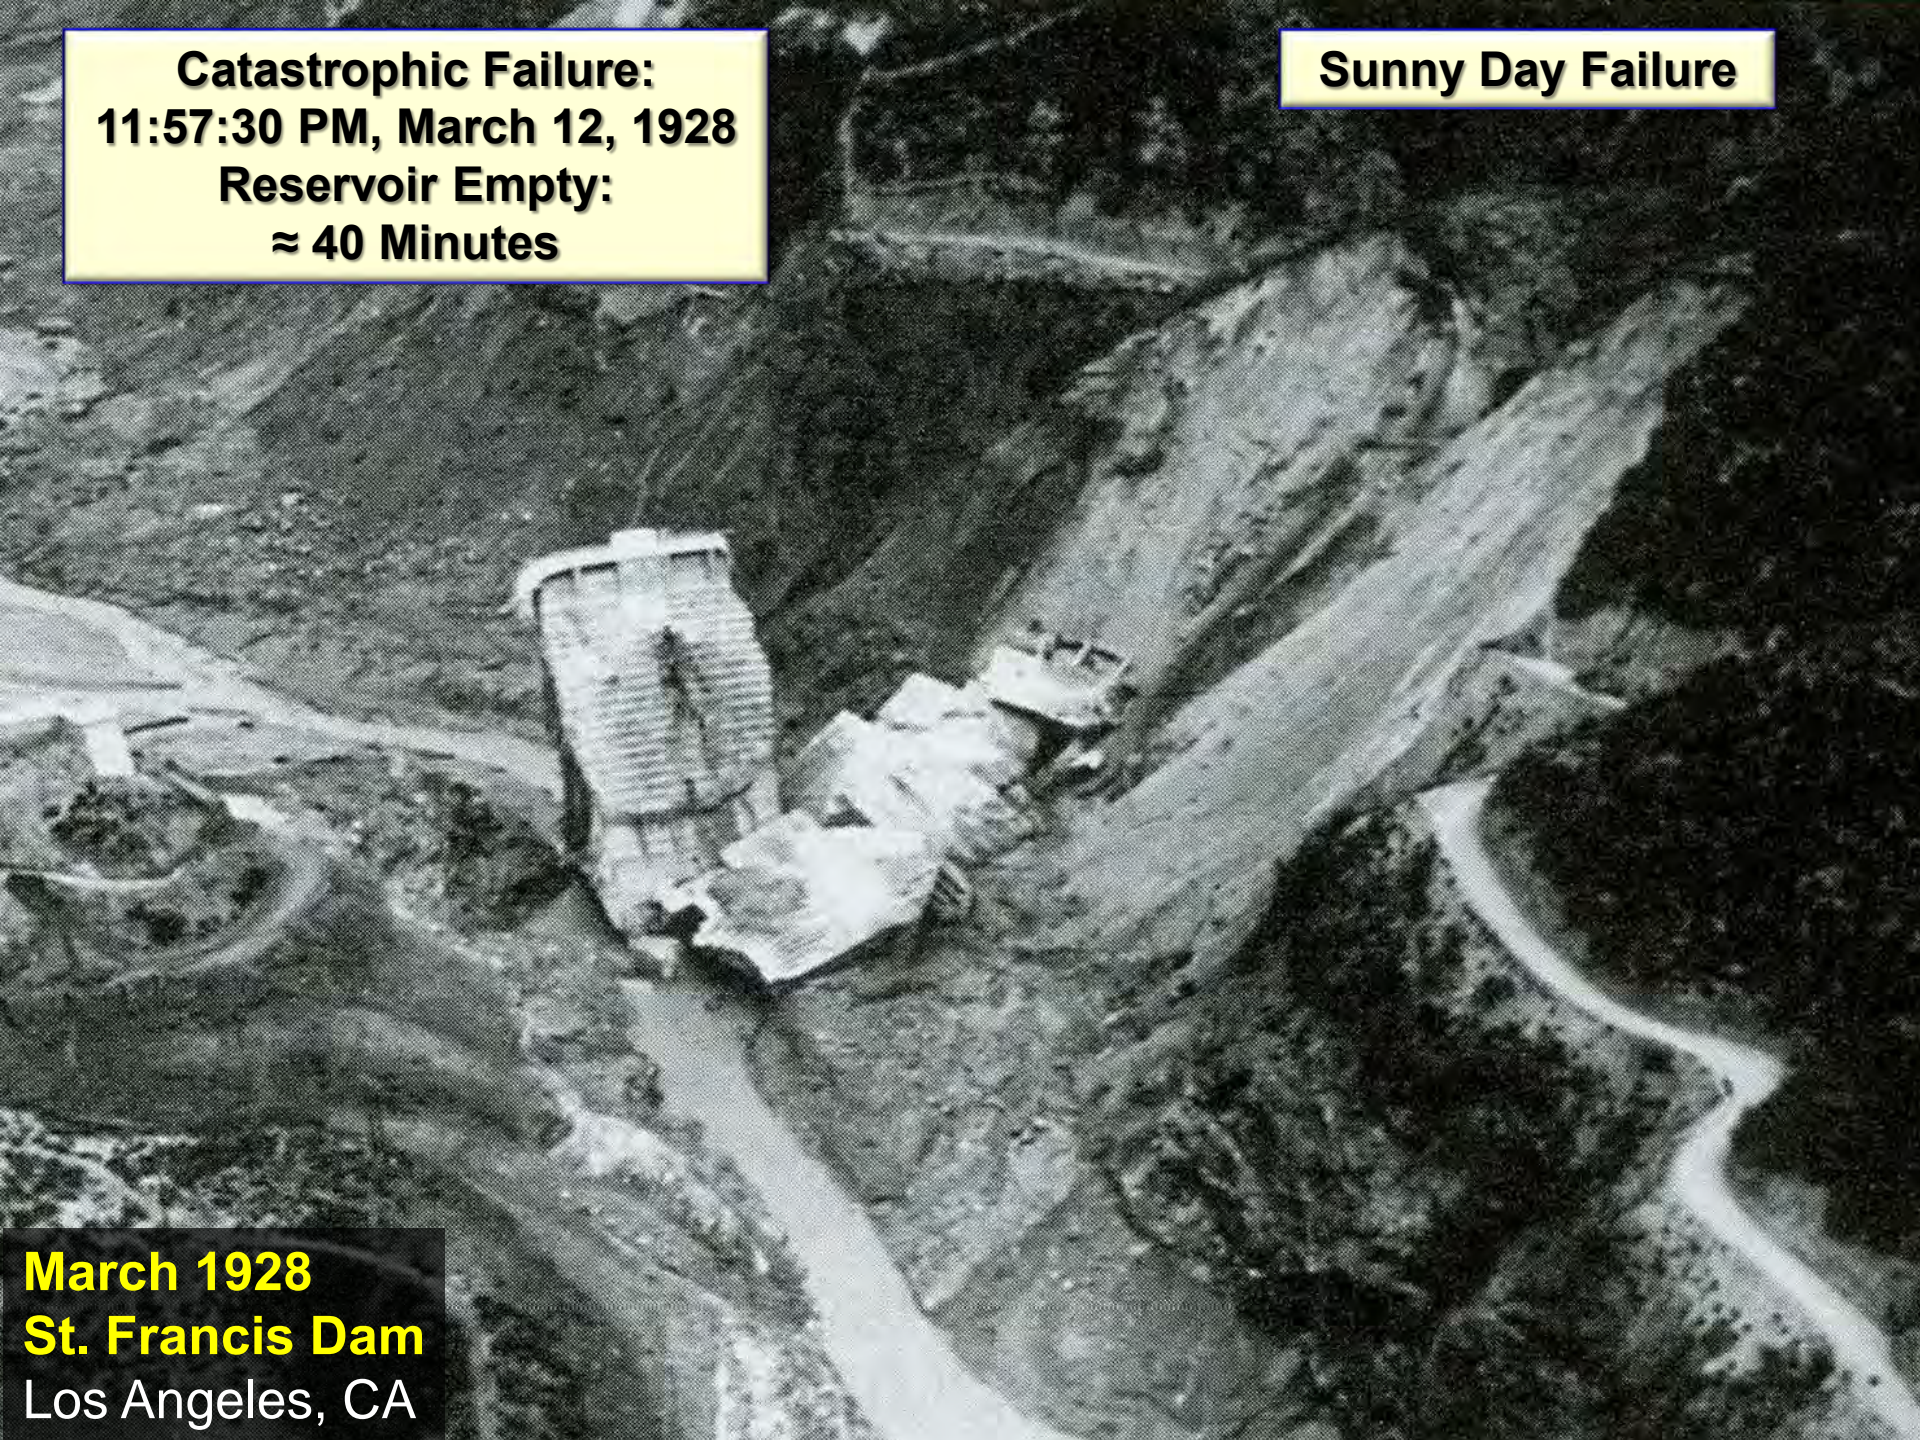
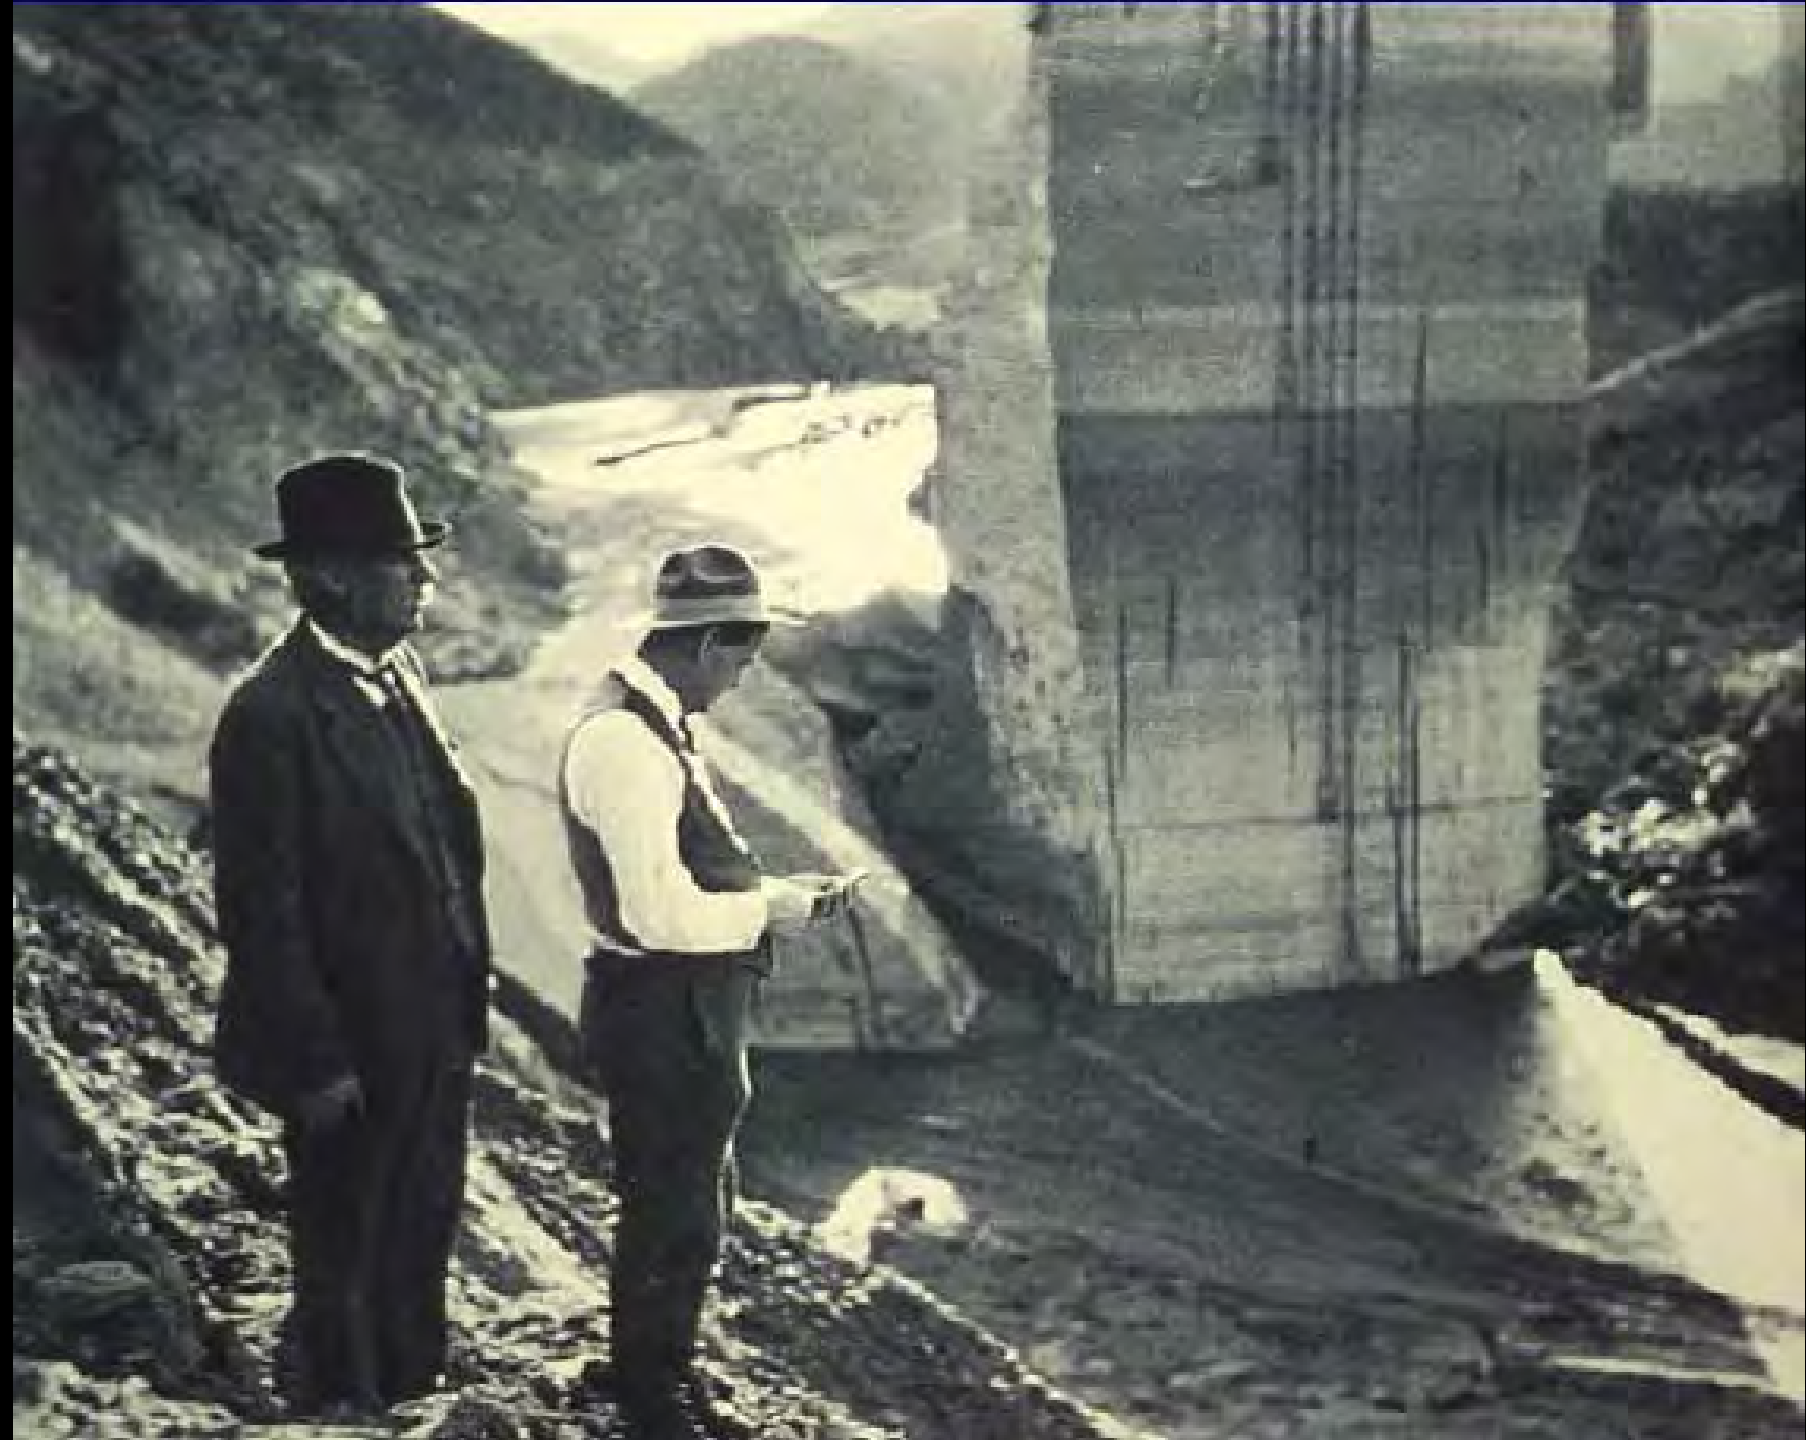
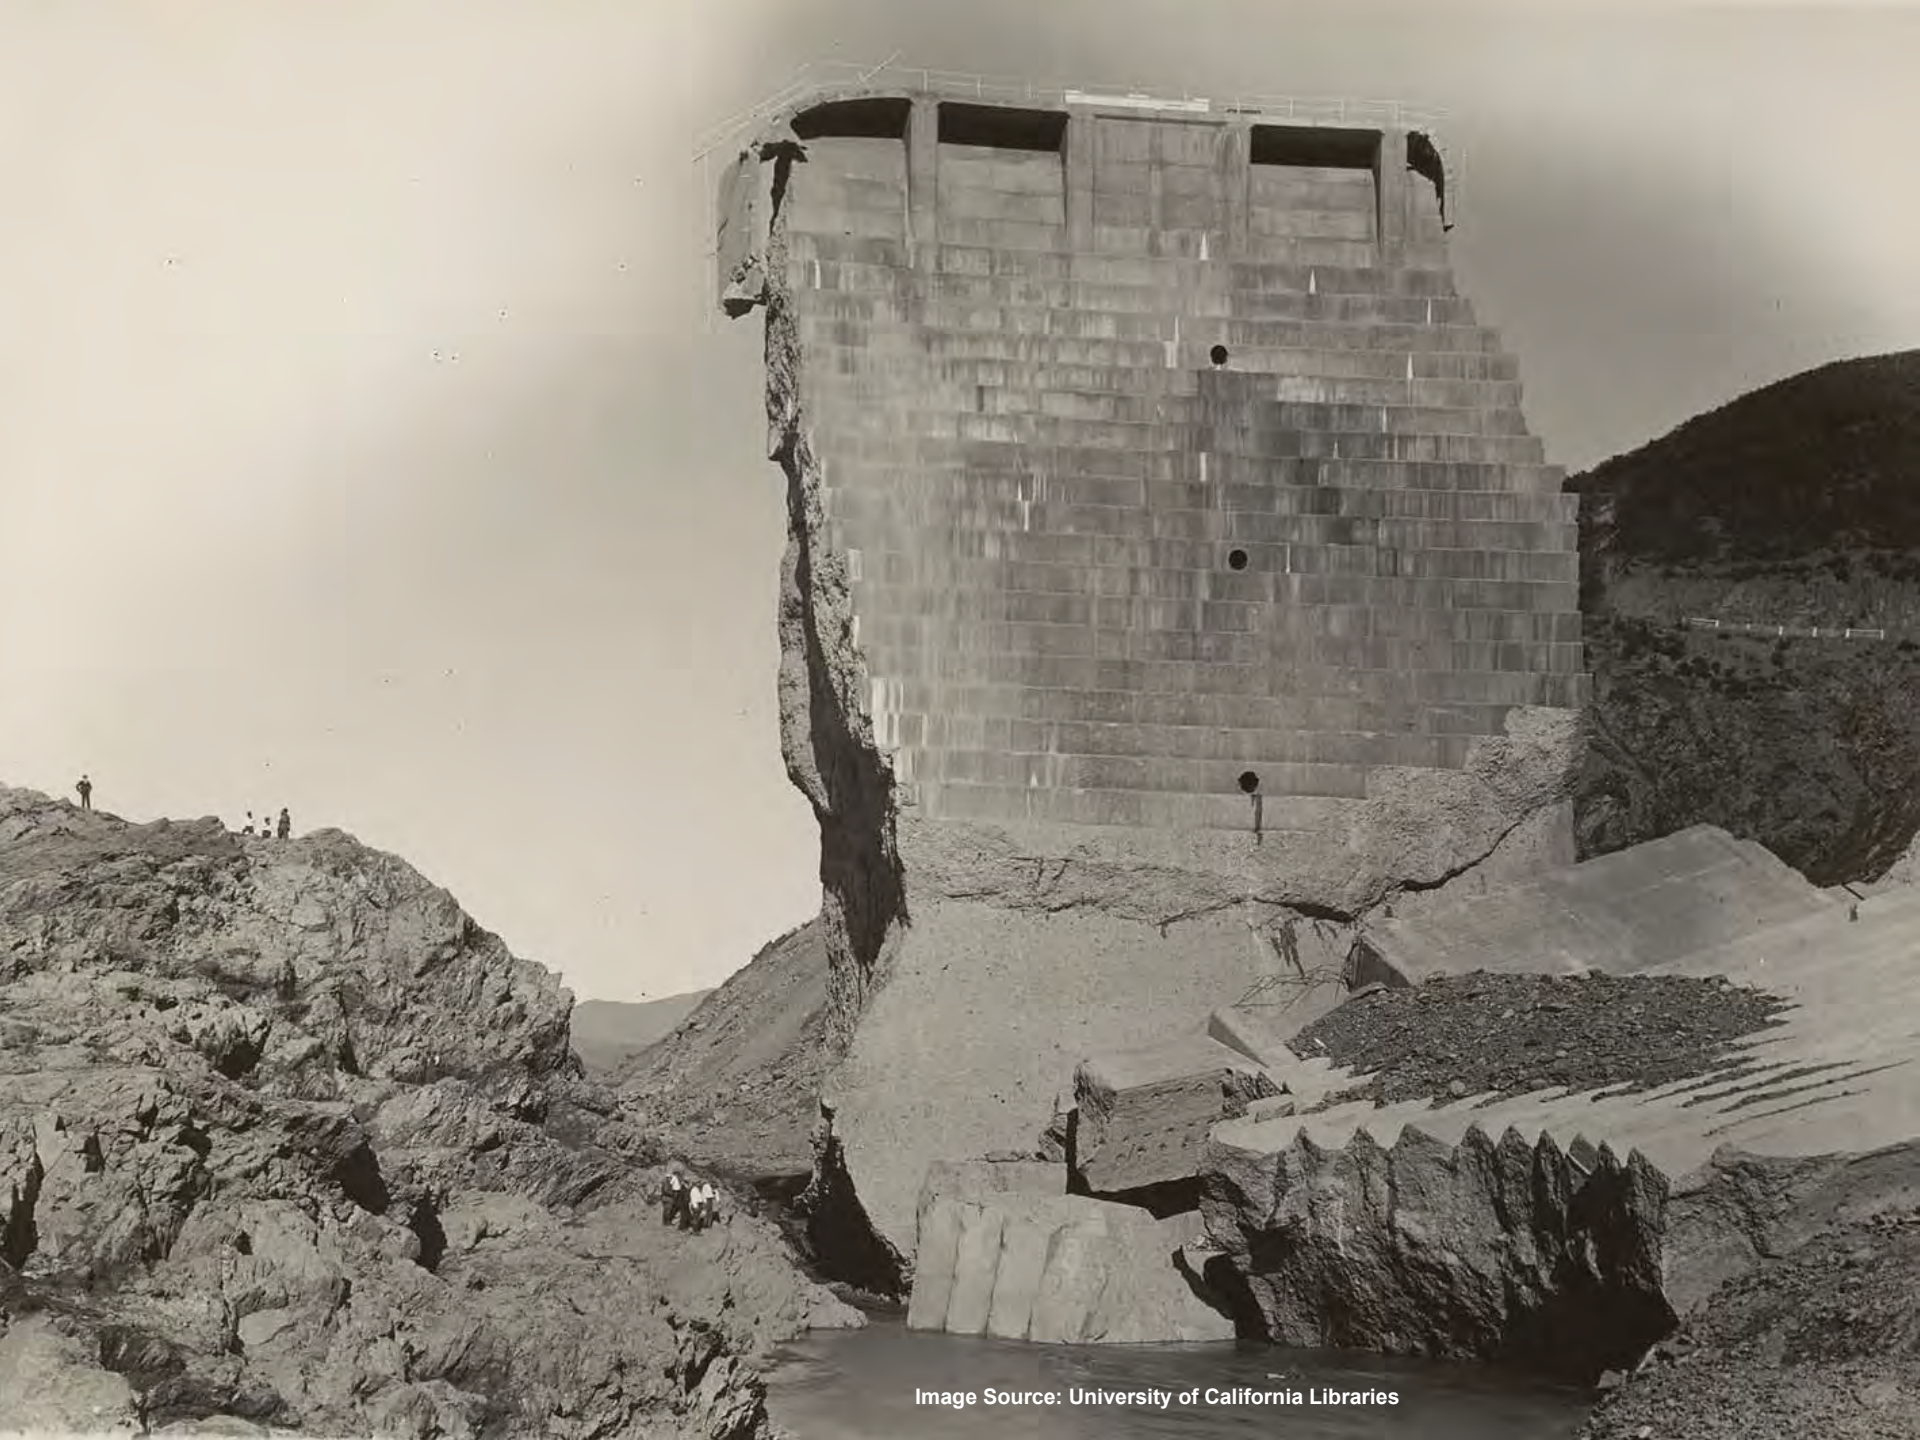
March 1928
St. Francis Dam
Los Angeles, CA

Catastrophic Failure:
11:57:30 PM, March 12, 1928
Reservoir Empty:
≈ 40 Minutes

Sunny Day Failure

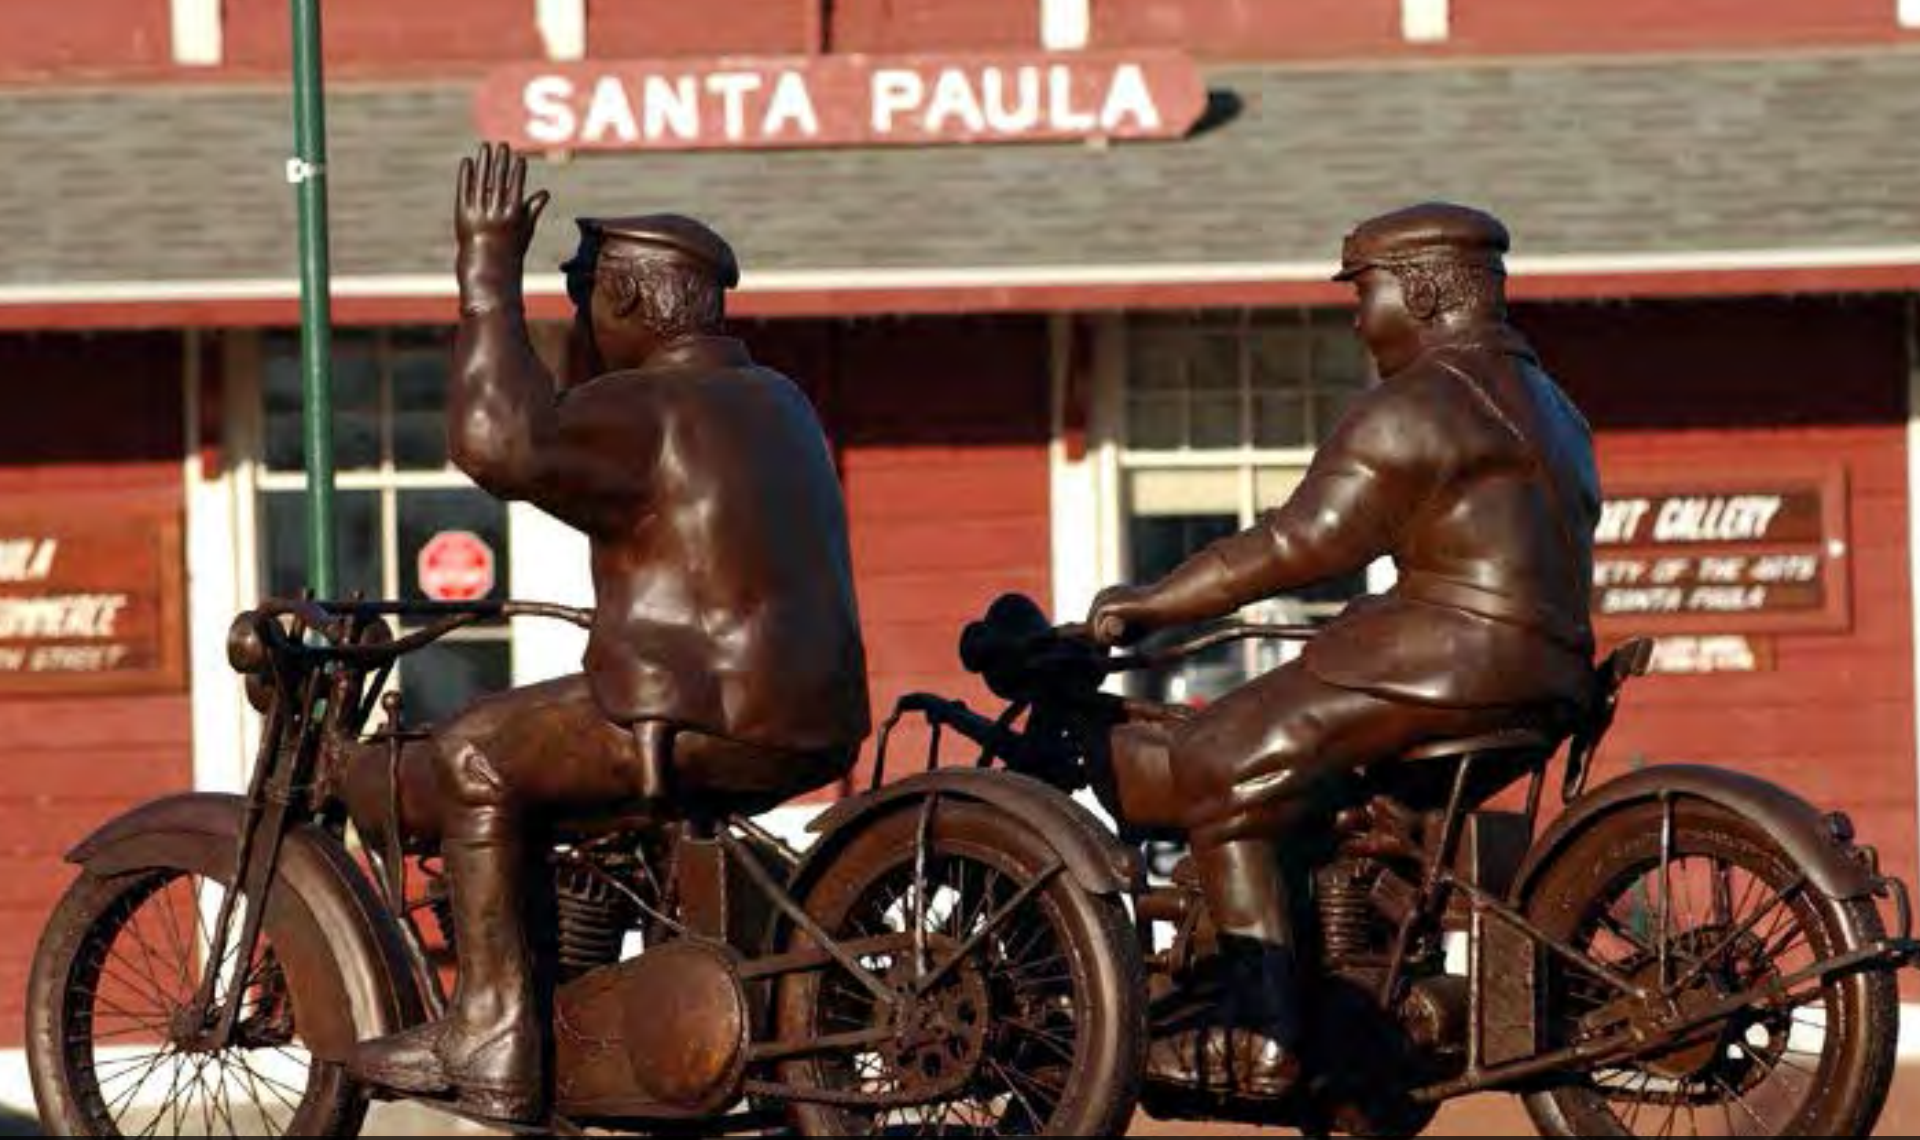
Loss of life ~450
