Lessons Learned from Concrete Dam Failures

Gannett Fleming

Maryland
Department of
the Environment

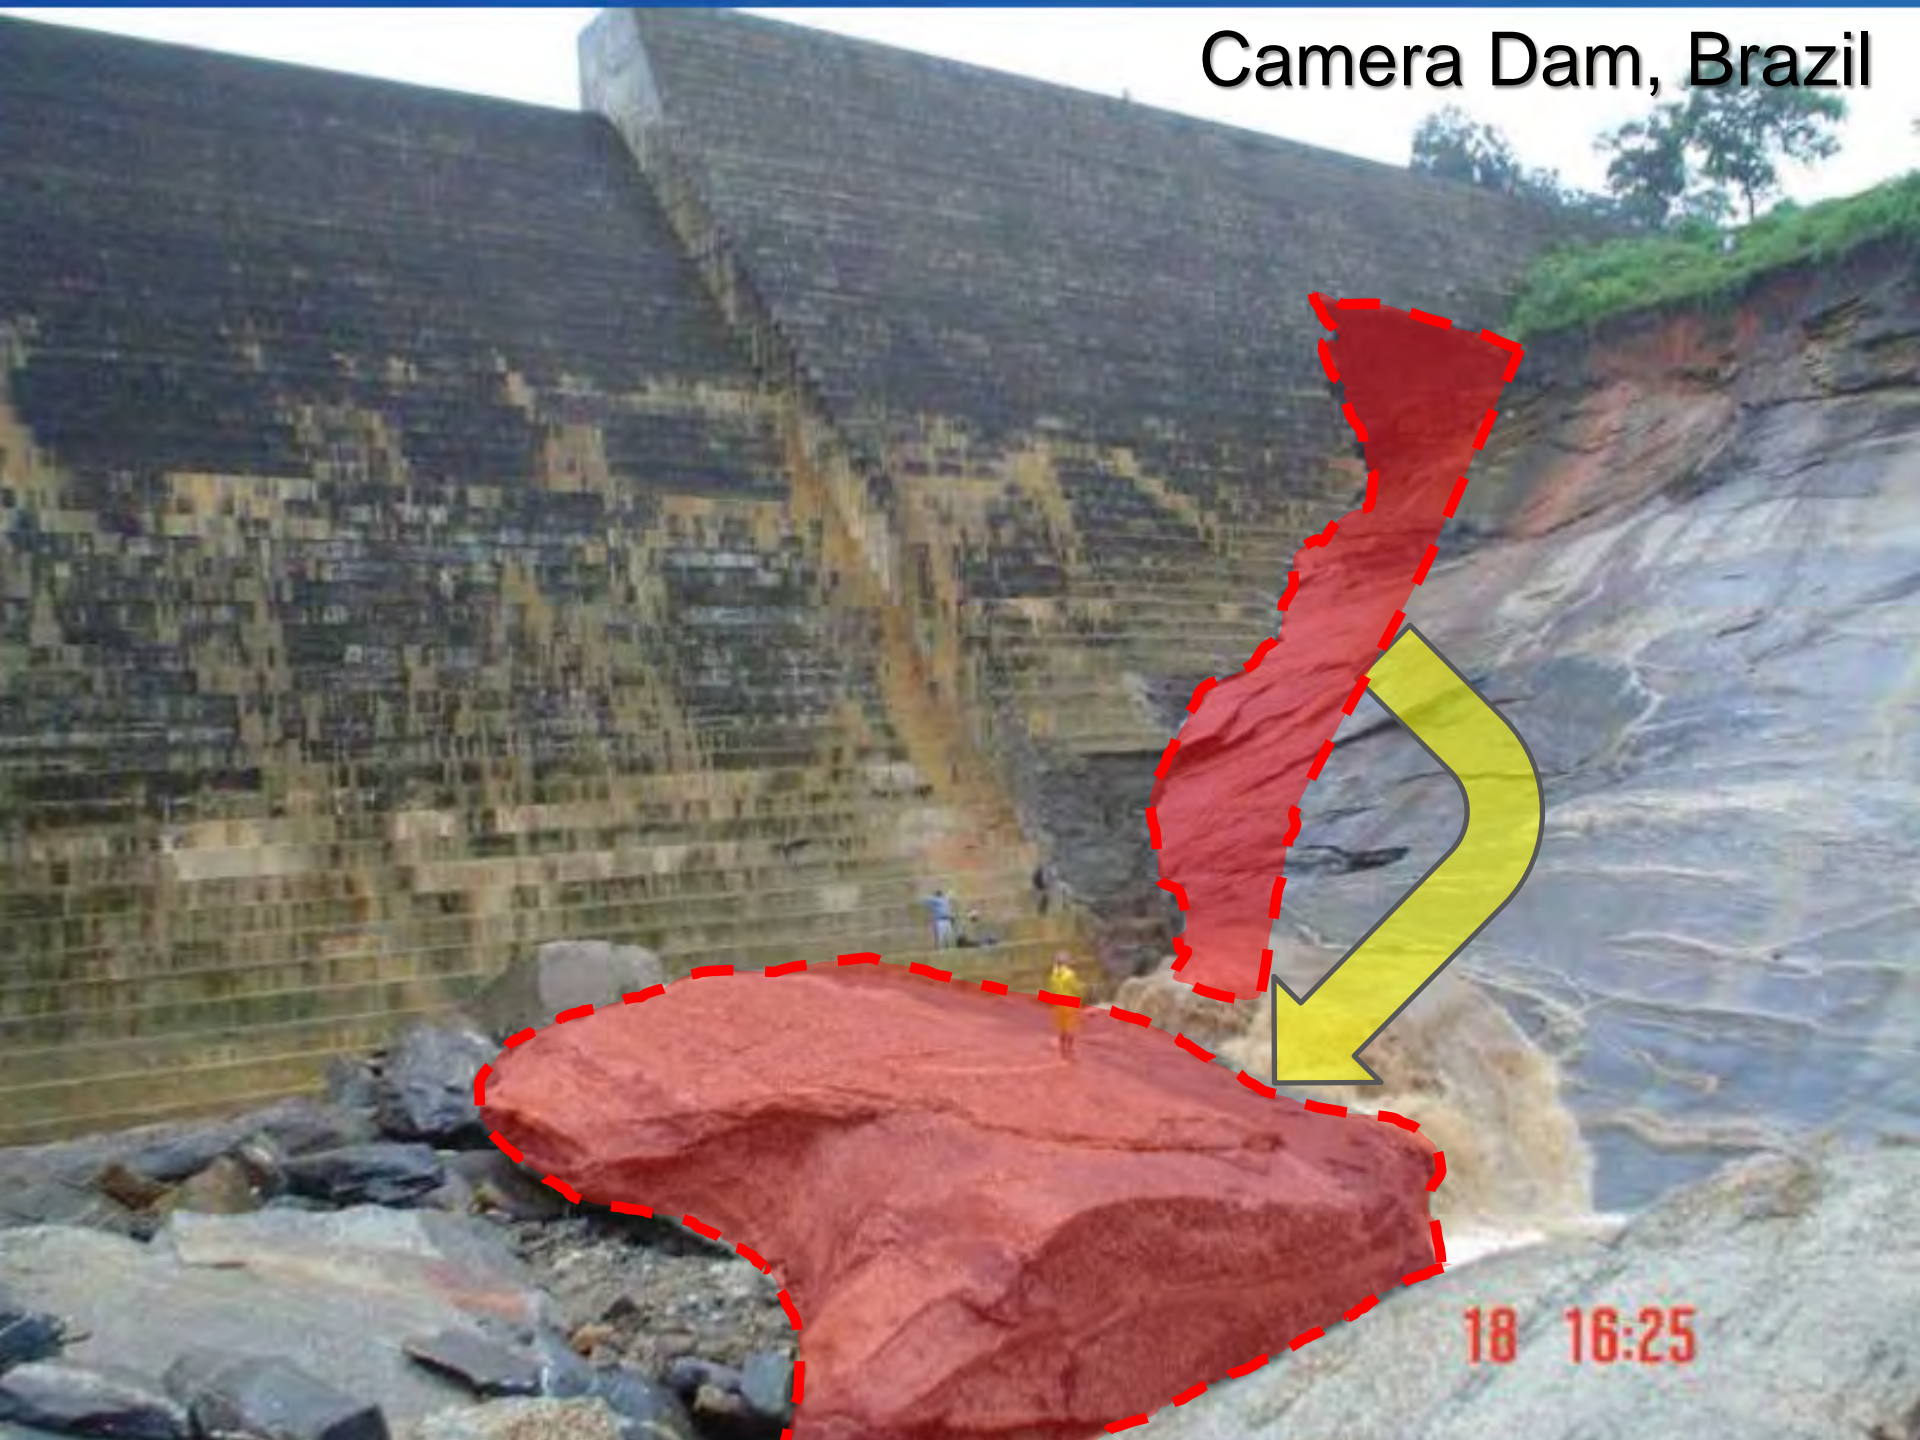
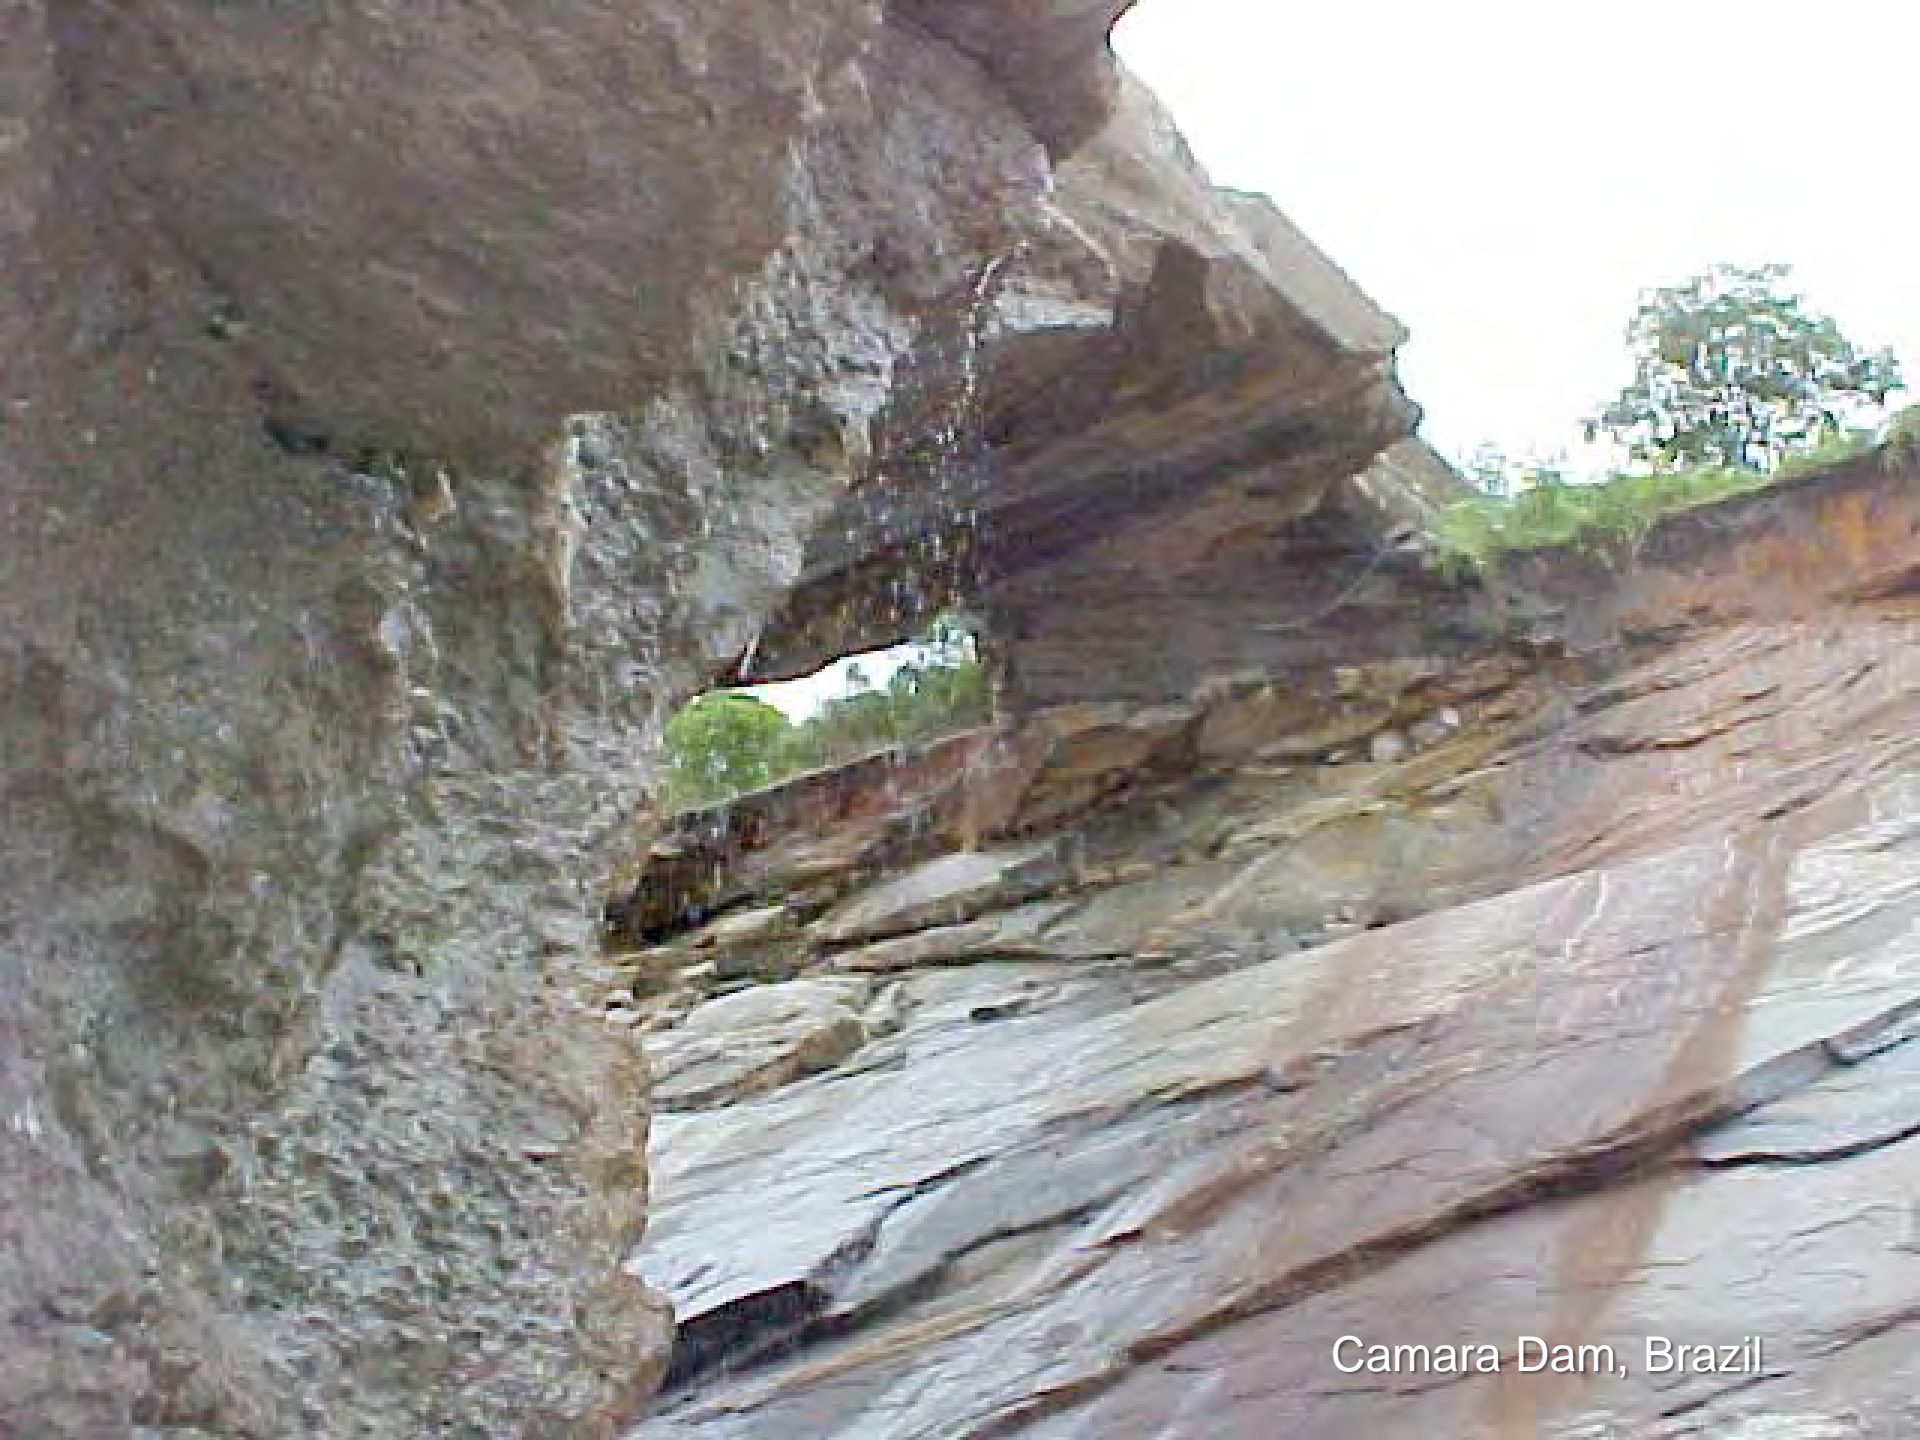
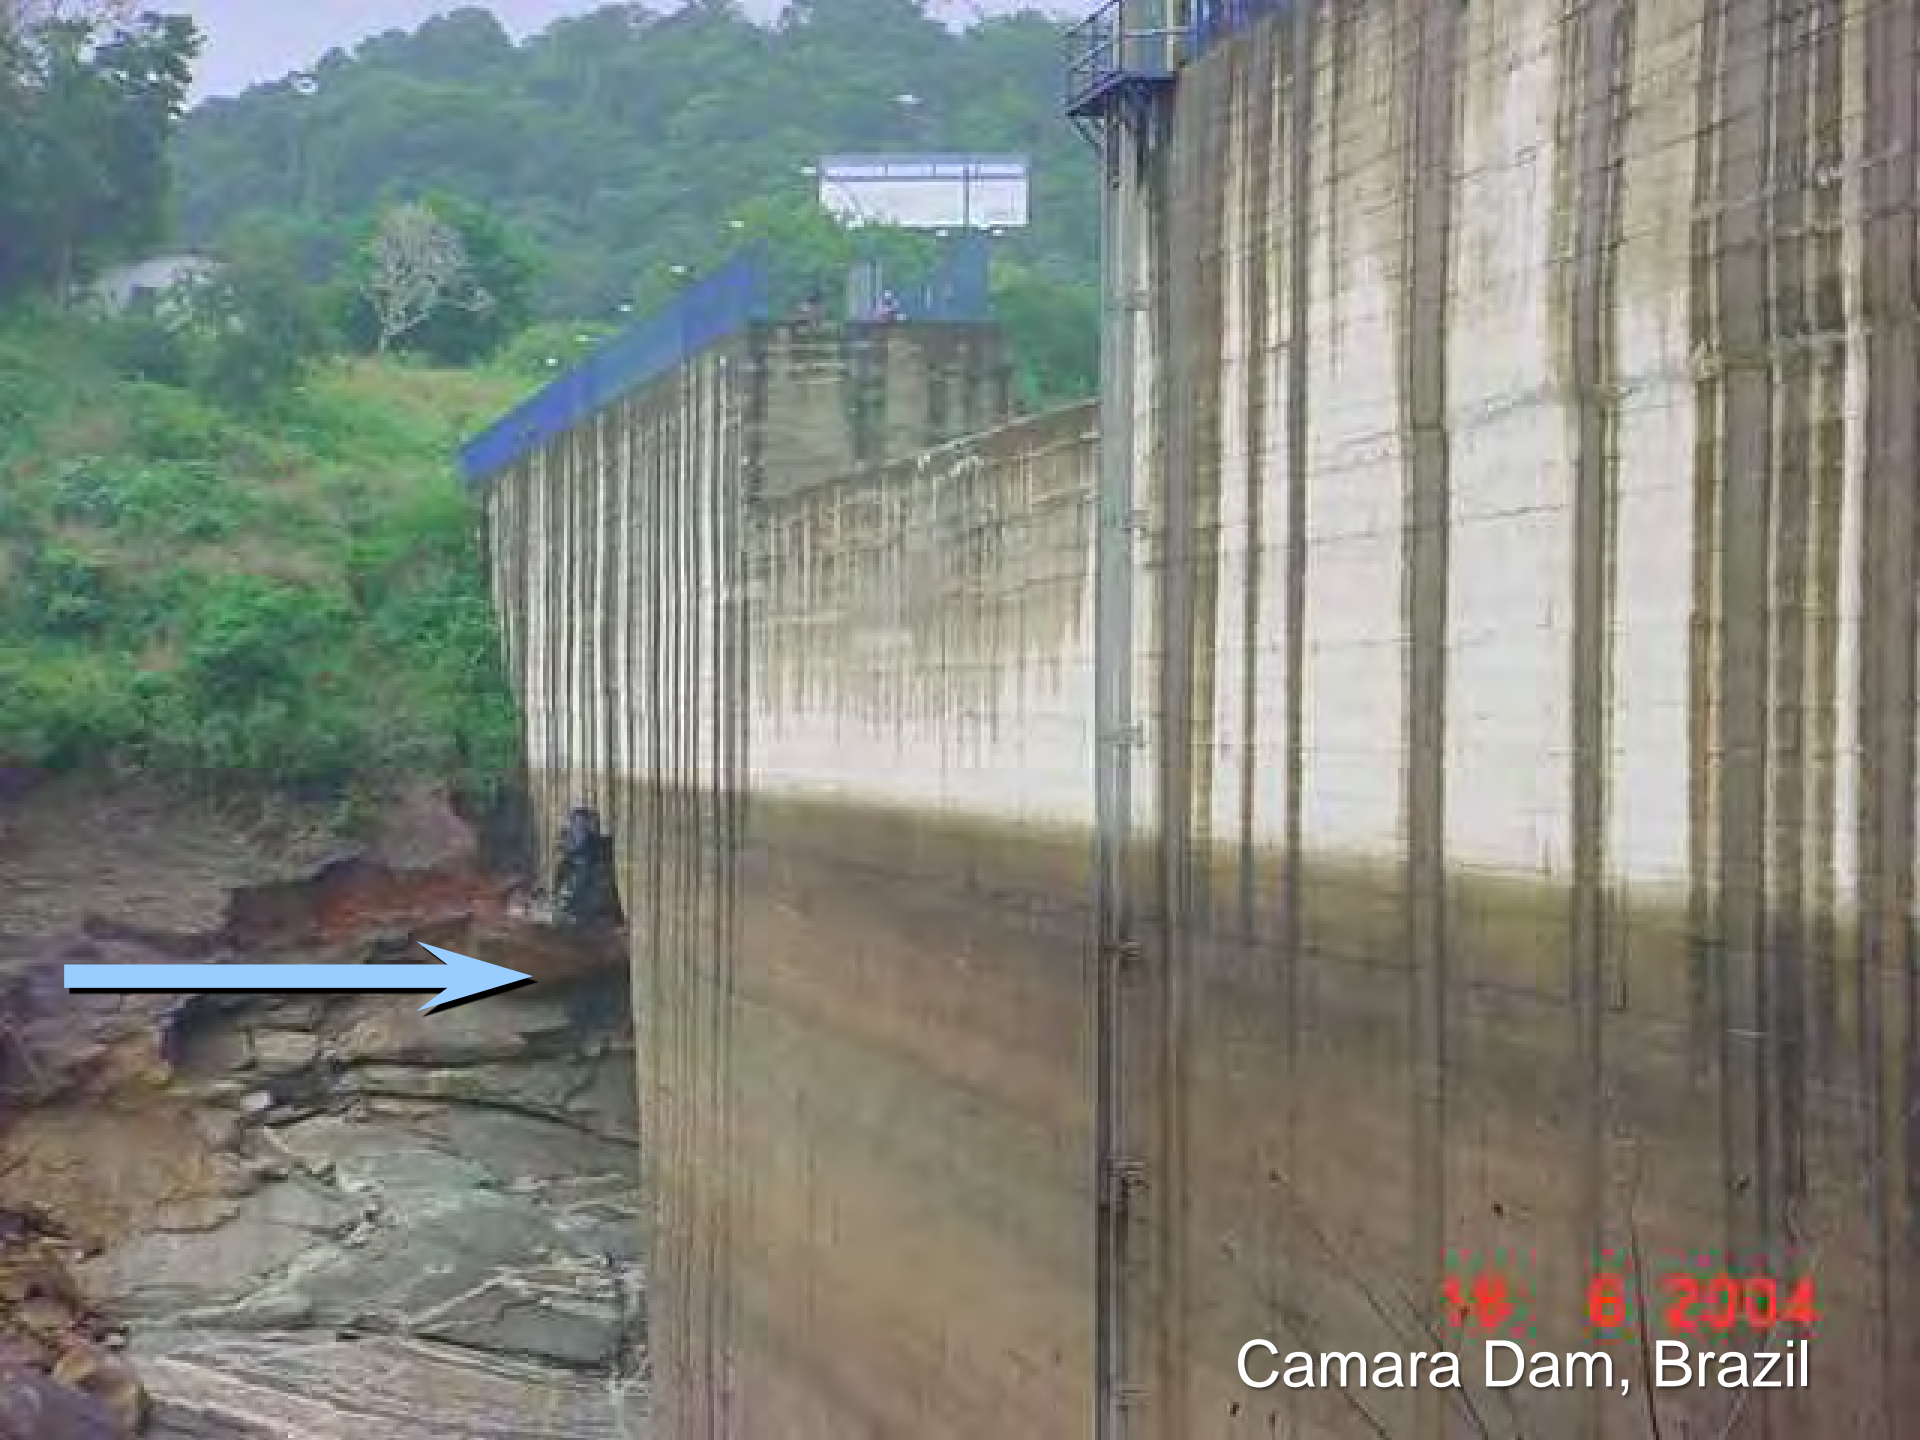
Camera Dam, Brazil

- RCC Dam Constructed 2002
- Failed July 17, 2004 during flood
- 5 fatalities

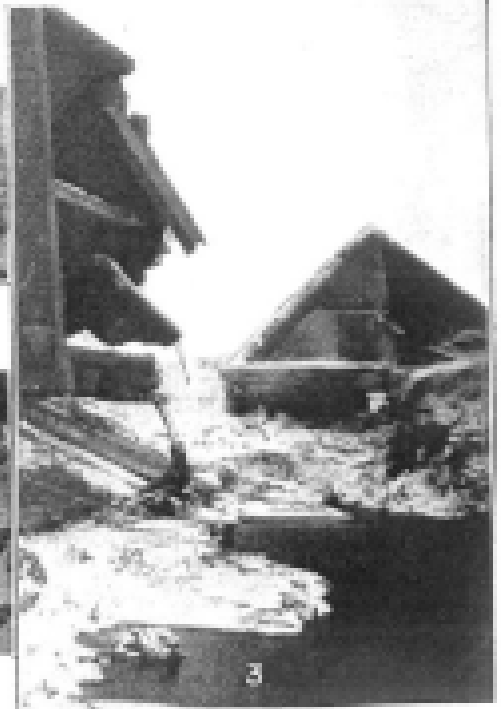
Stony River Dam Near Petersburg, WV

Failure: 1914, 6 Months After Reservoir Impoundment

51 Feet High

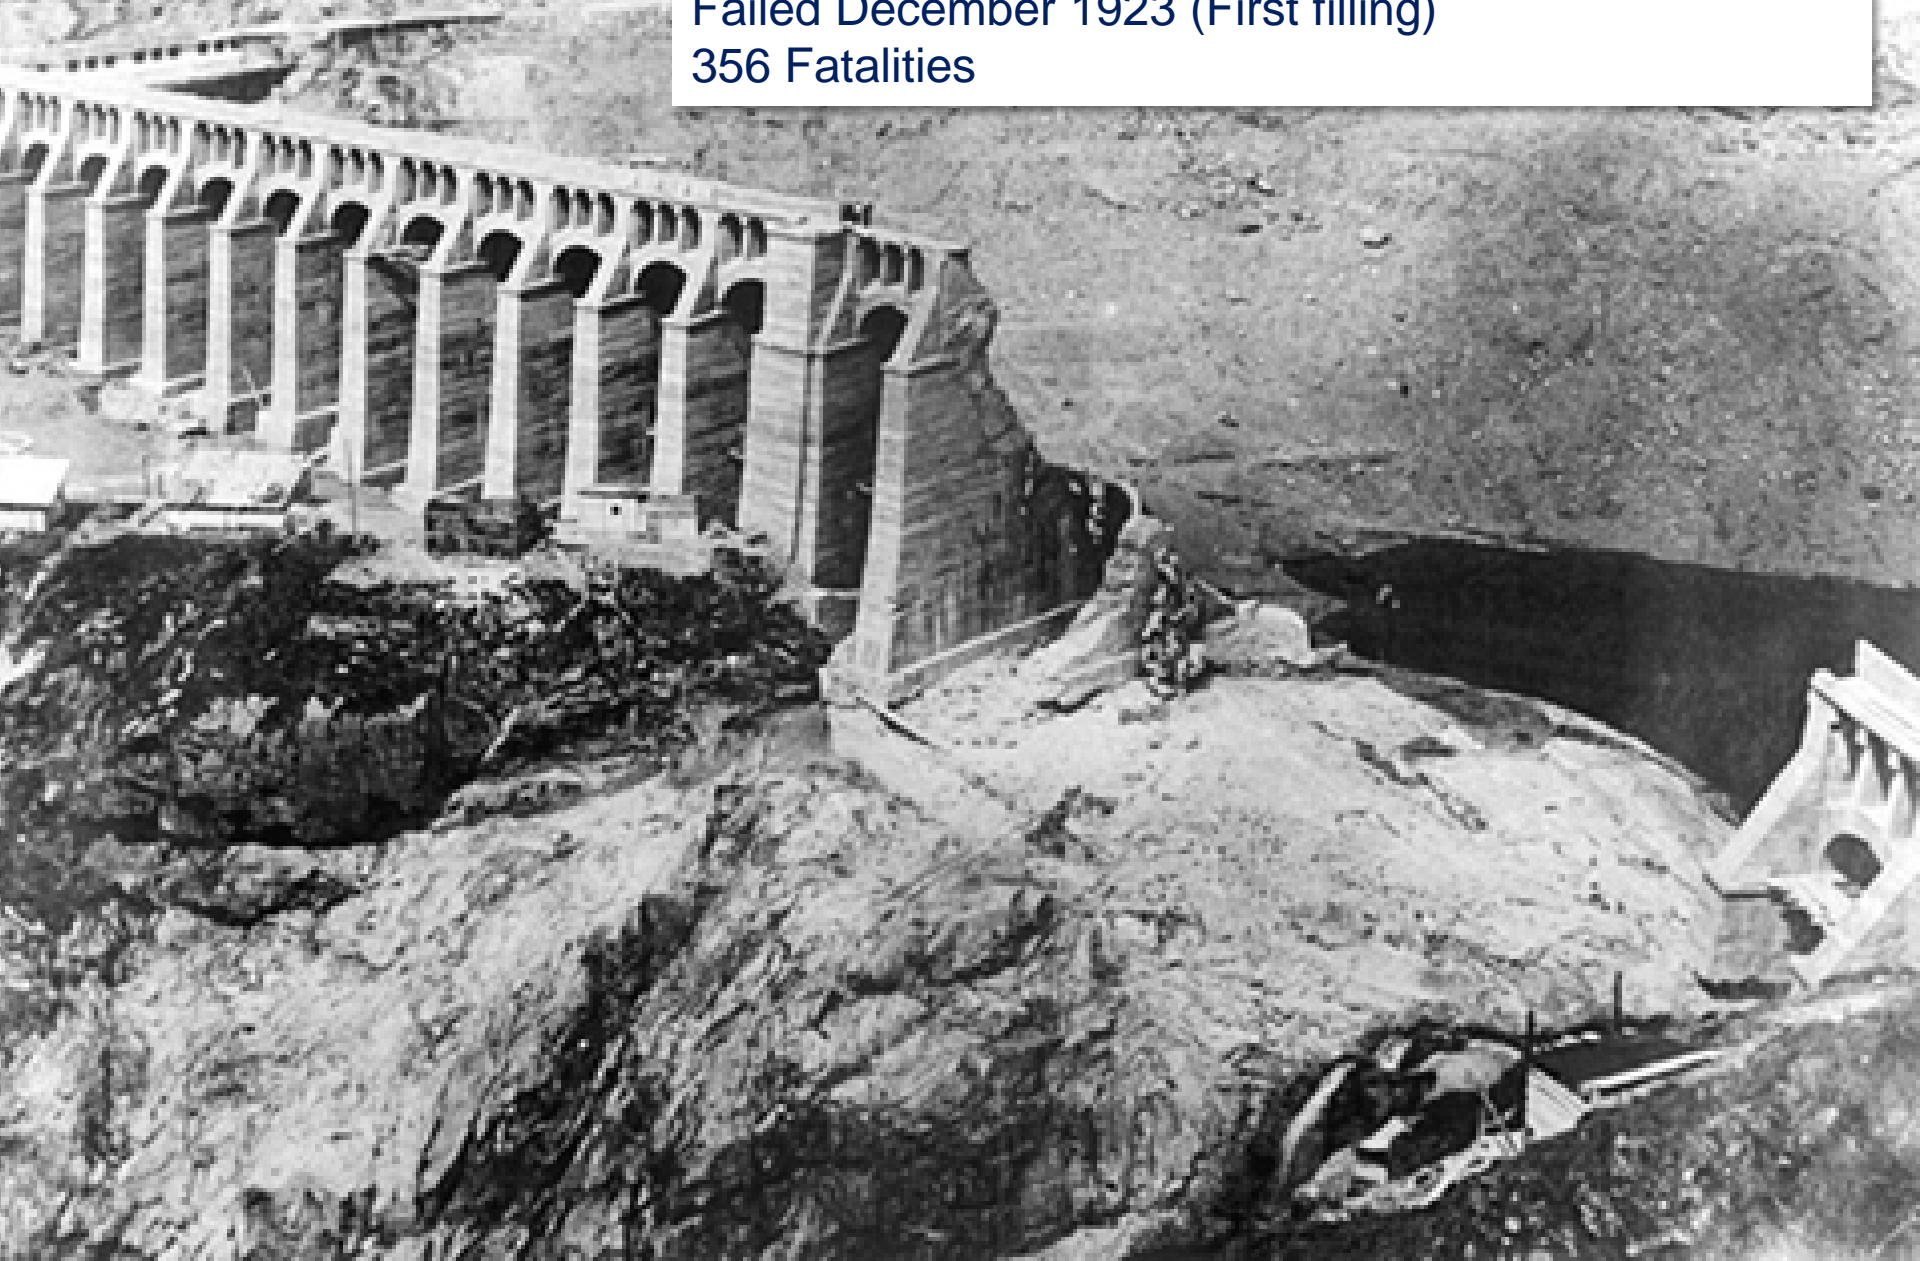
Cause: Poor workmanship and construction materials
Failed December 1923 (First filling)
356 Fatalities

The concrete in the arches was of a poor quality and it was reinforced with anti-grenade scrap netting that had been used during World War I. There were also indications that the dam was poorly joined with its foundation. Additionally, the concrete was believed to not be completely cured when the reservoir was filling. Reportedly, workers who complained about the construction techniques were fired.

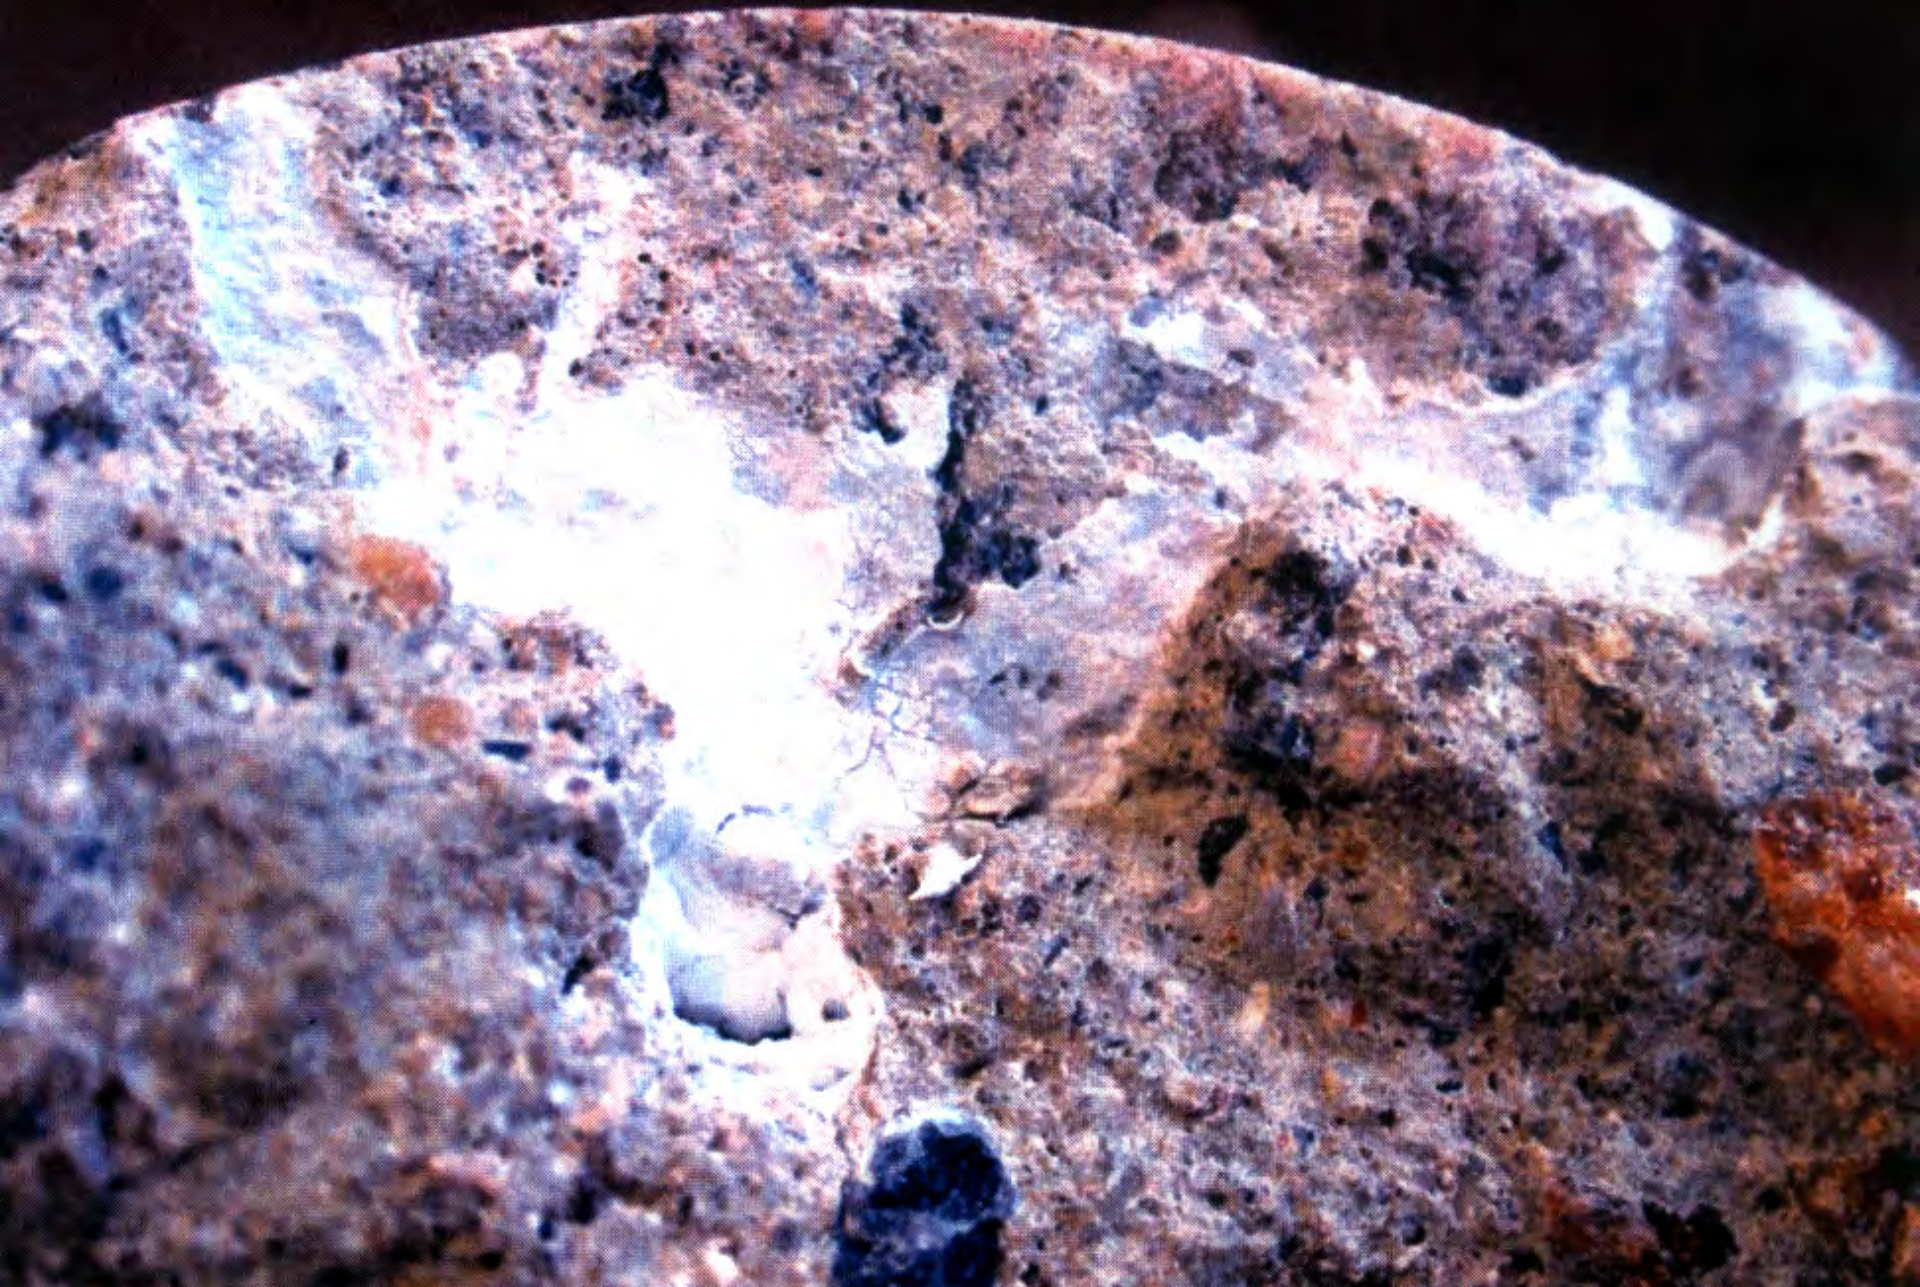
Alkali-Silica Reaction (ASR) Gel

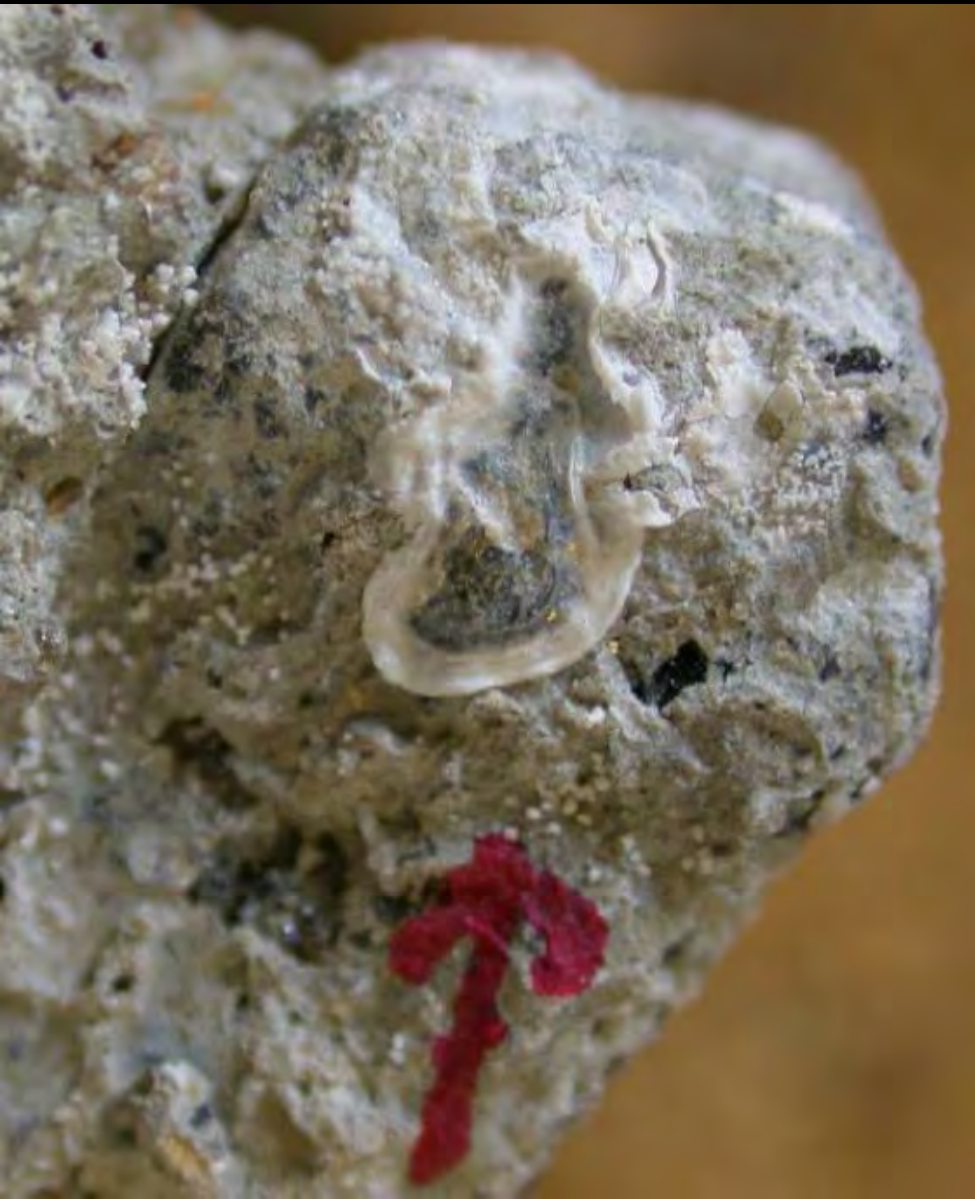
ASR Gel

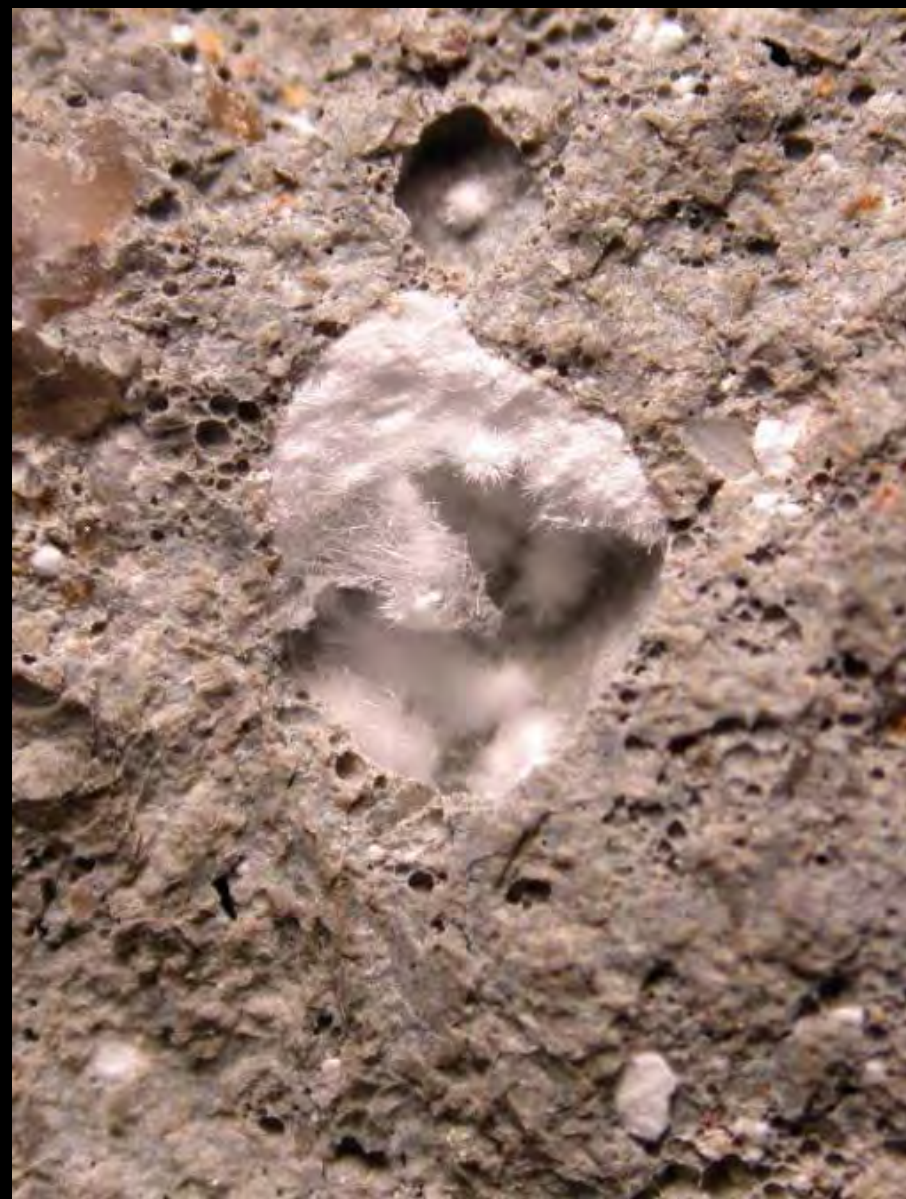
Ettringite

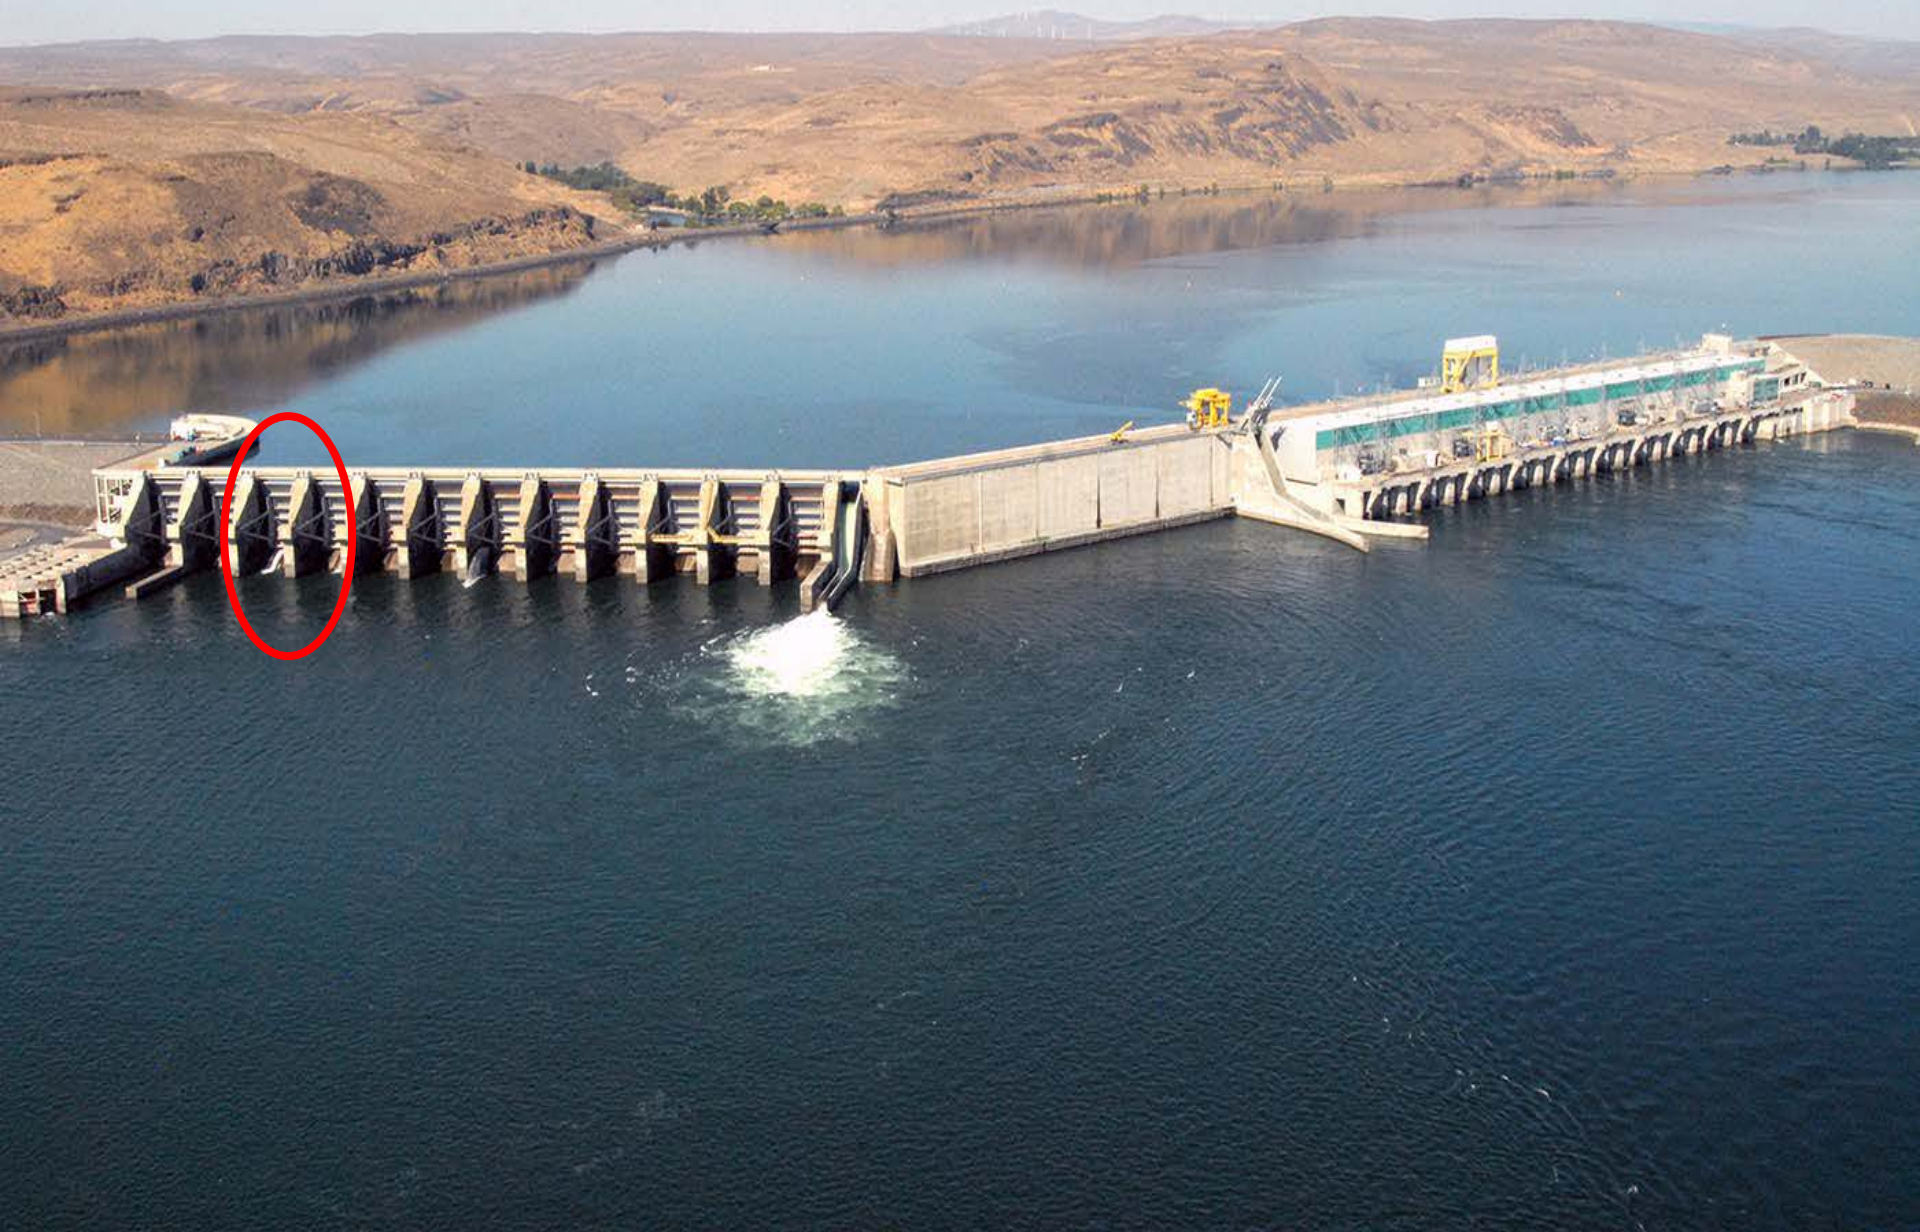
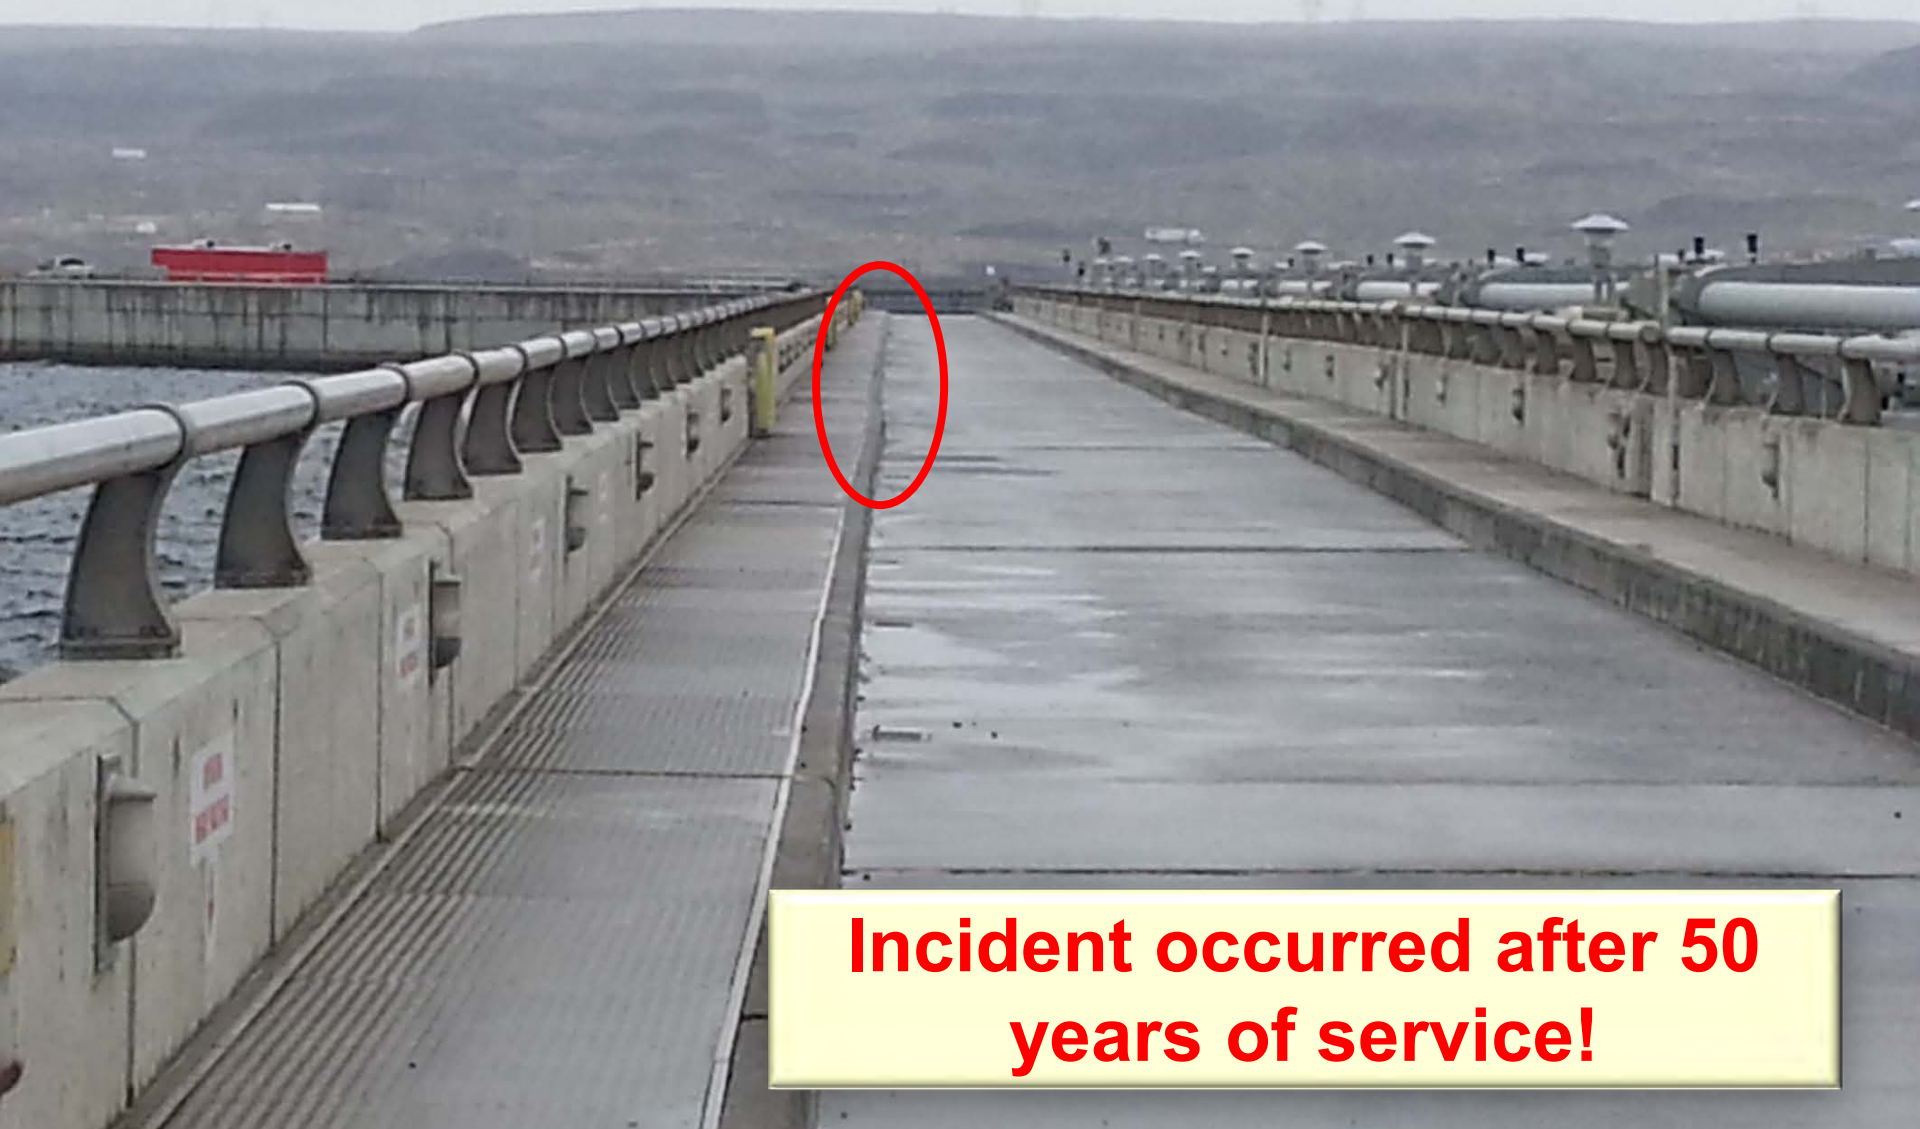
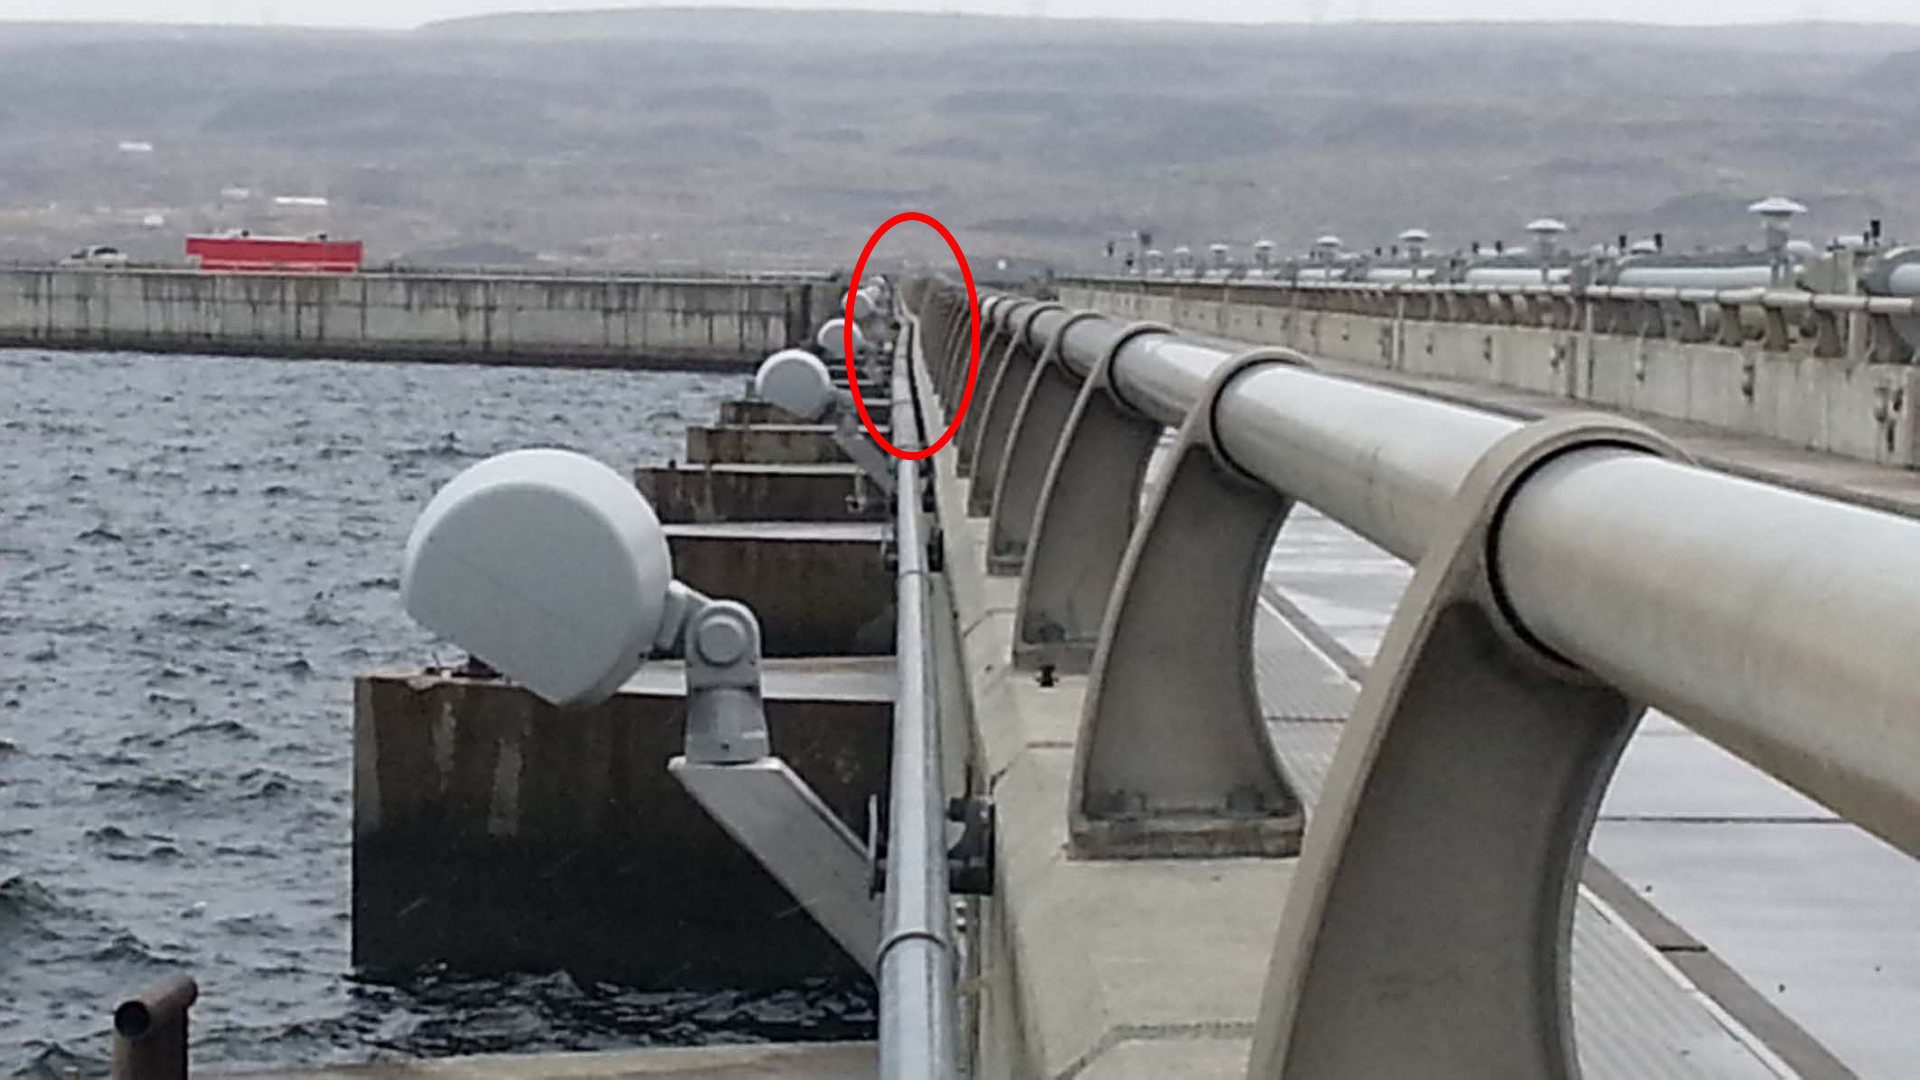
Wanapum Dam,
Columbia River near Vantage, Washington

Engineers were tipped to a possible problem Tuesday when they noticed a slight bowing of a concrete curb on the dam deck. They also noticed that the affected

The heightened alert at the dam comes after divers Thursday discovered a crack in one of the dam's concrete support piers that measures 2 inches wide by 65 feet long.

**Incident occurred after 50
years of service!**

The PUD will draw the reservoir behind the dam down another 14 feet by Tuesday for a total expected drawdown of 20 feet, Stredwick said.
