Lessons Learned from Concrete Dam Failures

Gannett Fleming

Maryland
Department of
the Environment

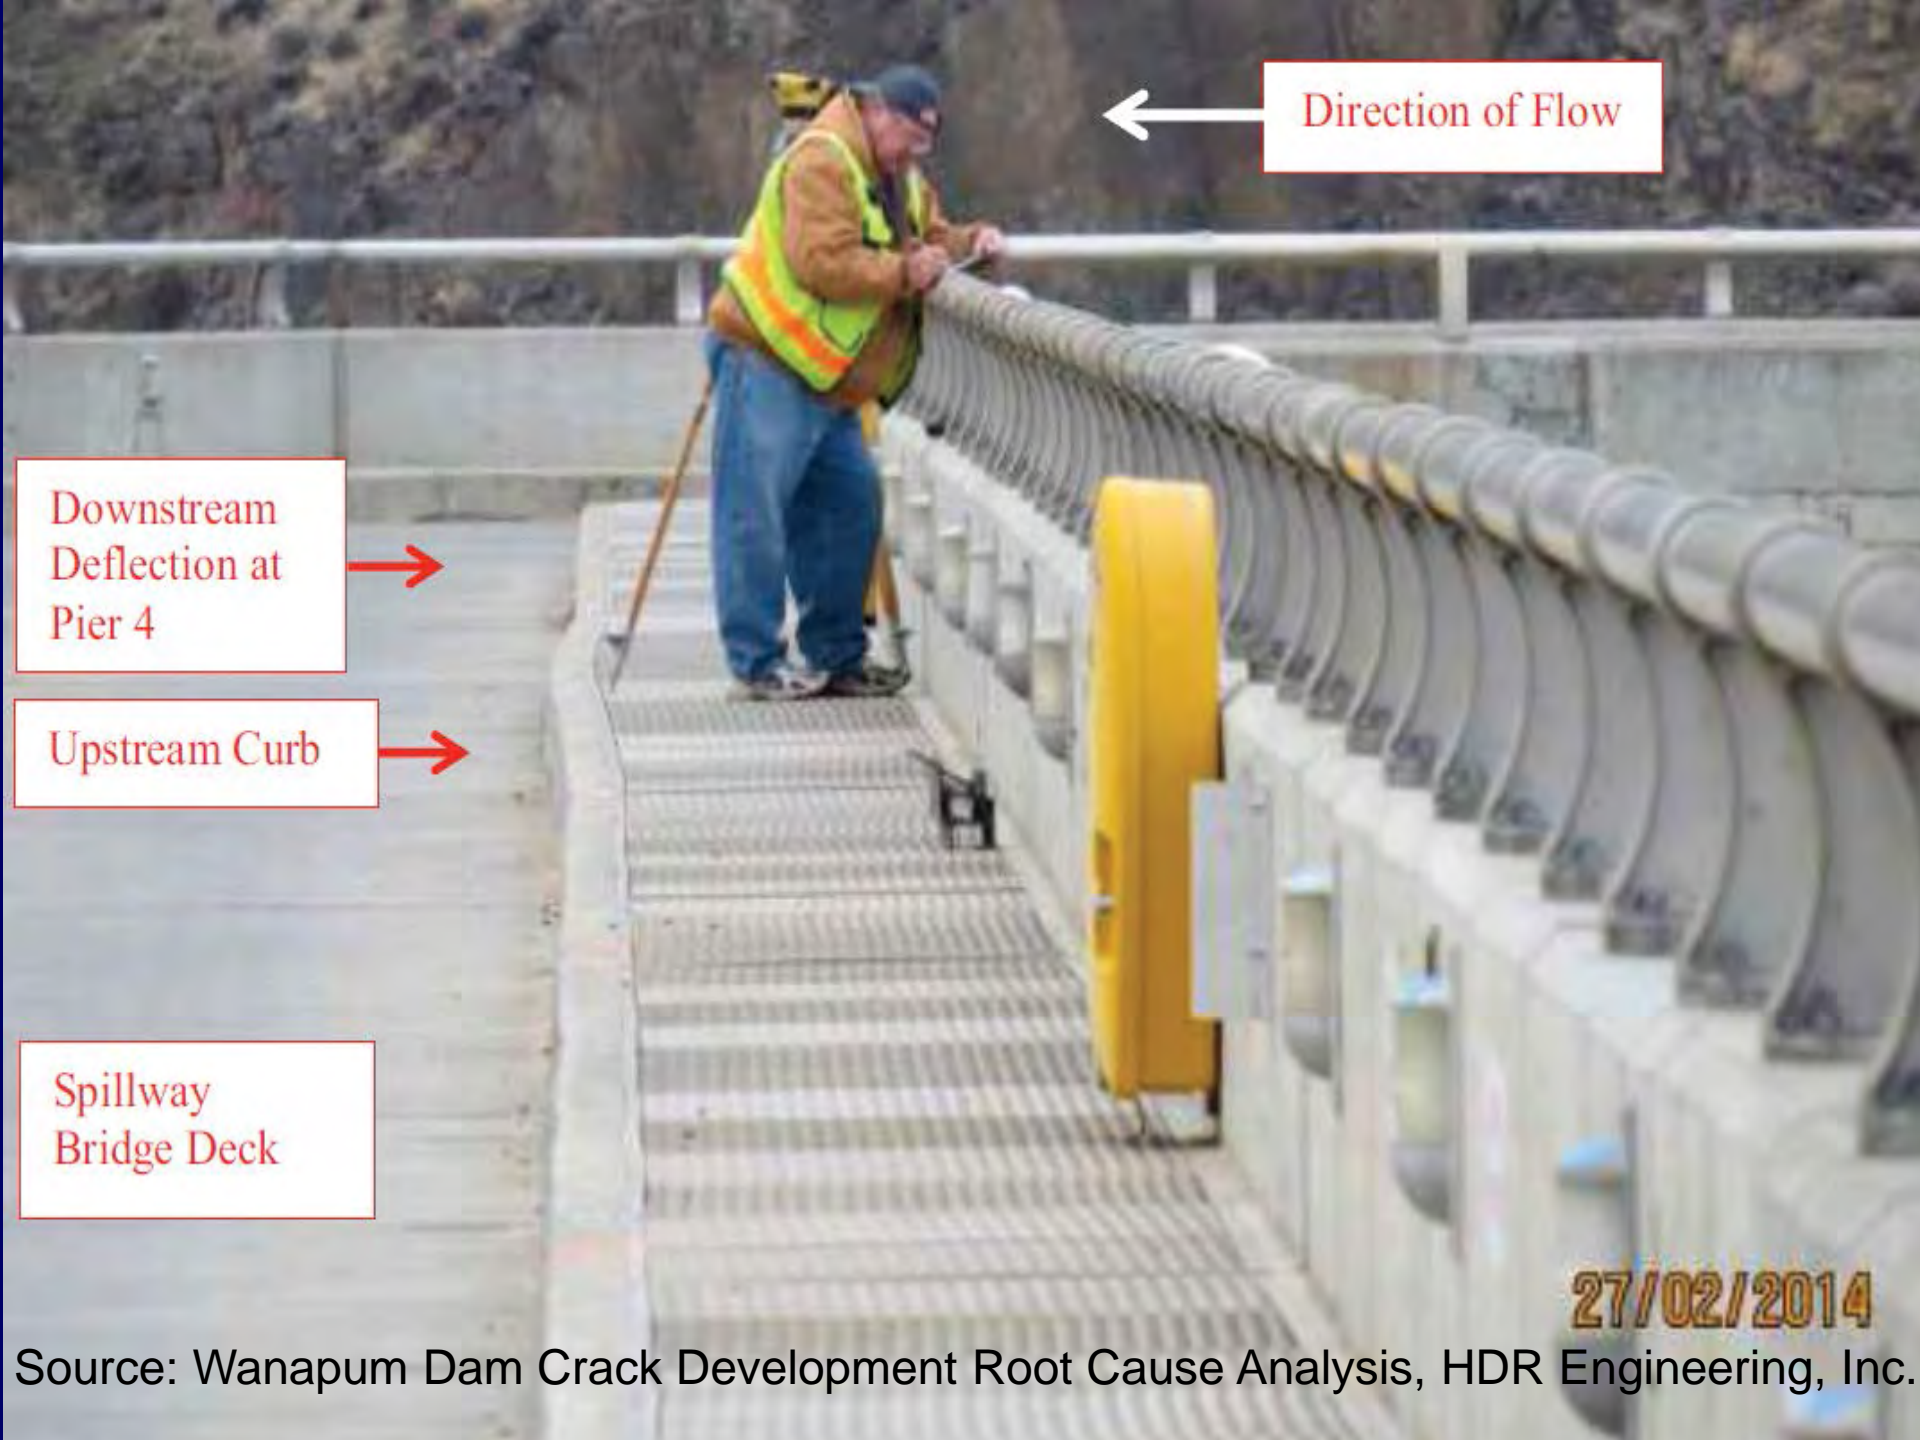
Wanapum Dam

→ Downstream Deflection at Pier 4

→ Upstream Curb
